Section 6

Watershed Plan Structural Actions

6.1 Introduction

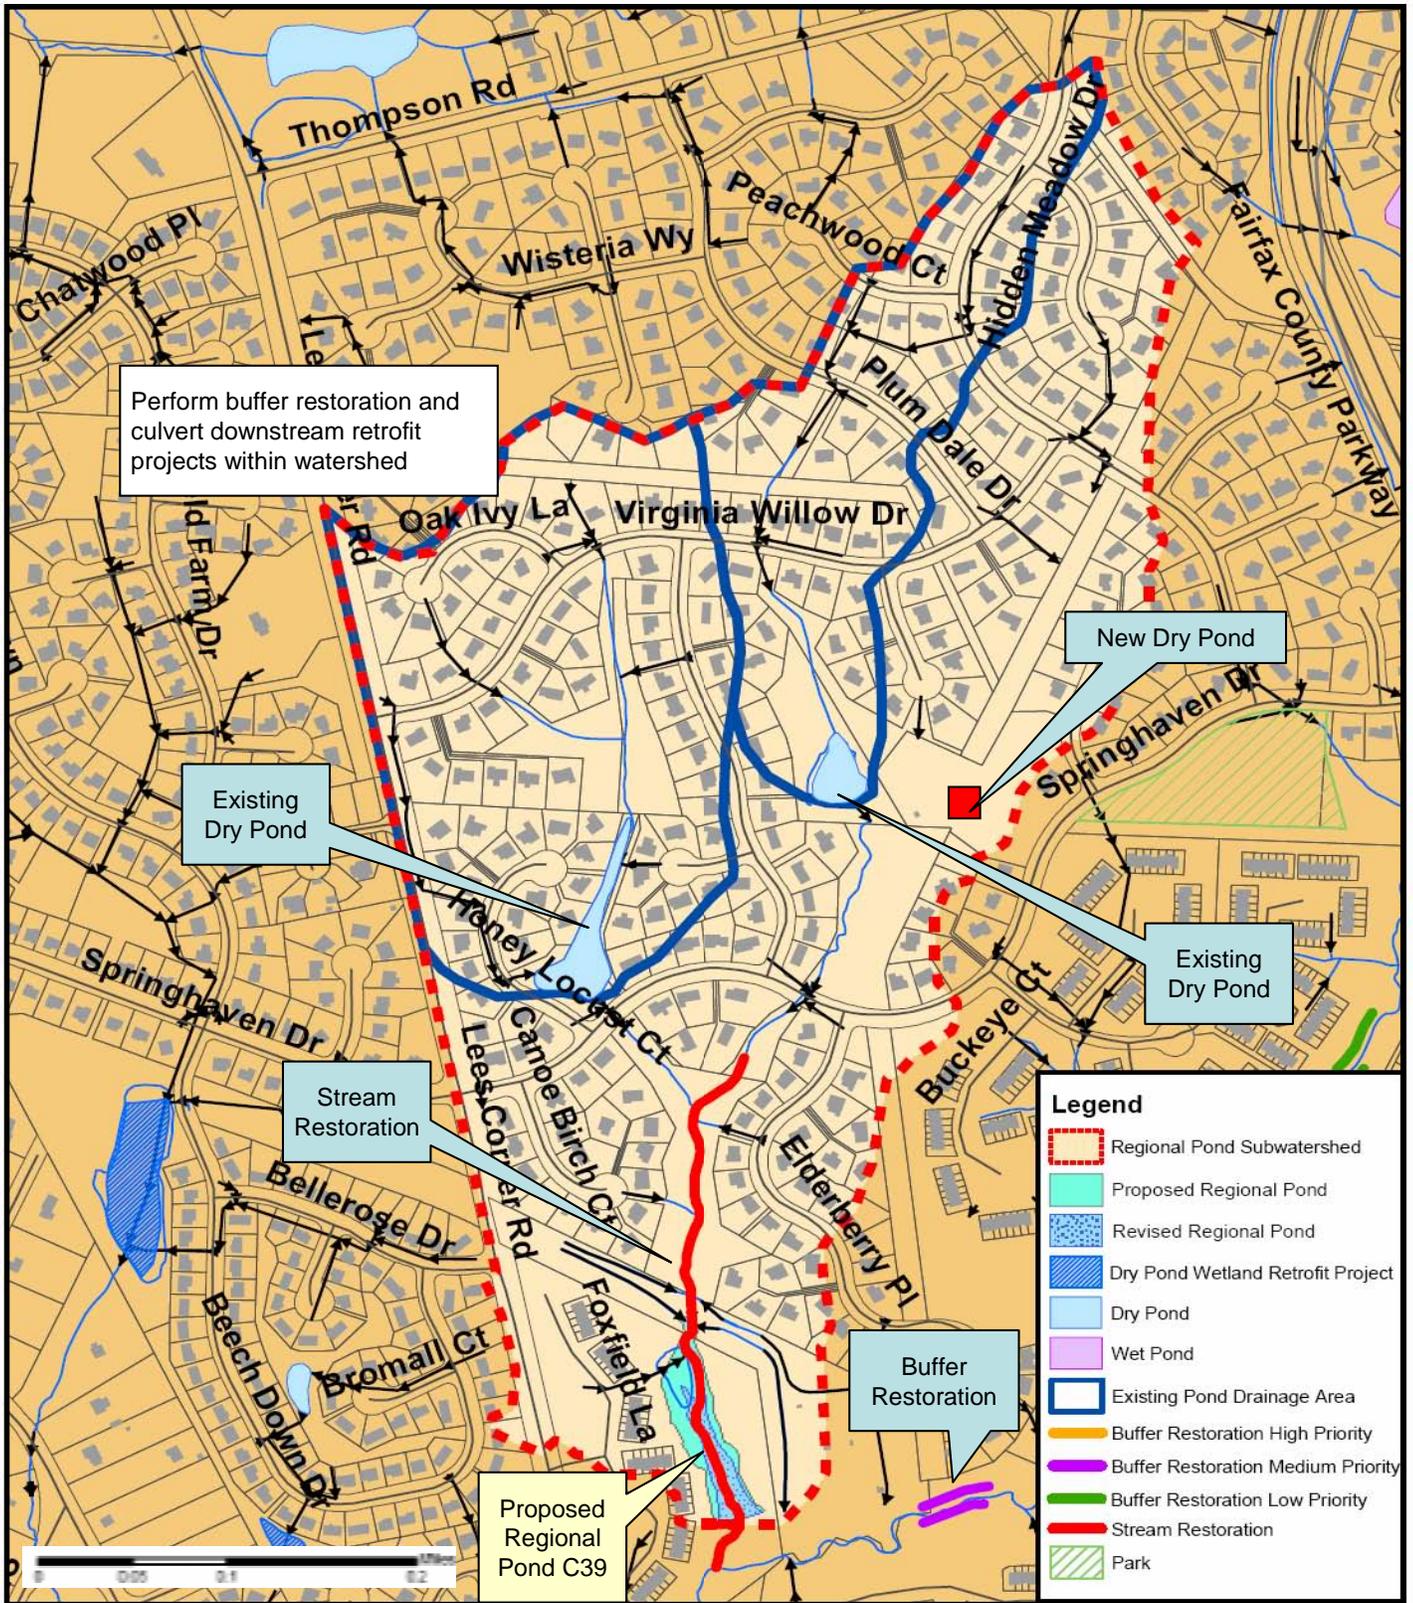
Figure 6-12
Proposed Regional Pond C39

The stream on which this pond is located is included in a stream restoration project due to the low stream-bank stability scores. Field reconnaissance indicates no active stream erosion.

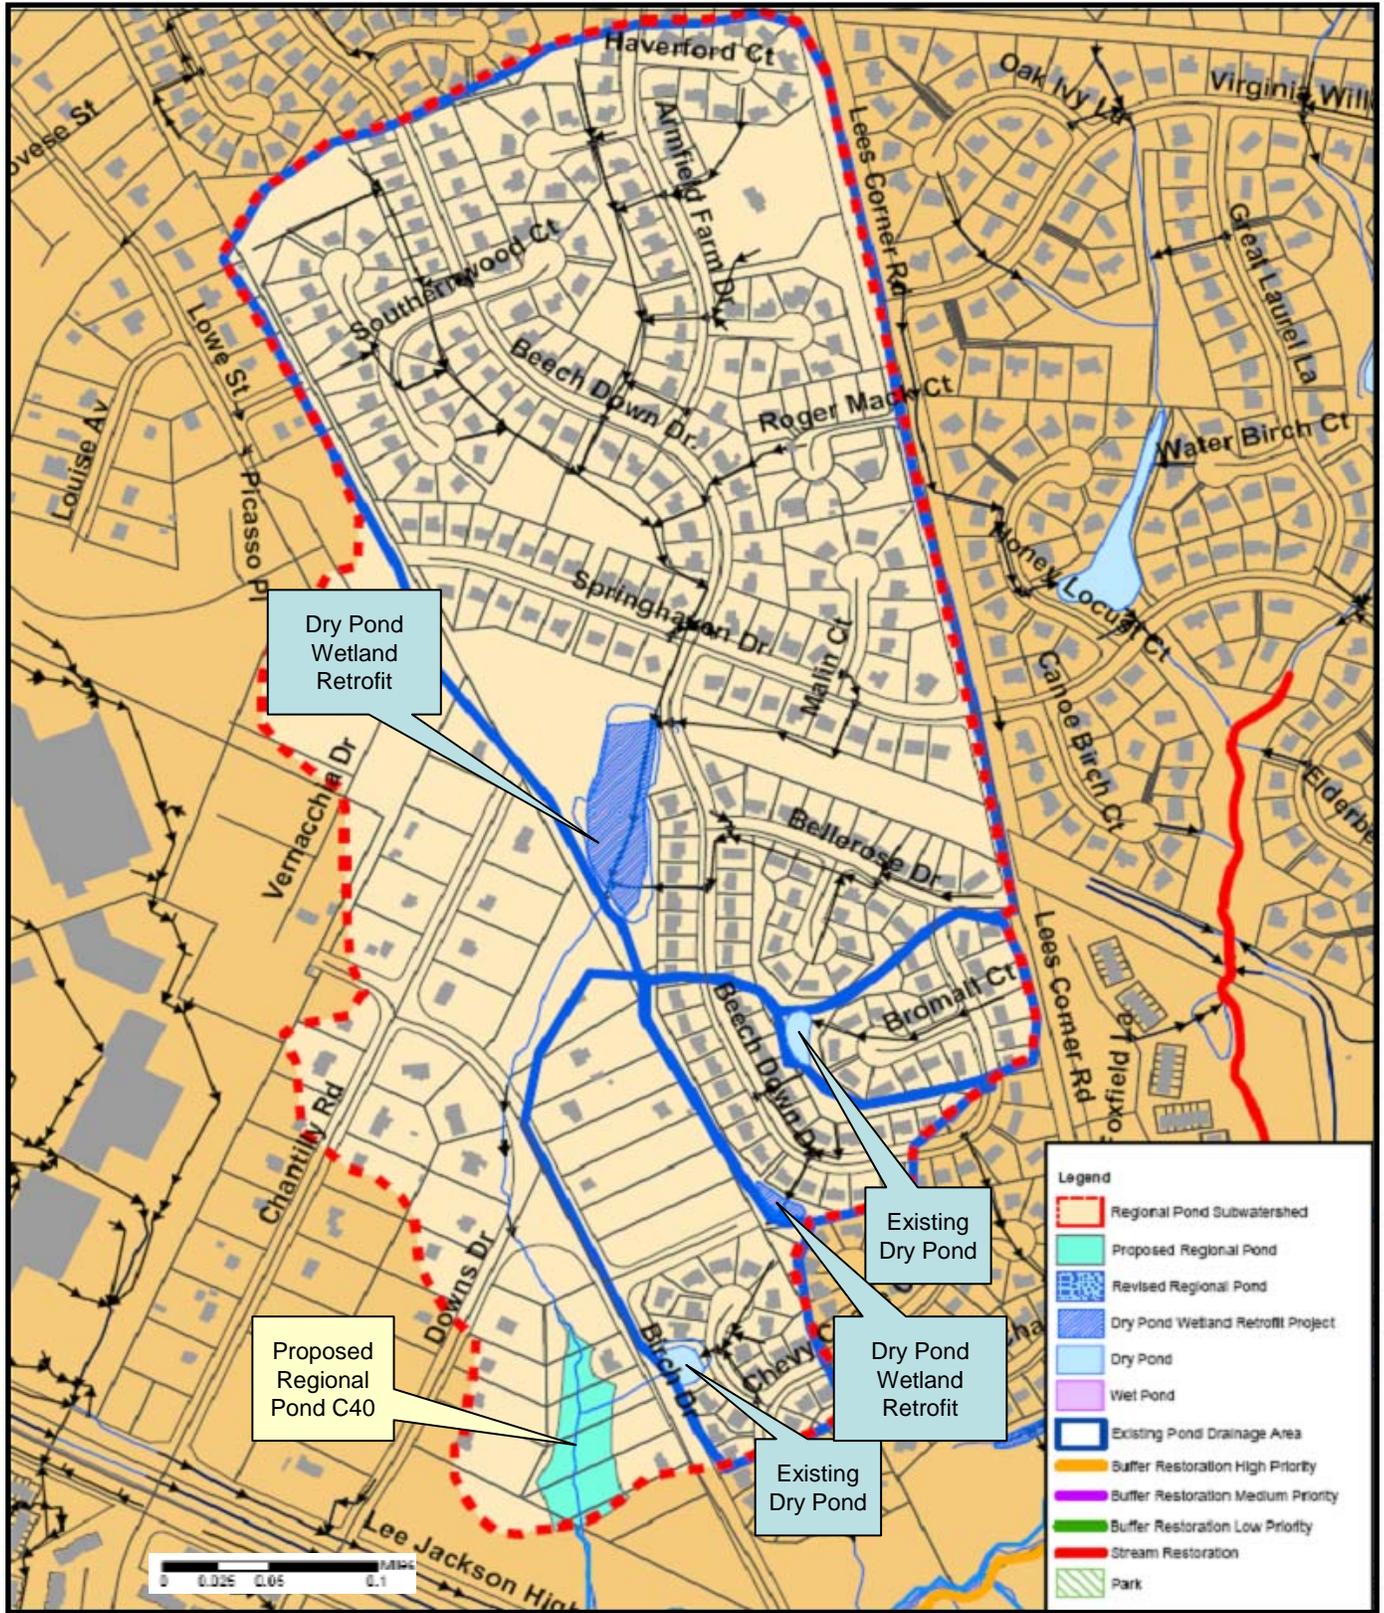
Figure 6-13
Proposed Regional Pond C40

The proposed pond removes 43 pounds of phosphorus per year as shown in Table 6-23. Construction of a regional pond with sufficient storage to provide stormwater benefits is not feasible commensurate with both the cost of constructing this facility and the impacts on nearby residences and private property.

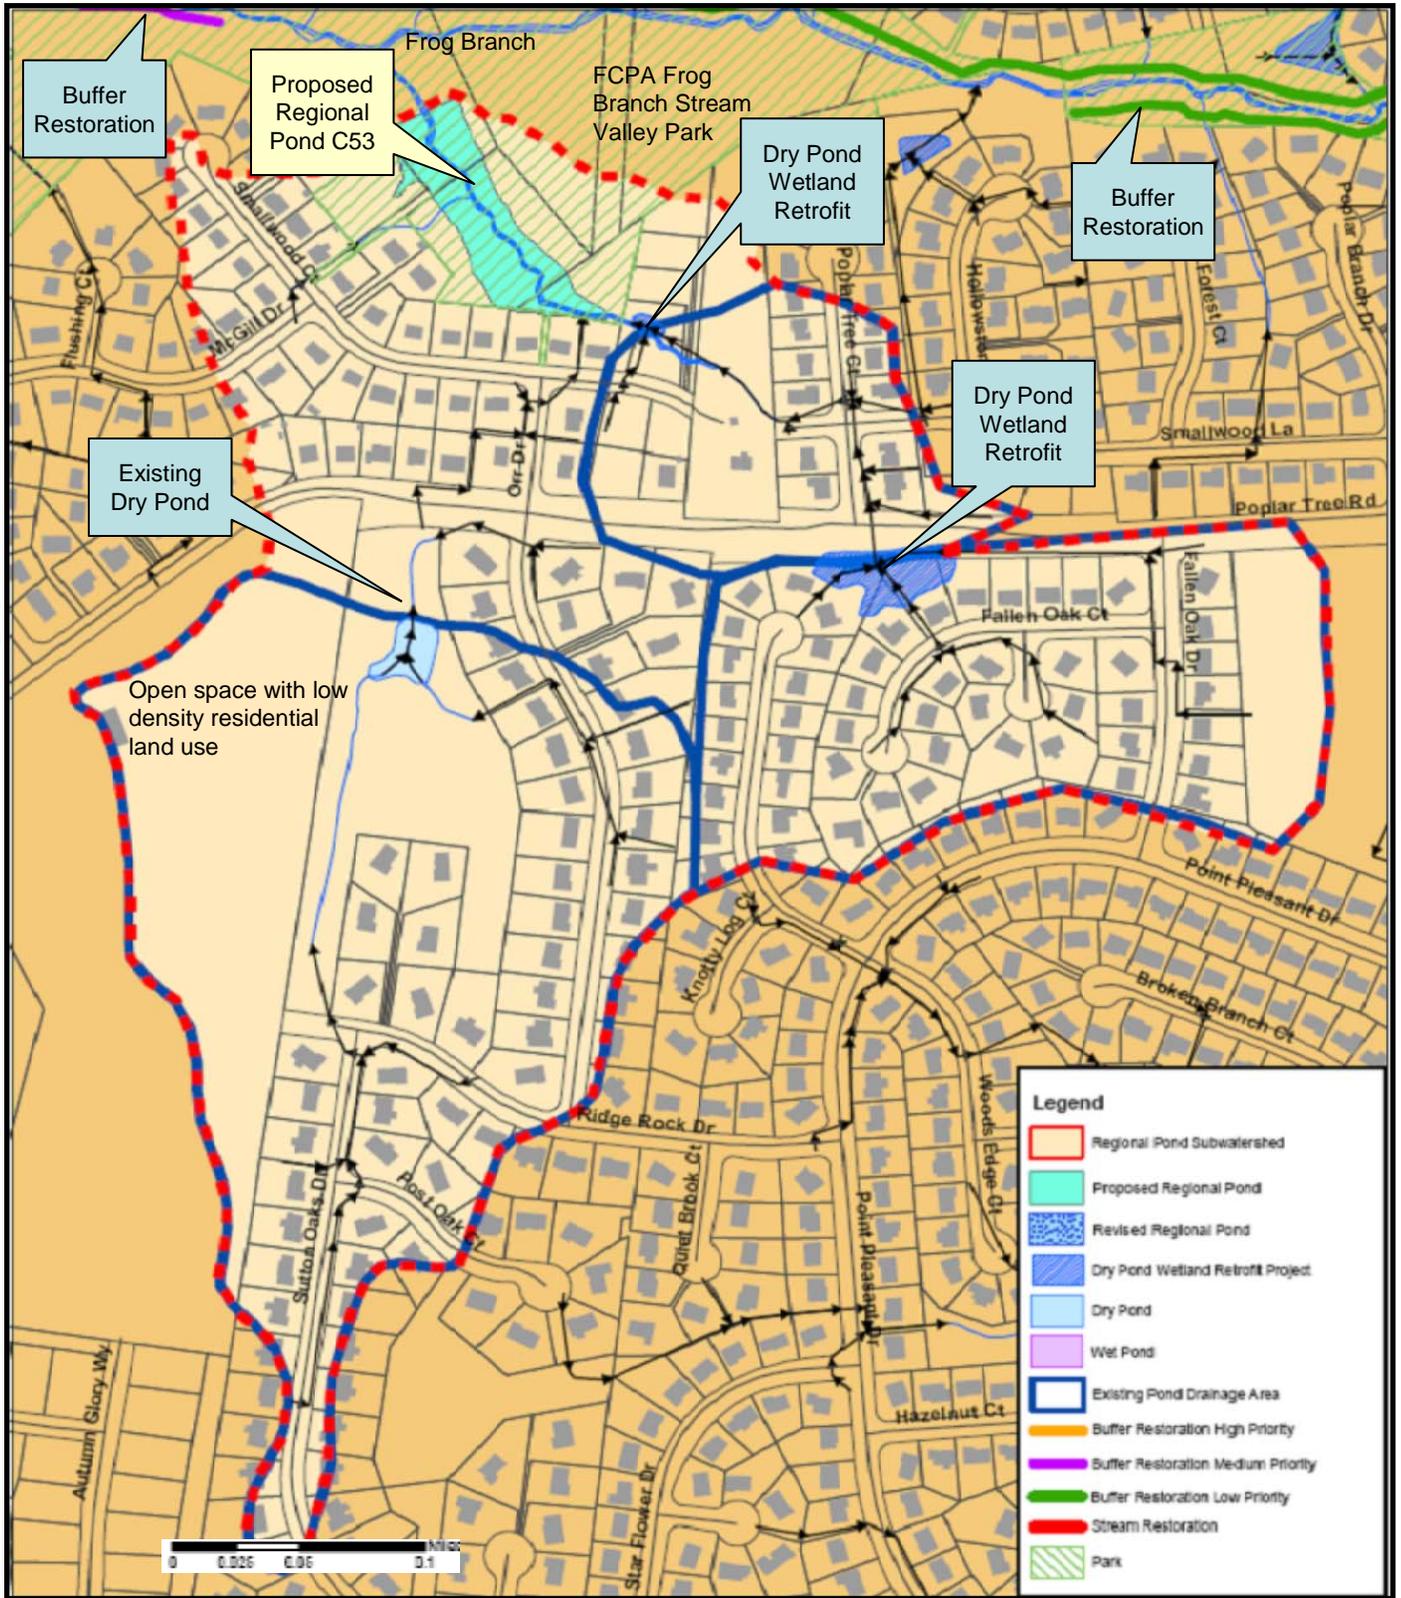
Figure 6-14
Proposed Regional Pond C53

The map in Figure 6-14 and data in Table 6-24 provides an overview of the conditions within the proposed regional pond watershed. These include the existing stormwater facilities and watershed plan structural projects.

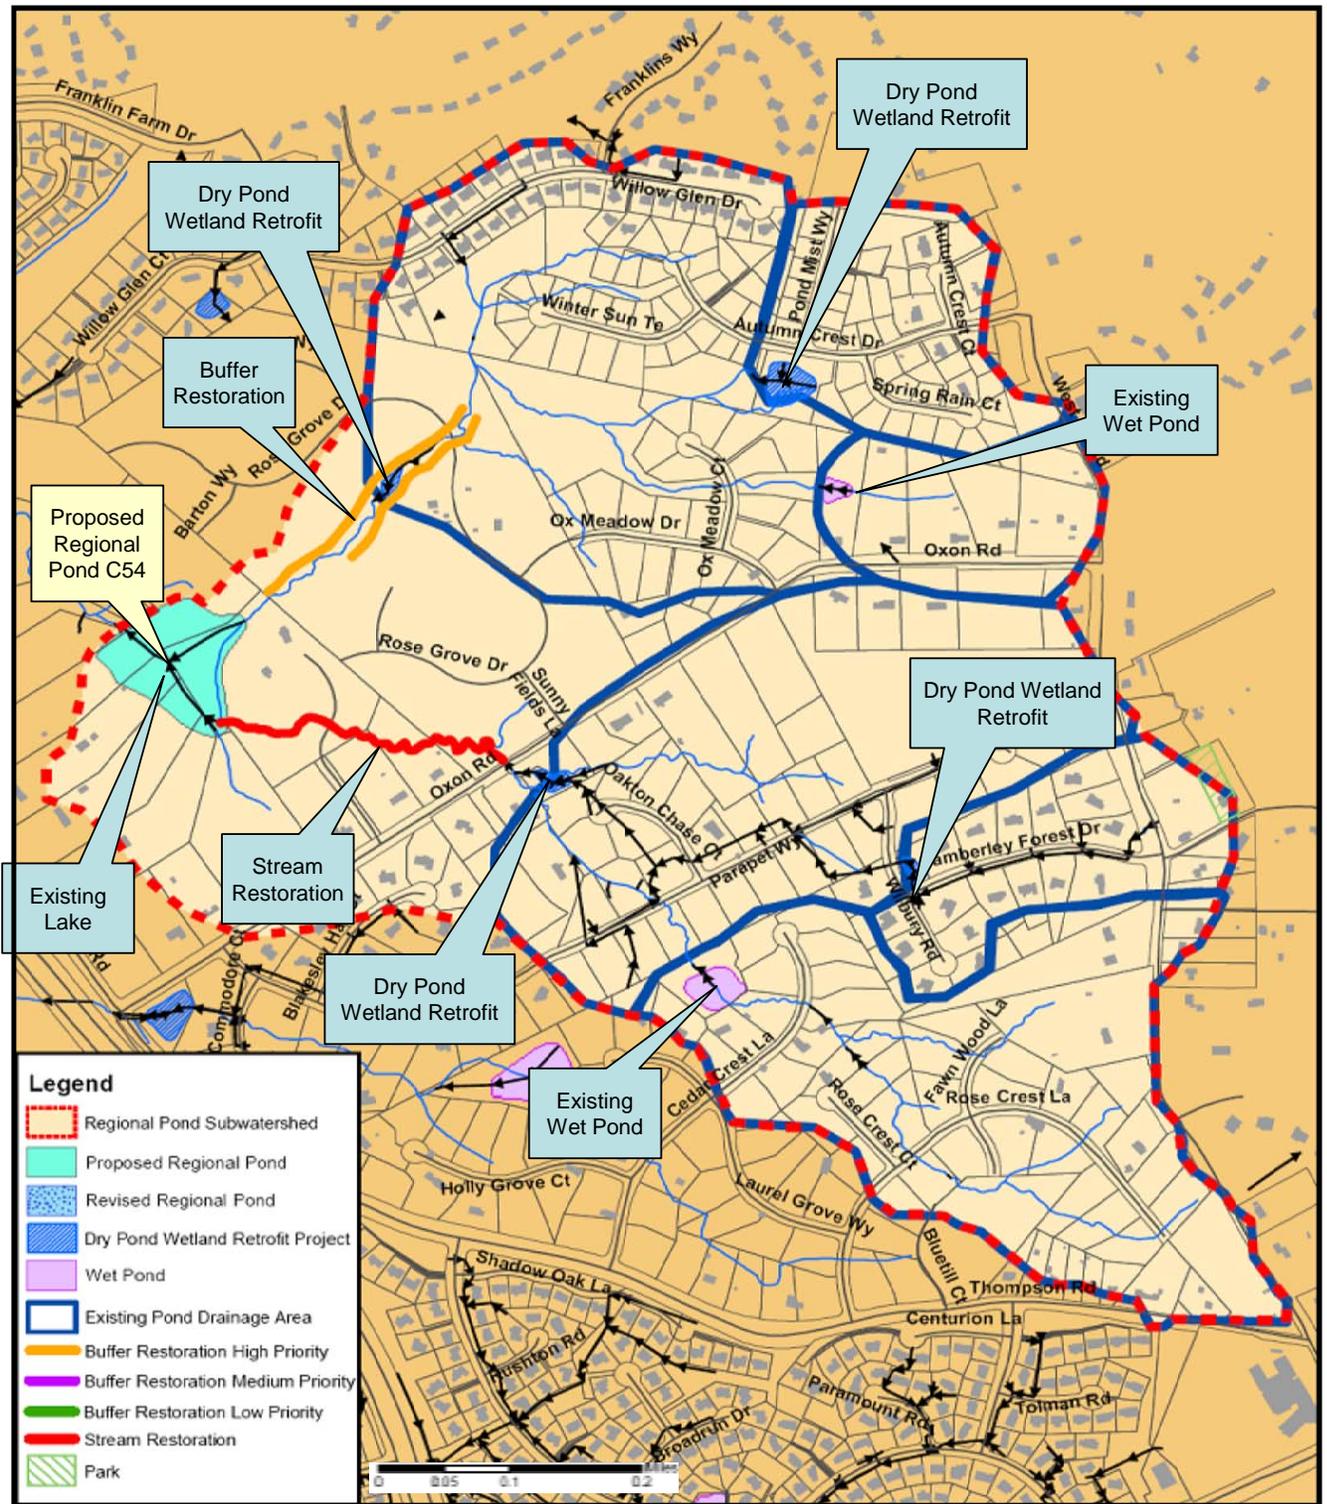
Figure 6-15
Proposed Regional Pond C54

The existing development near the pond is large-lot, single-family residential but has a planned land use of low-density residential. These sites will likely be developed at the higher planned density. In fact, many of these large lots have been developed as this study progressed.

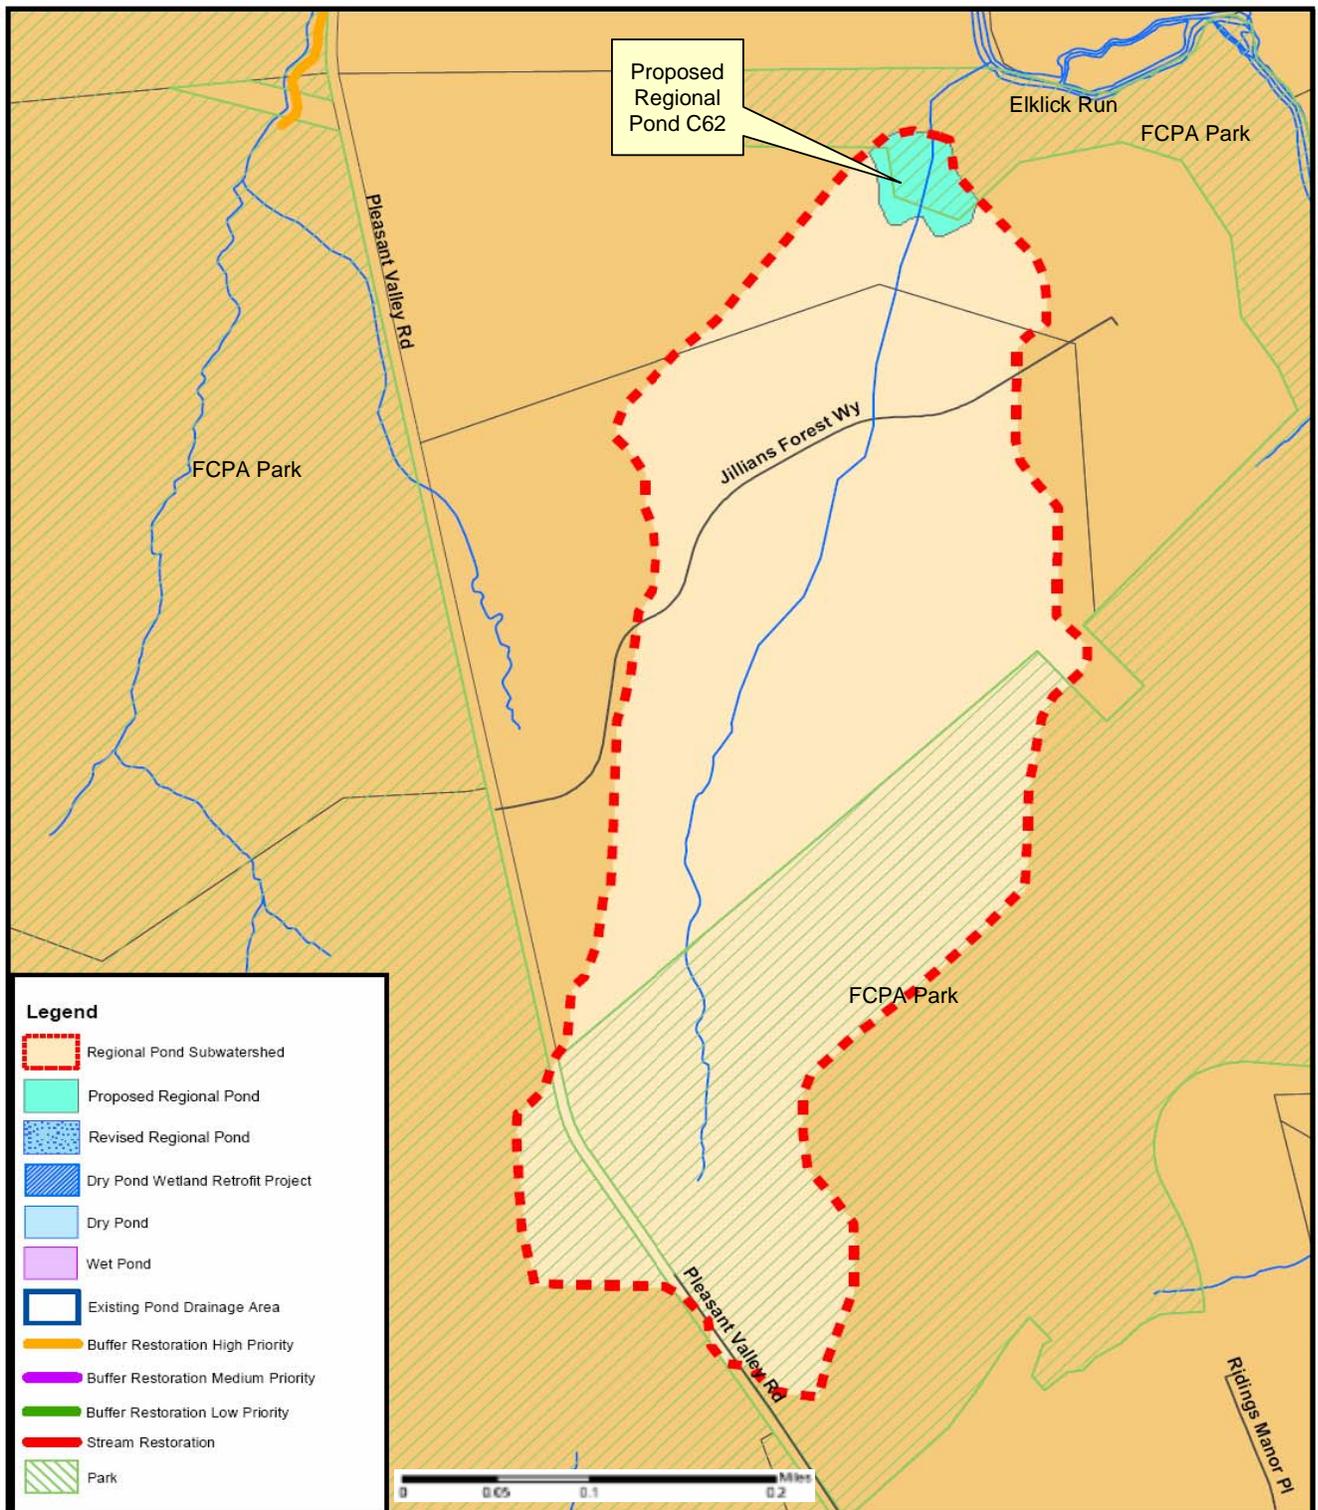
Figure 6-16
Proposed Regional Pond C62

No stormwater controls exist in the undeveloped watershed, and there is no opportunity or need for alternative ones.

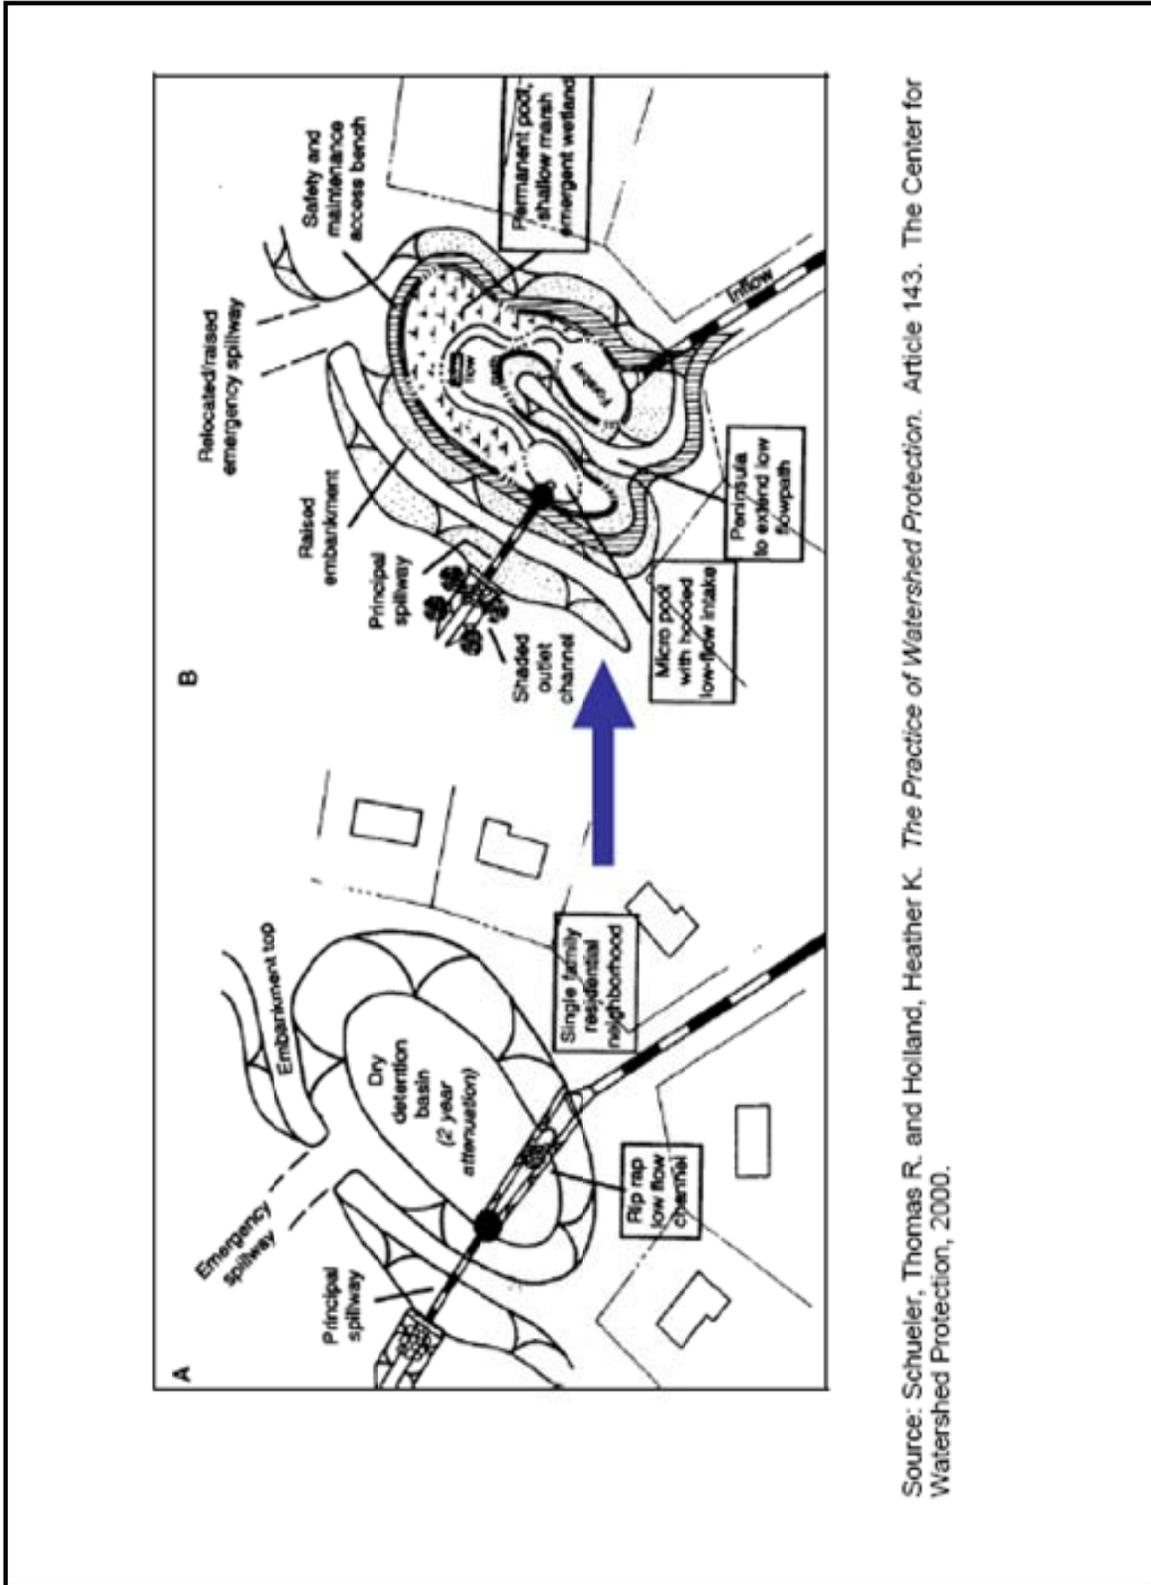
Figure 6-17
Dry Pond Wetland Bottom Retrofit

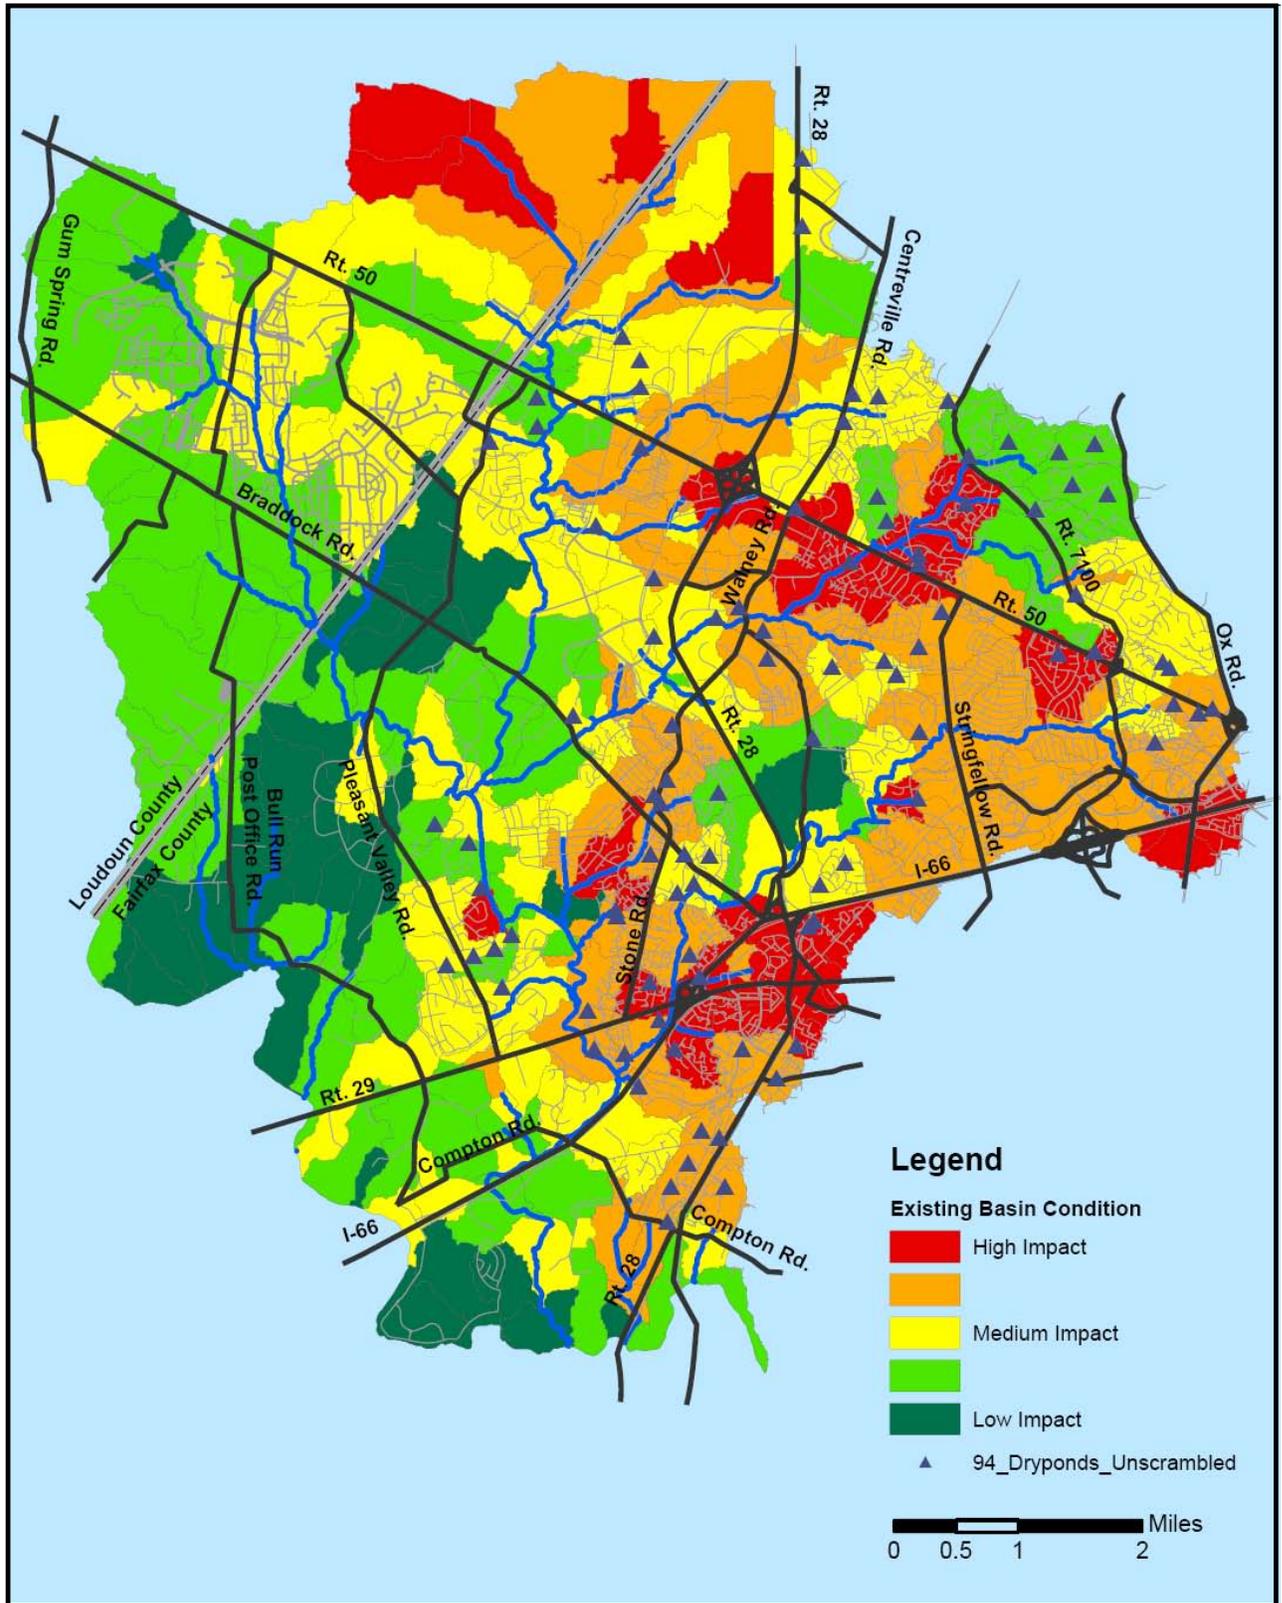
Figure 6-18
Dry Pond Wetland Retrofit Project Locations

Figure 6-18 shows the general location of the 94 dry pond retrofit projects in the watershed plan. Figures presented at the end of this section provide additional details on the location of the ponds within the major subwatersheds.

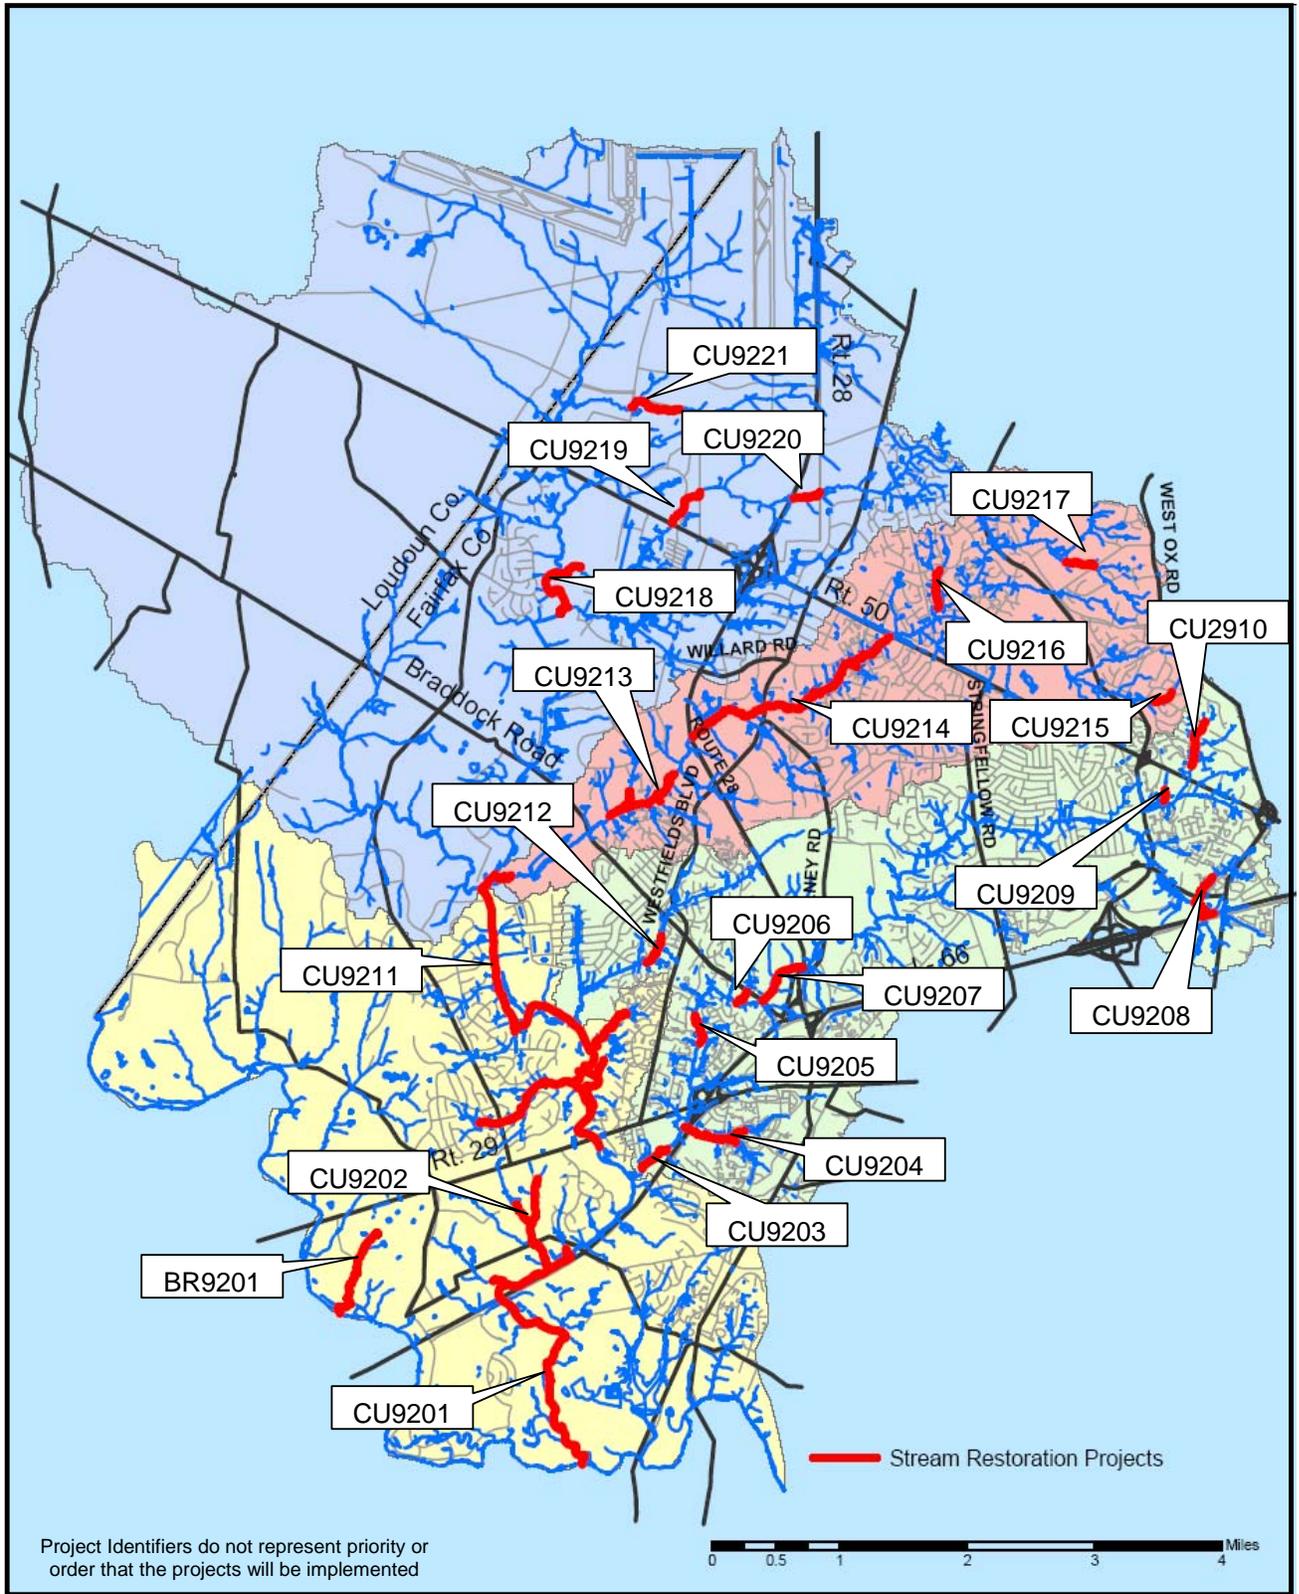
Figure 6-20
Location of Stream Restoration Projects in the
Cub Run and Bull Run Watersheds

* Projects are provided a priority rating score that varies from 1 to 10 based on the severity of the existing stream erosion. A 10 is a high priority restoration reach and 1 is a low priority restoration reach. The priority rating score does not indicate the implementation order.

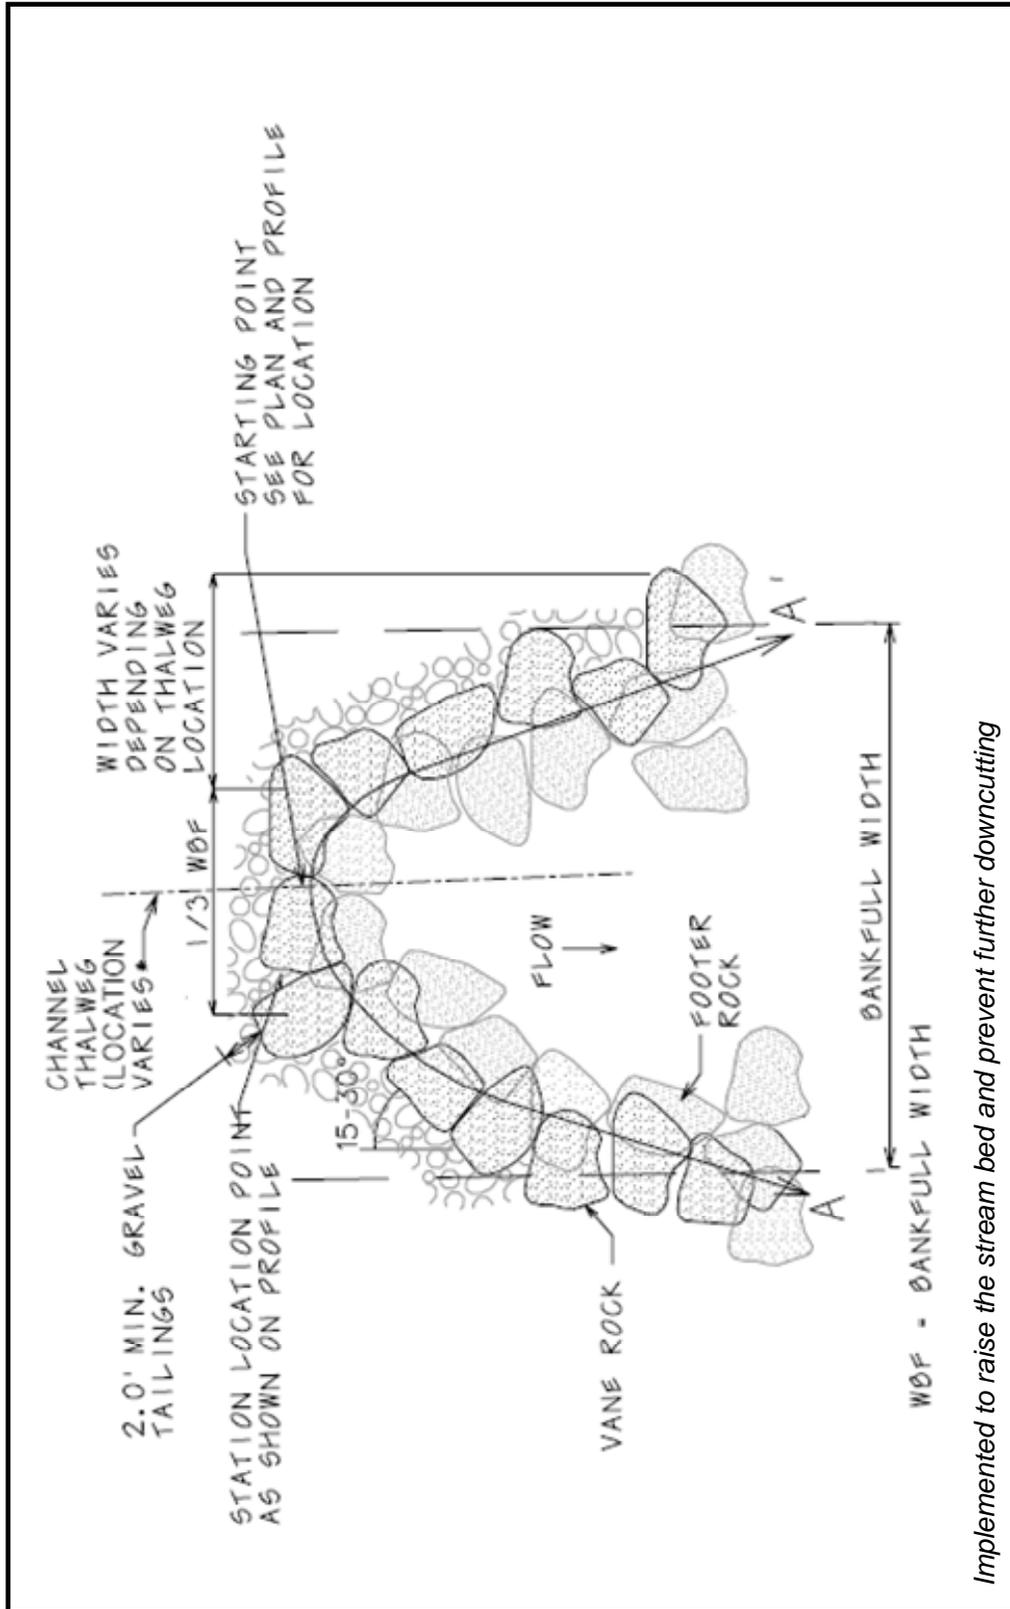
Channel incision will be addressed using grade control structures to create a barrier to down-cutting and riffle aggradation structures, to accumulate bed load and raise the invert of the stream channel. This will connect the streams to the floodplain and rejuvenate wetland systems. The restoration will recognize road culvert and utility crossings elevations, maintain or enhance higher-quality pool classes, and establish high value riffle, run and/or glide habitats. These measures control future down-cutting and restore the streams' connection to the floodplain without significant tree removal or floodplain excavation. Controlling the grade at one location will prevent further down-cutting and promote sediment deposition in upstream reaches while reducing sediment transport to downstream reaches. Grade control structures will likely be incorporated with other modifications to improve riparian buffer, control bank erosion, address channelization and restore/enhance instream habitat. Figures 6-21 and 6-22 provide typical construction details for grade control structures.

Figure 6-21
Rock Cross Vane Plan View

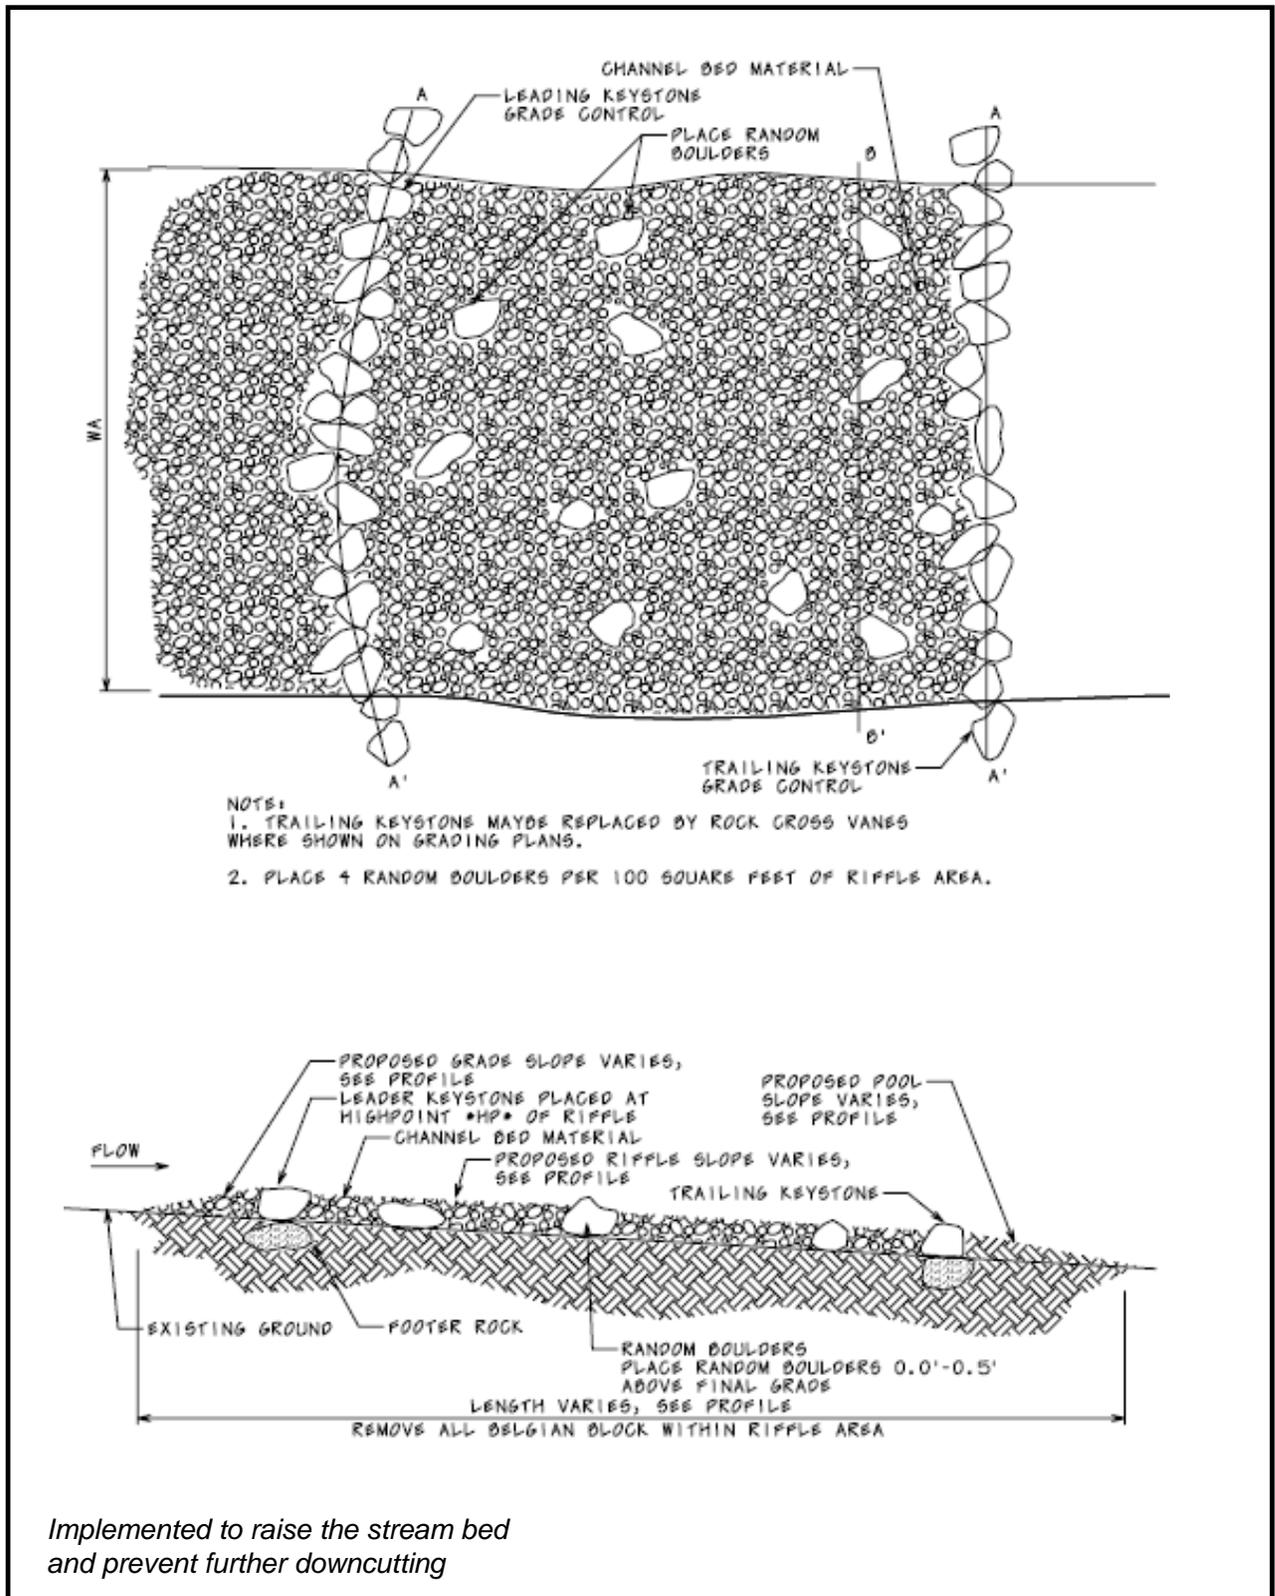
Figure 6-22
Plan and Profile Riffle Structure
Used to Control Channel Incision

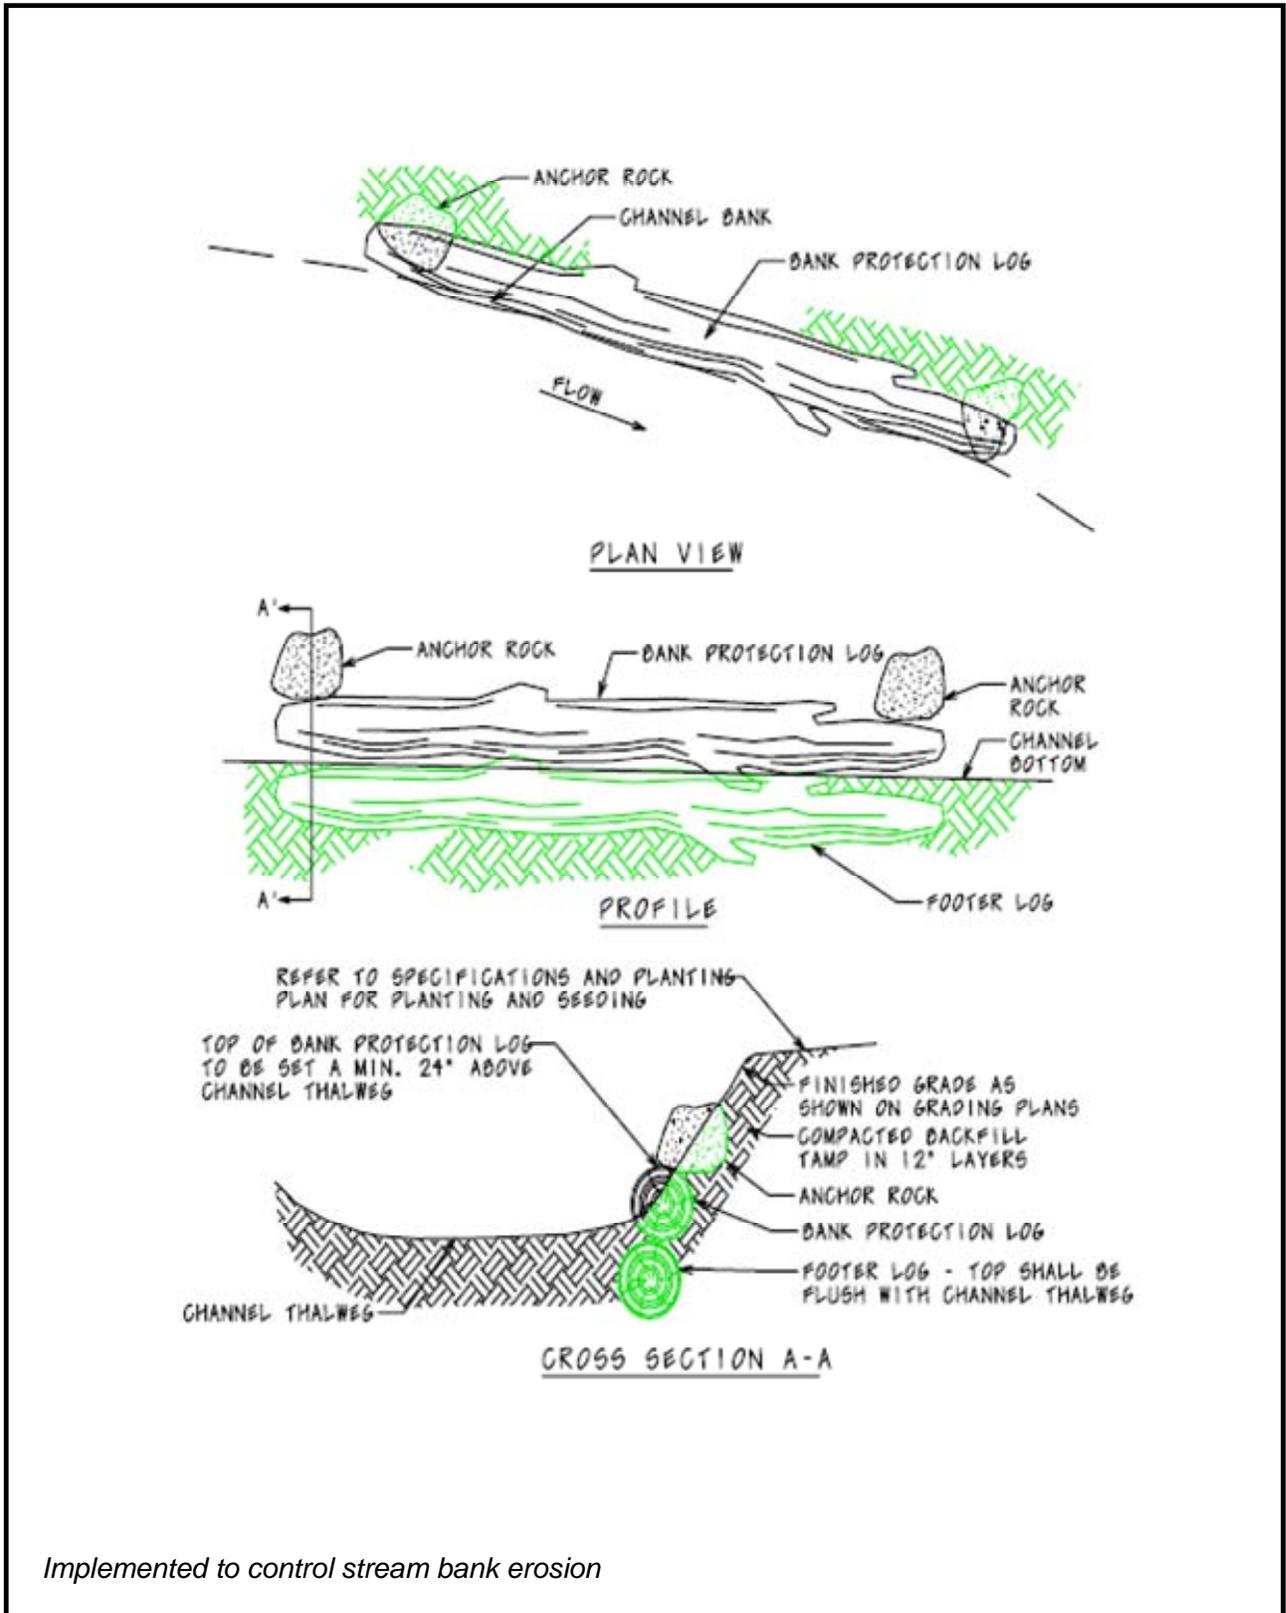
Implemented to control stream bank erosion

Figure 6-23
Plan and Profile Riffle of Log Bank Protection
