Section 6

Watershed Plan Structural Actions

6.1 Introduction

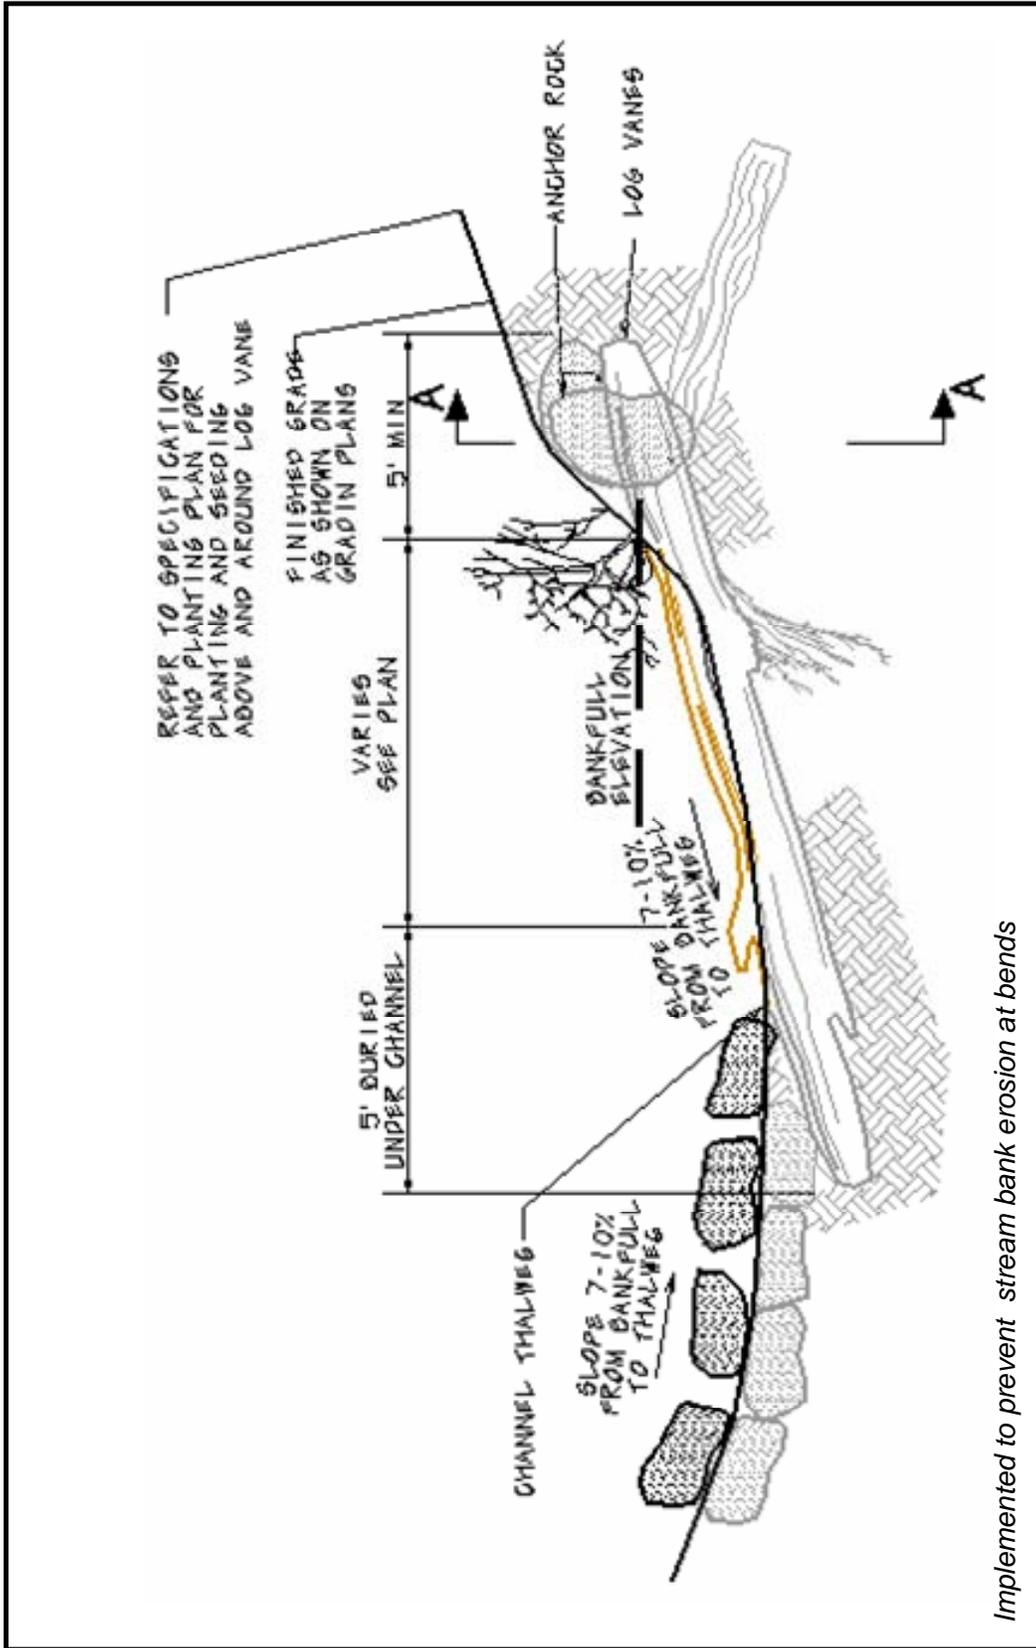
Figure 6-25
Root Wad/Log "J" Hood Vane Profile

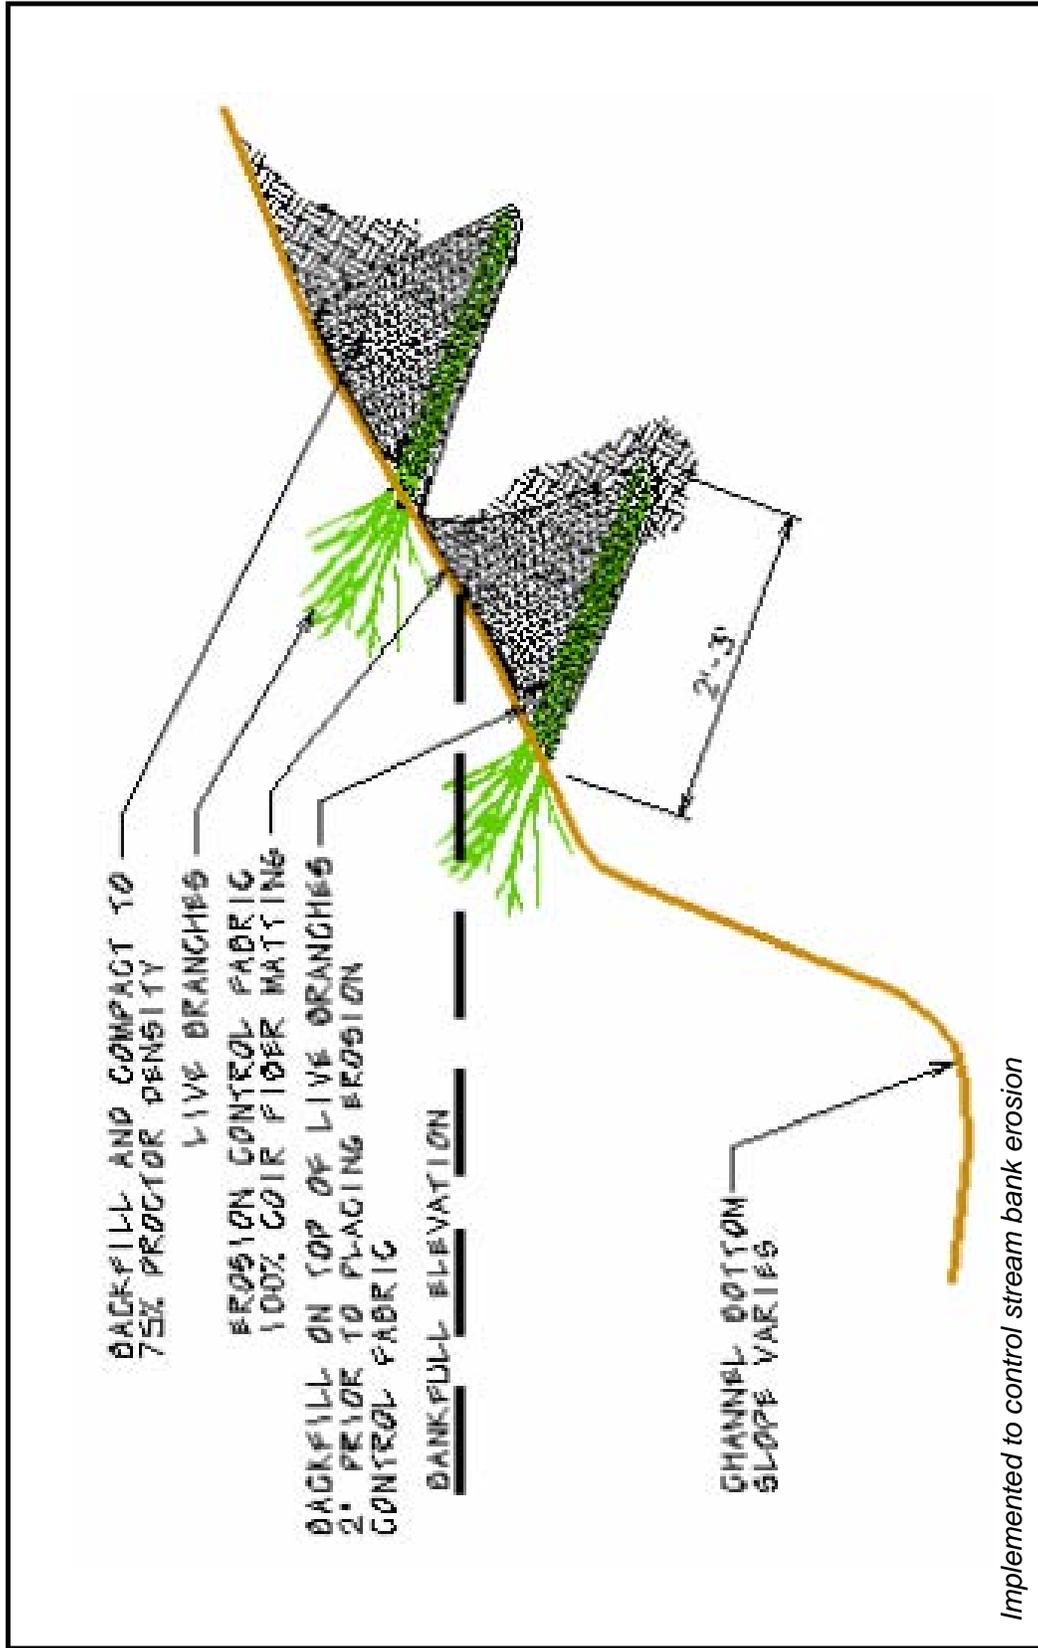
Figure 6-26
Live Branch Layering Cross Section

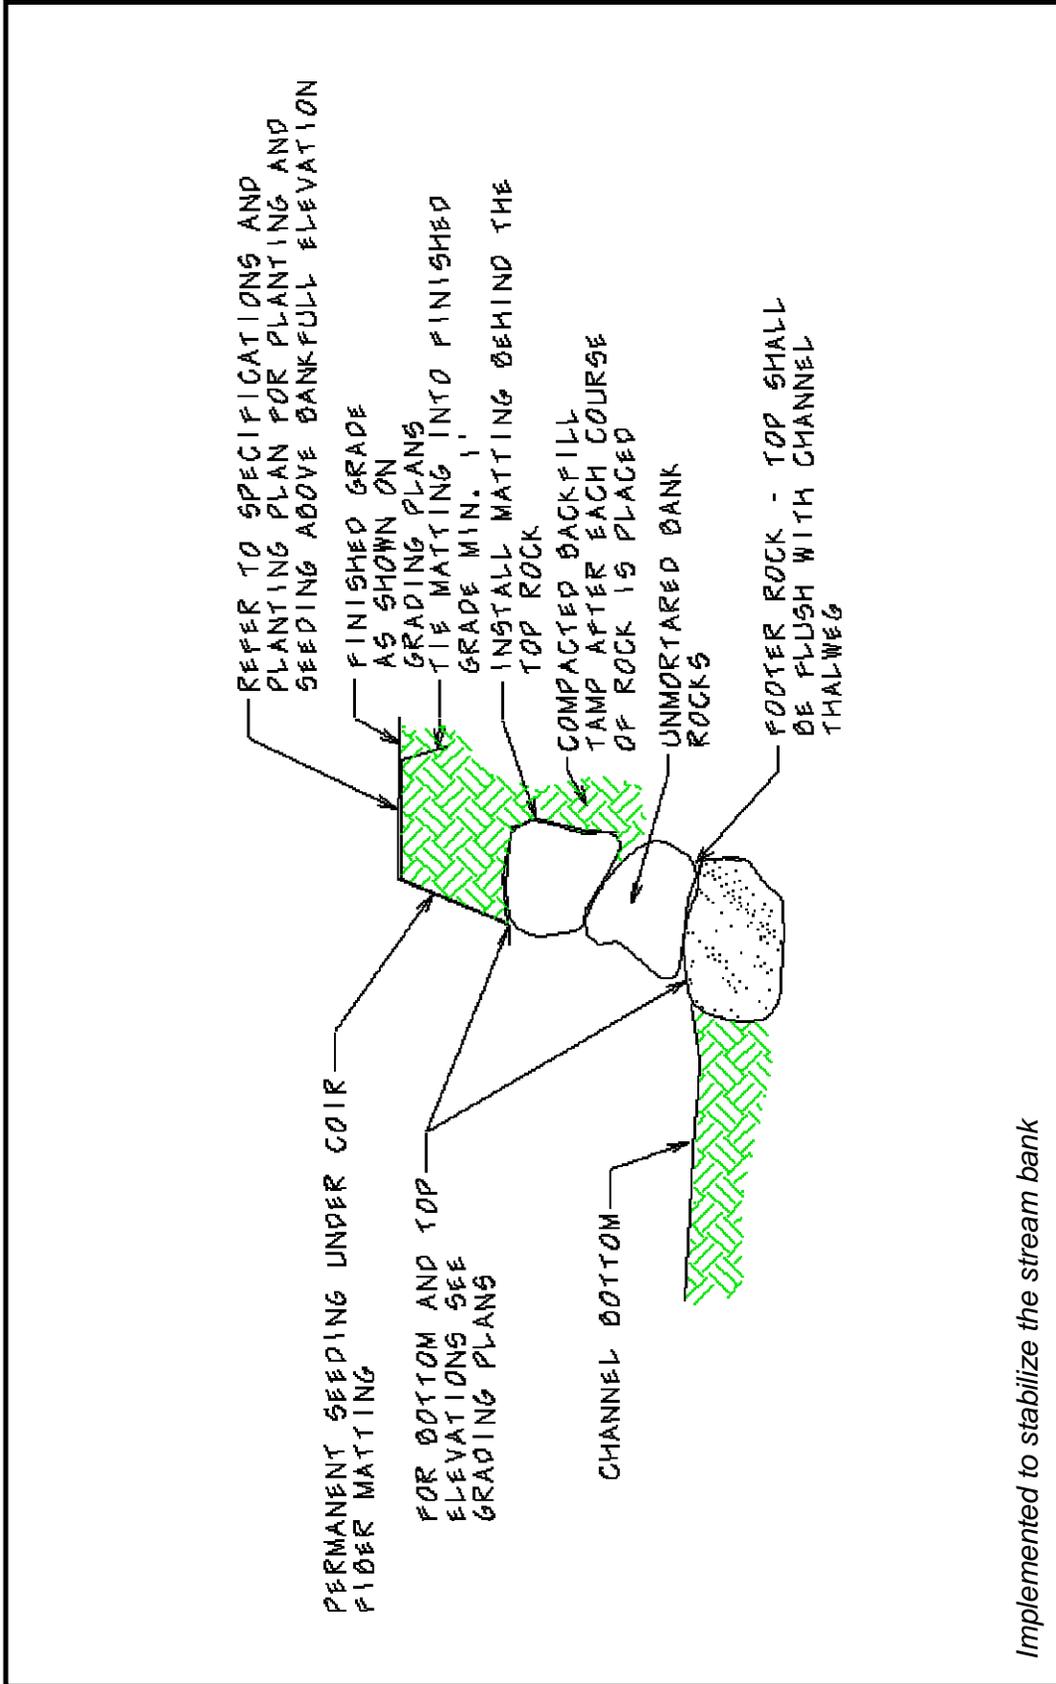
Figure 6-27
Boulder Bank Stabilization Section

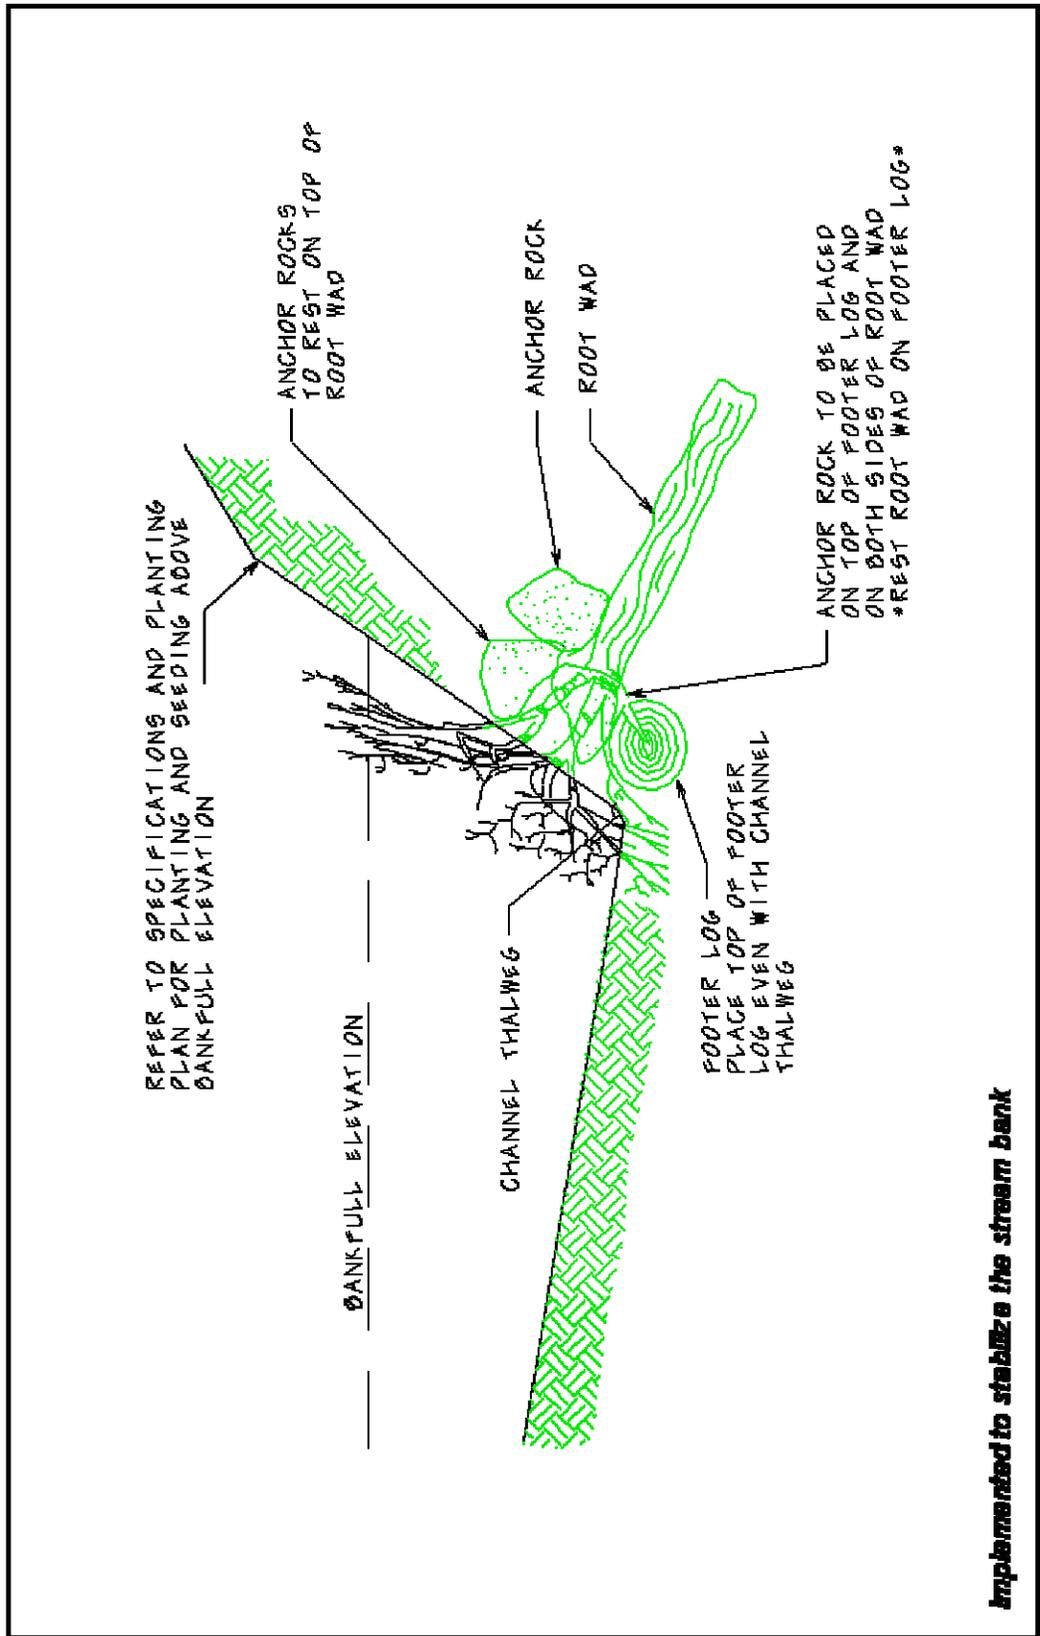
Figure 6-28
Root Wad Revetment Stream Bank Protection

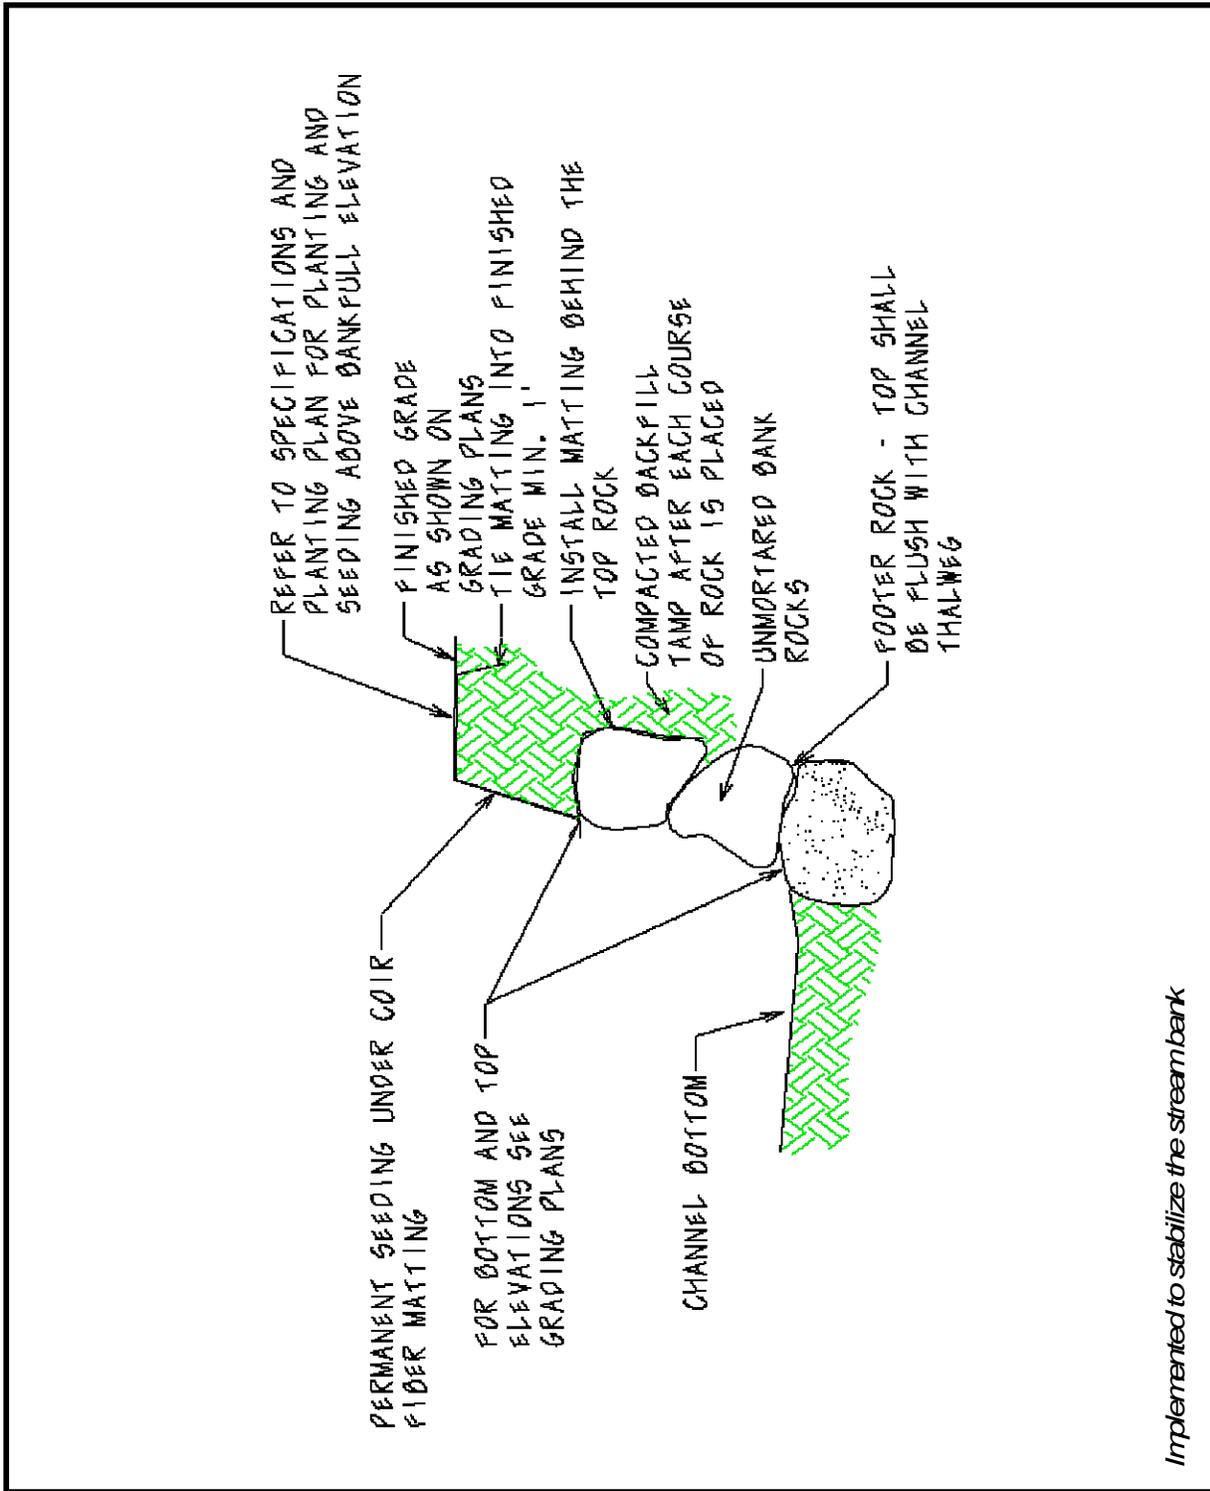
Figure 6-29
Live Branch Layering Combined with
Boulder Toe Stabilization Cross Section

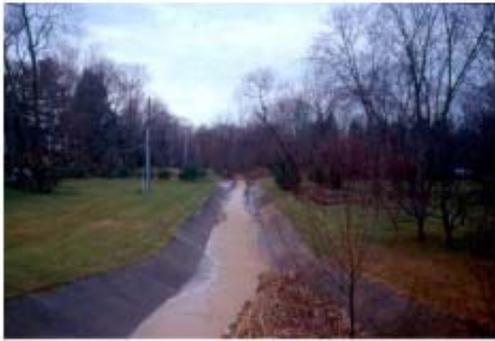
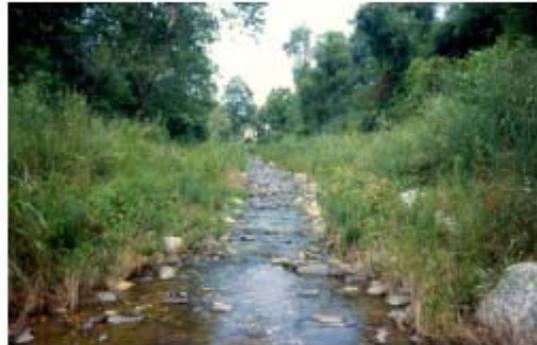
**Spring Branch Stream
Restoration**

Before Restoration

After Restoration

Figure 6-30
Photographs of Streams Before and After Restoration

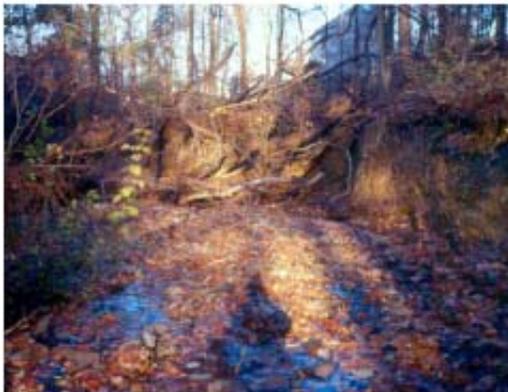
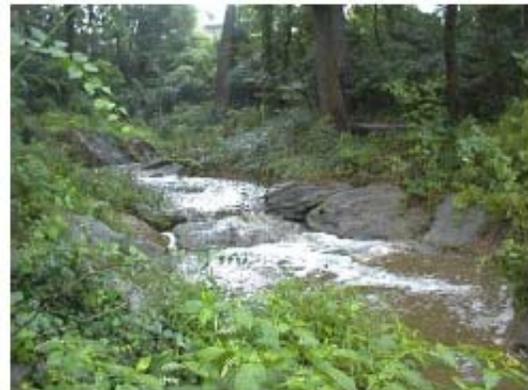
**Minebank Run Stream
Restoration**

Before Restoration

After Restoration

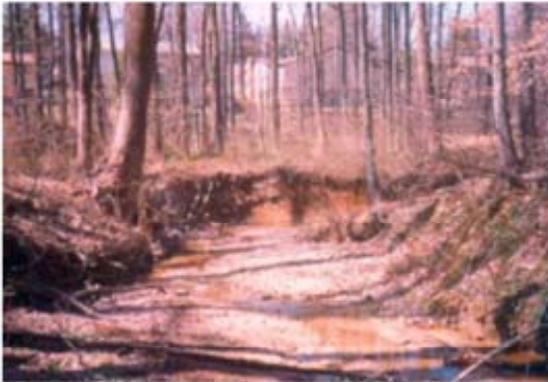
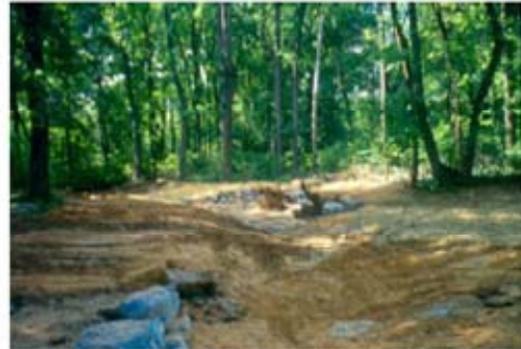
**Kingwood Stream
Restoration**

Before Restoration

After Restoration

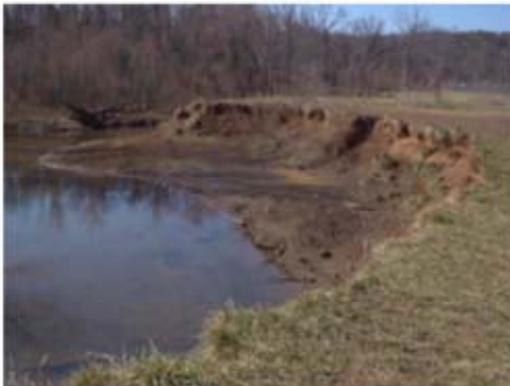
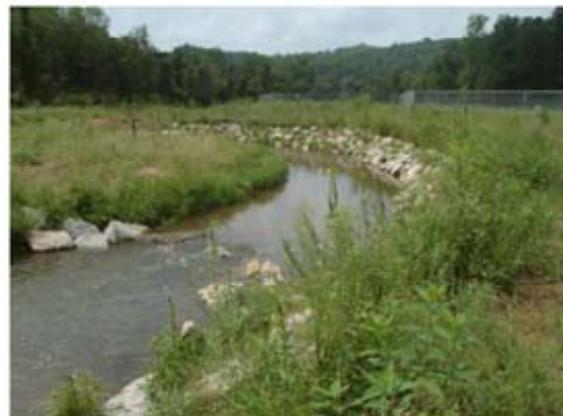
**Moore's Creek Stream
Restoration**

Before Restoration

After Restoration

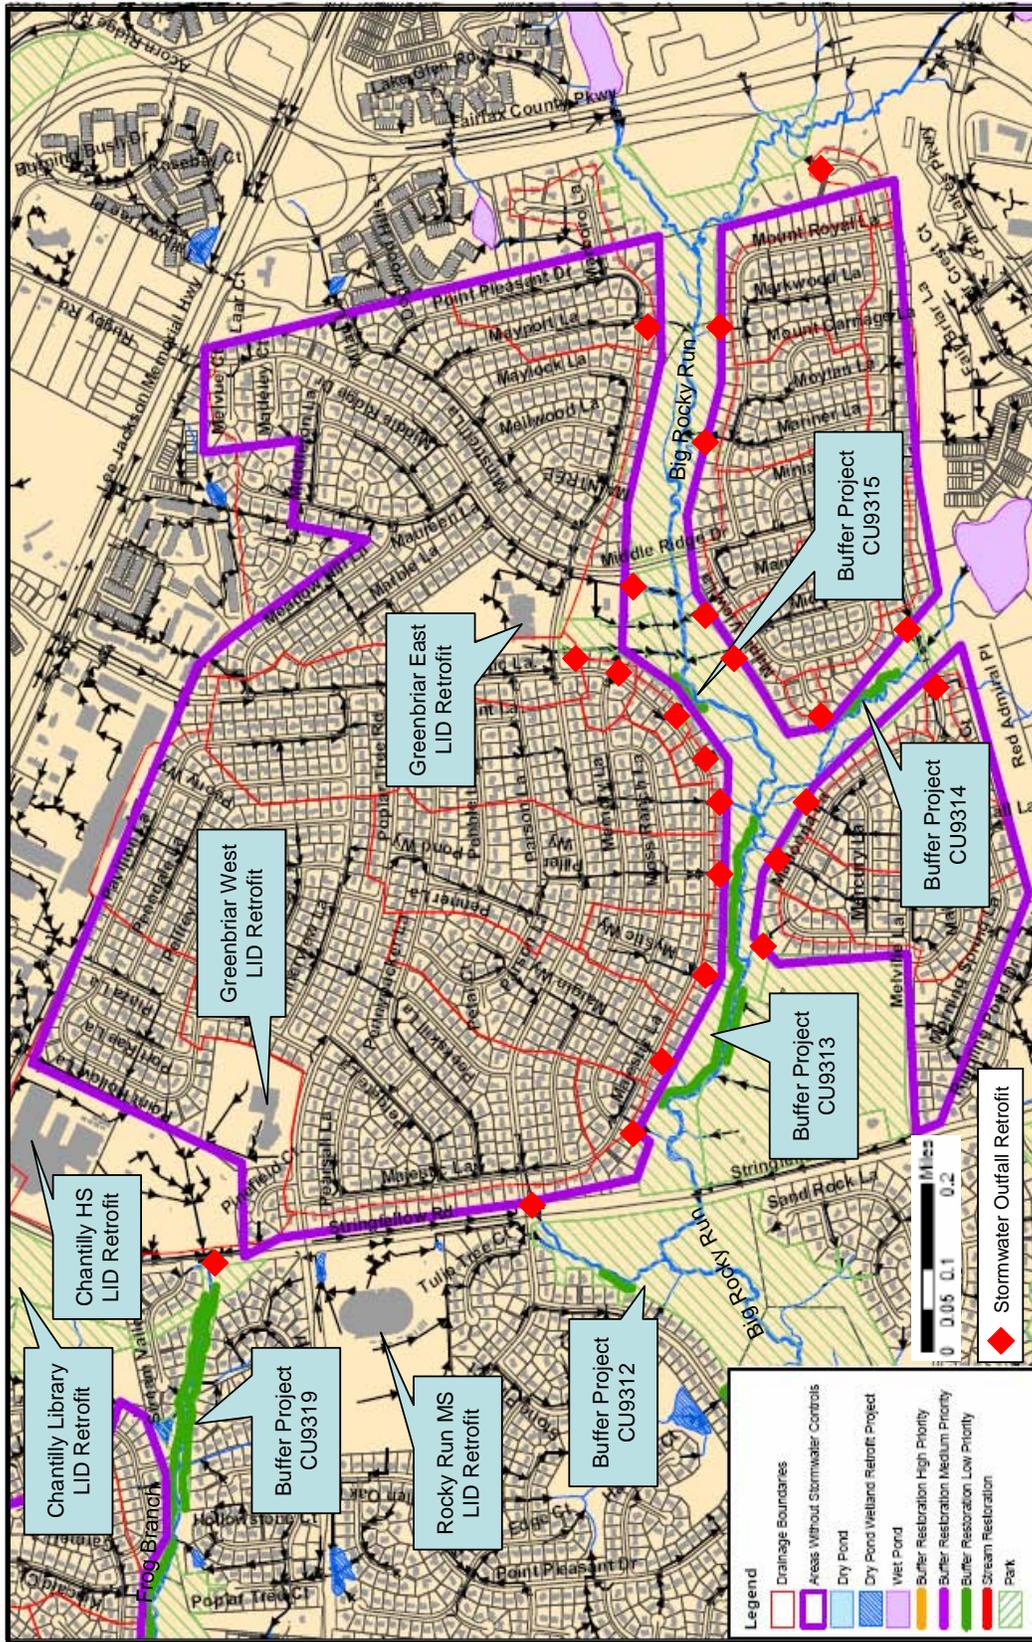
Figure 6-33
Summary of Proposed Stormwater Controls Near Greenbriar and Birch Pond

The drainage systems within these older neighborhoods consist entirely of closed pipe conduit systems with no opportunity for upstream culvert retrofit projects.

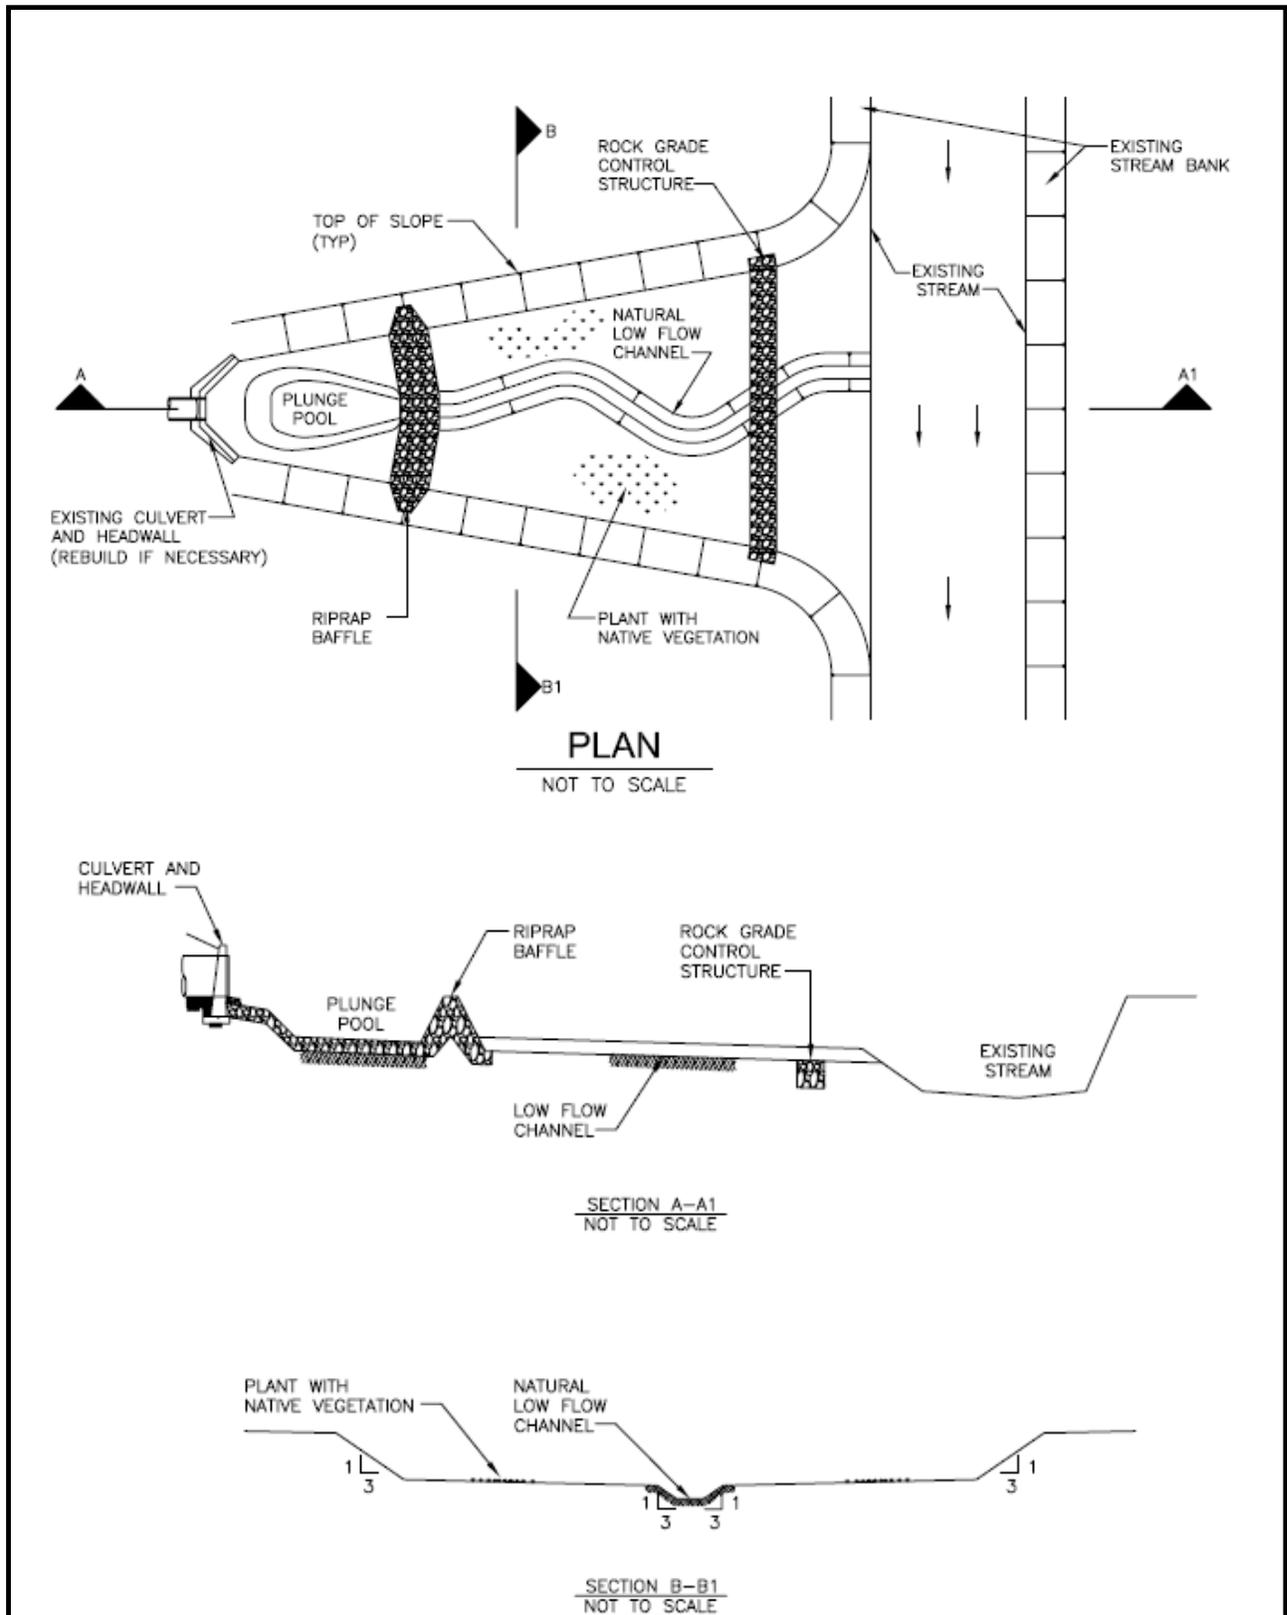
- Velocity dissipaters and flow spreading features to slow the velocity at the outfalls and upon entering the streams. These will typically be rock structures. Figure 6-37 provides an example of the possible improvements. Design of the improvements will depend on site conditions.
- Plunge pools and wetland systems at the outfall locations
- Stream restoration, using bioengineering, to improve and stabilize the streams that receive the flow from these outfalls
- Buffer restoration, including removal of non-native species, creating “no-mow” zones and planting native vegetation.

Figure 6-37
Conceptual Retrofit for Uncontrolled Stormwater Outlets

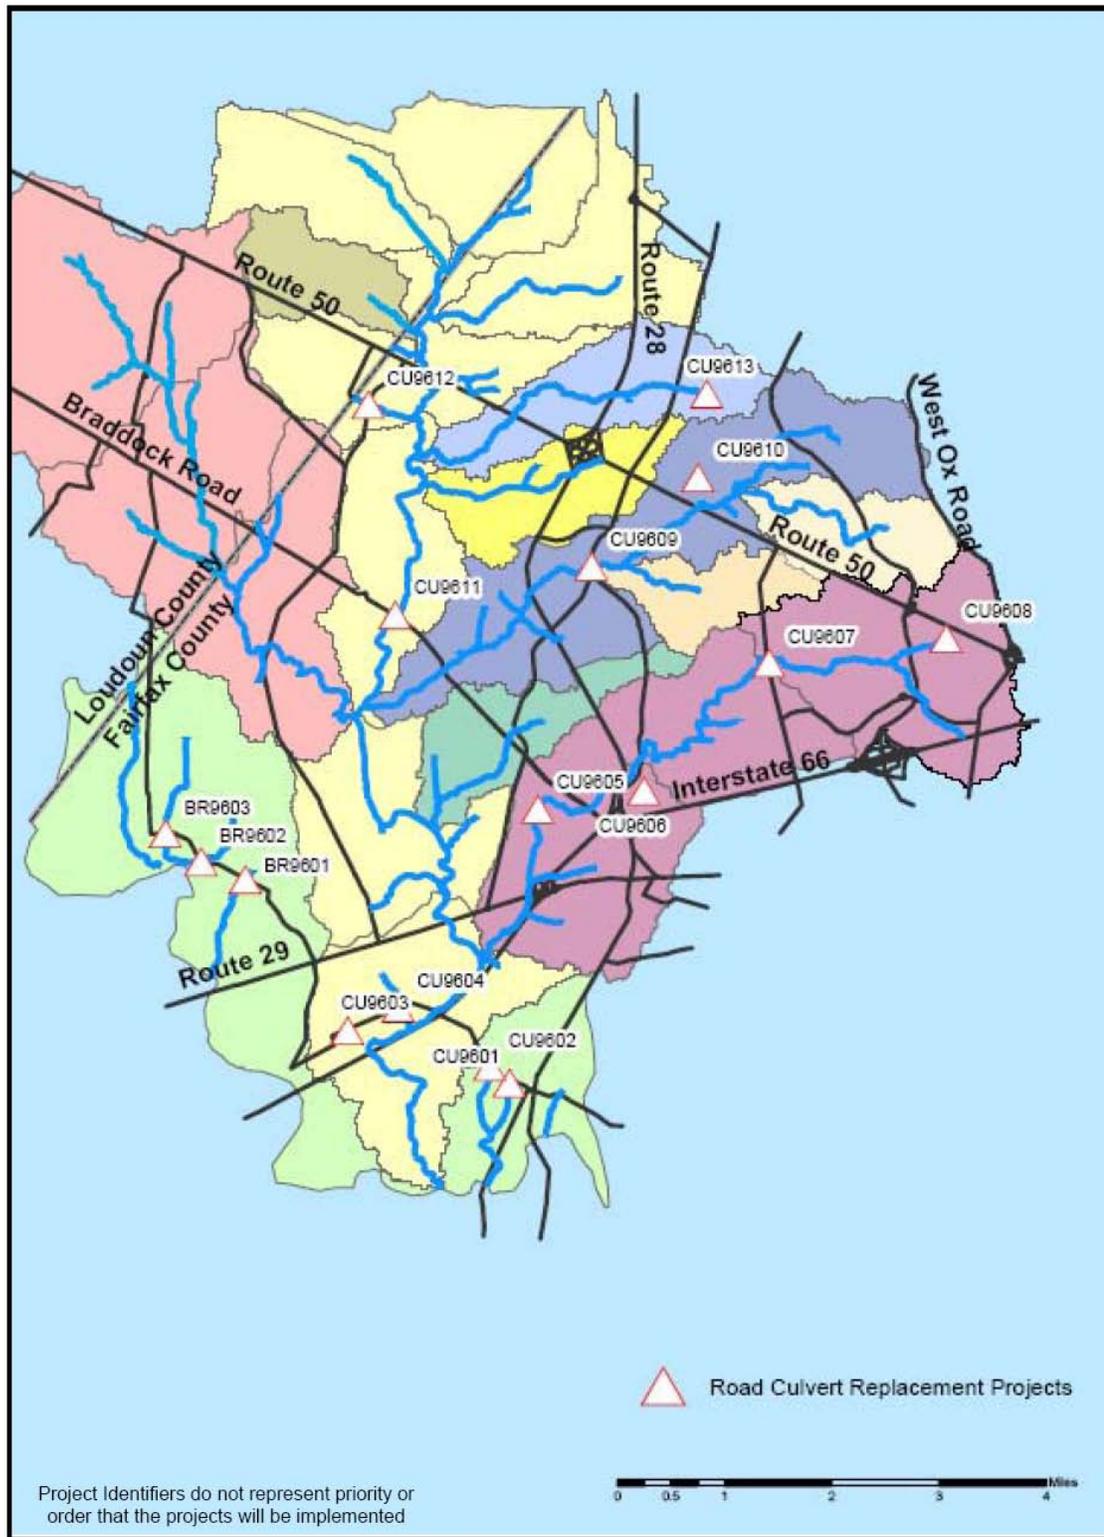
Figure 6-39
Road Culvert and Bridge Replacement Projects

Table 6-39 lists the locations where the existing culvert and bridges do not have sufficient capacity to prevent frequent flooding. Figure 6-39 shows these locations.

Culverts and bridges at identified locations are recommended for replacement to provide sufficient capacity to accommodate frequently occurring flood flows. These locations have been identified from various sources, including previous stormwater planning studies, flooding memorandums, the public and watershed modeling.

These projects reduce the frequency of roadway flooding and the potential safety concerns, economic impacts and damage.
