Tripps Run (upper portion of subwatershed) - Selected Project Sites

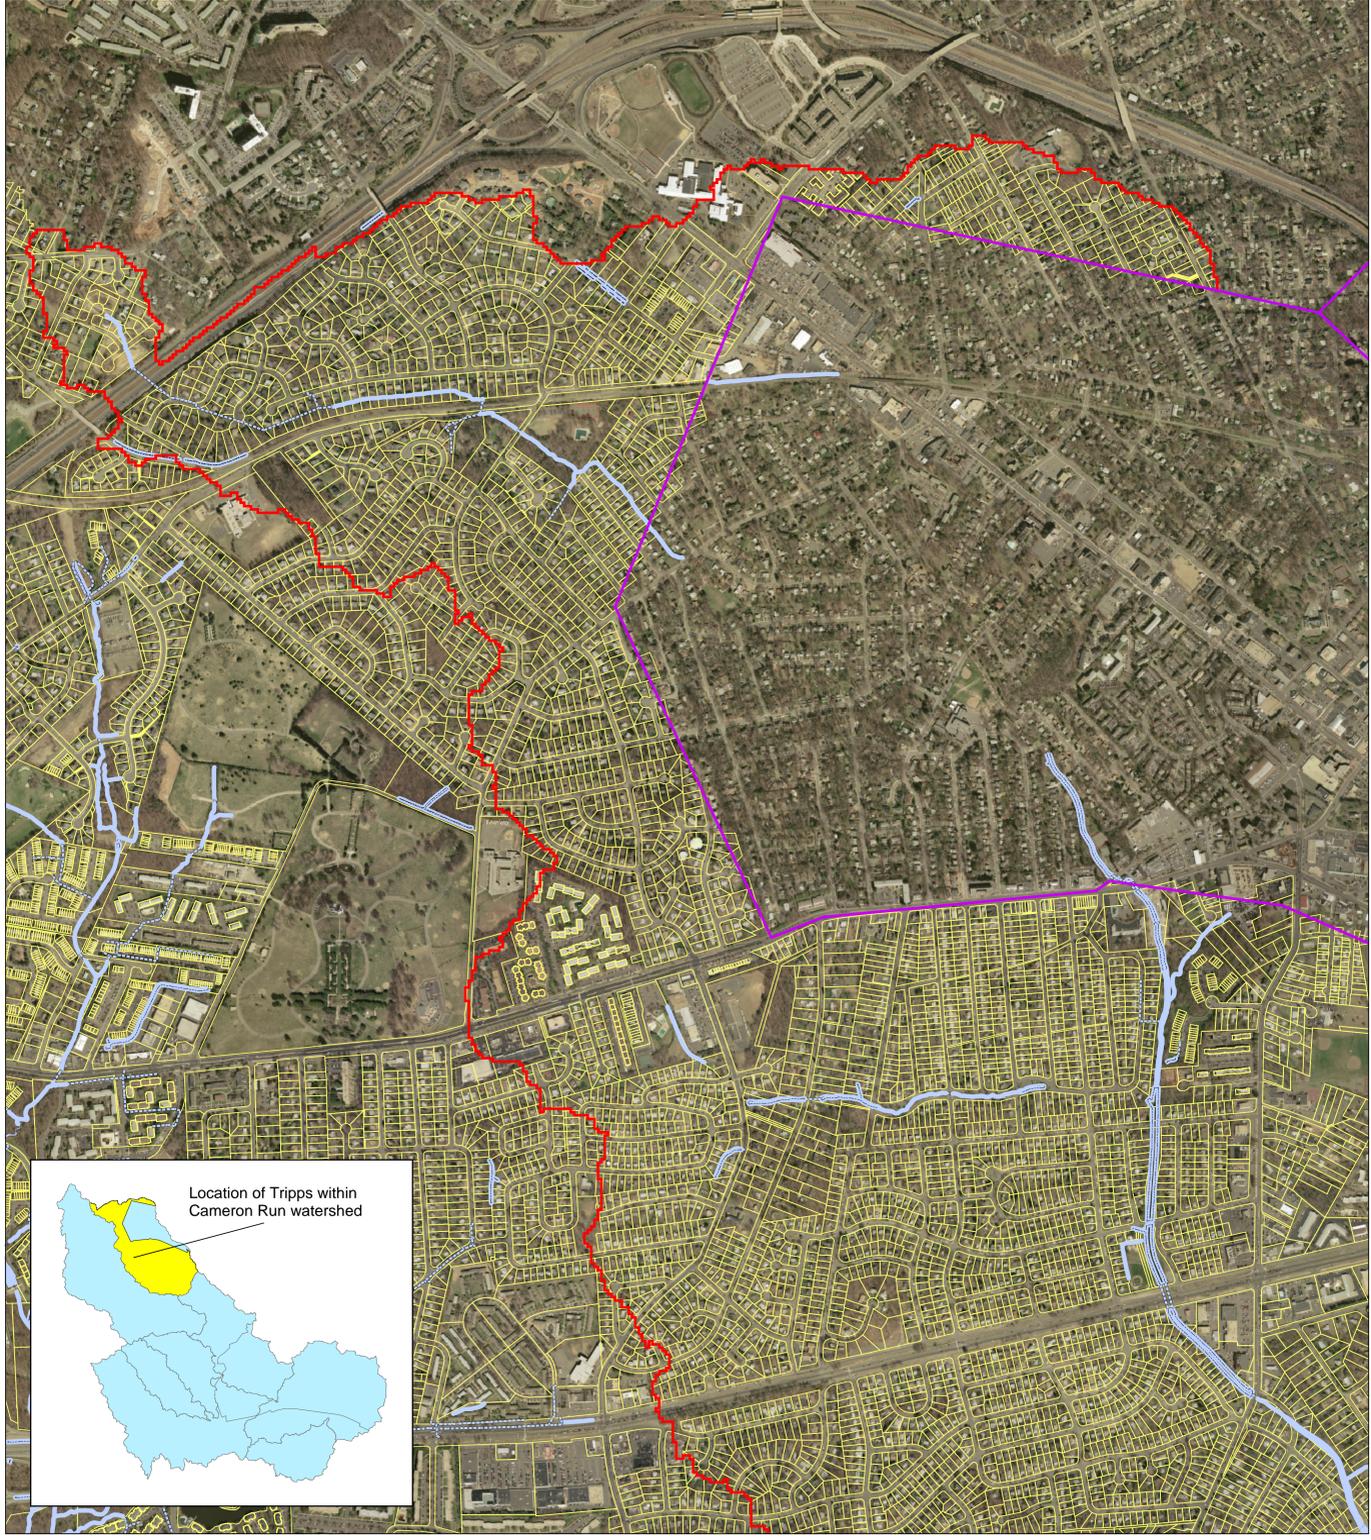
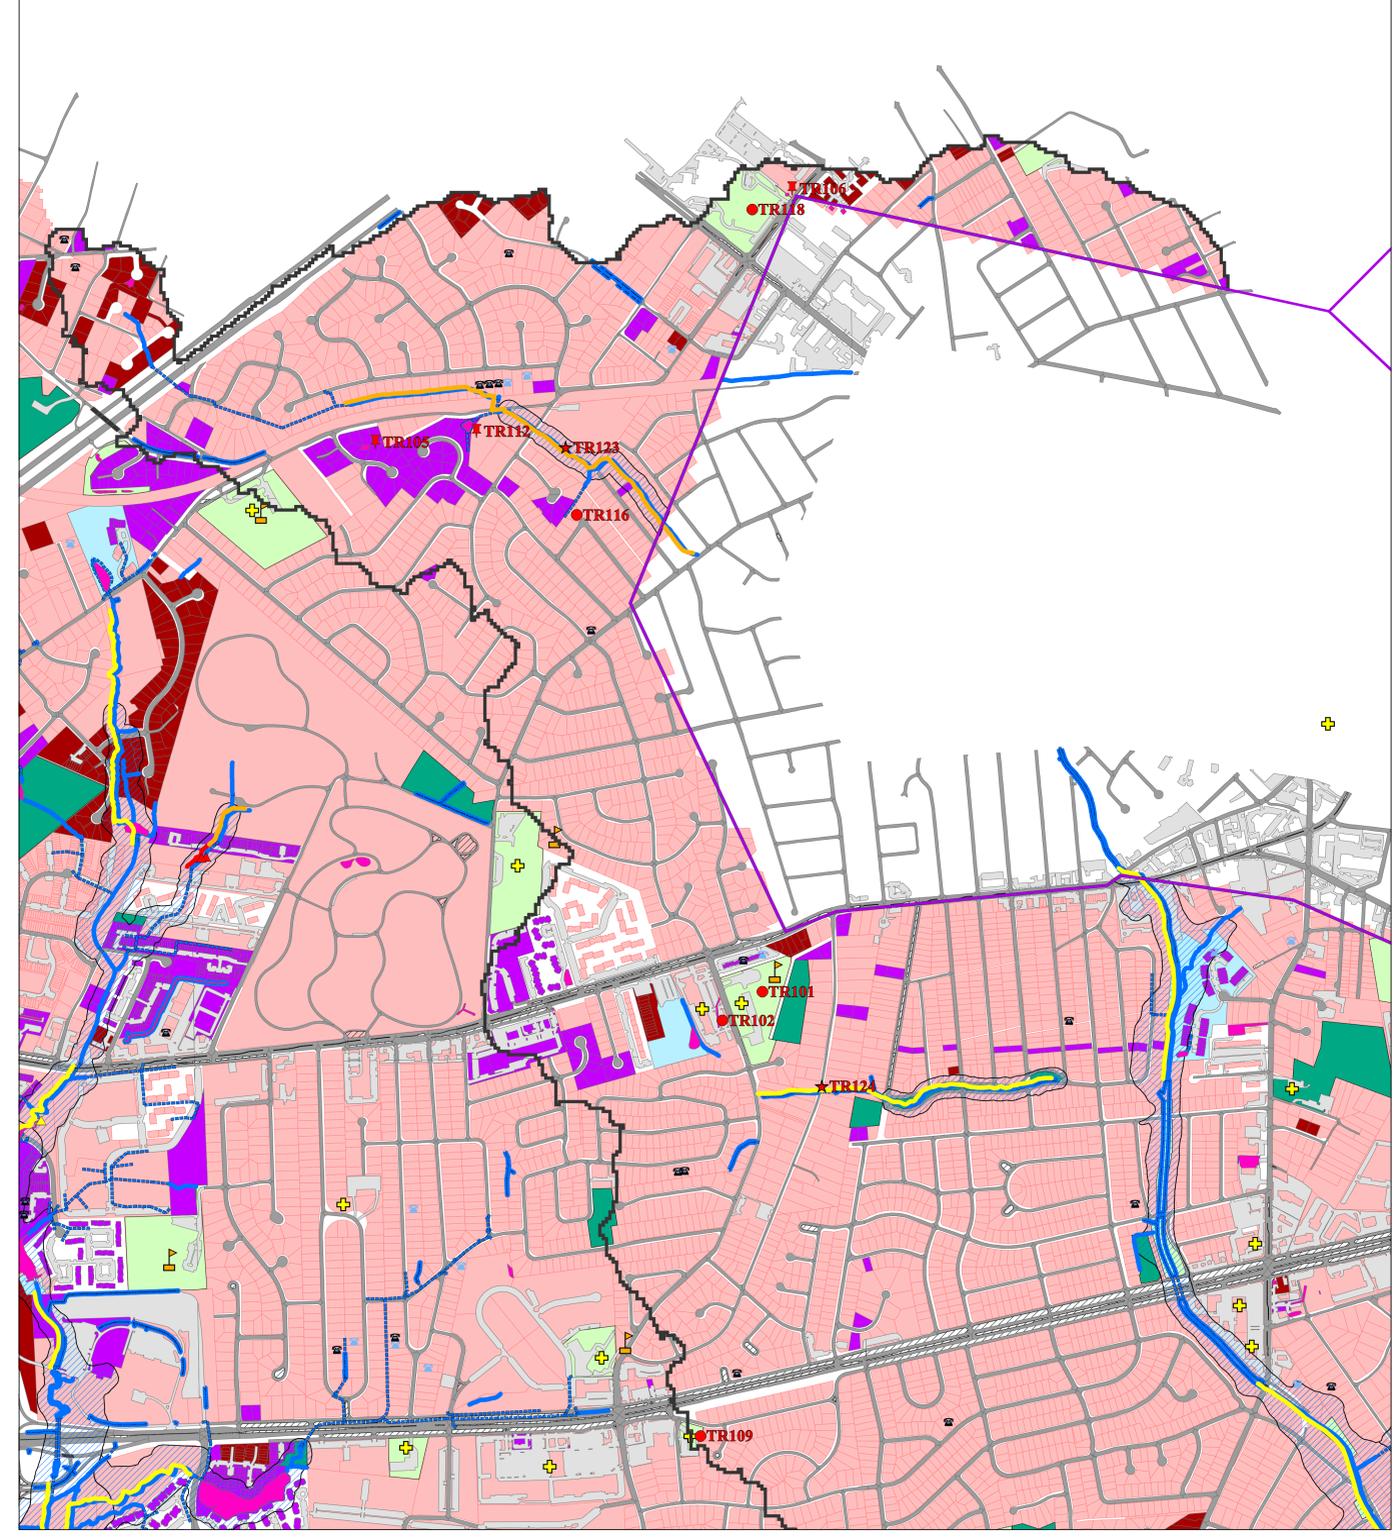
Site ID	Project Description	Area (acres)	Percent Impervious	Relative Flow Reduction low = 1 moderate = 2 high = 3	Relative WQ Benefit low = 1 moderate = 2 high = 3	Ranking Score
TR102	BMP retrofit	60.84	51%	2	2	124.98
TR118	Disconnect roof drains and route to cistern for watering fields; parking lots - rain gardens along margin, traffic island gardens, infiltration; green roofs; possible 1-yr EDD	9.81	54%	3	2	31.77
TR116	Ch. 2 street with storm sewer pipe: retrofit to linear rain garden with detention cells; rain barrels and tree box filters for houses and streets; capture/divert drainage for Hughes Ct. too	15.43	20%	2	2	12.43
TR101	Disconnect roof drains and redirect to rain gardens; filter strip along parking lot in back directed to rain gardens prior to storm sewer inlet	5.94	39%	2	2	9.16
TR109	Roof drains and lot to cistern for fire trucks at station or one-year EDD	3.49	43%	3	1	4.55
TR106	BMP retrofit	1.28	54%	2	2	2.77

TR105	BMP retrofit	2.26	18%	2	2	1.65
TR112	BMP retrofit	2.11	5%	2	2	0.38
TR123	Bioengineering and natural stream channel design to stabilize stream banks and beds, improve habitat	-	-	-	-	-
TR124	Bioengineering and natural stream channel design to stabilize stream banks and beds, improve habitat	-	-	-	-	-
