The Belle Haven, Dogue Creek and Four Mile Run Watershed Management Plan was initiated by the Fairfax County Department of Public Works and Environmental Services (DPWES). The Project Team consists of the following County staff, Watershed Advisory Group members, and consultants:

The *Belle Haven, Dogue Creek, and Four Mile Run Watersheds Management Plan* provides a summary of the current and future conditions of these three watersheds and presents a strategy for restoring and preserving their water resources. The plan was initiated by Fairfax County as part of a multi-year, multi-objective program to preserve and restore the County's natural environment and aquatic resources, and is consistent with the Fairfax County Board of Supervisors' Environmental Agenda adopted in June 2004. It has also been prepared as part of the process of compliance with state and federal laws and mandates, including Virginia's Chesapeake Bay Initiatives and the federal Clean Water Act.

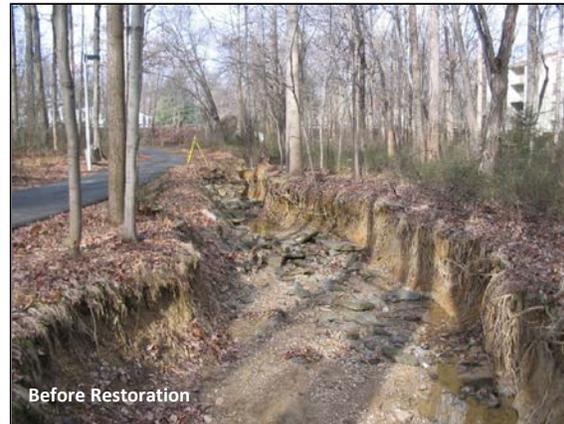
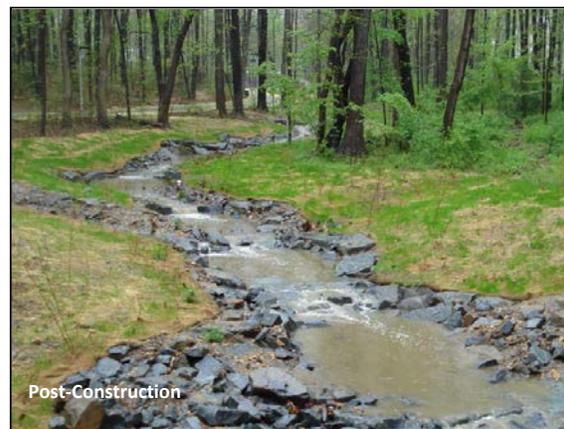
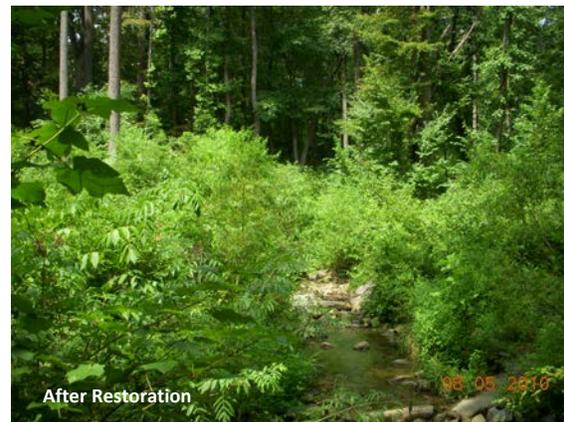
Less extensive restoration approaches could be undertaken where there is insufficient space or the existing flows make it infeasible to recreate a natural channel. These could involve armoring stream banks with rock or bioengineering materials to prevent further erosion, grading to lay back over-steepened banks and create a more stable cross-section.

Figure 4-5: Stream restoration (Source: Fairfax County)

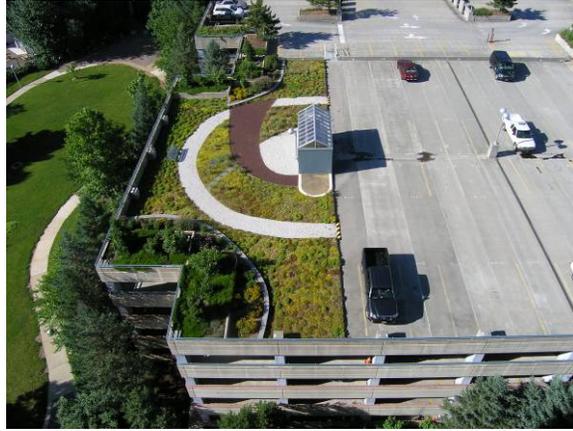
**Figure 4-11: Green roof on a parking building (Source: Fairfax County)**

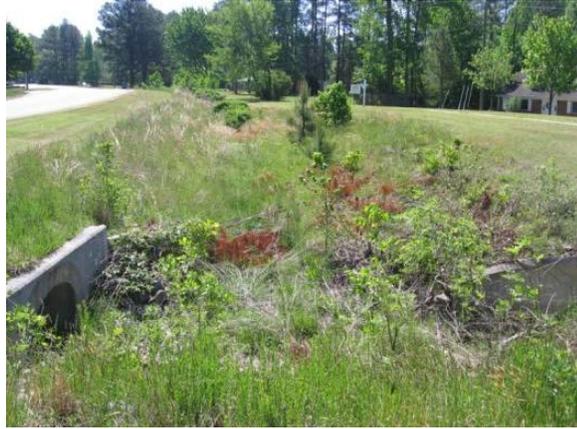
However, because of the proximity to roads and utilities, infiltration systems and vegetated swales may only be feasible in lower-density residential areas.

**Figure 4-14: Vegetated swale for roadside drainage (Source: KCI)**

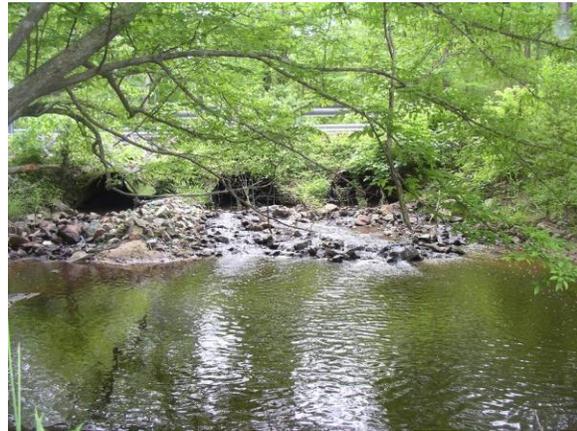
For all of these types of projects, a key design consideration is to avoid potential flooding downstream. By removing constrictions, streamflows will increase, and conditions must be analyzed to make sure that flood mitigation at one site does not move the problem downstream to another.

Figure 4-16: Obsolete culvert (Source: KCI)

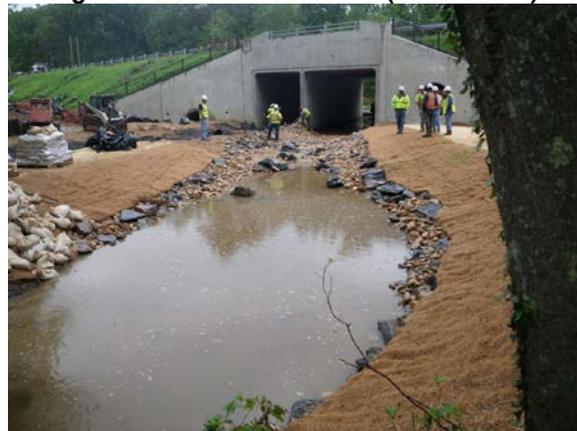
Figure 4-17: New replacement culvert (Source: KCI)

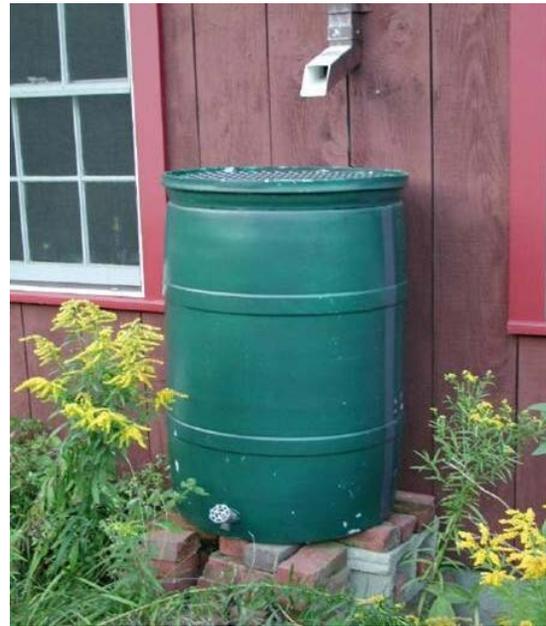
Figure 4-20: Rain barrel (Source: Project Clean Water)

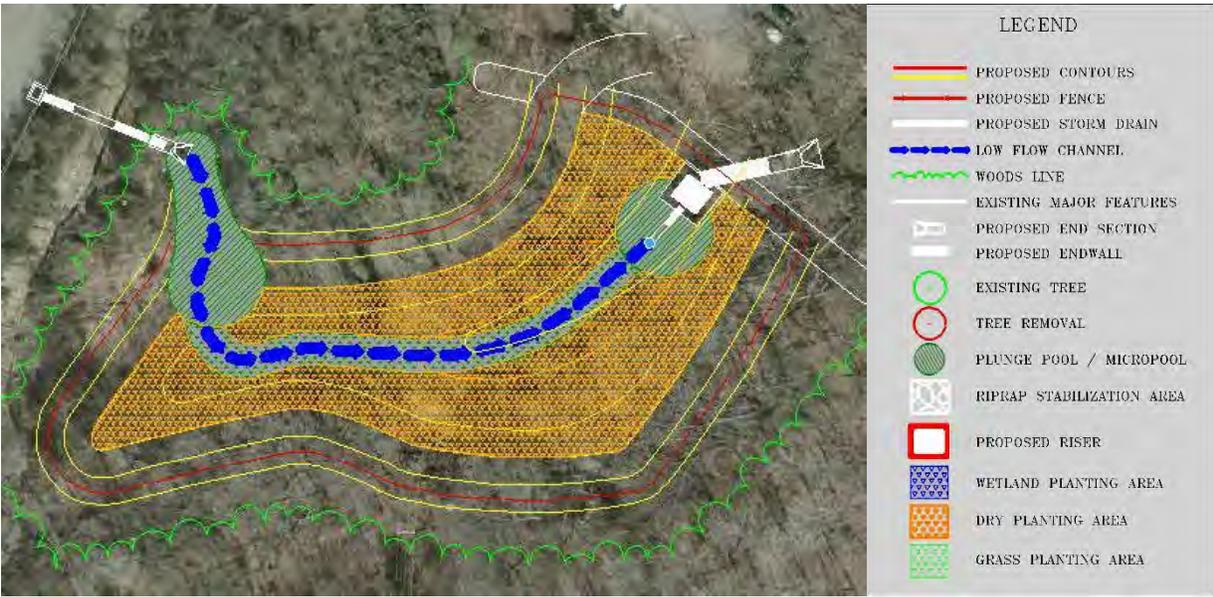
*Project Area Map*

**Description:** This project is proposed to create an extended detention dry pond with a sediment forebay at Fairchild Property. The pond is designed for multiple benefits: to provide quantity and quality control for a large untreated impervious area upstream, to reduce erosive flows downstream, to work with the proposed stream restoration projects in Quander Brook and to improve conditions at adjacent storm drain outfalls. Runoff from commercial, industrial and residential area along Richmond Highway will be treated by this pond for pollutants including nitrogen, phosphorus and total suspended solids.

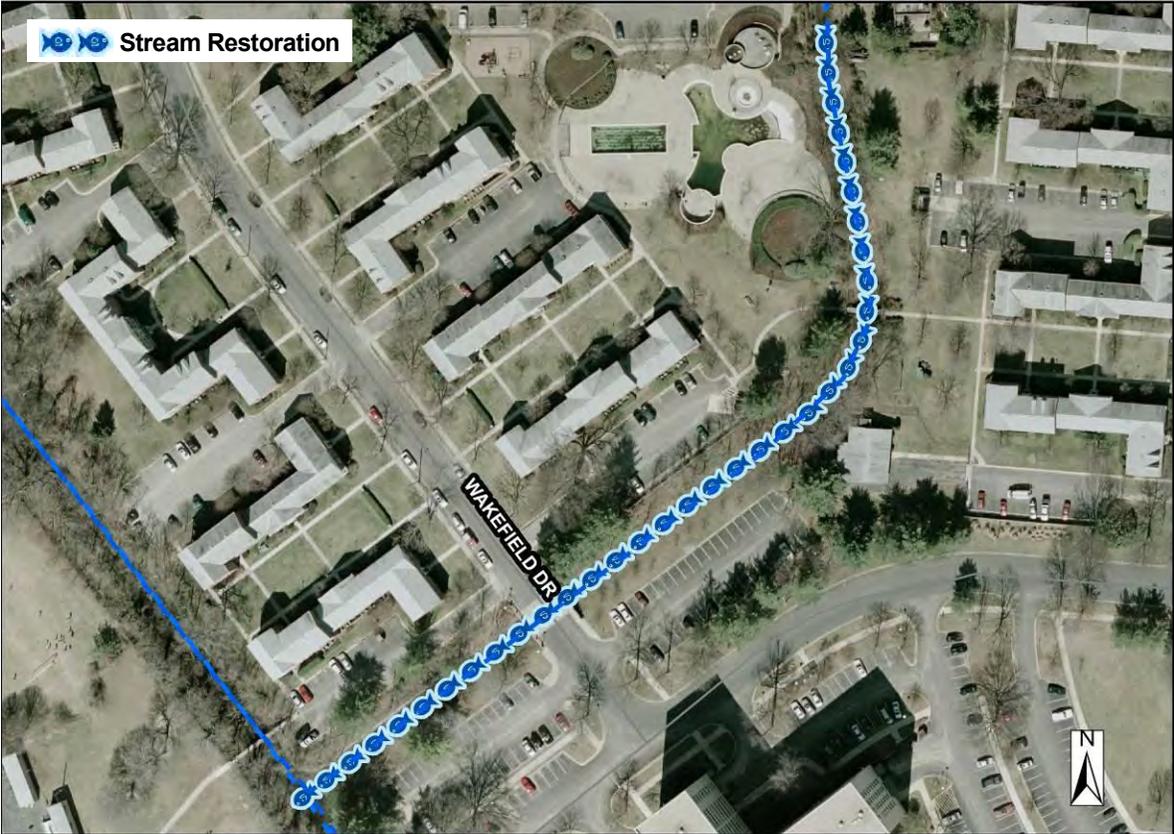
**Description:** This project is located between Potomac Avenue and Wakefield Drive and extends from Belle View Boulevard downstream to the confluence with the Belle Haven West Channel. Currently, this channel is concrete lined and very straight with mowed grass or trees on each side of the channel. Restoration efforts should focus on removing the existing 1130 feet of concrete channel and replacing it with a more natural channel with an improved buffer on each bank.

*Project Area Map: Conceptual plan showing potential project location*

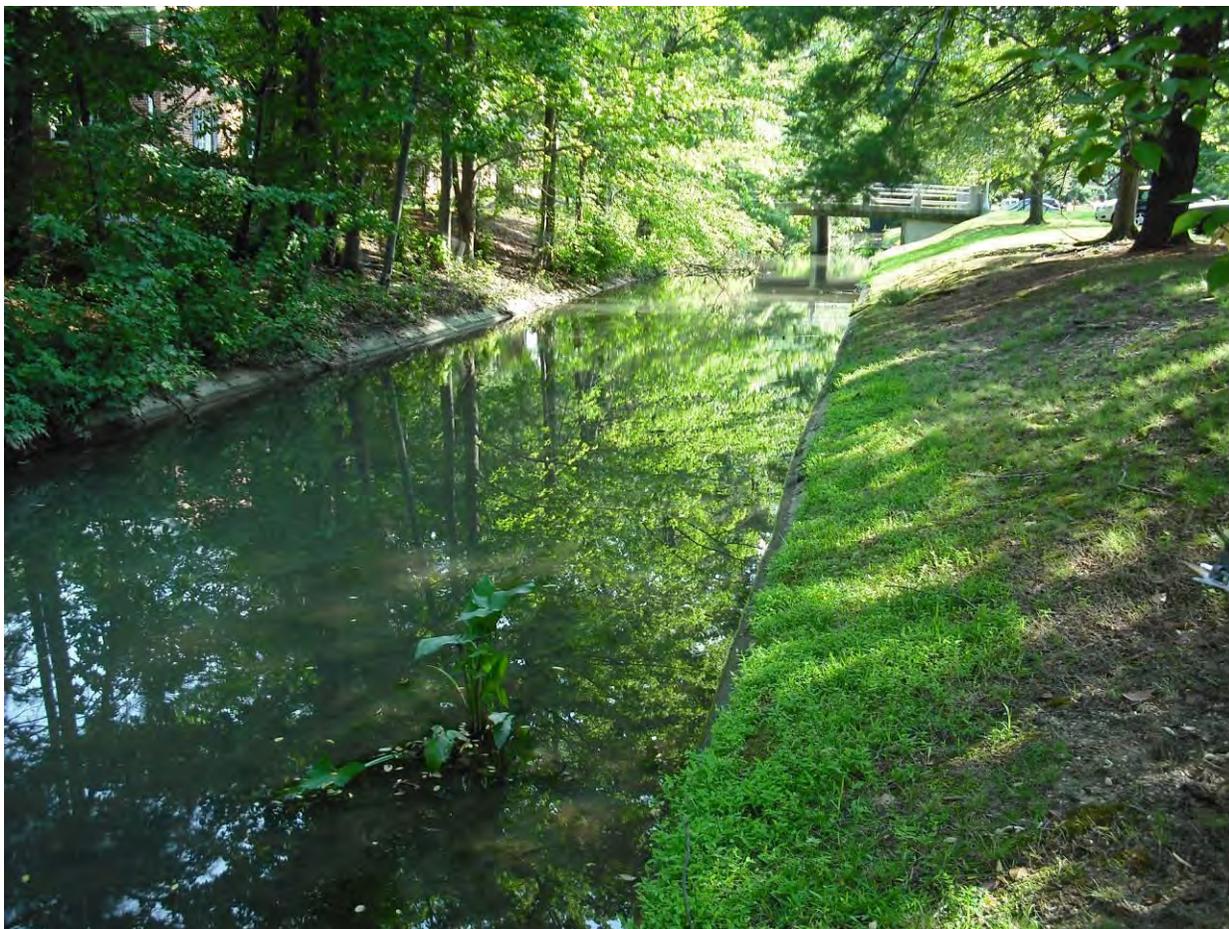
**BE9201\_1.jpg: View of concrete channel section**

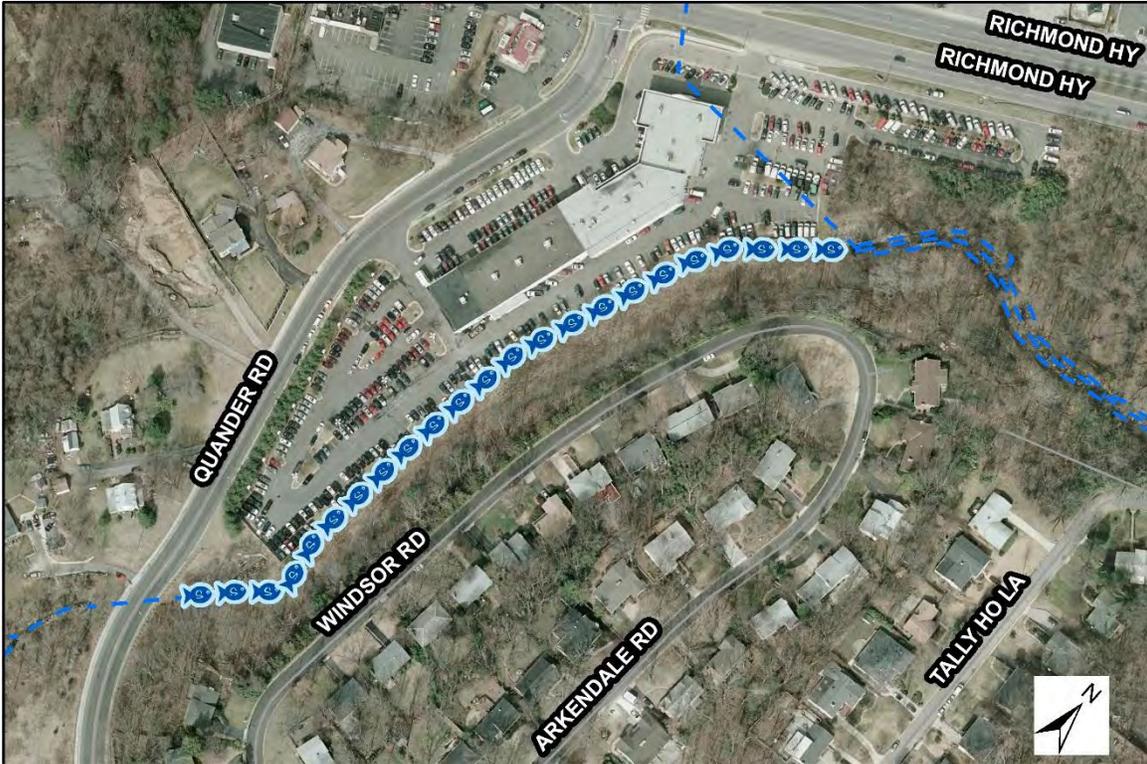
**Description:** Based on the modeled 100-year flow, buildings that are currently on the upstream and downstream sides of Quander Road appear to be affected due to two culverts under Quander Road and just downstream which may not be sufficient for this large flow. The proposed projects will daylight the culvert adjacent to the car dealership which will help to reduce the back water effect in this area. Restoration of this channel should follow the design and construction of BE9103 and BE9202 to allow for proper stream design and construction between projects. It should also be noted that BE9200 is located just downstream of this project and should be considered when designing the new channel for this project.

*Project Area Map: Conceptual plan showing potential project location*

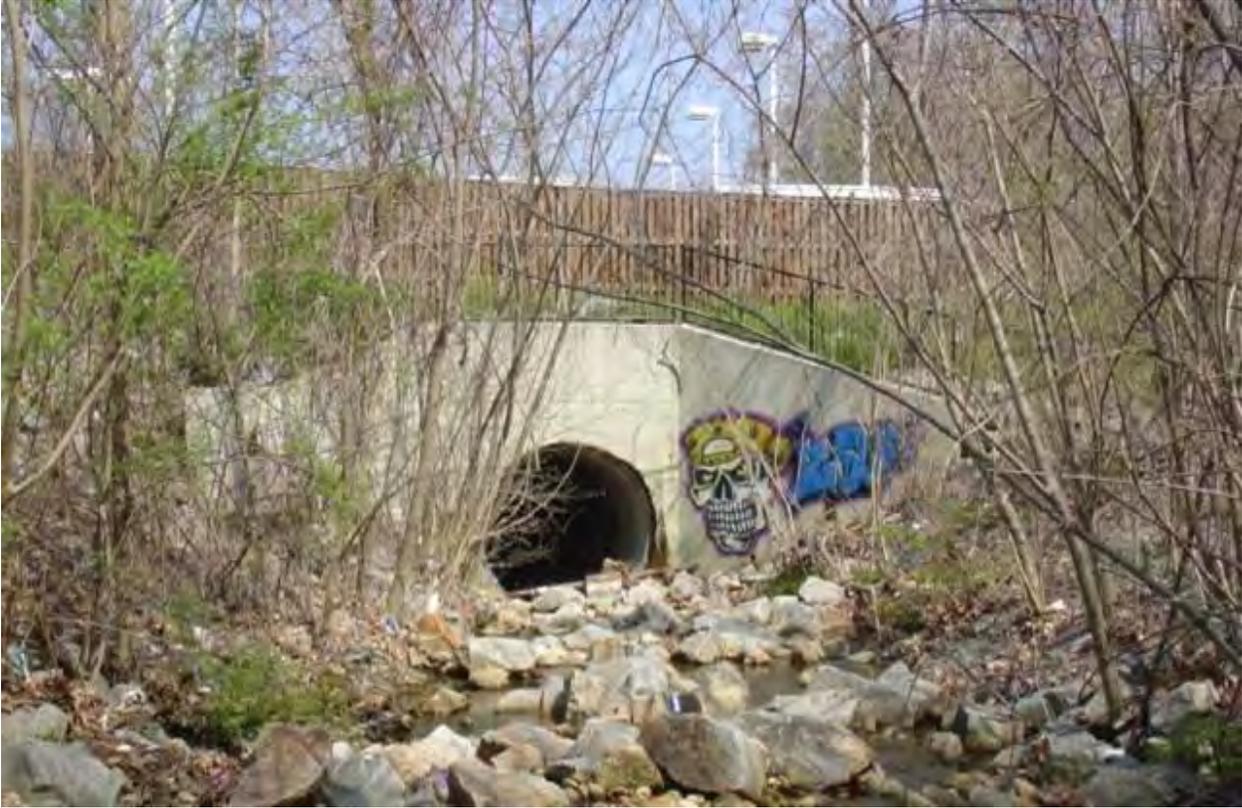
**BE9601\_1.jpg: View of Pipe downstream of Quander Road**

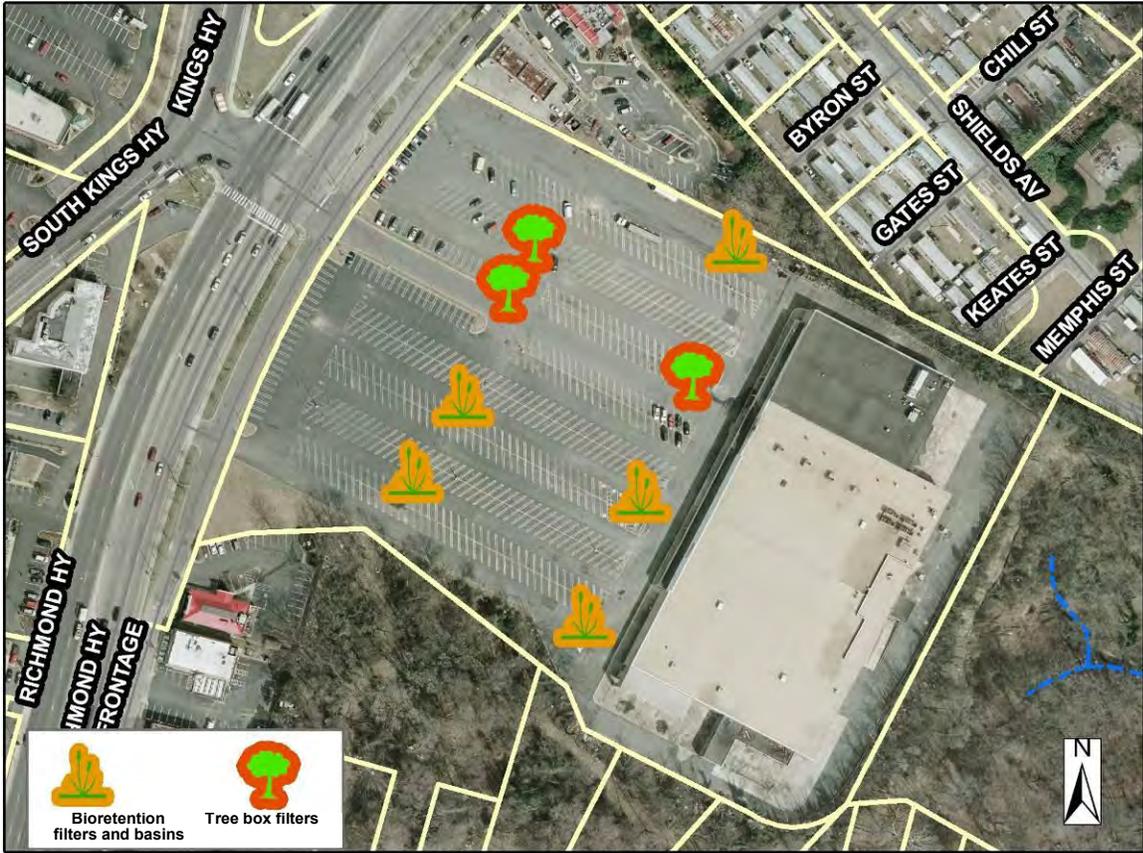
**Description:** Installation of bioretention filters and basins and tree box filters is proposed to treat the runoff from a large commercial strip mall parking lot located along Richmond Highway. A portion of this parking lot in the north is used for a park and ride. The majority of the south parking lot is not used and little grading would be necessary. This project is located just upstream of project BE9103, which is a proposed stormwater facility.

*Project Area Map: Conceptual plan showing potential project location*

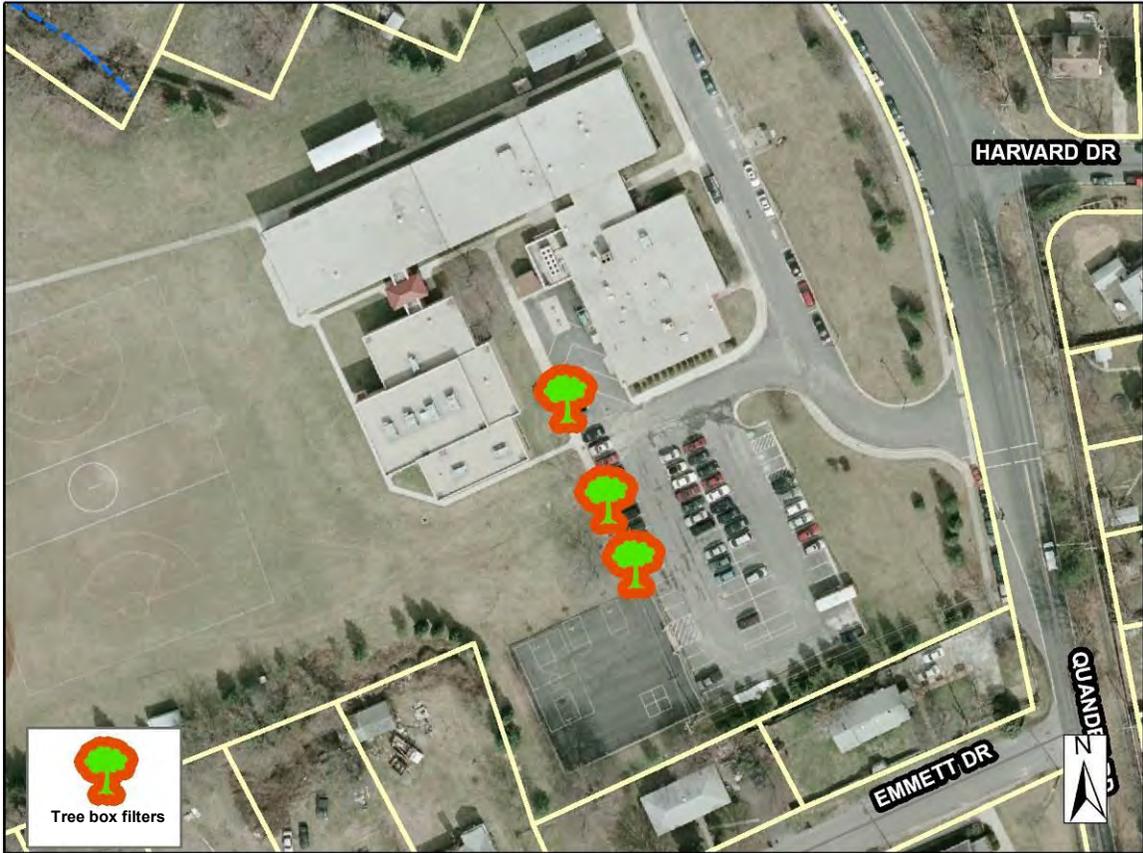
**Description:** The proposed project is to install tree box filters to receive parking lot runoff at Quander Road School. The project site is the parking lot east of the school near the entrance. Tree box filters will be installed at three existing inlets in the parking lot.

*Project Area Map: Conceptual plan showing potential project location*

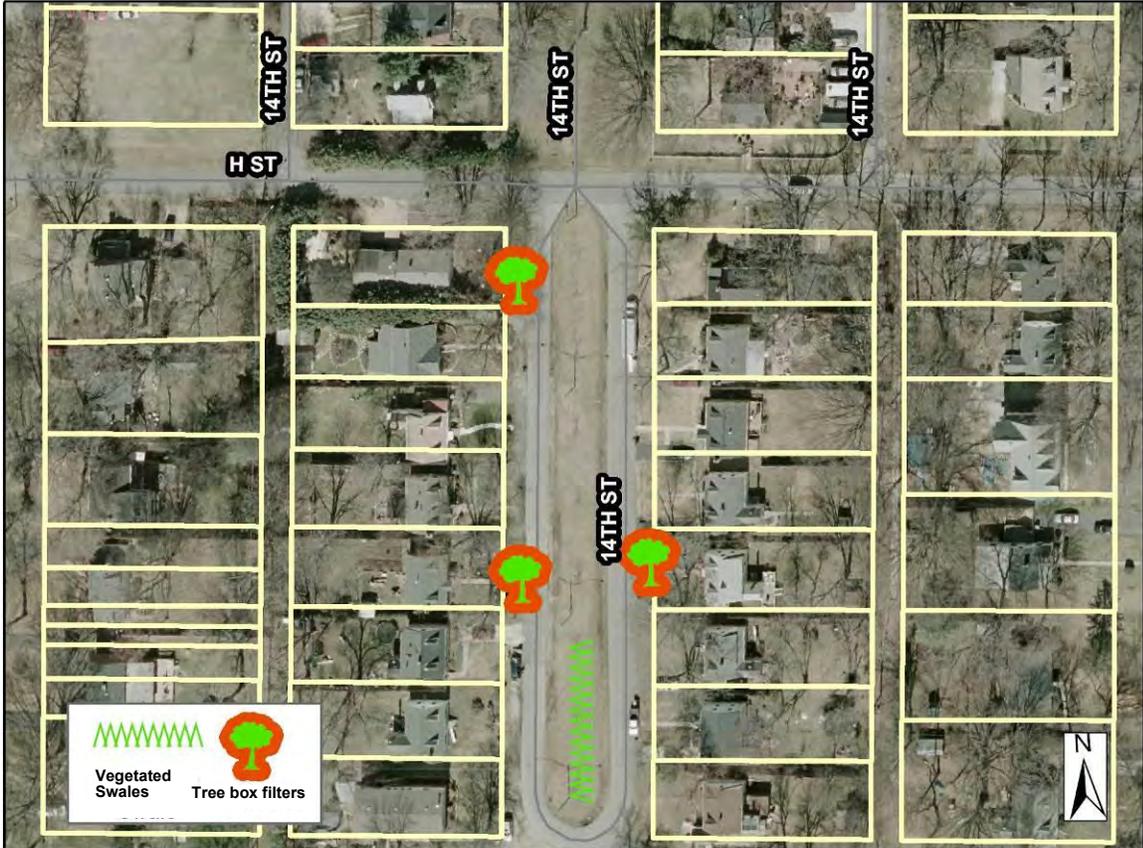
**Description:** This project proposes installation of vegetated swale in the median of 14<sup>th</sup> Street and installation of tree box filters at the inlets along the roadway. The proposed swale will receive the roadway runoff and roof runoff from the medium density residential area north of the project site. Three tree box filters will be installed on the existing inlets and the median will be graded to create a vegetated swale.

*Project Area Map: Conceptual plan showing potential project location*

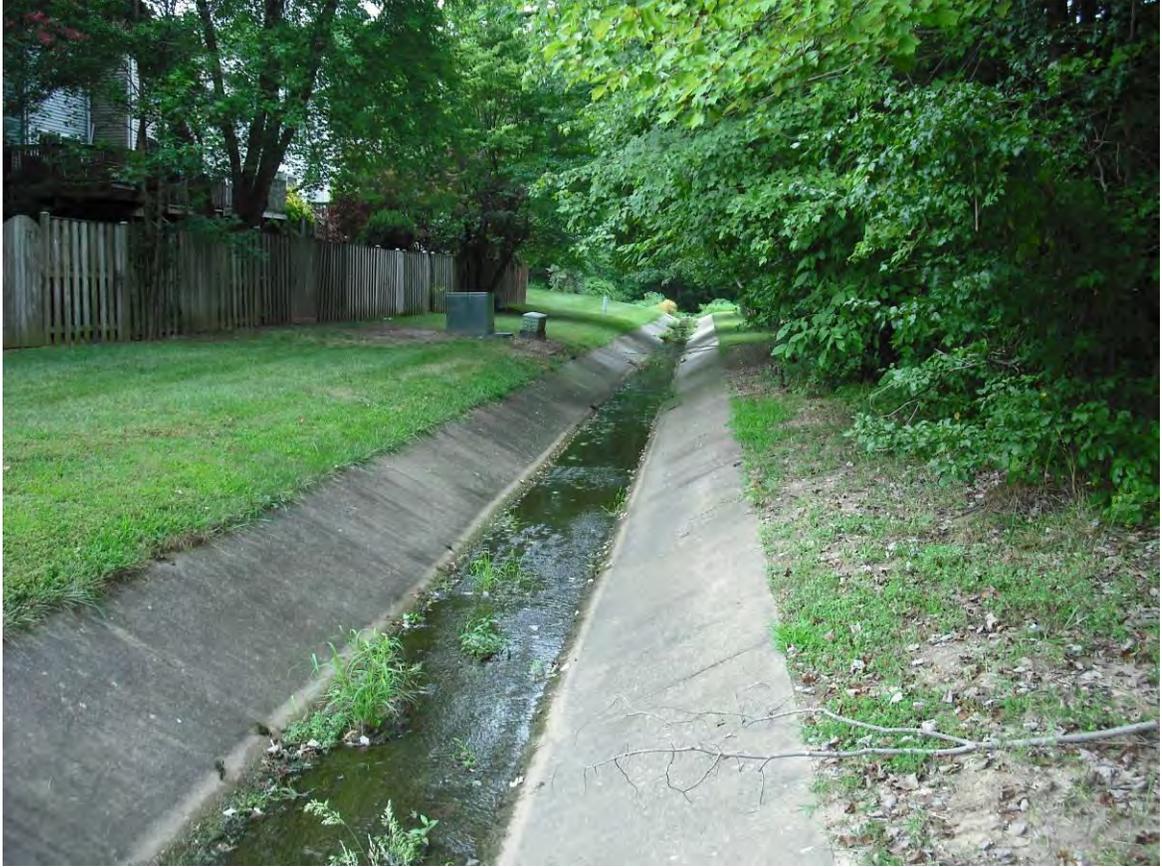
**DC9210\_1.jpg: View of the existing concrete channel**

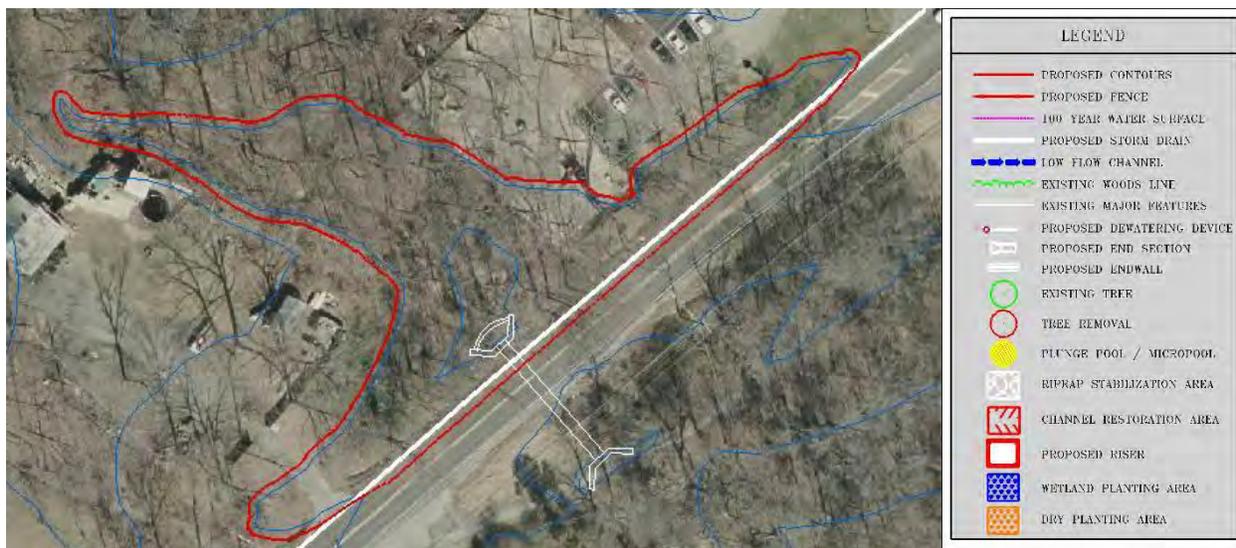
Project Area Map: Conceptual plan showing potential location of culvert retrofit
