Lower Occoquan Watershed Management Plan

Fairfax County Department of Public Works and Environmental Services - Stormwater Planning Division

Prepared by: PBS&J, an Atkins company
December 22, 2010

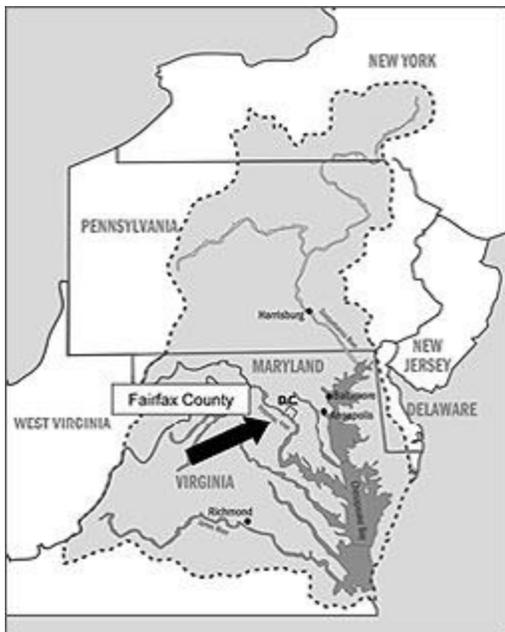
Figure 1-2: The Chesapeake Bay watershed

The size of a watershed can be subjective; it depends on the scale that is being considered.

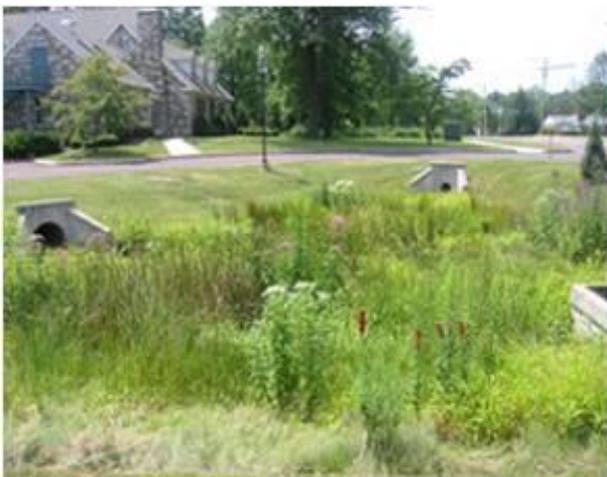
Figure 4-1: Dry stormwater pond

A new stormwater pond project involves the creation of an extended detention dry pond that will improve water quality and quantity treatment for the surrounding area. Wet pond retrofits will modify the existing pond to increase pollutant removal and to provide adequate channel protection above the permanent pool. The retrofit will create a better-functioning environment for gravitational settling, biological uptake, and microbial activity with a permanent pool of standing water, providing for high and reliable pollutant removal performance. The pool prevents re-suspension of sediments and other pollutants and allows for numerous pollutant removal mechanisms to operate. Dry pond retrofits will modify the existing pond to provide adequate downstream channel protection and allow for better function of temporary ponding using a control structure, which enables particulate pollutants to settle out, providing fair to good removal for particulate pollutants.

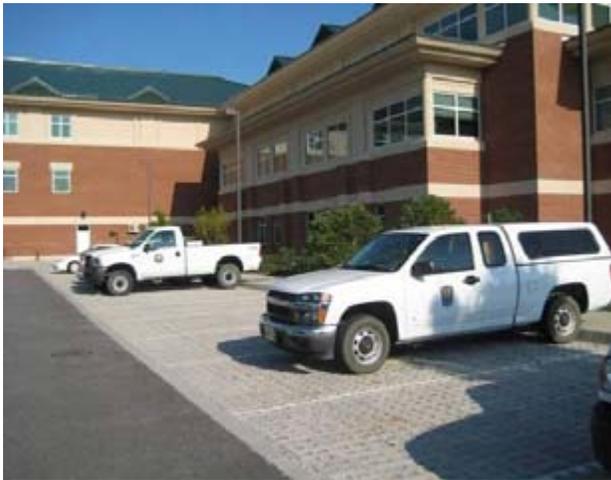
Figure 4-3: Parking lot pervious pavement

A BMP/Low Impact Development (LID) project is designed to minimize the impact of changes in land use on surface and groundwater systems, with the primary goal of mimicking predevelopment site hydrology. BMP/LID projects can be either structural or non-structural in form. Structural BMP/LID projects include: bioswales, pervious pavement, and bioretention filters. Bioswales will capture sheet flow from impervious areas and reduce runoff volume and increase groundwater recharge. Pervious pavement will treat and/or reduce parking lot runoff using a (semi-)porous material that allows runoff to infiltrate and then trap pollutants in the soil. The pavement will also allow for surface storage, reducing runoff volumes. Bioretention will capture sheet flow from impervious areas and create an ideal environment for filtration, biological uptake and microbial activity, providing moderate to high pollutant removal. It will also reduce the outflow to the storm sewer system.

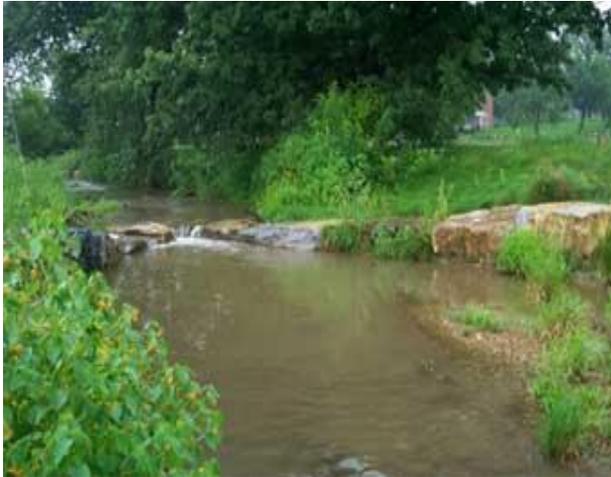
Figure 4-7: Cross vane added to stream

Stream restoration is the re-establishment of the general structure, function and self-sustaining behavior of a stream. Restoration can include numerous methods such as installation of structures and planting of vegetation to stabilize and protect stream banks, reshaping or re-aligning stream banks, and repairing stream bed erosion in order to restore the natural morphology of the stream. A stream restoration project can consist of reopening to daylight, sections of a stream that had previously been piped. This is also known as daylighting. Other stream restorations include improving conditions around a stream's inflow pipes by providing outfall protection with energy dissipation devices. This will also help to minimize erosion.

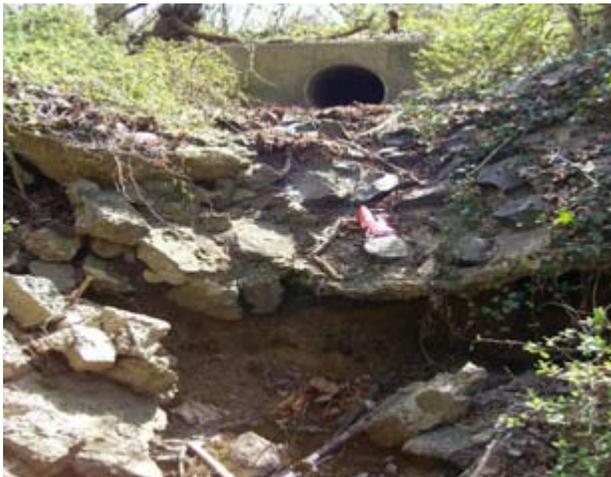
Figure 4-9: An eroded outfall

Outfall improvement projects consist of several different measures designed to reduce erosive velocities and sediment loads at the stormwater outfalls. Outfall improvement projects can include reconstruction of the outfall to provide an energy dissipation device and erosion protection, reconstruction of roadside swales or concrete channels with vegetated plantings, and construction of a new storage and treatment area below an outfall.

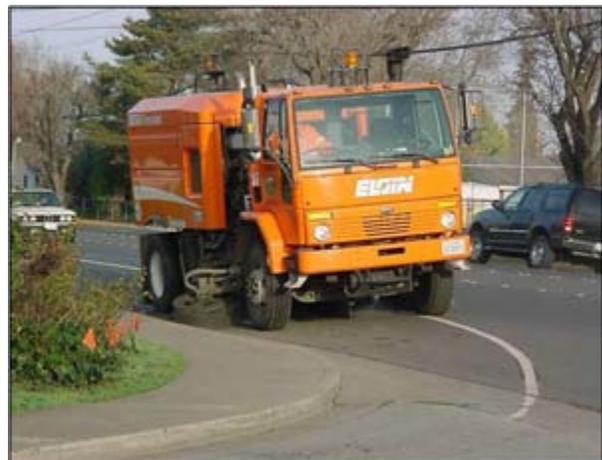
Figure 4-12: Street-sweeping truck

Street sweeping helps reduce the amount of potential pollutants entering nearby streams and storm systems. In addition, these programs add the aesthetic benefits of having clean streets and the safety benefits of removing debris that can block storm systems and stormwater facilities. Areas where these projects were proposed are primarily comprised of dense residential development, many of which have streets that are piped directly into the nearby streams with little to no stormwater controls.

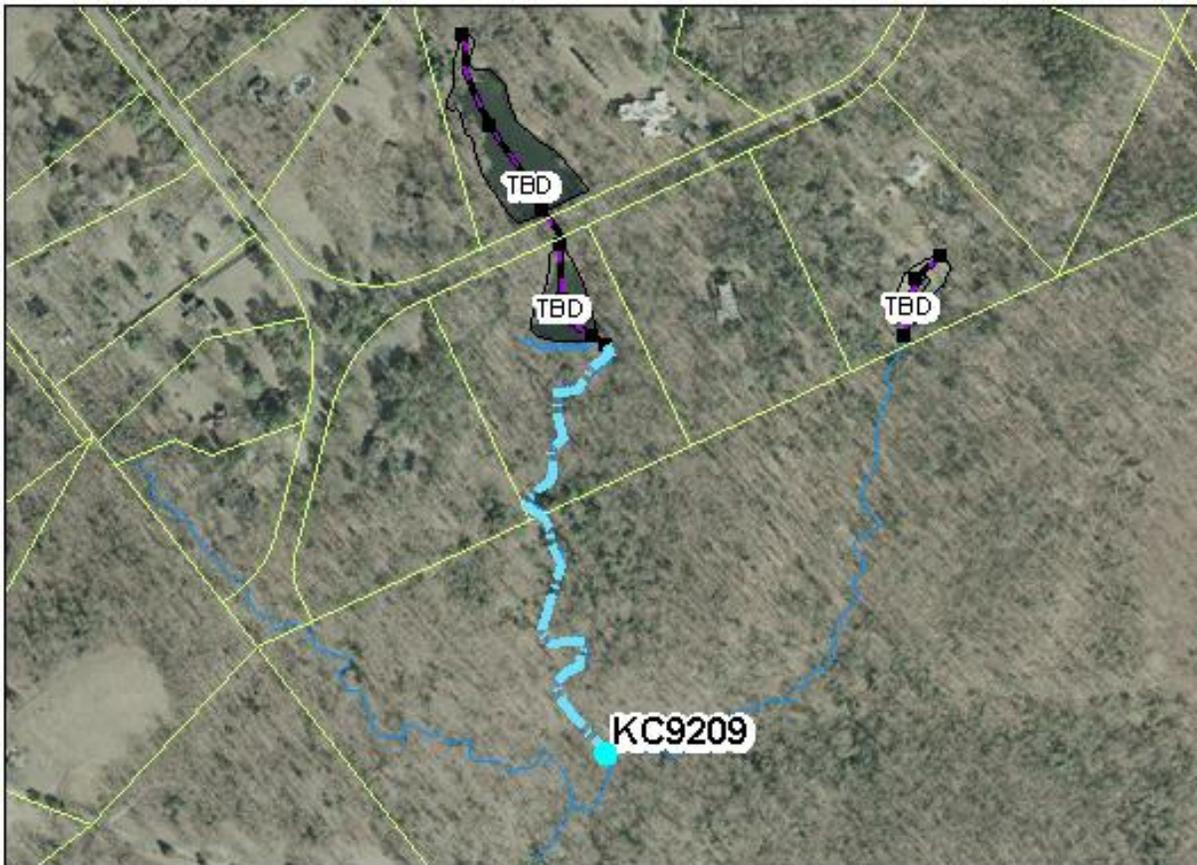
Description: The stream south of Springfield Drive in Lorton shows indicators of poor channel morphology. The stream is downstream of two ponds, and ultimately discharges into Belmont Bay. A project is proposed to repair bank and bed erosion to restore channel morphology. Erosion will be stabilized through the use of bank shaping, toe protection, erosion control fabrics and rapid vegetation establishment. To reduce further erosion the banks will be armored using geofabrics, fabric-encapsulated rocks or equivalent.

- Stream Restoration
- Storm Network
- Property Line
- Streams

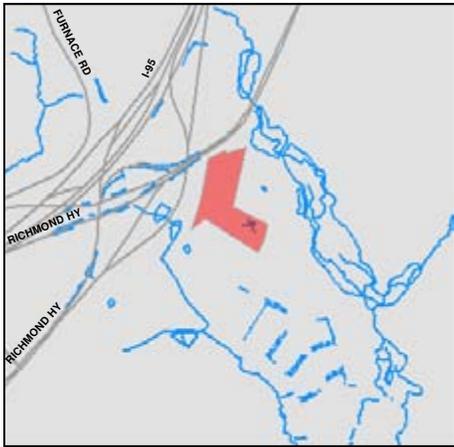
MB9104 Stormwater Pond Retrofit

Address: 10418 Old Colchester Rd., Lorton, Virginia
Location: Pond at Mason Neck West Park
Land Owner: Public/Local – Fairfax County Park Authority
PIN: 1134 01 0040A
Control Type: Water quality and quantity control
Drainage Area: 6.62 acres
Receiving Waters: Tributary of Giles Run

Description: A dry pond retrofit is proposed at Mason Neck West Park located off of Old Colchester Road in Lorton. The project proposes to create an extended detention dry pond with sediment forebays. The retrofit will modify the existing pond to provide adequate downstream channel protection and allow for better function of temporary ponding using a control structure, which promotes particulate pollutant settlement.

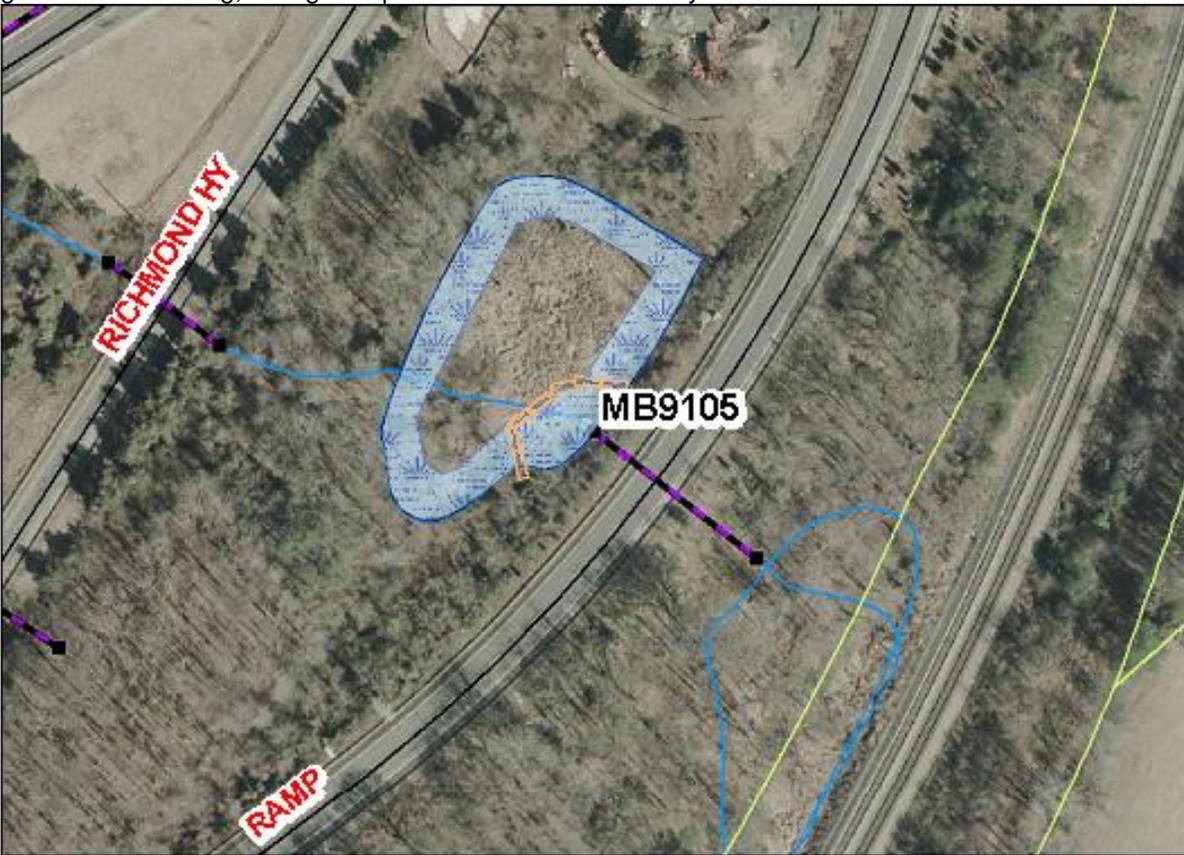
Description: This project proposes the retrofit of an existing pond between Richmond Highway and west of the Old Colchester Road ramp to create a wetland system with sediment forebay and bench planting. The primary problem indicators are pollutants, including nitrogen, phosphorus and total suspended solids. The retrofit will modify the existing pond to increase the time stormwater travels through the facility. The retrofit will add areas of high marsh and low marsh to the pond with tree peninsulas and will create a better functioning environment for gravitational settling, biological uptake and microbial activity.

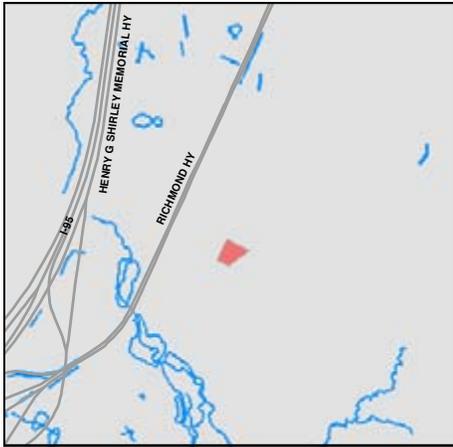
MB9107 Stormwater Pond Retrofit

Address: 10119 Giles Run Rd., Burke, Virginia
Location: Dry pond near Giles Run Rd.
Land Owner: Private – private owners
PIN: 1132 03 E2
Control Type: Water quality and quantity control
Drainage Area: 0.79 acres
Receiving Waters: Tributary of Giles Run

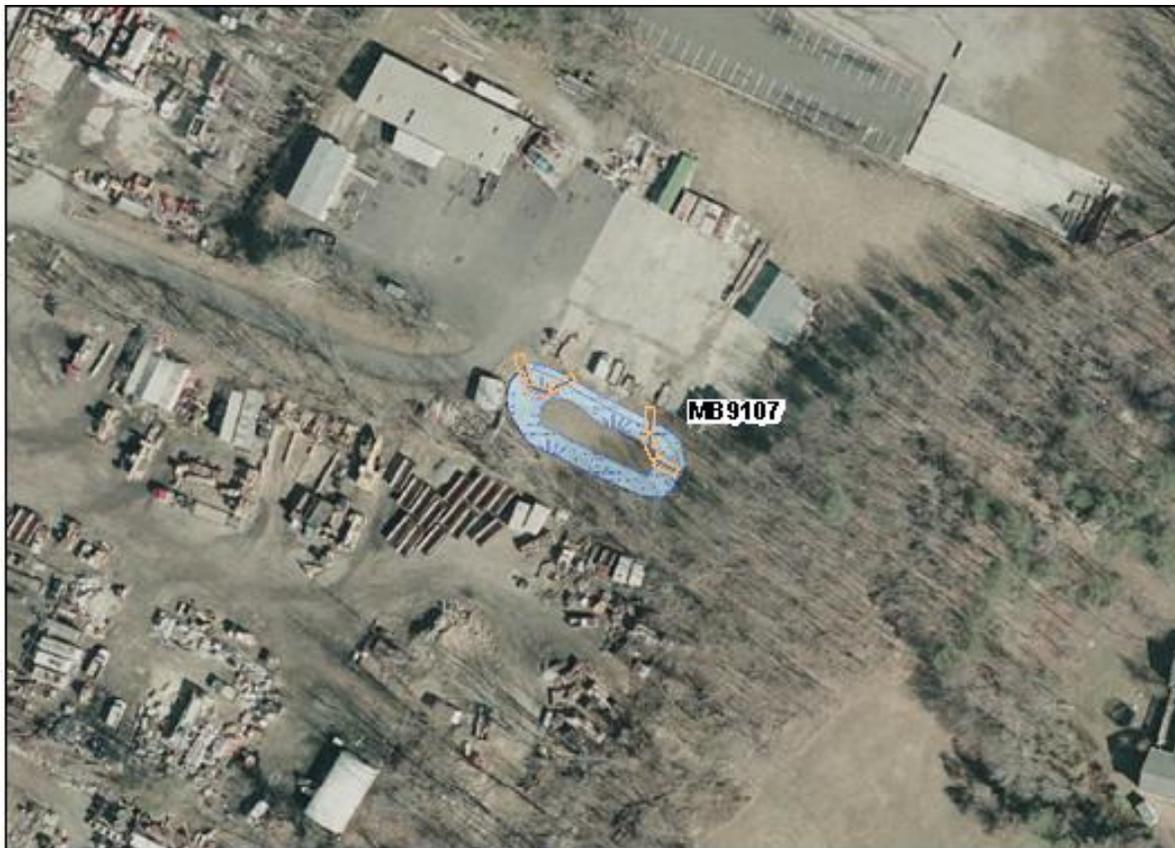
Description: A dry pond is located in an industrial area off of Richmond Highway. This project proposes retrofitting the existing dry pond to create an extended detention dry pond with sediment forebays. The retrofit will modify the existing discharge structure to increase the time stormwater is detained in the pond. The pond will be expanded to handle this larger treatment volume. This retrofit will provide better downstream channel protection and promote particulate pollutant settlement. Pollutant indicators include nitrogen, phosphorous and total suspended solids.

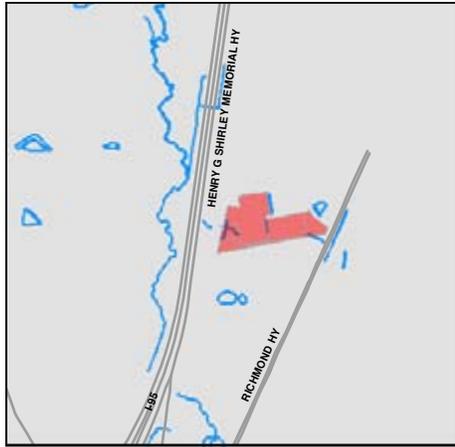
MB9109 Stormwater Pond Retrofit

Address: 8115 Mims St., Lorton, Virginia
Location: Pond at Cardinal Concrete
Land Owner: Private – Cardinal Concrete Co., Lorton Storage LLC, Liliana Enterprises LLC
PIN: 1132 04 0001, 1132 04 0002B, 1132 04 0002C
Control Type: Water quality and quantity control
Drainage Area: 97.26 acres
Receiving Waters: Tributary of Giles Run

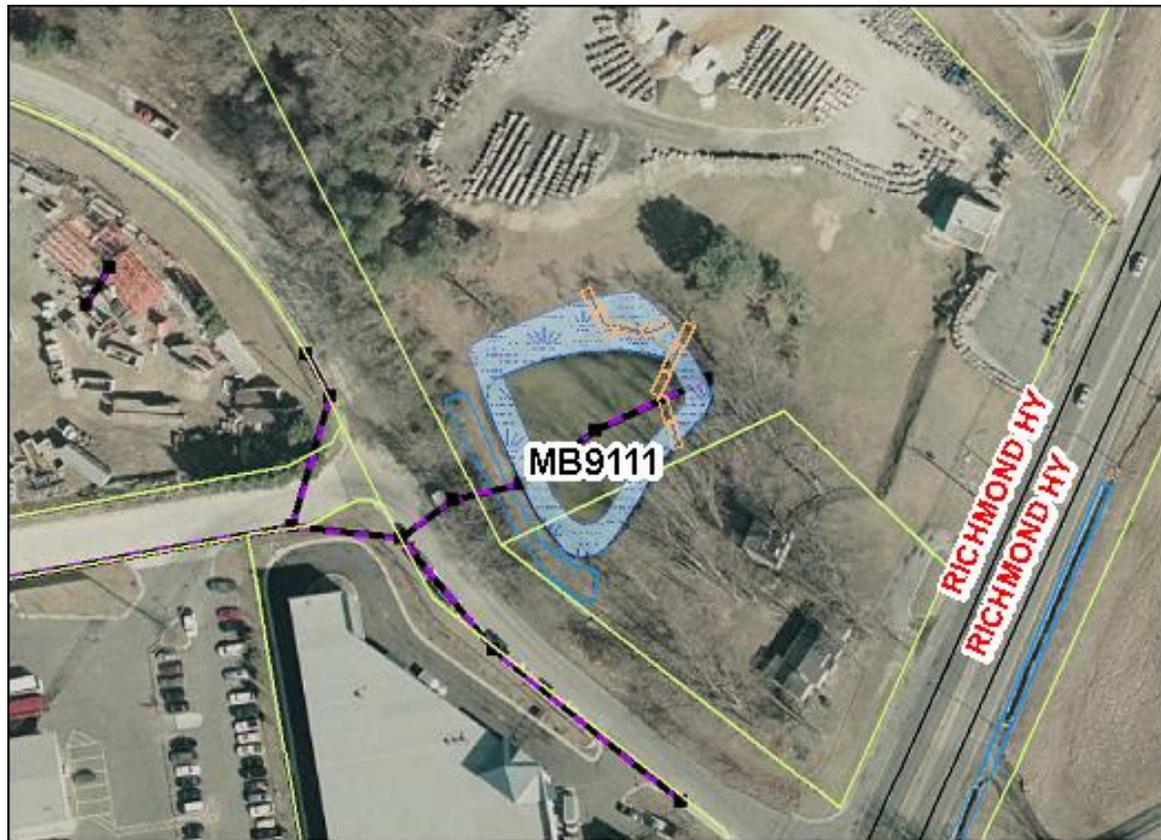
Description: This project proposes retrofitting an existing wet pond east of Mims Street to create a constructed wetland system, with sediment forebay and an engineered landscaping plan. The retrofit will extend the flow path of stormwater runoff in the wetland by enlarging the facility's size and creating high and low marsh areas. The primary pollutant indicators are nitrogen, phosphorous and total suspended solids. The retrofit will increase pollutant removal and provide better channel protection above the permanent pool of standing water. The pool prevents re-suspension of sediments and other pollutants.

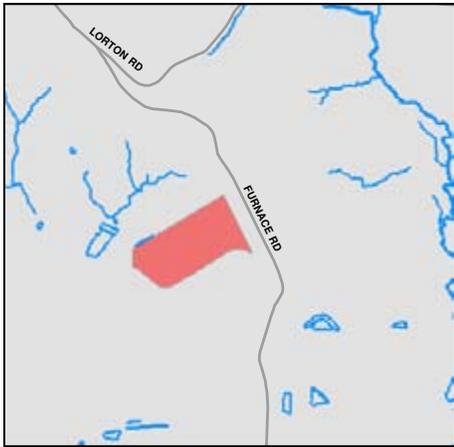
MB9114 Stormwater Pond Retrofit

Address: 9850 Furnace Rd, Lorton, Virginia
Location: I-95 Landfill
Land Owner: Public/Local – Fairfax County Board of Supervisors
PIN: 1073 01 0020
Control Type: Water quality and quantity control
Drainage Area: 2.59 acres
Receiving Waters: Tributary of Giles Run

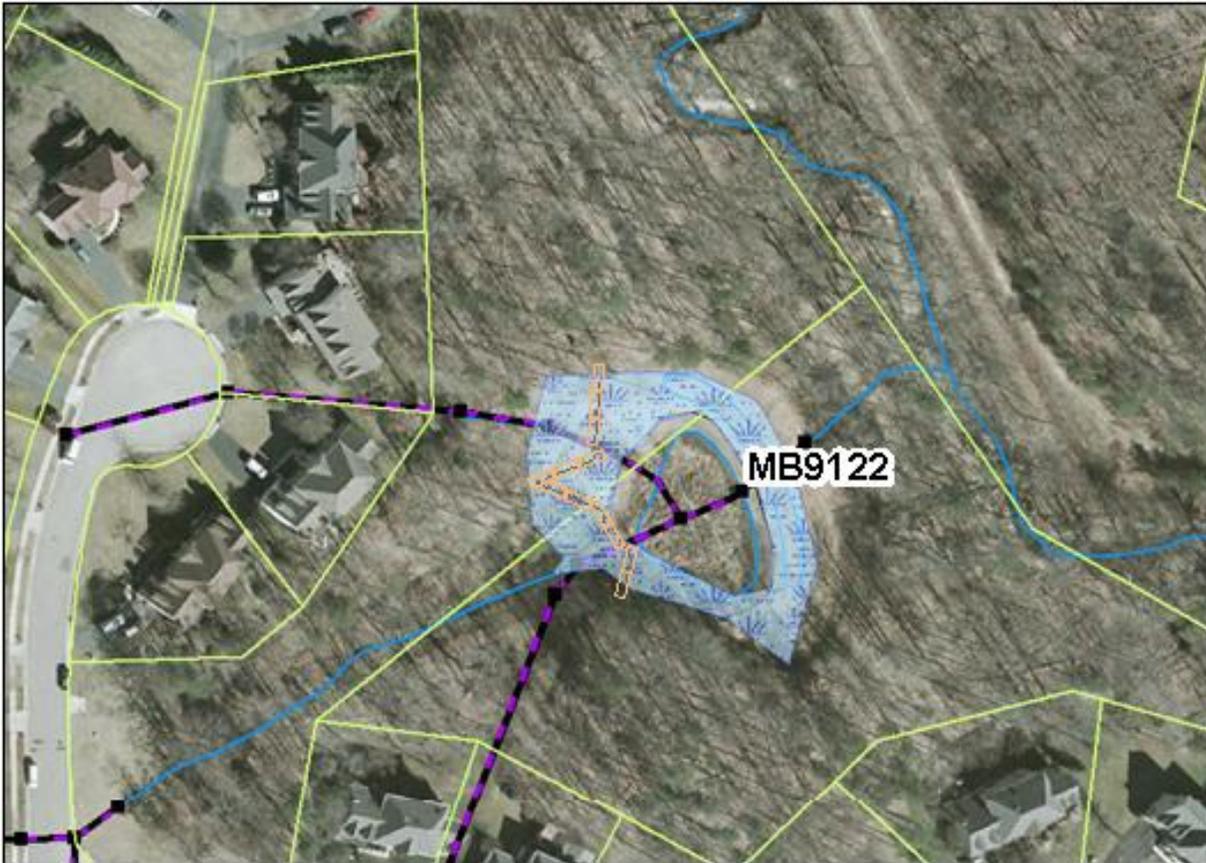
Description: This project proposes the retrofit of an existing public pond east of Cross Chase Circle to create a wetland system with sediment forebays and bench planting. The existing dry pond receives runoff from two pipes and a channel, and sheet flow from the back of the residential houses. The wetland retrofit will include adding two sediment forebays for the stormwater inflows, expanding the pond to provide more time to treat stormwater in the pond and creating high and low marsh areas in the pond to increase the biological uptake in the pond.

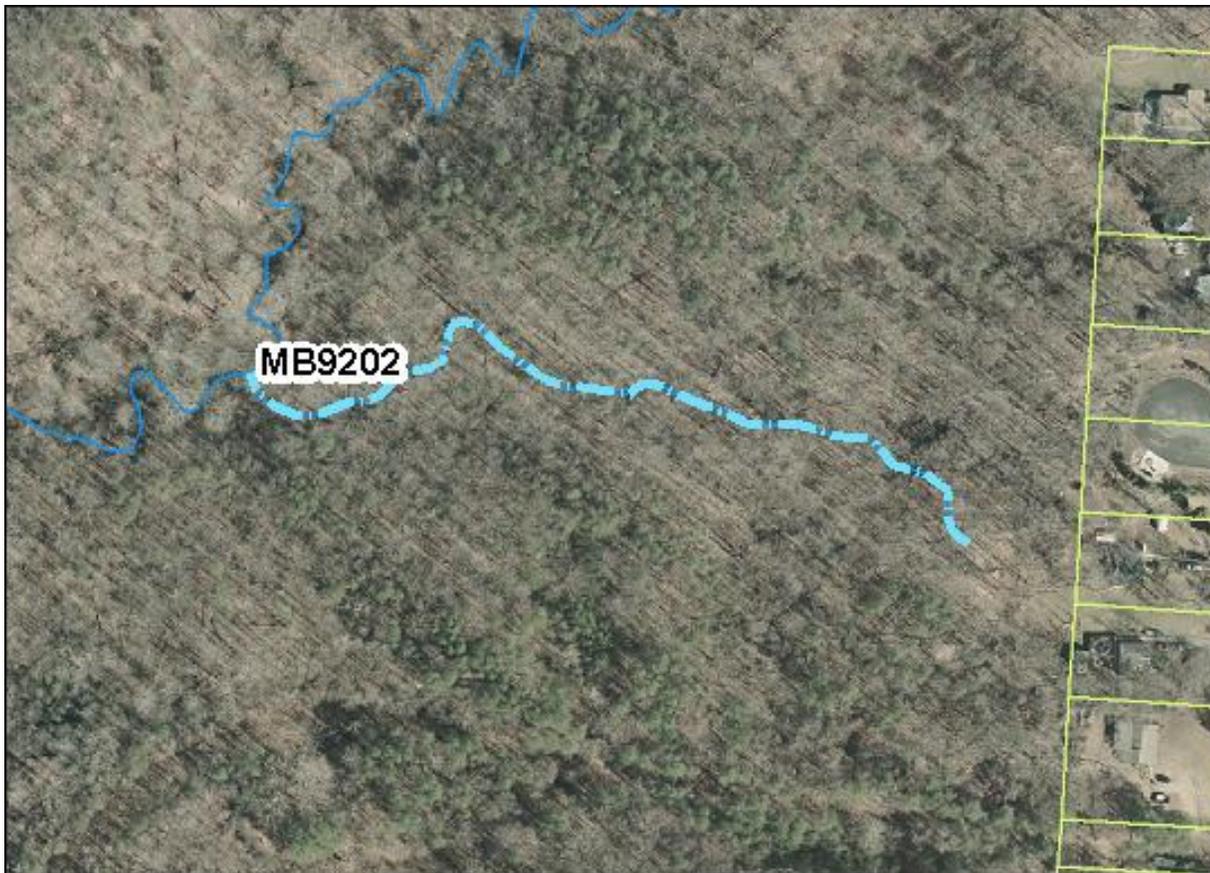
Description: This project proposes the restoration of a stream southeast of Old Colchester Road that flows from east to west. The project proposes to restore channel morphology by improving bed and bank erosion. Erosion will be stabilized through the use of bank shaping, toe protection, erosion-control fabrics and rapid vegetation establishment. The banks will be armored using geofabrics, fabric encapsulated rocks or the equivalent to reduce further erosion. The stream receives runoff from residential housing to the east and surrounding wooded areas.

— Stream Restoration
 — Storm Network
 Property Line
— Streams

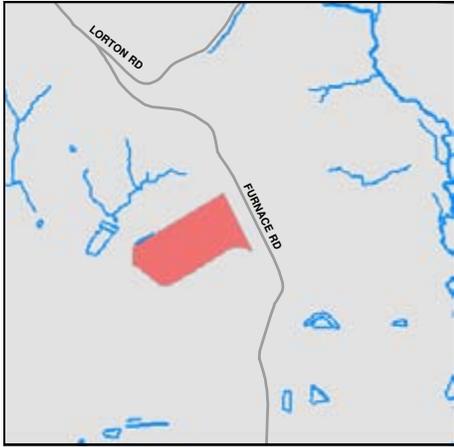
MB9506 BMP/LID

Address: 9850 Furnace Rd, Lorton, Virginia
Location: I-95 Landfill
Land Owner: Public/Local – Fairfax County Board of Supervisors
PIN: 1073 01 0020
Control Type: Water quality and quantity control
Drainage Area: 3.72 acres
Receiving Waters: Tributary of Giles Run

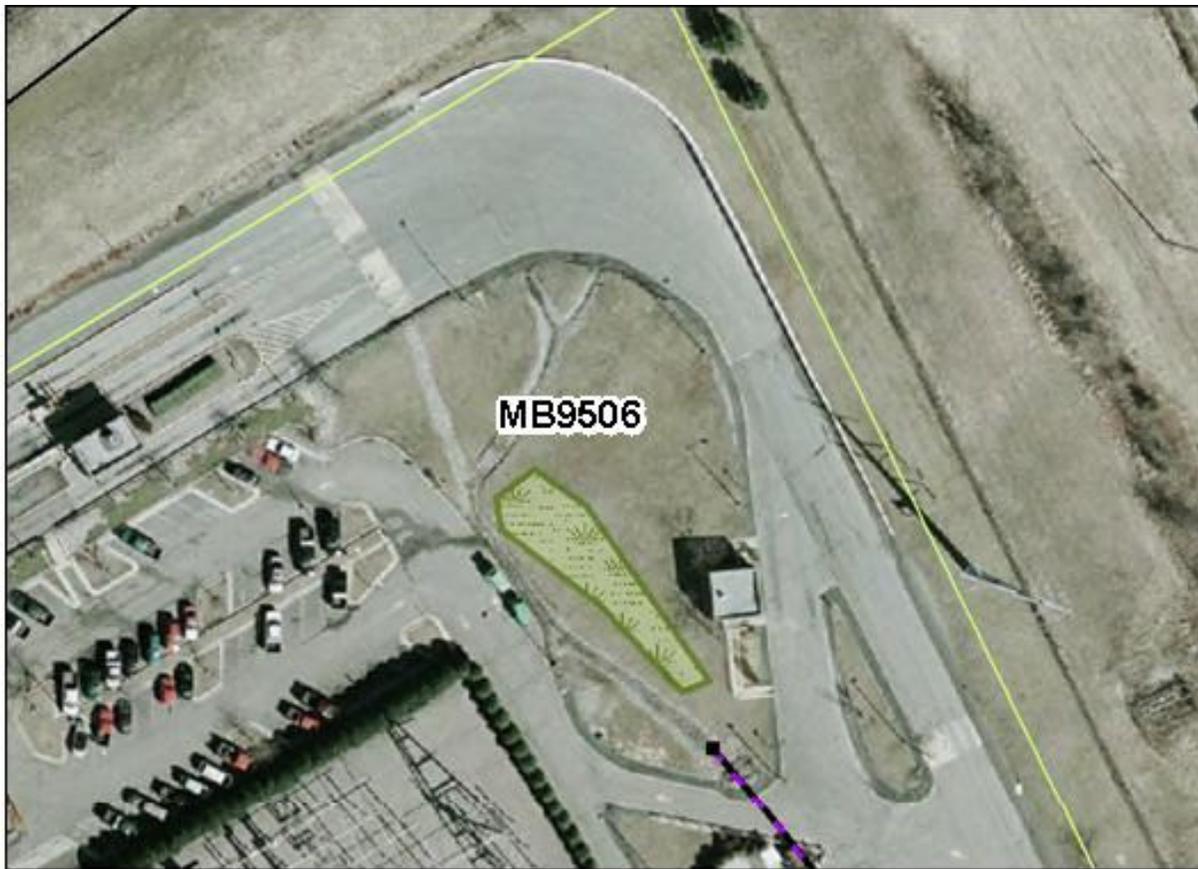
Description: This project proposes the construction of a bioretention area at Fairfax County Landfill. The bioretention landscaping feature will receive runoff from parking lots. The bioretention landscaping feature will have a filter layer made of 18 – 48 inches of sand placed below a mulch layer. During a storm, the runoff will pond 6 – 9 inches, drain through the bioretention filter media, infiltrate into the native soil or outfall to the storm system. The primary indicators are upland sediment, total suspended solids and pollutants, including nitrogen and phosphorous.

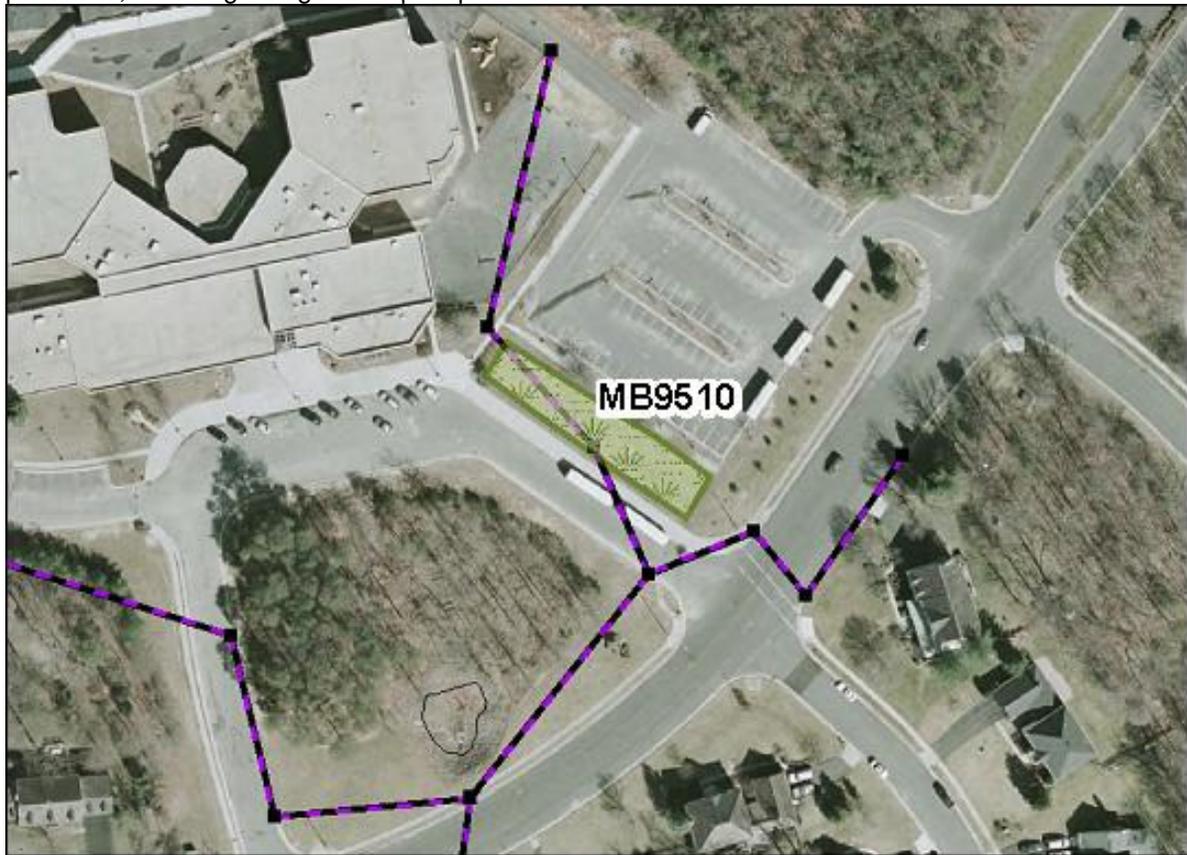
Description: This project proposes the construction of a bioretention area at Silverbrook Elementary School on Crosspointe Drive. The bioretention landscaping feature will receive runoff from the parking lot and building. A filter layer made of 18 – 48 inches of sand will be placed below a mulch layer. During a storm, the runoff will pond 6 –9 inches in the bioretention area, filter through the bioretention media soil, and either outfall to the existing storm system or infiltrate into the native soil. The primary indicators are upland sediment, total suspended solids and pollutants, including nitrogen and phosphorous.

- Bioretention Area
- Storm Network
- Property Line

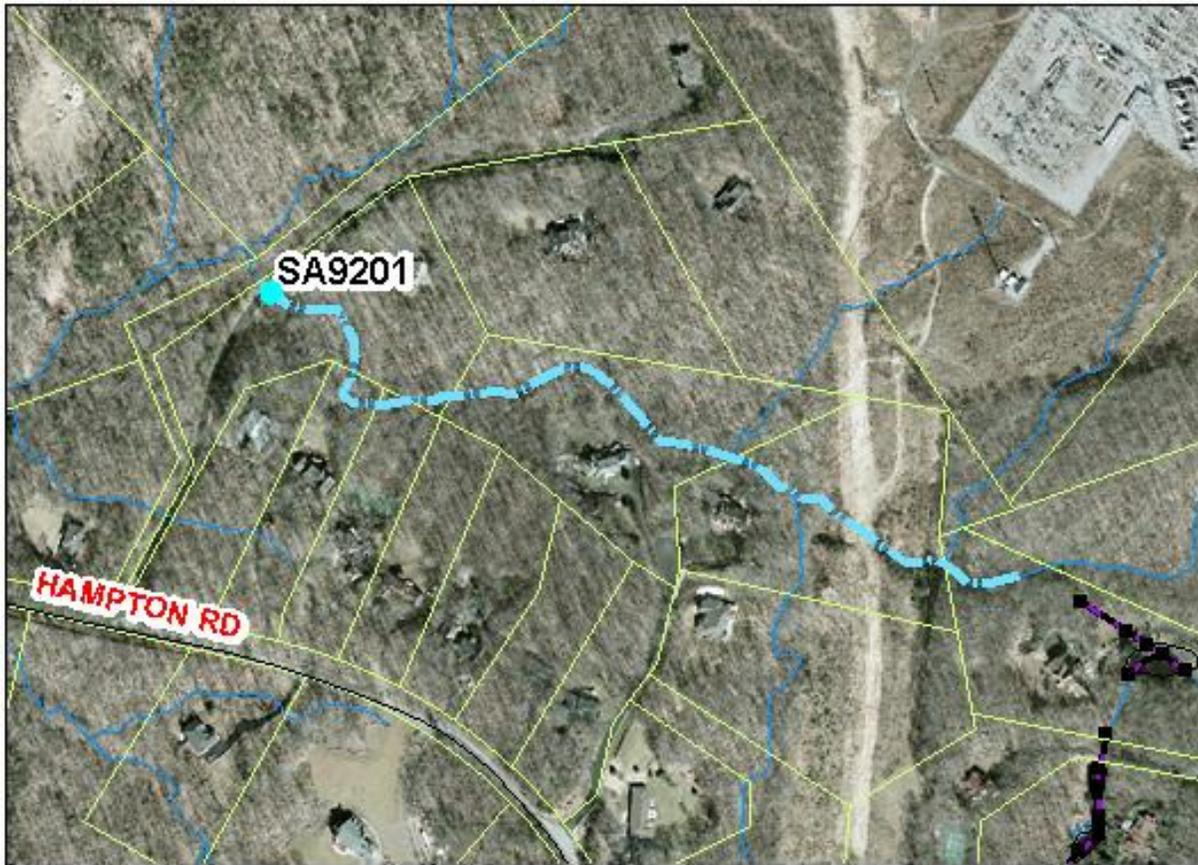
Description: The stream near Birch Cliff Drive conveying runoff from houses, wooded area, and substation area upstream of outfall to Occoquan Reservoir has indicators of poor channel morphology. This project proposes spot improvements along the stream to restore channel morphology and repair eroded areas. Erosion will be stabilized through the use of bank shaping, toe protection, erosion control fabrics and rapid vegetation establishment.

- Stream Restoration
- Storm Network
- Property Line
- Streams

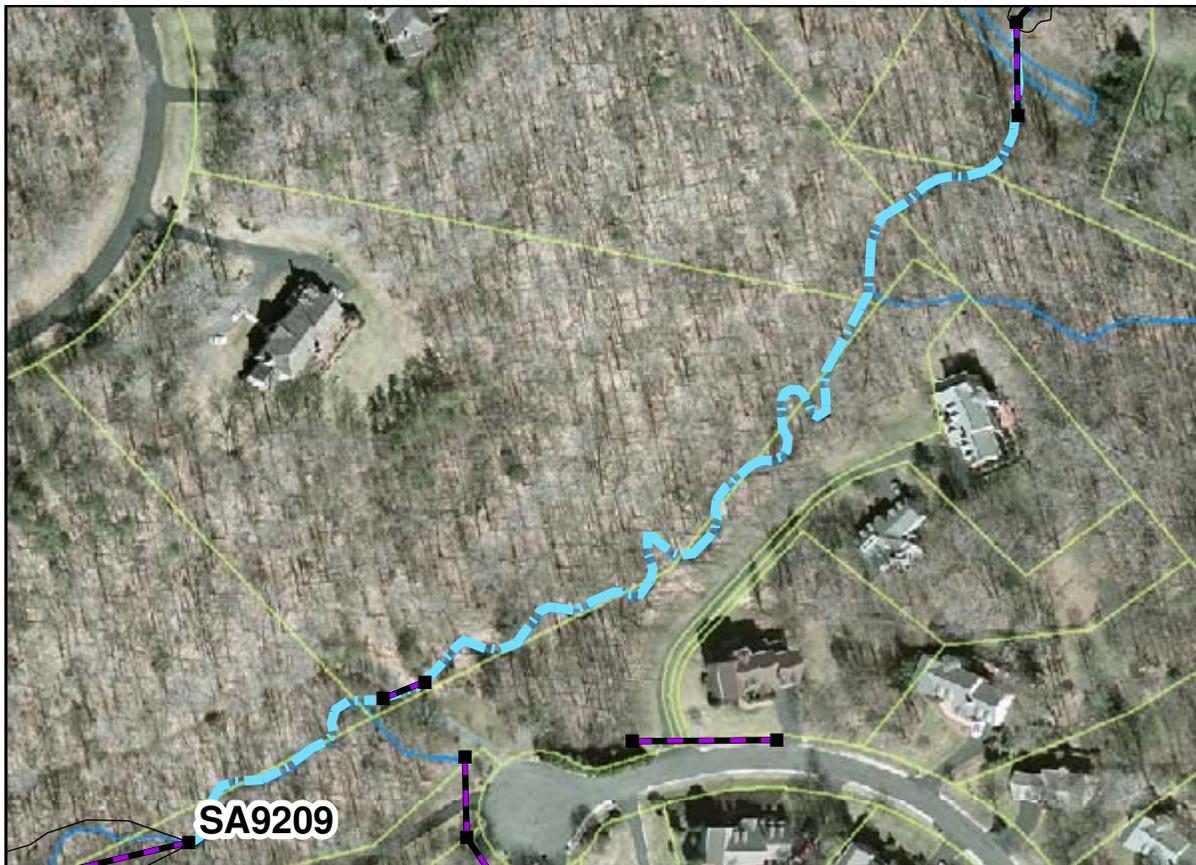
Description: The stream section upstream of Beechnut Court in Fairfax Station conveys runoff from wooded area, housing, and Ox Road has indicators of poor channel morphology. This project proposes spot improvements along the stream to restore channel morphology and repair eroded areas. Erosion will be stabilized through the use of bank shaping, toe protection, erosion control fabrics, and rapid vegetation establishment. The banks will be armored to reduce further erosion using geofabrics, fabric encapsulated rocks or equivalent.

- Stream Restoration
- Storm Network
- Property Line
- Streams

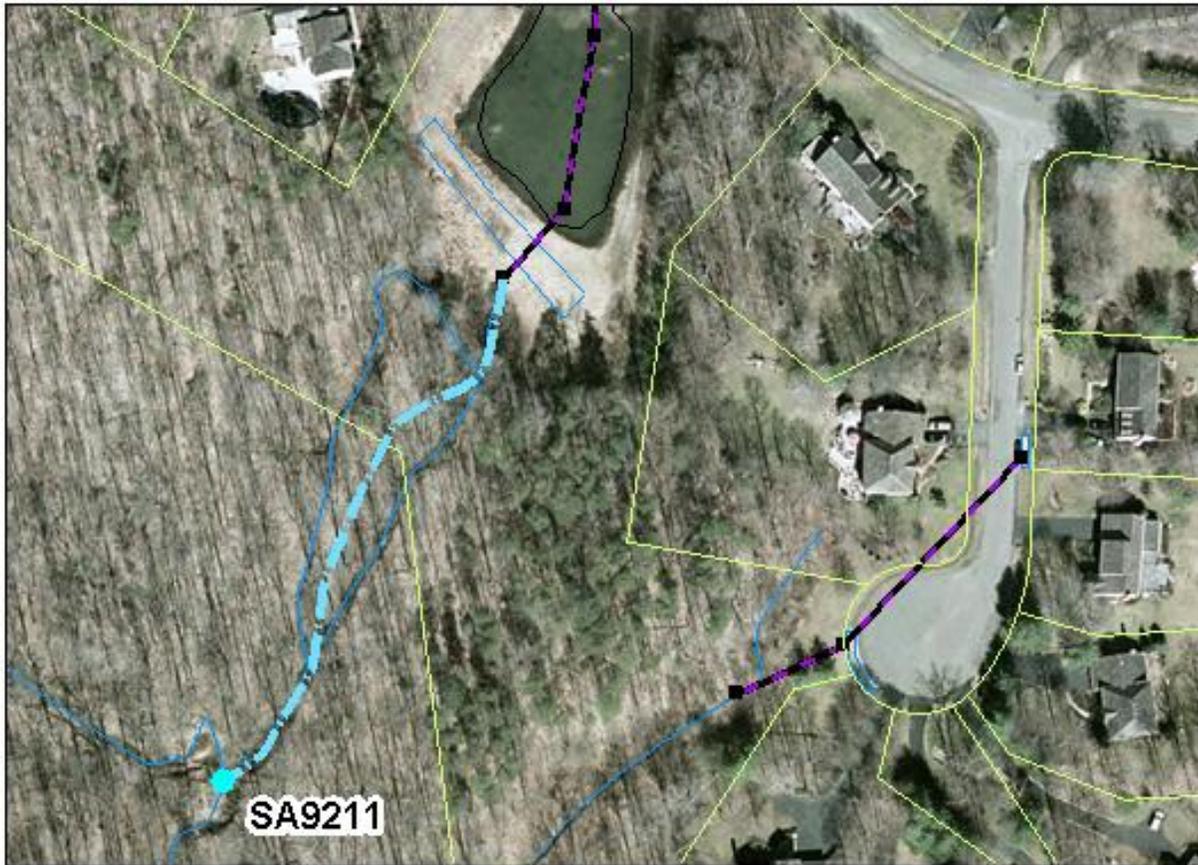
SA9211 Stream Restoration

Description: The stream section east of Streamwood Place in Fairfax Station where two streams converge, conveys runoff from adjacent houses, streets and wooded area has indicators of poor channel morphology. This project proposes spot improvements along the stream to restore channel morphology and repair eroded areas. Erosion will be stabilized through the use of bank shaping, toe protection, erosion control fabrics and rapid vegetation establishment. The banks will be armored to reduce further erosion using geofabrics, fabric encapsulated rocks or equivalent.

- - - - Stream Restoration
 - - - - Storm Network
 - Property Line
 - Streams
- Lower Occoquan Watershed Management Plan 5-93

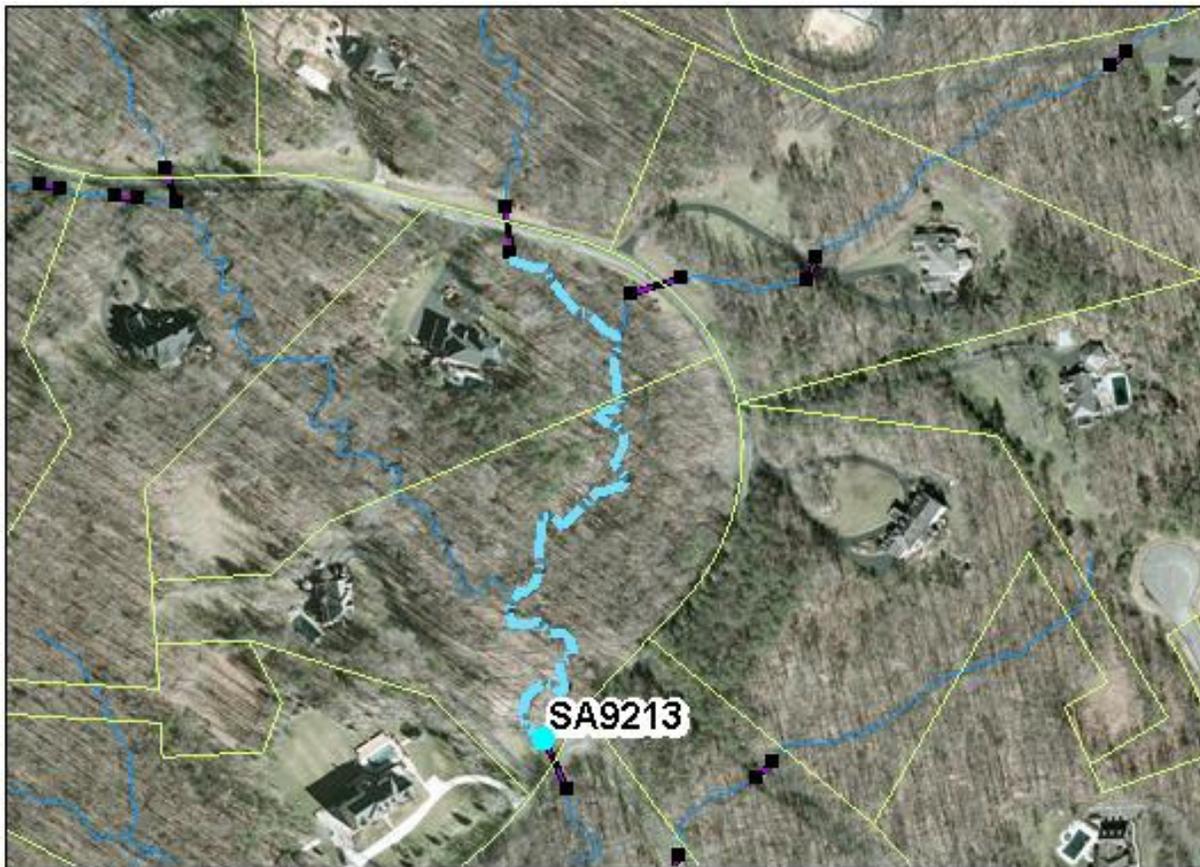
Description: The stream section east of Wolf Run Shoals Road in Fairfax Station conveying runoff primarily from wooded area, several houses, and a building with parking lot, has indicators of poor channel morphology. This project proposes spot improvements along the stream to restore channel morphology and repair eroded areas. Erosion will be stabilized through the use of bank shaping, toe protection, erosion control fabrics, and rapid vegetation establishment.

- Stream Restoration
- Storm Network
- Property Line
- Streams

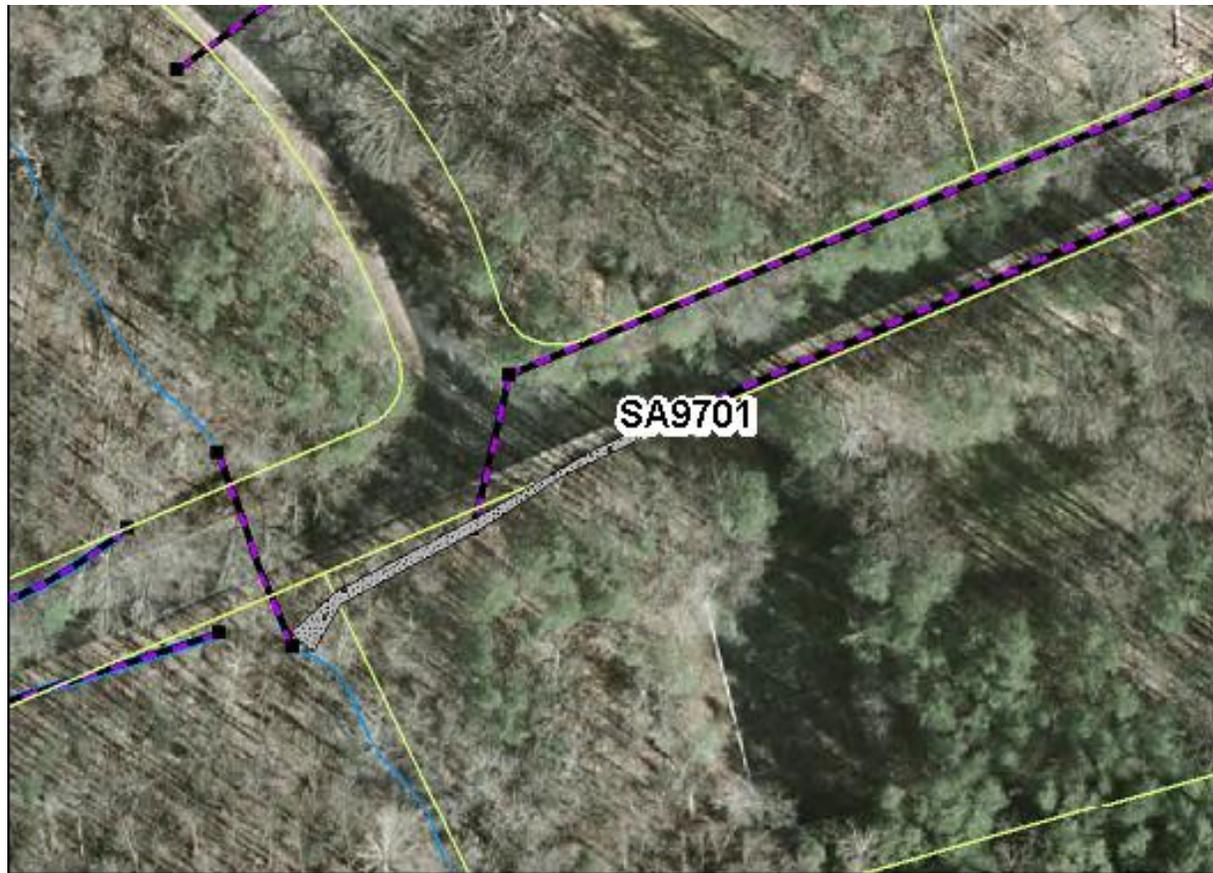
SA9701 Outfall Improvement

Description: This project proposes removing the outfall section of an existing concrete swale along Silverleaf Drive to reduce erosive velocities to the stream and reduce pollutants. Currently, stormwater runs off of Silverleaf Drive into the concrete swale and directly into the adjacent stream with no stormwater treatment. The receiving stream has poor channel morphology. Replacing the existing concrete swale with a natural swale with check dams and step pools, to reduce velocity and encourage infiltration, would help downstream erosion.

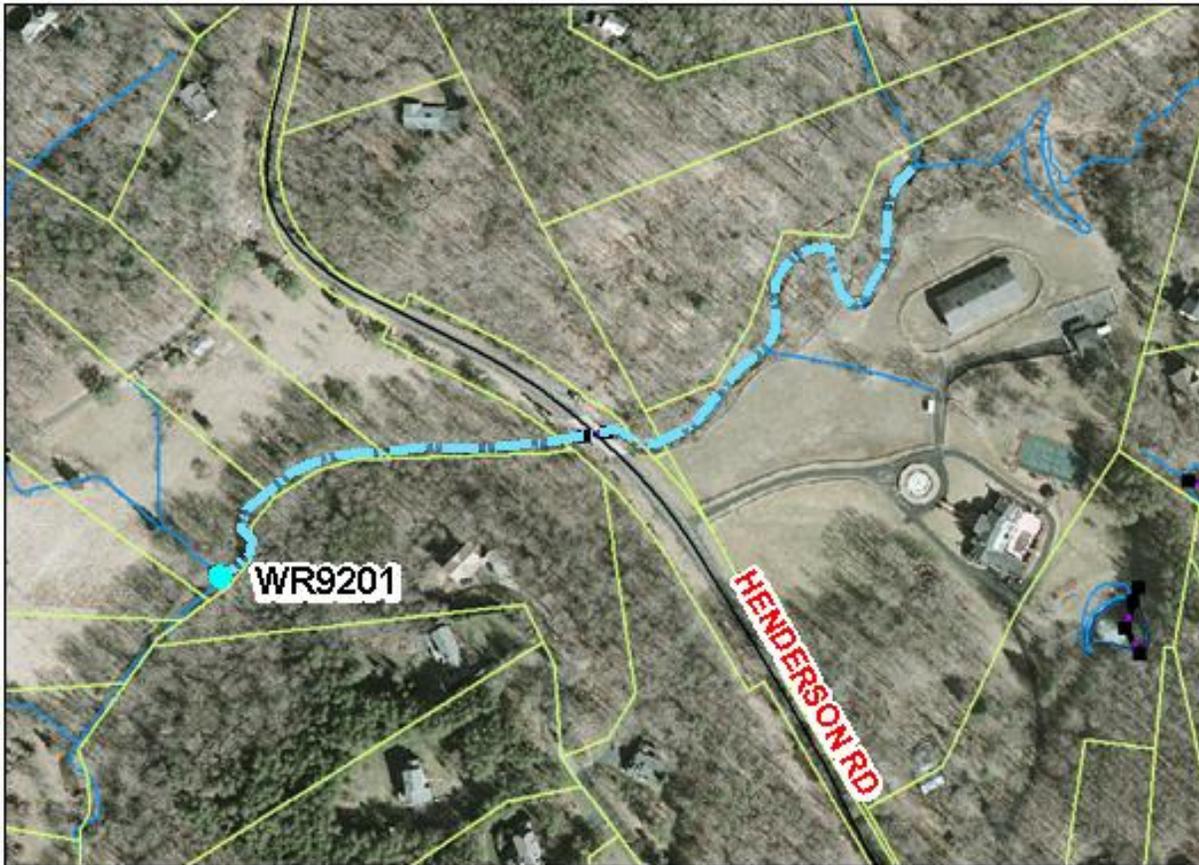
Description: The stream section east of Wolf Valley Drive in Fairfax Station is conveying runoff from wooded area and houses and has indicators of poor channel morphology. The stream crosses under Henderson Road and eventually outfalls to Occoquan Reservoir. This project proposes repairing bank and bed erosion to restore channel morphology. Erosion will be stabilized through the use of bank shaping, toe protection, erosion control fabrics and rapid vegetation establishment. The banks will be armored using geofabrics, fabric encapsulated rocks or equivalent to reduce further erosion.

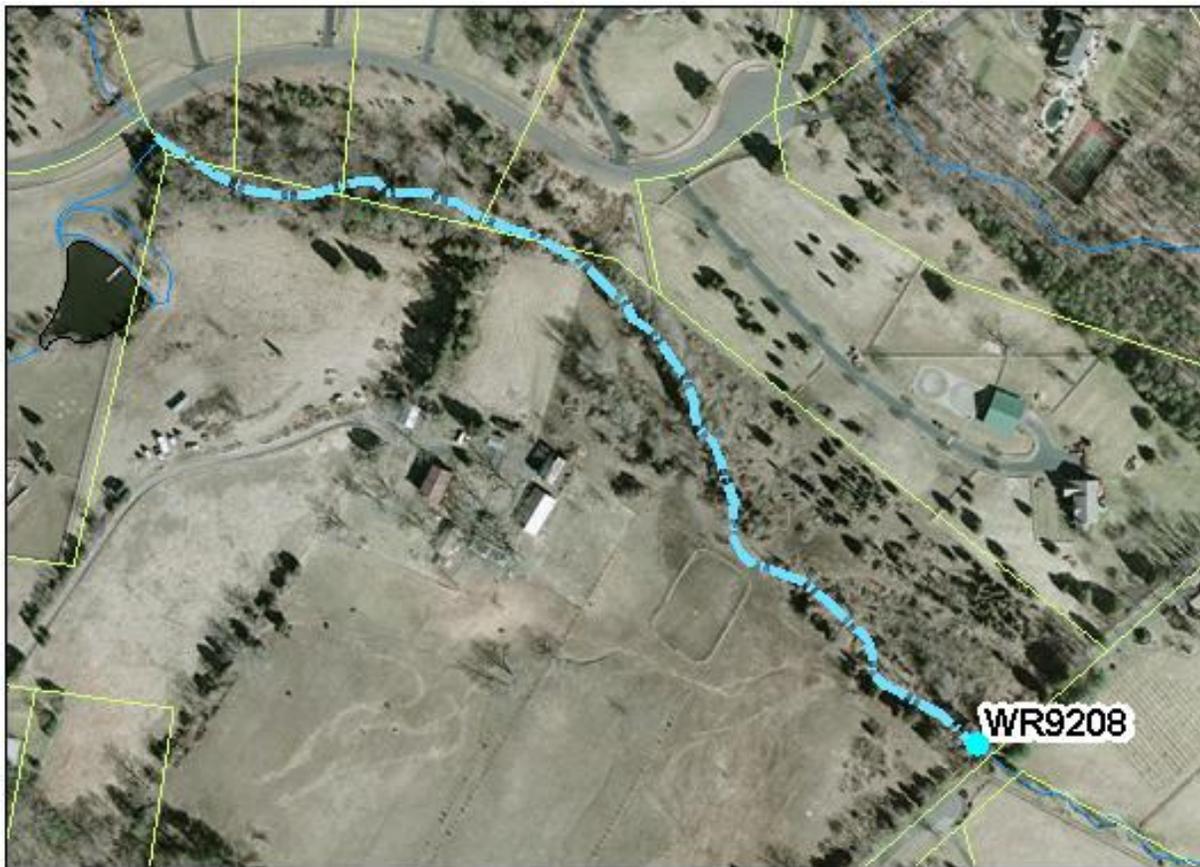
WR9208 Stream Restoration

Description: The stream section east of Turtle Valley Drive is conveying runoff from open space and houses and has indicators of poor channel morphology. This project proposes repairing bank and bed erosion to restore channel morphology. Erosion will be stabilized through the use of bank shaping, toe protection, erosion control fabrics and rapid vegetation establishment. The banks will be armored using geofabrics, fabric encapsulated rocks or equivalent to reduce further erosion.

- Stream Restoration
- Storm Network
- Property Line
- Streams
