Lower Occoquan Watershed Management Plan

Fairfax County Department of Public Works and Environmental Services - Stormwater Planning Division

Prepared by: PBS&J, an Atkins company
December 22, 2010

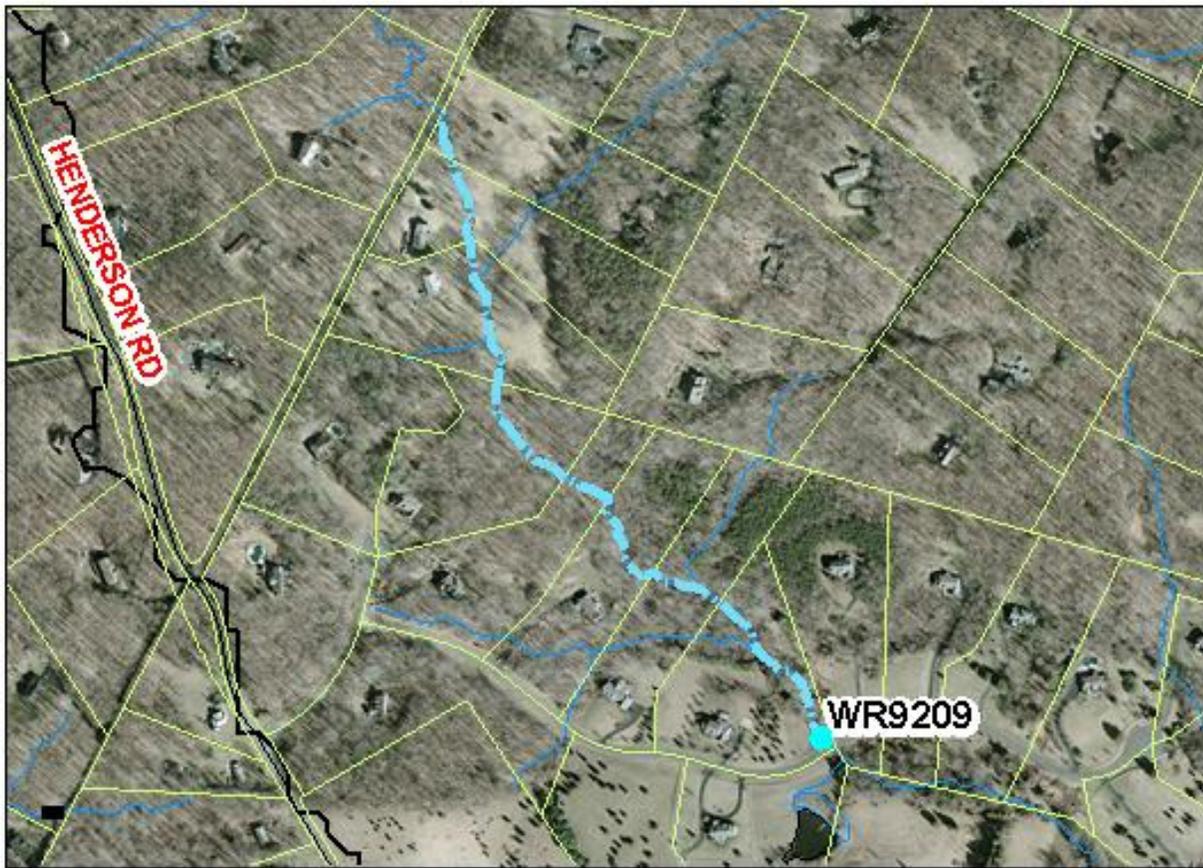
Description: Stream section near Rose Hall Drive conveying runoff from upstream houses and wooded area has indicators of poor channel morphology. The stream is in a steep wooded area and portions are close to homes and roadways. This project proposes repairing bank and bed erosion to restore channel morphology. Erosion will be stabilized through the use of bank shaping, toe protection, erosion control fabrics and rapid vegetation establishment. The banks will be armored using geofabrics, fabric encapsulated rocks or equivalent to reduce further erosion.

Stream Restoration		Storm Network		Property Line		Streams
--	--------------------	--	---------------	--	---------------	--	---------

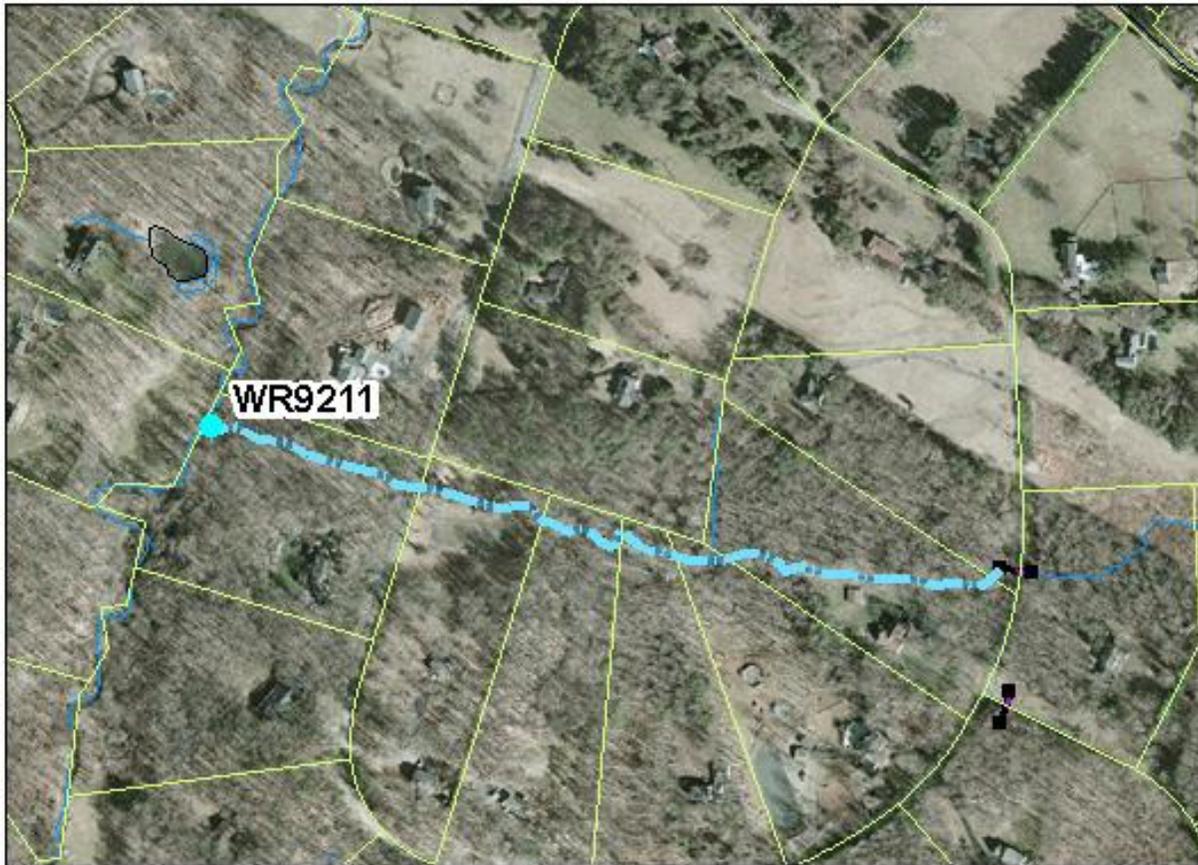
Description: The stream section west of Amkin Drive is conveying runoff from upstream houses and wooded area and has indicators of poor channel morphology. The stream receives runoff from adjacent residential and wooded areas and conveys stormwater from the stream to the east. This project proposes repairing bank and bed erosion to restore channel morphology. Erosion will be stabilized through the use of bank shaping, toe protection, erosion control fabrics and rapid vegetation establishment. The banks will be armored using geofabrics, fabric encapsulated rocks or equivalent to reduce further erosion.

- Stream Restoration
- Storm Network
- Property Line
- Streams

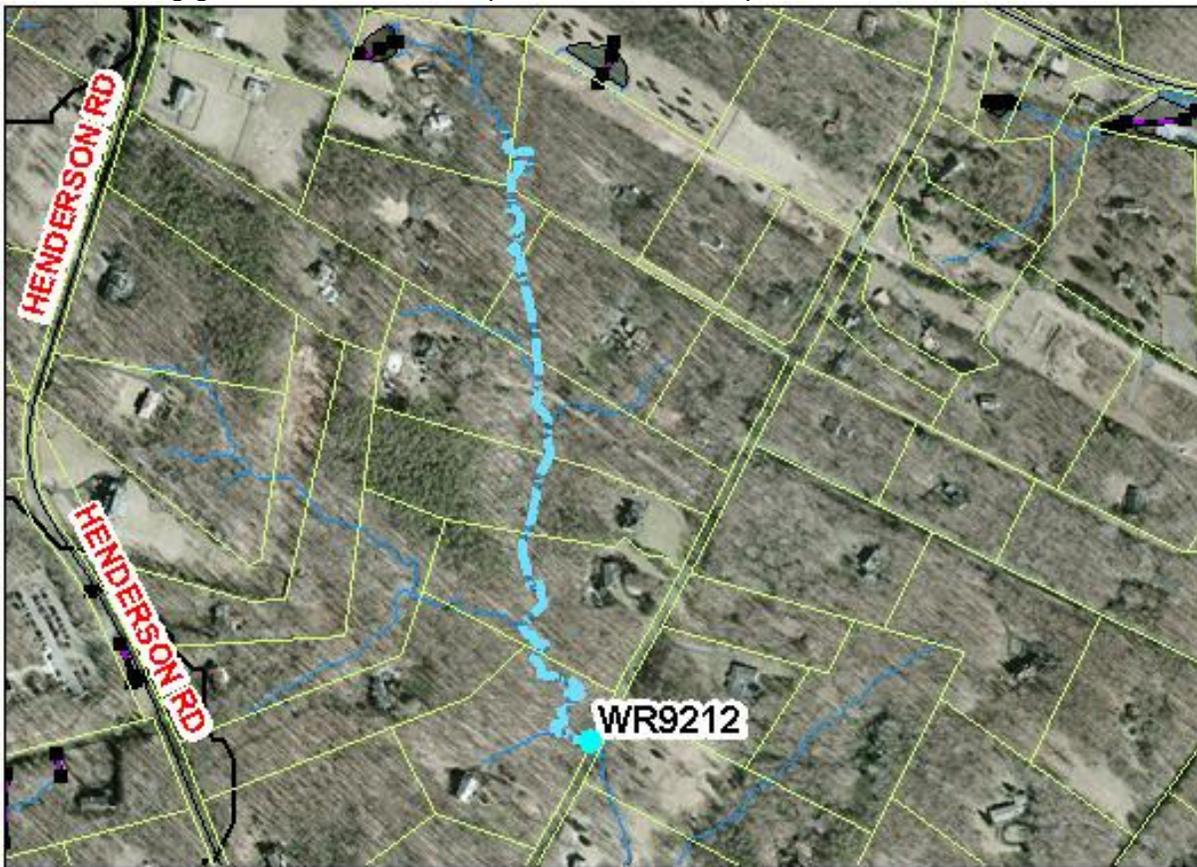
Address: 7610 Maple Branch Rd., Clifton, Virginia
Location: Stream section upstream of Maple Branch Rd.
Land Owner: Private – private owners
PIN: 0861 09 0004, 0863 02 0002, 0863 02 0003, 0863 02 0005, 0863 12 0004, 0863 12 0005A, 0863 12 0006A, 0863 12 0007
Control Type: Water quality control
Drainage Area: N/A
Receiving Waters: Tributary of Wolf Run

Description: The stream section near Maple Branch Road is conveying runoff from upstream houses and wooded area and has indicators of poor channel morphology. This project proposes repairing bank and bed erosion to restore channel morphology. Erosion will be stabilized through the use of bank shaping, toe protection, erosion control fabrics and rapid vegetation establishment. The banks will be armored using geofabrics, fabric encapsulated rocks or equivalent to reduce further erosion.
