Little Rocky Run – Johnny Moore Creek Watershed Management Plan

December 2010

Prepared by
AMEC Earth & Environmental, Inc.

Fairfax County Department of Public
Works and Environmental Services
Stormwater Planning Division

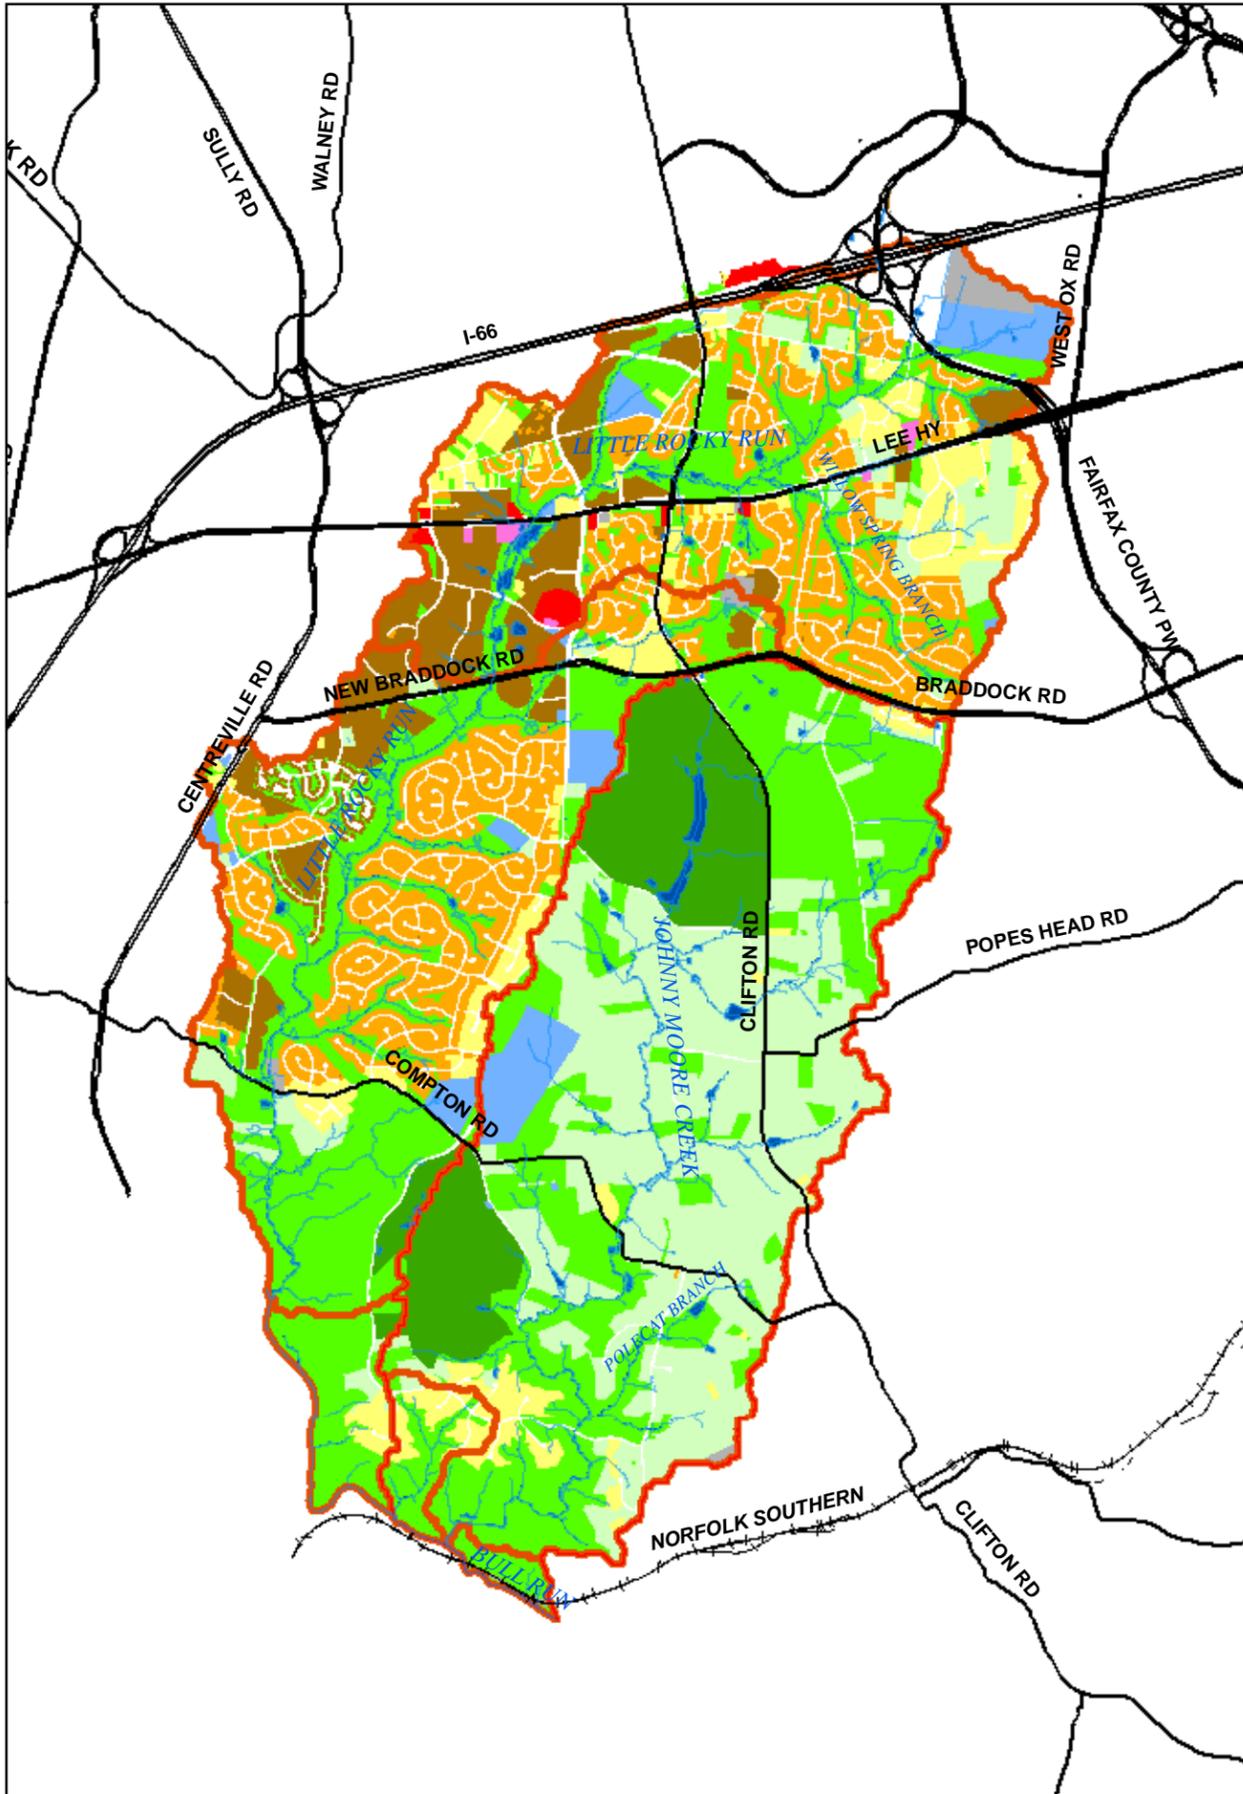
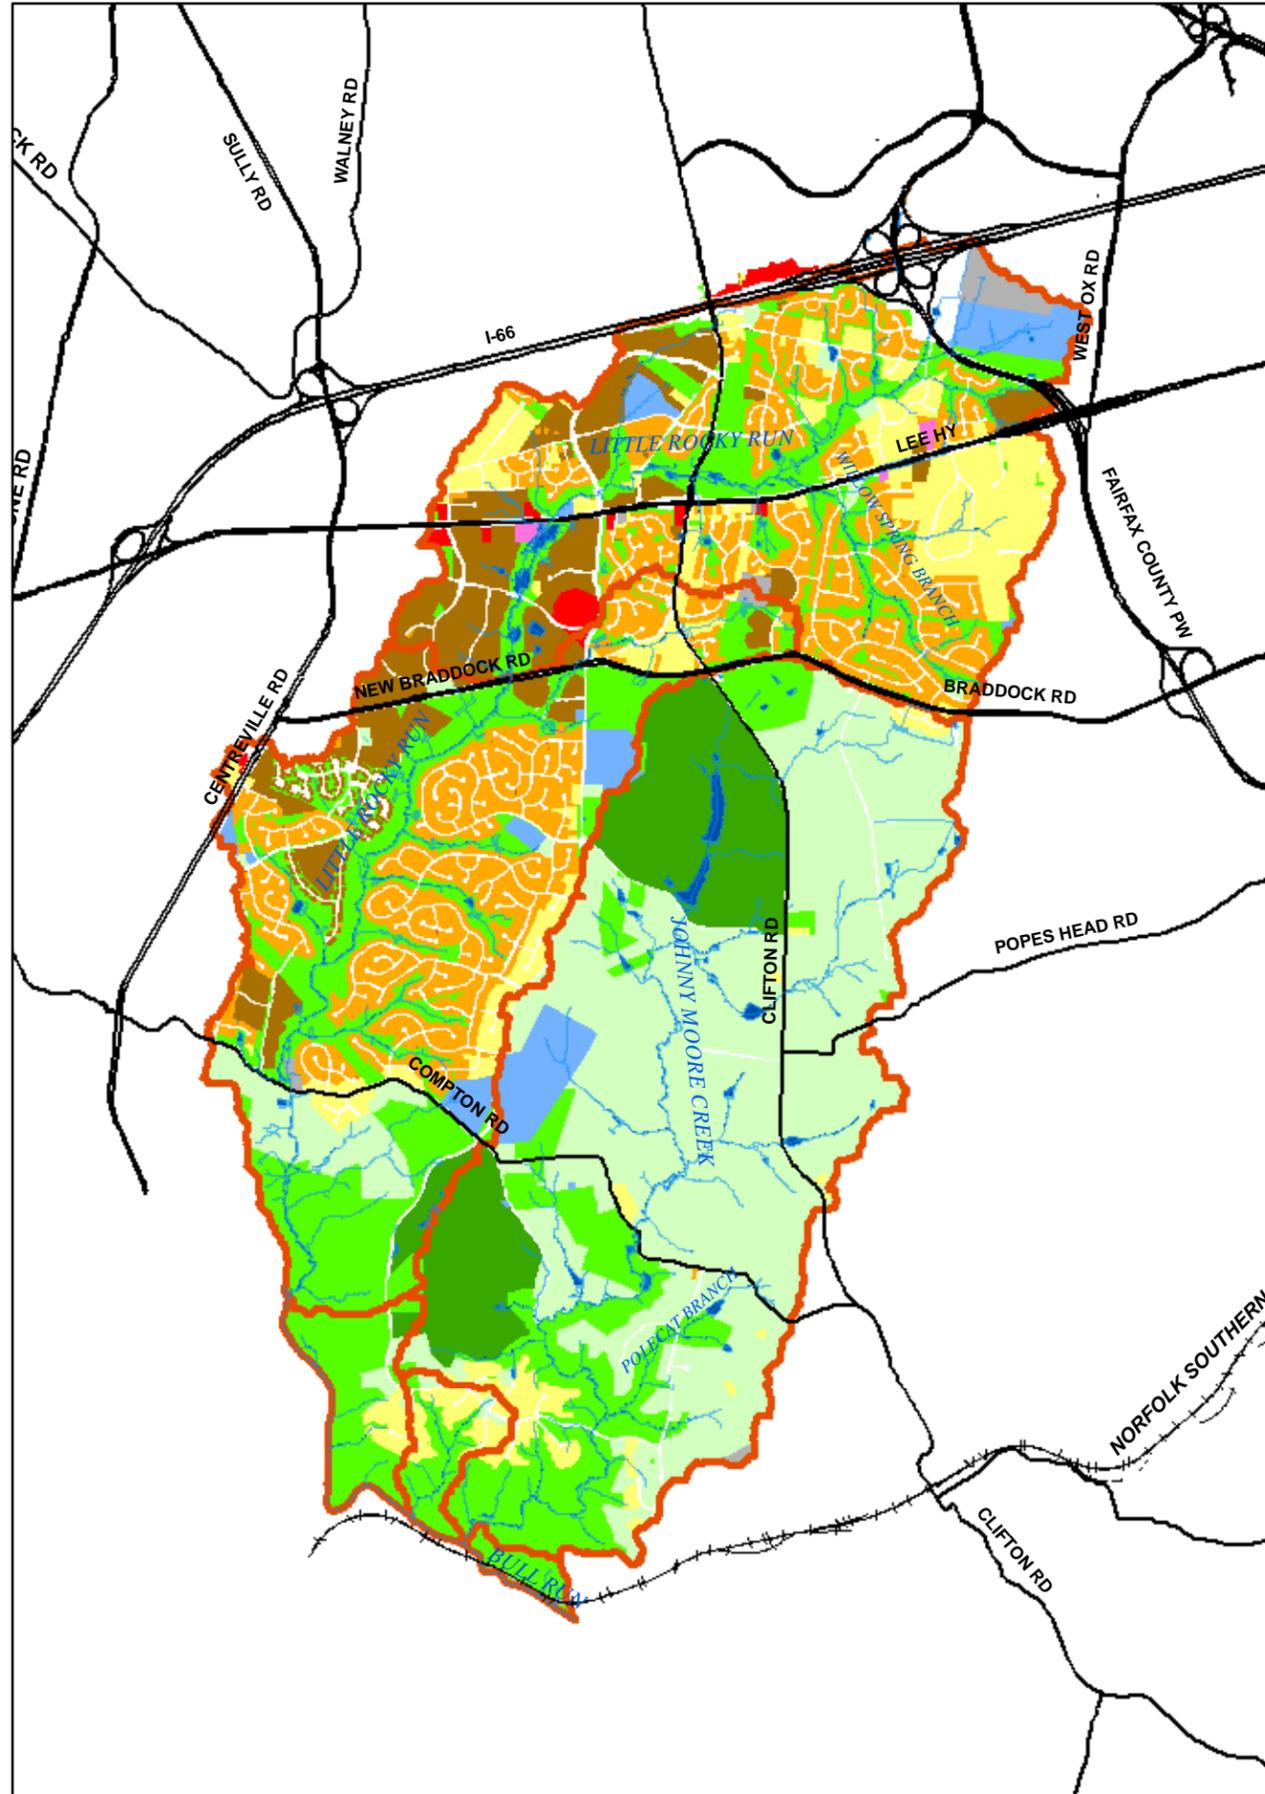
Map 3-3 Existing and Future Land Use Maps

Existing Conditions Land Use Map

Future Conditions Land Use Map

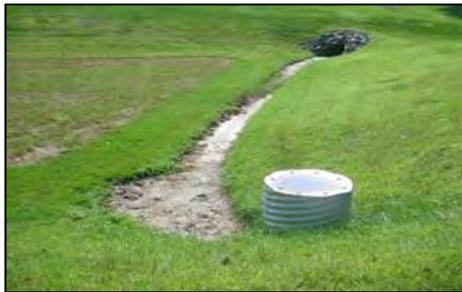
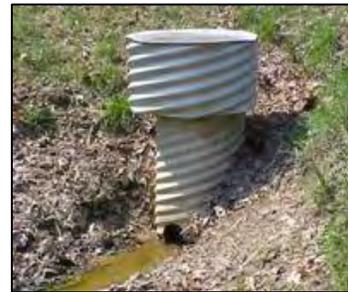
Problematic Conditions:

Stormwater Pond was non-functional due to deterioration of control structures and depleted storage volume.

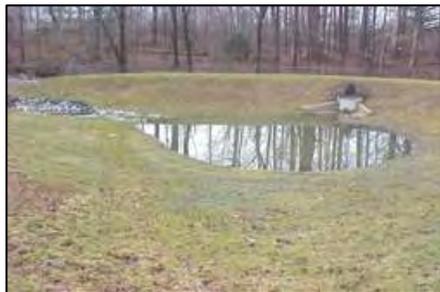
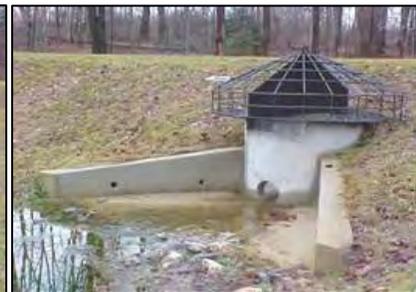
The pond has been seeded with an approved wetland seed mix and is currently stabilizing. Once it is stable the control devices (BMP plate and Trash Rack) will be installed.

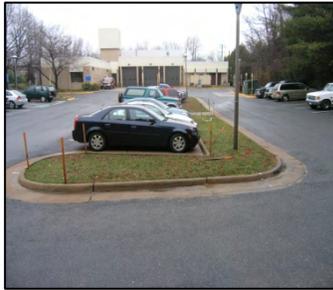
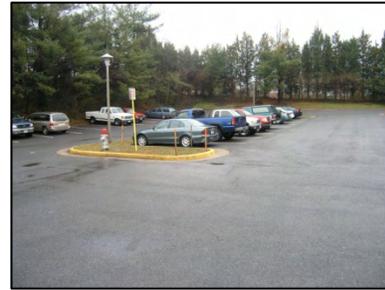
Problematic Conditions:

Stormwater from impervious surfaces lacked quality and quantity treatment. Installation of a rain garden (bioretention basin) provides for water quality treatment and groundwater recharge through infiltration. The porous pavement provides for greater infiltration of runoff.

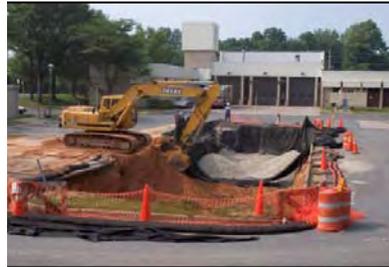
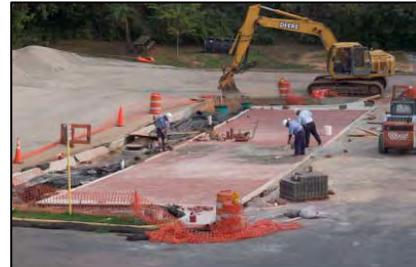
Stormwater runoff is treated by rapid filtering through bioretention soil media, biological and biochemical reactions within the soil matrix and around the root zones of the plants, and infiltration into the underlying soil strata.

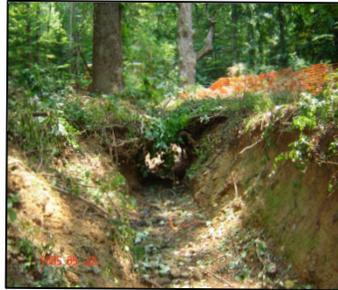
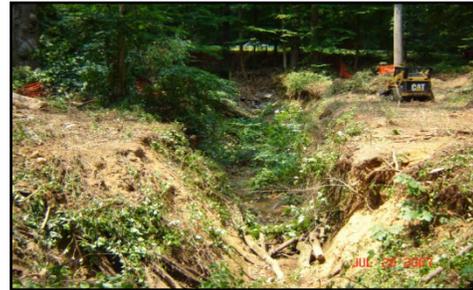
Problematic Conditions:

Large quantities of uncontrolled stormwater caused bank erosion, tree loss and negative impacts to aquatic life.

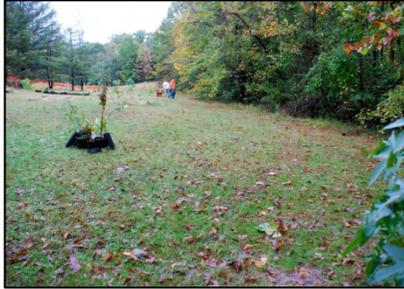
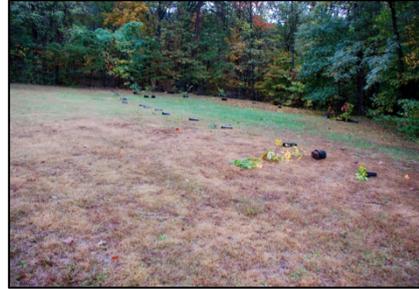
Problematic Conditions:

Lack of a native riparian buffer decreases the amount of rain that infiltrates into the groundwater and increases the amount of pollutants that enter our waterways.

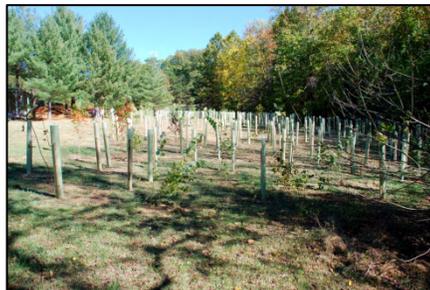
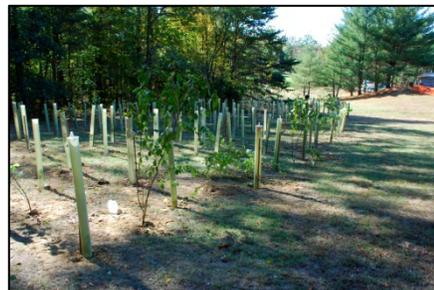
Future monitoring and maintenance is required to ensure survival of the plants. When mature, this area will provide a balanced ecosystem that will help reduce stormwater impacts and create habitat for wildlife.

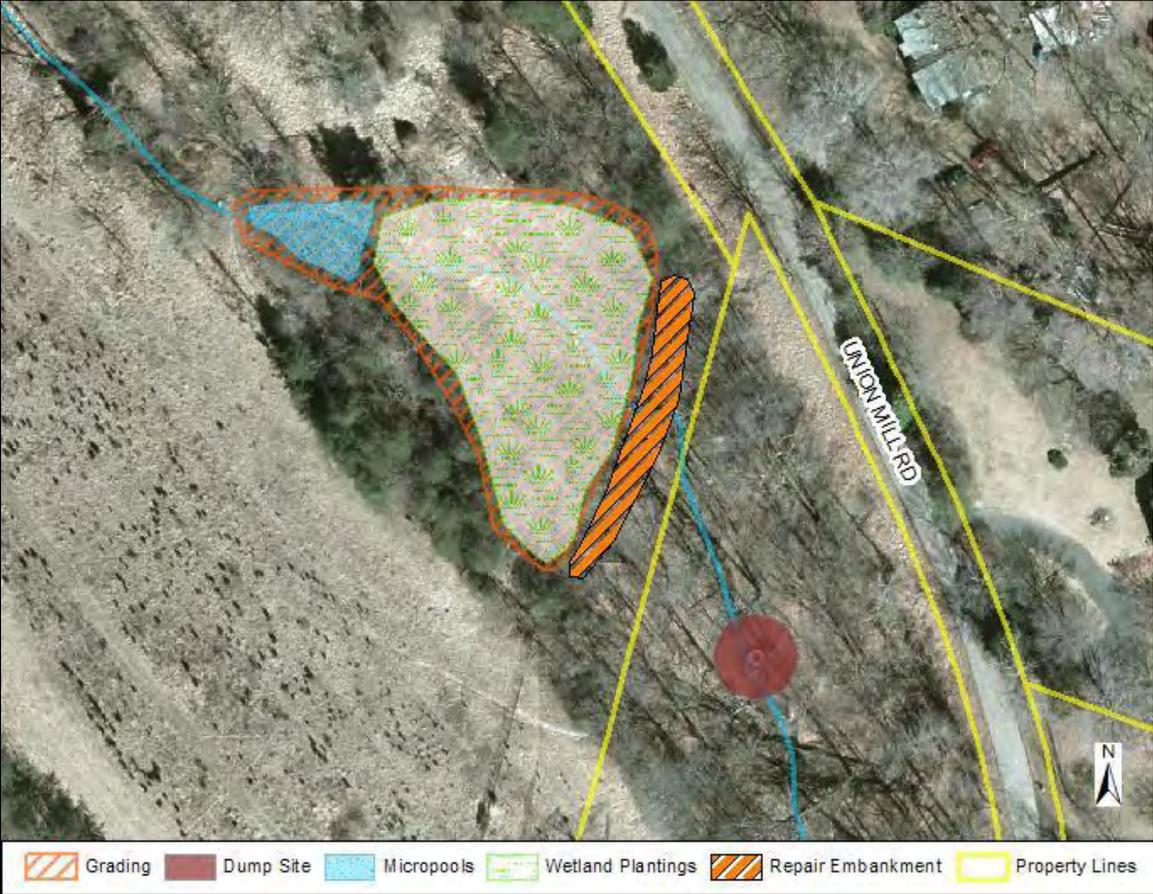
Project Area Map

Description: Pond retrofit JM9100 addresses a stormwater pond that has fallen into disrepair and currently provides little to no detention or treatment. JM9100 calls for pond embankment repairs, new micropools and wetland plantings, and removal of debris downstream of the pond.

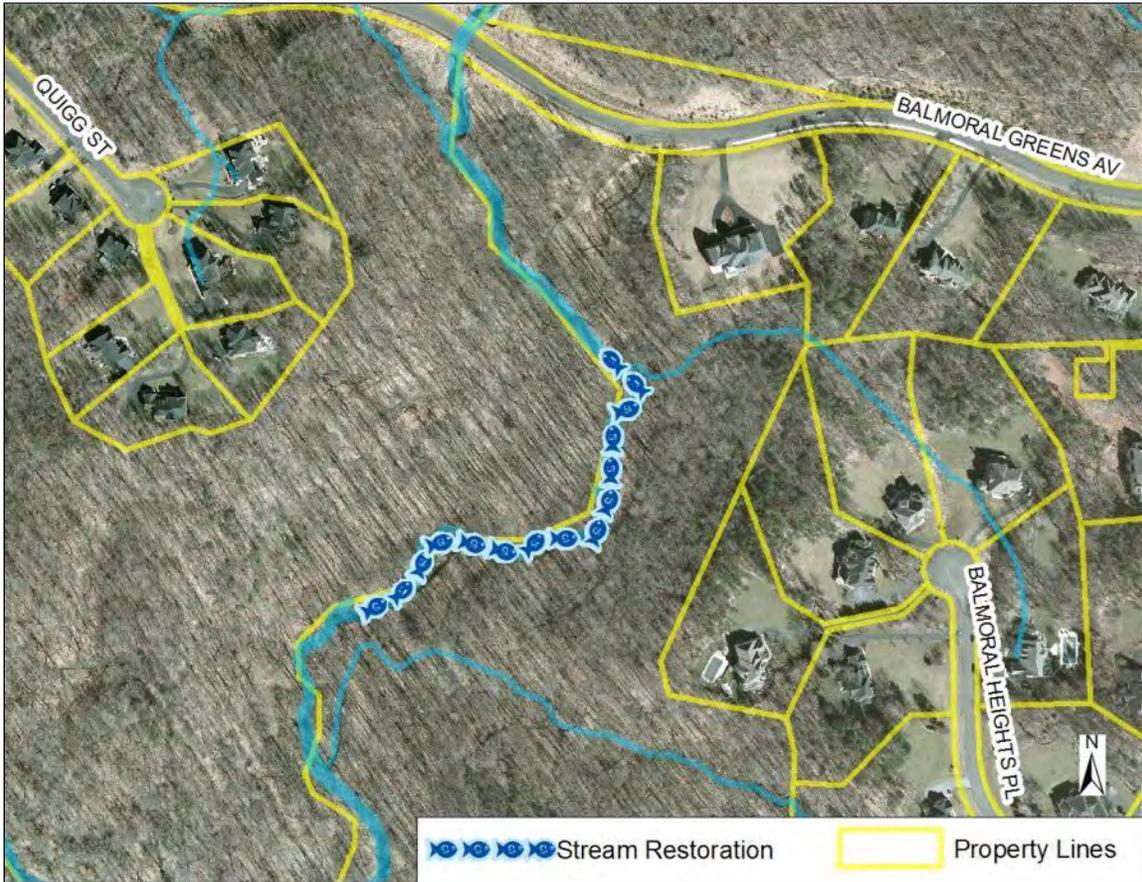
Project Area Map

Description: Johnny Moore Creek suffers from severe bank erosion in the area shown below. Project JM9200 will restore the stream to a more stable, natural state to prevent future erosion and promote habitat health and diversity.

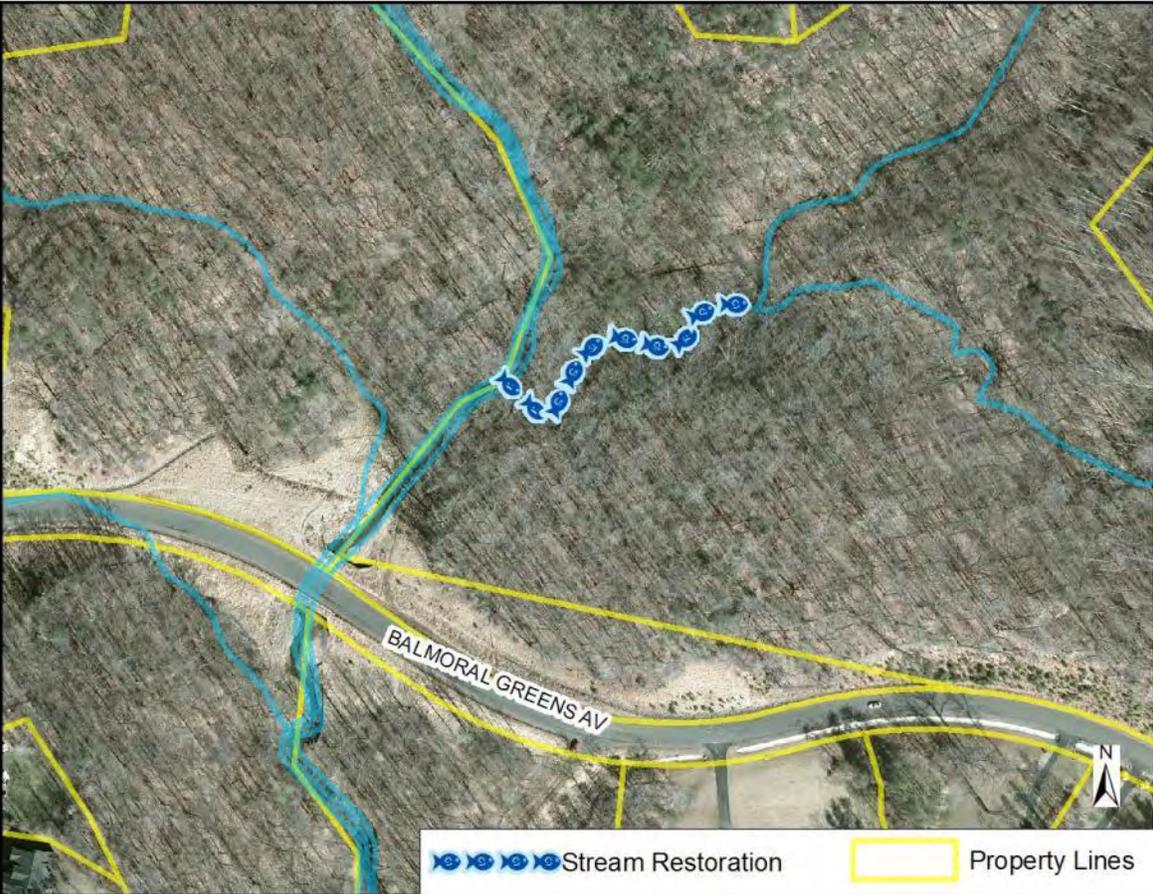
Description: Stream restoration project JM9201 addresses erosion in the downstream portion of Polecat Branch. Project JM9201 will restore the stream to a more stable, natural state to prevent future erosion and promote habitat health and diversity.

Stream Restoration Property Lines

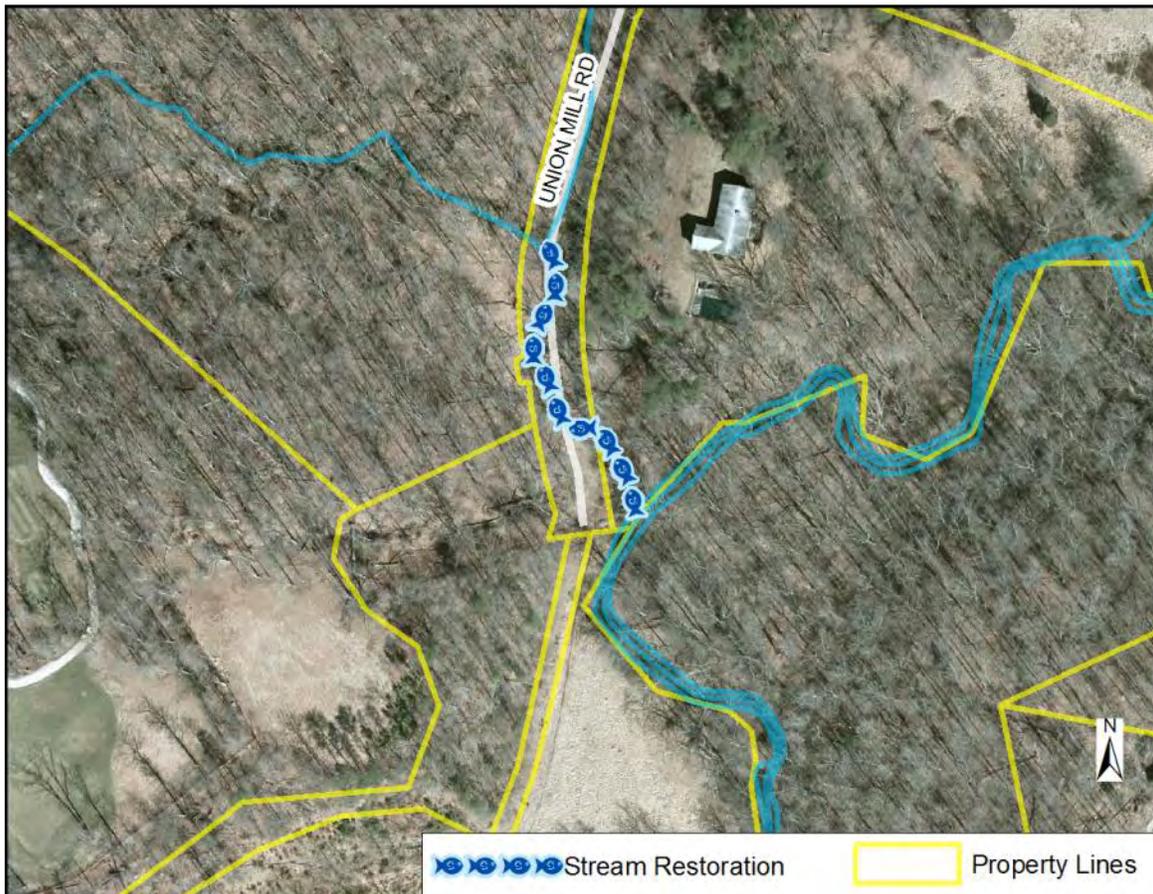
Project Area Map

Description: The tributary to Johnny Moore Creek that crosses Union Mill Rd (as shown below) suffers from erosion. Project JM9202 will restore the stream to a more stable, natural state to prevent future erosion and promote habitat health and diversity.

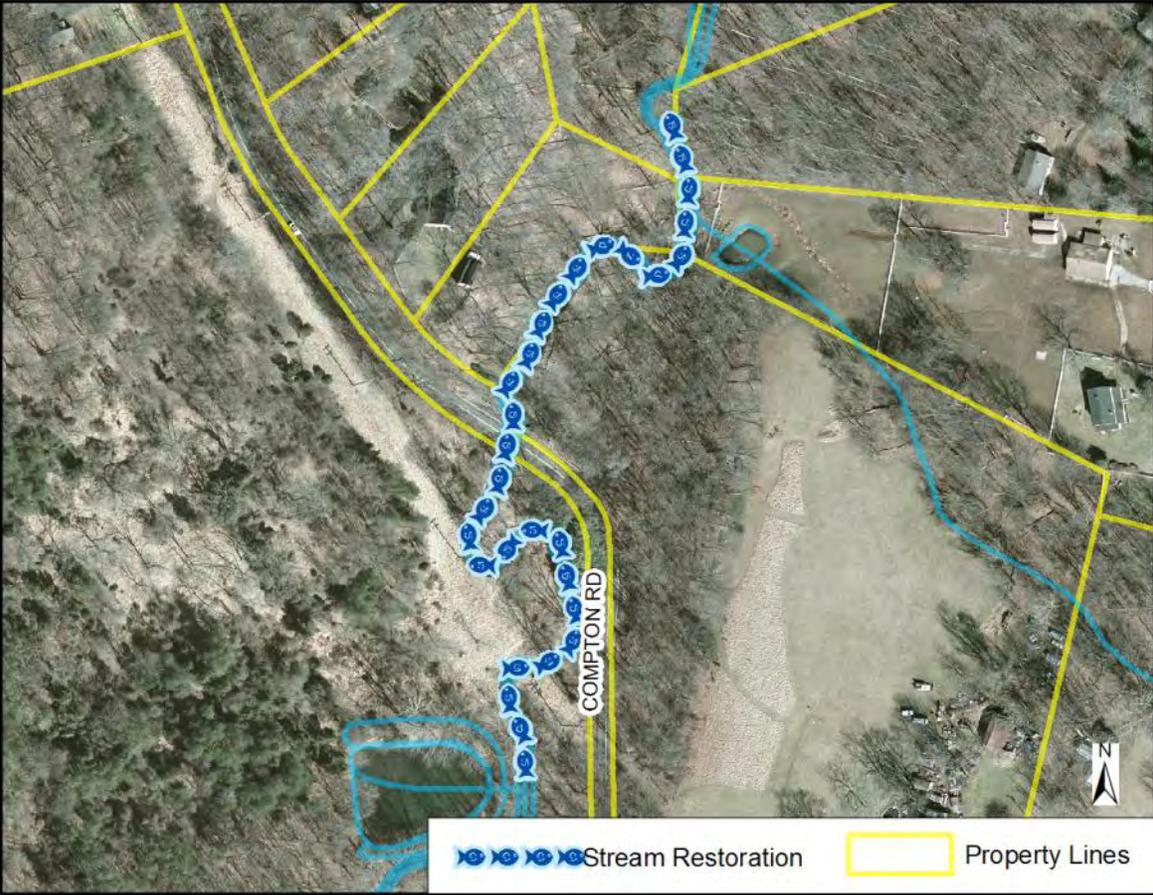
Project Area Map

Description: Johnny Moore Creek suffers from moderate bank erosion in this area. Project JM9203 will restore the stream to a more stable, natural state to prevent future erosion and promote habitat health and diversity.

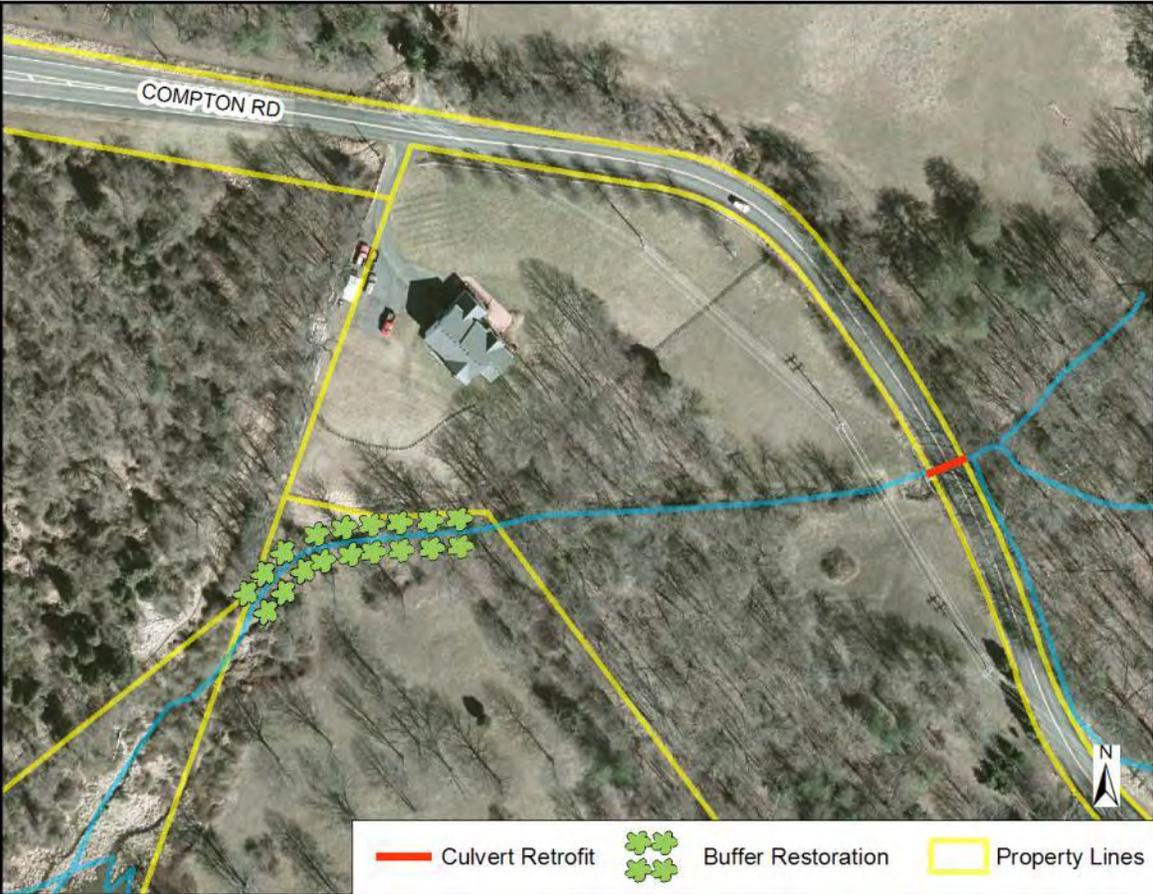
Project Area Map

Description: Project JM9400 consists of a culvert retrofit where a tributary of Polecat Branch crosses Compton Rd. A small buffer restoration downstream of the culvert retrofit site is also included.

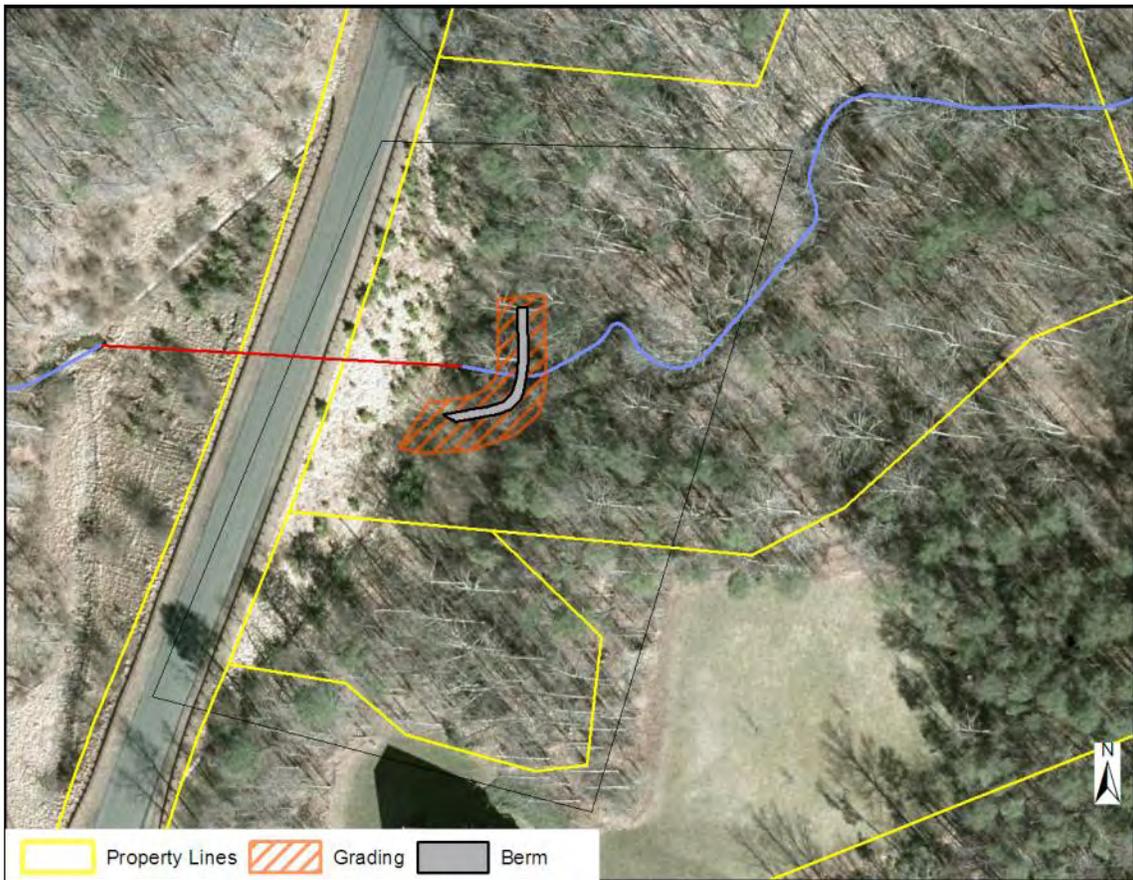
Project Area Map

Description: Project JM9500 is a culvert retrofit upstream of Balmoral Forest Road on Polecat Branch. The culvert retrofit will provide water quality treatment for an uncontrolled area. Road drainage infrastructure may need to be realigned to allow for berm construction.

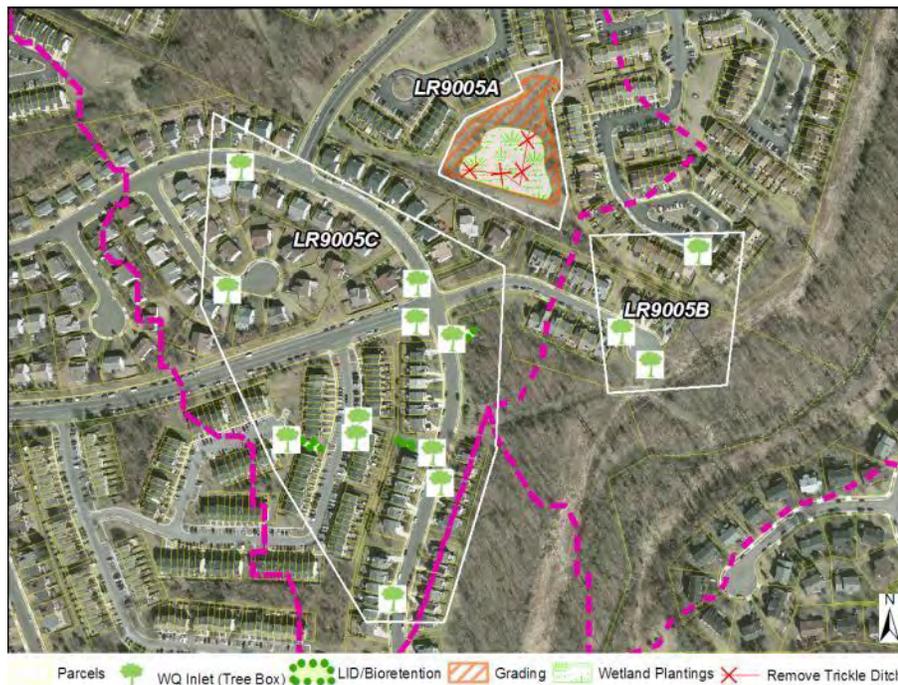
Project Area Map

Description: Project suite is alternative to Regional Pond R-05. LR9005A is a retrofit to existing facility 0829DP. Quality enhancements as well as storage increases are proposed. LR9005B is an LID application (3 tree box filters to replace curb drop inlets) to a small untreated portion of the subdivision. This area was not originally expected to be treated by the regional facility, but was added to the alternative suite because it is a strategic location to manage untreated runoff to obtain similar cumulative pollutant removal results as the original proposed pond. LR9005C involves treating the portion of the drainage area intended to drain to R-05 that is not treated by existing facility 0829DP for water quality. A combination of tree box filters (11) and bioretention areas (3) are proposed in order to eliminate the need for a pond at the outfall.

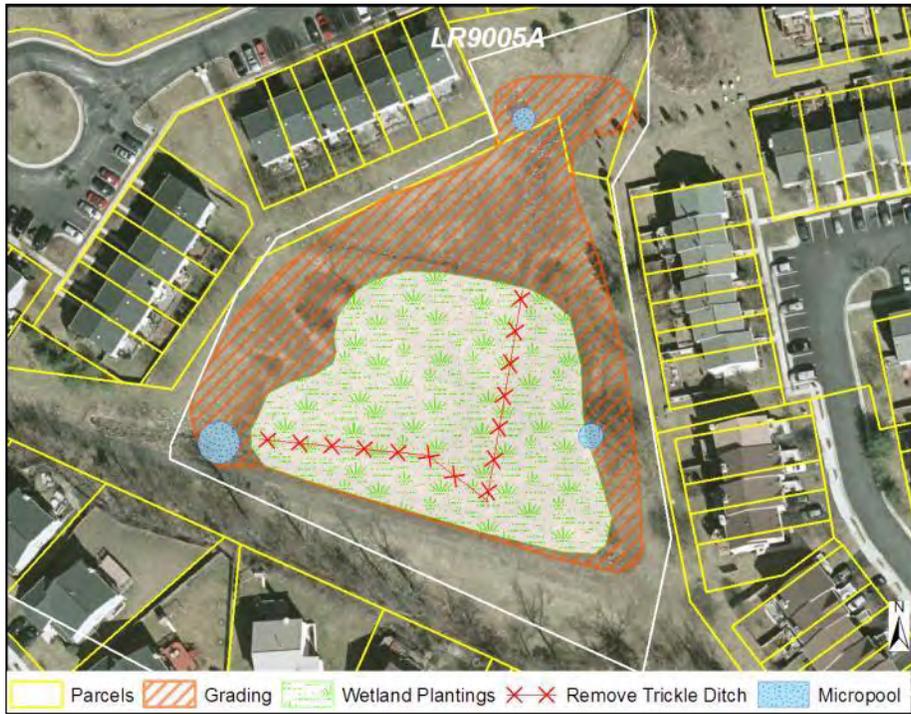
Project LR9005A:

Description: LR9005A is a proposed retrofit to existing facility 0829DP. Remove the existing trickle ditches. Add micropools and wetland plantings. Modify internal pond geometry – focus on extending the low flow path. Adding storage will depend on cooperation from HOA. Costs are summarized below:

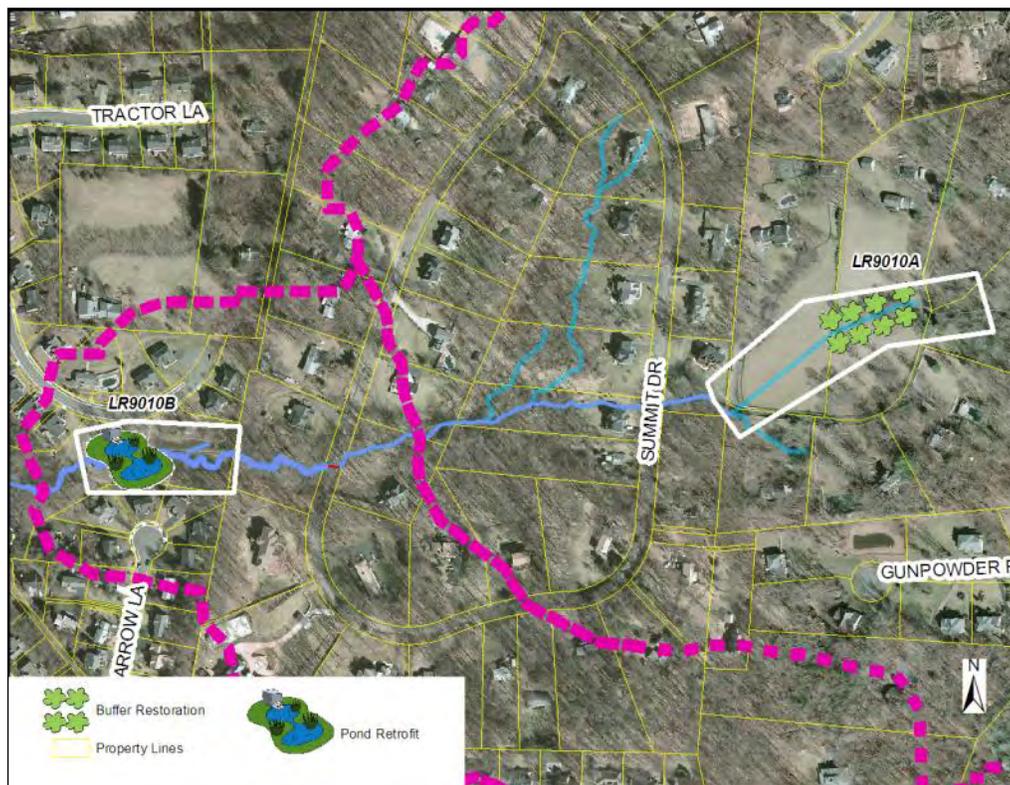
Project Area Map

Description: This project suite is an alternative to constructing Regional Pond R-10. LR9010A is a buffer restoration project that resides on private property. Just downstream of the proposed buffer restoration, the stream is piped for approximately 350 feet and would benefit from being daylighted, but it also resides on private property. LR9010B is a retrofit of existing stormwater pond 1452DP which proposes removing existing trickle ditches, increasing storage capacity, adding micropools and wetland plantings and altering pond geometry.

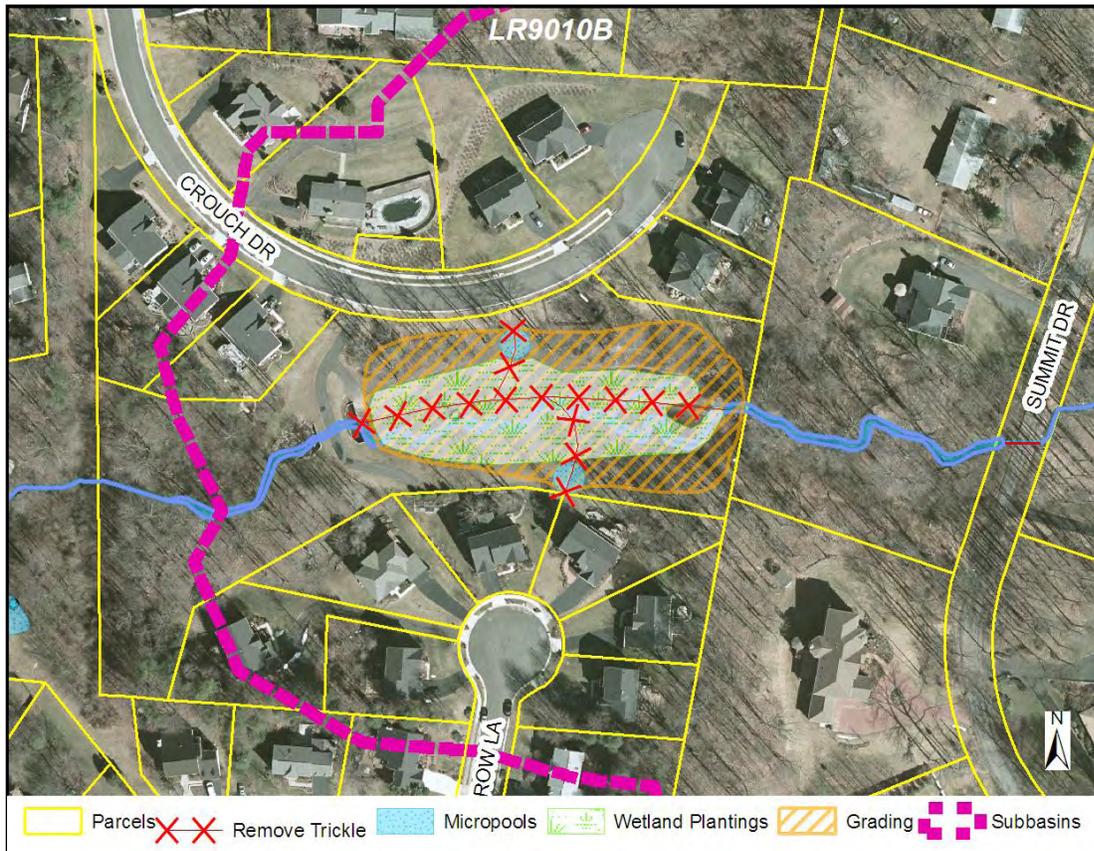
Project LR9010B:

Description: LR9010B is a retrofit to existing facility R-19. Remove the existing trickle ditches. Add micropools and wetland plantings. Modify internal pond geometry – focus on extending the low flow path.

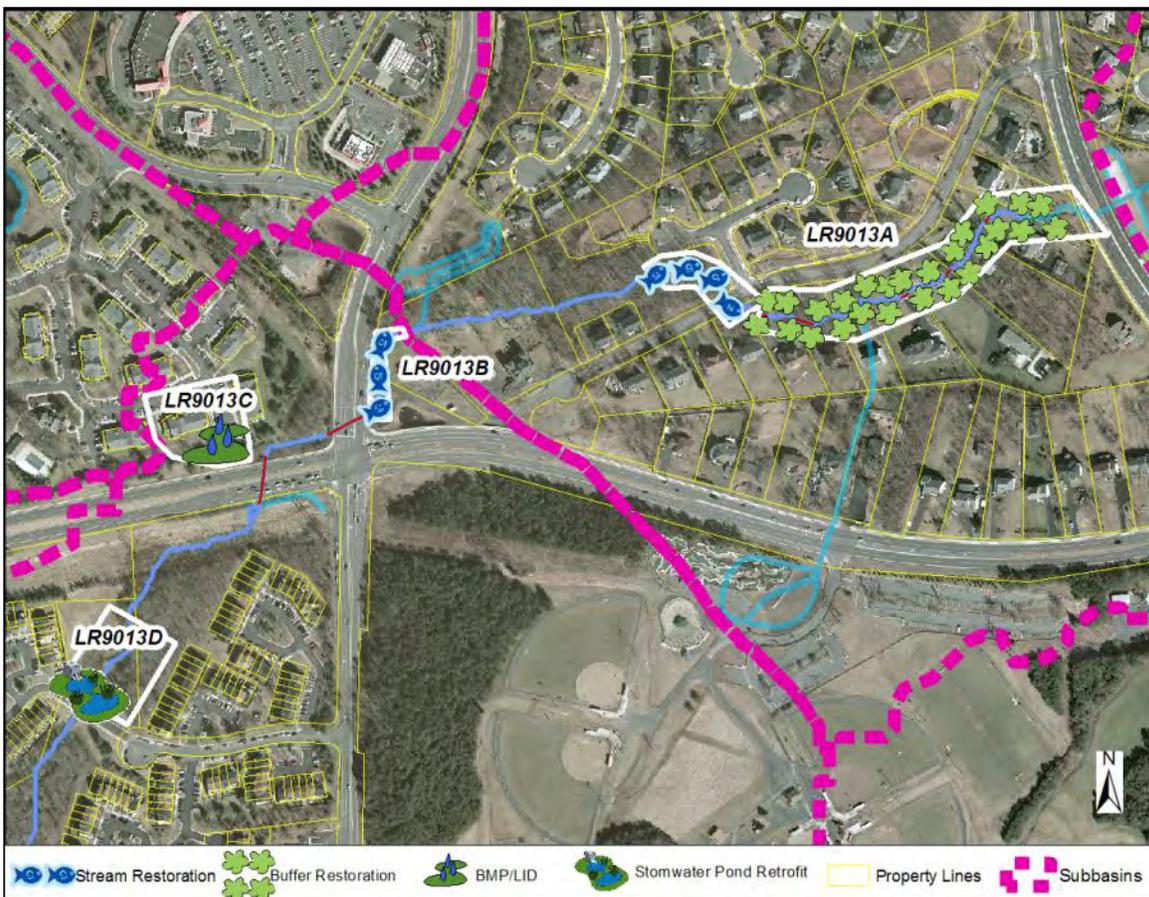
LR9013 Project Area Map

Description: The LR9013 Regional Pond Alternative Group is a replacement for regional pond R-13. It consists of a stream and buffer restoration (LR9013A), a second stream restoration (LR9013B), a new BMP (LR9013C) and a pond retrofit (LR9013D).

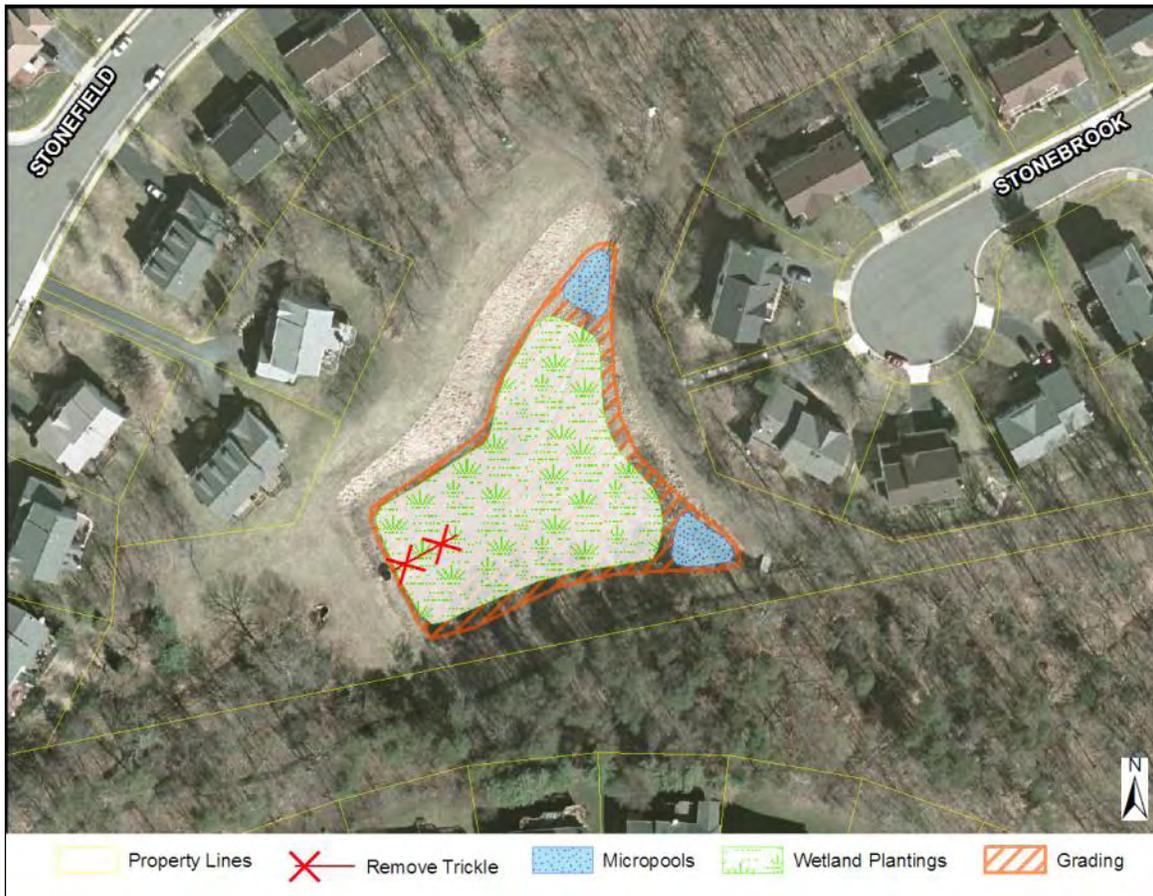
Description: Project LR9100 involves the retrofit of an existing pond to include wetland plantings and alter the existing pond geometry to extend the flow path. The project will also include removal of existing trickle ditches and the addition of micropools.

Property Lines Remove Trickle Micropools Wetland Plantings Grading

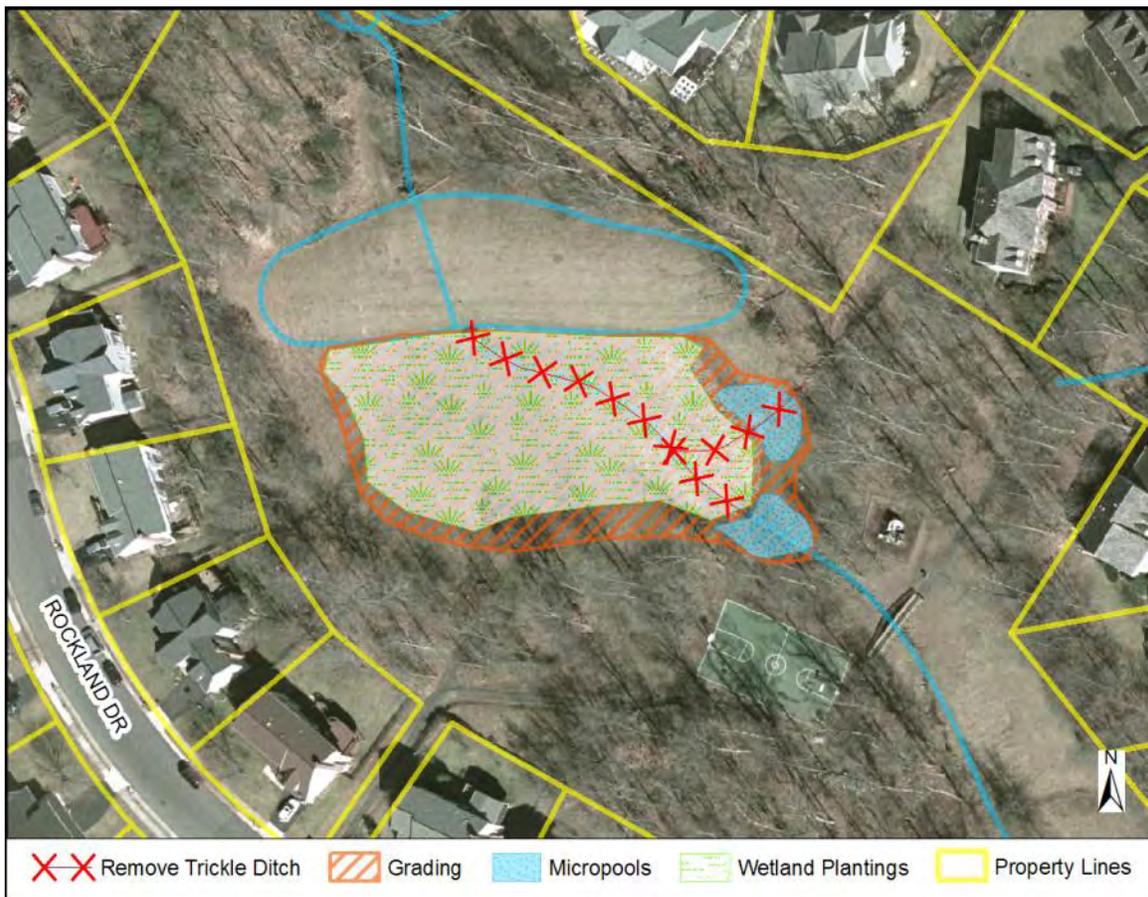
Description: Project LR9102 is a retrofit of an existing stormwater pond. LR9102 will remove existing trickle ditches, increase storage capacity and lower peak flows, and will add micropools and wetland plantings.

X X Remove Trickle Ditch
 Grading
 Micropools
 Wetland Plantings
 Property Lines

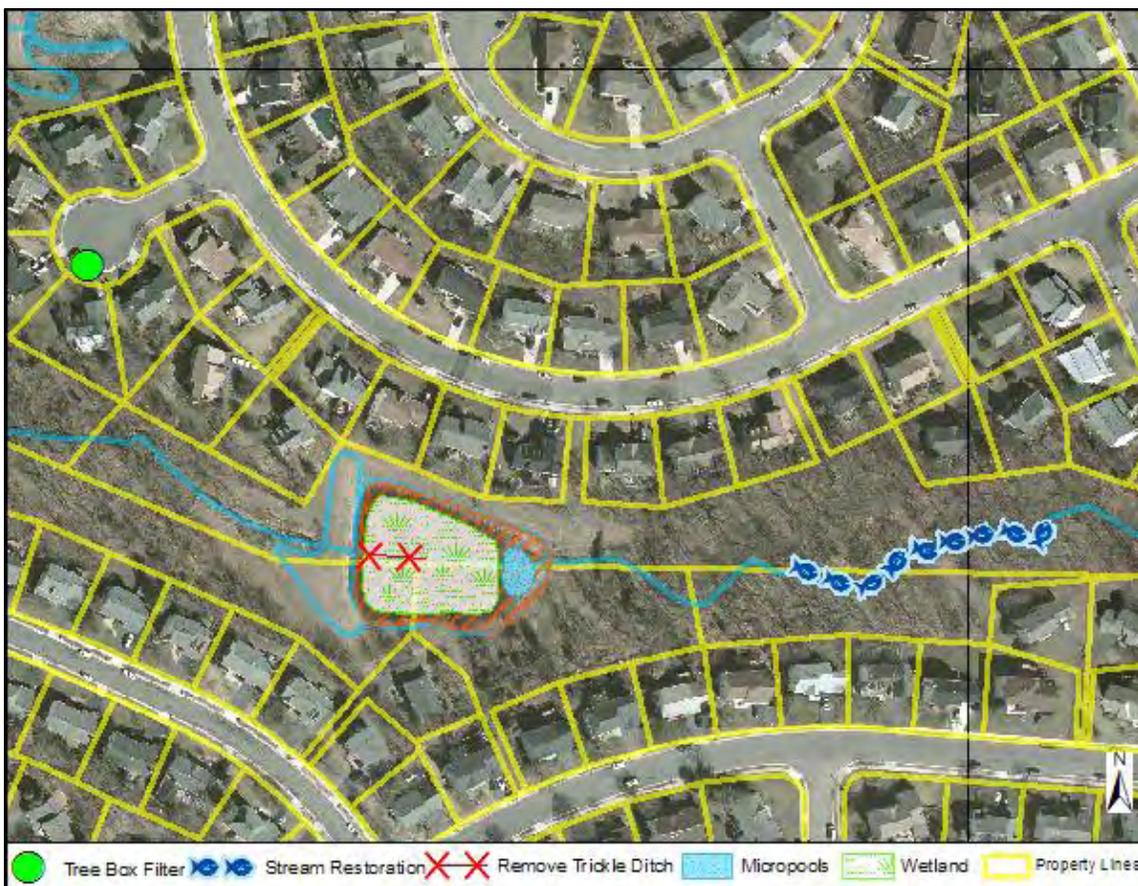
Project Area Map

Description: The LR9103 project area suffers from channel erosion and a clogged pond riser structure. LR9103 will restore the stream to a more stable, natural state to prevent future erosion and promote habitat health and diversity. The pond retrofit includes clearing the riser structure, constructing micropools and adding wetland plantings. New BMP/LID facilities will also be installed nearby.
