Little Rocky Run – Johnny Moore Creek Watershed Management Plan

December 2010

Prepared by
AMEC Earth & Environmental, Inc.

Fairfax County Department of Public
Works and Environmental Services
Stormwater Planning Division

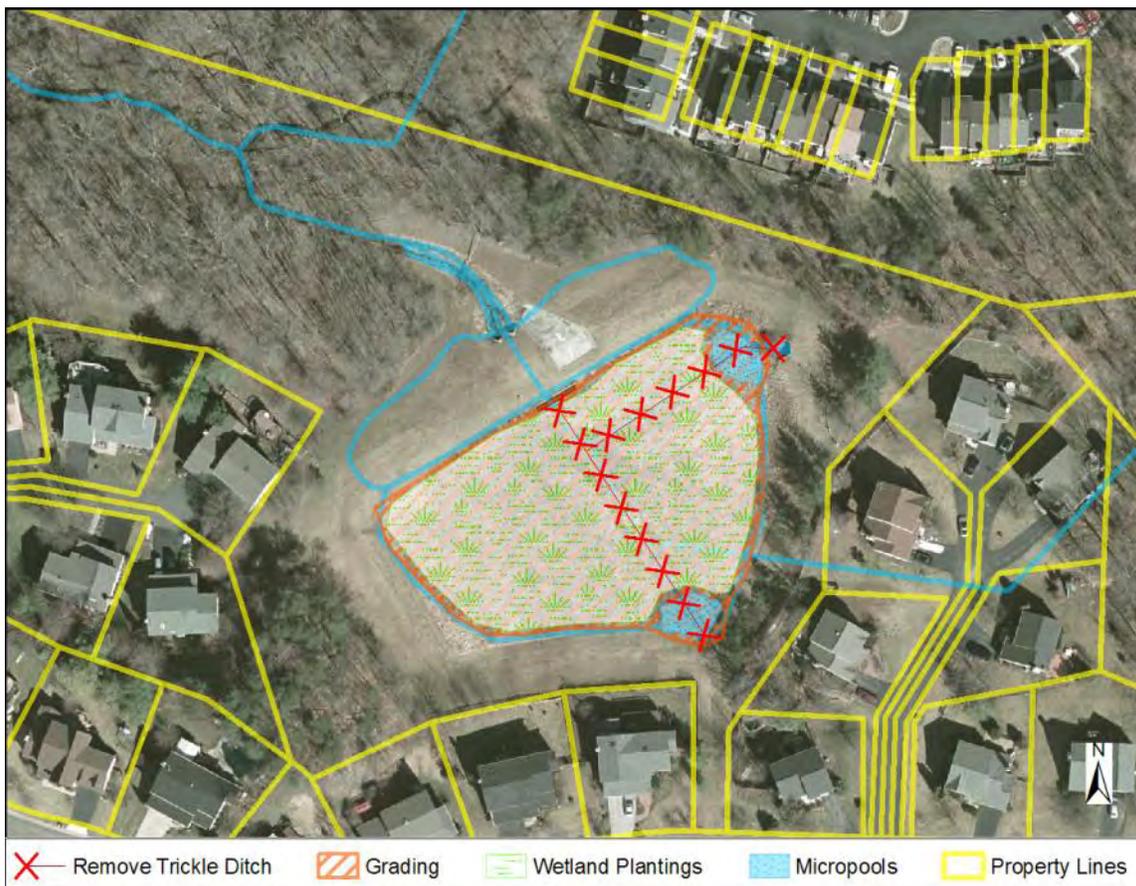
Project Area Map

Description: Project LR9106 will retrofit an existing stormwater pond to provide improved water quality control. Existing concrete trickle ditches will be removed in combination with constructing new micropools and adding wetland plantings.

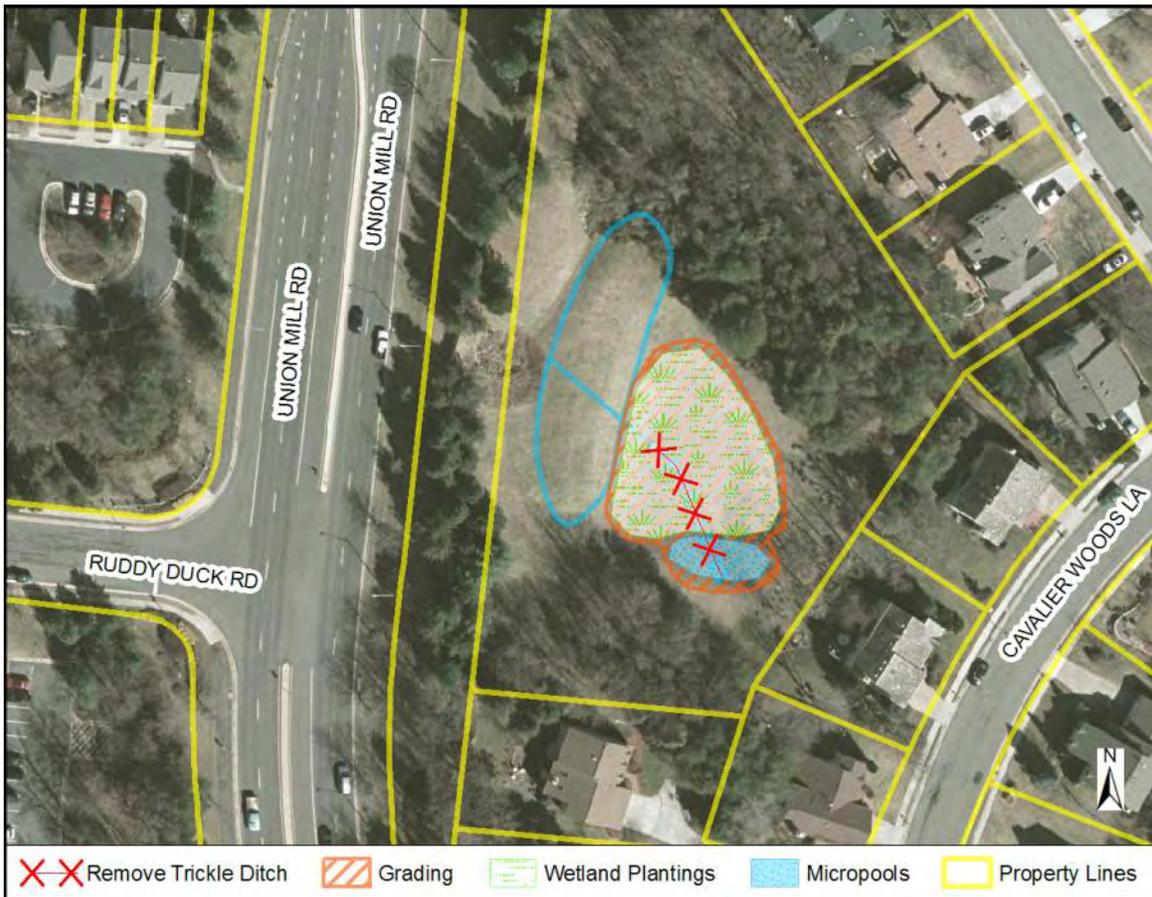
Description: Project LR9109 is a retrofit of the existing stormwater pond shown below. The existing trickle ditch will be removed in combination with constructing micropools and adding wetland plantings.

X Remove Trickle Ditch
 Grading
 Wetland Plantings
 Micropools
 Property Lines

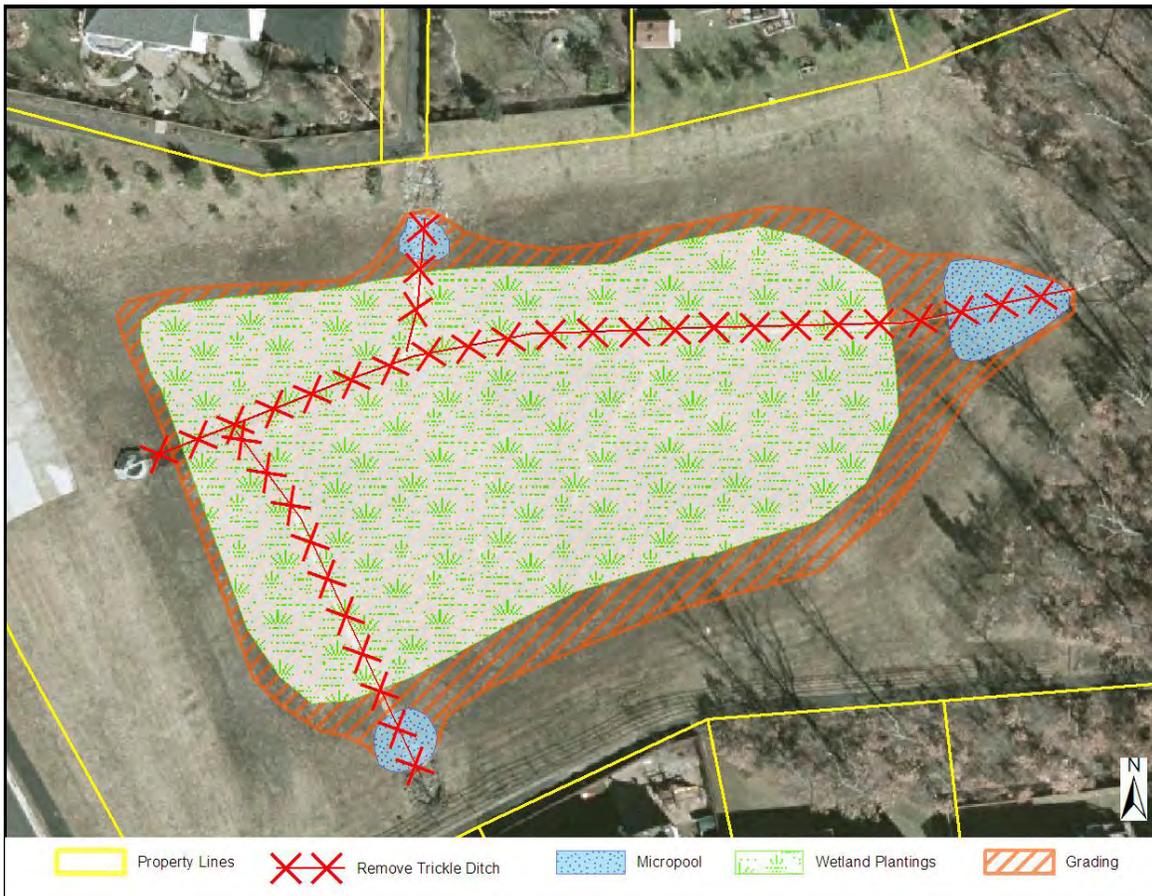
Project Area Map

Description: Project LR9110 includes the retrofit of an existing facility to include wetland plantings and micropools, removal of trickle ditches and modification of the pond geometry to extend the low flow path.

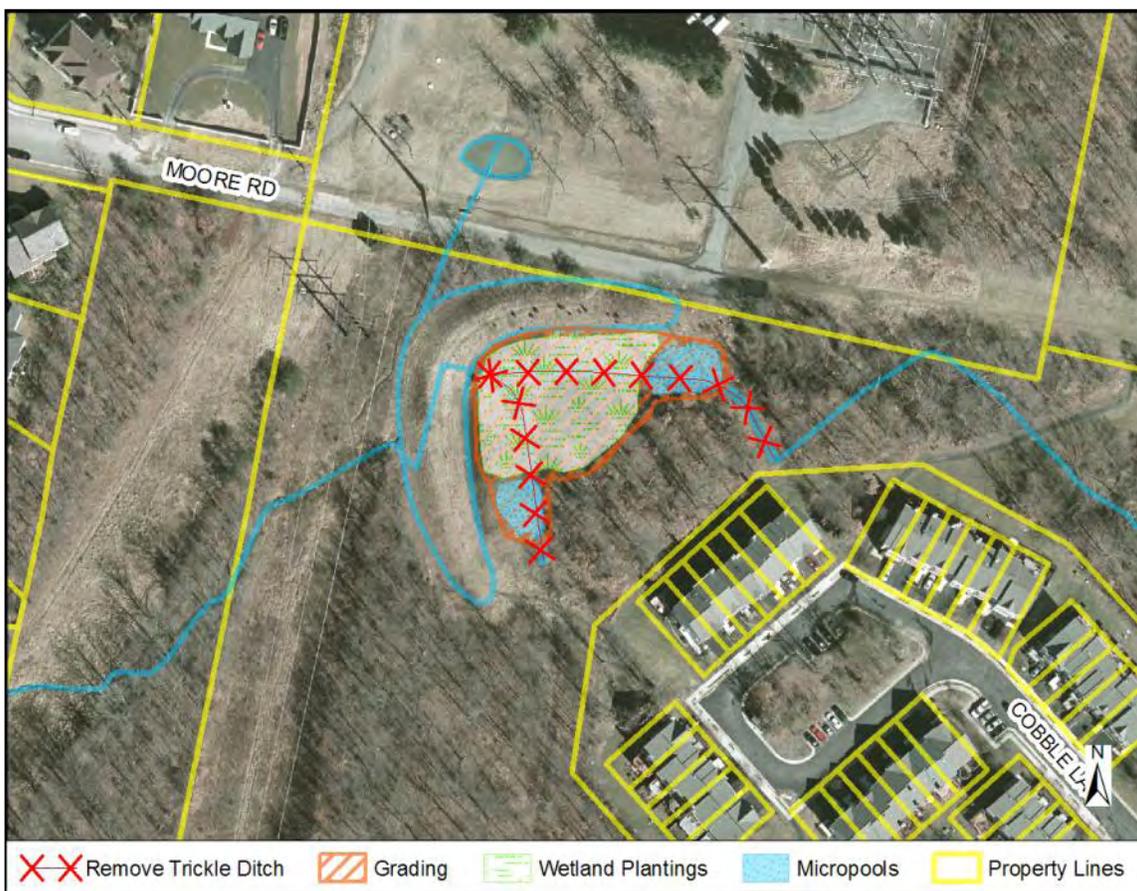
Project Area Map

Description: Project LR9111 will retrofit an existing stormwater pond to provide improved water quality control. Existing concrete trickle ditches will be removed in combination with constructing new micropools and adding wetland plantings.

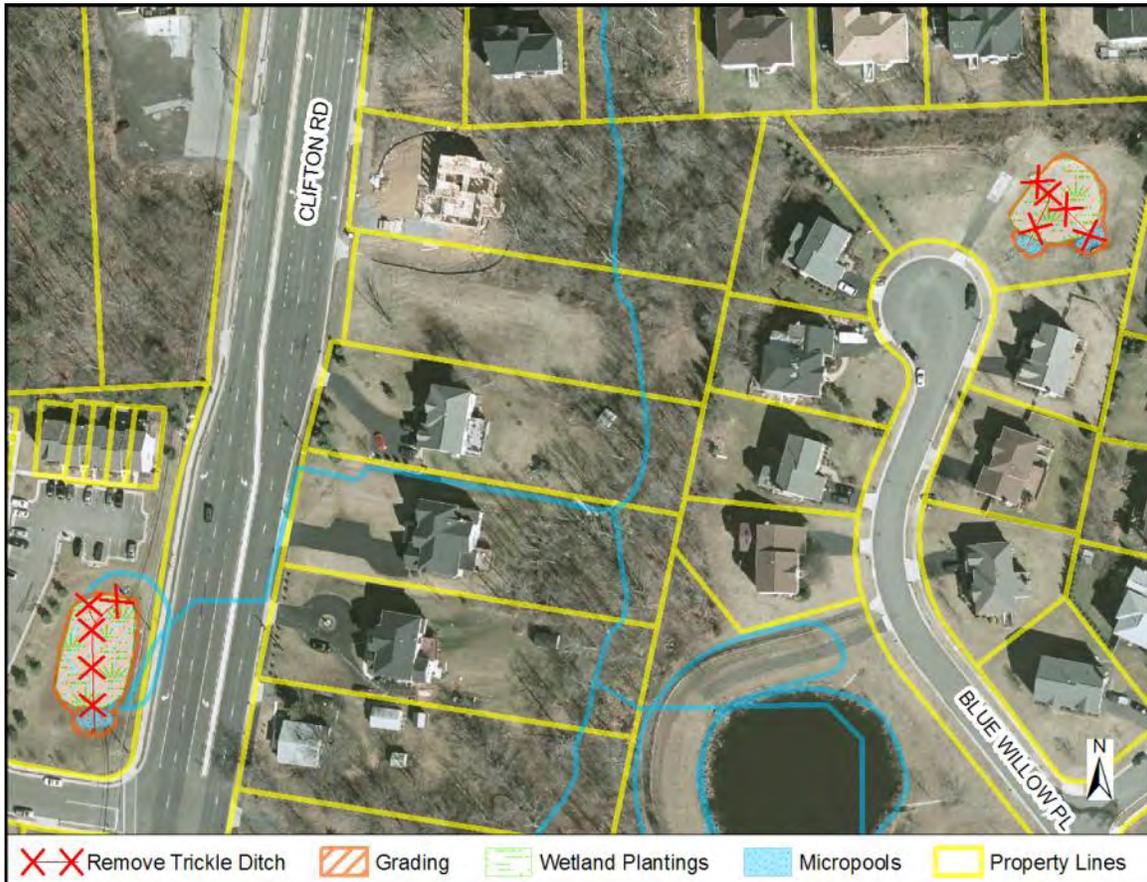
Description: Project LR9114 will retrofit two existing stormwater ponds to provide improved water quality control. Existing concrete trickle ditches will be removed in combination with constructing new micropools and adding wetland plantings.

X X Remove Trickle Ditch
 Grading
 Wetland Plantings
 Micropools
 Property Lines

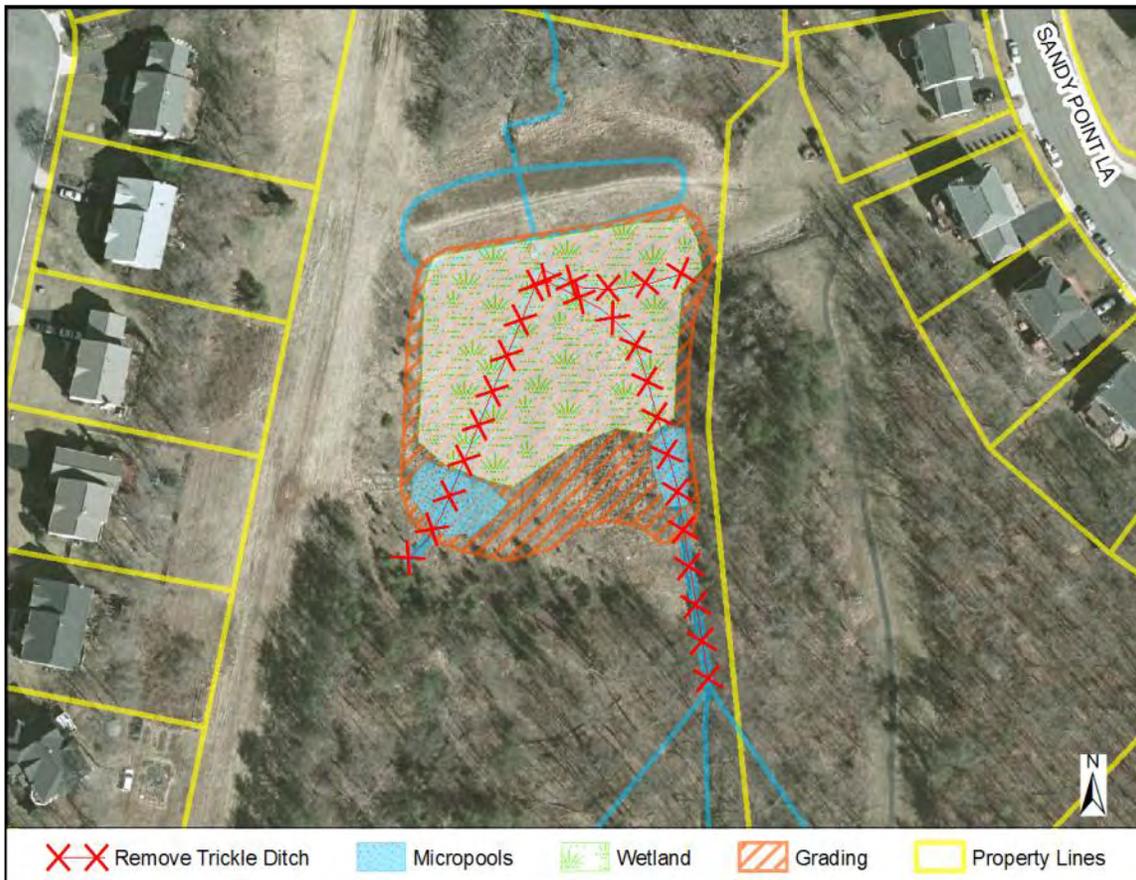
Project Area Map

Description: Project LR9115 is a retrofit of R-7, an existing regional stormwater pond. Storage volume will be increased, existing trickle ditches will be removed and micropools and wetland plantings will be added.

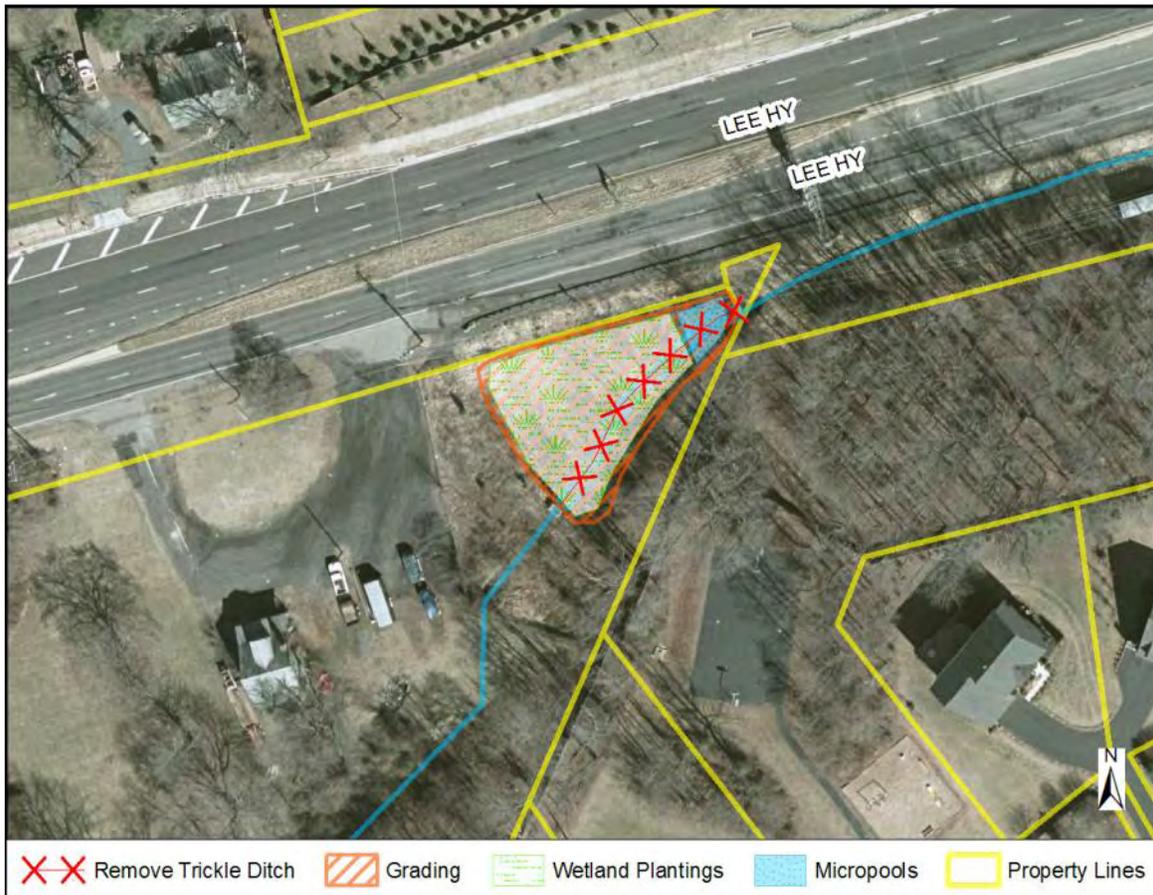
Description: Project LR9117 will retrofit an existing stormwater pond to provide improved water quality control. Existing concrete trickle ditches will be removed in combination with constructing new micropools and adding wetland plantings.

Remove Trickle Ditch Grading Wetland Plantings Micropools Property Lines

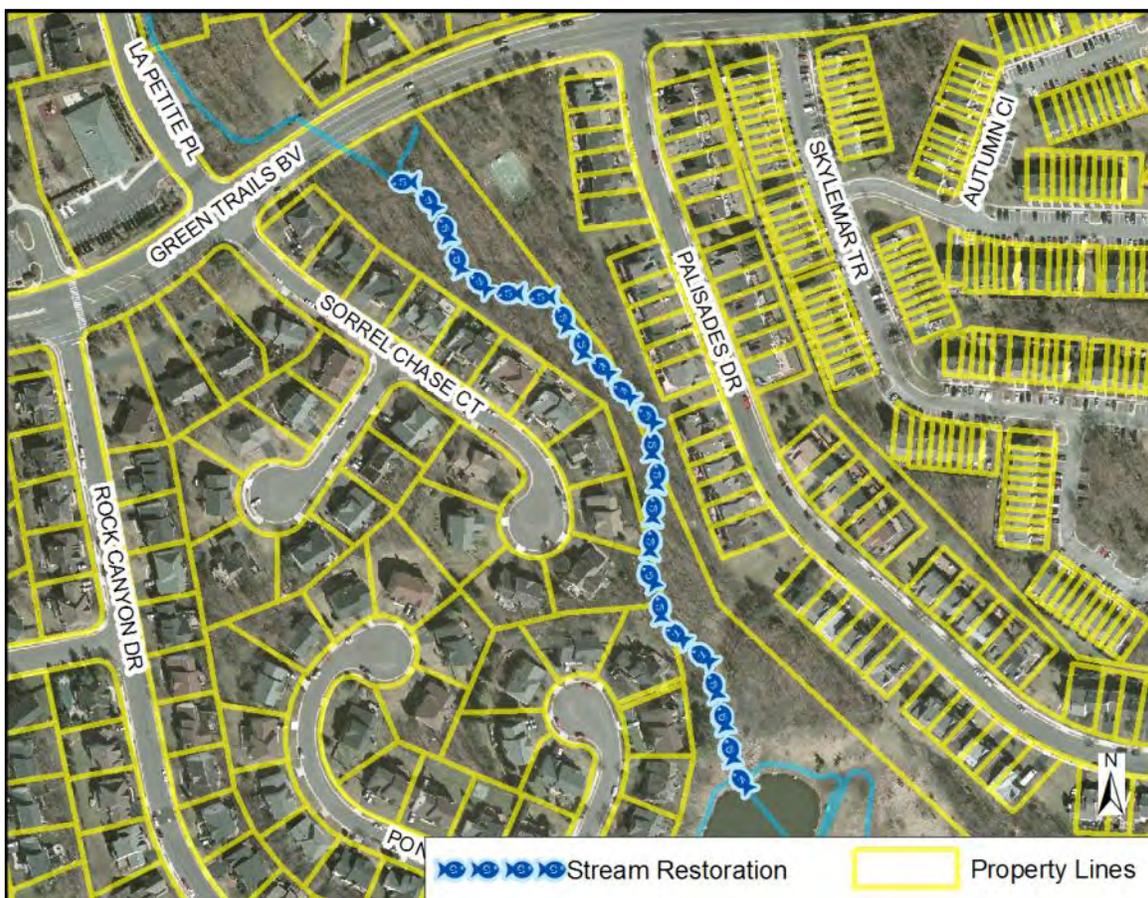
Project Area Map

Description: The Green Trails Homeowners Association has noted that the tributary to Little Rocky Run shown below suffers from erosion and poor flow. Subsequent field visits confirmed a stagnant system with little habitat support. Project LR9201 will restore the stream to a more stable, natural state to prevent future erosion and promote habitat health and diversity.

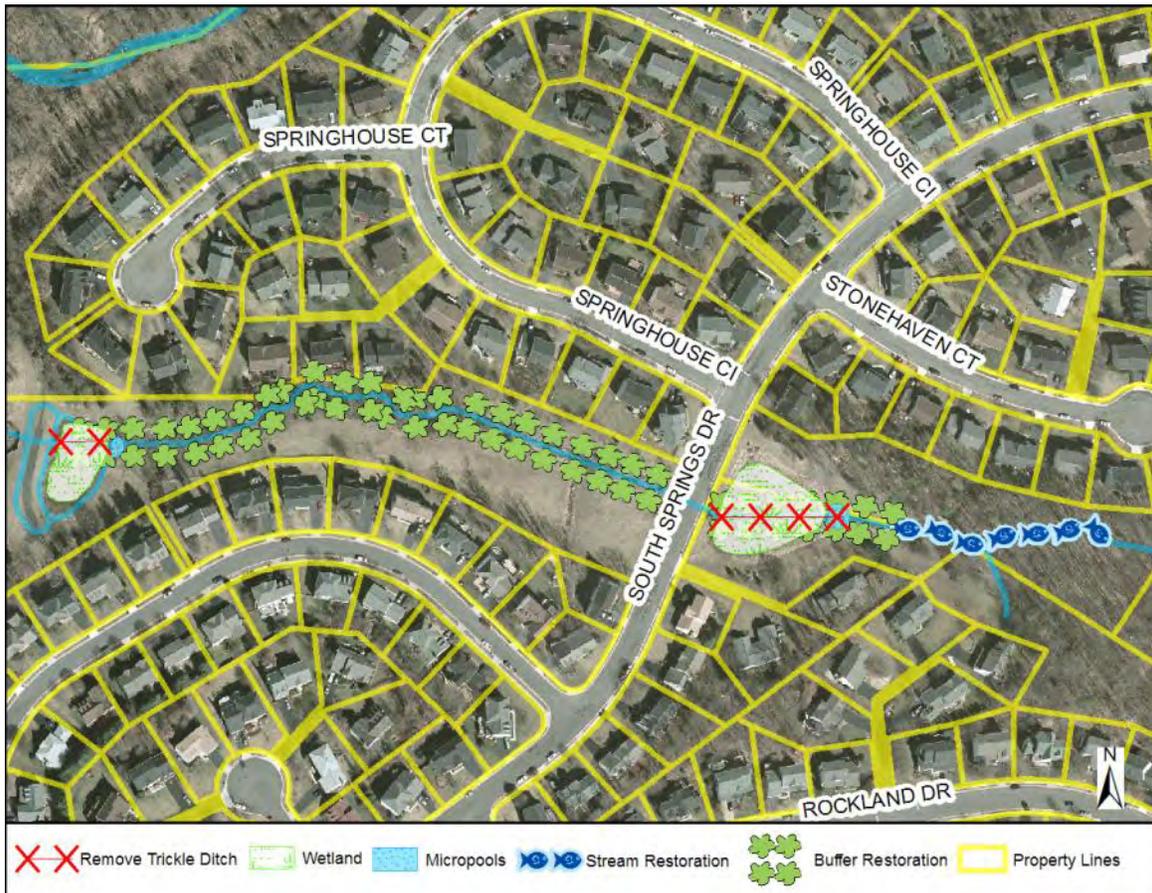
Project Area Map

Description: Project suite LR9202 will provide improved water quality control. It incorporates stream restoration, buffer restoration and pond retrofit techniques.

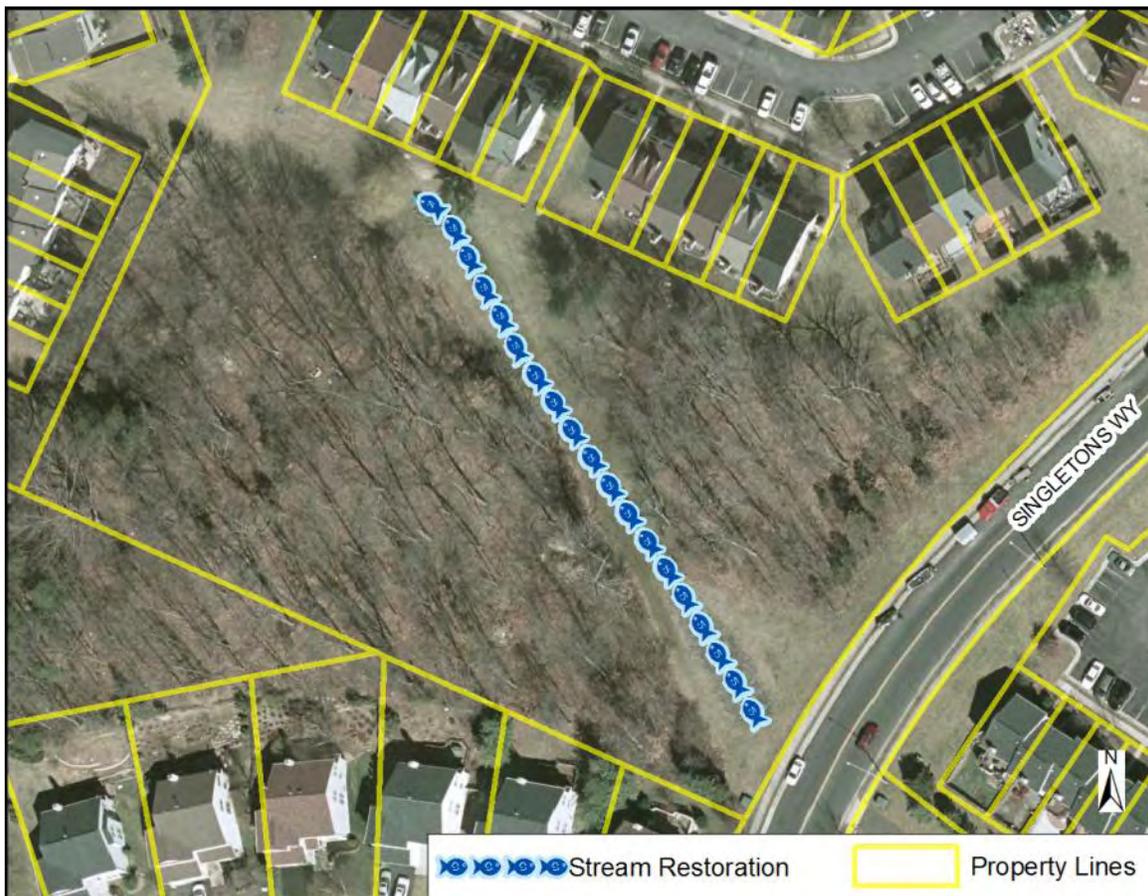
Project Area Map

Description: Project LR9203 will restore the existing paved ditch shown below with a natural channel system. This small stream restoration will use step pools to dissipate excess energy and prevent future erosion.

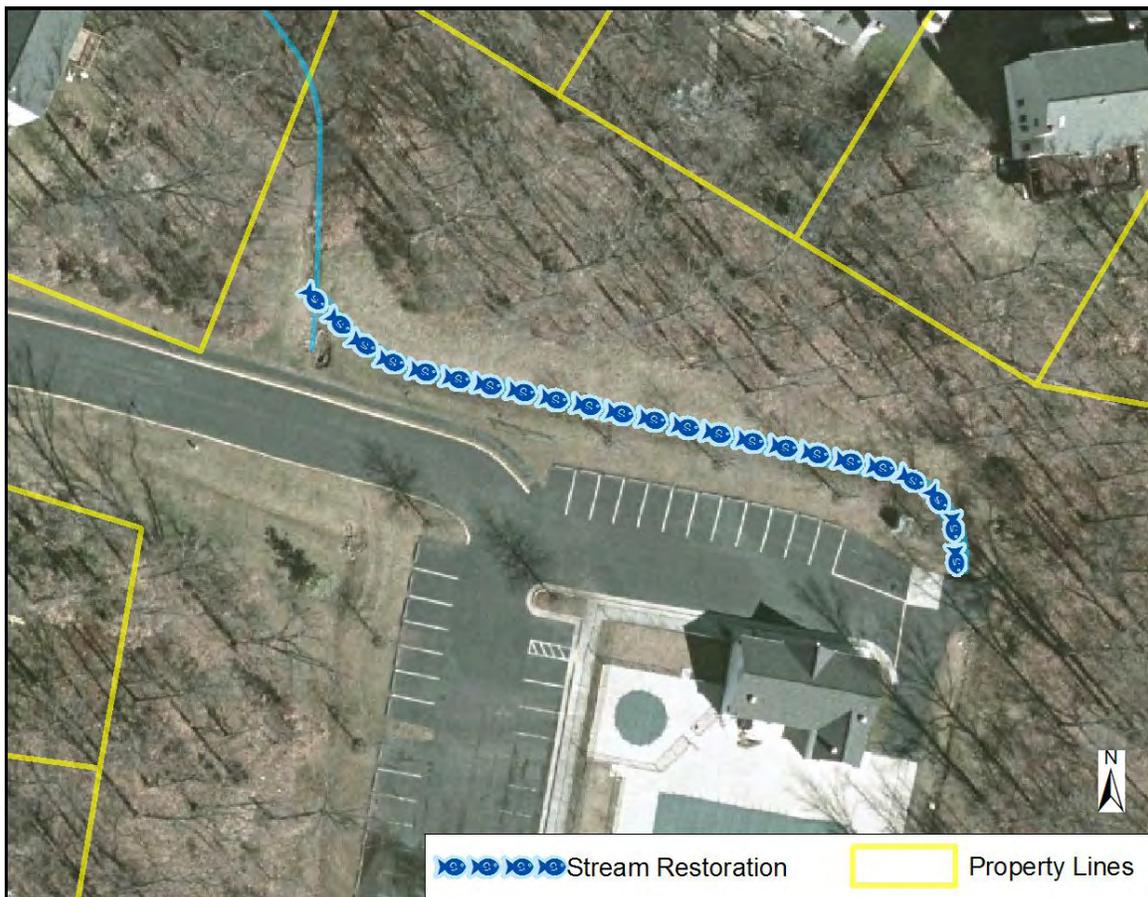
Project Area Map

Description: Stream restoration LR9204 will restore the concrete ditch shown below to a natural stream channel. This small restoration stream restoration project will consist of linear bioretention basins – a unique stream restoration technique which will significantly reduce construction costs.

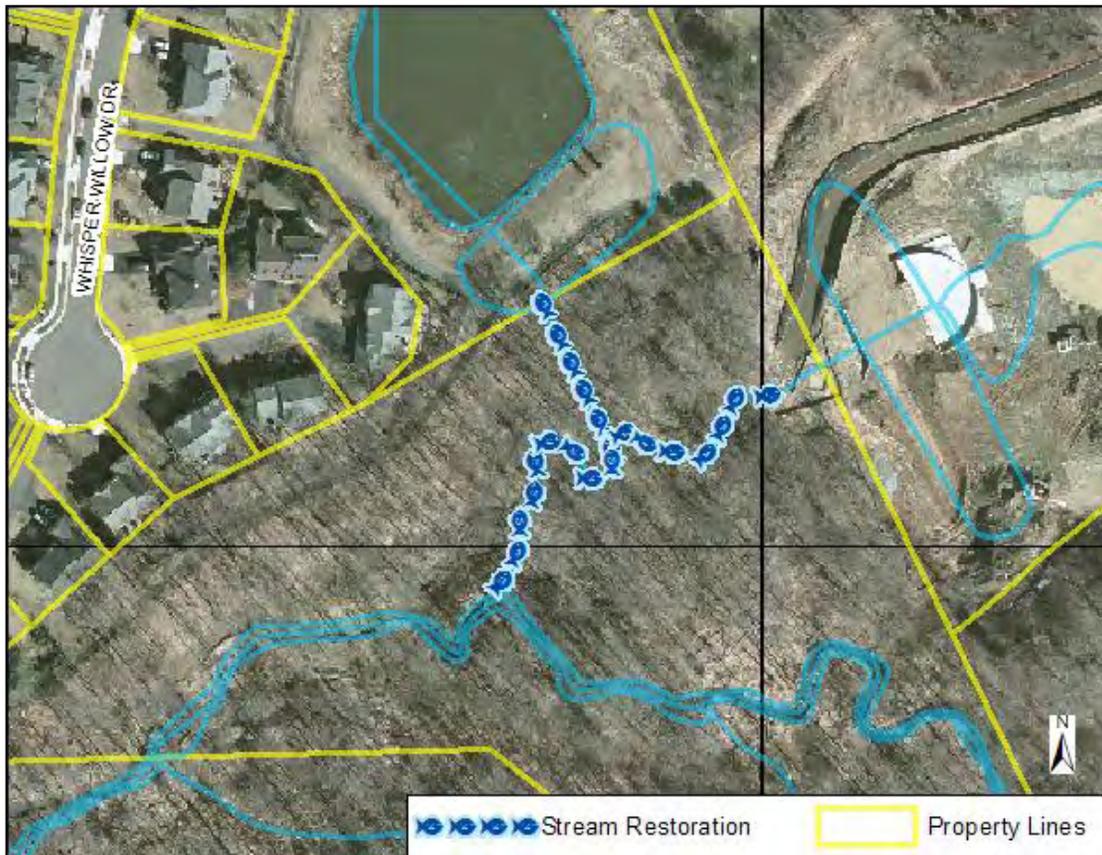
Project Area Map

Description: The pond outfalls shown below that drain to Little Rocky Run are causing scouring and erosion. Stream restoration project LR9205 will restore the stream to a more stable, natural state to prevent future erosion and promote habitat health and diversity.

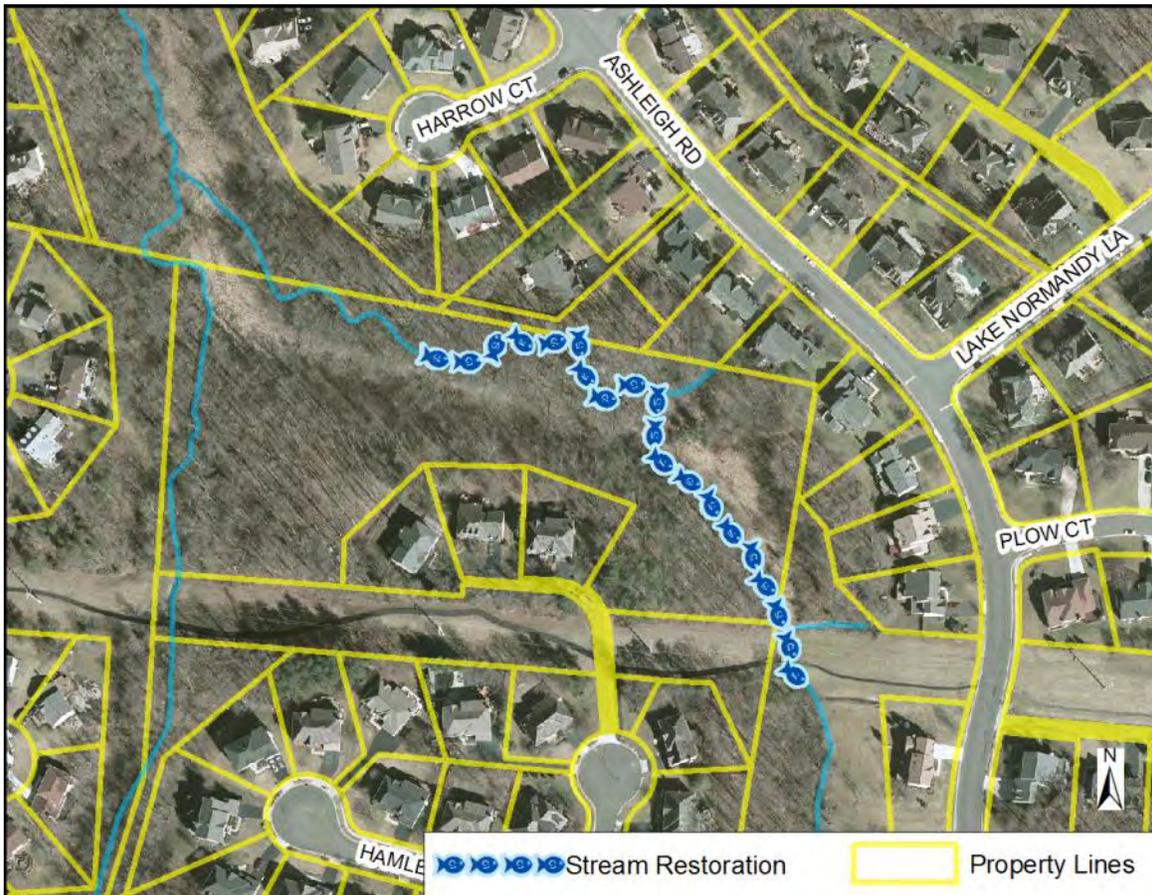
Project Area Map

Description: The unnamed tributary to Willow Spring Branch shown below suffers from channel erosion. LR9207 will restore the stream to a more stable, natural state to prevent future erosion and promote habitat health and diversity.

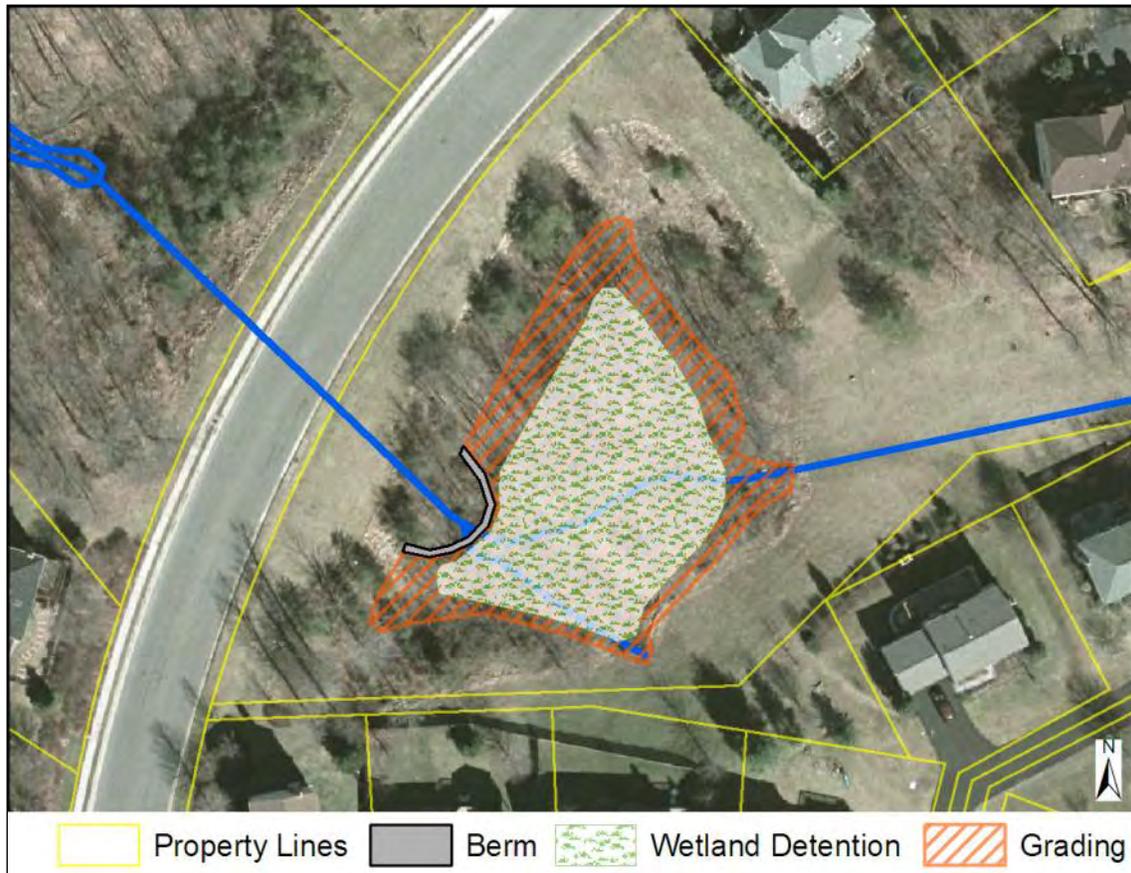
Project Area Map

Description: Proposed project is to retrofit existing culvert crossing to allow for water quality control. Use a gabion wall to create shallow wetland marsh upstream.
