A. Proposed Building Construction Sequence Plan

B. Existing Conditions/Historic Analysis Floor Plans

C. Existing Conditions Elevations

D. Design Options - Drawings

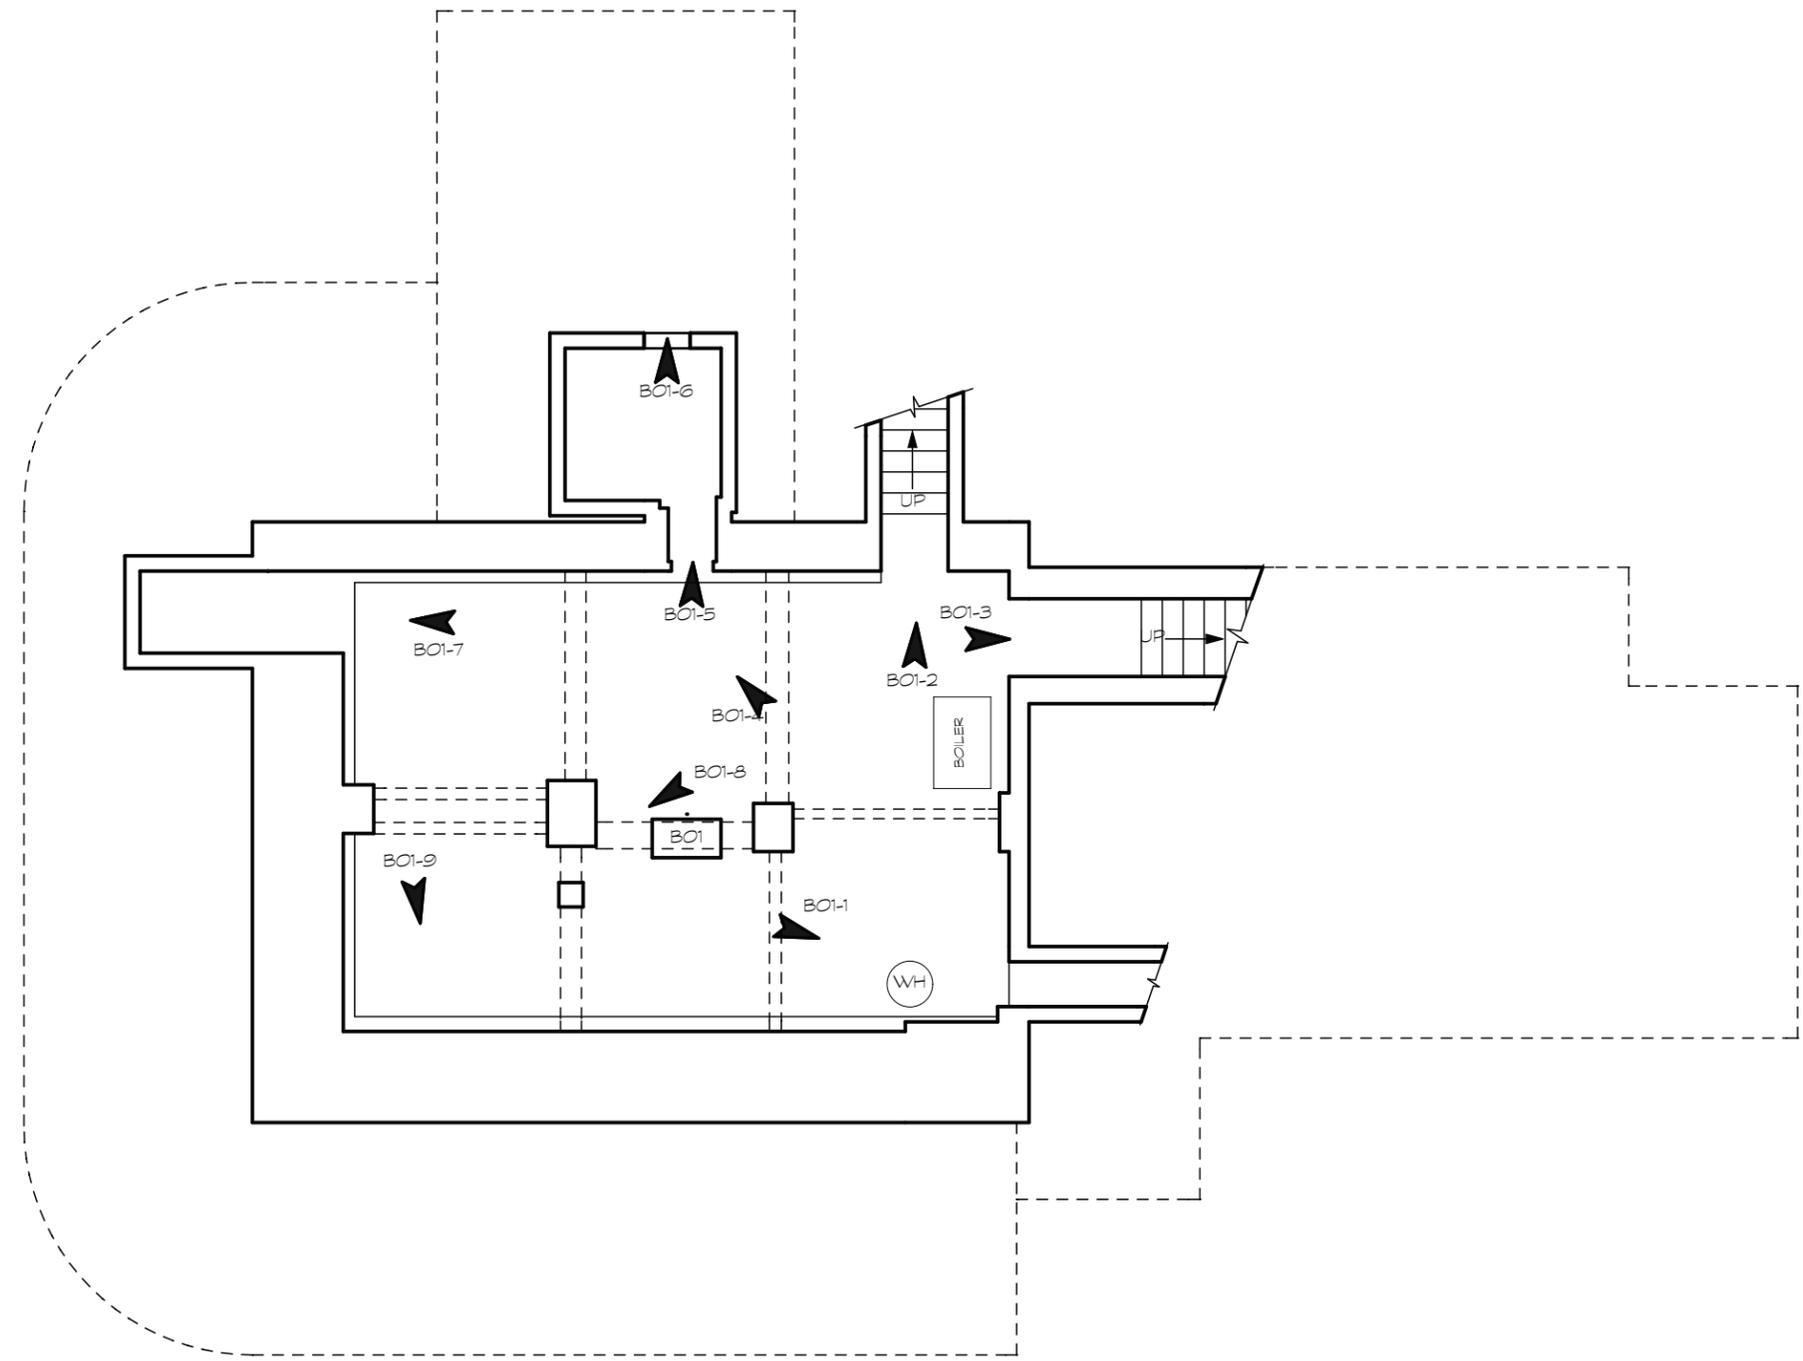
PHOTO LOCATION PLAN - BASEMENT
 SCALE: 1/8" = 1'-0"

- PHOTO LOCATIONS
- ROOM NUMBERS

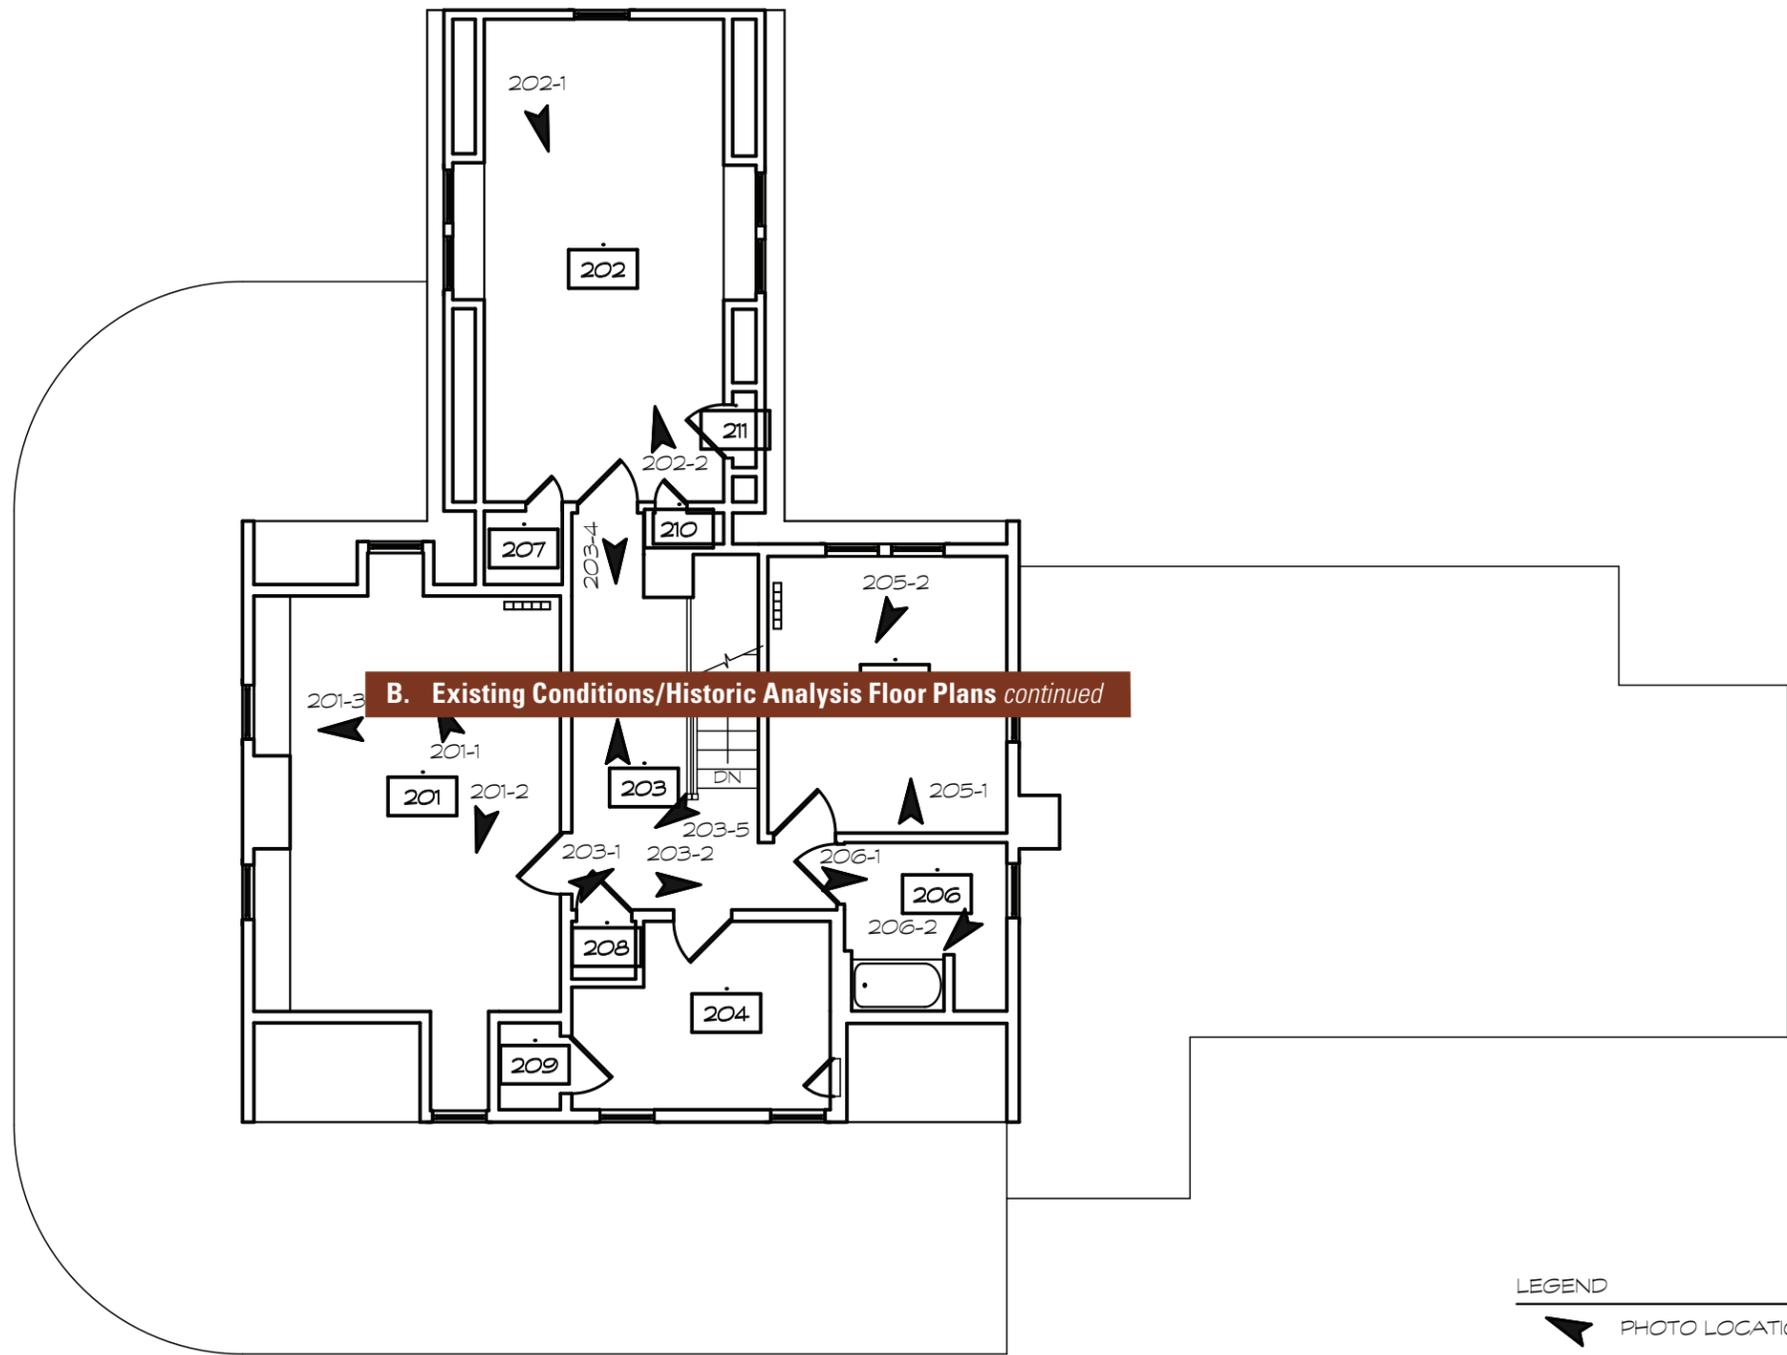
PHOTO LOCATION PLAN - 2ND FLOOR
 SCALE: 1/8" = 1'-0"

PHOTO LOCATIONS

ROOM NUMBERS

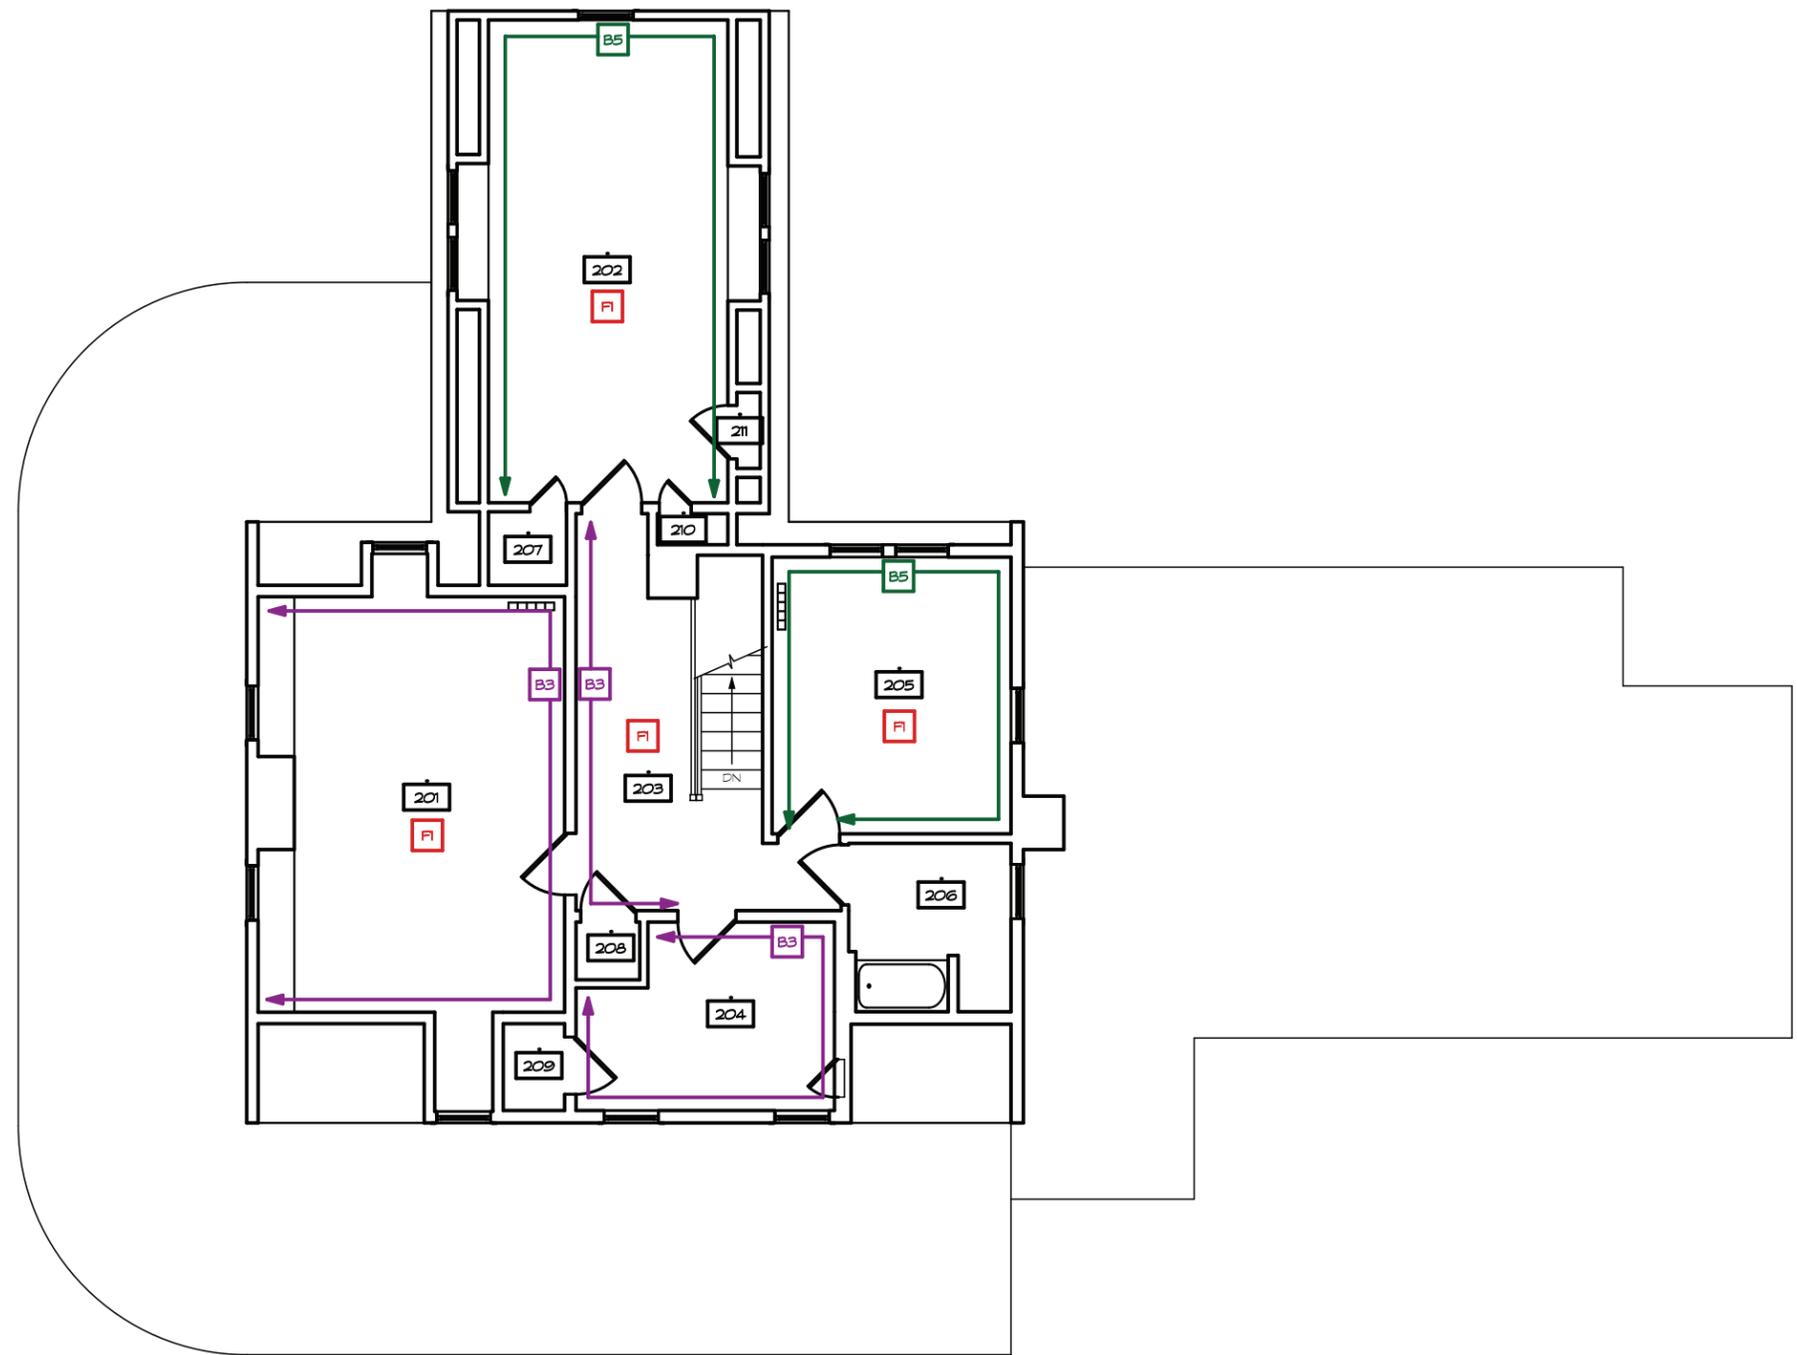
ANALYSIS PLAN - FLOORING & BASE 2ND FLOOR
SCALE: 1/8" = 1'-0"

- B1 3 3/4" BEADED BASE (LATE 18TH CENTURY)
- B2 6 1/2" HIGH TWO PIECE BASE WITH OGEE CAP (EARLY 20TH CENTURY)
- B3 6 1/8" BASE W/ MOLDED CAP (EARLY 20TH CENTURY)
- B4 6 1/2" ONE-PIECE BASE (MID 20TH CENTURY)
- B5 8" HIGH TWO PIECE BASE WITH OGEE CAP (MID 20TH CENTURY)
- F1 T&G OAK FLOOR (EARLY 20TH CENTURY)
- F2 VINYL TILE (POSSIBLY ASBESTOS CONTAINING) (MID 20TH CENTURY)

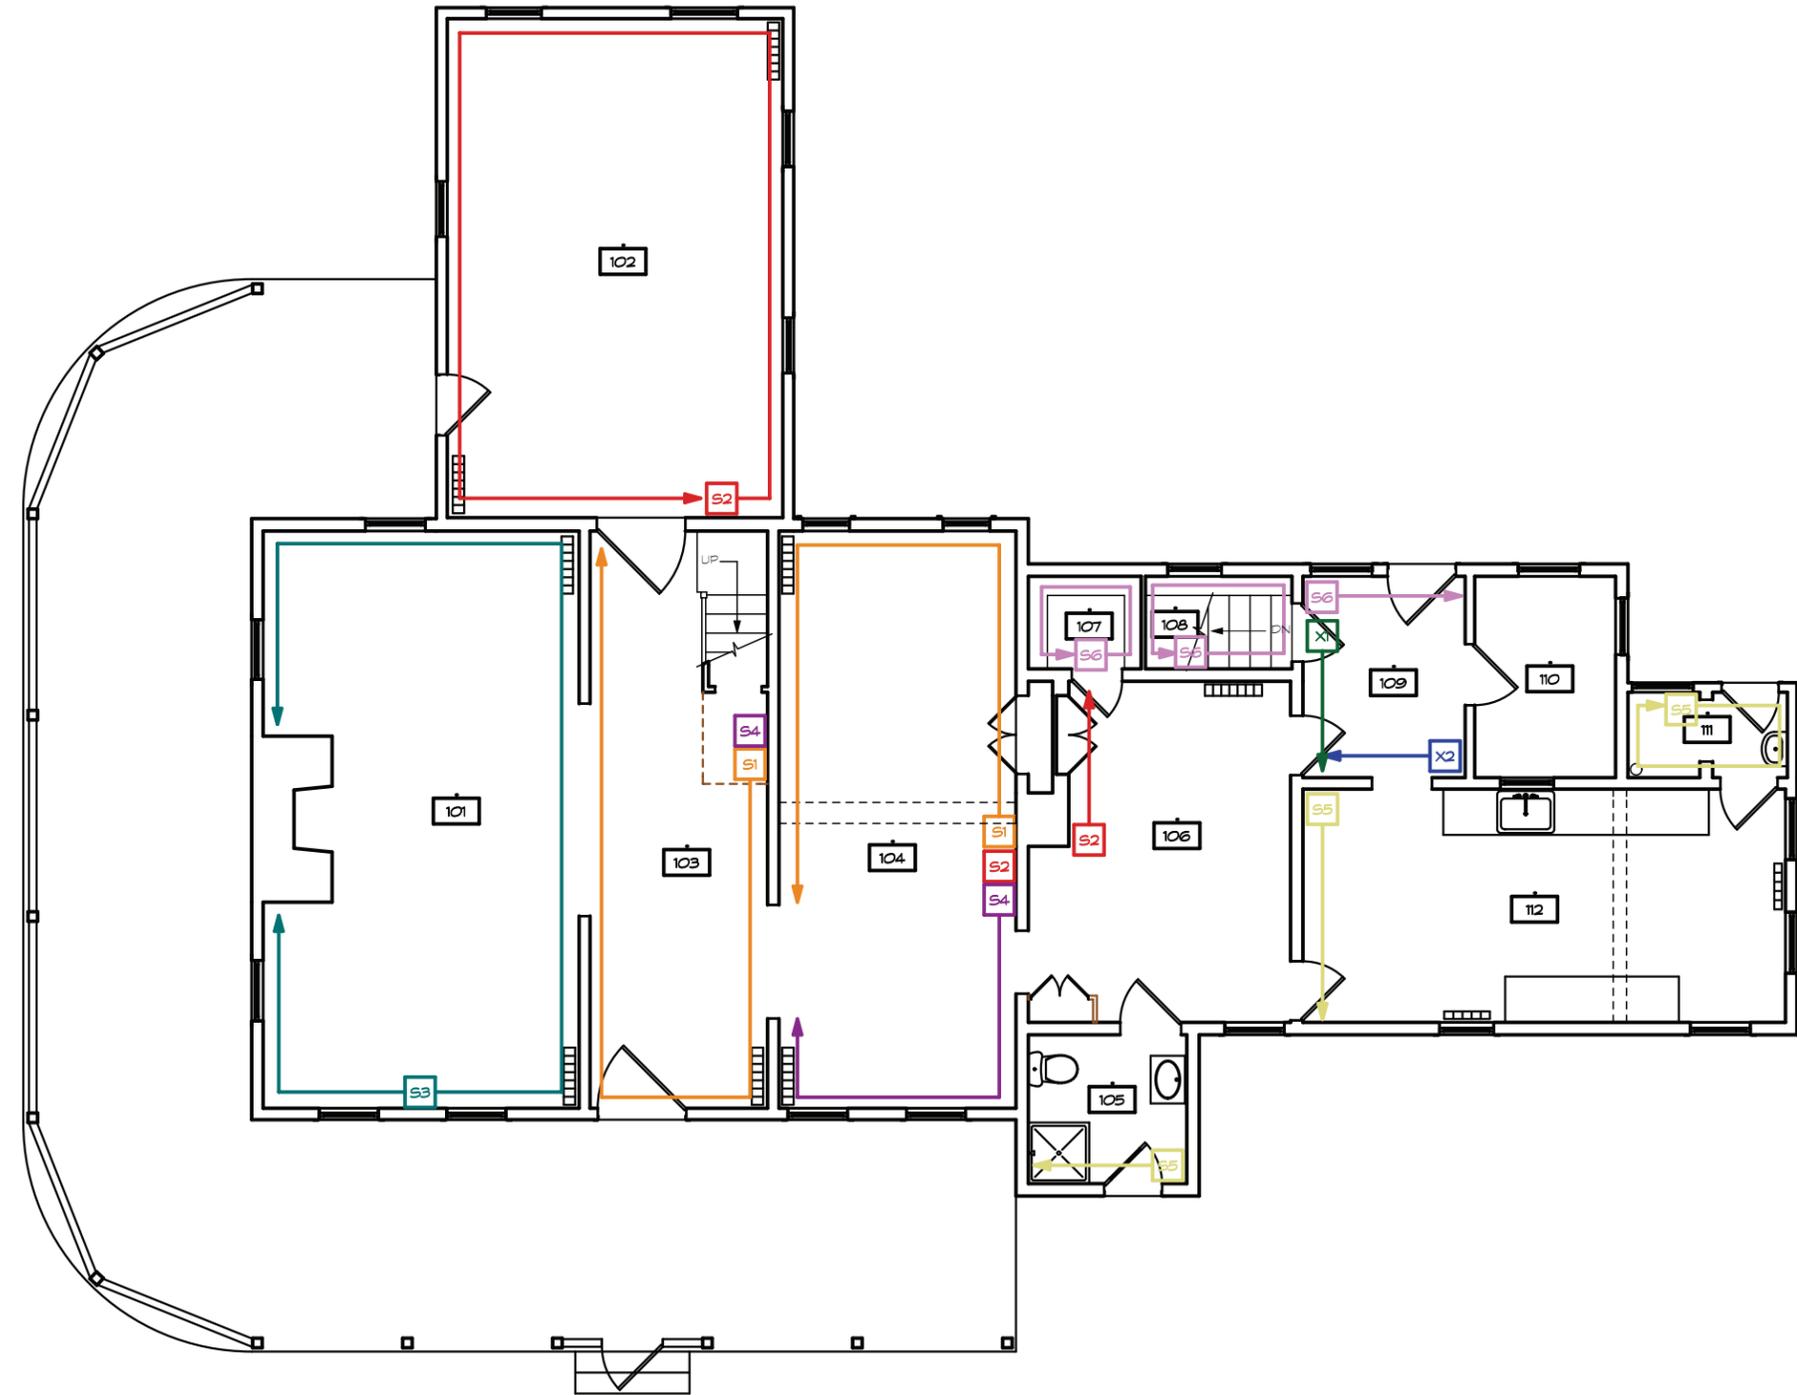
ANALYSIS PLAN - WALL FINISHES 1ST FLOOR

- S1 PLASTER W/ SPLIT WOOD LATHE (LATE 18TH CENTURY)
- S2 PLASTER WITH METAL MESH LATHE (EARLY 20TH CENTURY)
- S3 PLASTER WITH ROCK LATHE (MID 20TH CENTURY)
- S4 TONGUE AND GROOVE BEADED BOARD WAINSCOT (LATE 19TH CENTURY)
- S5 HARDBOARD W/ LATTICE STRIPS FINISHING SEAMS (MID 20TH CENTURY)
- S6 BOARD WALL FINISH (MID 19TH CENTURY)
- S7 GYPSUM BOARD (MID 20TH CENTURY)
- X1 BEVELED CLAPBOARD SIDING (LATE 18TH CENTURY) (LATE 19TH CENTURY)
- X2 GERMAN SIDING (LATE 19TH CENTURY)

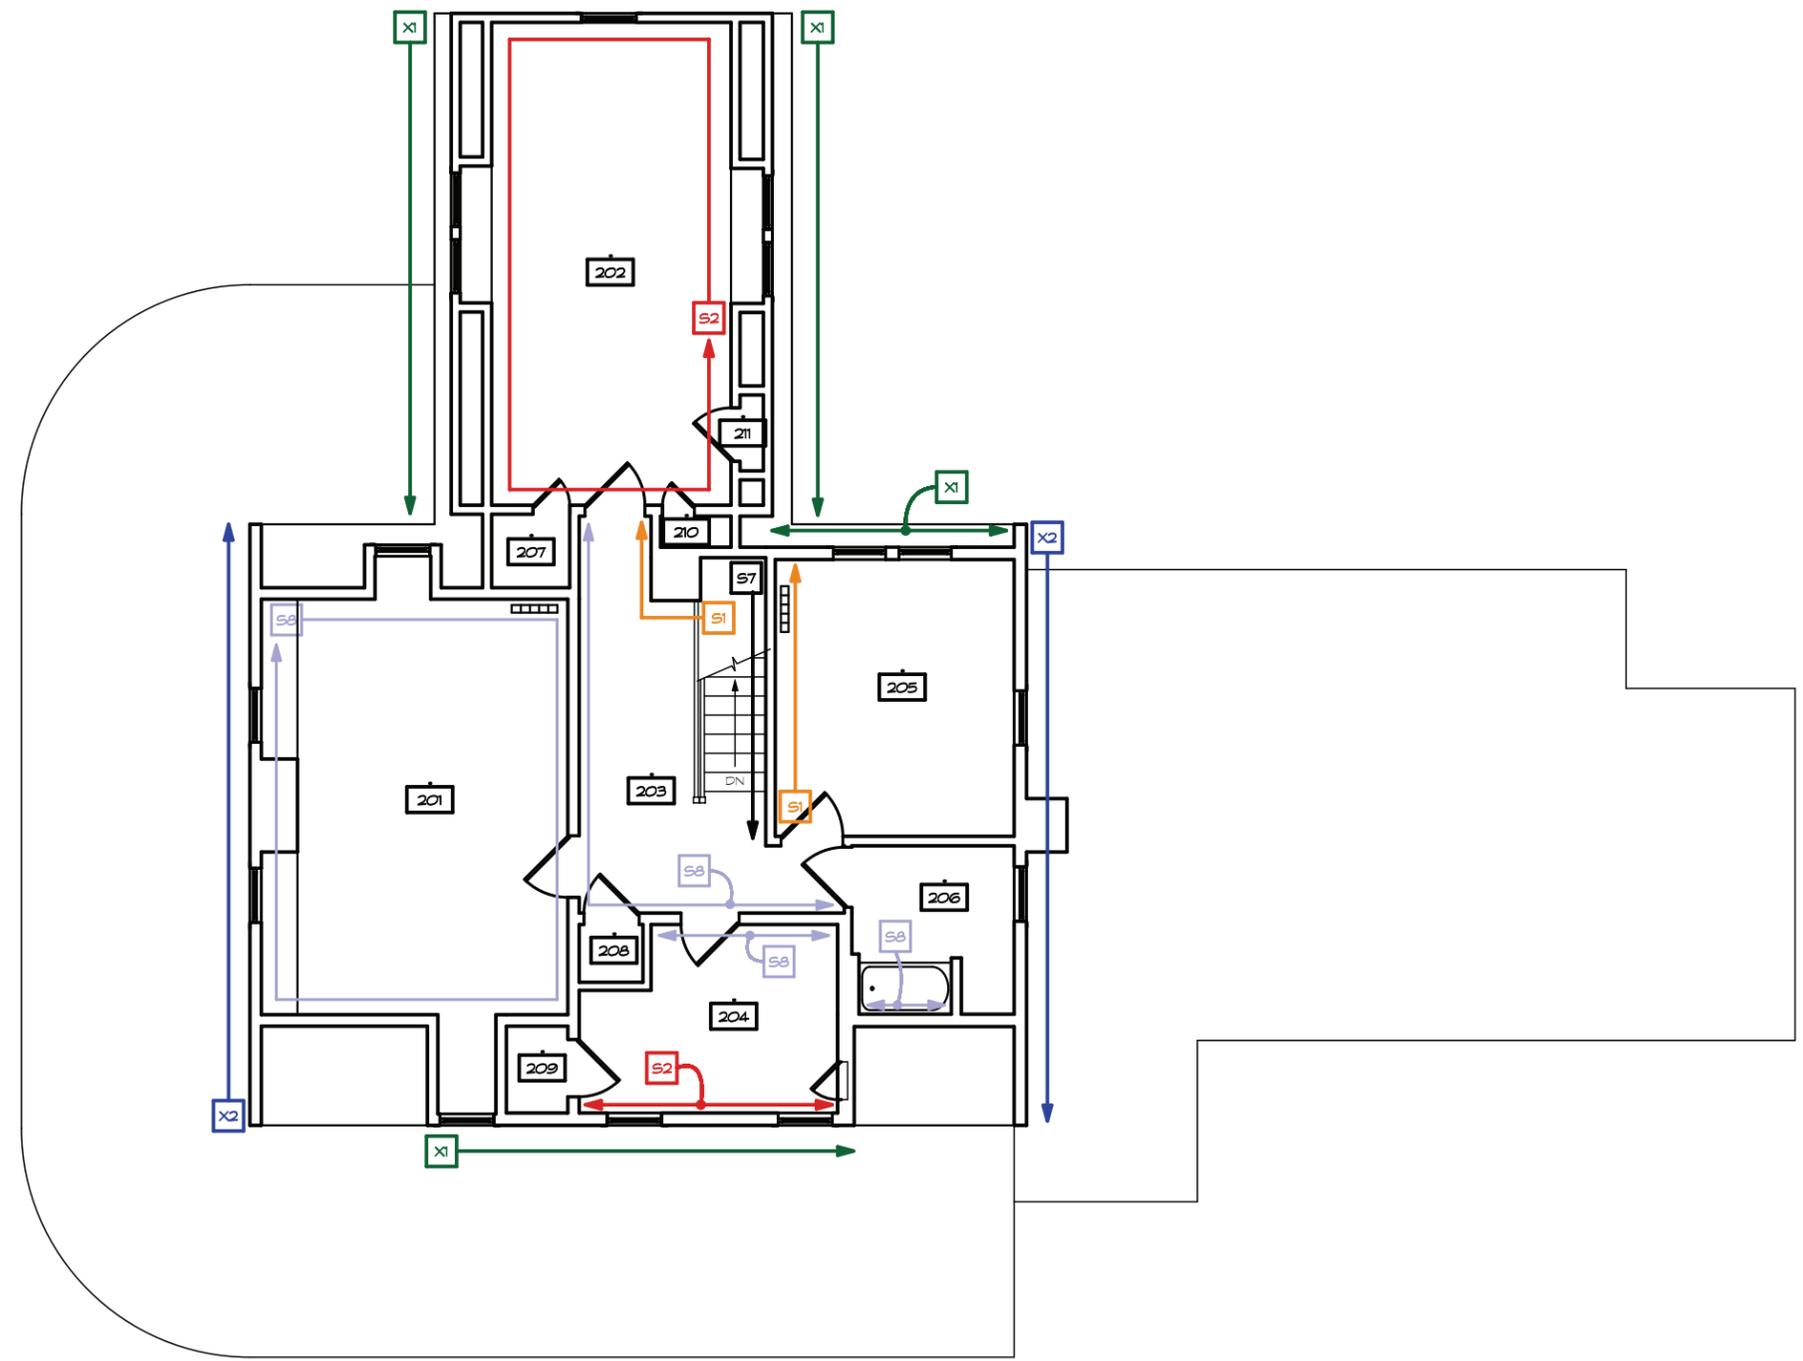
ANALYSIS PLAN - WALL FINISHES 2ND
SCALE: 1/8" = 1'-0"

- S1 PLASTER W/ SPLIT WOOD LATHE (LATE 18TH CENTURY)
- S2 PLASTER WITH METAL MESH LATHE (EARLY 20TH CENTURY)
- S3 PLASTER WITH ROCK LATHE (MID 20TH CENTURY)
- S4 TONGUE AND GROOVE BEADED BOARD WAINSCOT (LATE 19TH CENTURY)
- S5 HARDBOARD W/ LATTICE STRIPS FINISHING SEAMS (MID 20TH CENTURY)
- S6 BOARD WALL FINISH (MID 19TH CENTURY)
- S7 GYPSUM BOARD (MID 20TH CENTURY)
- S8 T&G OAK FLOOR (EARLY 20TH CENTURY)
- X1 BEVELED CLAPBOARD SIDING (LATE 18TH CENTURY) (LATE 19TH CENTURY)
- X2 GERMAN SIDING (LATE 19TH CENTURY)

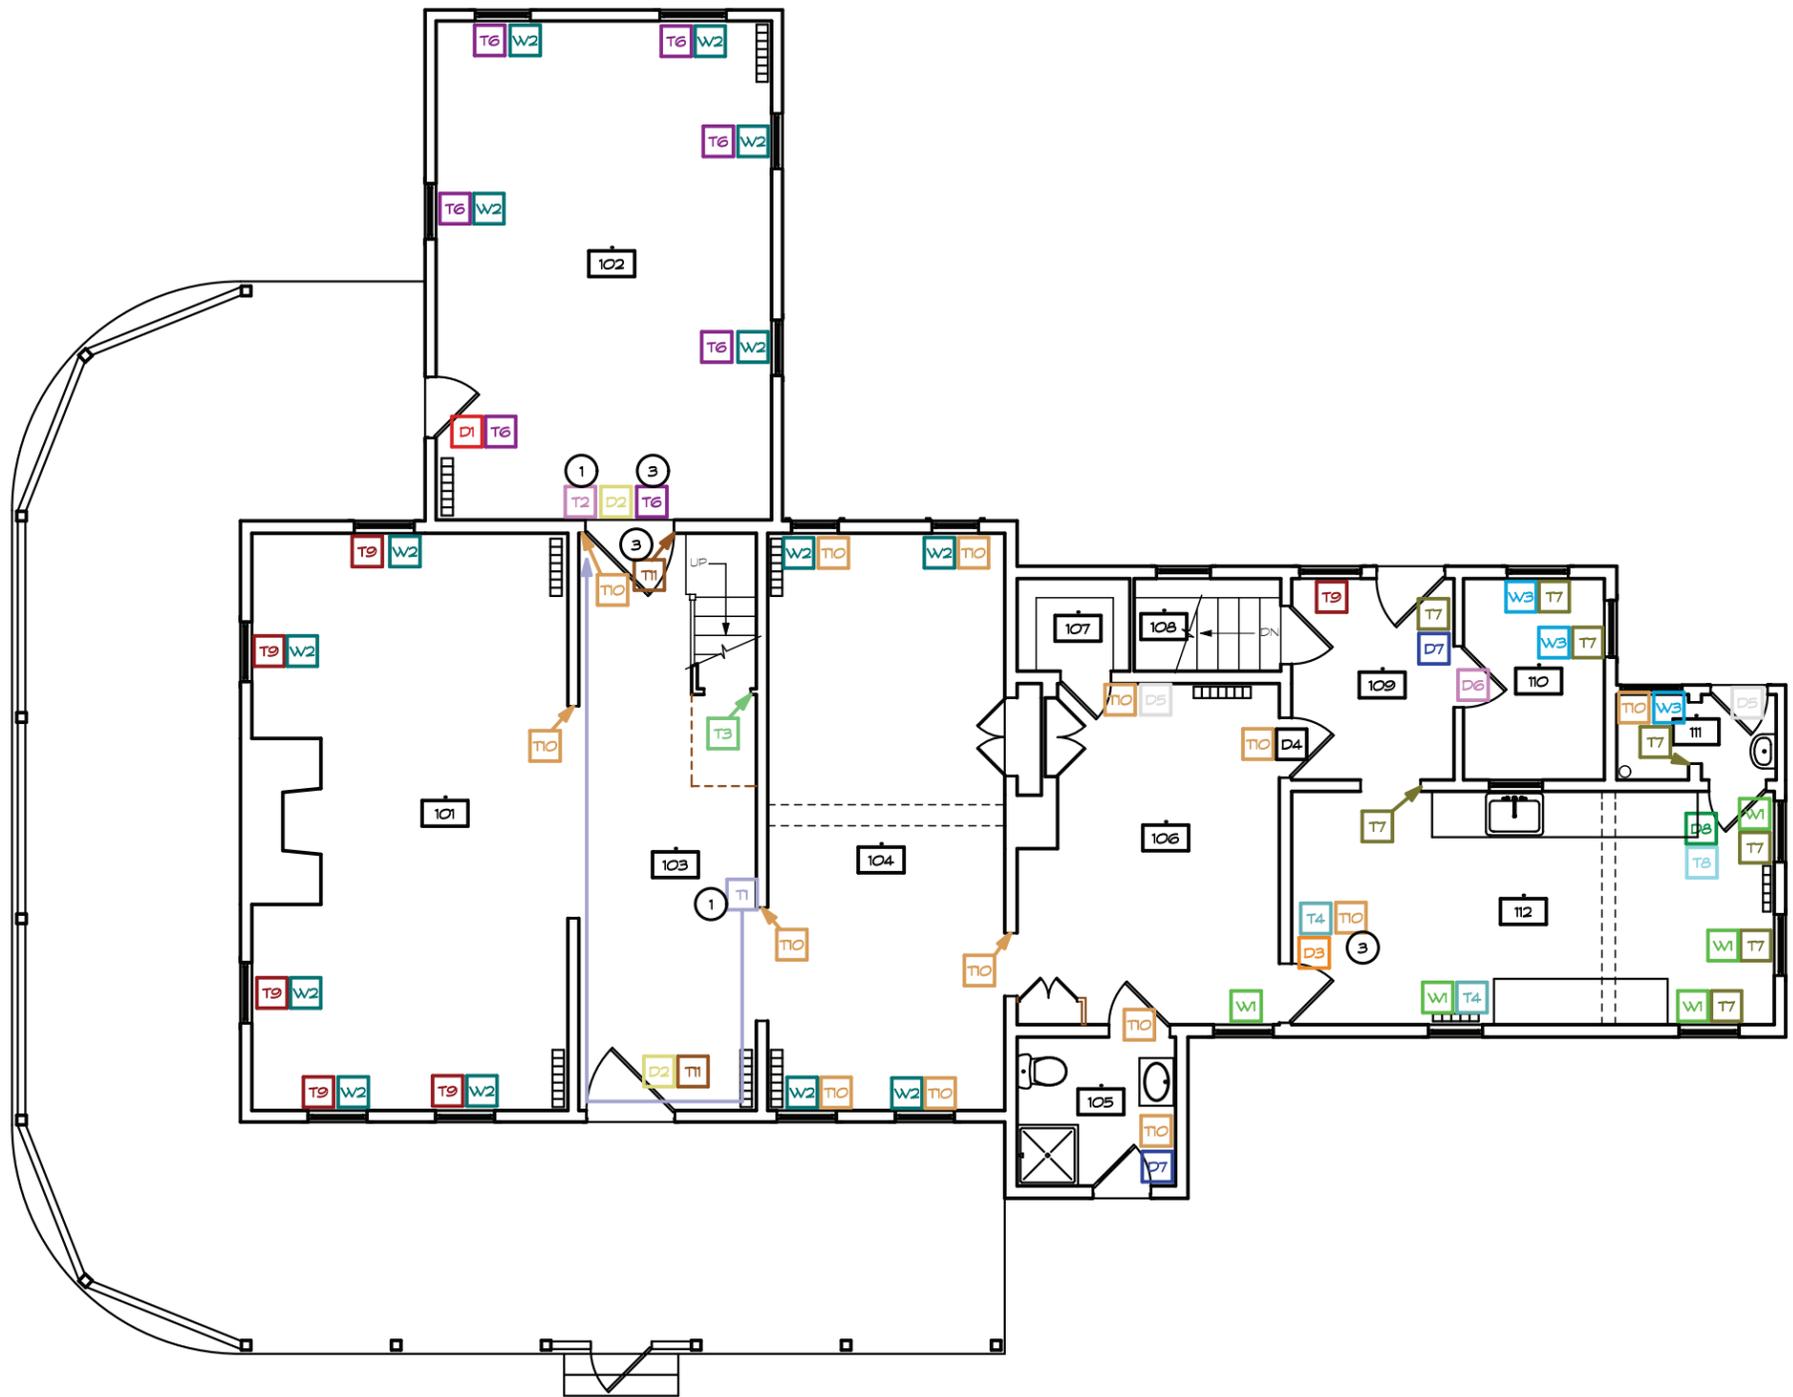
ANALYSIS PLAN - DOOR & WINDOW TRIM 1ST FLOOR
SCALE: 1/8" = 1'-0"

- W1 6/6 DOUBLE HUNG WINDOW
- W2 2/2 DOUBLE HUNG WINDOW (EARLY 20TH CENTURY)
- W3 6 PANE CASEMENT WINDOW (LATE 18TH CENTURY?)
- W4 6/6 DOUBLE HUNG WINDOW (ATYPICAL MUNTINS)

- D1 4 PANEL - DOOR (LATE 19TH CENTURY)
- D2 5 PANEL VETICAL/HORIZONTAL PANEL DOOR (EARLY 20TH CENTURY)
- D3 5 PANEL HORIZONTAL PANEL DOOR (EARLY 20TH CENTURY)

- D4 4 PANEL - GLASS IN TOP PANEL DOOR (LATE 19TH CENTURY)
- D5 10 PANEL GLASS PANE DOOR (MID 20TH CENTURY)
- D6 TWO PANEL DOOR (MID 20TH CENTURY)
- D7 6 PANE GLASS/HORIZONTAL LOWER PANEL DOOR (MID 20TH CENTURY)

- D8 1 PANEL DOOR (MID 20TH CENTURY)
- D9 BUILT UP BOARD DOORS (EARLY 20TH CENTURY)
- T1 3 1/2" BEADED CHAIR RAIL (LATE 18TH CENTURY)
- T2 4 1/8" BEADED CASING W/ BACKBAND (LATE 18TH CENTURY)

- T3 SMALL BULLNOSE CASING (LATE 18TH CENTURY)
- T4 3" MOLDED CASING (LATE 19TH CENTURY)
- T5 SMALL TRIM AT DORMER EDGES (LATE 18TH CENTURY)
- T6 4" FLAT CASING W/ ROUNDED EDGES, HEADER STOP, HEADER CAPITAL (MID 20TH CENTURY)

- T7 FLAT CASING W/ PROJECTING HEADER (MID 20TH CENTURY)
- T8 DOOR TRIM W/ TRANSOM
- T9 FLAT CASING MITRED W/ ROUNDED EDGE (MID 20TH CENTURY)
- T10 FLAT CASING W/O PROJECTING HEADER (MID 20TH CENTURY)

- T11 4 7/8" MOLDED CASING (LATE 19TH CENTURY)
- 1 BEHIND LATER CONSTRUCTION
- 2 WAINSCOT HEIGHT
- 3 DIFFERENT TRIM ON OPPOSITE SIDES OF DOOR
- 4 TWO LAYERS OF LATHE PLUS WAINSCOT

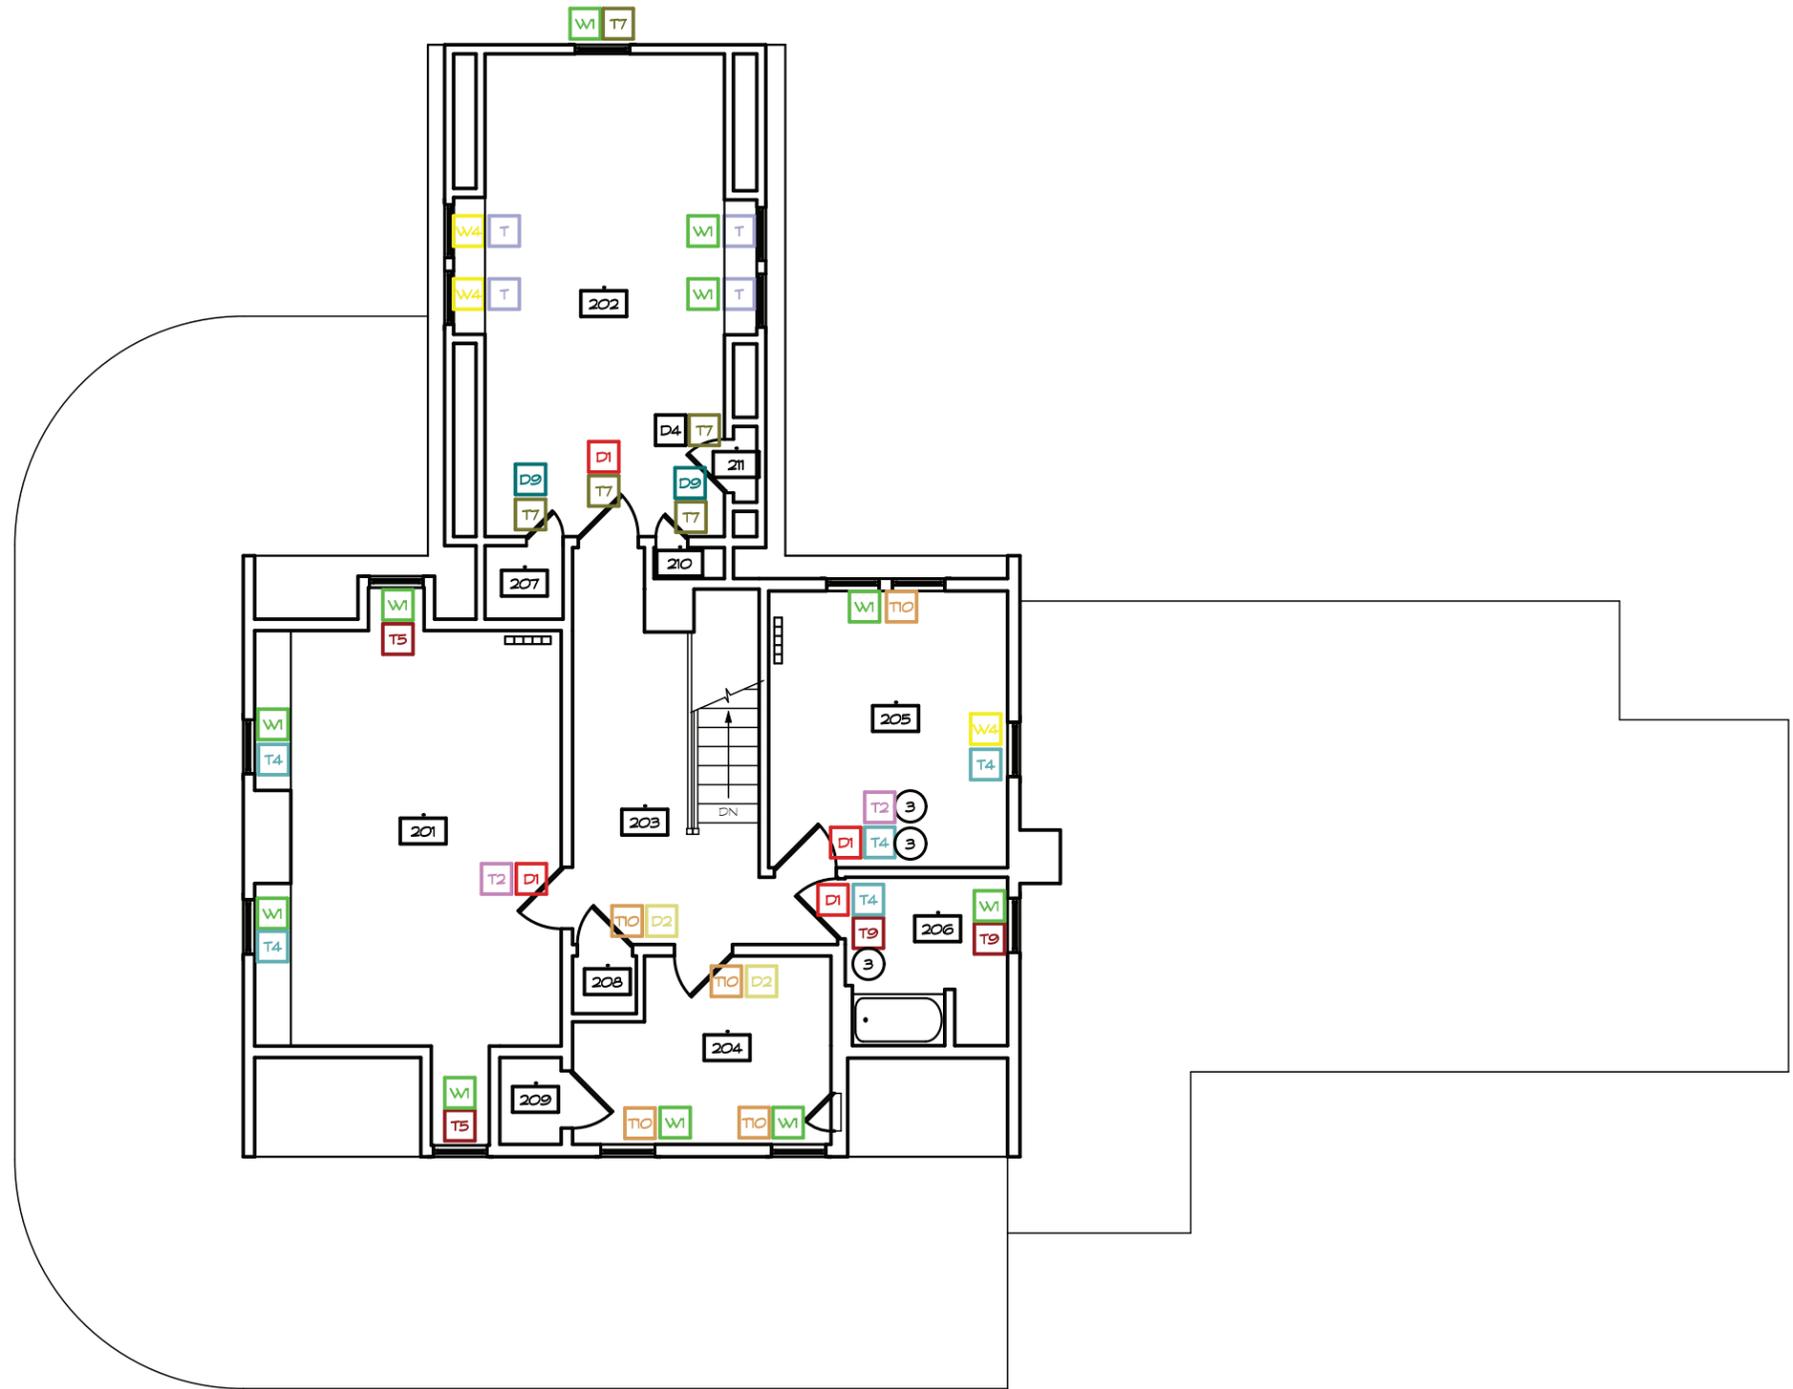
ANALYSIS PLAN - DOOR & WINDOW TRIM 2ND FLOOR

- W1 6/6 DOUBLE HUNG WINDOW
- W2 2/2 DOUBLE HUNG WINDOW (EARLY 20TH CENTURY)
- W3 6 PANE CASEMENT WINDOW (LATE 18TH CENTURY?)
- W4 6/6 DOUBLE HUNG WINDOW (ATYPICAL MUNTINS)

- D1 4 PANEL - DOOR (LATE 19TH CENTURY)
- D2 5 PANEL VETICAL/HORIZONTAL PANEL DOOR (EARLY 20TH CENTURY)
- D3 5 PANEL HORIZONTAL PANEL DOOR (EARLY 20TH CENTURY)

- D4 4 PANEL - GLASS IN TOP PANEL DOOR (LATE 19TH CENTURY)
- D5 10 PANEL GLASS PANE DOOR (MID 20TH CENTURY)
- D6 TWO PANEL DOOR (MID 20TH CENTURY)
- D7 6 PANE GLASS/HORIZONTAL LOWER PANEL DOOR (MID 20TH CENTURY)

- D8 1 PANEL DOOR (MID 20TH CENTURY)
- D9 BUILT UP BOARD DOORS (EARLY 20TH CENTURY)
- T1 3 1/2" BEADED CHAIR RAIL (LATE 18TH CENTURY)
- T2 4 1/8" BEADED CASING W/ BACKBAND (LATE 18TH CENTURY)

- T3 SMALL BULLNOSE CASING (LATE 18TH CENTURY)
- T4 3" MOLDED CASING (LATE 19TH CENTURY)
- T5 SMALL TRIM AT DORMER EDGES (LATE 18TH CENTURY)
- T6 4" FLAT CASING W/ ROUNDED EDGES, HEADER STOP, HEADER CAPITAL (MID 20TH CENTURY)

- T7 FLAT CASING W/ PROJECTING HEADER (MID 20TH CENTURY)
- T8 DOOR TRIM W/ TRANSOM
- T9 FLAT CASING MITRED W/ ROUNDED EDGE (MID 20TH CENTURY)
- T10 FLAT CASING W/O PROJECTING HEADER (MID 20TH CENTURY)

- T11 4 7/8" MOLDED CASING (LATE 19TH CENTURY)
- 1 BEHIND LATER CONSTRUCTION
- 2 WAINSCOT HEIGHT
- 3 DIFFERENT TRIM ON OPPOSITE SIDES OF DOOR
- 4 TWO LAYERS OF LATHE PLUS WAINSCOT

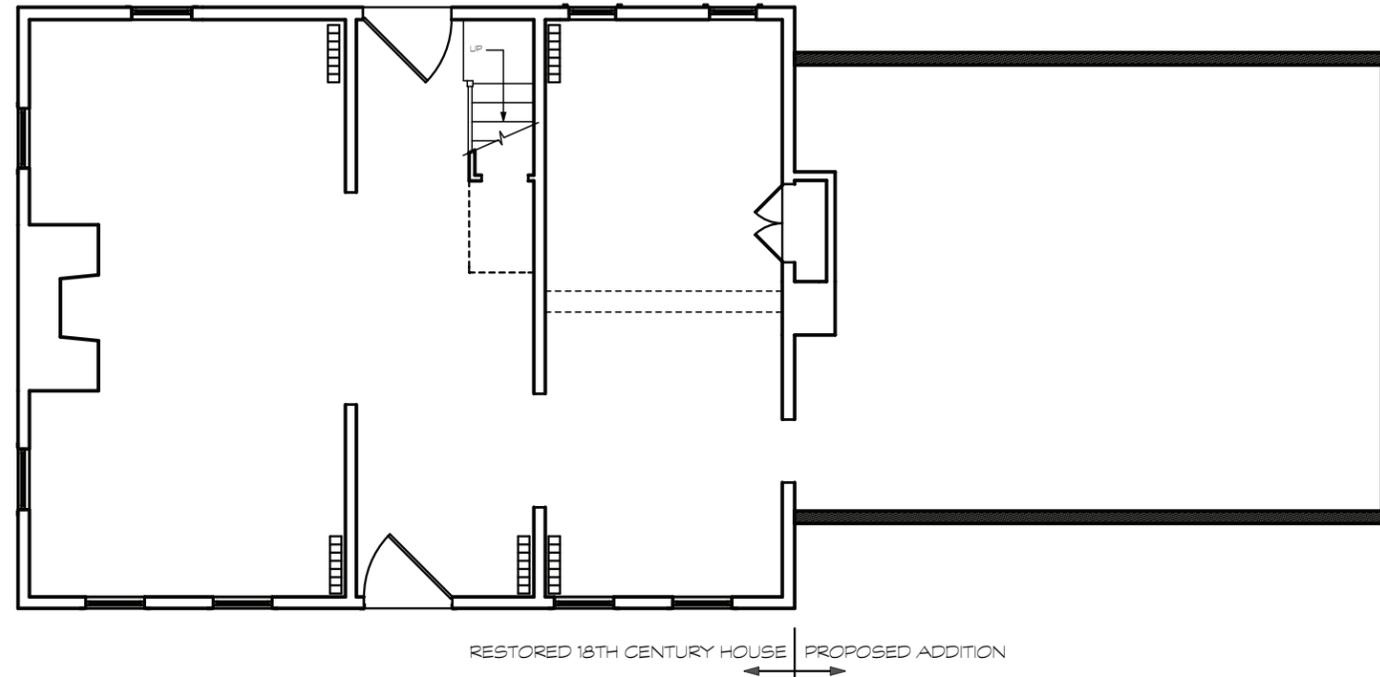
FLOOR PLAN - OPTION 1

NOTE: INTERIOR OF 18TH CENTURY HOUSE TO FURTHER DEVELOPED AFTER ADDITIONAL HISTORIC RESEARCH.

PROPOSED USE: HOUSE MUSEUM WITH PUBLIC FACILITIES IN ADDITION.

SAMPLE BUILDING PROGRAM:

- 1. EXHIBITS RELATED TO HISTORY OF SITE & BUILDING
- 2. HANDICAP RESTROOM FACILITIES.

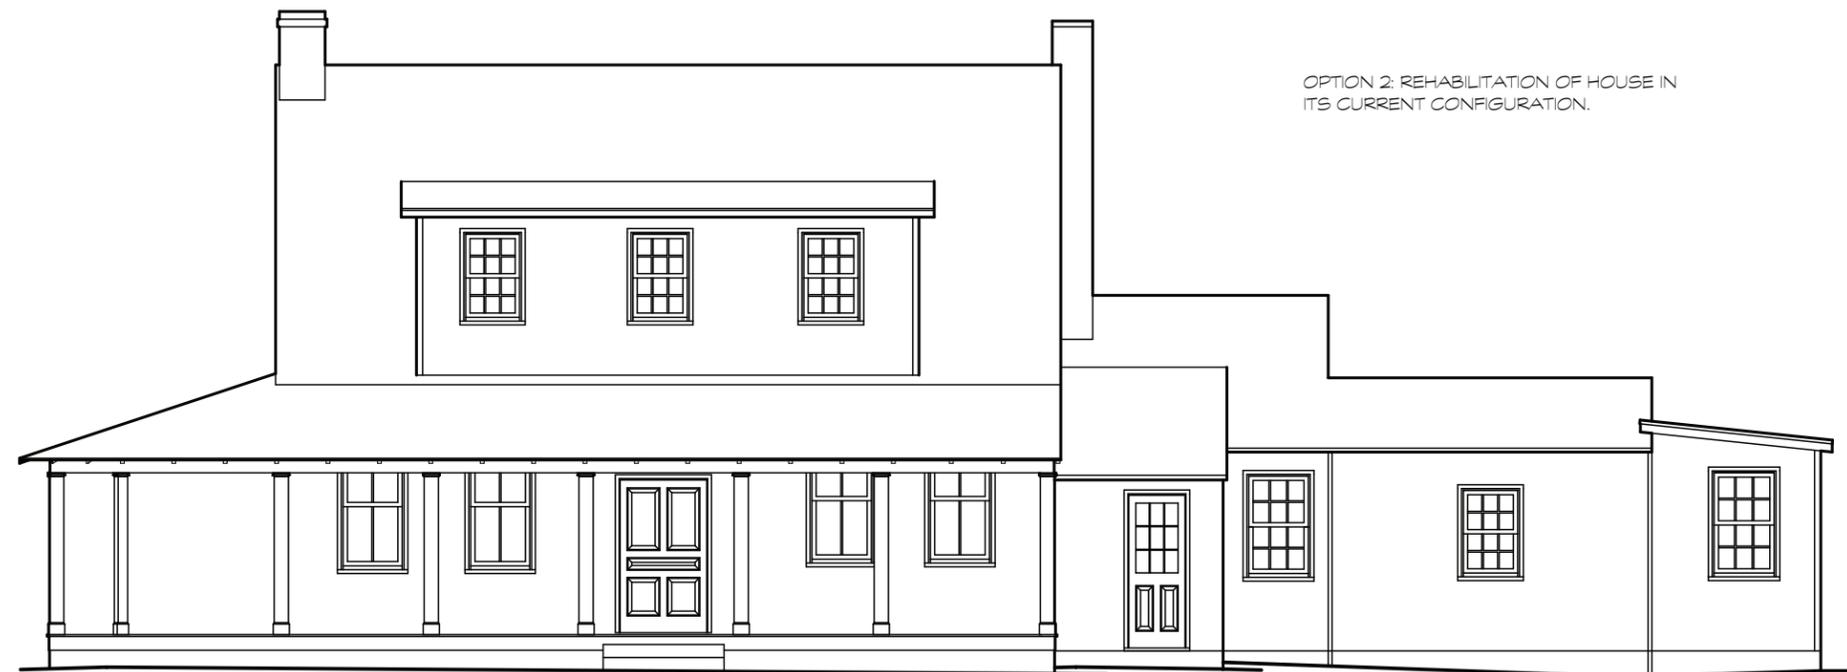
1 SOUTH ELEVATION - OPTION 2
SCALE: 1/8" = 1'-0"

OPTION 2: REHABILITATION OF HOUSE IN ITS CURRENT CONFIGURATION.

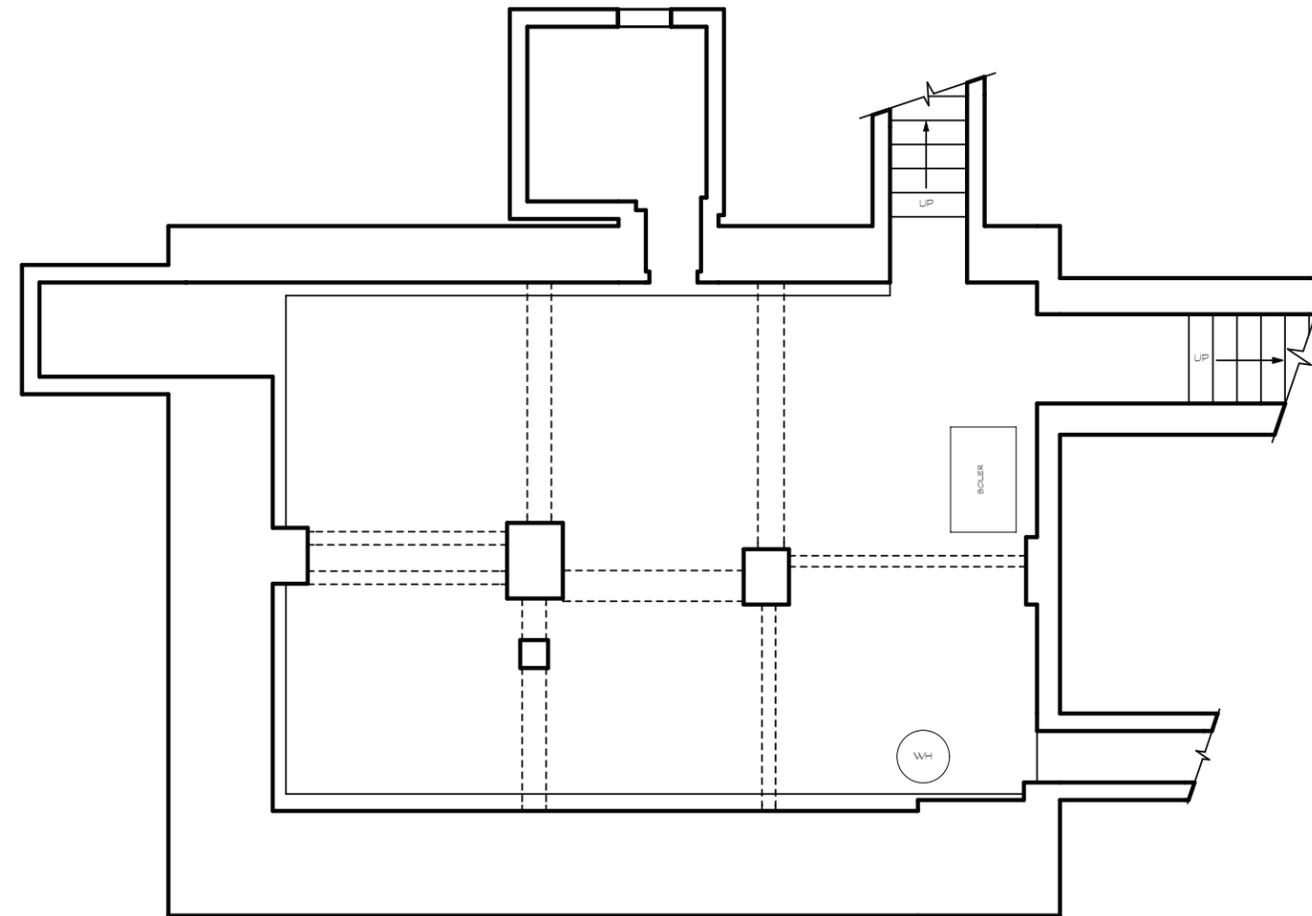
1 BASEMENT PLAN - OPTION 3
SCALE: 1/8" = 1'-0"

OPTION 3: SELECTIVE DEMOLITION TO FOUNDATION,
PRESERVE FOUNDATIONS AN INTERPRETIVE
TREATMENT PLAN.

NOTE: STABILIZE FOUNDATION AND MAKE IMPROVEMENTS
AS NEEDED FOR SAFETY AND SECURITY. ADD INTERPRETIVE
SIGNAGE WITH HISTORICAL INFORMATION ABOUT THE
BUILDING.
