OCTOBER 2009

Report of the McLean Pedestrian Task Force to Dranesville District Supervisor John Foust

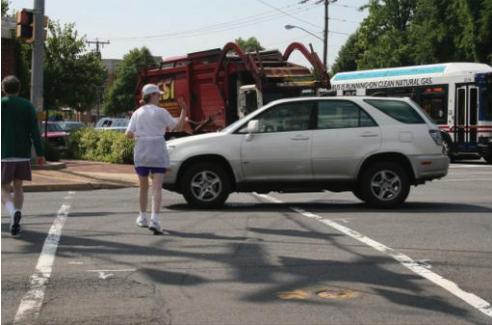
<p>Figure 2: A common experience in the central intersection</p>
	<p>Accessibility is hampered by missing, poorly designed and/or poorly maintained curb cuts throughout downtown</p>	<p>Install and repair curb cuts according to current standards along the main routes of Old Dominion, Chain Bridge, and Elm Street then develop a priority list for other downtown streets.</p>

Location	Problem Identification	Proposed Solutions	Comments/Photos
Universal	<p>Disregard of pedestrians by many motorists and improper conduct by pedestrians and bicyclists</p> <p>According to Virginia code:</p> <p><i>The driver of any vehicle shall yield the right-of-way to pedestrians crossing at a clearly marked crosswalk.</i></p> <p><i>No pedestrian shall enter or cross an intersection in disregard of approaching traffic.ⁱⁱ</i></p>	<p>Improve pedestrian, bicyclist, and motorist behavior through:</p> <ul style="list-style-type: none"> • Better signage • More public education • Increased presence of law enforcement

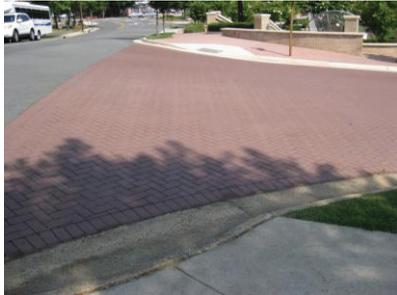
</div> <p>Figure 4: Imprinted brick-color asphalt is a great distinctive surface</p>

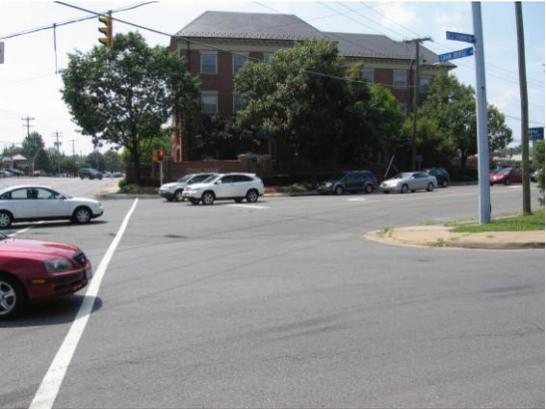
<p>Figure 5: A sidewalk to nowhere in the central intersection of downtown McLean</p>

Location	Problem Identification	Proposed Solutions	Comments/Photos
Central Intersection of Old Dominion Drive and Chain Bridge Road	<p>On south side of Elm Street and Chain Bridge Road, pedestrians are stranded in triangular island because the sidewalk ends and there is no marked crosswalk from the island across Old Dominion Drive or Elm Street</p>	<p>Build sidewalks on both sides of island</p> <p>Add crosswalks from island across intersections or extend island to existing crosswalk</p>

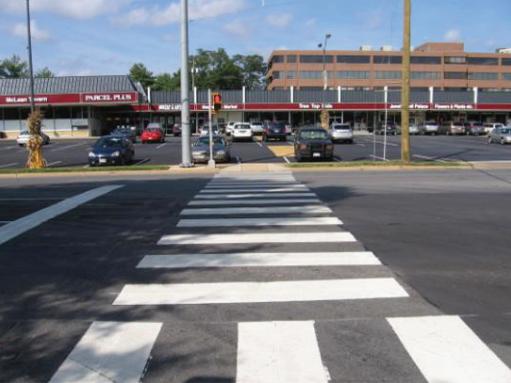
<p>Figure 6: An example of a good crosswalk</p> <p><i>A wide curb radius typically results in high-speed turning movements by motorists, and reducing curb radii forces vehicles to slow upon turning. Tighter turning radii are most important where street intersections are not at right angles.^v</i></p>

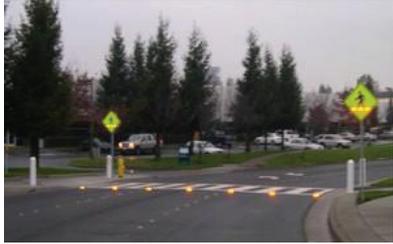
<p>Figure 7: Flashing lights in roadway get a driver's attention</p> <p><i>“... the presence of a raised median (or raised crossing island) was associated with a significantly lower pedestrian crash rate at multi-lane sites with both marked and unmarked crosswalks.”^{vi}</i></p>

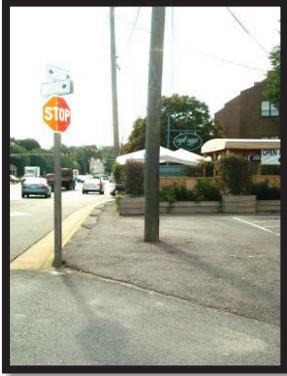
<p>Accessibility is severely compromised by missing sidewalk segments :</p> <ul style="list-style-type: none"> • Between Lowell and Whittier in front of Café Oggi on west side of Old Dominion • In front of Tony’s Building near Corner Lane <p>Accessibility is limited in other places by poorly maintained sidewalks and other obstructions</p>	<p>Install sidewalk consistent with overall design hierarchy</p> <p>Consider making a future bike lane with dual pedestrian use at this narrow point in roadway</p> <p>Please see Appendix A for details</p>

<p>Figure 8: Sidewalk encroachment in front of Café Oggi on Old Dominion Drive. Oops, no sidewalk, all asphalt!</p>

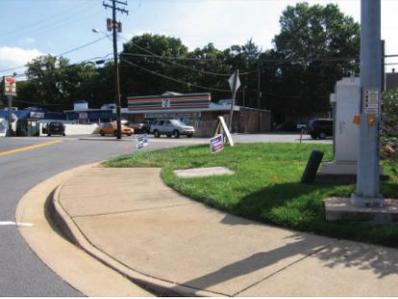
<p>Figure 11: One is left stranded in the pedestrian island at Chain Bridge Road and Old Chain Bridge Road</p>
	<ul style="list-style-type: none"> Dolley Madison and Chain Bridge Road 	<p>On-demand pedestrian-only cycle in signal sequence to protect pedestrians from cars turning left onto Dolley Madison</p> <p>Ladder design crosswalk</p>

Location	Problem Identification	Proposed Solutions	Comments/Photos
Chain Bridge Road	<ul style="list-style-type: none"> Old Chain Bridge Road and Chain Bridge Road: There is no crosswalk on south side of intersection on Old Chain Bridge Road, the sidewalk ends abruptly in the triangular island, and there is no crosswalk across Chain Bridge Road to sidewalk in front of Rocco's 	<p>Add crosswalk and signal on north side of intersection at Old Chain Bridge Road</p> <p>Add crosswalk from island across Chain Bridge Road</p> <p>Complete sidewalk in triangular island</p>

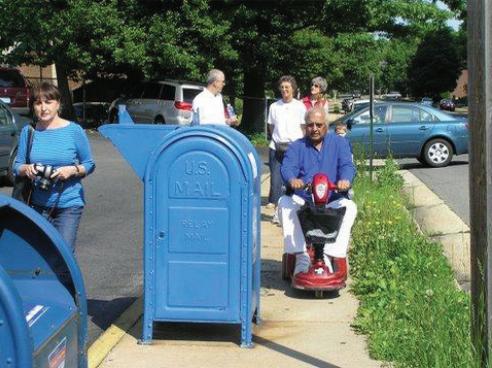
<p>Figure 16: At US post office on Elm Street, mailboxes obstruct the sidewalk</p>

Location	Problem Identification	Proposed Solutions	Comments/Photos
Elm Street	<p>Elm Street is an important secondary route for commercial and local traffic. Access is severely limited in many places:</p> <ul style="list-style-type: none"> • Near the intersection with Chain Bridge Road on north side of Elm Street near “old” McDonalds, there is no sidewalk and passage is obstructed by a newspaper stand and a dumpster • On south side of Elm, few sidewalks exist between Chain Bridge Road and Beverly Road • Bolted mail boxes severely obstruct pedestrian use of the sidewalk in front of Post Office. <p>Accessibility is limited in other places by poorly maintained sidewalks and other obstructions</p>	<p>Build sidewalk consistent with overall design hierarchy</p> <p>Build sidewalk consistent with overall design hierarchy</p> <p>Reposition mailboxes</p> <p>Please see Appendix A</p>	<p>Sidewalks should be wide enough to comfortably accommodate three people walking</p>

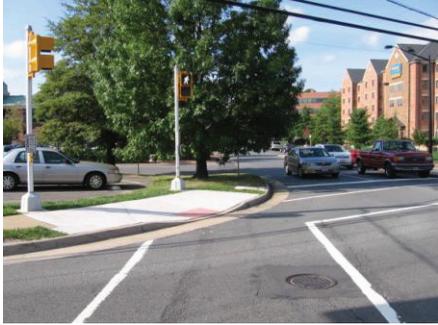
<p>Figure 17: At Beverly Drive and Old Dominion Drive, pedestrians are forced into Beverly Drive where sidewalk abruptly ends</p>

Location	Problem Identification	Proposed Solutions	Comments/Photos
Beverly Drive	<p>An important secondary route, Beverly Drive is a link between high-density residential dwellings on the north end and commercial activities on the south end. It also provides bike access from Dolley Madison.</p> <p>Crosswalks are poorly marked or missing:</p> <ul style="list-style-type: none"> • Old McLean Village Drive to bus stop <p>Sidewalk segments are missing in key spots on west side of road:</p> <ul style="list-style-type: none"> • In front of Verizon facility, near Ingleside • Near Medicine Chest, between Redmond Drive and Old Dominion • At driveway for Cardinal Bank Building <p>Best option for bicycle access from Dolley Madison, but contains no markings for bike safety</p>	<p>Ladder or horizontal bar design crosswalks, as determined by pedestrian volume</p> <p>Install sidewalks consistent with overall design hierarchy</p> <p>Install sidewalks consistent with overall design hierarchy</p> <p>Install sidewalks consistent with overall design hierarchy</p> <p>Add chevrons/lanes on both sides with signage</p>

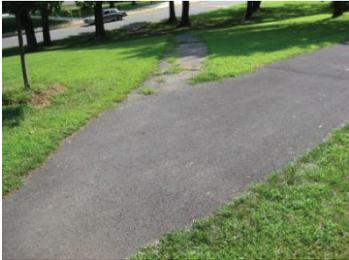
<p>Figure 23: Upgrade old trail which joins new trail in front of Langley High School</p>
Balls Hill Road	Dangerously narrow and unmarked for bicyclists	Widen and add lanes from Lewinsville Road to Georgetown Pike	
Haycock Road	Haycock Road is an important connection between West Falls Church metro and McLean	<p>Widen and add lanes from Westmoreland Street to West Falls Church Metro</p> <p>Upgrade current trail on north side of road and connect it across the Haycock Elementary School grounds to Westmoreland Street</p>

Location	Problem	Proposed Solution	Comments/Photos
Great Falls Street	Narrow and dangerous for cyclists, but an important route between McLean and City of Falls Church	Widen and add lanes from Dolley Madison Boulevard to City of Falls Church line	
Georgetown Pike	<p>Narrow in places and unmarked for bicyclists</p> <p>Trail between Langley High School and Ridge Drive in a state of disrepair</p>	<p>Widen and add bike lanes on western side from Chain Bridge Road to Dolley Madison Boulevard</p> <p>Widen and add lanes between Old Dominion Drive and River Bend Road</p> <p>Repair trail to the same quality as the recently re-paved one in front of Langley High School</p>

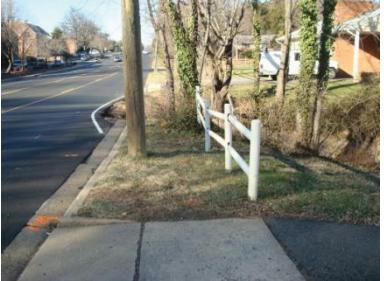
<p>Figure 27: A much-needed sidewalk is slated for installment on north side of Westmoreland and Saucy Branch</p>
	<p>Alternative Route: Northwest up Westmoreland to Pimmit Run. Follow the natural path along Pimmit Run to Old Dominion Road and then turn NW into downtown.</p>	<p>Currently, pedestrians must scurry across the road; visibility is limited for both pedestrians and drivers because of the dip and curve in the road</p>	<p>Install ladder-design crosswalk</p> <p>Add hip-high “Yield to Pedestrian” sign</p> <p>Improve signage in both directions warning of upcoming crosswalk</p>

Route Description	Problem	Proposed Solution	Comments/Photos
Longfellow Middle School	<p>Primary Route: Northwest up Westmoreland Avenue to Chain Bridge Road and northeast into downtown.</p>	<p><i>Currently, the sidewalk ends abruptly</i>, and pedestrians must perilously cross Westmoreland near Saucy Branch in order to reach a sidewalk on the south side of Westmoreland, then cross back to the other side of Westmoreland at the intersection with Chain Bridge. Most pedestrians choose to walk in the road rather than cross</p>	<p><i>Install a sidewalk along the north side of Westmoreland Avenue between the bridge over Saucy Branch and the property of Redeemer Lutheran Church</i></p>

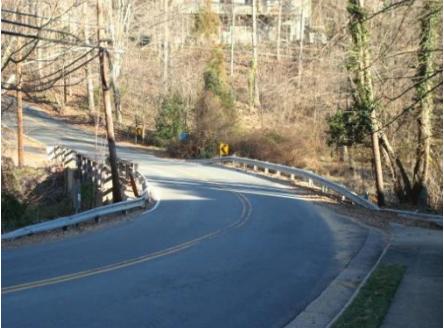
<p>Figure 28: Dangerous crossing over Pimmit Run on Old Chesterbrook Road</p>

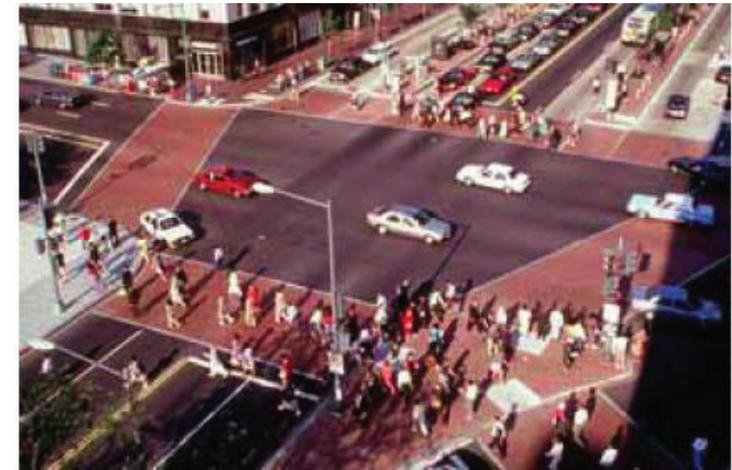
- **Distinctive surface:** A distinctive treatment of surface material in crosswalks can raise the visibility of pedestrians. A design hierarchy that calls for different treatment of crossings (e.g., for better visibility or aesthetics, or to provide tactile guidance for people with visual impairments), can employ a different texture than street asphalt such as stamped asphalt. Different colors can be painted on the asphalt (stamped or smooth) to further distinguish the crossings from the rest of the street, but in all cases the two parallel white lines should remain.
- **Raised:** Crosswalks that are raised above the surrounding pavement provide extra visibility for pedestrians and slow traffic by creating a natural speed hump.

Figure 30: Distinctive surfaces make crosswalks stand out from safety and aesthetic perspectives

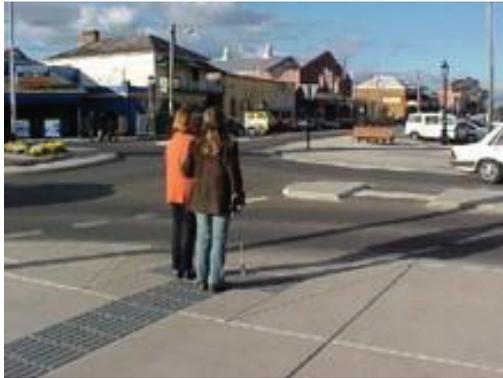
Figure 31: Good elements for pedestrians: reduced crossing distance, cut in median, tactile warning strip in curb cut

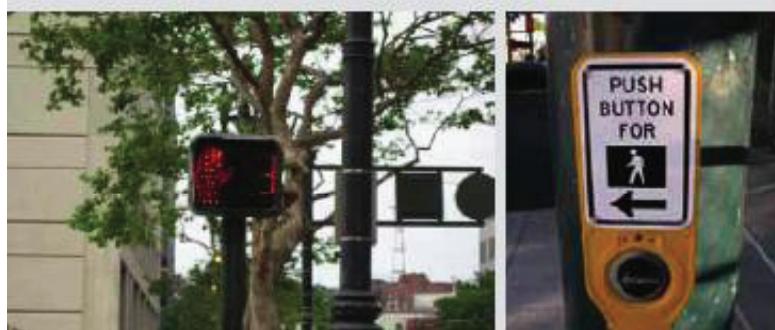
- **Push buttons:** It is important to make sure that pushbuttons are responsive to pedestrians and very noticeable. We recommend that the buttons be silver and at least 2” inches in diameter, with the direction clearly marked by an arrow directly above the button.

They should be conveniently located no more than 42 inches above pedestrian travel ways, face toward pedestrians and meet all accessibility standards.

Figure 33: The way it should be: Countdown signals with large, visible buttons

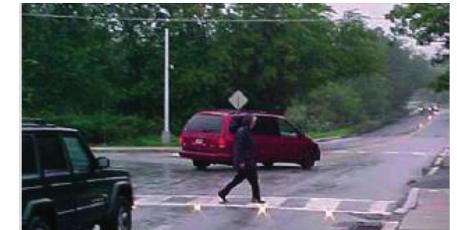
Use ladder design for best visibility and provide curb ramps directly aligned with the crossing at each side. As a caution, these should be used only where motorists' visibility is good, and at least 200 feet from nearest intersection crossing.

Figure 34: Even in the rain, drivers take notice of in-road flashing lights

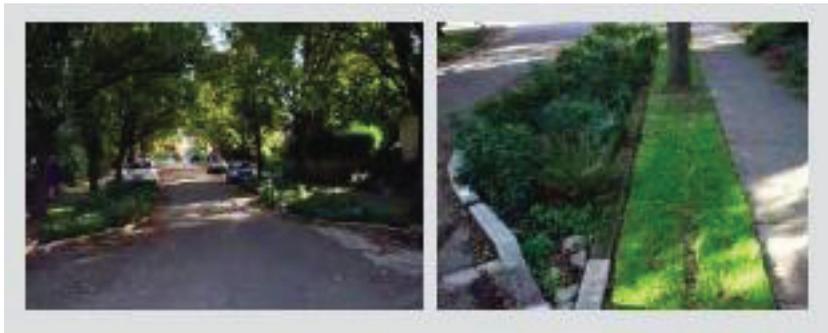
- **Bumpouts:** Physical measures that narrow the roadway, even for short distance, slow traffic. Bump-outs are most commonly used on streets that have on-street parking. "Bumping out" the sidewalk into the turning lane reduces the radius of each curb, and slows vehicles that are turning. Bump-outs have the added benefit of reducing crossing distances for pedestrians.

Figure 35: Examples of bumpouts

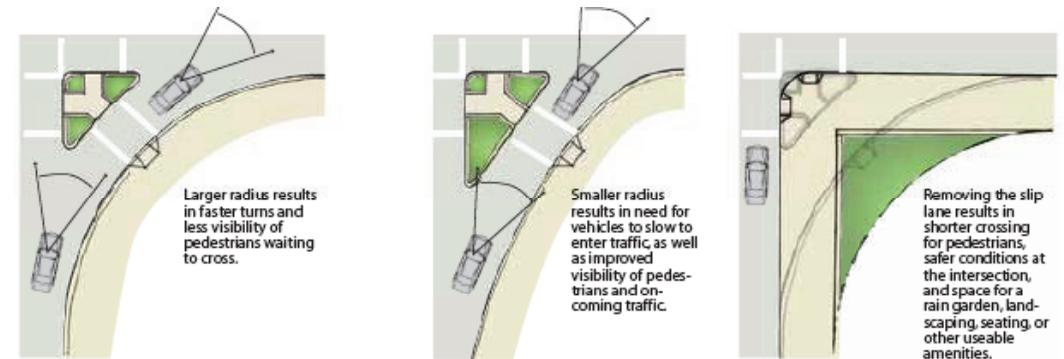
- **Reduced curb radii:** Curb radii can be altered from a curve to a more nearly right angle configuration, using all non-essential vehicular turning space to add pedestrian space to the sidewalk in a location where pedestrians wait to cross. These measures also reduce the crossing distance for pedestrians. These, however, are difficult and expensive retrofits. They also reduce the flexibility of roadways and can block turning lanes.

Figure 36: Progression of reduced curb radii shows increasingly safer conditions for pedestrians

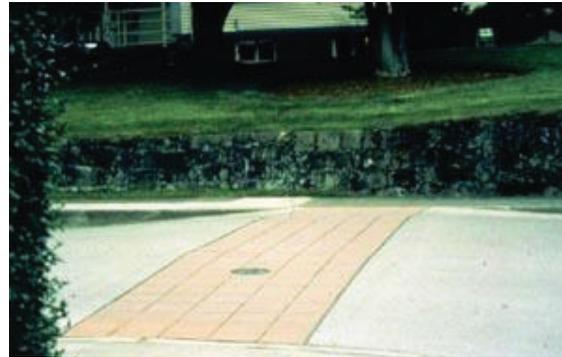
- **Slightly raised crosswalks:** Raised crosswalks reduce vehicular speeds at pedestrian crossings by acting as a low speed hump.

Figure 37: Raised crosswalk with distinctive surface provides visibility and slows vehicles
