HUNTLEY MEADOWS WETLAND RESTORATION

Alexandria, VA

CONNECTING ECOLOGY and COMMUNITY through INNOVATIVE ENGINEERING

2014 ACEC ENGINEERING EXCELLENCE AWARDS

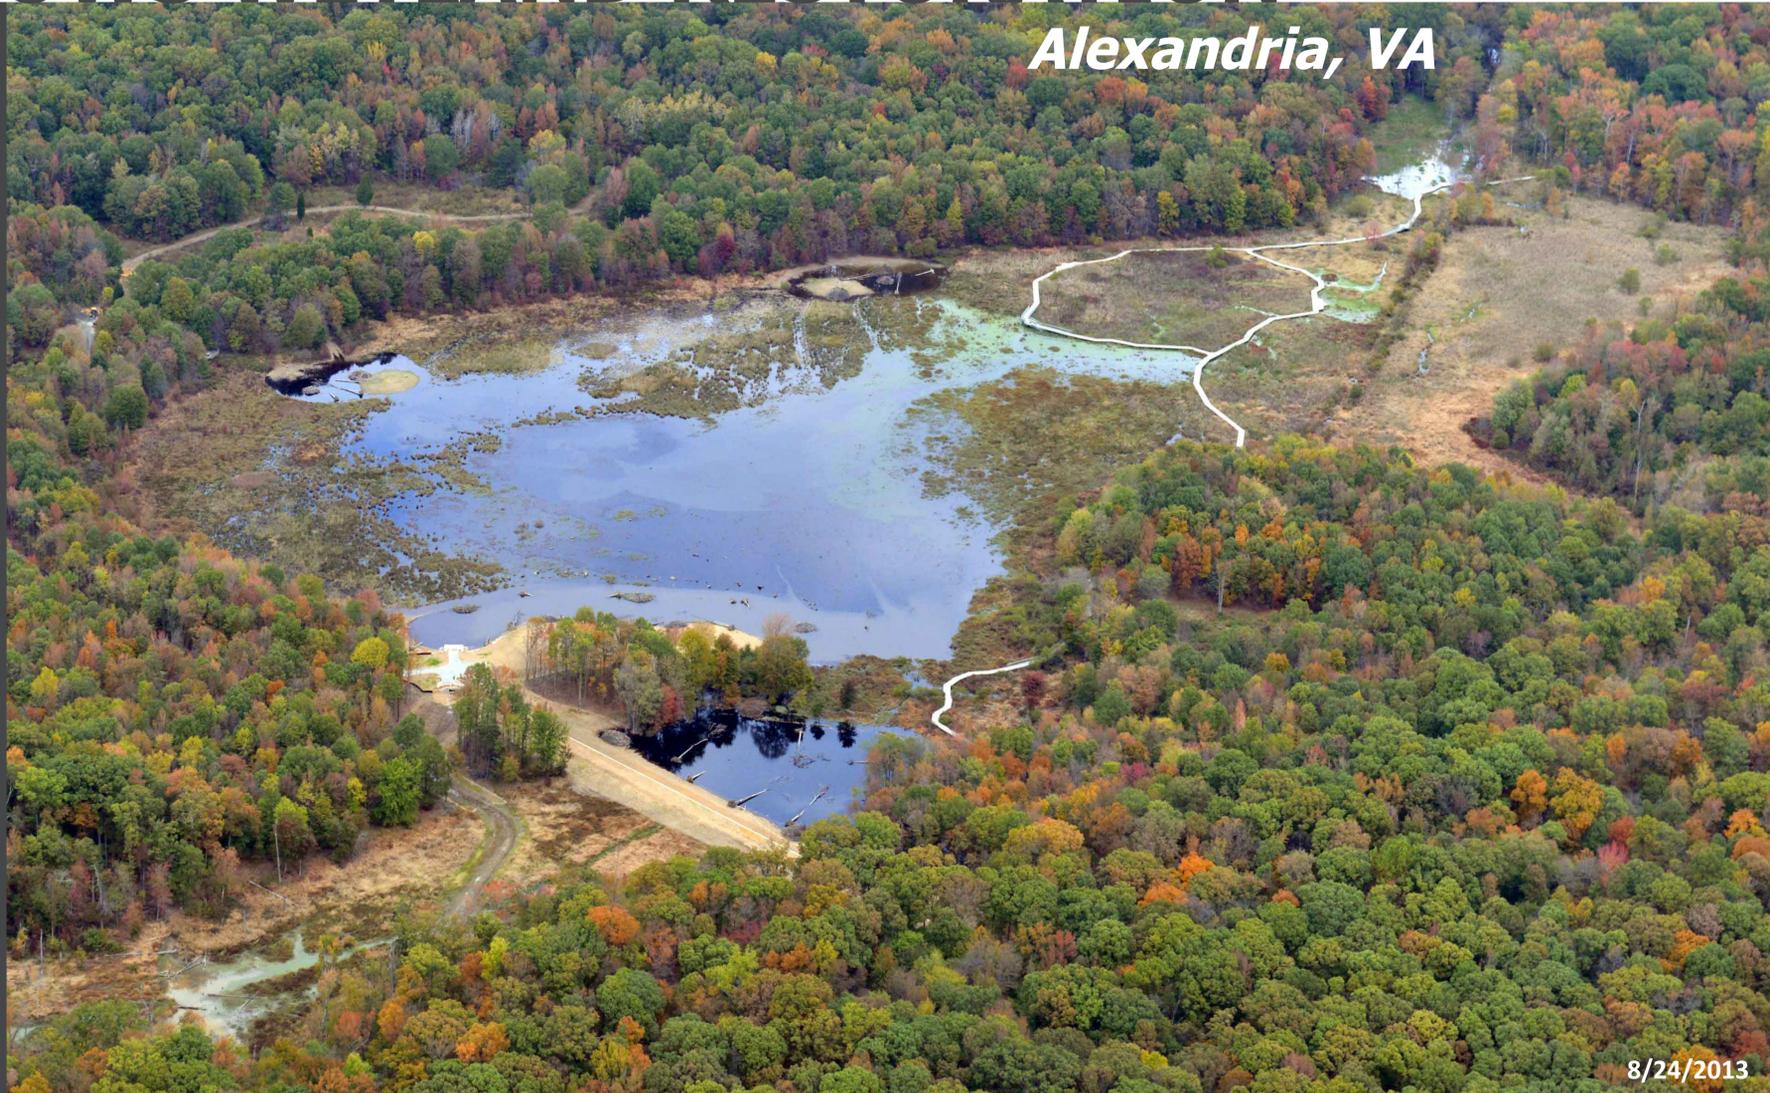
8/24/2013

Located in Alexandria, VA, the ±40 acre central wetland area in Huntley Meadows Park is the largest non-tidal wetland in Northern Virginia. Due to the vast ecological value of hemi-marsh systems, the Fairfax County Park Authority decided to recreate the wetland's previous hemi-marsh condition, which is known to have one of the highest levels of biodiversity and ecological function.

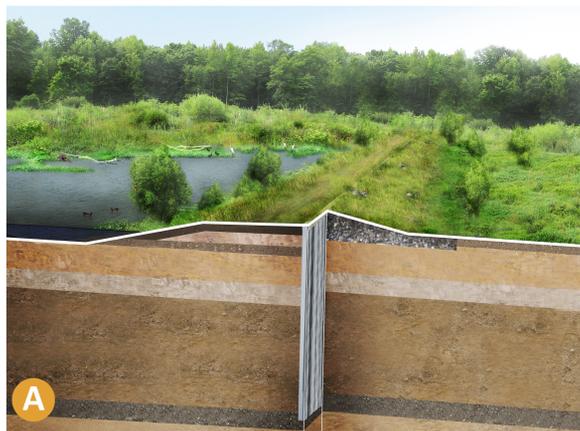
WSSI designed water control structures, which blend seamlessly into the natural environment. Vinyl sheet-pile was combined with an earthen-dam rock structure to allow large storm events to overtop the structure without degradation while eliminating the need for a dedicated emergency spillway.

- A. Conceptual rendering of the Water Control Structure
- B. Installation of vinyl sheet-pile
- C. Habitat pool adjacent to water control structure

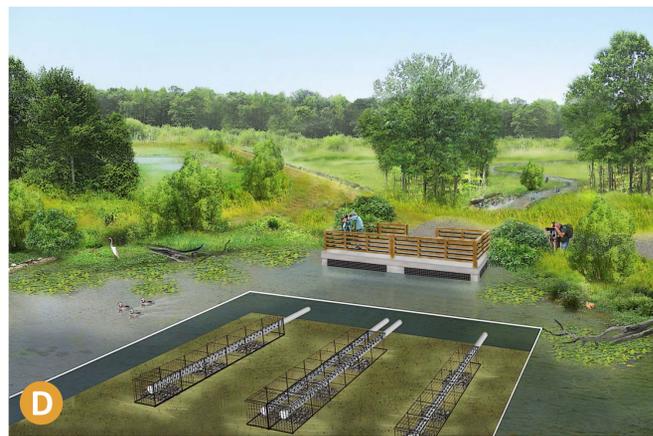
WSSI incorporated Clemson Beaver Pond Levelers into the design to control the water surface elevation in the system without any risk from beaver damming activities. Because beavers tend to construct dams where significant surface flow is present, WSSI designed a submerged inlet to convey base flows which discourages further damming activities by beavers as surface flows are eliminated. This technique, along with adjustable slide gates, allows management of the water level to achieve the biological diversity goals of the hemi-marsh system while allowing for continued habitation of beaver.

- D. Concept rendering of the Clemson Beaver Pond Levelers, with the Water Control Structure (seen above and left of the observation platform)
- E. Image of the installed Clemson Beaver Pond Levelers during construction, including downed trees to be utilized for additional habitat
