Landscape Certification

Forest Conservation Branch Site Development and Inspections Division Fairfax County Land Development Services 12055 Government Center Parkway, Suite 535, Fairfax, VA 22035 Phone: 703-222-0801, TTY 711 www.fairfaxcounty.gov/landdevelopment

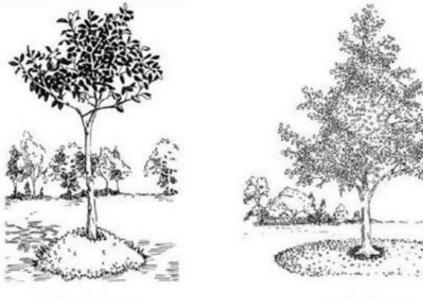
Figure 2. Graphic demonstrating correct and incorrect mulching techniques. Copyright © 2016 Treefolks.org

Improper Mulch Root flare buried & Mulch piled high up against the trunk

Proper Mulch Root flare visible at the base of the tree & Mulch extends to dripline of canopy

Mulch bed is 2-4 inches deep. Near, but not touching, the trunk (Figures 1 & 2) per ANSI A300.6. PFM 12.0505.5F2
 Plantings are established at the correct depth and width—root flare is exposed (Figures 1 & 2) per ANSI A300.6. PFM 12.03104E
 Burlap and at least 1/2 of the wire basket are removed (if used) per ANSI A300.6 (Figure 1). PFM 12.0505.3
 All plantings are <u>ALIVE</u> and in good condition per ANSI Z60.1. Replace any dead or dying. PFM 12.05051D
 All plantings are the same SPECIES and SIZE (per ANSI Z60.1) as noted on the approved site plan. Substitutions can be made through the proper procedure with FCON. PFM 12.0505.1A
 Staking (per ANSI A300.6), if necessary, is completed with ArborTie® or equivalent. Hose & Wire will not be accepted. PFM 12.0505.3C
 Pruning cuts follow ANSI A300.1. PFM 12.0506.5
 Plantings are not in easements, are at least four feet from signs, and are the prescribed distances from transformer boxes. At the time of installation, if conflicts between plantings and site utilities arise, minor shifts in planting location may be acceptable upon notice to FCON. ANSI A300.7. PFM 12.0315.5
