5.11 Lower Occoquan – Project Fact Sheets

Project fact sheets for each 10-yr structural project included in the Lower Occoquan Watershed Management Plan are included in this section. Individual project fact sheets are comprised of the following information:

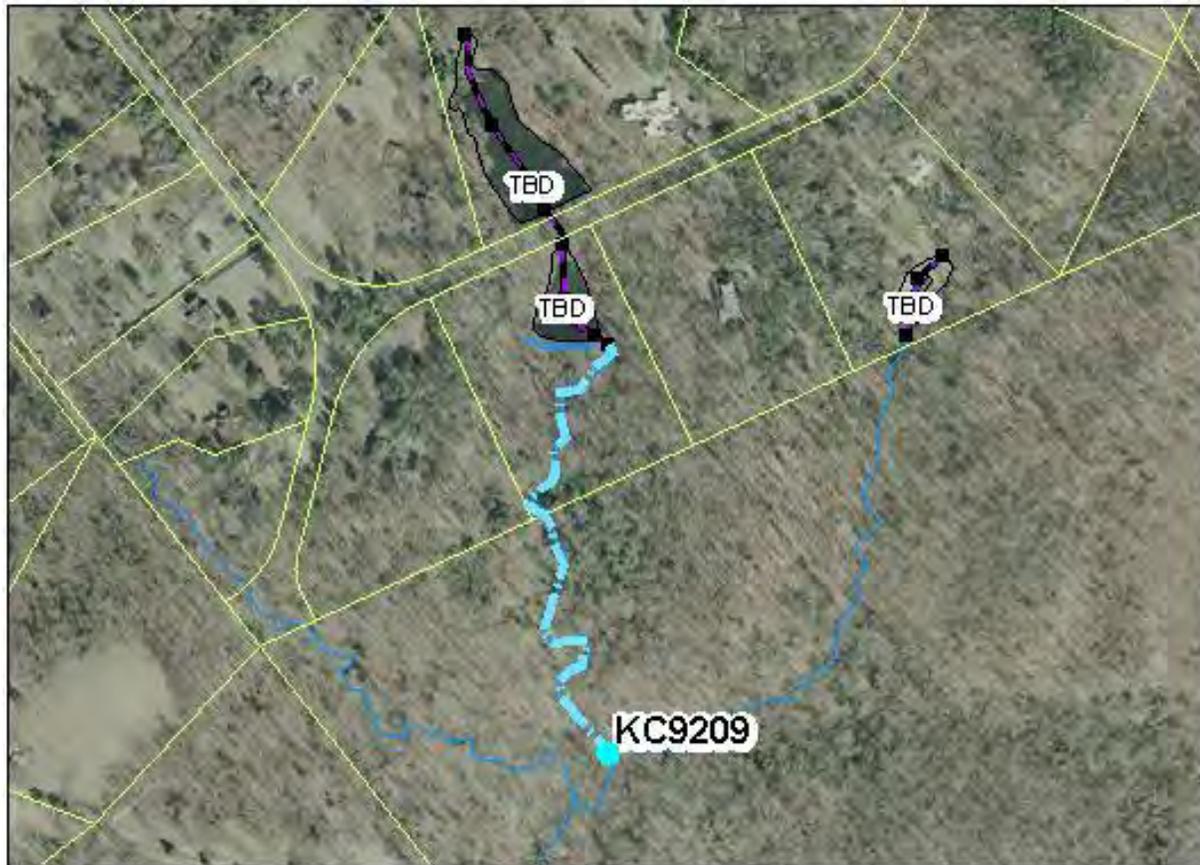
KC9209 Stream Restoration

Description: The stream south of Springfield Drive in Lorton shows indicators of poor channel morphology. The stream is downstream of two ponds, and ultimately discharges into Belmont Bay. A project is proposed to repair bank and bed erosion to restore channel morphology. Erosion will be stabilized through the use of bank shaping, toe protection, erosion control fabrics and rapid vegetation establishment. To reduce further erosion the banks will be armored using geofabrics, fabric-encapsulated rocks or equivalent.

Project Design Considerations: Field investigation revealed that the stream is severely eroded, especially directly downstream from the pond, and has created a "waterfall" that drops approximately 5 feet. The stream is narrowing and deepening, and receives discharge from upstream pond and runoff from primarily wooded areas to the east and west. Energy dissipation devices downstream of the pond would be beneficial in reducing erosion to the stream by decreasing velocities.

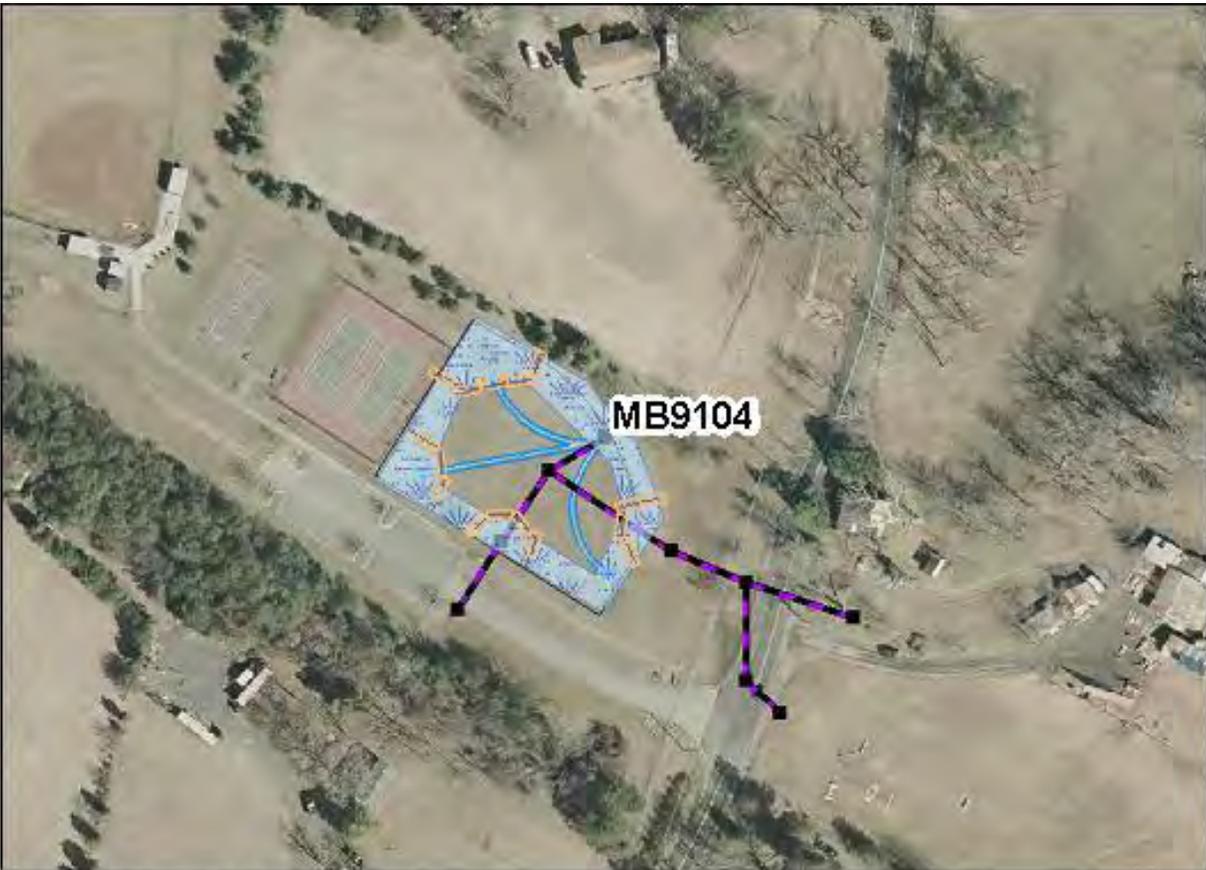
MB9104 Stormwater Pond Retrofit

Description: A dry pond retrofit is proposed at Mason Neck West Park located off of Old Colchester Road in Lorton. The project proposes to create an extended detention dry pond with sediment forebays. The retrofit will modify the existing pond to provide adequate downstream channel protection and allow for better function of temporary ponding using a control structure, which promotes particulate pollutant settlement.

Project Design Considerations: The project occurs on a state park with ample open space. County records show that the pond is not located in a storm drain easement. The available head difference in the pond appears minimal. The pond has three concrete pilot channels to direct low flows to the outlet. These should be removed. Due to the ponds minimal head, a micro-pool will need to be created. The pond’s safety bench and aquatic bench should be landscaped to prevent access to the pool, due to the pond’s location in the park. The pond receives many inflows. Sediment forebays should be constructed for inflows that drain 10 percent or more of the contributing drainage area. The total area of the sediment forebays should equal approximately 10 percent of the pond’s surface.

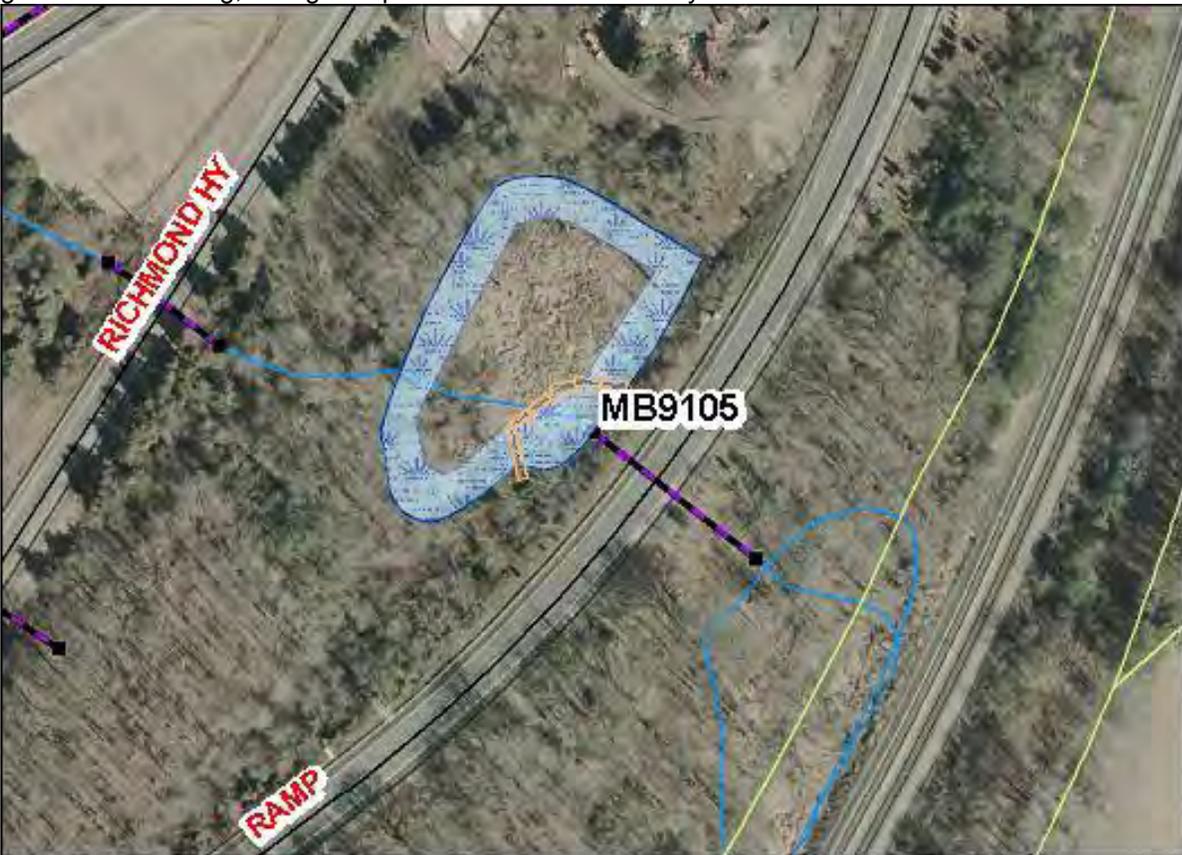
MB9105 Stormwater Pond Retrofit

Description: This project proposes the retrofit of an existing pond between Richmond Highway and west of the Old Colchester Road ramp to create a wetland system with sediment forebay and bench planting. The primary problem indicators are pollutants, including nitrogen, phosphorus and total suspended solids. The retrofit will modify the existing pond to increase the time stormwater travels through the facility. The retrofit will add areas of high marsh and low marsh to the pond with tree peninsulas and will create a better functioning environment for gravitational settling, biological uptake and microbial activity.

Project Design Considerations: Pond water quality treatment functions could be greatly improved with this retrofit. The existing pond footprint will need to be enlarged. The expansion should minimize impacts to the existing vegetation and should incorporate this vegetation into the wetland's tree peninsulas. The existing pond does not have a discharge structure. County records show that the pond is not located in a storm drain easement, but it is located in the road right-of-way.

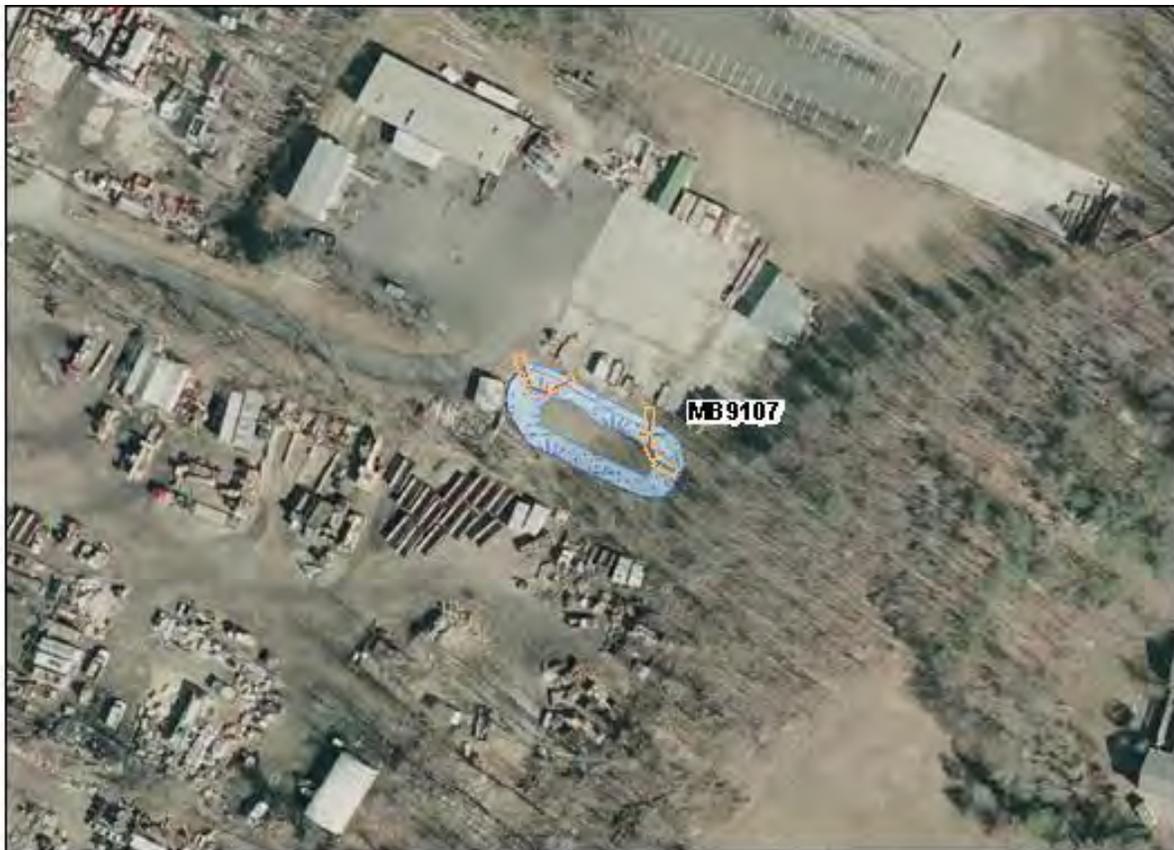
MB9107 Stormwater Pond Retrofit

Description: A dry pond is located in an industrial area off of Richmond Highway. This project proposes retrofitting the existing dry pond to create an extended detention dry pond with sediment forebays. The retrofit will modify the existing discharge structure to increase the time stormwater is detained in the pond. The pond will be expanded to handle this larger treatment volume. This retrofit will provide better downstream channel protection and promote particulate pollutant settlement. Pollutant indicators include nitrogen, phosphorous and total suspended solids.

Project Design Considerations: This project is located on private property. Per County records, this pond is not located in a storm drain easement. A swale will need to be added to direct runoff to the sediment forebay. The two forebays will be approximately 10 percent of the pond area. The expanded pond will have a safety bench, and an aquatic bench will be planted around the perimeter of the pond. The expansion of the pond should incorporate the existing vegetation as much as possible. The landscaping plan should allow the pond to mature into a native forest in the right places, yet keep turf along the embankment and all access areas.

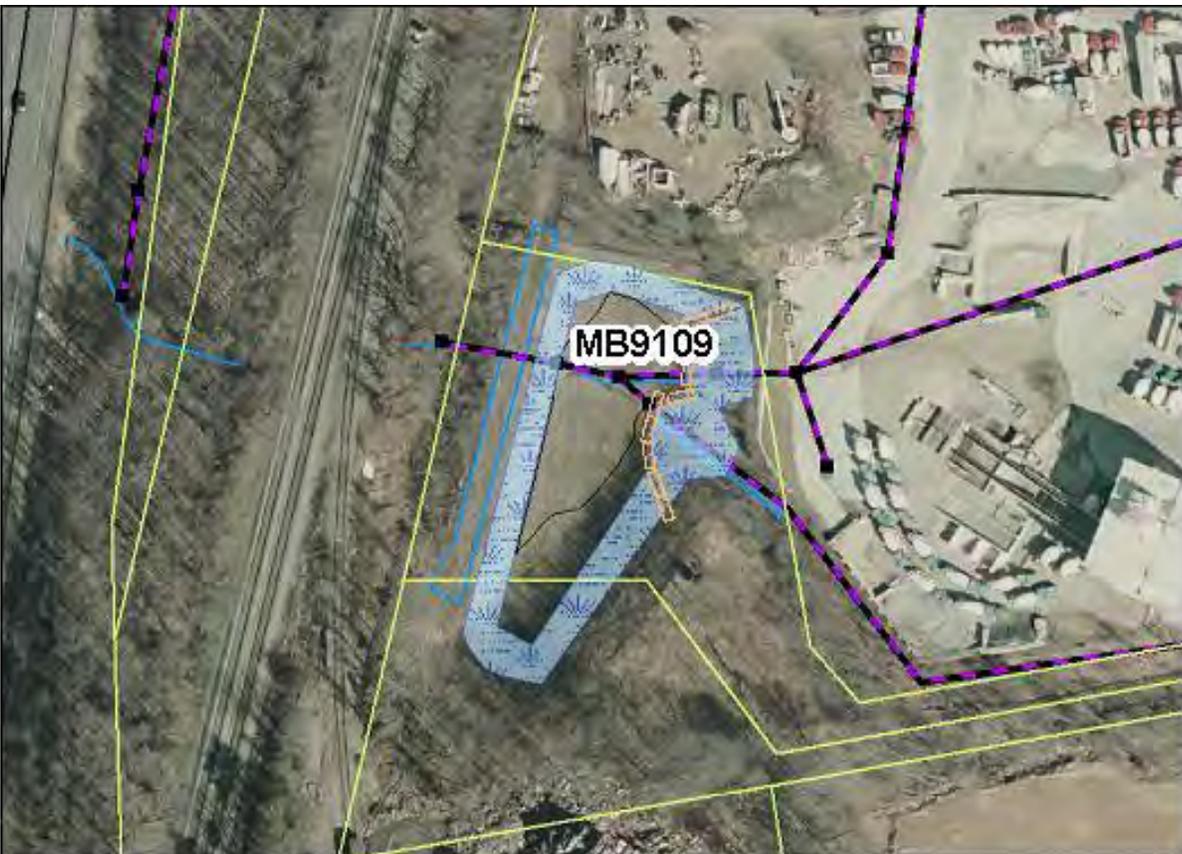
MB9109 Stormwater Pond Retrofit

Description: This project proposes retrofitting the existing pond west of Mims Street to create an extended detention pond with a sediment forebay. The pond currently receives stormwater runoff from a private concrete company. The primary pollutant problem indicators include nitrogen, phosphorus and total suspended solids. The pond's existing discharge structure will be modified to increase the time stormwater is treated in the facility. This will provide better downstream channel protection and will promote particulate settlement.

Project Design Considerations: County records show that the pond is located in a storm drain easement. The pond outfalls under a railroad track into the drainage system along Henry G. Shirley Memorial Highway. This highly industrialized area would benefit from additional stormwater treatment. The proposed sediment forebay should be sized to be at least 10 percent of the surface area of the pond. The pond will probably need to be expanded to accommodate the larger detention volume (see hatching on map). The aquatic bench and safety bench planting should incorporate the existing vegetation as much as possible.

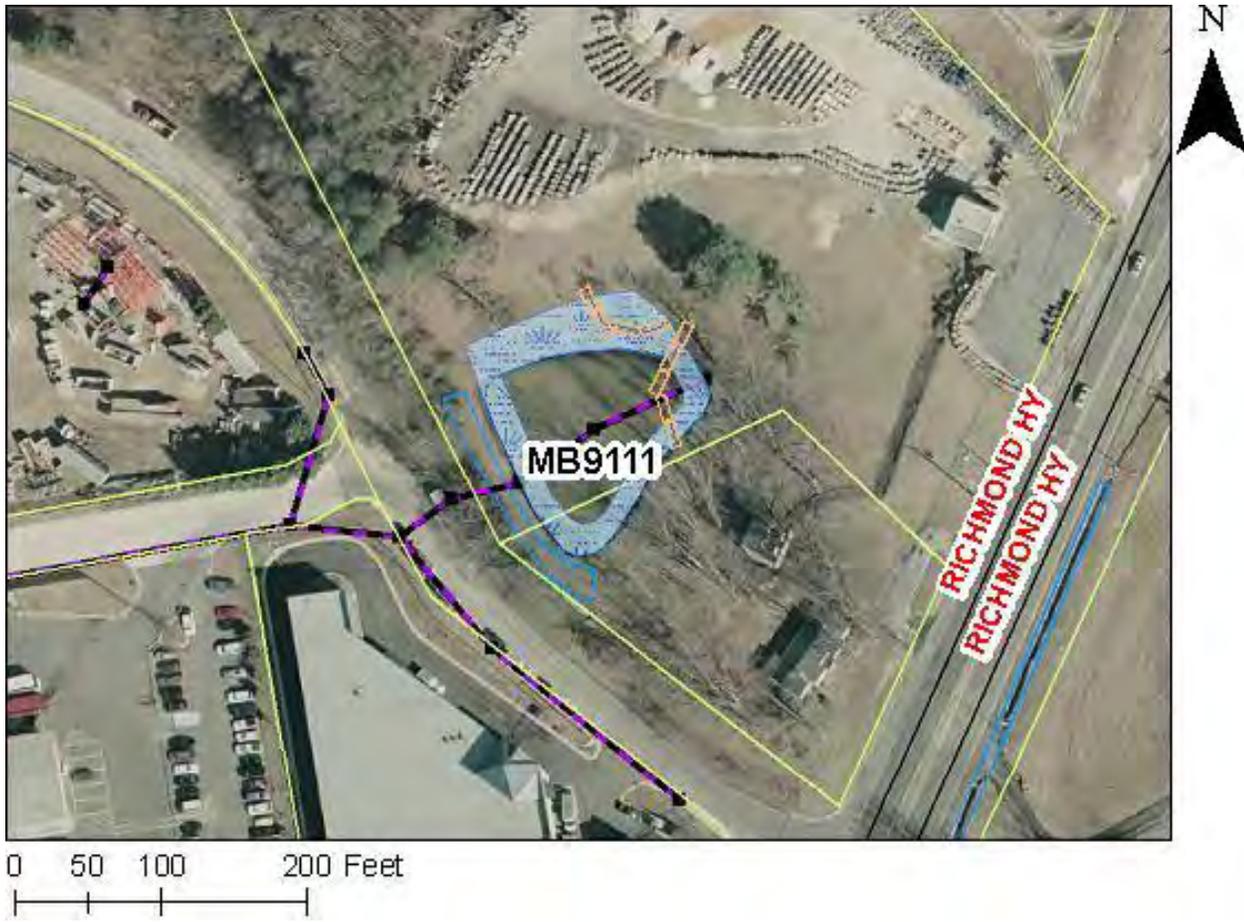
MB9111 Stormwater Pond Retrofit

Description: This project proposes retrofitting an existing wet pond east of Mims Street to create a constructed wetland system, with sediment forebay and an engineered landscaping plan. The retrofit will extend the flow path of stormwater runoff in the wetland by enlarging the facility’s size and creating high and low marsh areas. The primary pollutant indicators are nitrogen, phosphorous and total suspended solids. The retrofit will increase pollutant removal and provide better channel protection above the permanent pool of standing water. The pool prevents re-suspension of sediments and other pollutants.

Project Design Considerations: The existing wet pond collects runoff from an industrial area. Part of the pond is located on a wooded single-family home site. The remaining part of the pond is on a commercial parcel. Both parcels are owned by the same limited partnership. County records show no storm drain easements for the pond. When the pond is expanded, the area north of the pond should be regraded to a pretreatment swale. This swale would then discharge to sediment forebay. The total volume of the sediment forebays should be at least 15 percent of the treatment volume. To maximize the flow path in the wetland and increase pool vegetation, internal structures such as tree peninsulas and high marsh wedges should be added. The expansion should try to incorporate the existing vegetation as much as possible.

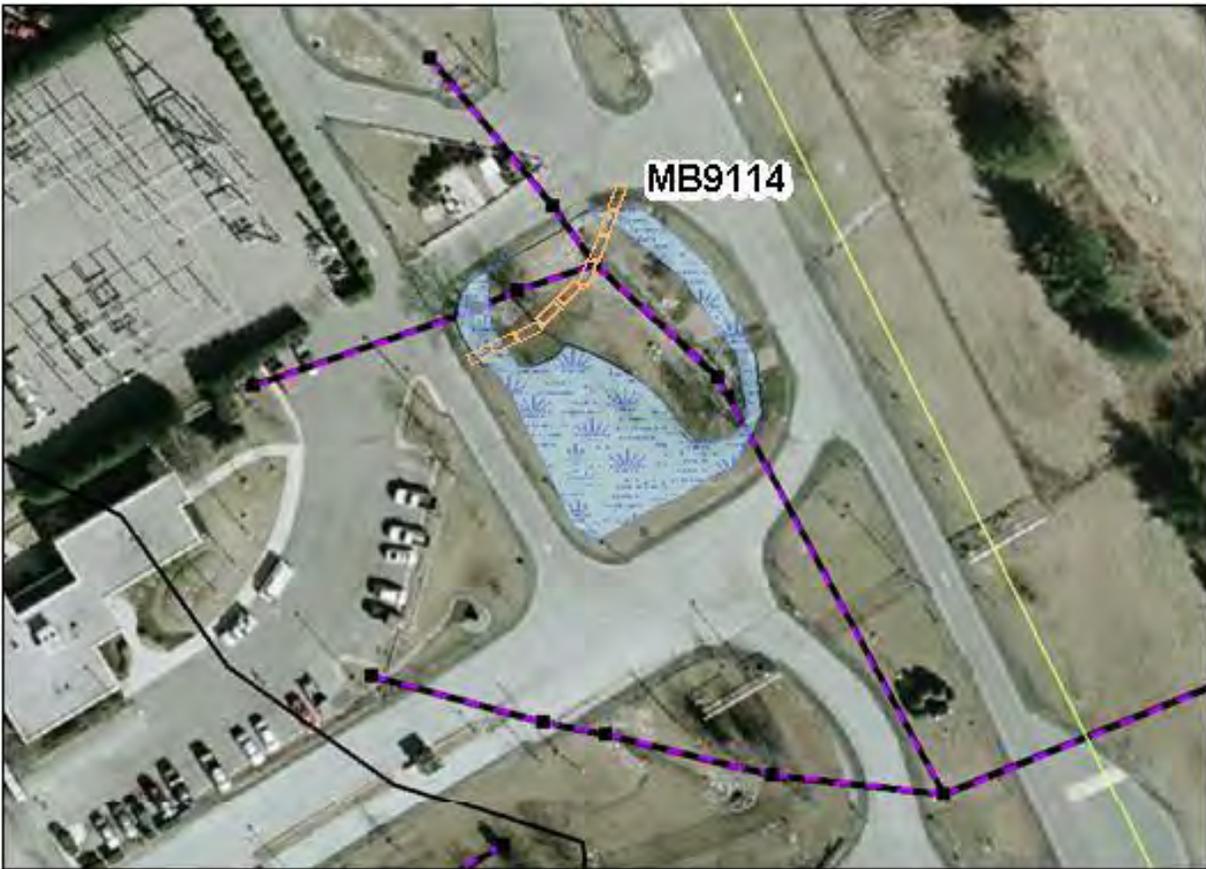
MB9114 Stormwater Pond Retrofit

Description: This project proposes to retrofit an existing dry pond at the Fairfax County Landfill off of Furnace Road in Lorton. A sediment forebay will be added to provide pretreatment to the pond’s two inflows. The pond’s existing discharge structure will be modified to increase the time water is detained in the pond. To handle the larger detention volume the pond will be enlarged. And an aquatic bench will be added to increase biological uptake of pollutants.

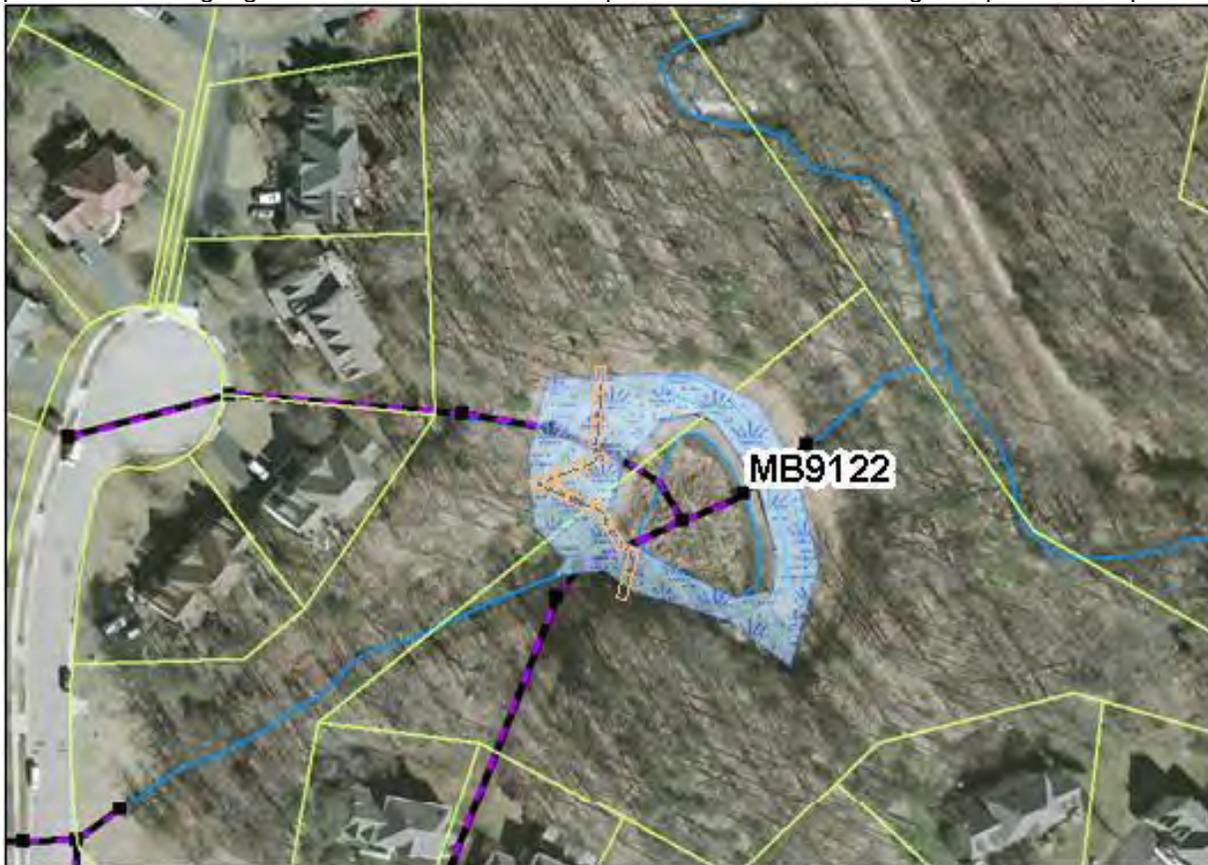
MB9122 Stormwater Pond Retrofit

Description: This project proposes the retrofit of an existing public pond east of Cross Chase Circle to create a wetland system with sediment forebays and bench planting. The existing dry pond receives runoff from two pipes and a channel, and sheet flow from the back of the residential houses. The wetland retrofit will include adding two sediment forebays for the stormwater inflows, expanding the pond to provide more time to treat stormwater in the pond and creating high and low marsh areas in the pond to increase the biological uptake in the pond.

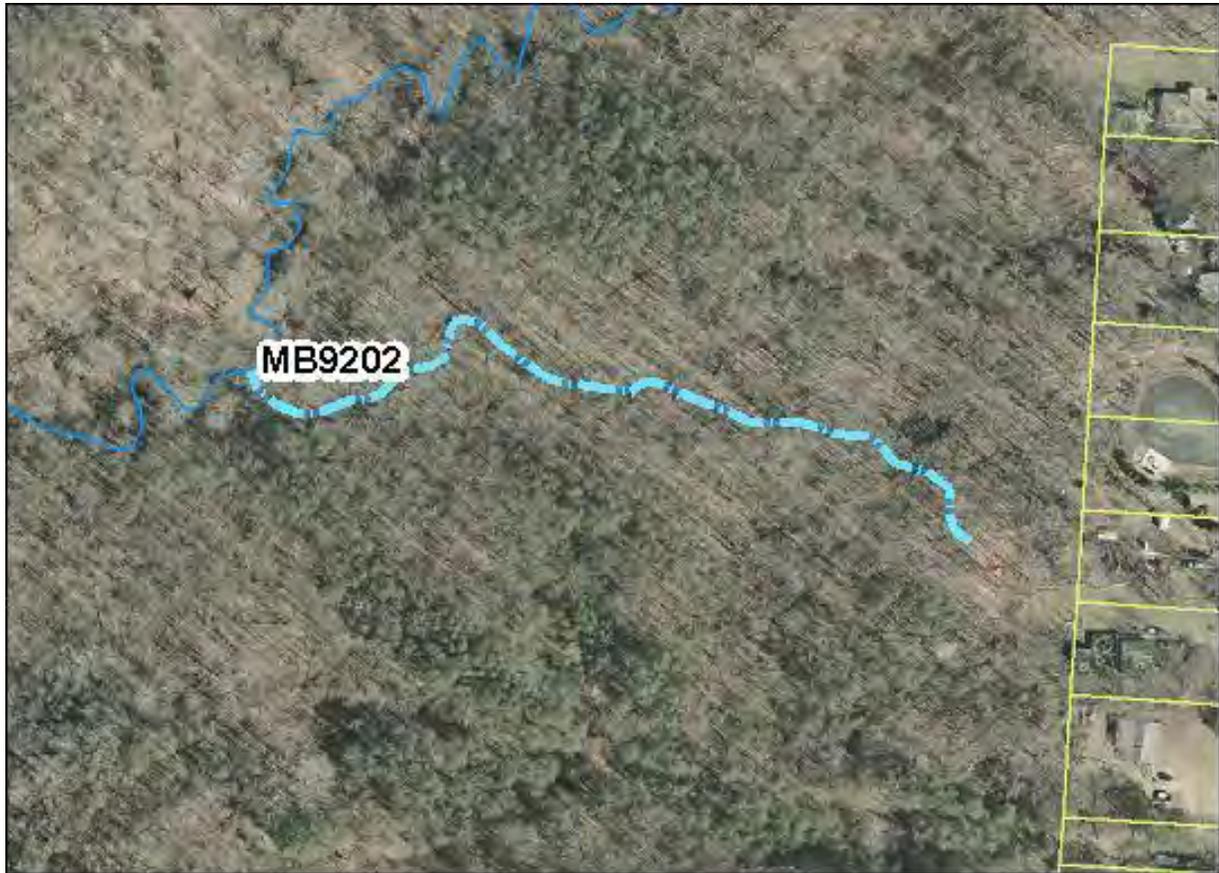
MB9202 Stream Restoration

Description: This project proposes the restoration of a stream southeast of Old Colchester Road that flows from east to west. The project proposes to restore channel morphology by improving bed and bank erosion. Erosion will be stabilized through the use of bank shaping, toe protection, erosion-control fabrics and rapid vegetation establishment. The banks will be armored using geofabrics, fabric encapsulated rocks or the equivalent to reduce further erosion. The stream receives runoff from residential housing to the east and surrounding wooded areas.

Project Design Considerations: Field investigation revealed severe erosion and would indicate a high priority should be set for this project. The area of highest erosion is the farthest upstream point where a "waterfall" has formed due to approximately 10 feet of erosion. Conditions marginally improve further downstream. The stream is created by several small swales discharging from the adjacent residential areas at the same point, which is causing severe erosion.

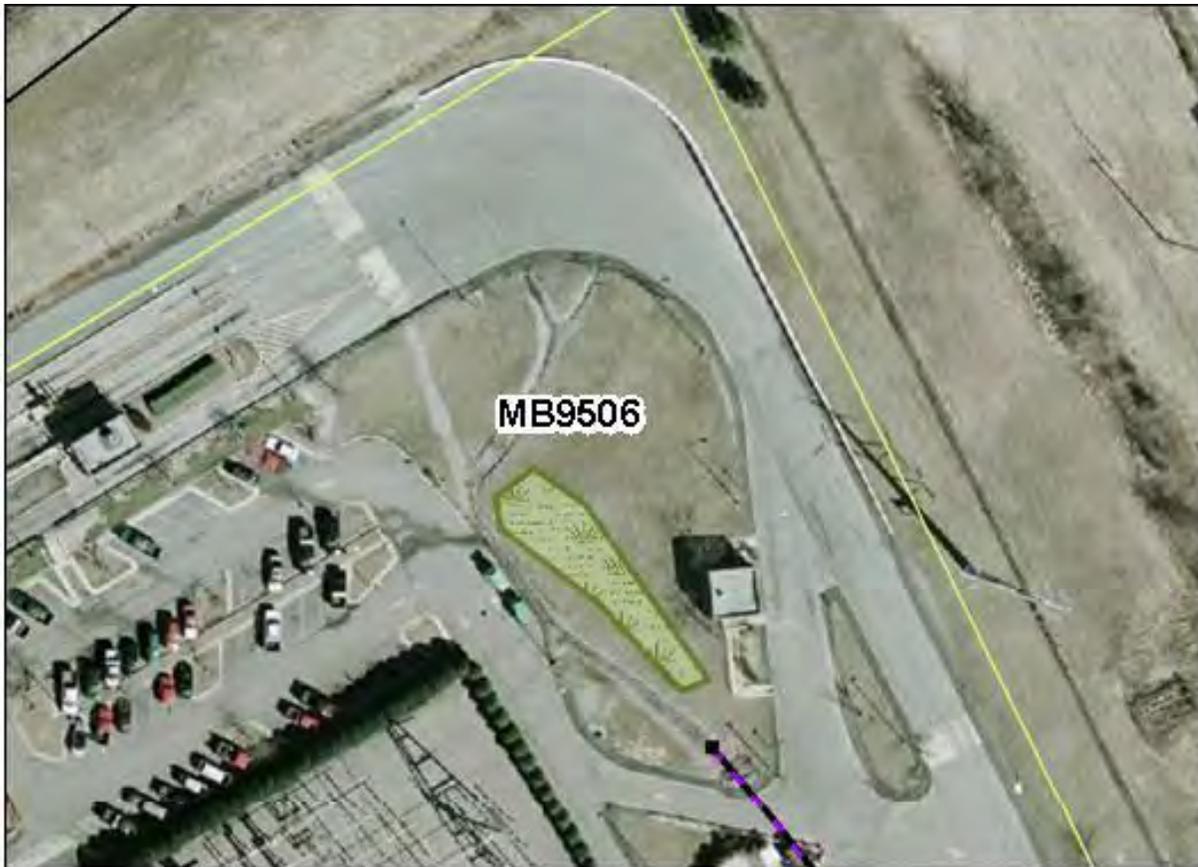
MB9506 BMP/LID

Description: This project proposes the construction of a bioretention area at Fairfax County Landfill. The bioretention landscaping feature will receive runoff from parking lots. The bioretention landscaping feature will have a filter layer made of 18 – 48 inches of sand placed below a mulch layer. During a storm, the runoff will pond 6 – 9 inches, drain through the bioretention filter media, infiltrate into the native soil or outfall to the storm system. The primary indicators are upland sediment, total suspended solids and pollutants, including nitrogen and phosphorous.

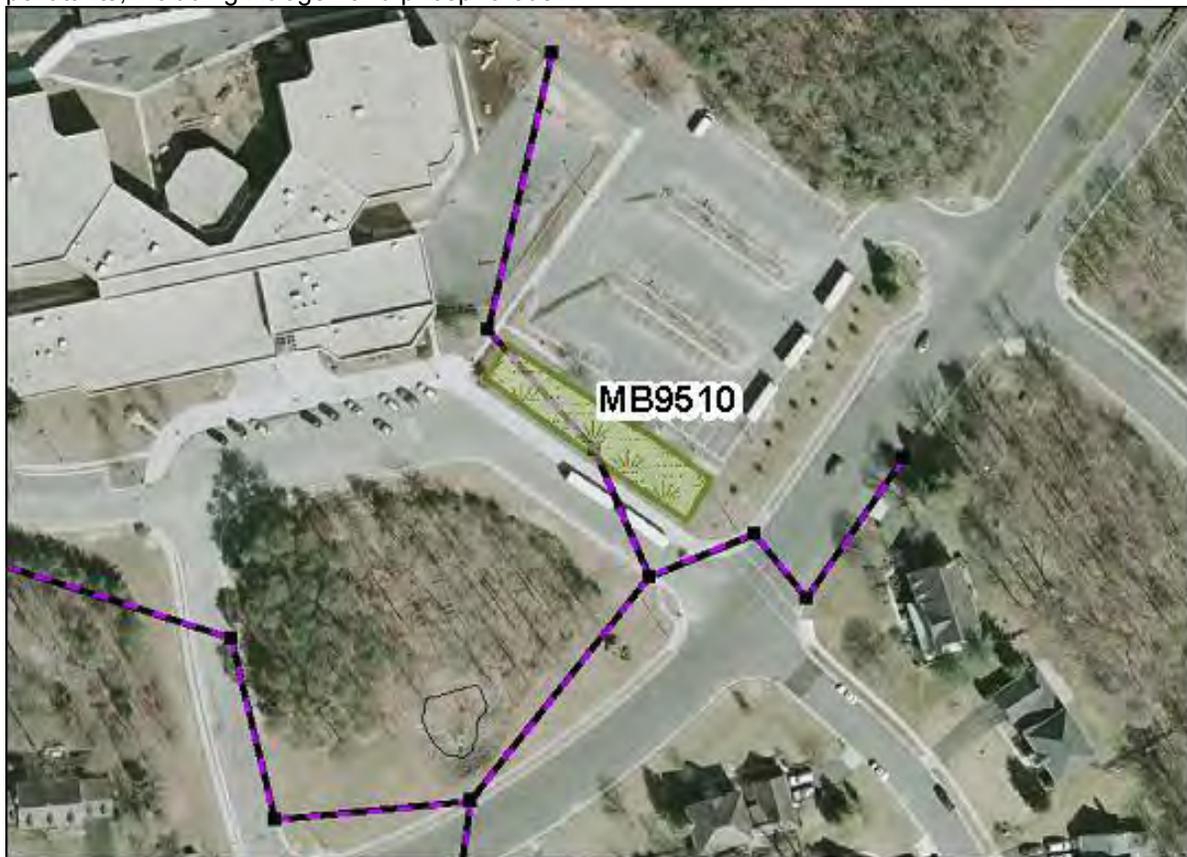
MB9510 BMP/LID

Description: This project proposes the construction of a bioretention area at Silverbrook Elementary School on Crosspointe Drive. The bioretention landscaping feature will receive runoff from the parking lot and building. A filter layer made of 18 – 48 inches of sand will be placed below a mulch layer. During a storm, the runoff will pond 6 –9 inches in the bioretention area, filter through the bioretention media soil, and either outfall to the existing storm system or infiltrate into the native soil. The primary indicators are upland sediment, total suspended solids and pollutants, including nitrogen and phosphorous.

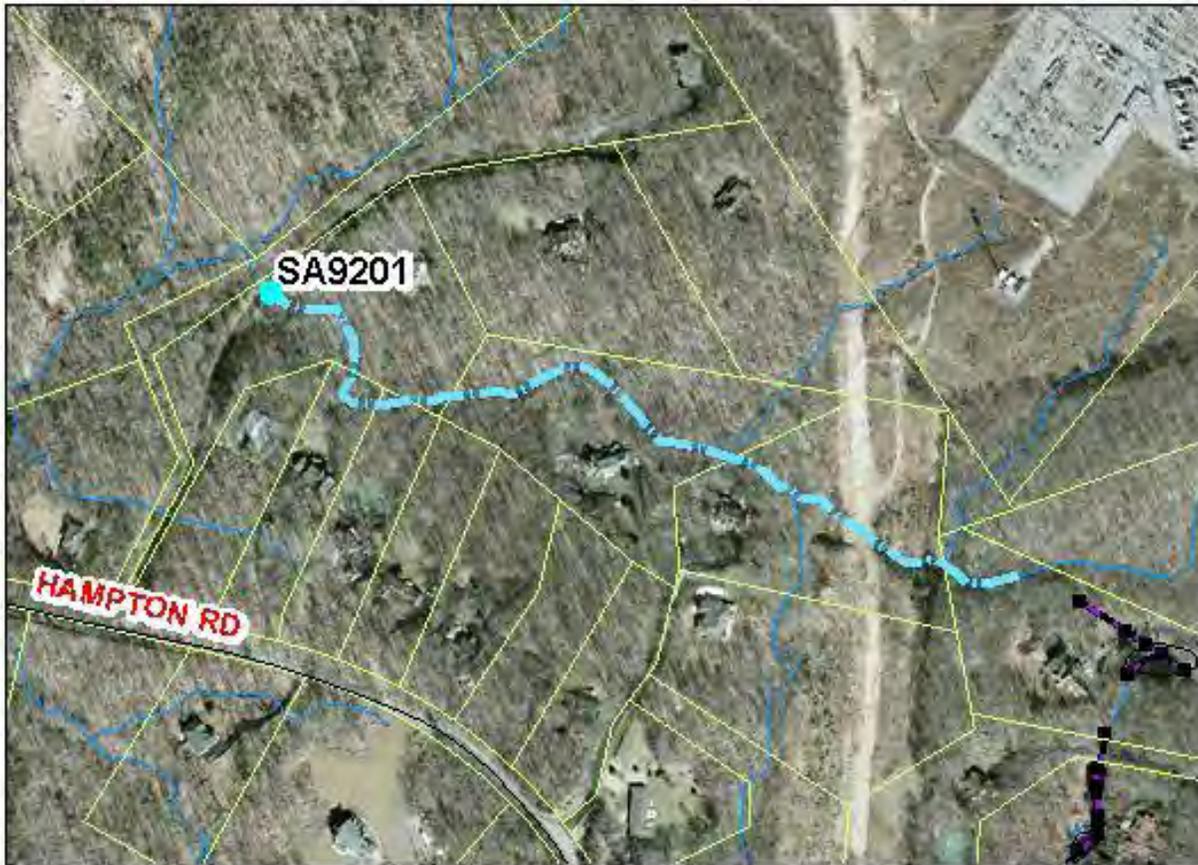
SA9201 Stream Restoration

Description: The stream near Birch Cliff Drive conveying runoff from houses, wooded area, and substation area upstream of outfall to Occoquan Reservoir has indicators of poor channel morphology. This project proposes spot improvements along the stream to restore channel morphology and repair eroded areas. Erosion will be stabilized through the use of bank shaping, toe protection, erosion control fabrics and rapid vegetation establishment.

Project Design Considerations: The Watershed Advisory Group (WAG) commented that manmade impediments to the flow of the natural stream, including a fence near the culvert, are a hindrance to any effort at this site. Field investigation revealed areas of slight to moderate erosion. Several peninsulas and islands have formed from sediment deposition. A dam has been created before the culvert. The stream has several areas that need spot repairs and cleanup of the man-made features that are obstructing natural flow.

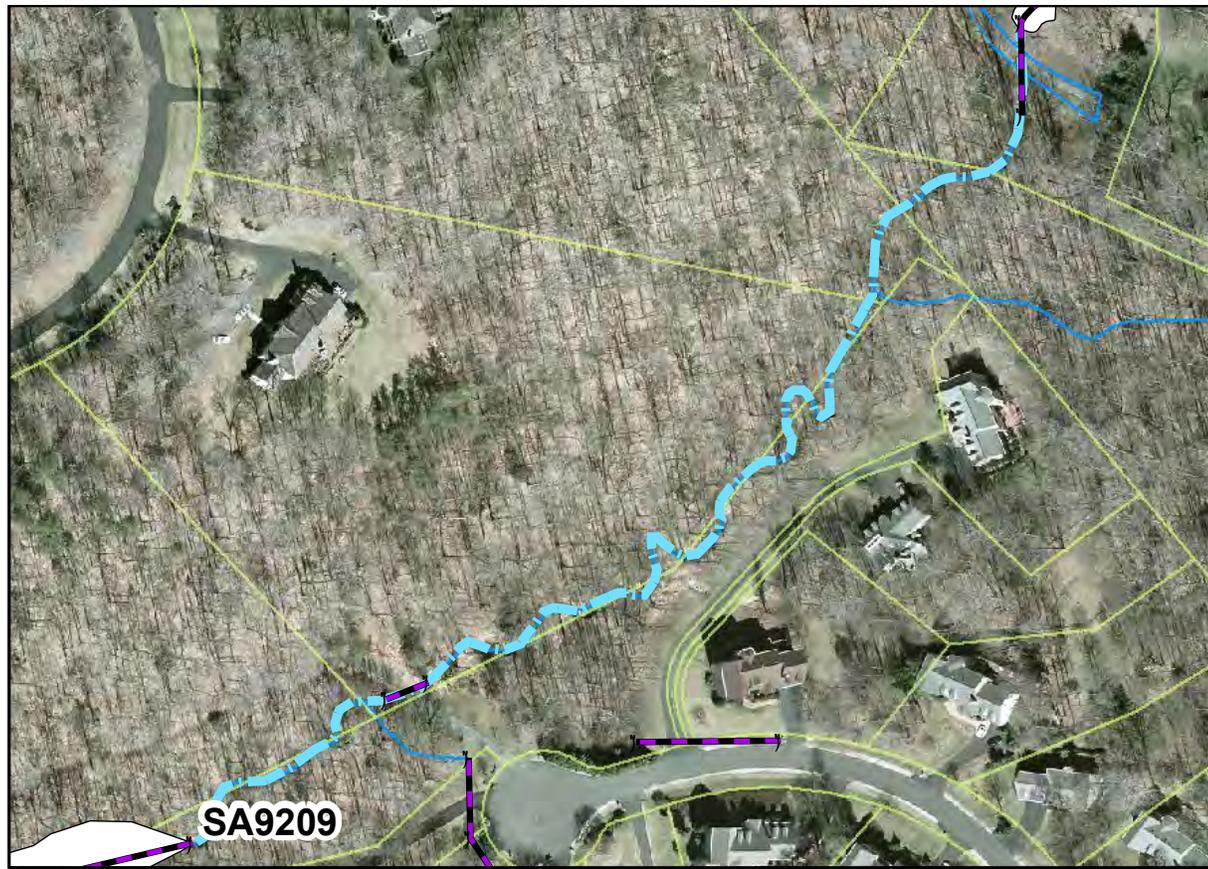
SA9209 Stream Restoration

Description: The stream section upstream of Beechnut Court in Fairfax Station conveys runoff from wooded area, housing, and Ox Road has indicators of poor channel morphology. This project proposes spot improvements along the stream to restore channel morphology and repair eroded areas. Erosion will be stabilized through the use of bank shaping, toe protection, erosion control fabrics, and rapid vegetation establishment. The banks will be armored to reduce further erosion using geofabrics, fabric encapsulated rocks or equivalent.

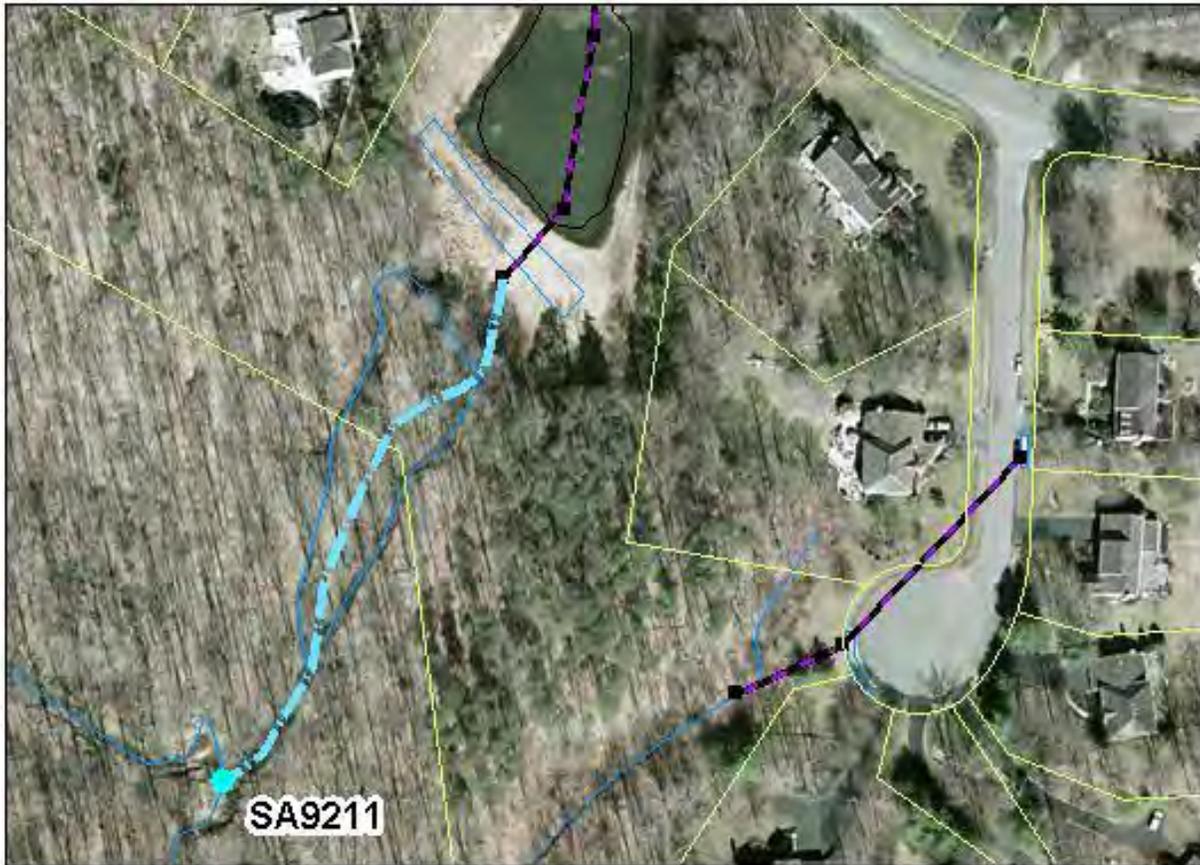
SA9211 Stream Restoration

Description: The stream section east of Streamwood Place in Fairfax Station where two streams converge, conveys runoff from adjacent houses, streets and wooded area has indicators of poor channel morphology. This project proposes spot improvements along the stream to restore channel morphology and repair eroded areas. Erosion will be stabilized through the use of bank shaping, toe protection, erosion control fabrics and rapid vegetation establishment. The banks will be armored to reduce further erosion using geofabrics, fabric encapsulated rocks or equivalent.

Project Design Considerations: This project is proposed on property owned by Fairfax County Park Authority and should be closely coordinated with the Park Authority. A section of stream is close to houses and roadways. Erosion has already had impacts on existing mature vegetation. The Watershed Advisory Group (WAG) has identified this project as critical. Field investigation revealed minor to moderate erosion. There are areas of significant sediment deposition. Spot improvements are recommended. This project should be executed in conjunction with project SA9803

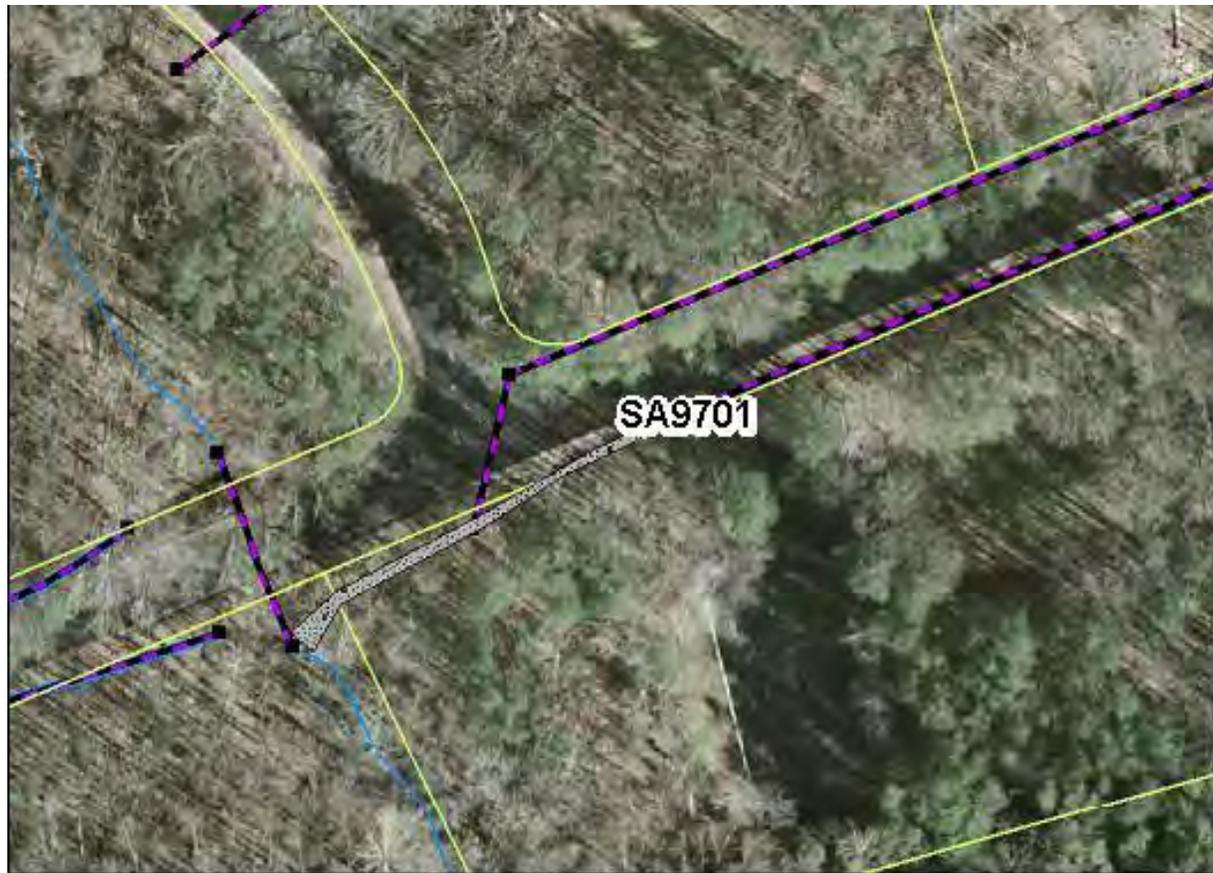
SA9701 Outfall Improvement

Description: This project proposes removing the outfall section of an existing concrete swale along Silverleaf Drive to reduce erosive velocities to the stream and reduce pollutants. Currently, stormwater runs off of Silverleaf Drive into the concrete swale and directly into the adjacent stream with no stormwater treatment. The receiving stream has poor channel morphology. Replacing the existing concrete swale with a natural swale with check dams and step pools, to reduce velocity and encourage infiltration, would help downstream erosion.

Project Design Considerations: When the existing concrete channel is removed, the remaining soils will need to be amended to improve infiltration of the compacted soils. The number of check dams and step pools necessary for the retrofit will be determined by the existing slope of the swale. GIS contour data yields an estimated slope of 7 percent for the existing concrete swale. A settling basin might need to be constructed at the end of the proposed retrofit. This settling basin should receive flow from the culvert under Silverleaf Drive to be more effective at reducing erosive velocities in the stream. County records show that the project is not located in a storm drain easement, and the swale is located outside the road right-of-way and on private property.

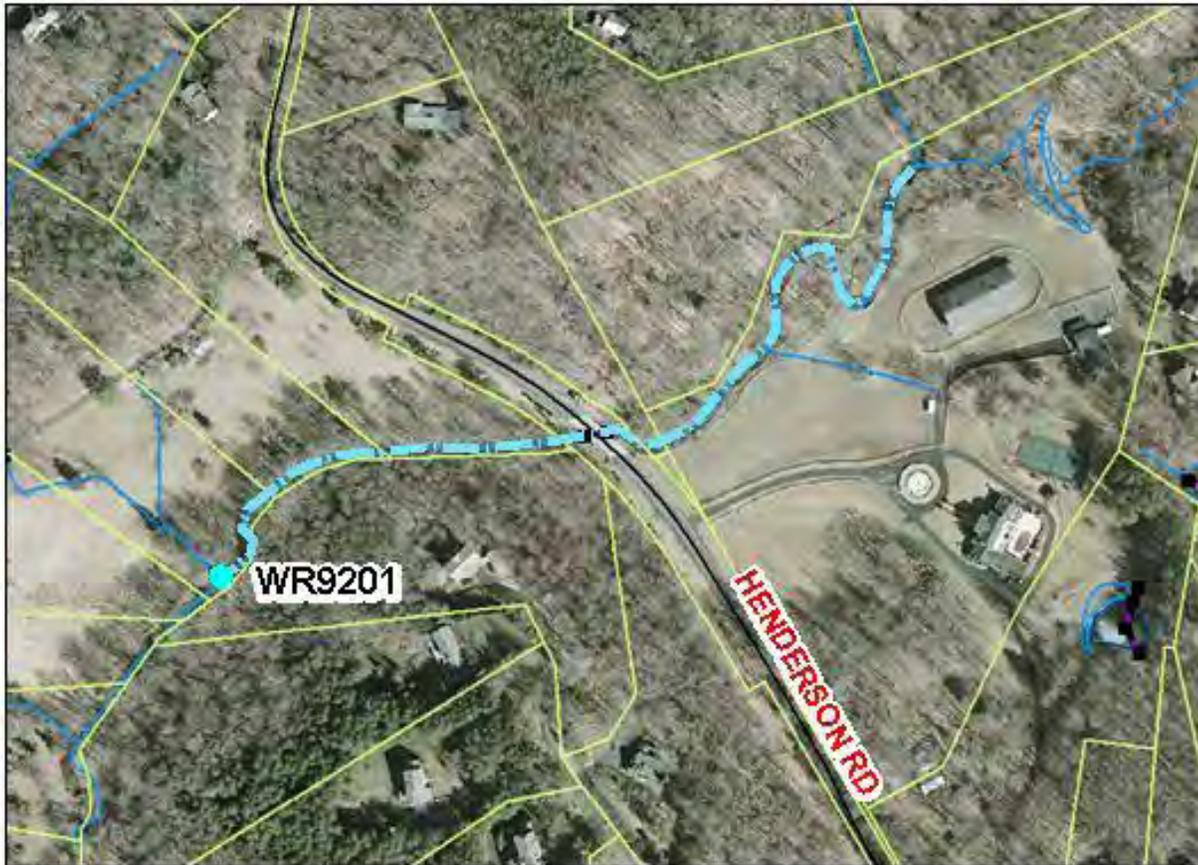
WR9201 Stream Restoration

Description: The stream section east of Wolf Valley Drive in Fairfax Station is conveying runoff from wooded area and houses and has indicators of poor channel morphology. The stream crosses under Henderson Road and eventually outfalls to Occoquan Reservoir. This project proposes repairing bank and bed erosion to restore channel morphology. Erosion will be stabilized through the use of bank shaping, toe protection, erosion control fabrics and rapid vegetation establishment. The banks will be armored using geofabrics, fabric encapsulated rocks or equivalent to reduce further erosion.

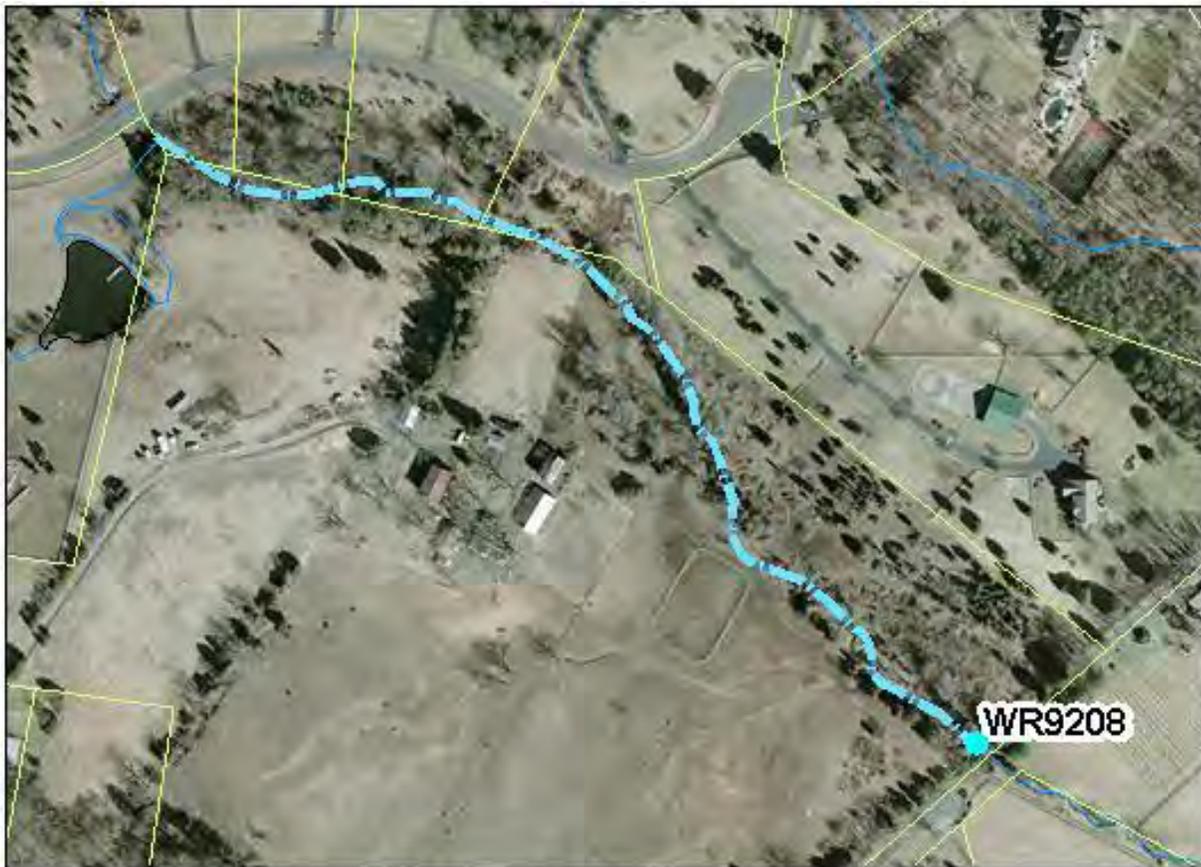
WR9208 Stream Restoration

Description: The stream section east of Turtle Valley Drive is conveying runoff from open space and houses and has indicators of poor channel morphology. This project proposes repairing bank and bed erosion to restore channel morphology. Erosion will be stabilized through the use of bank shaping, toe protection, erosion control fabrics and rapid vegetation establishment. The banks will be armored using geofabrics, fabric encapsulated rocks or equivalent to reduce further erosion.
