5.11 Lower Occoquan – Project Fact Sheets

Project fact sheets for each 10-yr structural project included in the Lower Occoquan Watershed Management Plan are included in this section. Individual project fact sheets are comprised of the following information:

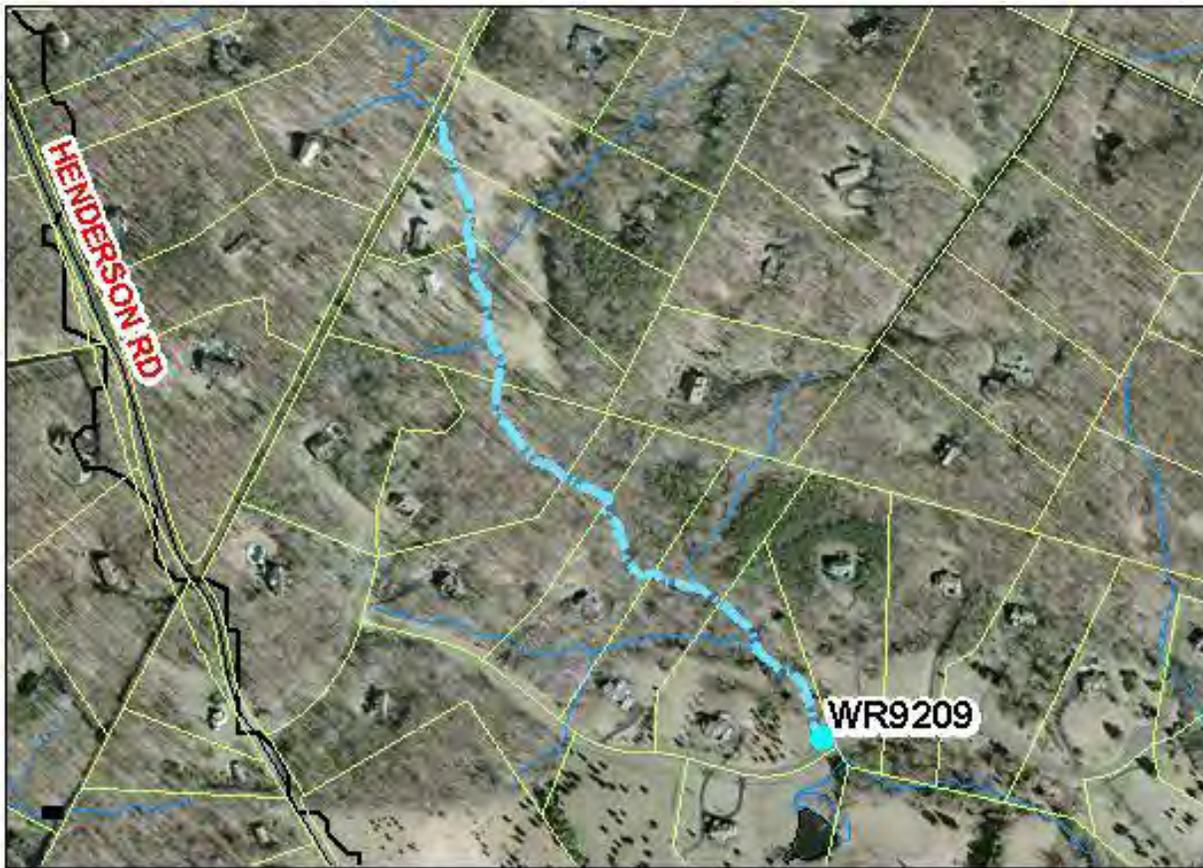
WR9209 Stream Restoration

Description: Stream section near Rose Hall Drive conveying runoff from upstream houses and wooded area has indicators of poor channel morphology. The stream is in a steep wooded area and portions are close to homes and roadways. This project proposes repairing bank and bed erosion to restore channel morphology. Erosion will be stabilized through the use of bank shaping, toe protection, erosion control fabrics and rapid vegetation establishment. The banks will be armored using geofabrics, fabric encapsulated rocks or equivalent to reduce further erosion.

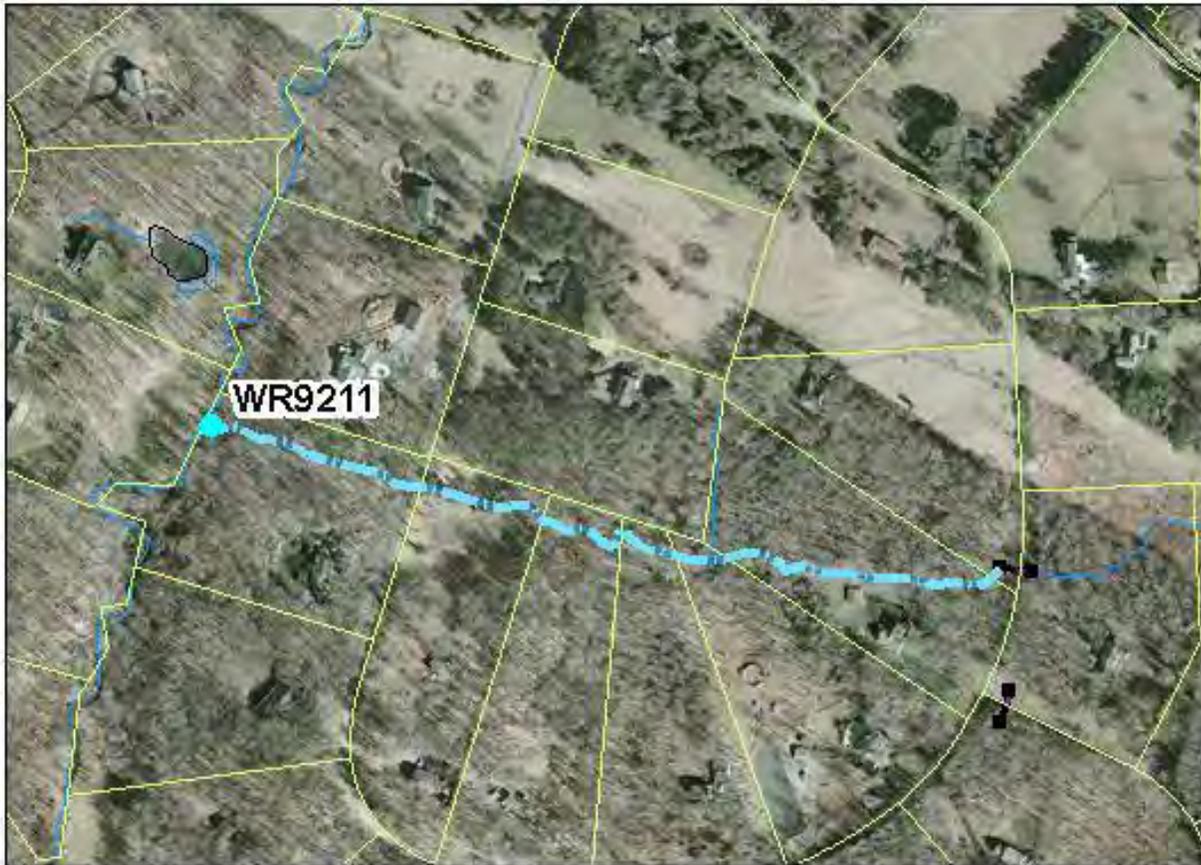
WR9211 Stream Restoration

Description: The stream section west of Amkin Drive is conveying runoff from upstream houses and wooded area and has indicators of poor channel morphology. The stream receives runoff from adjacent residential and wooded areas and conveys stormwater from the stream to the east. This project proposes repairing bank and bed erosion to restore channel morphology. Erosion will be stabilized through the use of bank shaping, toe protection, erosion control fabrics and rapid vegetation establishment. The banks will be armored using geofabrics, fabric encapsulated rocks or equivalent to reduce further erosion.

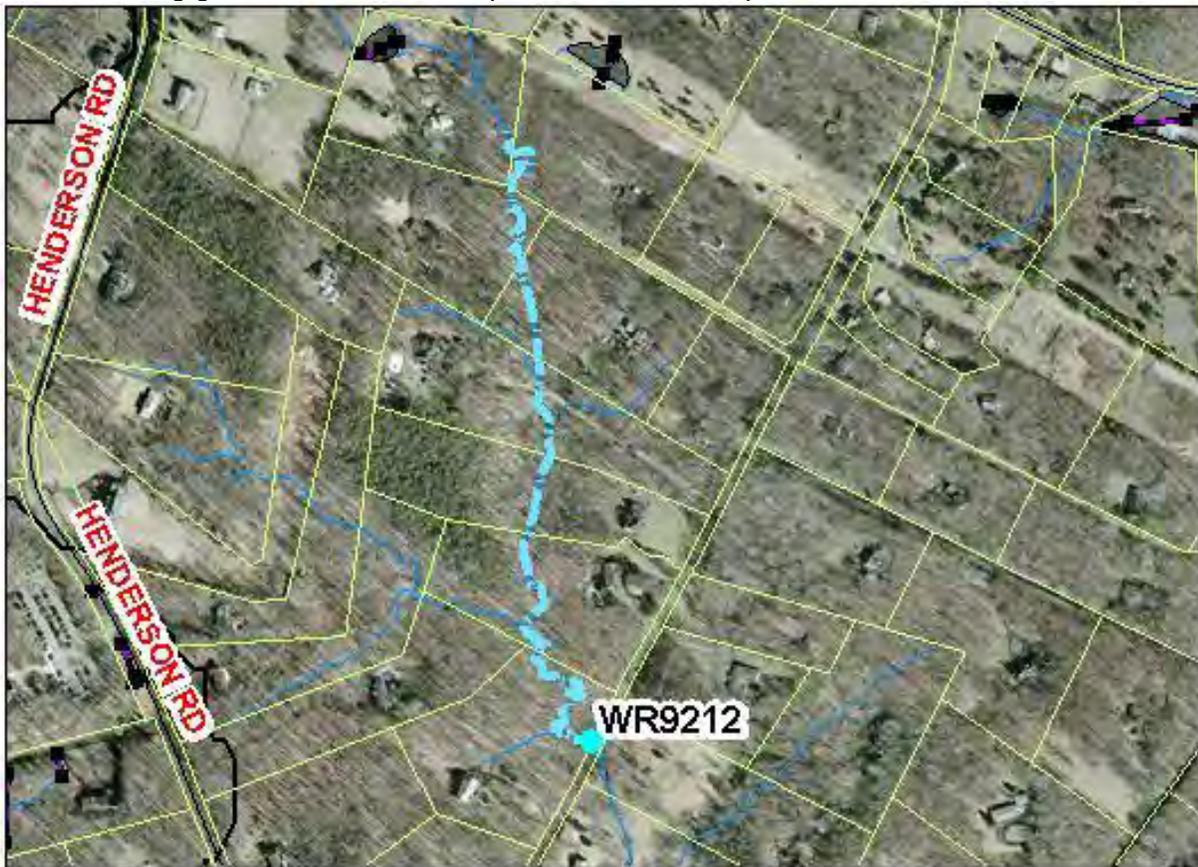
WR9212 Stream Restoration

Description: The stream section near Maple Branch Road is conveying runoff from upstream houses and wooded area and has indicators of poor channel morphology. This project proposes repairing bank and bed erosion to restore channel morphology. Erosion will be stabilized through the use of bank shaping, toe protection, erosion control fabrics and rapid vegetation establishment. The banks will be armored using geofabrics, fabric encapsulated rocks or equivalent to reduce further erosion.
