HISTORIC CENTREVILLE PARK

MASTER PLAN

Prepared by:
The Fairfax County Park Authority

APPROVED 12-10-2008

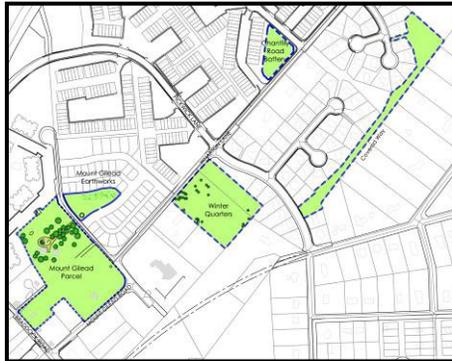
Figure 3: Parcel Map

The park parcels are listed in the Fairfax County parcel identification system, as parcels 54-4 ((1)) 38A, 54-4 ((1)) 23, 54-4 ((24)) B1, 54-4 ((14)) B, 54-4 ((10)) portion of parcel A.

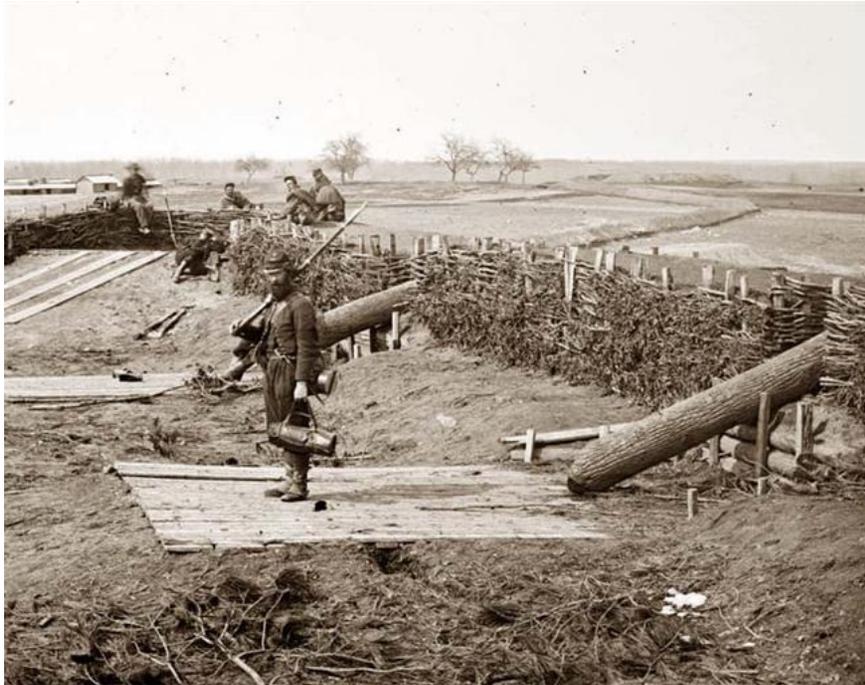
Figure 8: Civil War Fortifications with Quaker Guns at Centreville

as much of their equipment and supplies they could carry....a day later Union troops entered Centreville finding, to their surprise, that what had appeared to be heavily armed fortifications, were in fact Quaker Guns-logs painted black to resemble cannon” CLR 2-24

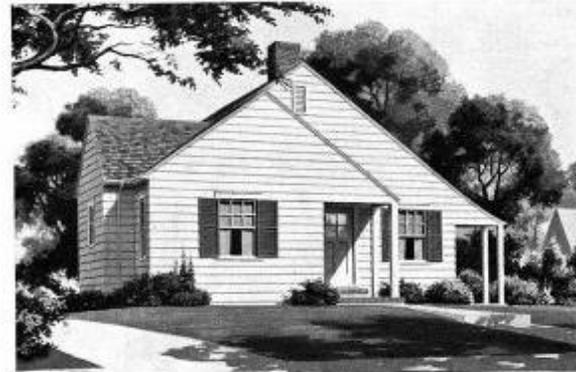
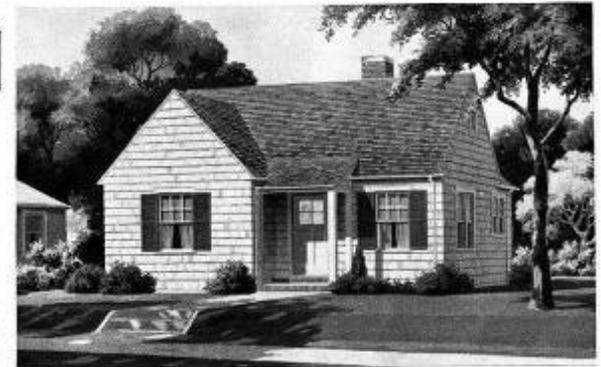
Figure 10: Sears Catalog Page with Brentwood Model

MODERN HOME
No. 13394C
ALREADY CUT AND FITTED
PRICE \$869⁰⁰

The Brentwood No. 13394C is planned with clear bevel siding for exterior walls while the "D" plan is shown with wide shingles.

MODERN HOME
No. 13394D
ALREADY CUT AND FITTED
PRICE \$923⁰⁰

These homes can be built on a 30 ft. lot. Height of ceilings 8 ft. 3 in. Cellar stairs lead to full basement providing space for furnace, fuel, fruit storage and laundry.

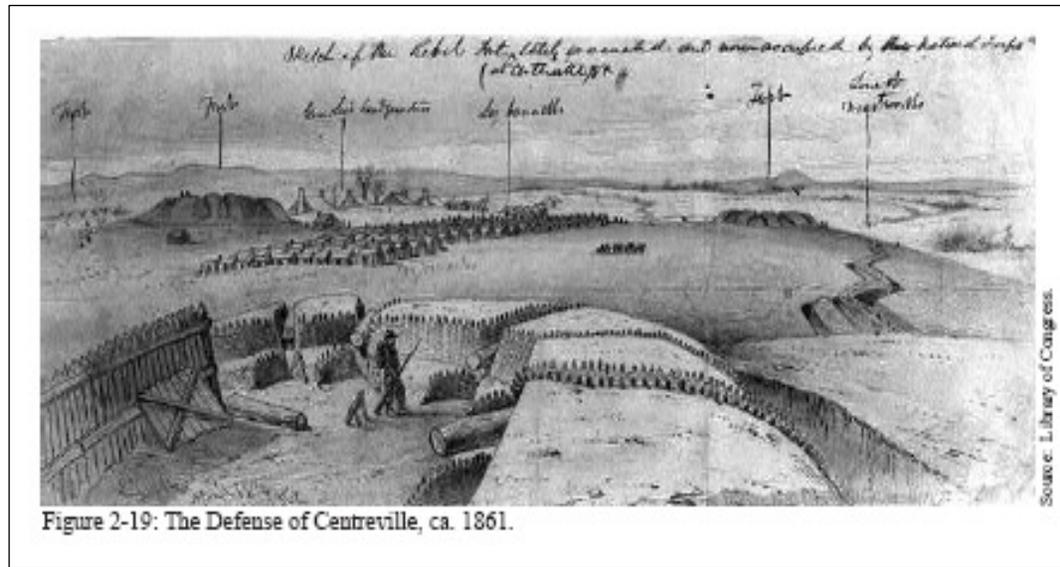
Figure 13: Union Sketch of Civil War Fortifications

Figure 2-19: The Defense of Centreville, ca. 1861.

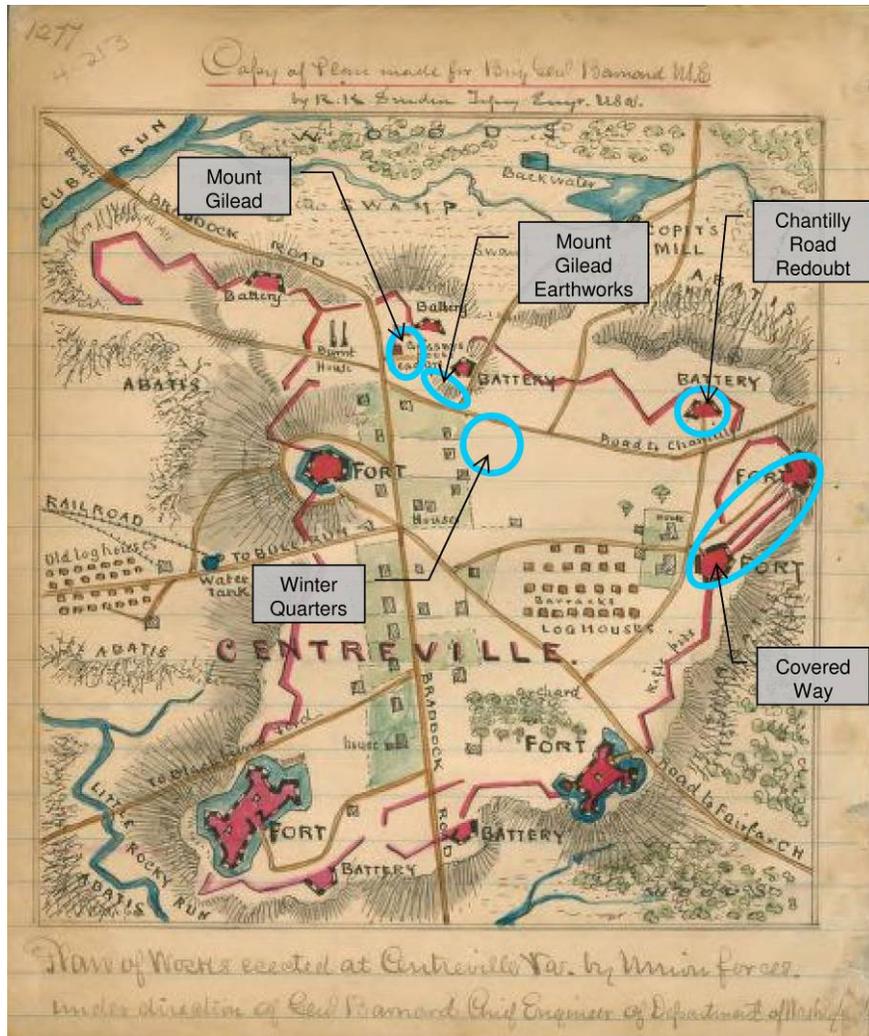
Figure 14: Union Map of Centreville Fortifications and Union Modifications, notes added by FCPA

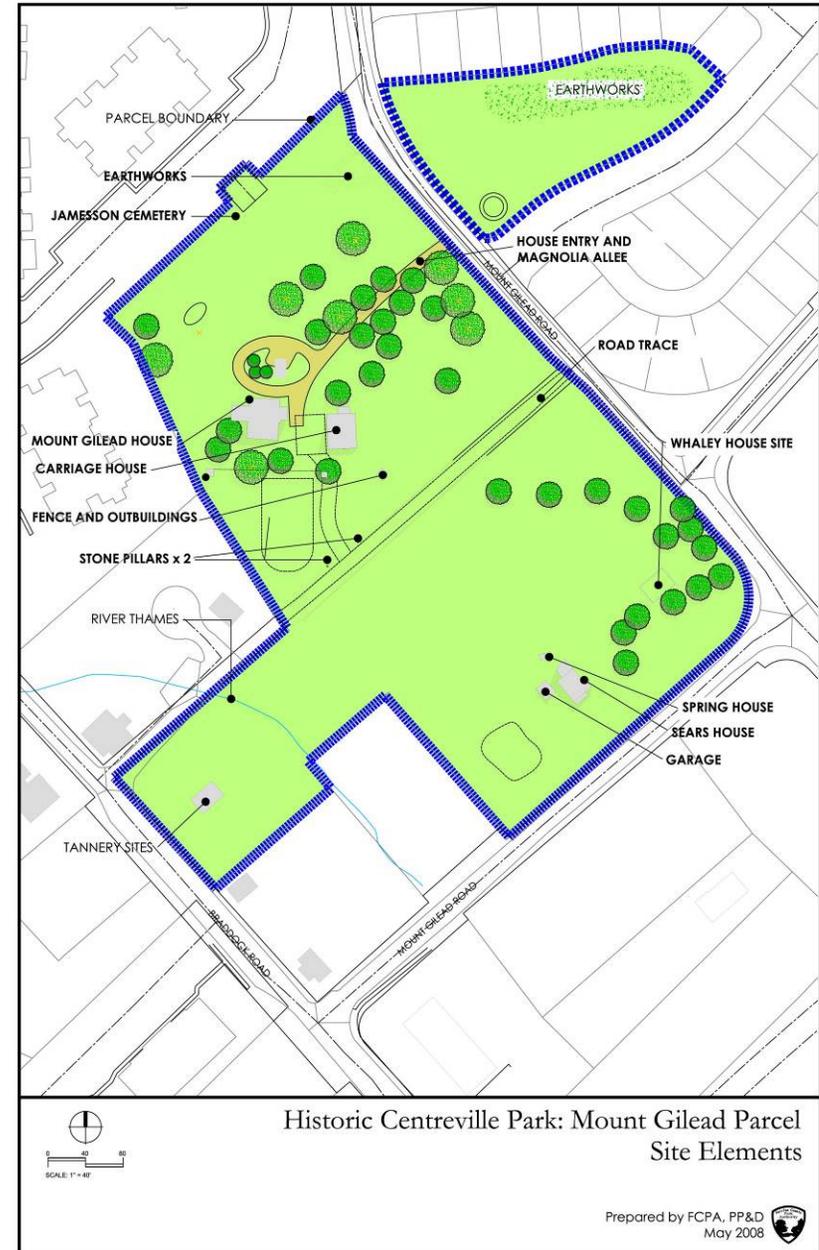
Figure 15: Mount Gilead Parcel Site Elements

- The most prominent feature is the Mount Gilead House and grounds. Believed to have been built circa **1785**, it is known to have served as a tavern called the Black Horse for several years. The "front" of the house that we see today was originally the back of the house; and what is now the "back" of the house was the front in the 18th and 19th centuries. It was part of the original Newgate community, as settled in the late 18th century. It is the last remaining structure from the original community of Newgate and is an important historical resource. Since its original construction, it has been utilized as a tavern, a Civil War officer's headquarters, and back to a residence. It was occupied first by Confederate troops early in the war,

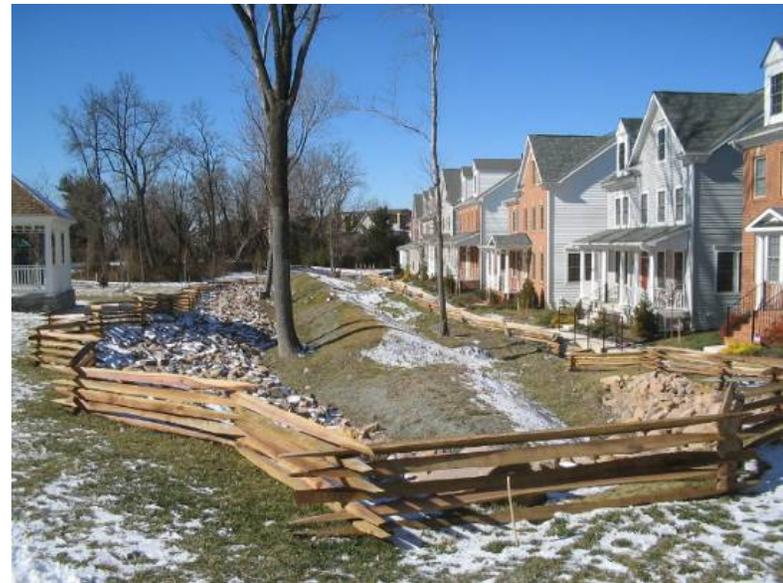
Figure 17: Civil War Earthworks

The site contains an extension of the Civil War earthworks found at Mount Gilead. These were preserved when the adjacent residential development was built and are a part of

the extensive Centreville Earthworks. The site also contains a modern gazebo, tot lot and sidewalks constructed at the time of the residential development. The western portion of the parcel contains a tree preservation area.

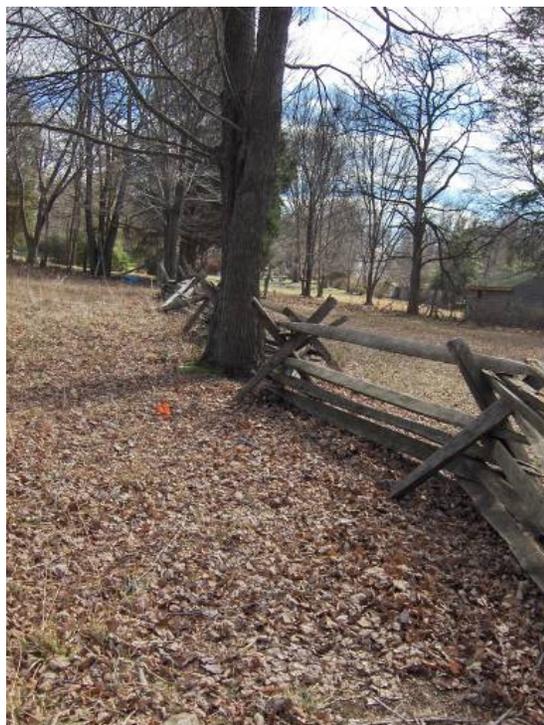
Figure 18: Typical landscape at Winter Quarters site

This parcel contained a 1950s era single family home that was removed by the Park Authority. The remainder of the site is open field with some forested area to the north. This parcel contains an intact Civil War era landscape containing a number of features, including a small star shaped foundation, which is still an unknown structure. It is an extremely unusual

structure, as it has a stone foundation, while almost all other structures of this era were earthworks. Not on the main line of fortifications, this is the only known, remaining interior military structure in Centreville. This foundation was above grade and visible in 1937 aerial photos but is now completely buried. The remainder of the site is open and was likely utilized for soldier encampments. In

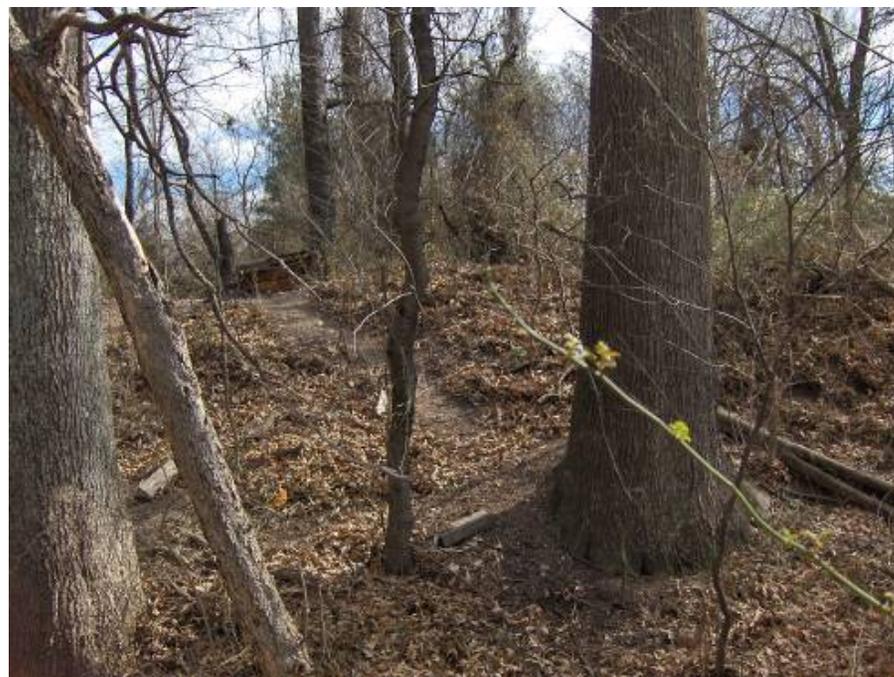
Figure 19: Footpath at Chantilly Road Redoubt

This parcel contains well preserved remnants of a Civil War era Redoubt or Bastion. It is also known as the West Fort. Future archaeological work may shed more light on its function. The fort is in an excellent state of preservation with minimal disturbance.

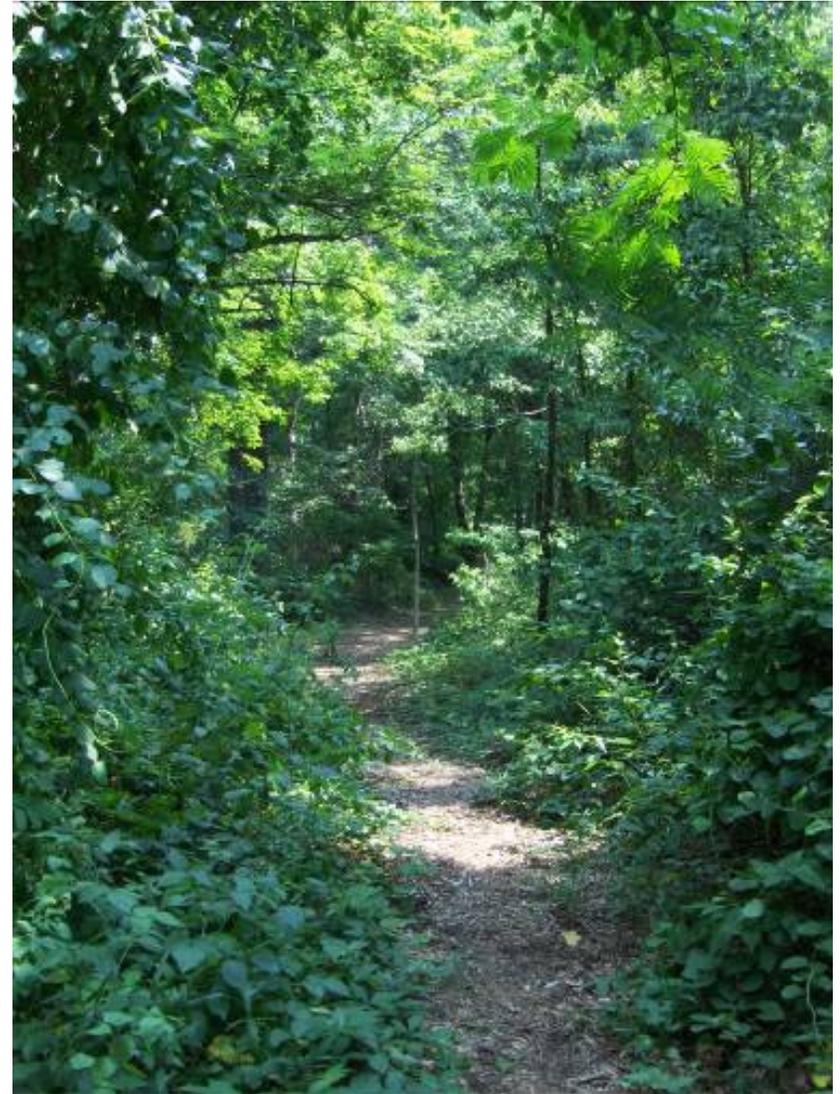
Figure 20: Covered Way

The Covered Way site contains earthwork remnants of three significant Civil War era fortification elements generally thought to have been constructed by Union forces after overtaking the Centreville fortifications. These elements are commonly known as the Middle Fort, Covered Way and Apex Fort. The Middle Fort earthworks are heavily degraded and are partially contained on the adjacent property. The Covered Way is a walkway that was used to travel between fort elements and be protected from enemy fire. The Apex Fort is a large earthwork fortification that is partially on the Covered Way parcel. These fortifications continue both north and south onto the adjacent privately owned parcels.

This fort complex was atop the bluffs overlooking Rocky Run offering an expansive view of the lower valleys and potential enemy troops. A recent survey of the parcel indicated Native American remnants such as large numbers of stone tool fragments and debitage.

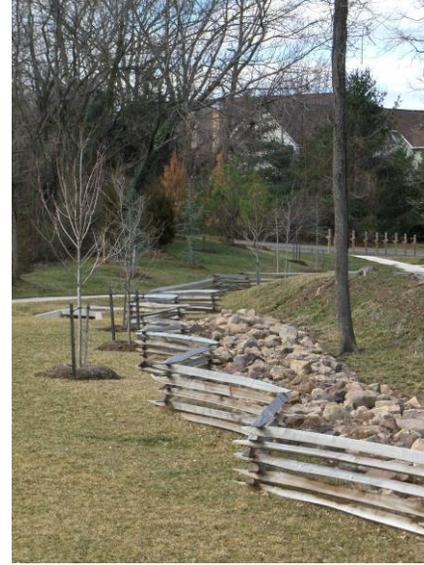
Figure 23: Civil War Earthworks

The parcel containing the majority of the fort is typified by a highly disturbed mid-succession forest dominated by Virginia pine, tulip tree and red maple. There is a large degree of recent pine blow-down as well as dumping from neighboring properties and off trail use. This site has a relatively low percentage of non-native invasive plant cover, but given the

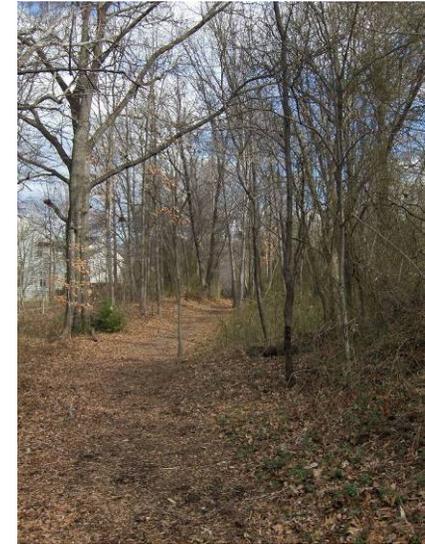
Figure 24: Covered Way Footpath

The Covered Way is typified by moderately dense woody cover consisting of trees shrubs and vines. The vegetation appears to be supplying a good degree of protection for the earthworks, however, the vegetation will need to be managed to prevent any possible damage to the earthworks from disruptive root systems, potential throw if trees are blown down or fall, and prevention of non-native invasive plant species introduction.

The site has obvious signs of regular human disturbance

Despite the poor condition of the plant communities, the earthworks are currently stable and appear to be benefiting from the continued woody plant cover.

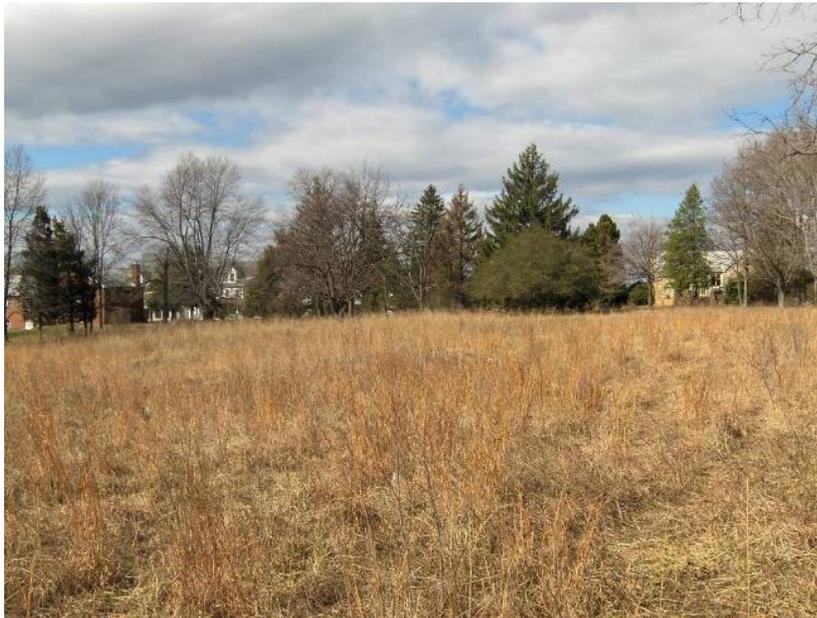
Figure 25: Meadow Landscape at The Winter Quarters

Approximately the northeastern one third of the property consists of a highly disturbed early succession forest with low species diversity and a high degree of non-native invasive coverage; The southeastern portion of the property contains a field over one acre in size that includes many desirable native meadow species and provides beneficial habitat; and

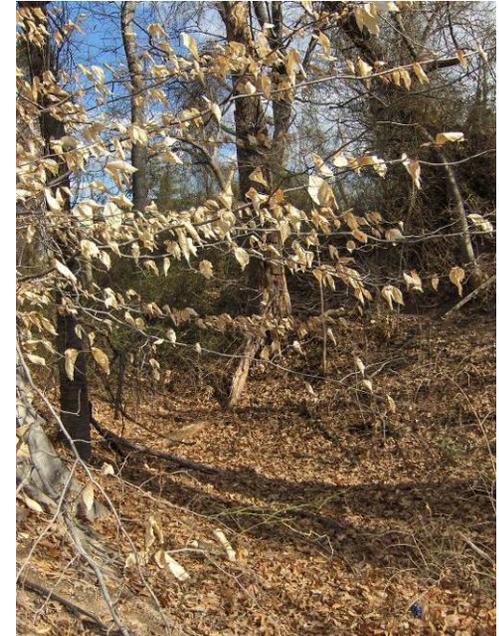
Figure 26: Redoubt

The large red oaks located at the base of the earthwork are 30 inches in diameter or larger. It is hard to gauge the age due to extreme variability of growth based on local conditions, however, it is quite possible that these trees have been growing there since soon after the earthworks were abandoned. It is likely that these mature trees have helped protect the earthwork from rain and wind erosion and human activity.

An extremely thick growth consisting of invasive, poisonous and thorny plants has also likely helped preserve the earthwork since the vegetation greatly limits human access and activity.

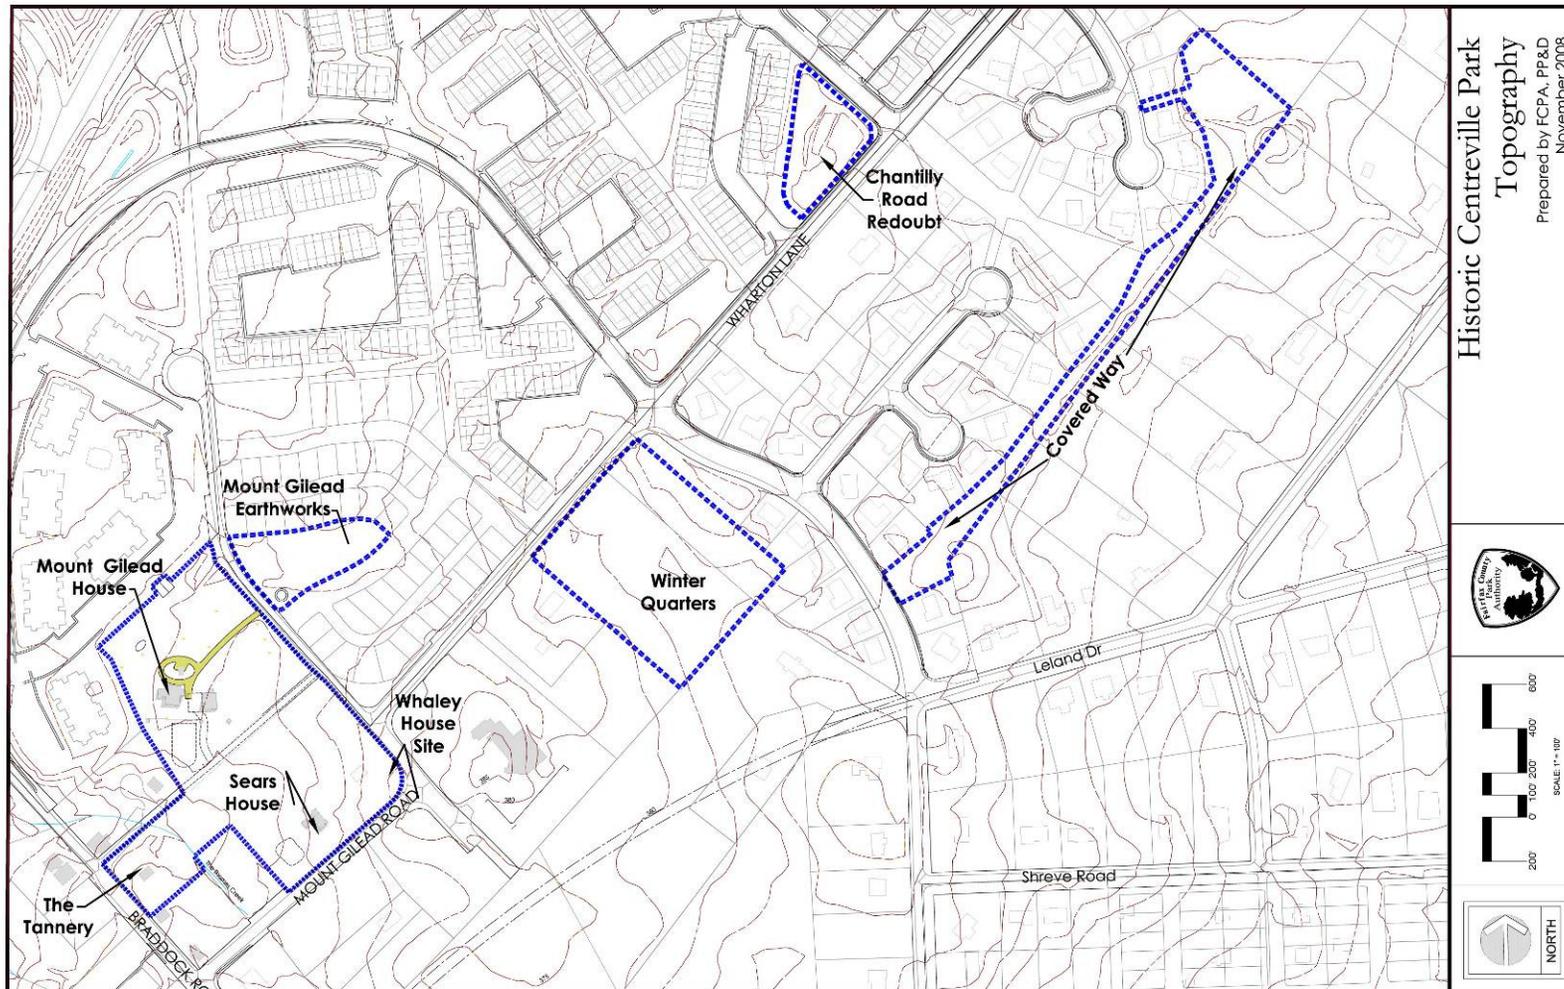
Figure 27: Topographic Map

The topography of the sites is generally flat plateau on the Centreville Ridge. The areas of earthwork remnants do show noticeable grade differences and are apparent as man made elements in the landscape. Most of the earthworks laid fallow after the war and where they were not removed due to farming or development, they are currently covered with dense underbrush and mature canopy trees.

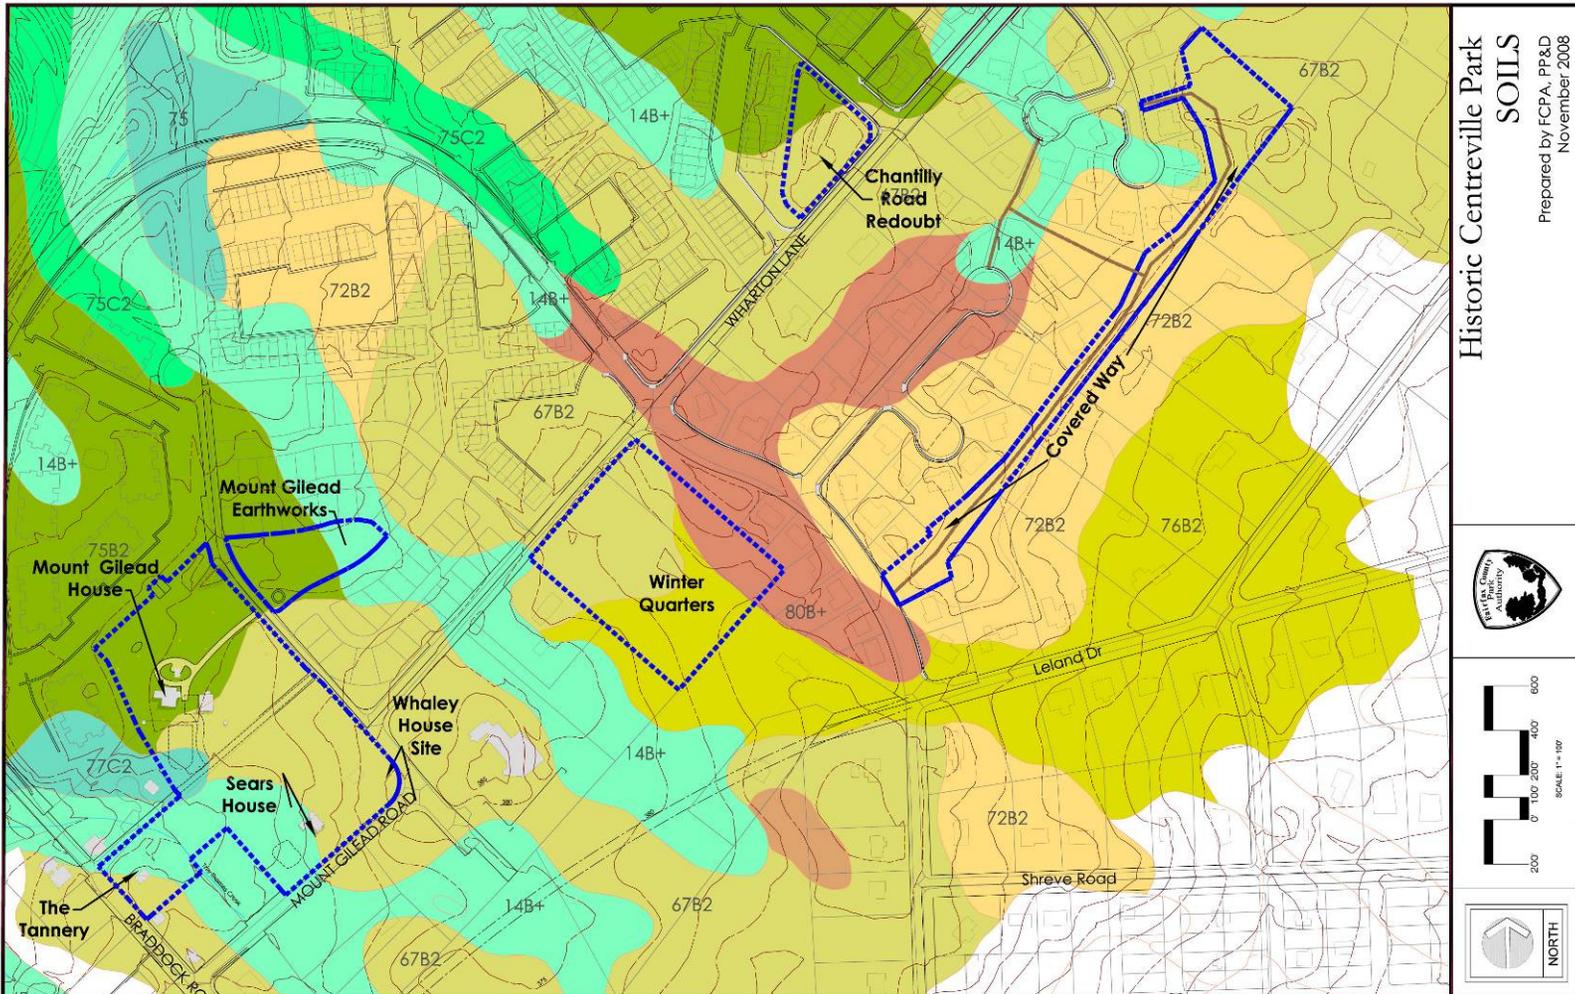
Figure 28: Soils Map

The soils in this area are typical of ridge top and stream valley landforms. Most of them are suitable for farming, but have some erosion potential. A full description of the soil types and characteristics can be found in Appendix A

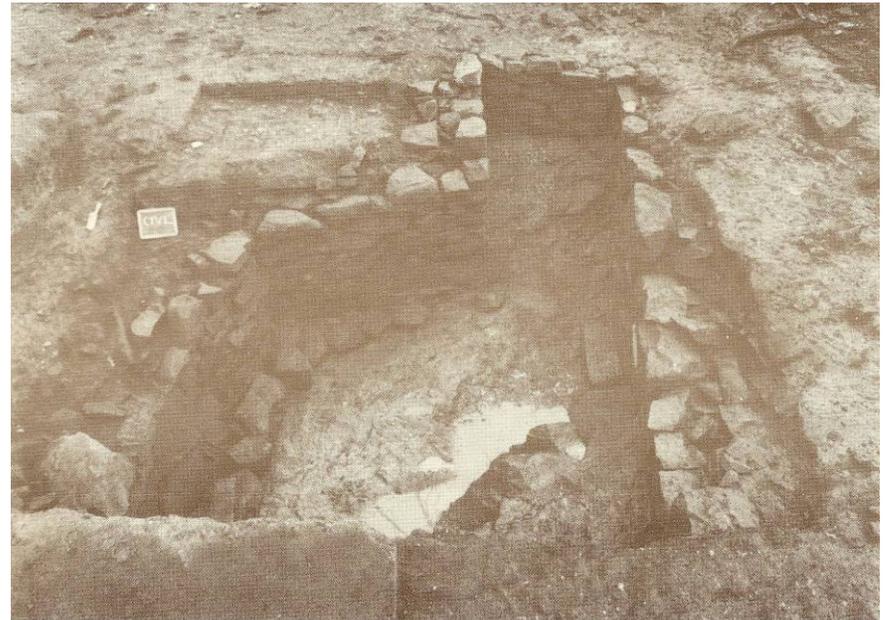
Figure 30: Tannery Excavation

The Tannery archaeological Area on the Mount Gilead site will be a rehabilitation zone.

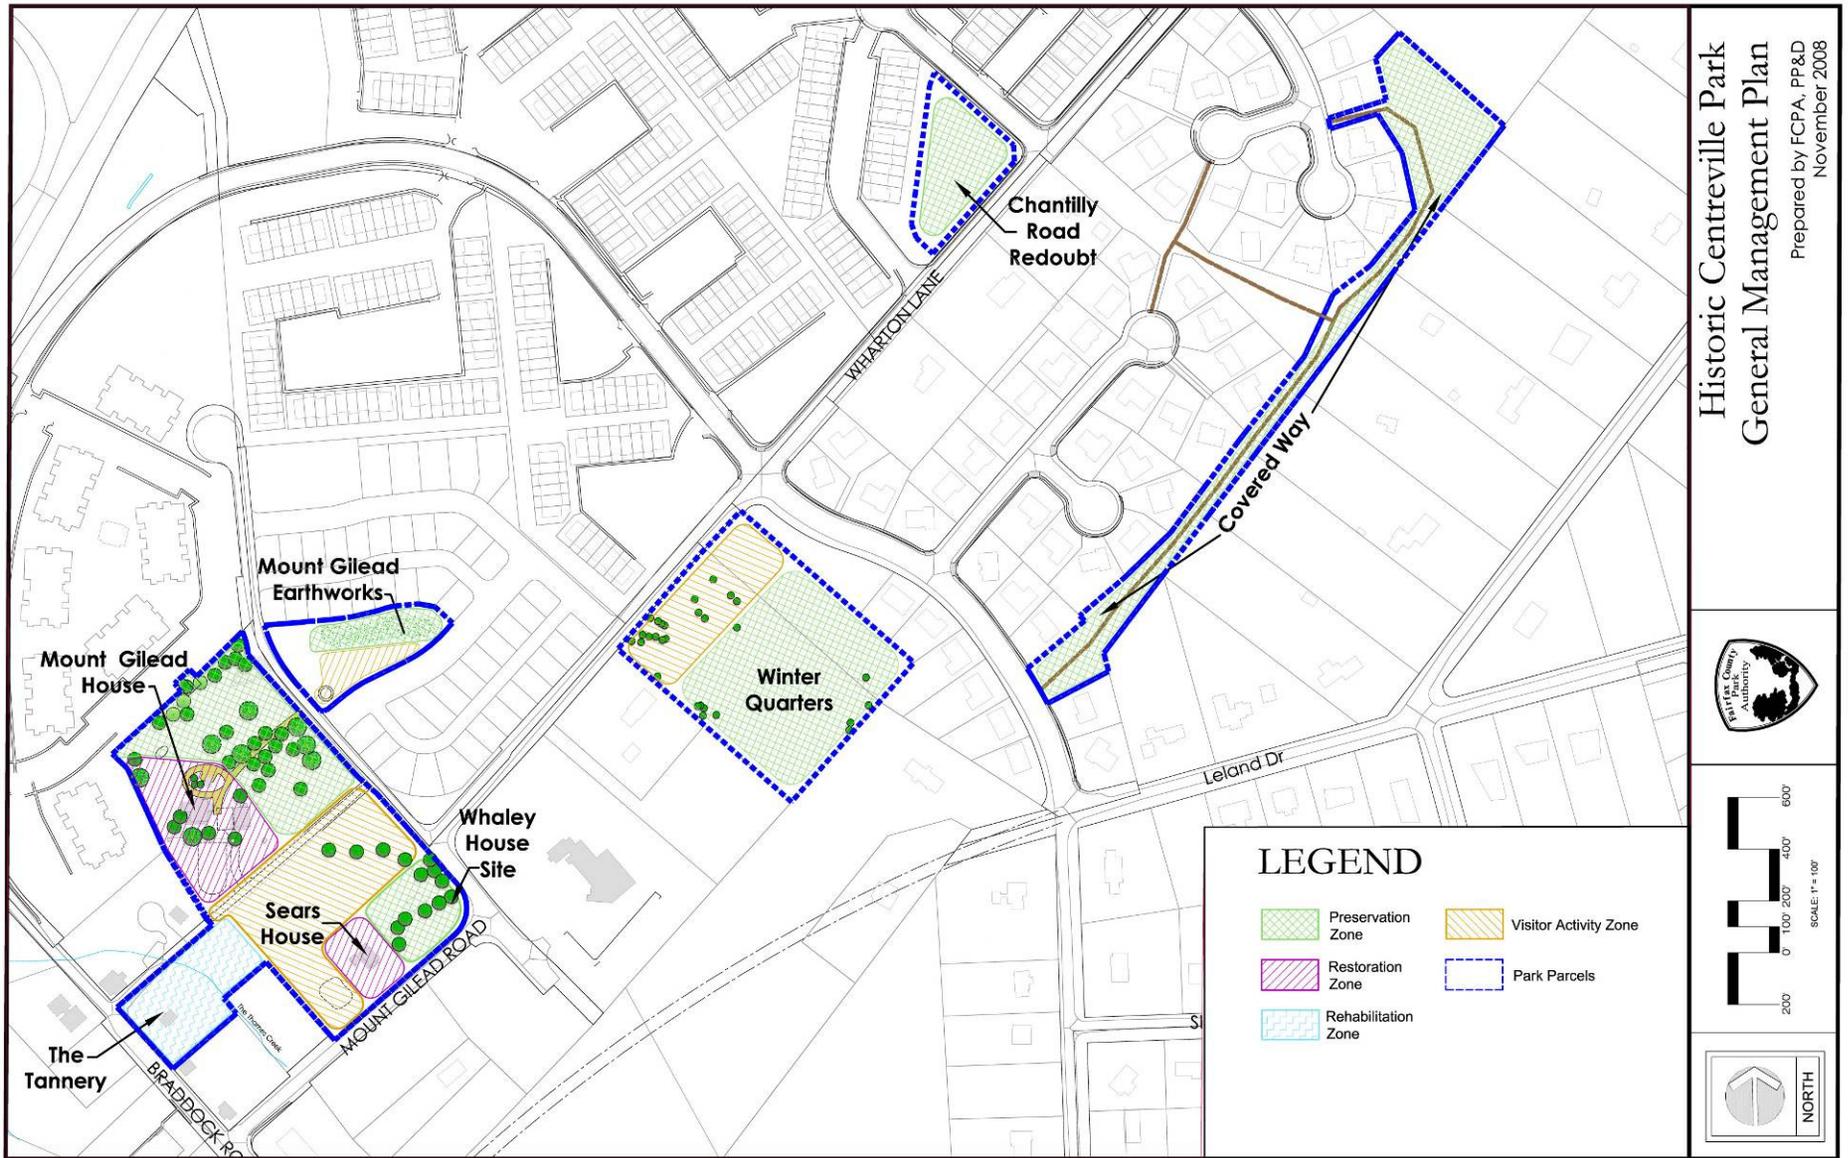
Figure 31: General Management Plan

Management zones have been defined to provide a framework for decision-making. Existing uses, existing conditions and recommendations from residents and Park Authority staff were considered in the development of the management zones. The framework provides broad flexibility within a range of potential uses for each management zone. The General Management Plan Map on page xx depicts the location of these management zones.

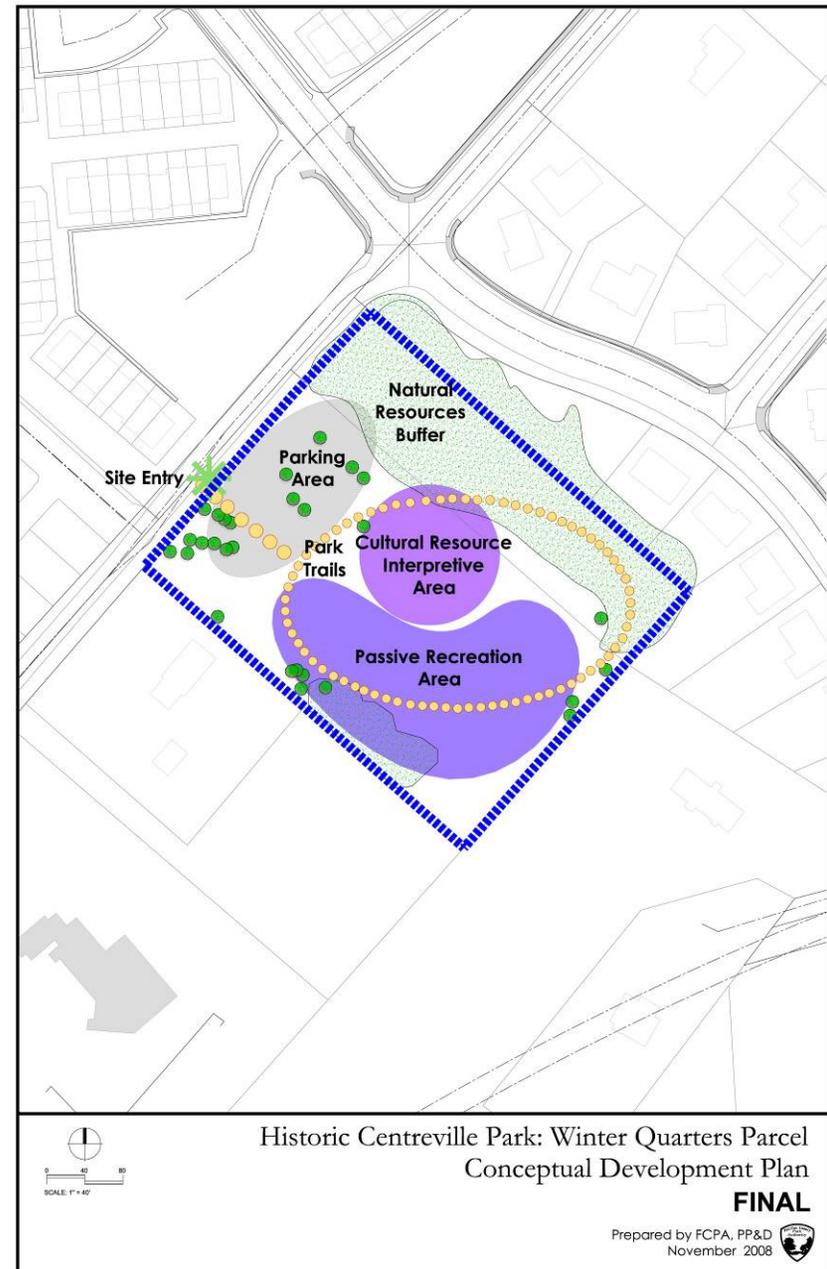
Figure 36: Winter Quarters CDP

Additionally, there are numerous cultural resource sites throughout the park that link to this site. The signage should include references to the related Civil War resources in the area and direct the visitor to a self-guided walking tour of the various sites.

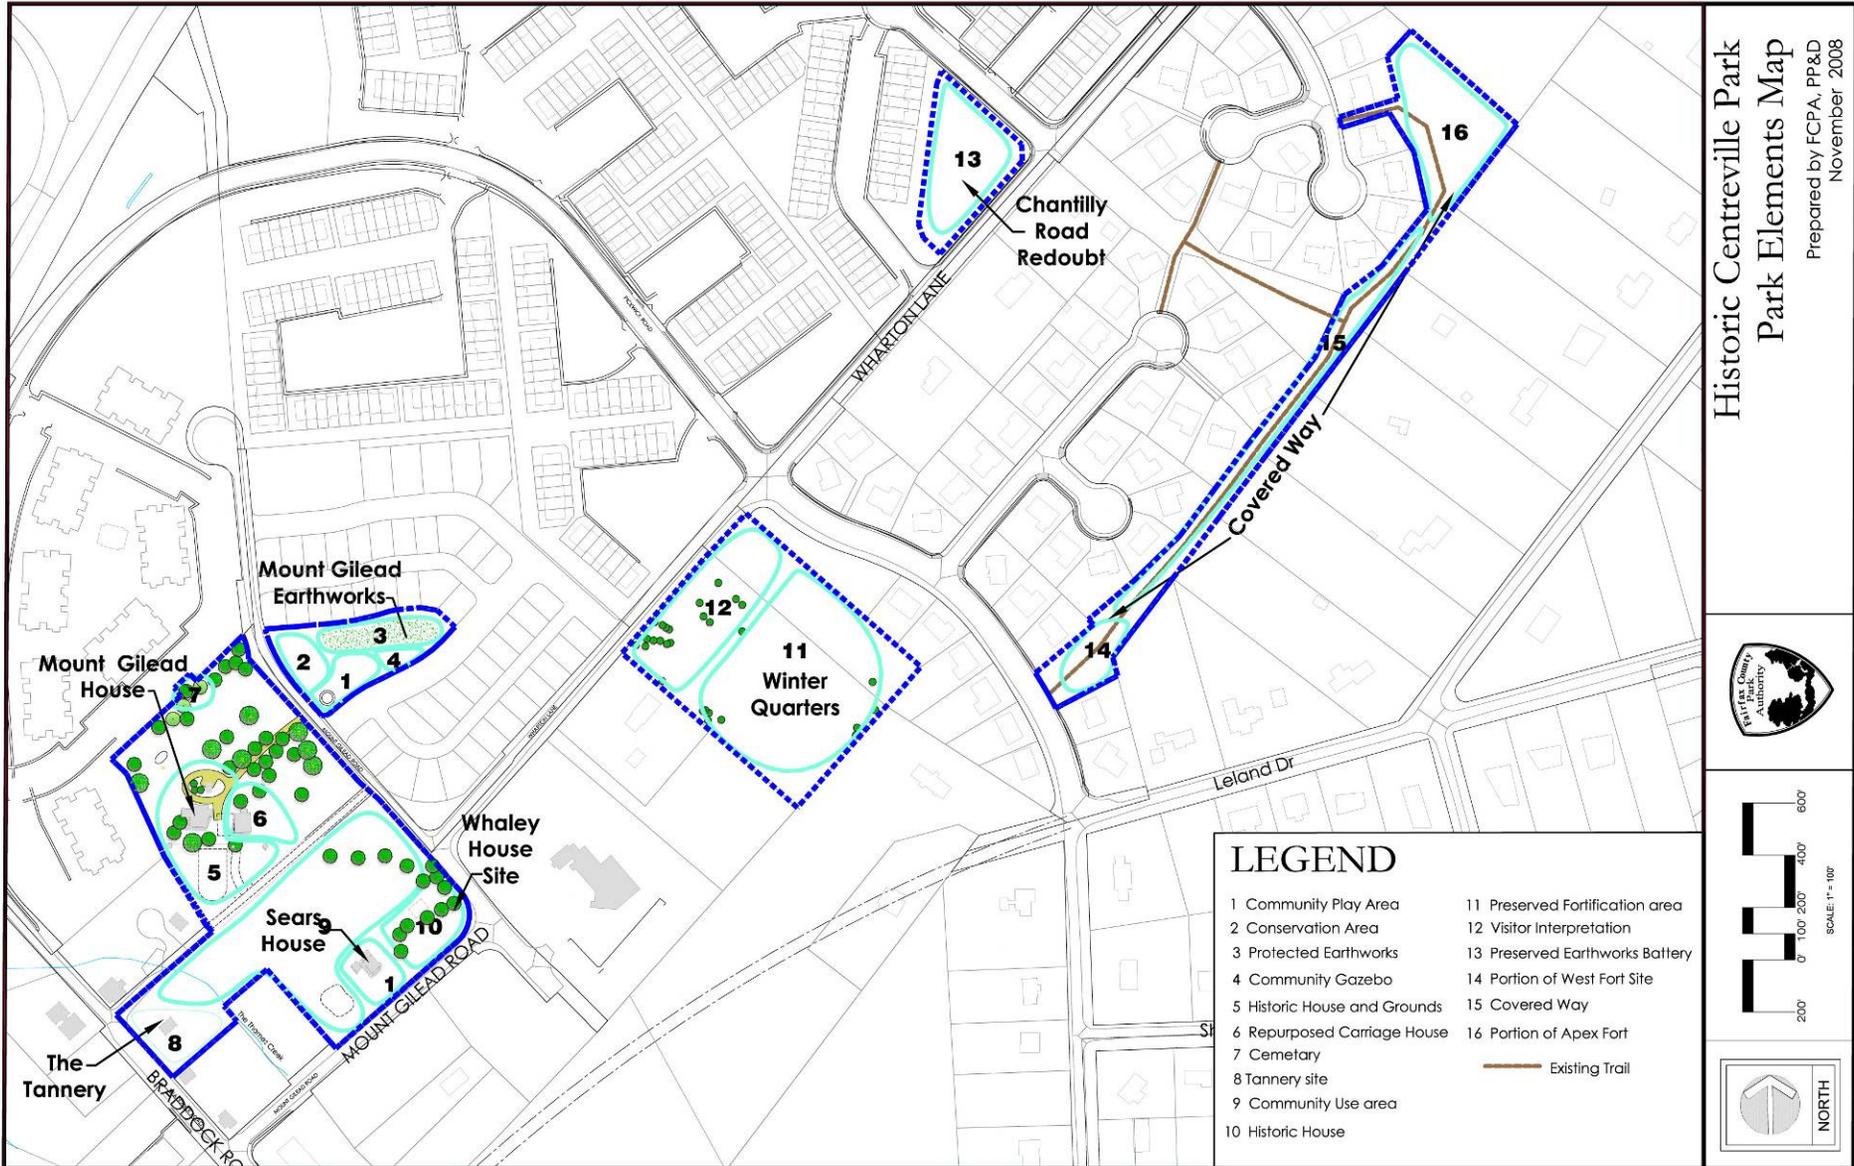
Appendix C: Park Elements Plan

Historic Centreville Park
Park Elements Map
Prepared by FCPA, PP&D
November 2008
