# KINGSTOWNE PARK

## MASTER PLAN

April 25, 2012

prepared by:  
The Fairfax County Park Authority  
and  
The Department of Public Works and  
Environmental Services

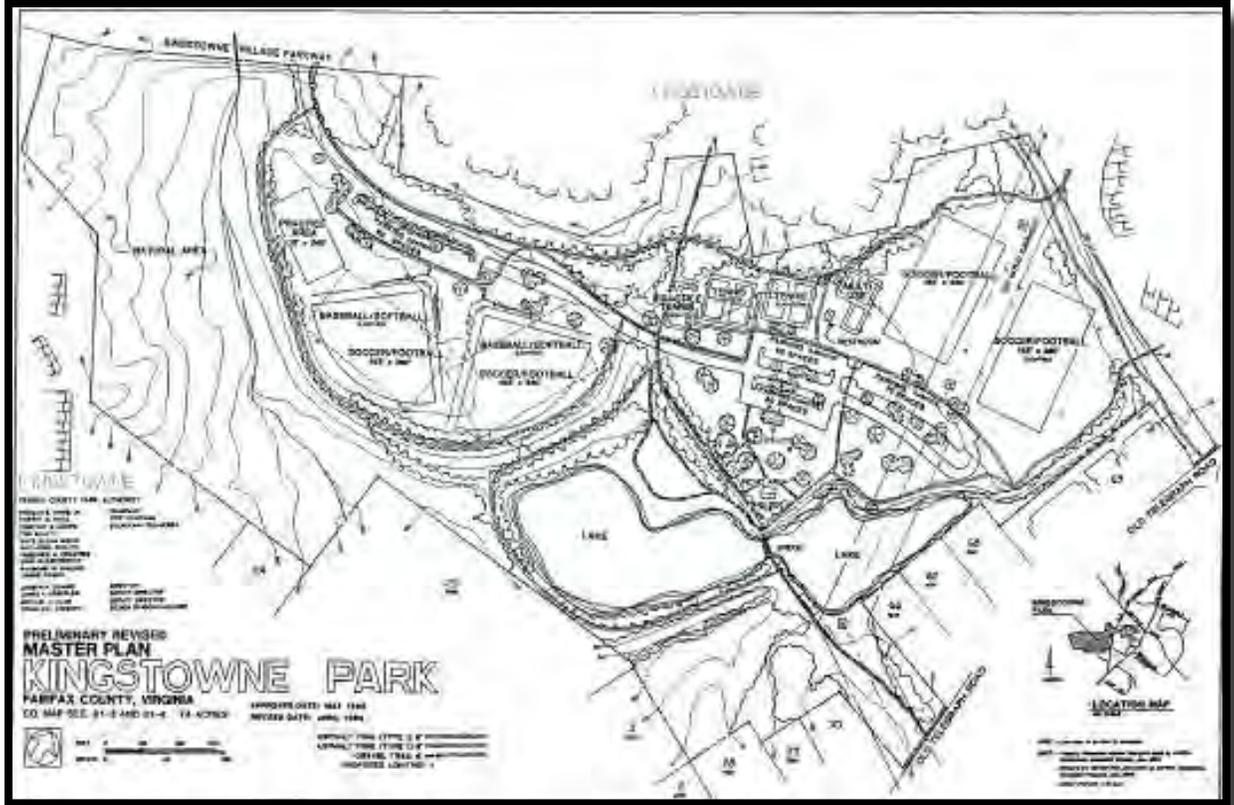
**Figure 3: Kingstowne Park Master Plan approved May, 1989.**

As a part of the zoning approval for the Kingstowne community the developer, Greendale Development Company, Inc., proffered to dedicate Kingstowne Park to the Fairfax County Park Authority. The rezoning and proffers were approved by the Board of Supervisors (BOS) on June 17, 1985 and later amended on July 8, 1999. The park was dedicated by Halle Enterprises and Kingstowne LP to the BOS and the Park Authority as joint owners on December 9, 2002. The proffered park plan approved in the 1989 rezoning action envisioned multiple athletic fields and other recreational facilities.

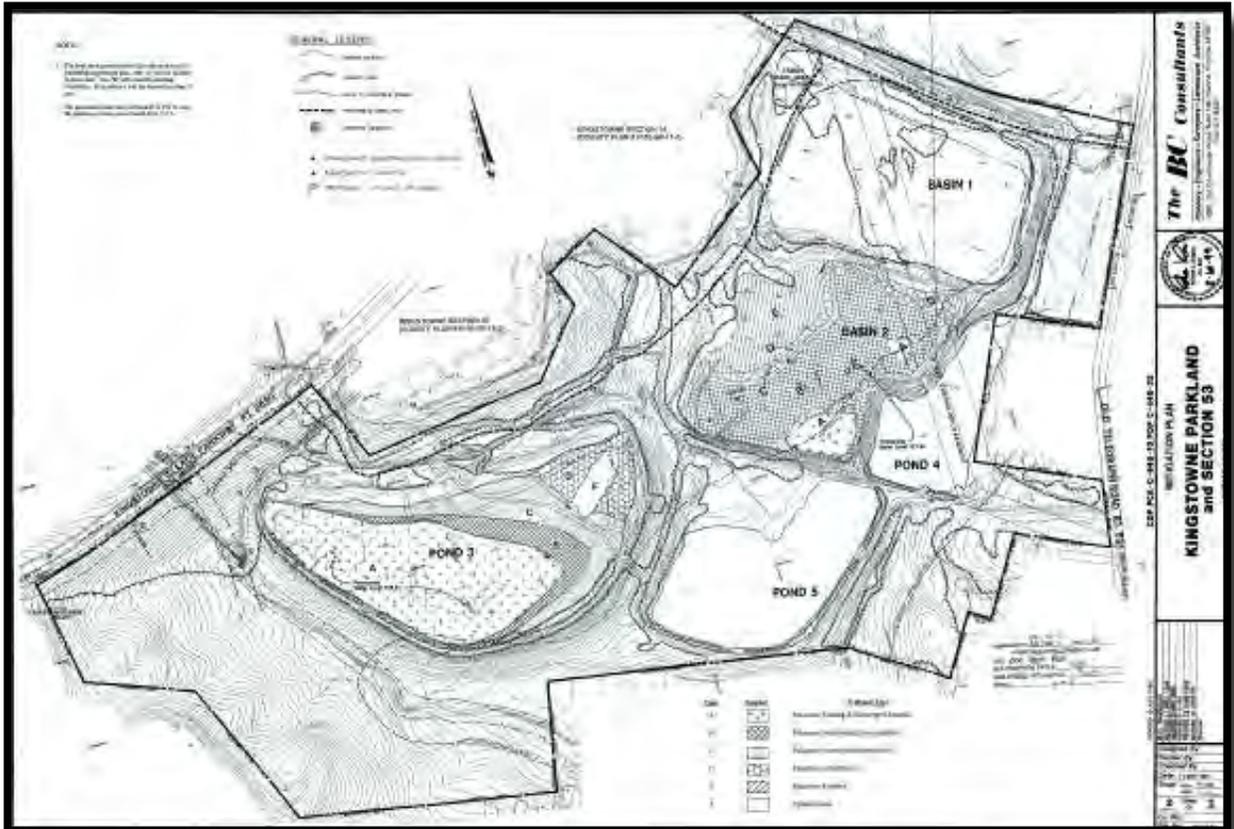
**Figure 4: Kingstowne Park Plan Approved in 1999 Proffered Condition Amendment**

During the course of construction of the Kingstowne community, the Environmental Protection Agency (EPA) made a determination that wetlands were impacted by Halle. This determination resulted in an Administrative Order of Consent between Halle and the EPA to mitigate the wetlands impacts. As a result of this order, the park site was selected as the location for wetlands mitigation to satisfy EPA requirements. The mitigation areas and ponds comprise approximately two thirds of the park area, limiting the ability to place park facilities as originally planned. As a result, the proffered park plan was amended through a proffered condition amendment (PCA) that converted the area planned for athletic fields to wetland mitigation areas. Each of these areas are distinct and numbered as shown in Figure 4.

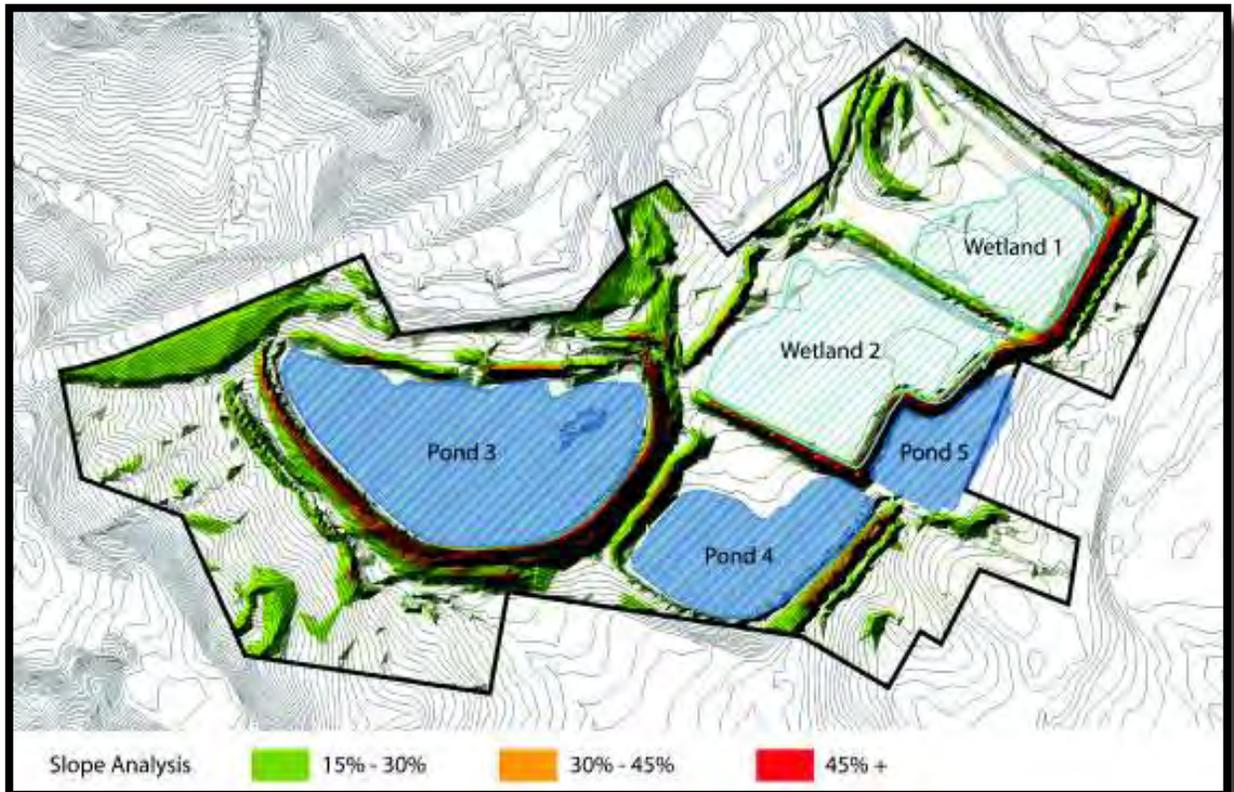
**Figure 8: Kingstowne Park Slope Analysis**

A large percentage of Kingstowne Park has slopes that exceed 15%. Development of facilities and trails on slopes greater than 15% is challenging and expensive due to the higher engineering and construction costs. Generally these steep slopes are avoided for development.

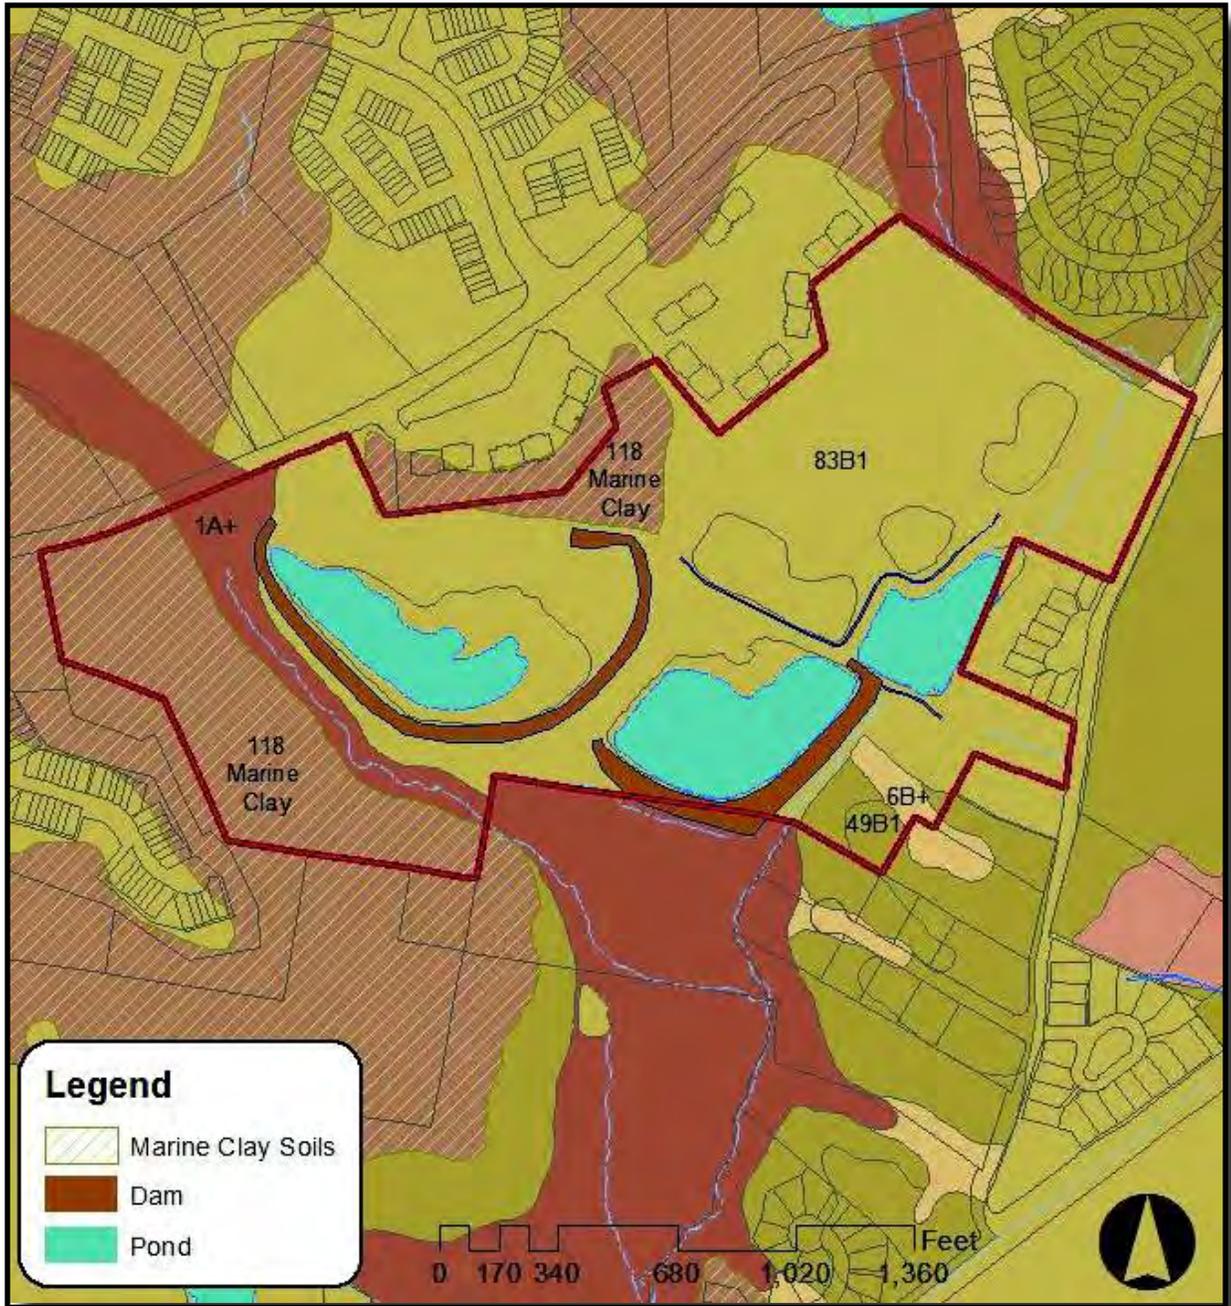
**Figure 10: Kingstowne Park Soils Map**

The predominant soils type present on the Kingstowne site is Galestowne Loamy Fine Sand (83B1). This soil is unremarkable for construction problems, and is located primarily within the wetlands mitigation areas. Portions of the site also contain Marine Clay (118), which is commonly found in this area of the County. Marine Clay is a problem soil noted for shrink swell issues and a tendency towards slippage at slopes greater than 16%.

A complete listing of the site soils and characteristics can be found in Table 2.

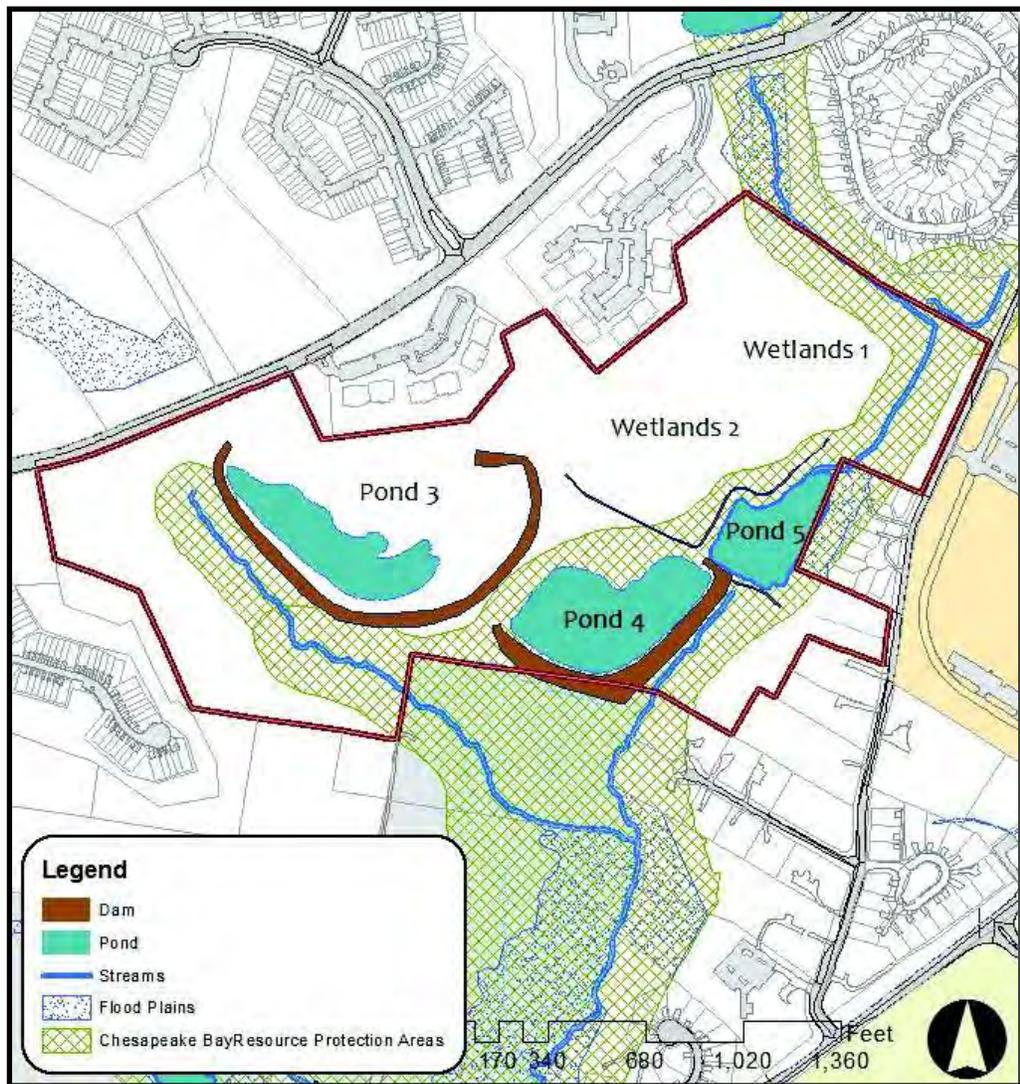
**Figure 11: Kingstowne Park Hydrology Map**

The Belle Haven, Dogue Creek and Four Mile Run Watershed Management Plan notes that while Piney Run was not ranked among high priority areas for stream problems, there were a few localized areas where potential projects were identified. No projects were located within the park.

There is a general recommendation in the watershed plan to monitor beaver dams as potential obstructions and to remove them if they are found to be contributing to erosion or flooding.

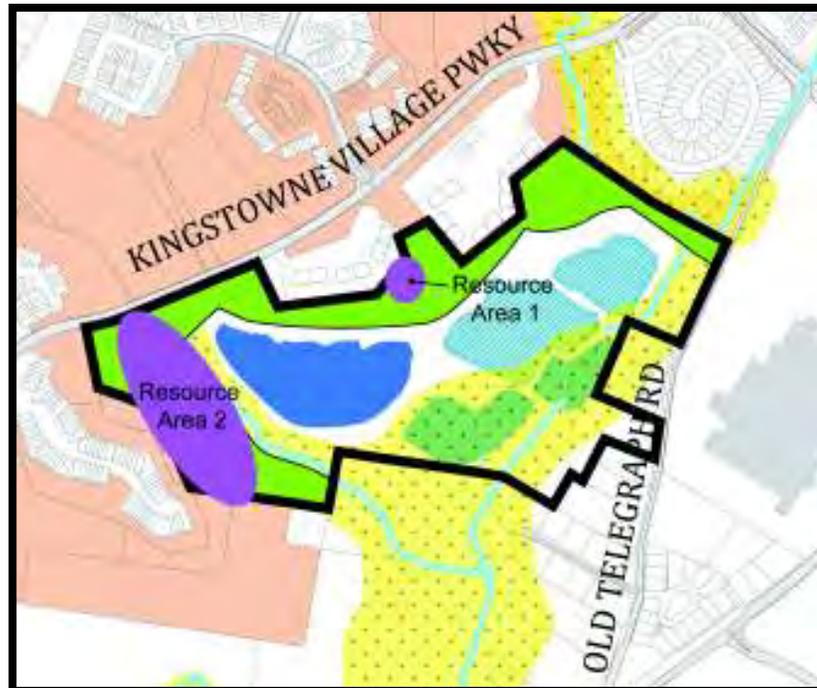
*Figure 13: Notable Natural Resource Areas 1 and 2*

There are two portions of the site which contain fair to very good quality natural resources. Resource Area 1 is a small forest stand just west of the picnic area along the northern edge of the park that contains mature tree cover. Resource Area 2 is a 10-acre forest block on the west side of the park that contains very good quality upland forest with intact soils. (Figure 13)

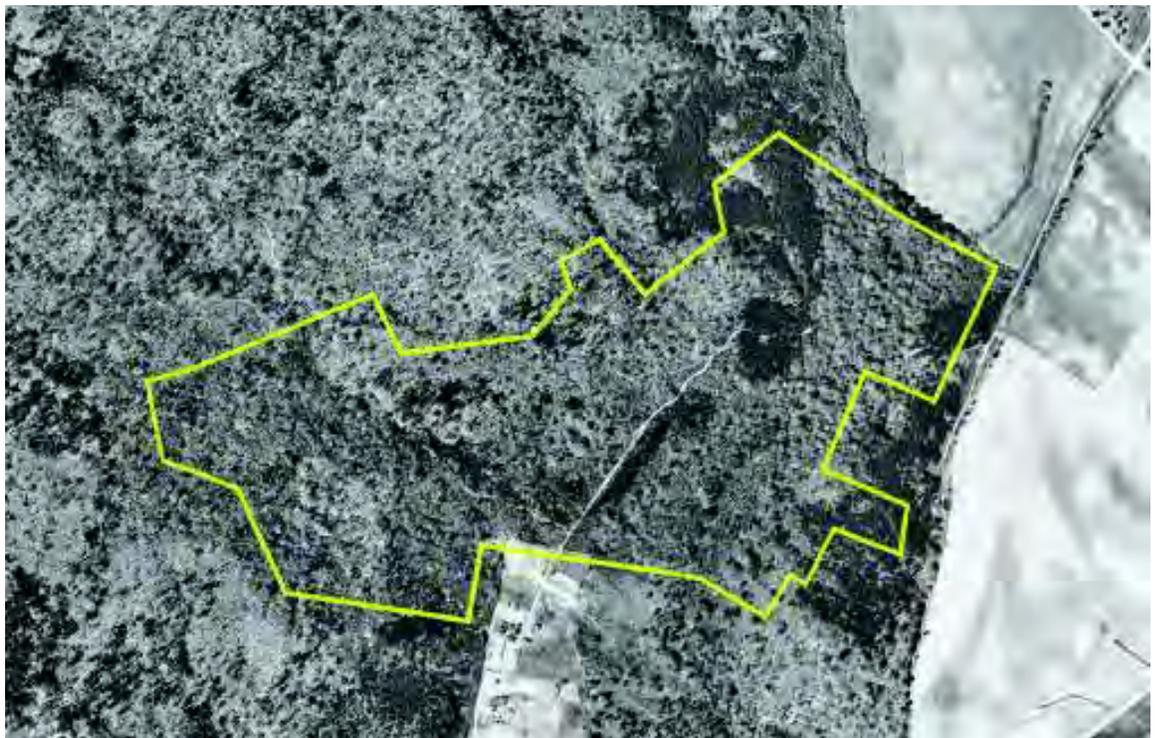
*Figure 14: 1937 Aerial photo (Fairfax County)*

As late as the mid 1930's the site was undeveloped and contained mature forest canopy and several small perennial streams. Development pressures are

evidenced in the surrounding properties as the aerial shows. Extensive clearing for farming is apparent east of the site. By the mid-1960s the site was the location of a quarry and slurry operation (Virginia Concrete Co. and Lehigh Portland Cement Co.) which effectively

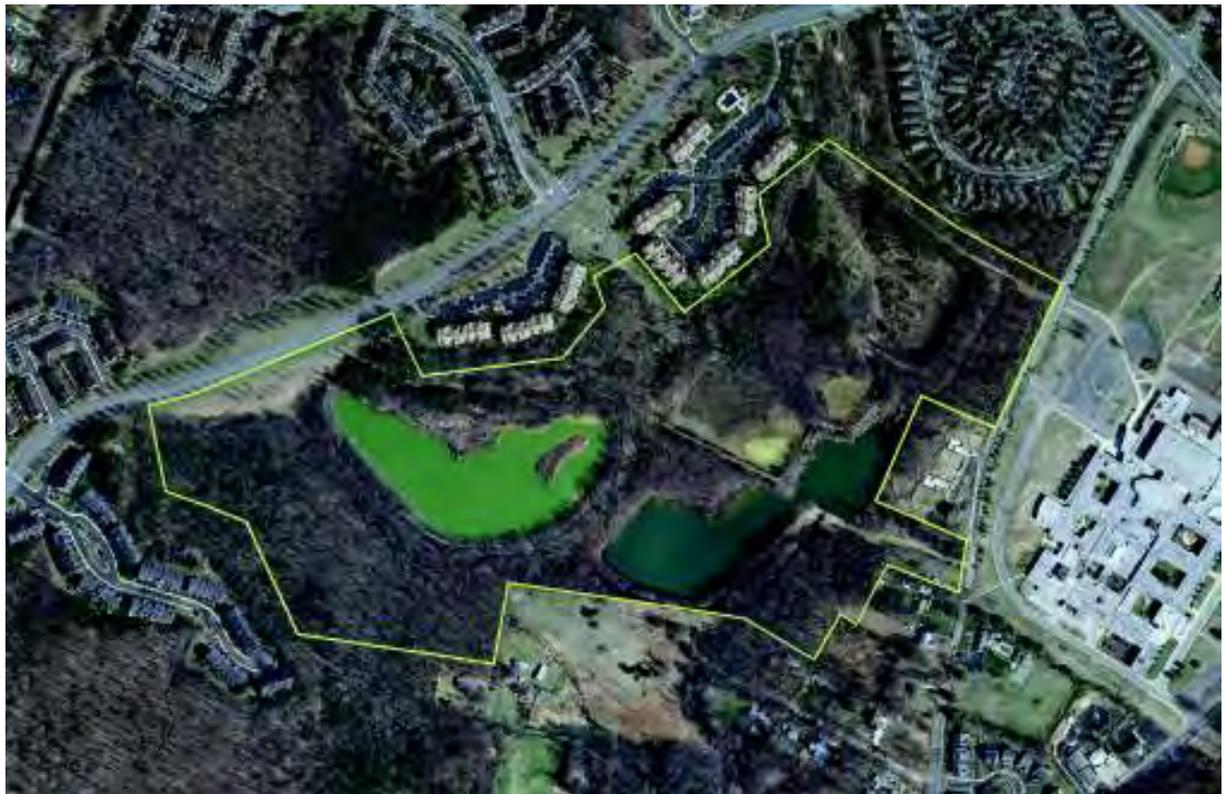
*Figure 17: 2009 Aerial photo (Fairfax County)*

family homes. The land that had previously been the quarry was proffered and dedicated to the Fairfax County Park Authority and Board of Supervisors. In the decades since the proffered park dedication and transfer, Kingstowne Park has been left relatively undisturbed. The forest has grown back and the park has become a habitat for local wildlife. This entire site has not returned to a fully undisturbed state as there are now two permanent wet ponds and three permanent wetlands basins located on the site.

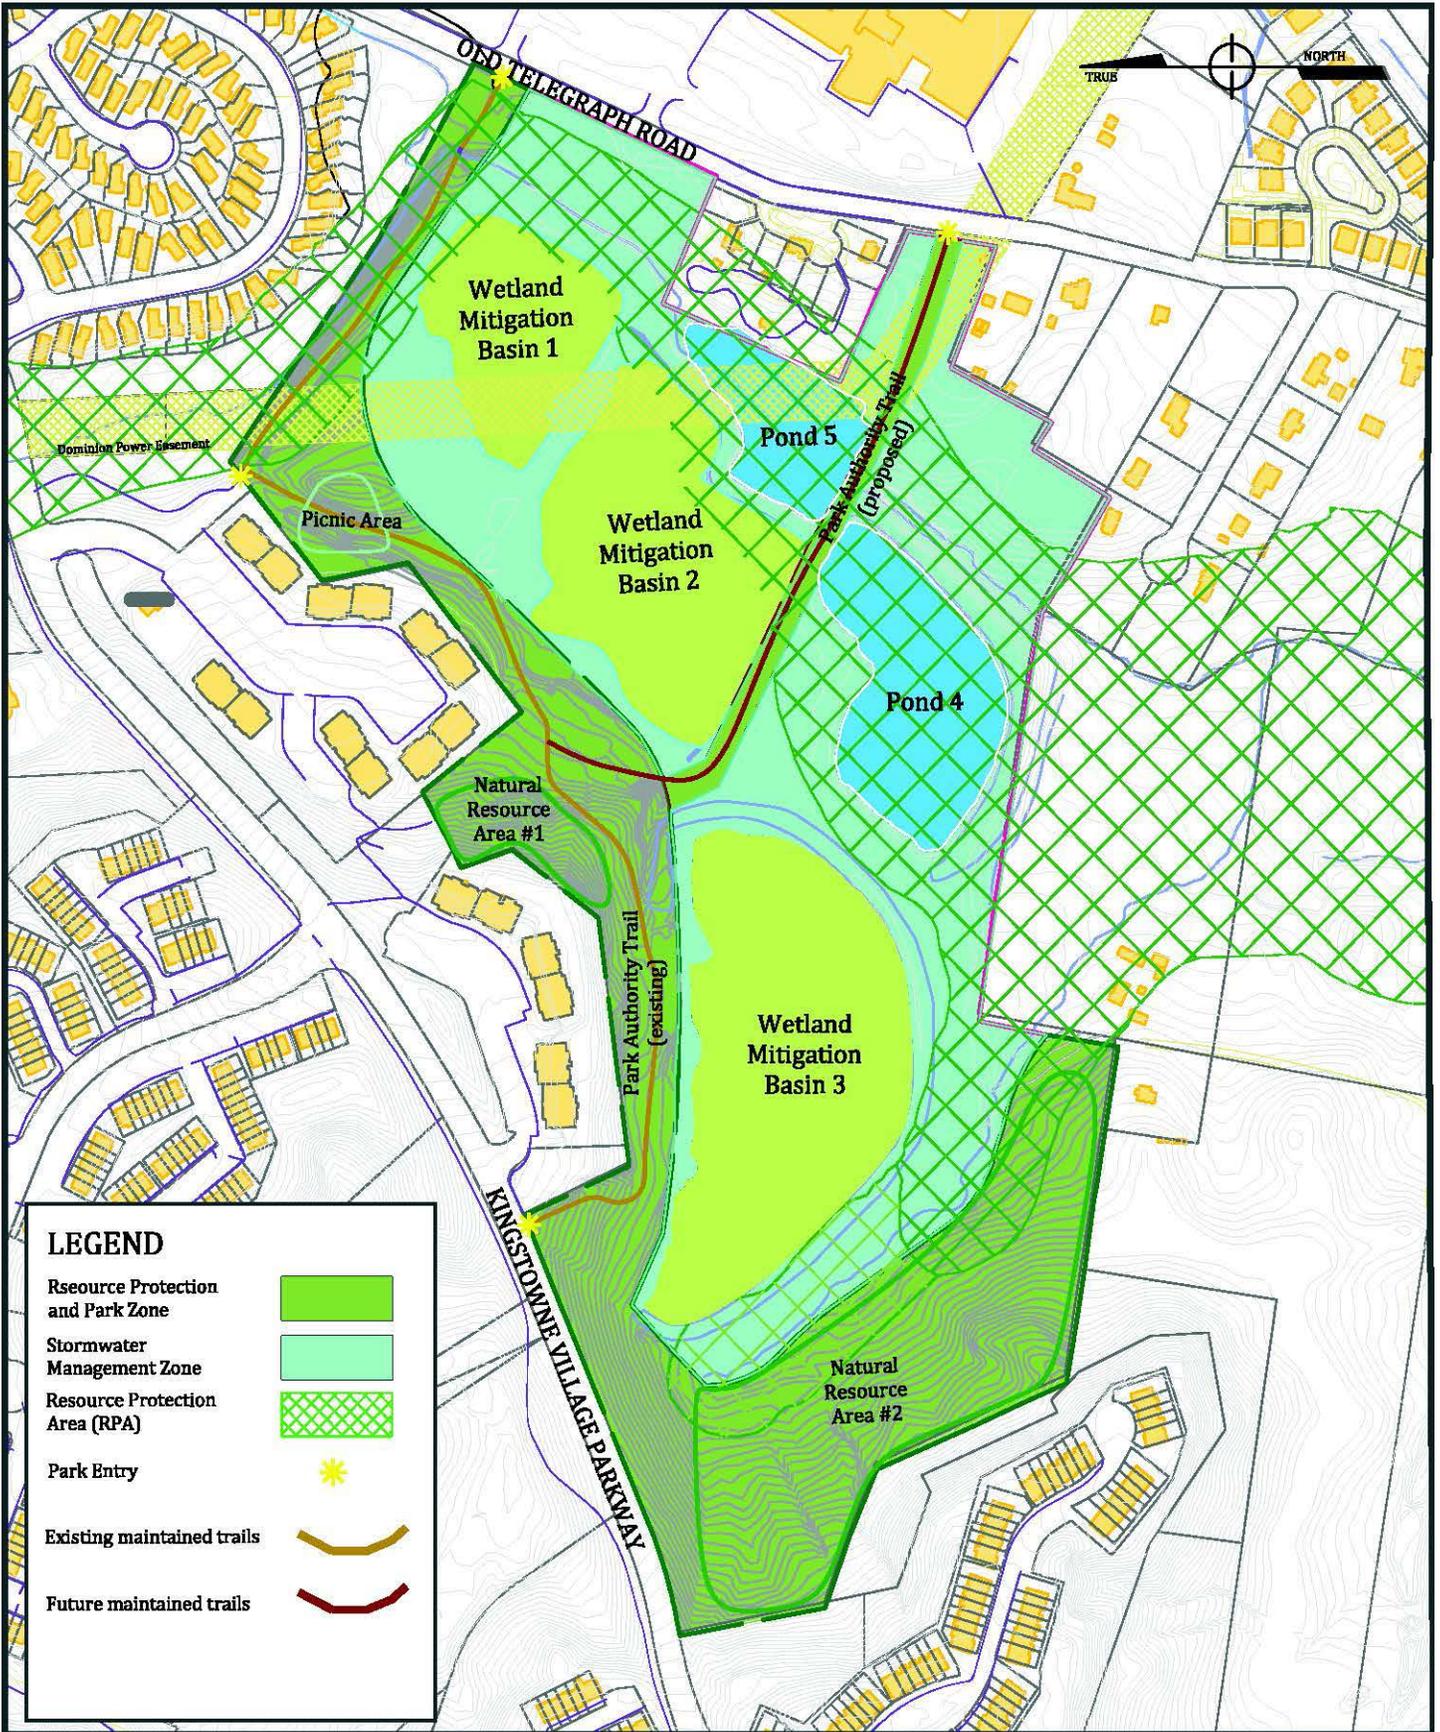
# Kingstowne Park Master Plan

A Conceptual Development Plan (CDP) provides recommendations for general locations of future park elements and facilities within the Park Zone only. The CDP contains descriptions of the proposed plan elements and design concerns and is accompanied by a graphic that shows the general location of the recommended park elements. A combined GMP/CDP plan graphic has been developed for Kingstowne Park. (Figure 18)

General Management Plan/Conceptual Development Plan  
 Fairfax County Park Authority/DPWES

The CDP provides general locations and recommendations for park facilities within the Park Zone only. The exact location of any additional park facilities will be determined by the site conditions at the time of design and construction.

A new trail is recommended to be located generally north/south as shown on the CDP, and would also connect to Old Telegraph Road just south of Hayfield Secondary School. A trail section at this location will require the installation of a bridge across the dam at Pond 5. This bridge shall be of sufficient width and load bearing capacity to allow for periodic use by Park Authority maintenance staff. The bridge or dam crossing shall be the responsibility of the County due to its integral nature as part of the dam structure. These trails will meet Park Authority standards for surface materials, width and maintenance.
