MARGARET WHITE HOUSE AND BARN Historic Structure Report

Falls Church, Virginia

Final Report

December 20, 2017
WJE No. 2015.3162.6

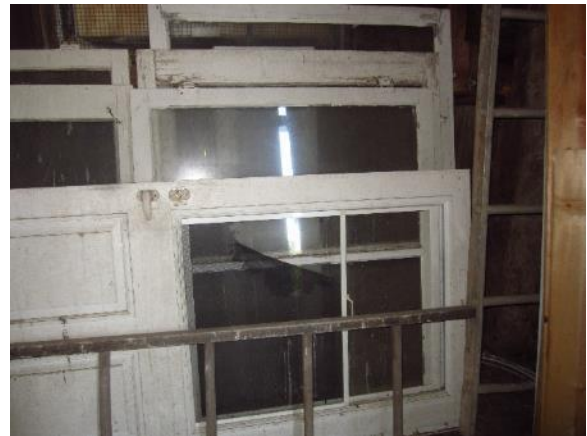
Figure 69. Abandoned white metal hinges, possibly for a screen door.

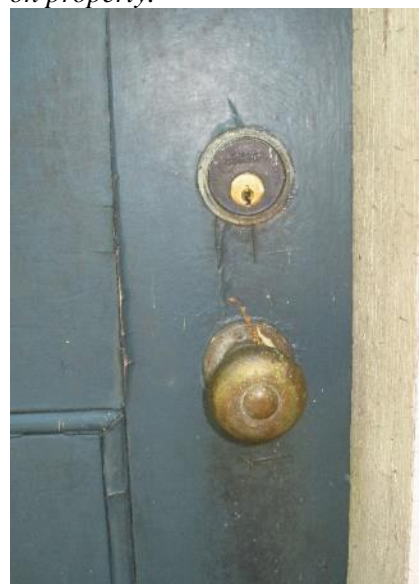
Figure 72. Metal doorknob and escutcheon located on west side exterior door.

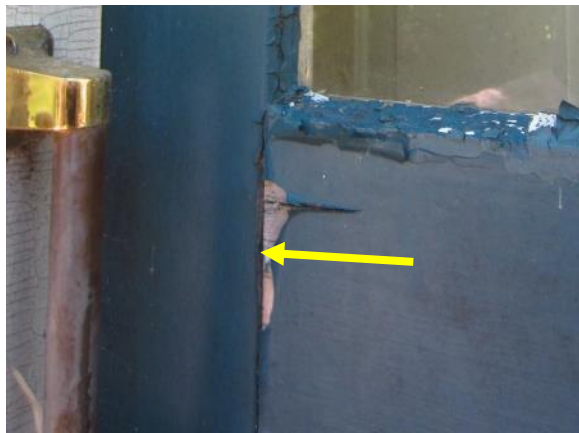
Figure 137. Typical separation of wood between stile and rail on door.

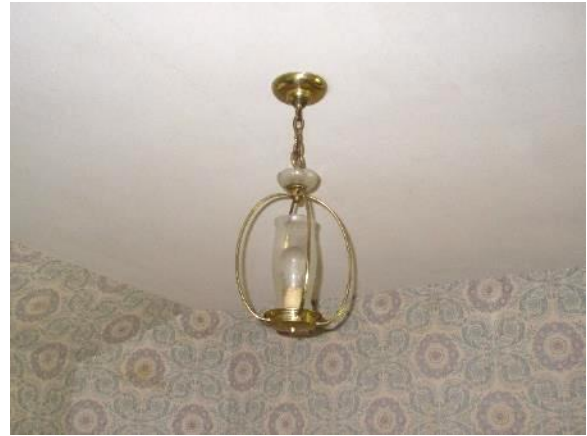
One hanging light fixture is centered above the landing rail (Figure 246). The fixture has a gold metal base, chain, and cage with one lightbulb. The bulb is encased in a glass shade. There is one wood switch plate and one clear outlet plate in the landing. A white metal register is located in a small alcove on the south wall that contains the window.

Figure 246. Second floor landing hanging light fixture.

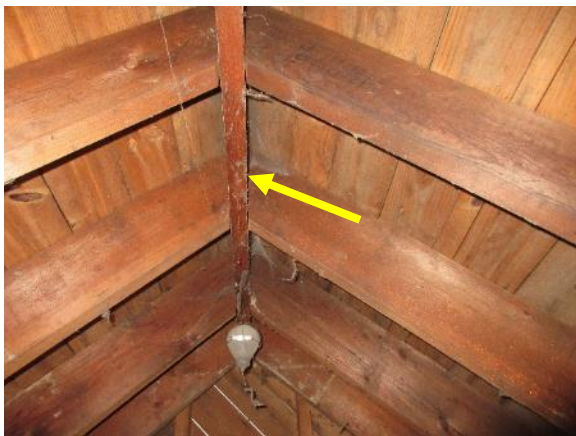
Figure 290. Brick chimney wall at southwest corner of attic above center core. Note moist wood above and adjacent to brick indicating water infiltration.

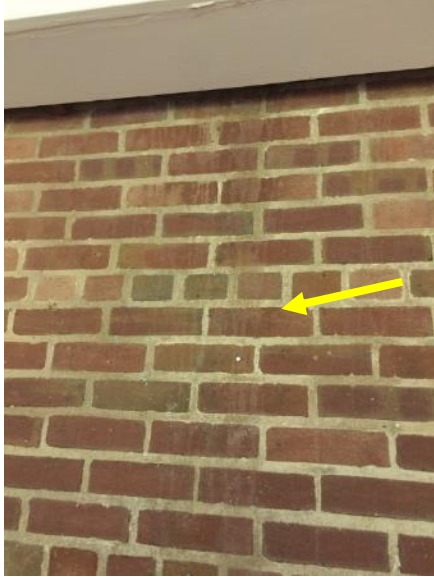
Figure 306. Streaking on brick in glass porch.

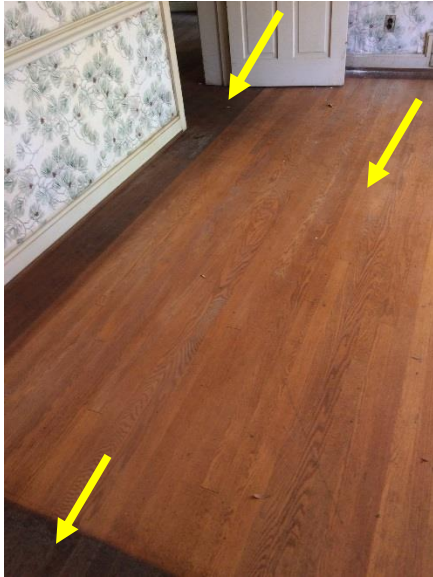
Figure 324. Color disparity between wood at center of room and wood at perimeter of room/hallway.

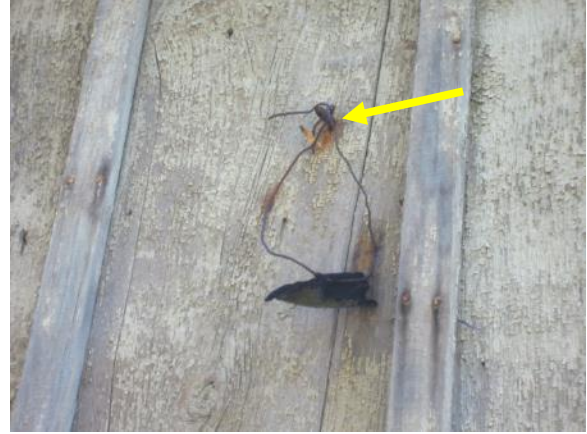
- Numerous hooks and wires are fastened into the wood boards on the west end and south side (Figure 377).
- Vegetation was observed on the wood on the east end and north side, extending under the roof. At the time of our survey the vegetation appeared to be dead (Figure 378).

Figure 377. Typical metal hooks in wood boards.
