ELLMORE FARMHOUSE Condition and Treatment Report

2739 West Ox Road, Herndon, VA

Final Report

WJE No. 2017.5127

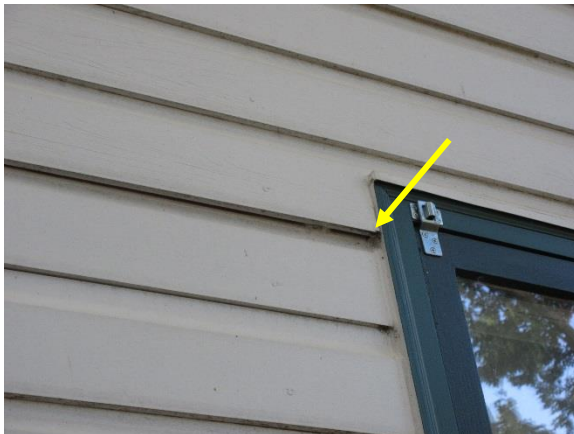
Figure 13. Displaced wood siding adjacent to window a northwest facade.

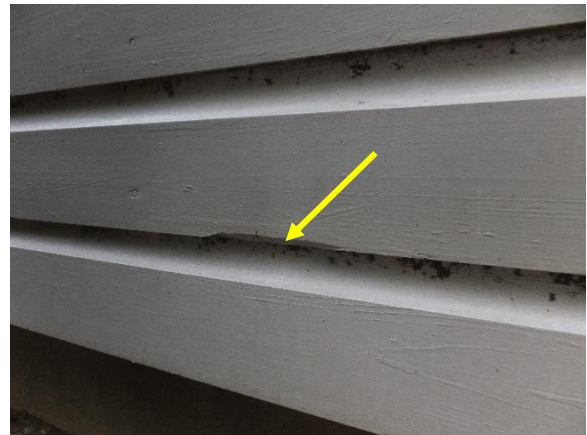
Figure 16. Chipped wood siding at base of siding at northeast facade.

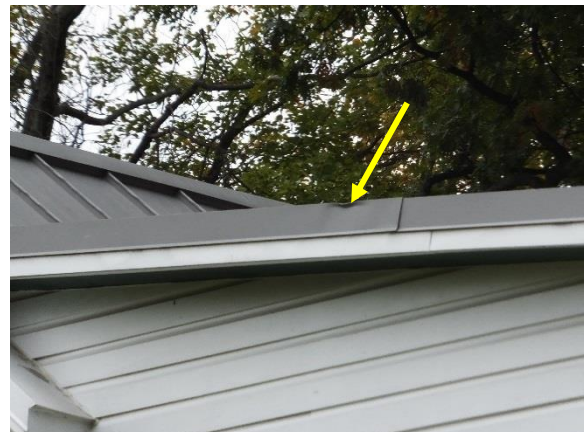
- The metal roofing throughout the home is in good condition with minor areas of soiling such as below gutters (Figure 31).
- A dent and area of displaced metal was observed at the metal coping on the southeast facade (Figure 32 and Figure 33).
- Most downspouts do not have splash pads or extension resulting in the discharged water being deposited close to the foundation (Figure 33 and Figure 34). One downspout was observed to be disconnected at the northwest elevation (Figure 35).

Figure 32. Dent in metal roof coping on southeast facade.

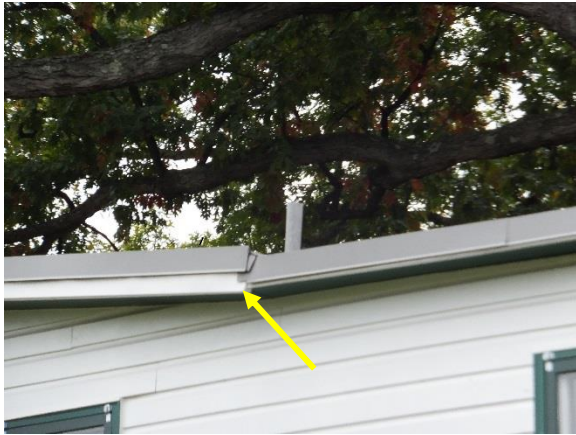
Figure 33. Displaced roof coping on southeast facade.

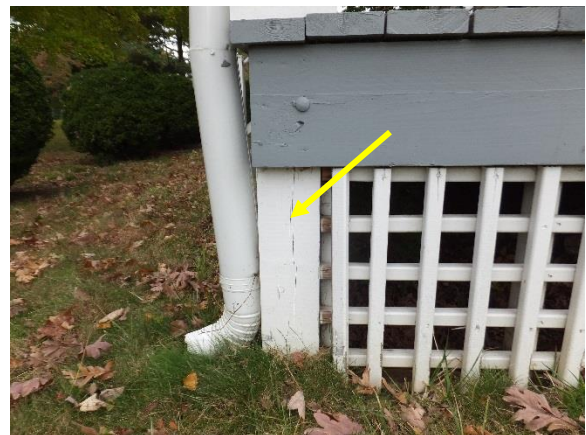
- The porch is generally in good condition with areas of minor deterioration at the door threshold, porch column and porch stairs due to the exposure to the elements. A vertical crack was observed along the base of the southeast porch column (Figure 36). The door threshold was observed to be uncoated (Figure 37) and paint deterioration at the porch stairs resulting in soft wood was exhibited (Figure 38). The decking joists have been replaced in recent years and are in good condition with minor areas of staining (Figure 39).
- The original stone foundation underneath the porch was observed to have deteriorated mortar joints (Figure 40).

Figure 36. Vertical separation (checking) at wood porch column.

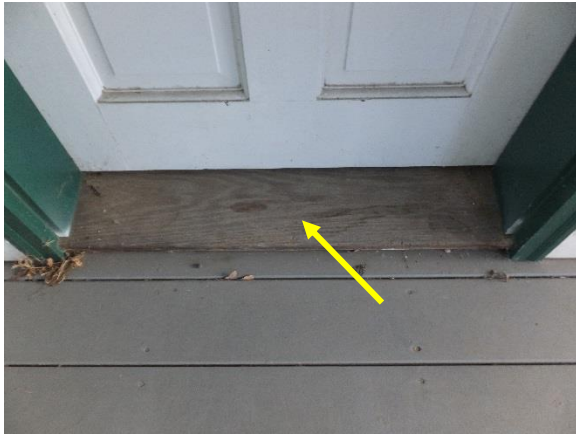
Figure 37. Uncoated wood door threshold at porch with minor areas of splintering.

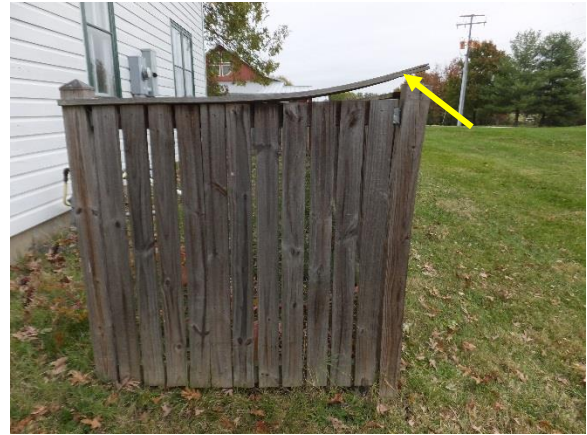
- The wood fence added on the southeast façade is fair condition with areas of multiple cracks, missing areas of wood, and missing rail caps (Figure 41). In addition, as the wood is uncoated, the fence exhibits staining, displacement, and bowing (Figure 42).

Figure 42. Bowed top rail of fence at southeast facade.

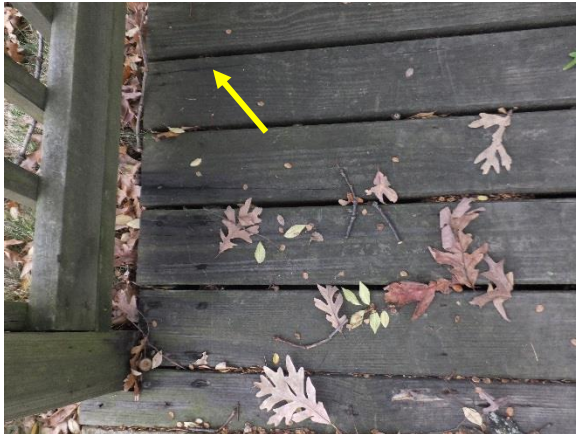
- The wood deck constructed on the northeast facade is generally in good condition with areas of minor deterioration including isolated cracks and wood deterioration due to exposure to the elements (Figure 43).

Figure 43. Multiple areas of splintered wood on wood deck at northeast facade.

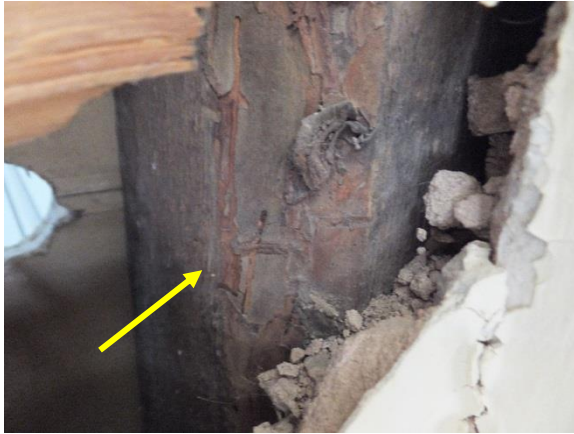
- Isolated areas of damaged plaster and drywall were observed throughout the home including stained and missing finishes likely due to previous water infiltration (Figure 52, Figure 53, Figure 54, Figure 55, Figure 56, Figure 57, and Figure 58). *Note: Although outside the scope of our work, the electrical outlet depicted in Figure 56 is partially exposed and unsecured wire runs through the plaster in Figure 54, which may present substandard electrical work.*

Figure 55. Original timber framing.

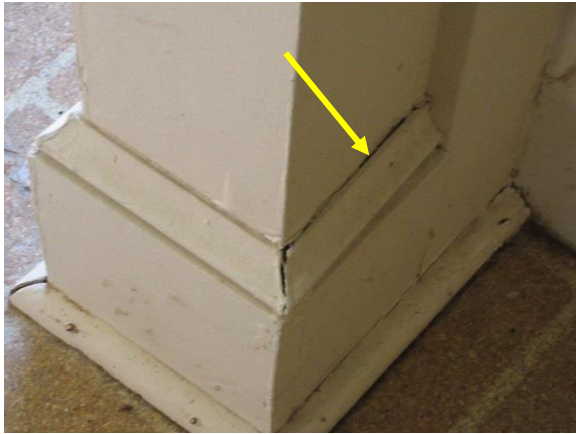
Figure 61. Gap and separation at crown molding, typical.

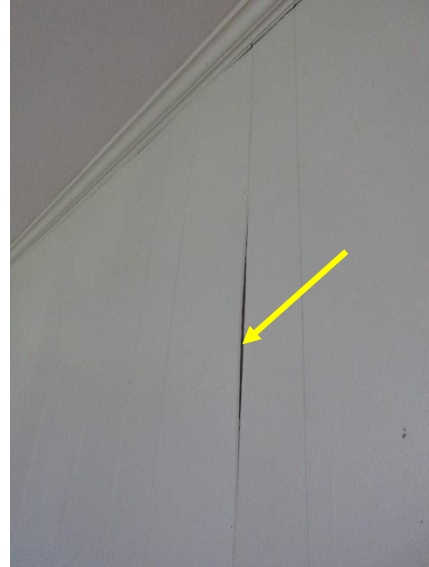
Figure 66. Displaced wood siding panel, typical.

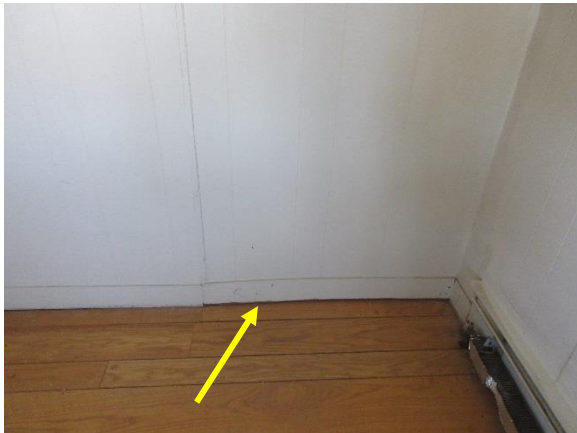
Figure 67. Bowed portion of wood siding panel in Room 210 (office).

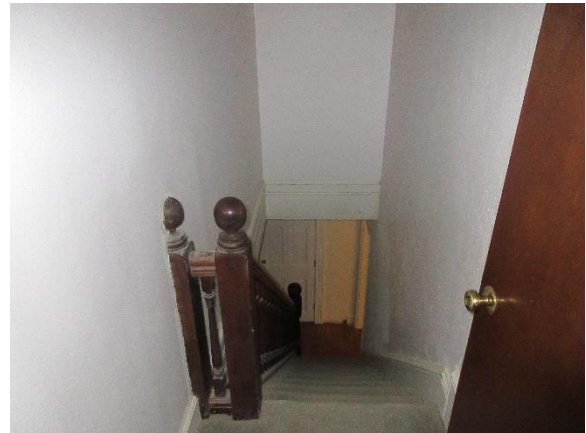
- The historic stairwell and handrail has been enclosed with drywall at the second floor (Figure 68). In addition, drywall installation, as well as exterior siding, has been installed to terminate exterior access for the stairwell located between room 203 (bedroom) and 210 (office) (Figure 69).

Figure 68. Drywall covering enclosing the historically open original stairwell and handrail.

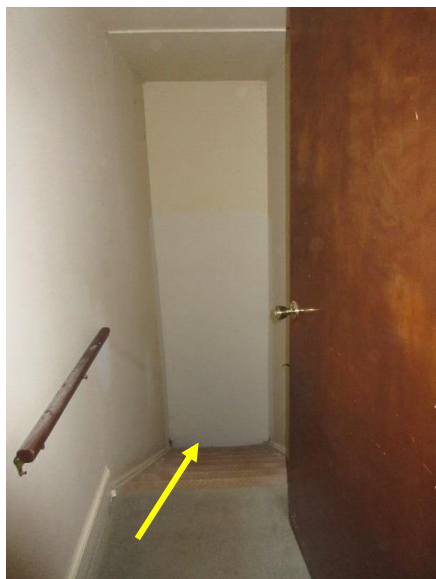
Figure 69. Terminated exterior access of stairwell at D205.

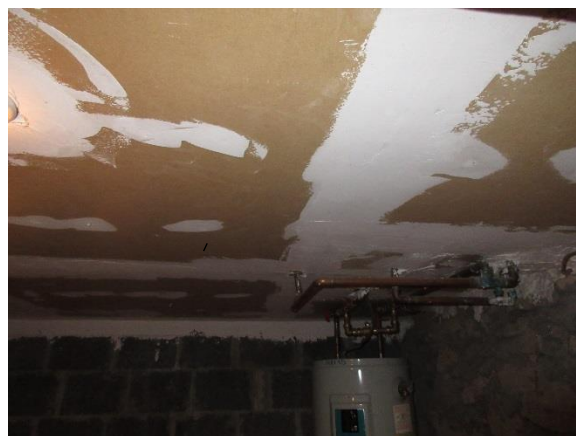
- In the cellar, several pipe penetrations through the drywall were observed. In addition, poor installation of drywall compound was observed between particle board panels and interfaces with foundation walls (Figure 70). Microbial growth is also apparent in isolated areas at the base of the drywall and ceiling (Figure 71 and Figure 72).

Figure 70. Drywall compound installation at gypsum ceiling panels in cellar.

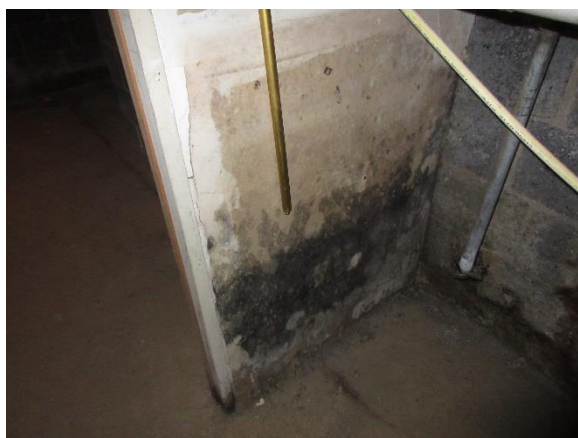
Figure 71. Potential microbial growth at drywall in cellar.

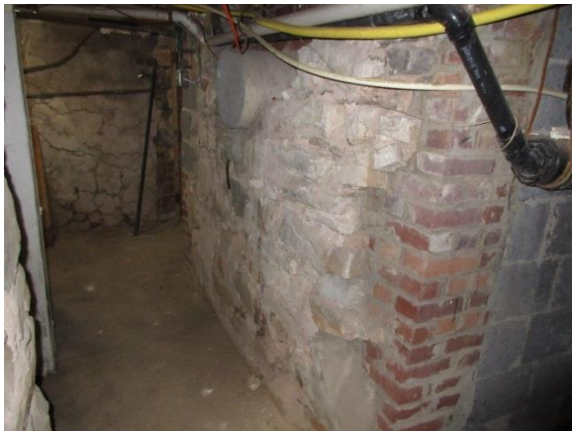
- Interior wall construction throughout the cellar consist of either fieldstone, CMU, concrete, or brick with many areas of the foundation walls covered with drywall. Most of the historic fieldstone is covered in a cementitious parge coat at the interior (Figure 75).

Figure 75. Different types of masonry construction in cellar fieldstone, brick, and CMU.

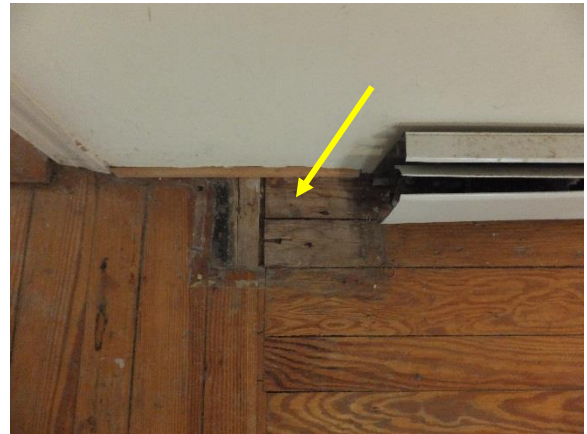
Figure 84. Exposed wood from pre-existing hallway structural elements. Note intersecting floors.
