LAHEY HOUSE Historic Structure Report

Vienna, Virginia

Final Report

WJE No. 2018.0216

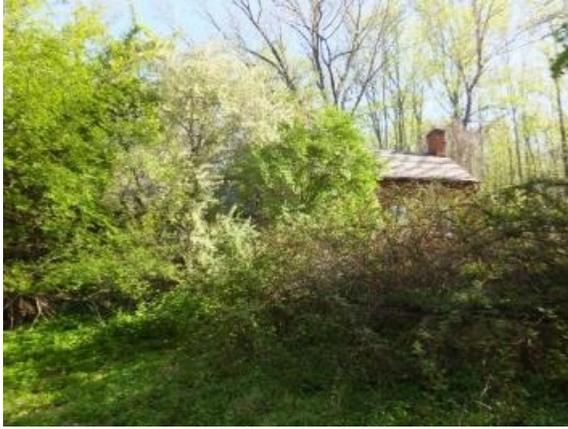
Figure 29. View of the south facade with immense vegetation growth.

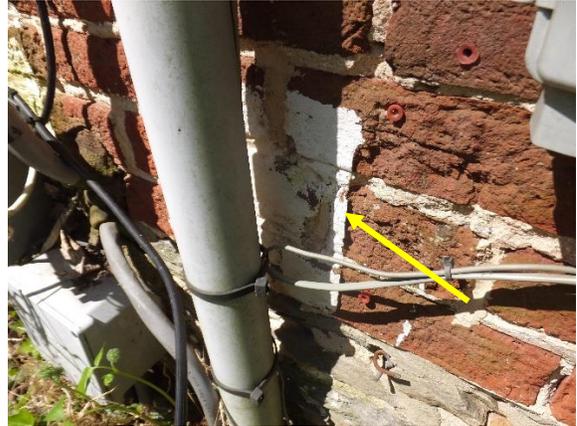
Figure 40. Remnant white coating observed at the east facade behind conduit.

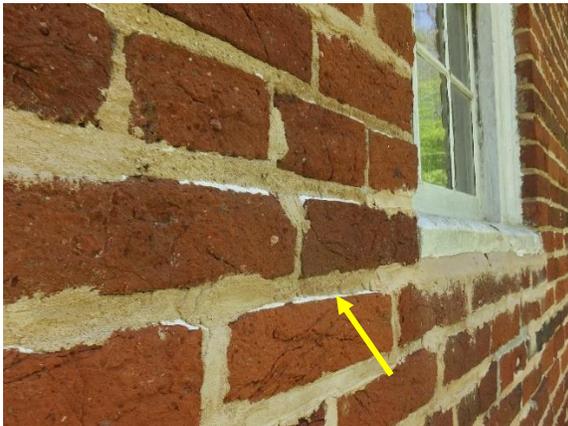
Figure 41. Isolated remnants of white coating observed on the north facade at the exposed brick-to-mortar surfaces.

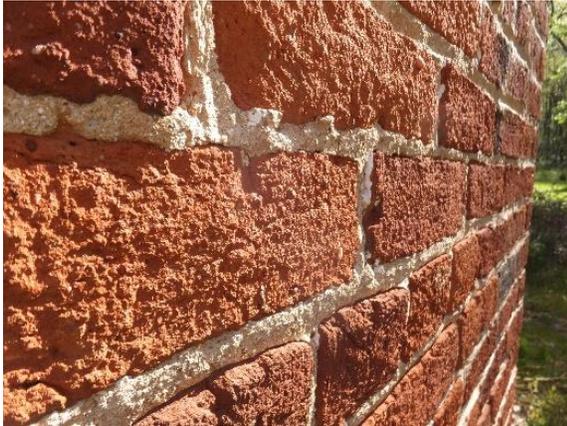
Figure 43. Rough brick and mortar surfaces at the lower brick units on the original section of the house.

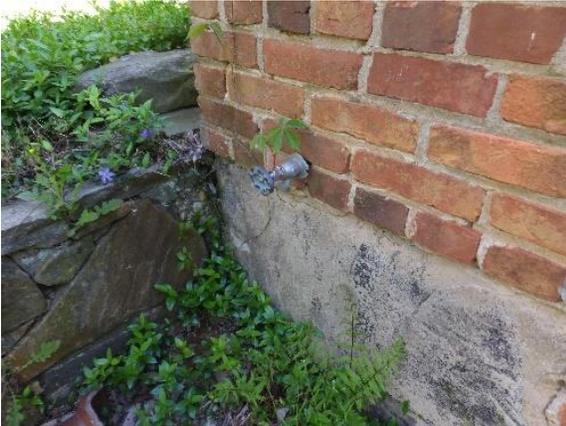
The 1941 addition is also constructed of red brick set in common bond with three stretcher brick courses between each header brick course (Figure 48); however, the addition has a CMU backup wall in lieu of brick. The exterior wythe of brick is set on top of a CMU and concrete foundation. The red brick units at the addition are approximately 8-1/2 inches by 2 inches with tan untooled mortar joints. There is some color variation with some lighter reds. Areas of selective repointing are present throughout the brick facades. The parge coated CMU block foundation was partially observed at the west facade to the north of the ground floor entry door. A black coating can be seen in isolated locations of this foundation, which may have been damproofing that has slowly degraded with UV exposure (Figure 49). There are utility

Figure 49. Exposed parged CMU foundation at the west facade.

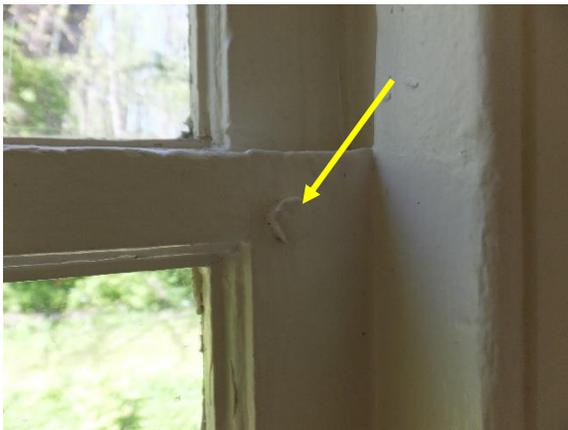
All of the double hung windows have been painted and secured shut, and no hardware (such as sash locks) was observed. The windows have approximately 1/8 inch thick wavy glass and 9-1/4 to 9-3/4 inch deep wood stools (Figure 59 and Figure 60). The number of glass lites per sash of the double hung windows are the same today as what was photographed in 1940 and 1941.

Figure 59. Sashes secured together at the interior.

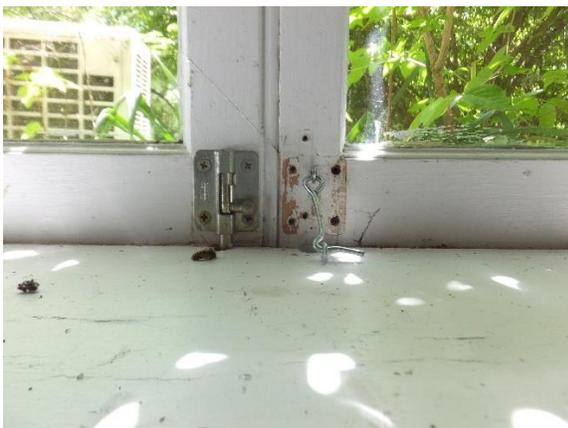
original house are present in the addition (Figure 65). There is paint shadowing near latches where different hardware may have been previously located. Some of the barrel locks securing the casement leaves to the stool have been removed.

Figure 65. Contemporary barrel lock and hook added to the bottom of casement windows.

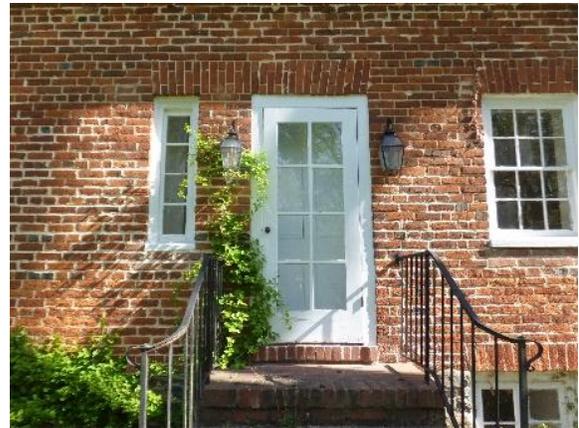
The door at the south facade is slightly off center to the east and is a white painted wood 4-paneled door with wood threshold (Figure 76 and Figure 77). This door appears to be the same one captured in photographs of the house in 1940 and 1941. The door knob and other hardware has been removed, and the keyhole has been painted shut. The 8-lite storm door has a round metal knob that is 1-3/4 inches in diameter (Figure 78).

Figure 76. 4-paneled door at the south facade with glass lite storm door.

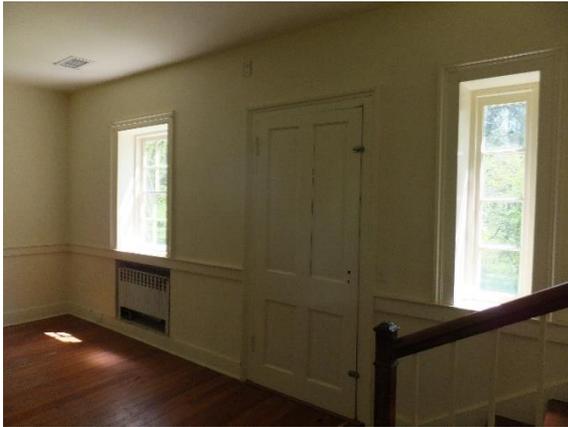
Figure 77. Interior view of the 4-paneled door in the Hall.

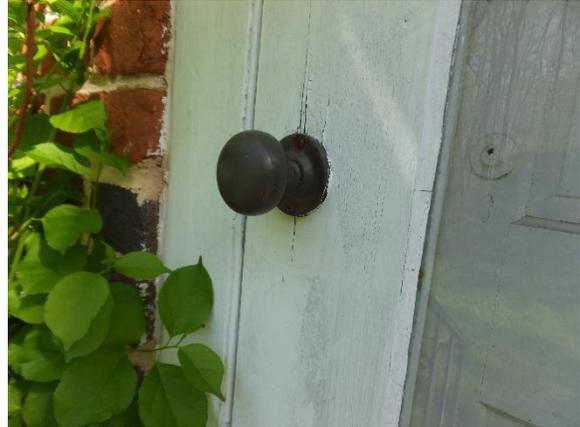
Figure 78. Typical metal knob at the exterior of storm doors.

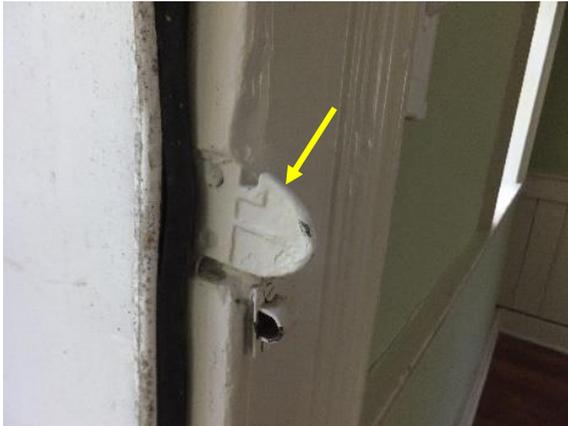
There are two board and batten bead doors, both located on the north facade. The doors have 8-lite storm doors with typical 1-3/4 inch diameter round metal knobs at the exterior and lever handles at the interior. Most of the exterior hardware on the board and batten bead doors has been removed; only a metal catch and thumb latch remain at the east door (Figure 79, Figure 80, and Figure 81).

Figure 79. Metal catch remaining at trim in Parlor. Note added hasp for barrel lock.

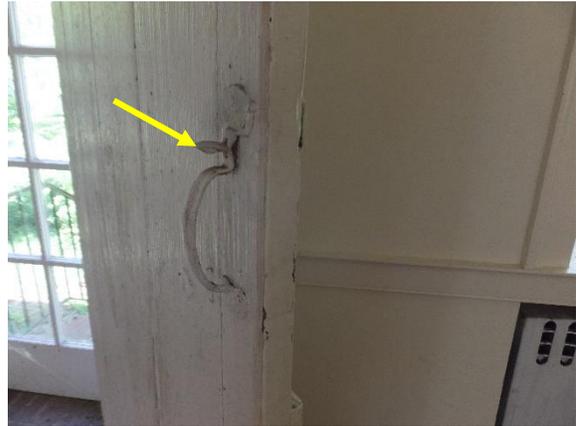
Figure 80. Thumb latch and handle remaining in Hall.

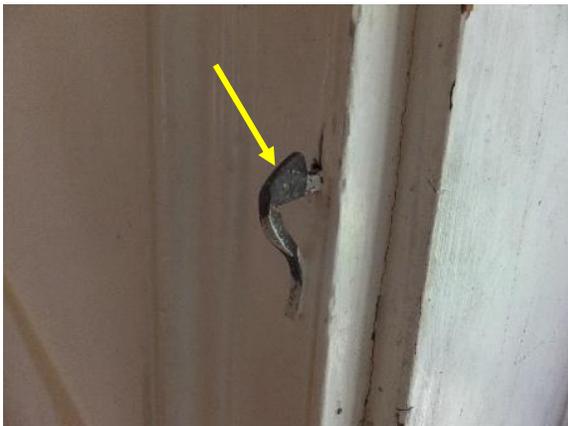
Figure 81. Metal catch remaining at trim in Hall.

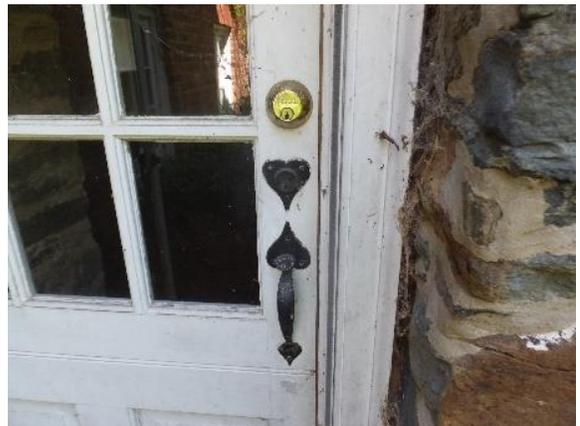
Figure 82. Typical exterior hardware at dutch doors.

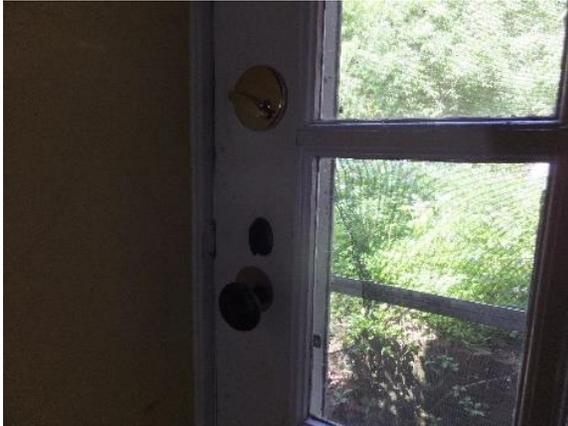
Figure 83. Typical interior hardware at dutch doors.

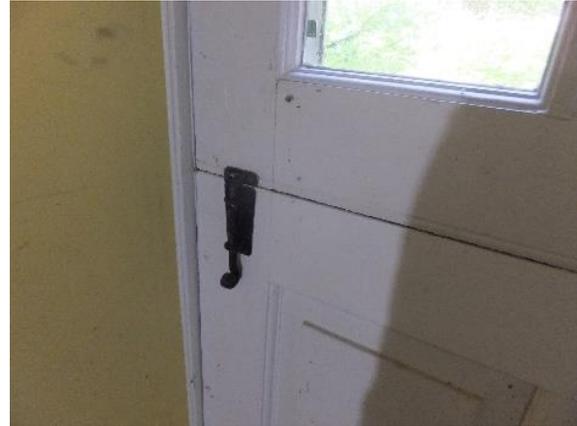
Figure 84. Typical interior door hatch at dutch doors.

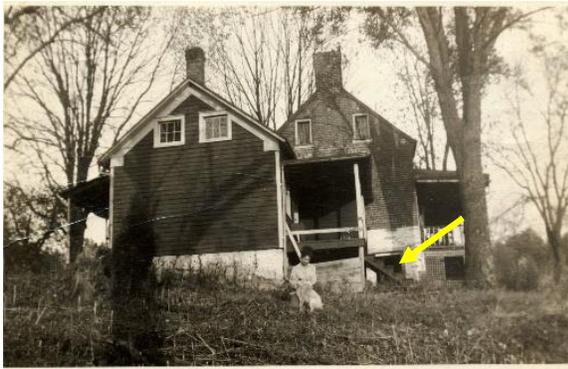
The door at the west facade enters into the cellar and is set in the stone foundation wall with a large timber lintel 4-1/4 inches tall and 7-1/2 inches deep. This door is a 9-lite and two paneled wood dutch door with a wood screen door. The door hardware is a heart shaped lock, thumb latch, and contemporary Schlage deadbolt at the exterior (Figure 83). At the interior the door has a 1-3/4 inch diameter metal knob to open the door from the interior and a sliding bolt to secure the door halves (Figure 84 and Figure 85). The dutch door has 1/8 inch thick plate glass and 1-1/4 inch wide muntins of similar profile as the casement muntins. It appears from historic photographs that this opening was previously a shorter louver, similar to the other cellar fenestration (Figure 85). Therefore, this opening was likely extended into grade by the Laheys during the 1941 addition work.

Figure 85. Photograph ca 1940 with wood kitchen still in place. Note opening in west foundation wall beyond.

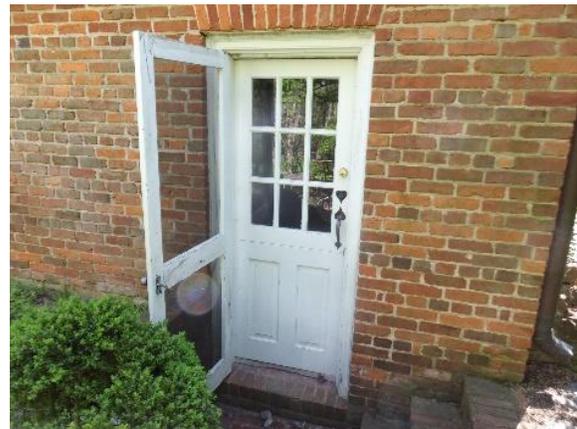
There is one door at the addition, which is located at the ground floor of the west facade. This is also a wood dutch door and is similar to the dutch door at the west facade of the original section of the home (Figure 86). The door is slightly below grade with brick steps leading down to the brick landing and a brick retaining wall that allows for

Figure 86. Kitchen door at the west facade of the addition.

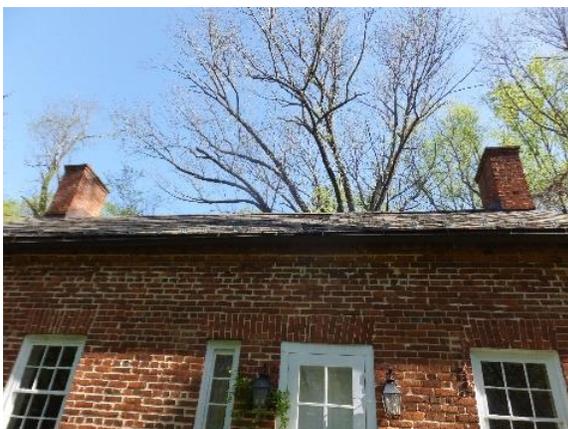
There are two interior end brick chimneys at the east and west gables of the original section of the home and one internal end brick chimney at the west gable end of the addition. The chimney at the addition is wider than the original brick chimneys (Figure 87 and Figure 88).

Figure 87. Interior end chimneys at the original section of the home.

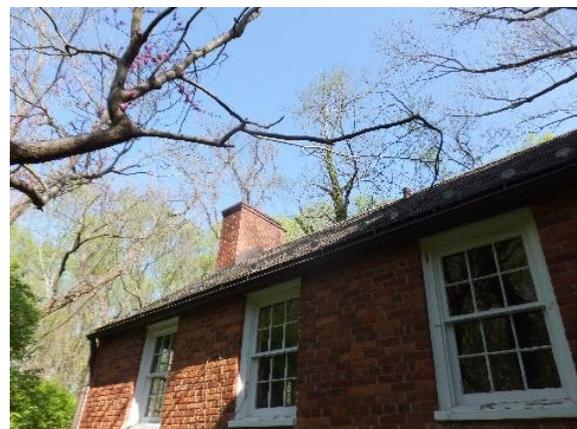
Figure 88. Interior end chimney at the west of the 1941 addition.

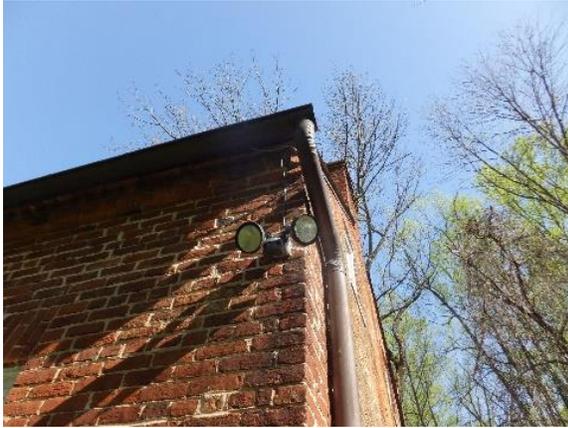
There are several non-original light fixtures at the exterior, which fall into two categories. One type of fixture is a contemporary security light typically installed at the corners of the house with two flood light bulbs (Figure 89). The other type is a non-original black metal and glass carriage wall sconce, which are located near doors at the original section of the home (Figure 90).

Figure 89. Typical security lights installed at corners of the home.

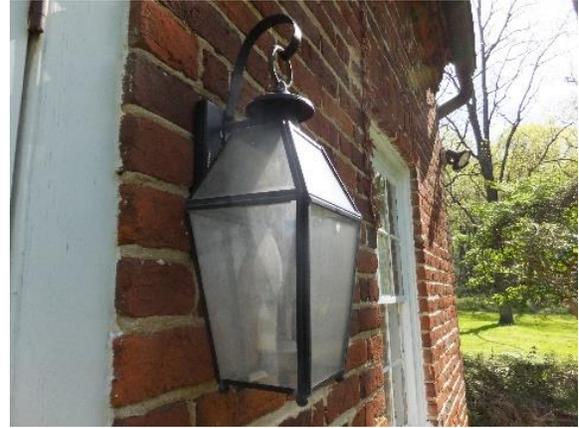
Figure 90. Typical metal and glass light fixtures adjacent to doors at the original section of the home.

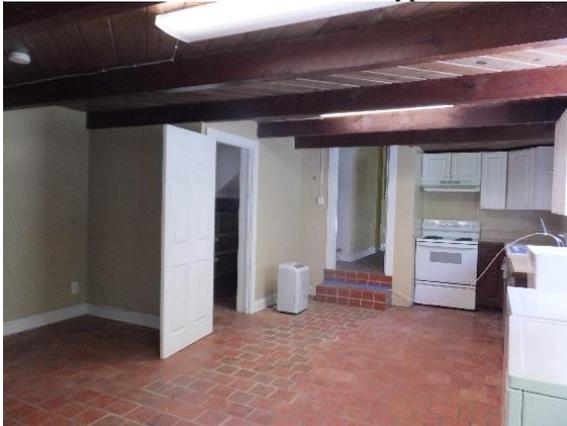
Figure 92. View into the kitchen from the west entry door.

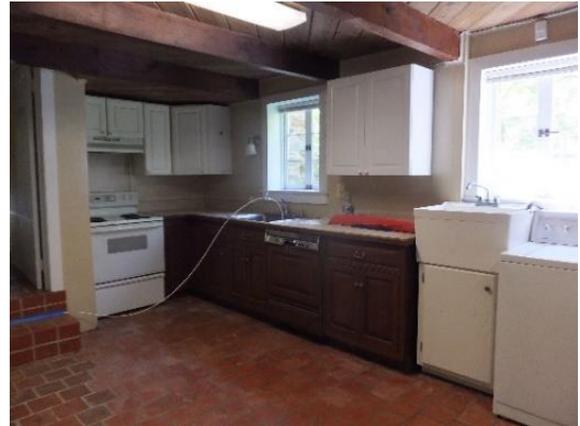
Figure 93. Cabinetry and plumbing located at the south wall of the kitchen.

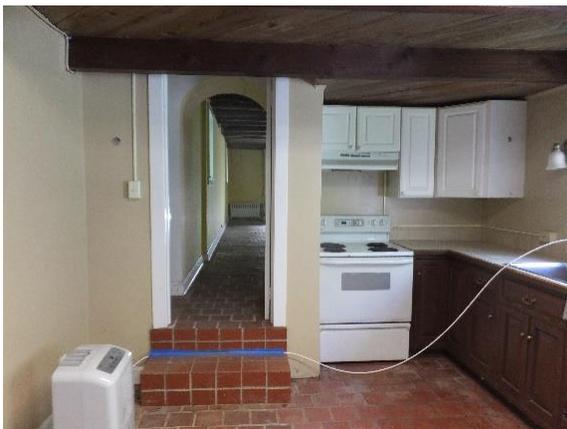
Figure 94. Arched entryway leading to the 1st floor stairs at the north and cellar beyond.

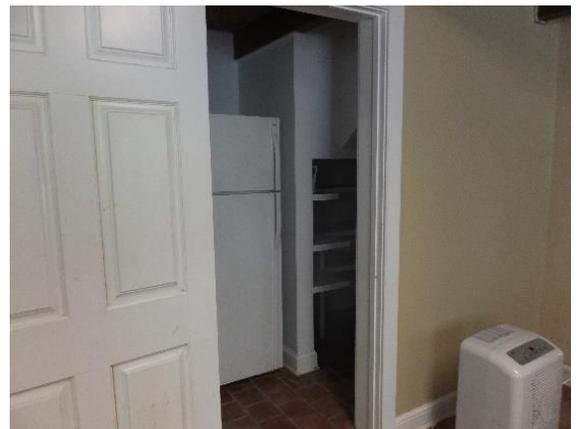
Figure 95. Pantry area in the kitchen.

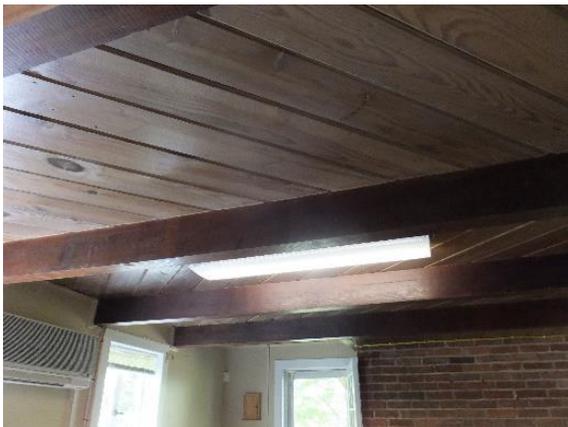
The kitchen floor has 6-1/2 inch square red clay tile with gray mortar joints that extend up the steps and landing at the east end of the room (Figure 104). Stair tread space is 1 foot deep and riser is 7-1/4 inches high. There may have been some replacement tiles between the steps and fireplace as the mortar joints in this location are wider and tiles are more varied in color than the rest of the tile. Sections of tile are missing in the utility closet as previous utilities have been removed that left the concrete slab exposed (Figure 105).

Figure 105. Area of removed utilities allowing the concrete slab to be exposed.

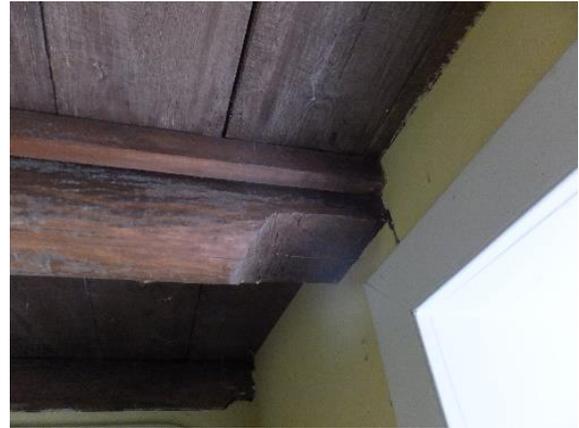
Figure 122. Exposed 3/4 round floor beams run north-to-south. Note shadowing adjacent to beams.

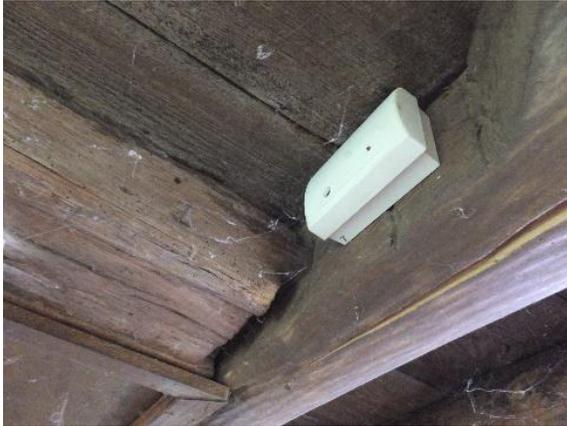
occurred, which penetrates through the beam and tenon from adjacent wood member (Figure 125 and Figure 126). The hole drilled at the south is 3-1/2 inches deep and the hole at the north is 3-3/4 inches deep. The drilling is not present at the west fireplace framed beam; however, there are several nails in a beam that correlates with a split in the beam. The sixth, seventh, and eighth 3/4 round floor beams, when counted from the west, are supported by a t-shaped 4-3/4 inch square wood post (Figure 127). The post sits atop a 1-foot and 9-1/2 inch wood plate set on the clay tile floor. Most of the 3/4 round floor beams in the cellar have splits, which occur the majority or full length of the beam. The eastern most floor beam has a retrofit piece of a nominal 2-inch thick wood member installed between the beam and subfloor wood planks that corresponds with a high spot near the fireplace in the hall (Figure 128).

Figure 125. Drilled beam location through tenon connection.

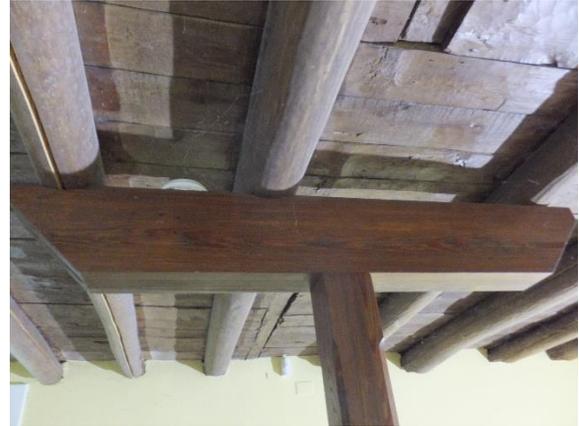
Figure 126. 3/4 round beam and interfacing tenon connection.

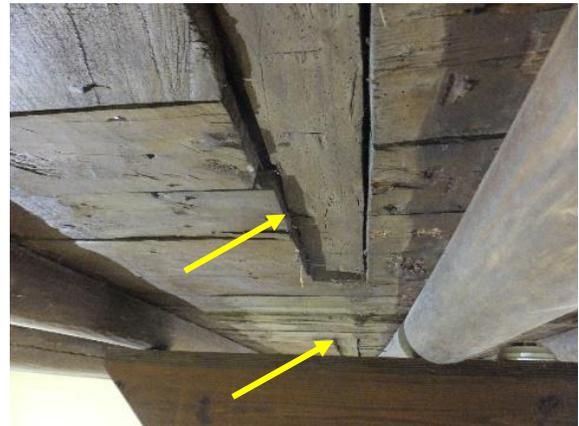
Figure 128. Retrofit of wood member between beam and subfloor.

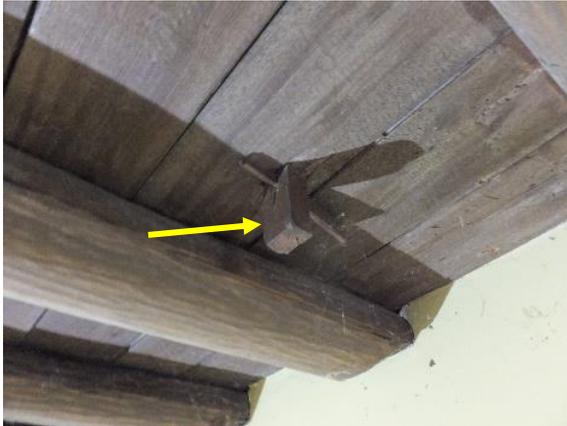
The wood plank subfloor for the hall is visible and runs east to west. Two areas of cut subfloor are located between the sixth and seventh beams (counted from the west). The subfloor cut areas measure 5 foot 7 inches long and 4-1/4 inches wide. These subfloor interruptions correspond with the interior wall between the hall and parlor rooms at the first floor (Figure 129). In addition, there is a wood peg and wood section penetrating the subfloor at the south end of the room between the seventh and eighth beams; this corresponds with the newel post in the hall (Figure 130). The newel post appears to be an original newel post as the mirrored newel post in the parlor room does not have the same base/peg anchorage and appears newer. The newel post base measures 4-3/4 inches tall, 2-1/4 inches wide, and 1-1/2 inches thick. No other interruptions or previous repairs in the subfloor that would indicate an original point of conveyance between the cellar and first floor were observed. This suggests that the cellar was either only accessible from a door at the exterior (southwest corner) or was possibly originally only a crawl space. The current stairwell between the ground floor and the first floor is located just west of the original west stone

Figure 129. Interruptions of subfloor that correspond with interior wall between the hall and parlor.

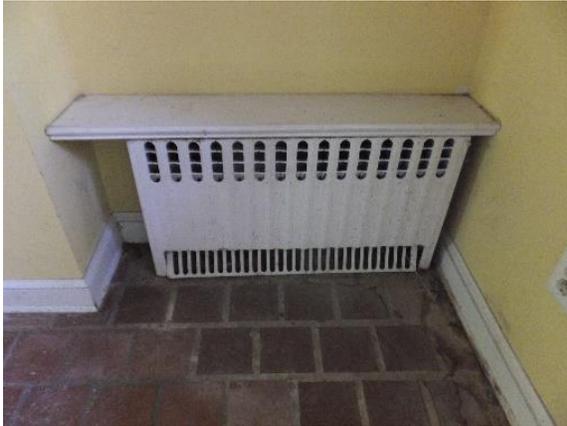
Figure 136. Radiator below shelving.

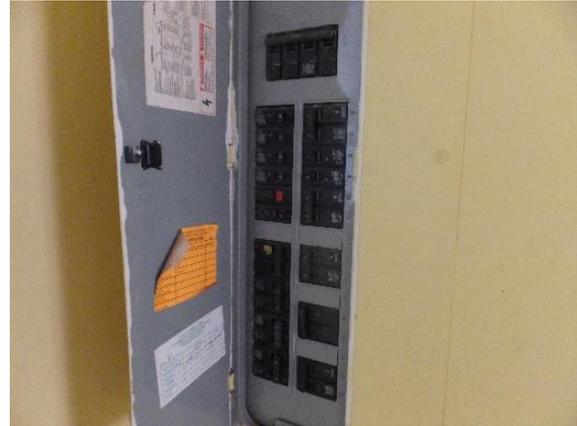
Figure 137. Electrical panel at the east wall.

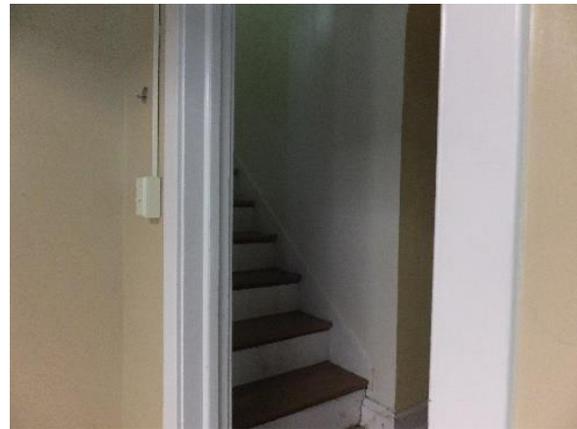
Figure 139. View into the first floor stairwell from the kitchen.

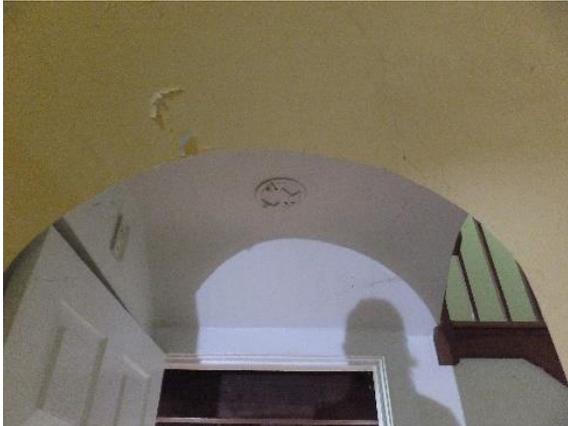
Figure 140. Barreled ceiling at the ground floor.

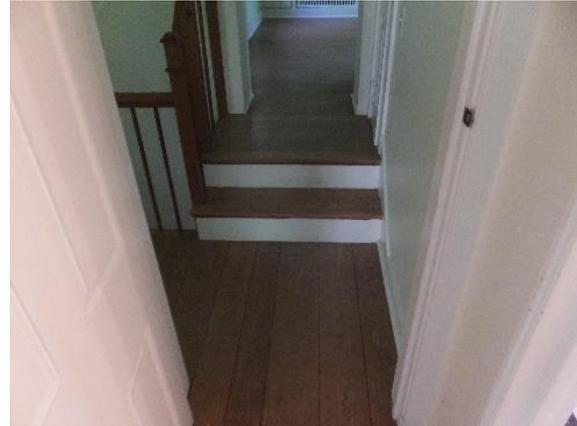
Figure 141. Transition from the 1941 addition to the original section of the home (top of picture) via steps.

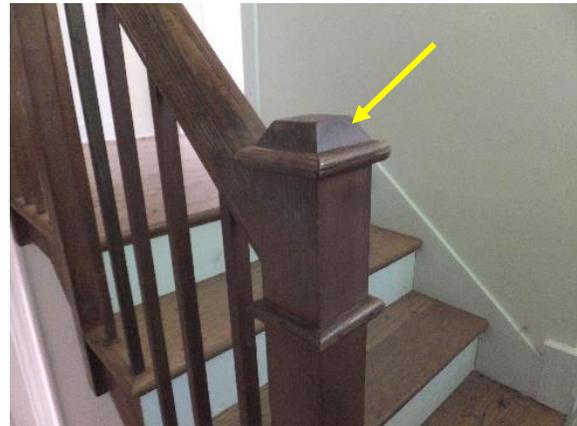
Figure 143. Detail of corner post that emulates an original post found in the hall.

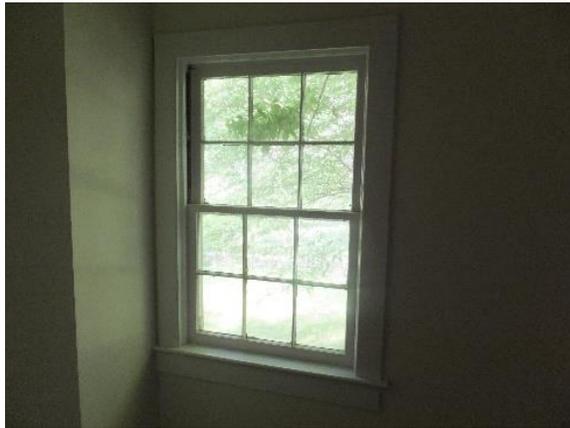
Figure 144. Window along the north wall of the stairwell.

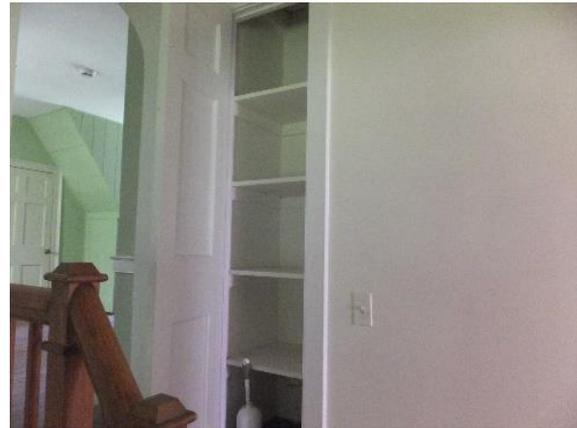
Figure 145. Shelving in the linen closet.

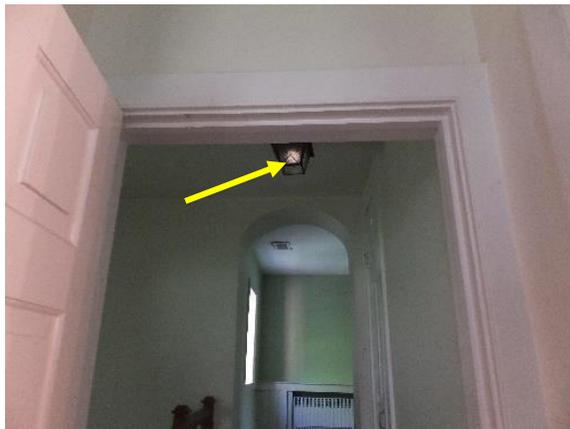
Figure 146. Ceiling mounted light fixture.

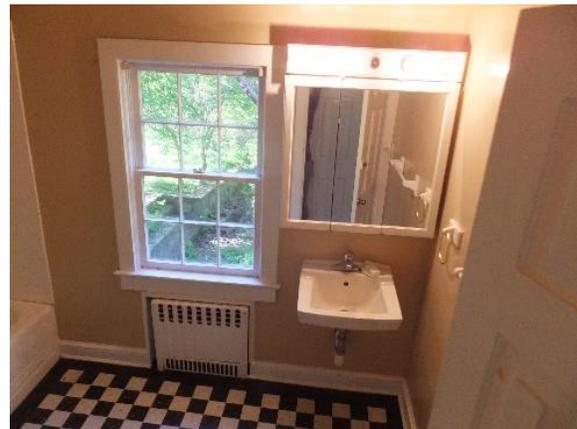
Figure 147. View into bathroom looking south.

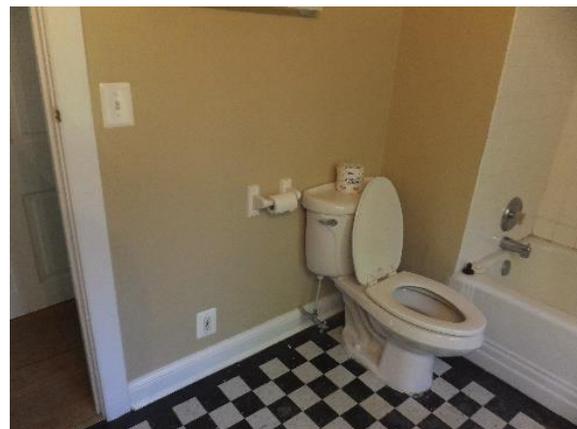
Figure 149. North wall of bathroom.

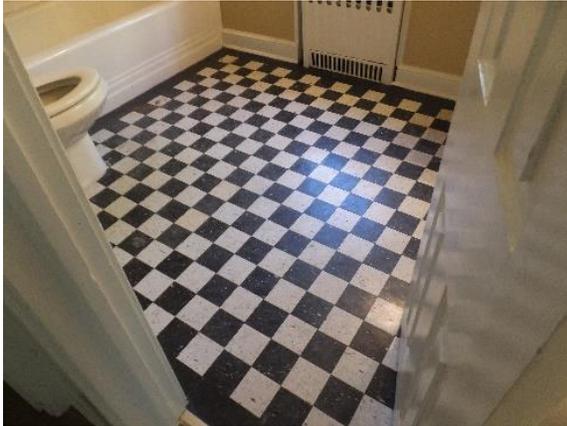
Figure 150. Checkerboard linoleum tile.

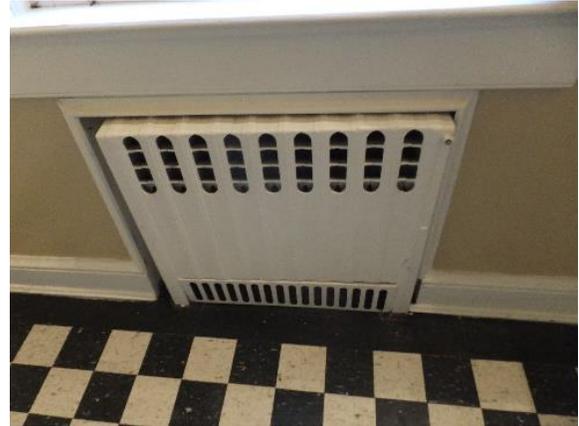
Figure 151. Radiator below the window built into the wall. This configuration is typical in the 1941 addition at this level.

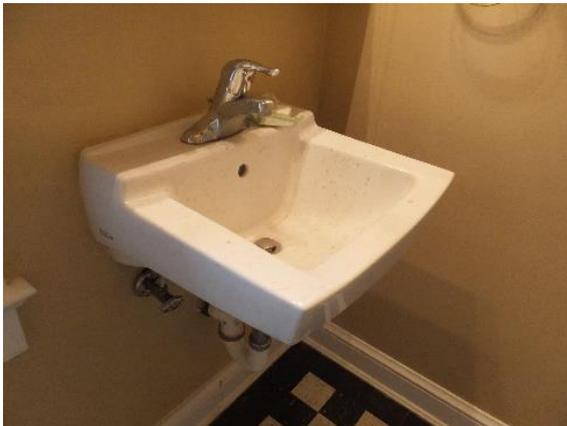
Figure 152. Non-original wall-mounted sink.

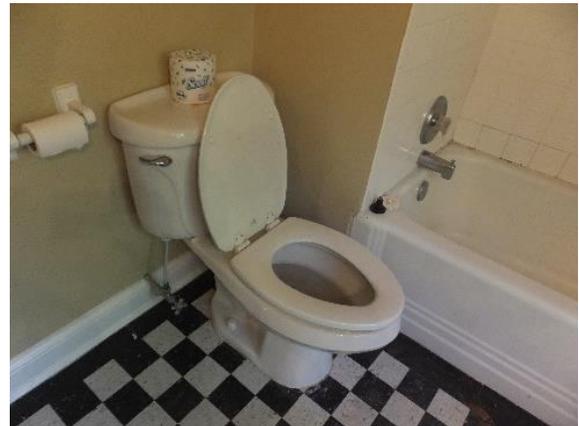
Figure 153. Non-original toilet.

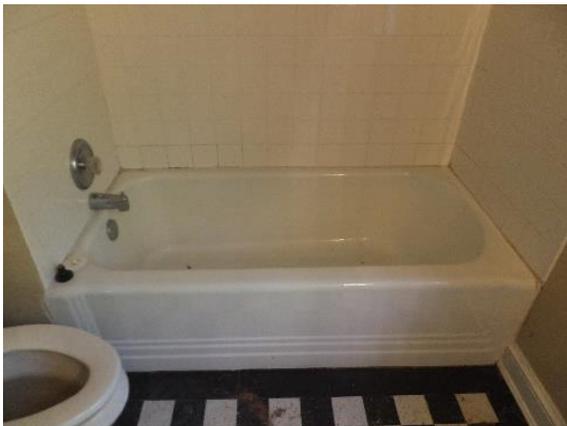
Figure 154. Tub and white square wall tiling.

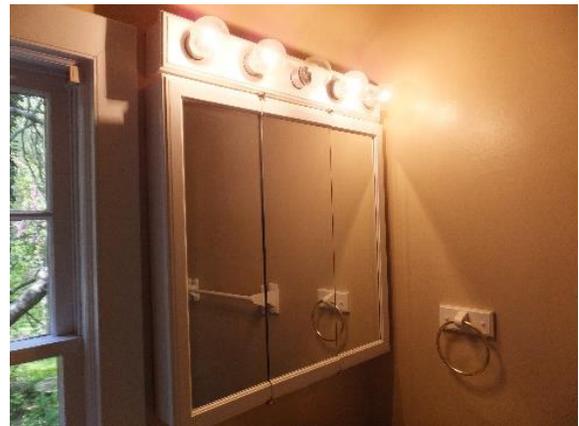
Figure 155. Non-original medicine cabinet.

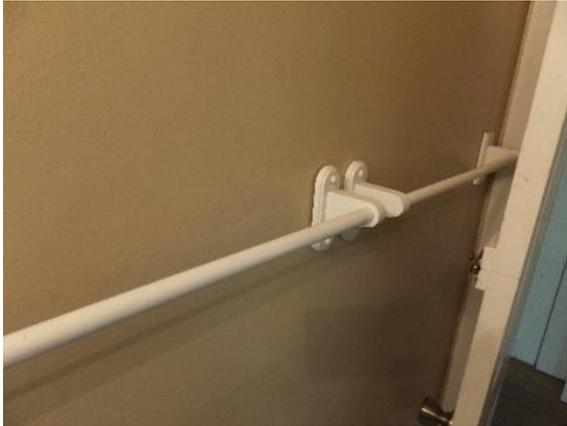
Figure 156. Towel bars at the west wall.

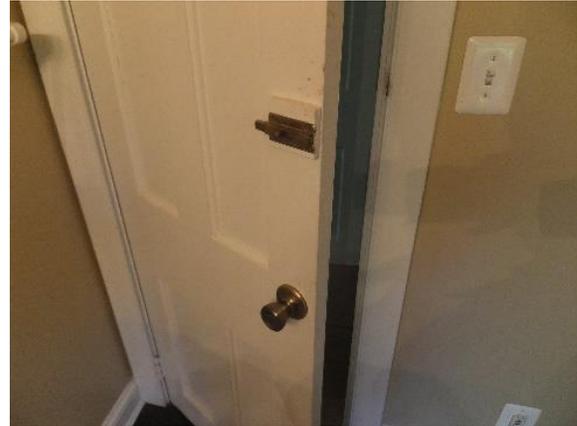
The 1-3/8 inch thick door is 6-paneled with no hardware at exterior, but a slide latch at the interior and a replacement pull knob (Figure 157).

Figure 157. Interior side door hardware.

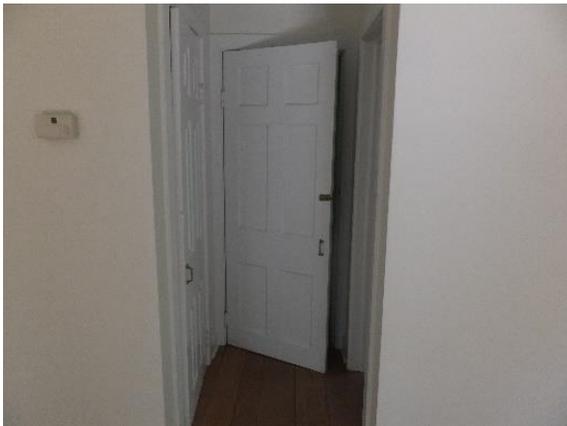
Figure 158. Door leading between the stairwell and living space.

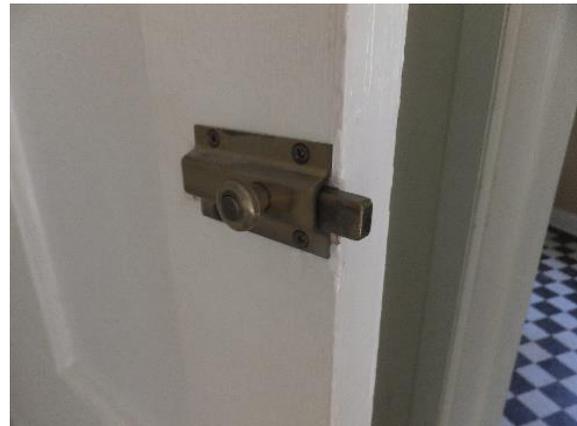
Figure 159. Bolt latch hardware on interior side of door.

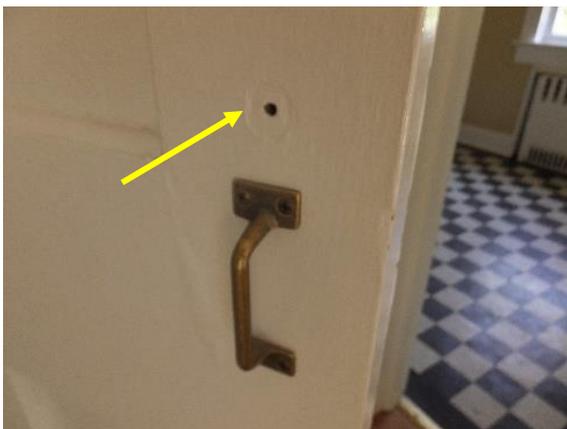
Figure 160. Typical pull handle on interior side of door with hole from other removed element above.

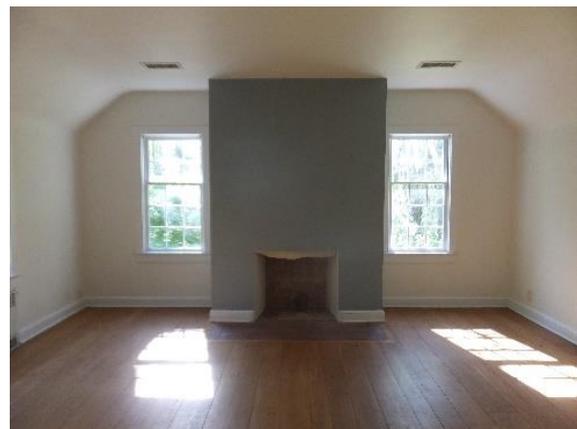
Figure 161. Viewing west into the living space.

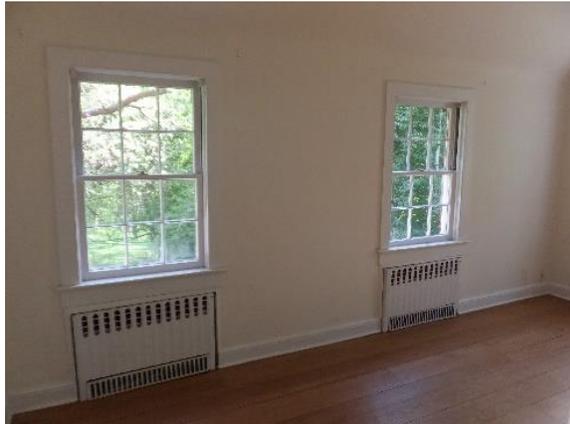
Figure 162. South wall of living space.

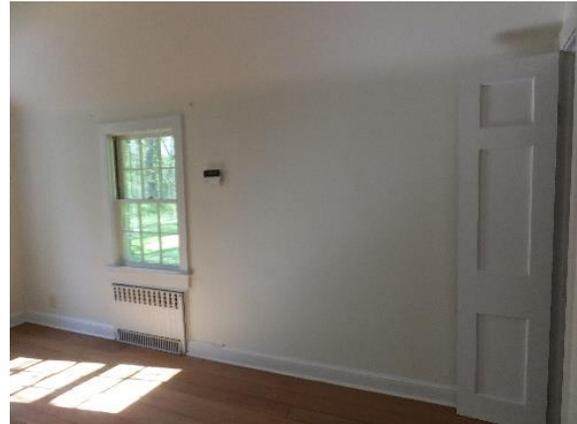
Figure 163. North wall of living space.

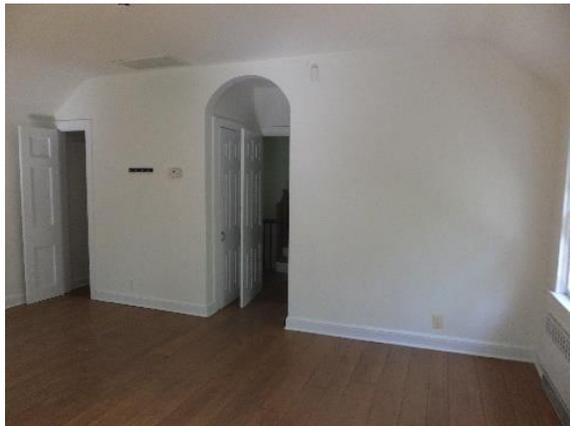
Figure 164. East wall of living space.

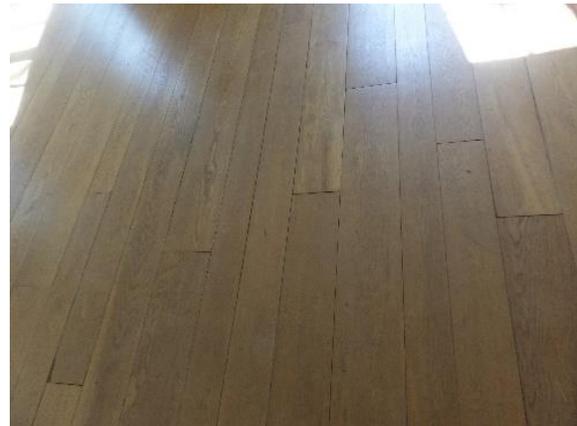
Figure 165. Wood floorboards in living space.

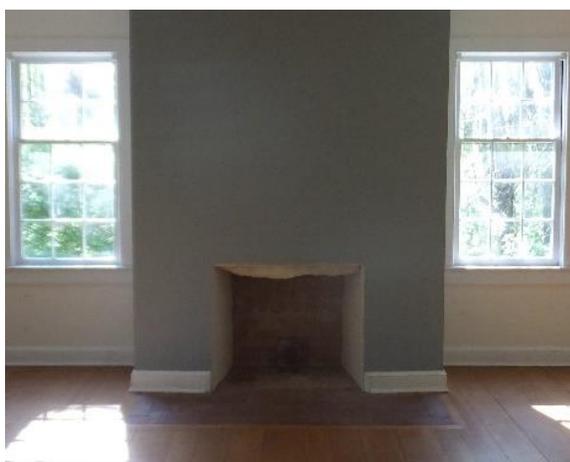
Wood floorboards in this room run east-to-west and are of varying widths, ranging from 5 to 8 inches (Figure 165). The fireplace at the west wall is simple with a parged finish. The firebox and hearth are brick masonry with a parge coating applied to the interior sides (Figure 166).

Figure 166. Parged fireplace centered at west wall.

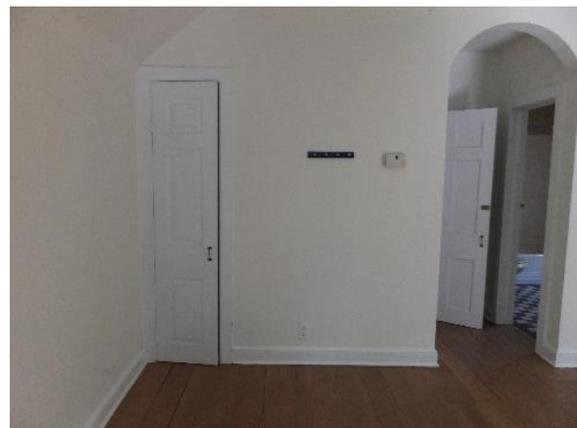
Figure 167. One closet located at the east wall.

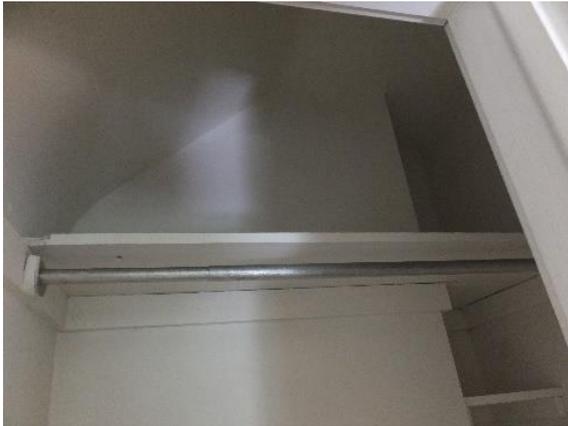
Figure 168. Interior of closet.

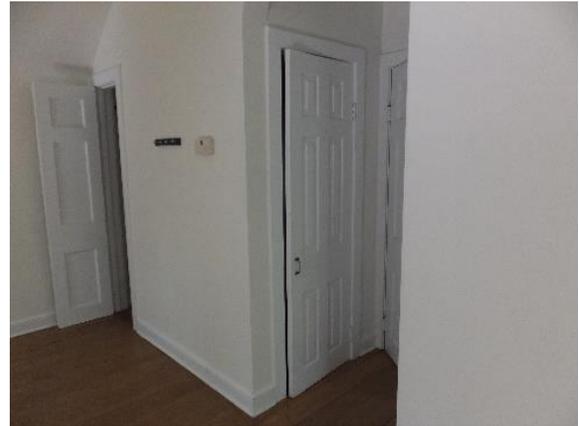
Figure 169. View of both closets from the southwest of the living space.

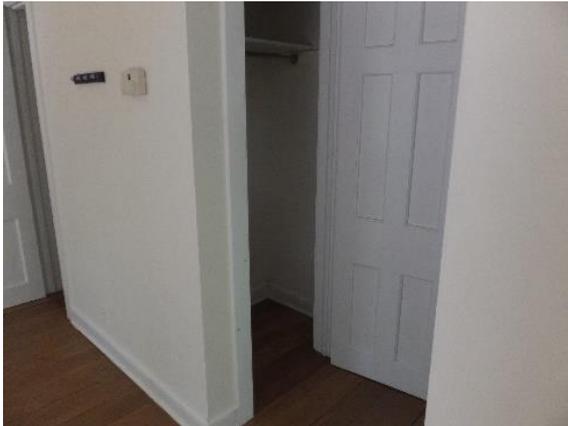
Figure 170. Interior of second closet.

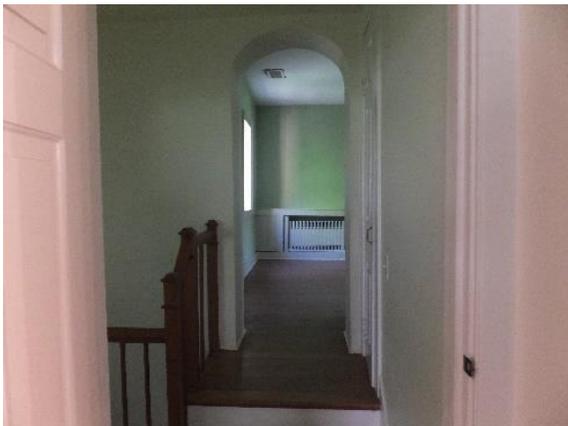
Figure 172. View into first floor stairwell and arched entryway to parlor.

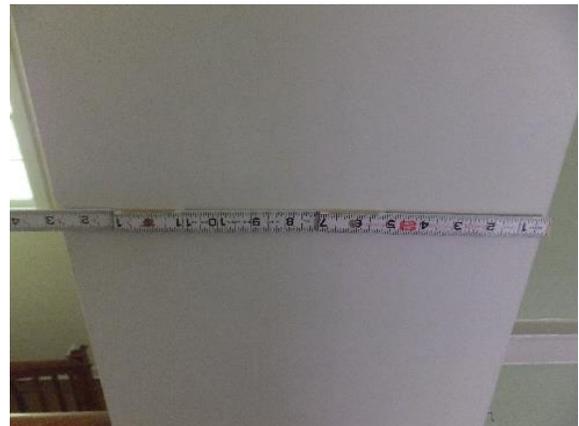
Figure 173. The entryway is cut through the original brick exterior west wall and is 14-3/4 inches thick with interior finishes.

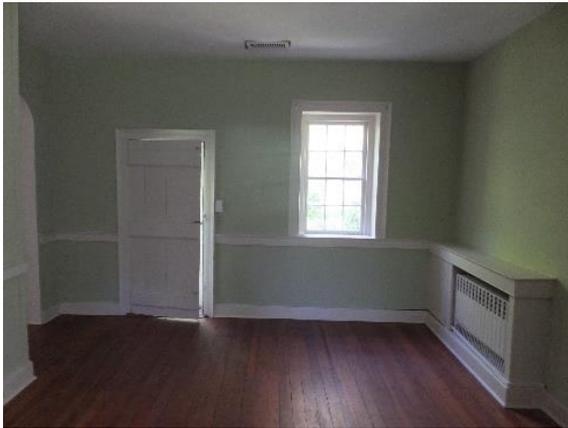
Figure 174. View of north wall in parlor.

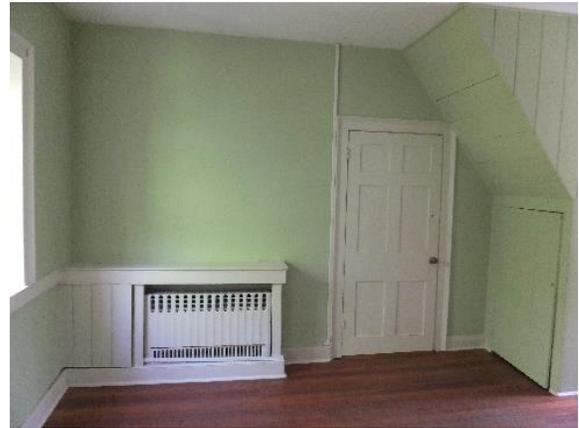
Figure 175. View of east wall in parlor.

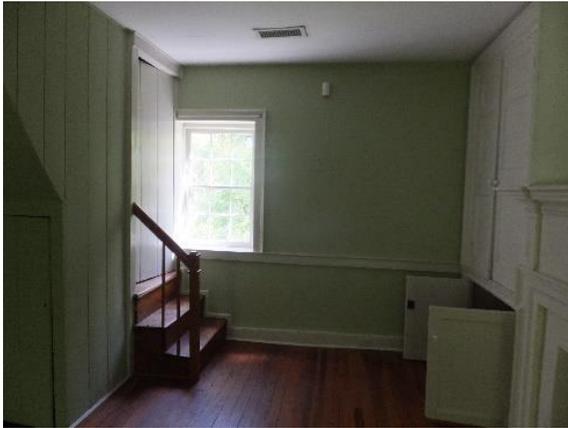
Figure 176. View of south wall in parlor.

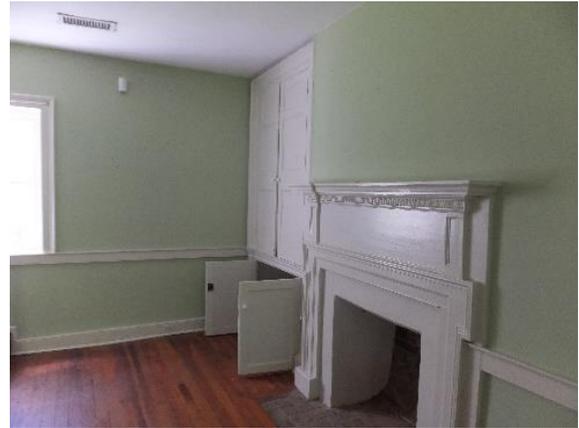
Figure 177. View of west wall in parlor.

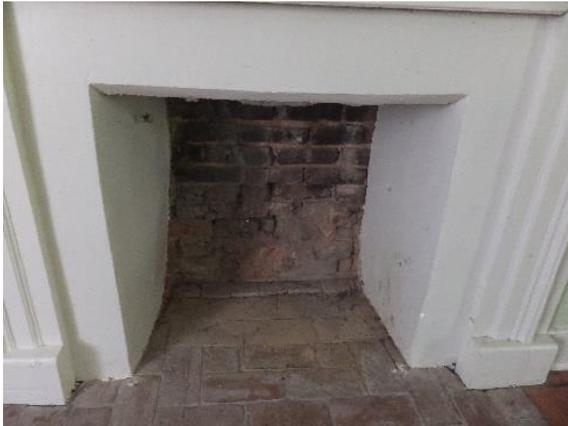
An ornate wood mantel and surround frame the fireplace (Figure 178 and Figure 179). There is a parge coating on the sides of the brick masonry firebox, similar to what was observed in the living space, which was likely an alteration performed by the Laheys (Figure 180). The surrounds of the fireplace are ornamented to reflect paneled pilasters with the mantel being a Federal Style influence with interlocking ribbed coursing directly below the mantel (Figure 181).

Figure 180. Parged sides of firebox.

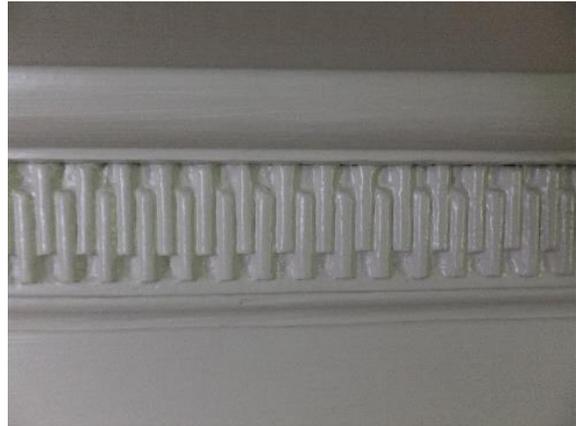
Figure 181. Close up view of detail below mantel.

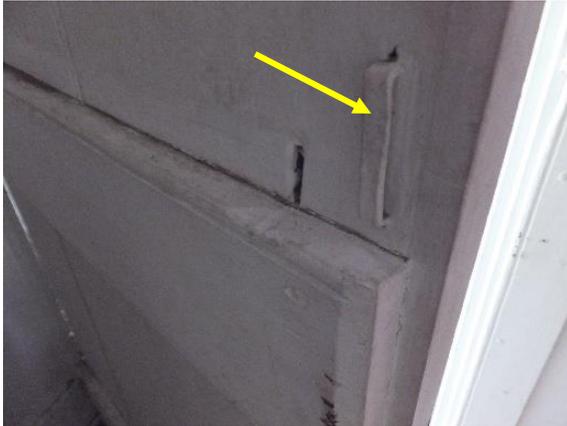
The 3/4 inch thick door has a replacement contemporary pull door knob and a key hole that is mostly painted over; on the stairwell side there is a receiver remaining from a previous lever latch (Figure 189 and Figure 190). The wood steps leading to the first floor landing are 10-1/4 inches wide, have 3/4 inch thick treads, and the risers are 7 inches tall. The handrail has square spindles spaced 4-1/2 inches o.c., and the 3-inch square newel and corner posts have the same ornate toppers as in the first floor stairwell (Figure 191). The handrail is curved at the top with beaded profiling below the curve and at the bottom of the rail. The handrail is 2-1/4 inches tall and 2-1/4 inches wide at the top. Given the less aged condition of the handrails, newel posts, and wood treads, along with differences in step dimensions and different style of stairwell door in this room in comparison with the hall, it is likely this entry to the stairwell was added during the Laheys 1941 addition. In addition, there is a wood threshold at the stairwell entry door in the parlor, but not the hall.

Figure 190. Interior side of stairwell door with strap for thumb latch lever remaining.

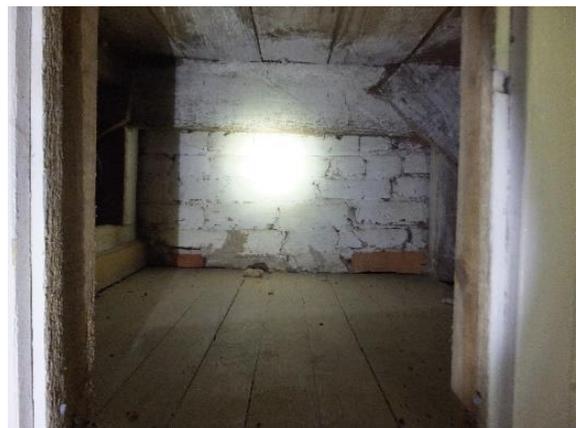
Figure 195. View into area below the stairs. Note white coating on south wall brick.

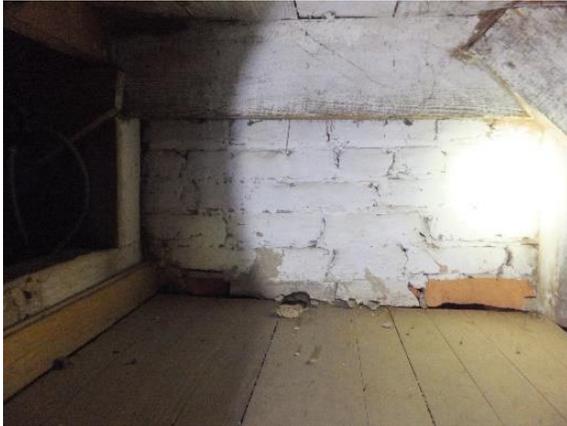
Figure 196. White coating on south wall brick and continuation of wood floorboards.

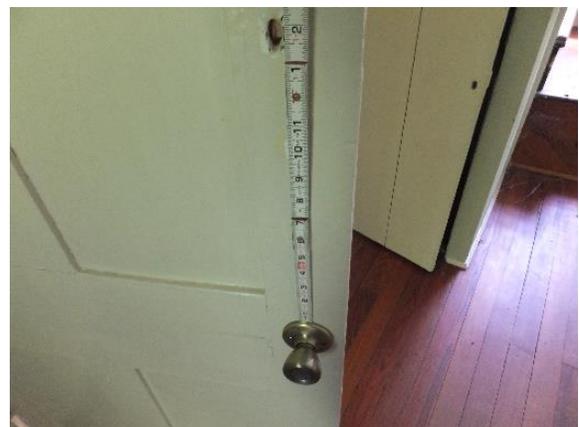
Figure 201. Contemporary pull knob added below key or hardware hole.
