LAHEY HOUSE Historic Structure Report

Vienna, Virginia

Final Report

WJE No. 2018.0216

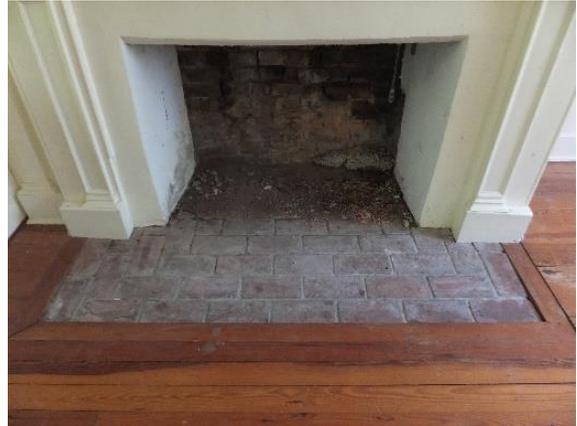
firebox is brick masonry with parged sides and a brick hearth, similar to the parlor (Figure 209). A typical damper pull handle is present (Figure 210). The hall has a built-in cabinet to the north of the fireplace that is similar to the cabinet in the parlor. The cabinet has the same pilaster design; however, the pilaster ornamentation extends the full height of the cabinet rather than just being present at the lower section (Figure 211 and Figure 212). Both of the upper doors are missing, but the hinges remain, and one of the lower doors has become detached and is laying on the floor. The wood flooring that originally continued into the cabinet space has been removed between the doors and the wall, exposing the subfloor. The interior wall near the floor has also been cut to accommodate utilities (Figure 213). The hardware present on the lower cabinet doors is similar to that observed on the parlor cabinet (Figure 214). The trim around the shelving is similar to the trim at the fireplace.

Figure 209. Parged sides of brick firebox. Note brick hearth.

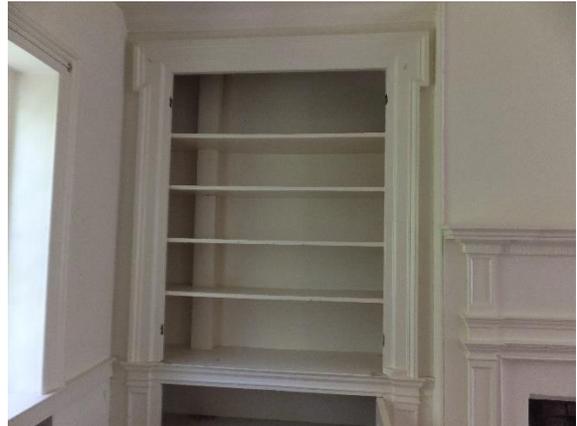
Figure 211. Built-in cabinetry to the north of the fireplace. Note missing upper doors.

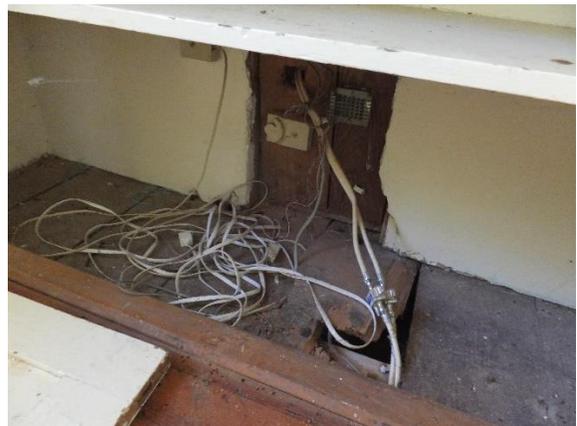
Figure 213. Interior finishes cut at east wall to accommodate wiring.

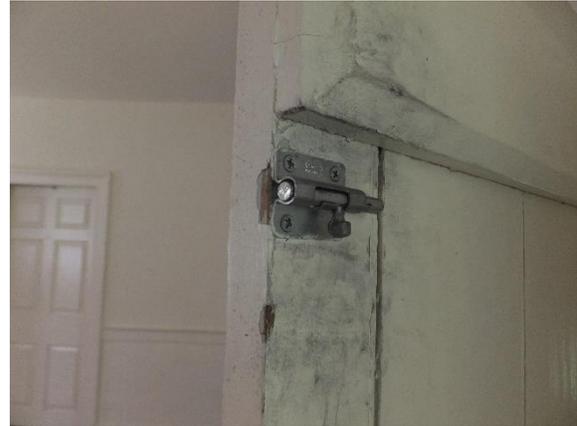
The north exterior door is a board and batten 1-1/8 inch thick bead door similar to the parlor door at the north wall. The interior hardware has been removed and two contemporary barrel locks have been added to secure the door from the interior (Figure 215). The door has two large 6-inch tall hinges, and the exterior thumb latch is still in place and has been painted white. A key hole is located below the thumb latch. The door casing is 12 inches wide to accommodate the thickness of the multi-wythe brick wall (Figure 216). A double hung window is located to the east of the north door. The south door is a 4-paneled 1-1/4 inch thick door with two hinges and two contemporary barrel locks to secure the door from the interior. The doorknob and likely rim

Figure 215. Typical barrel locks added to the interior sides of first floor exterior doors.

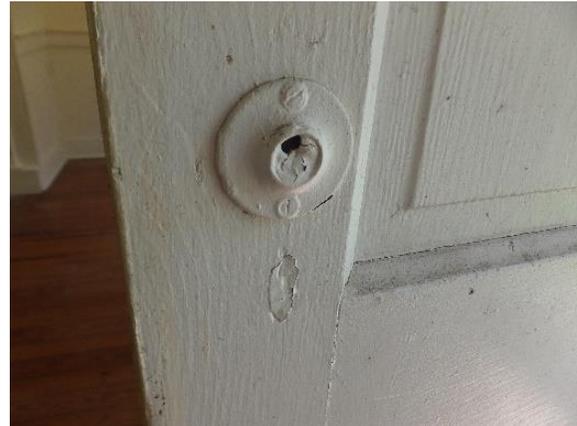
Figure 217. Remaining escutcheon from removed door knob at the south door.

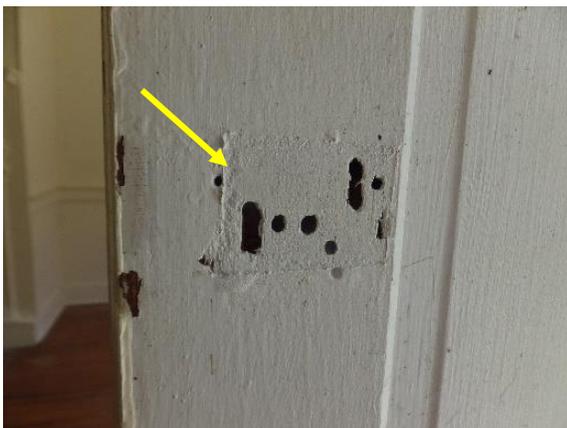
Figure 218. Holes and ghosting from a removed surface mounted lock, such as a rim lock, at the south door.

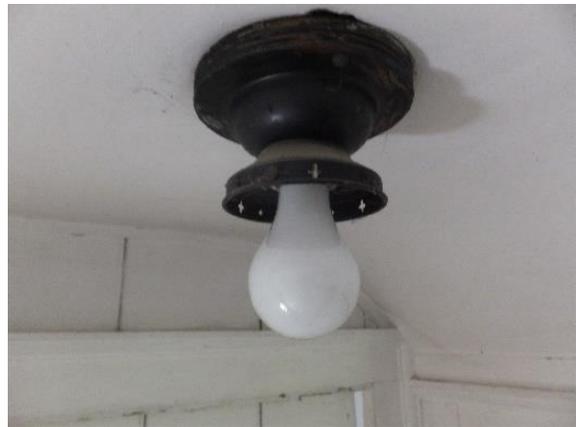
The white painted ceiling in the stairwell follows the slope of the roof (Figure 231). The ceiling flattens out above the top landing where a ceiling mounted metal light fixture is located. The glass shade of the black cross cut stamped metal fixture has been removed (Figure 232).

Figure 232. Ceiling-mounted light fixture in loft stairwell.

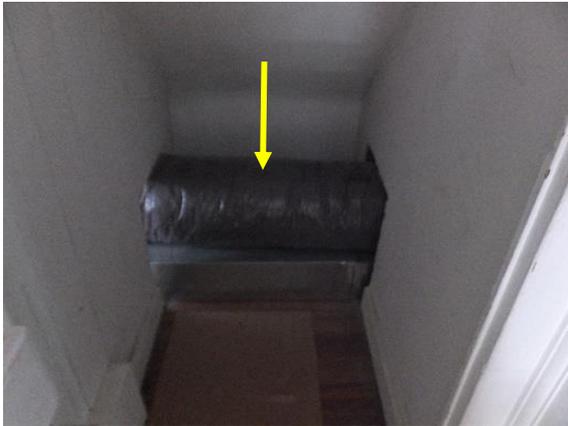
(Figure 233 and Figure 234). The ceiling in the closet follows the sloped roofline and the interior walls have been cut at the northernmost area of the closet at the floor to accommodate ductwork spanning between the two loft rooms (Figure 235). Similar to other board and batten bead doors in the home, all hand hardware has been removed from the door leaving a hole from a removed knob (Figure 236).

Figure 235. Ductwork running through the closet walls.

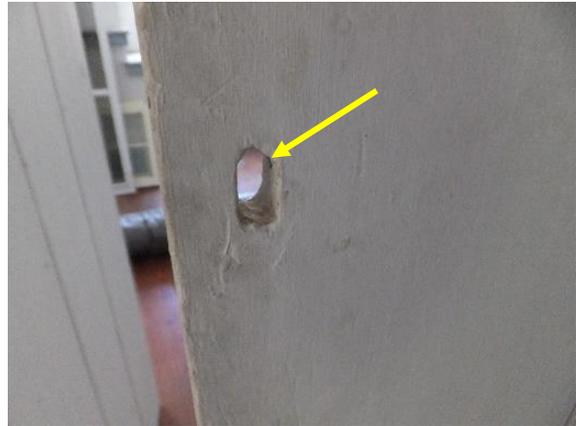
Figure 236. Remaining hardware hole in closet door.

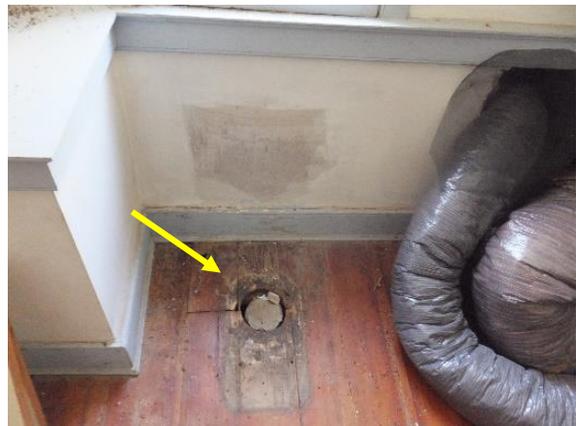
A 7/8 inch thick board and batten bead wood door with a 2-1/2 inch wood threshold leads from the stairwell to the west loft room. The room has white painted walls with blue trim. The ceiling is sloped to follow the roofline with a flat section in the center of the room. There is a likely original chimney and fireplace on the west wall that has been plastered over (Figure 237). Damaged interior finishes at the west wall with corresponding cuts in the wood floor indicate a removed toilet; abandoned plumbing lines that penetrate through the chimney indicate a removed sink; cut interior finishes at the east and south walls and abandoned plumbing lines indicate a removed tub. These observations indicate this room was converted into a bathroom at one point in time (Figure 238, Figure 239, and Figure 240).

Figure 238. Area of a removed toilet.

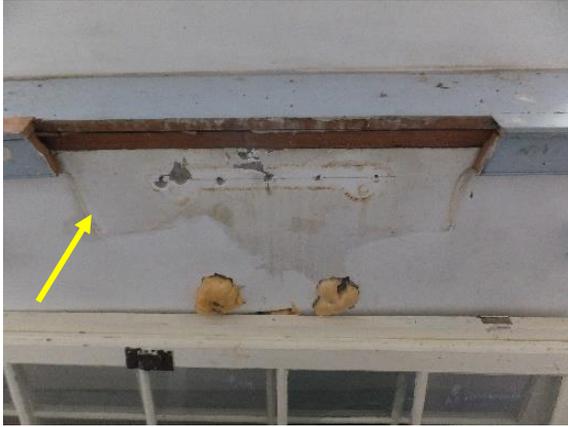
Figure 239. Evidence of a removed wall-mounted sink.

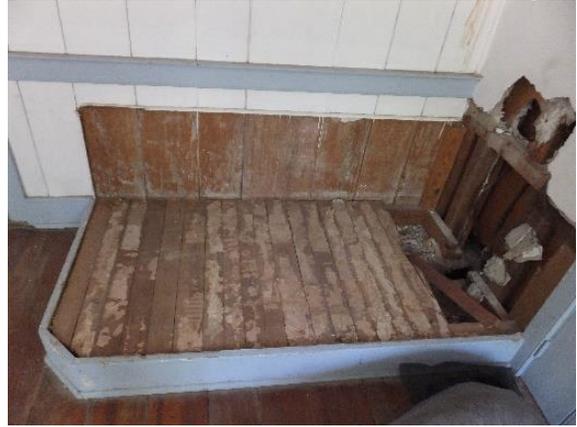
Figure 240. Removed tub with resultant disrupted interior finishes.

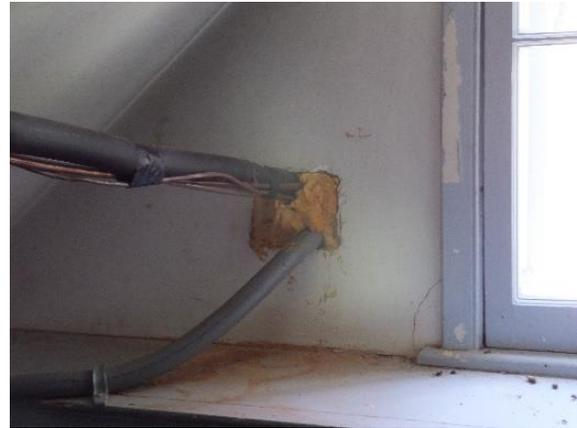
Figure 254. Mechanical conduit penetration through the east wall.

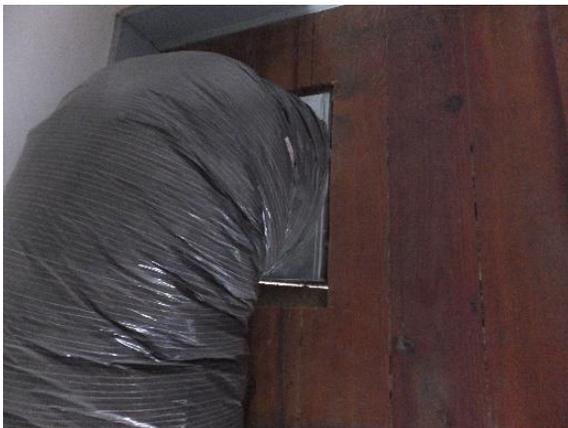
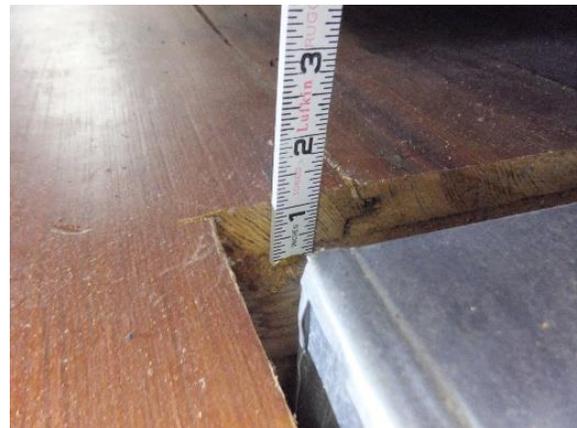
and groove floors at the second floor vary between 6 and 7-1/2 inches wide and run east-to-west. Information on the thickness and connection of the wood floors was obtained at the southwest corner of this room where a cut in the floor has been made to accommodate a large duct (Figure 255 and Figure 256). A 5 inch deep wood beam was observed at this cut section of floor and may be part of the original floor structural system.

Figure 255. Ductwork penetration through the wood floor was observed in both loft rooms.

Figure 256. Thickness of tongue-and-groove floorboards was observed at the ductwork cut in floor.

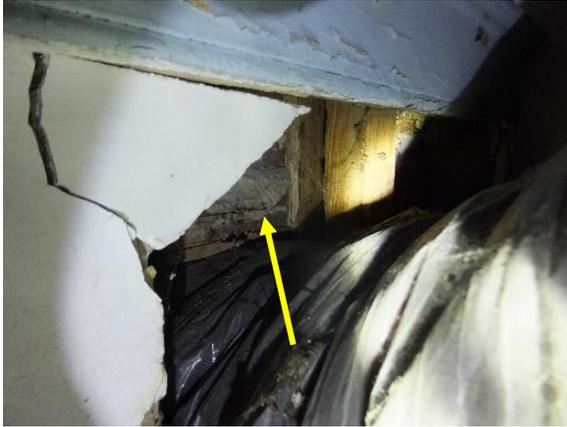
A penetration has been made at the north end of the west wall to accommodate the ductwork. The plaster assembly in this location is 3/4 inches thick comprised of 1/2 inch thick paper backed gypsum board, 1/8 inch thick sandy coat, and 1/8 inch thick gypsum finish coat. It is interesting to note that while the use of the rock lathe is similar to what was observed in the west loft, there is an absence of metal lathe. The plaster observation made at the west loft was at an exterior wall while the observation in the east loft was made at an interior wall. Beyond the hole, the original wood plaster and lathe assembly at the interior wall of the stairwell closet is visible (Figure 257).

Figure 257. Original plaster and wood lathe was observed in the interior wall ductwork penetration in the loft east room.

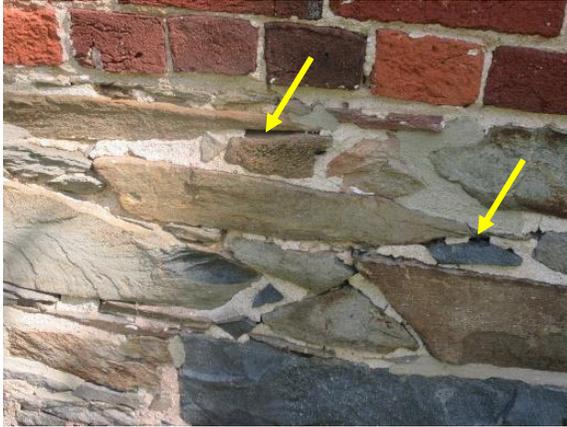
Figure 258. Missing mortar locations at fieldstone foundation.

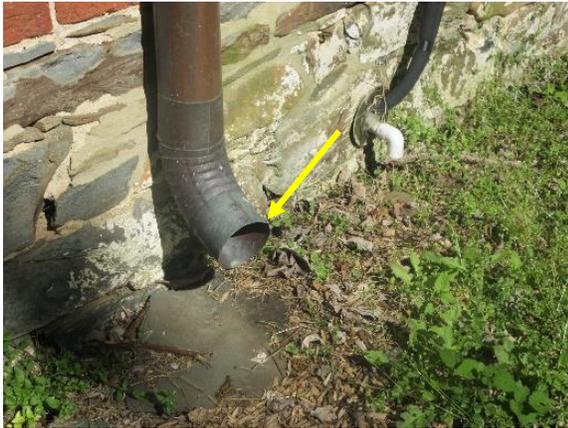
Figure 264. Downspout without a splash pad or extension.

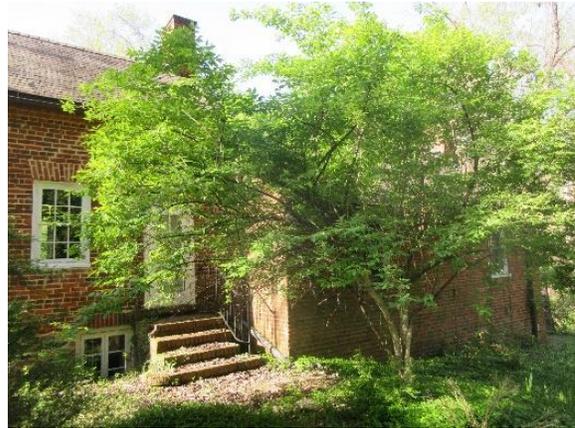
Figure 265. Heavy vegetation adjacent to home.

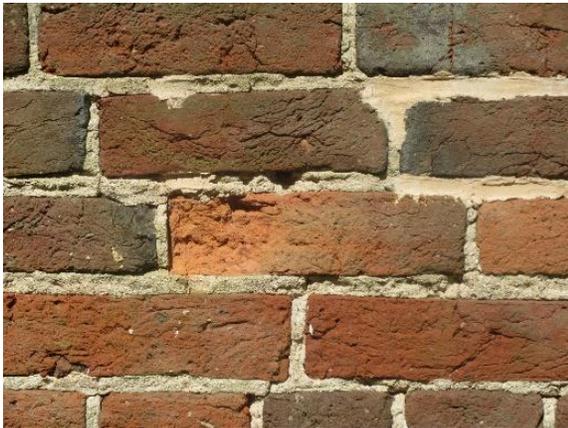
Figure 266. Imperfections in brick.

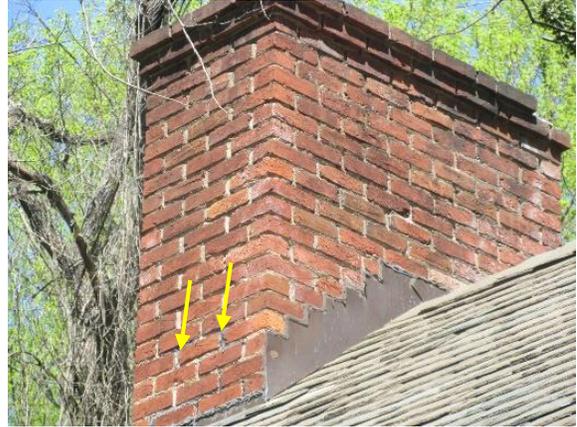
Figure 269. Sealant at mortar joint.

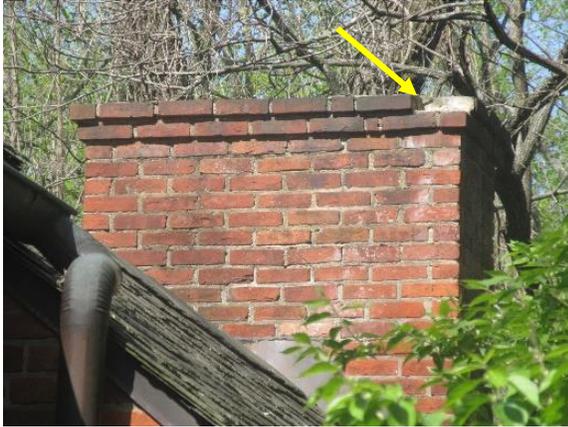
Figure 276. Surface staining at chimney caps. Note missing brick at corner of chimney cap.

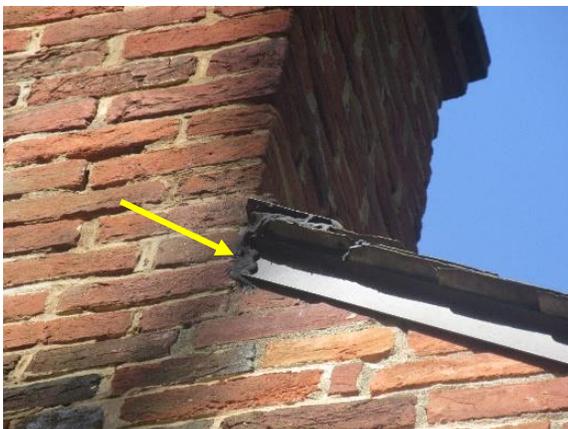
Figure 280. Mastic at south rake edge.

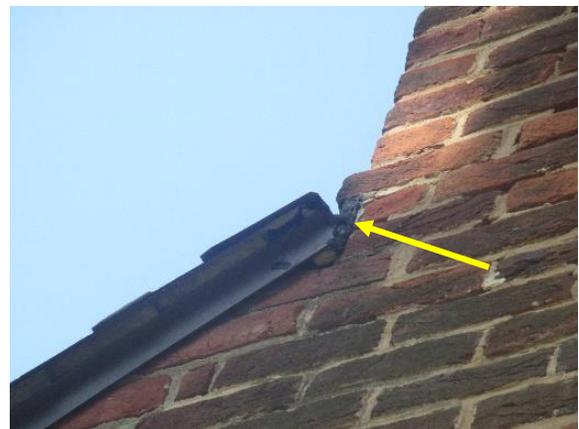
Figure 281. Mastic at north rake edge.

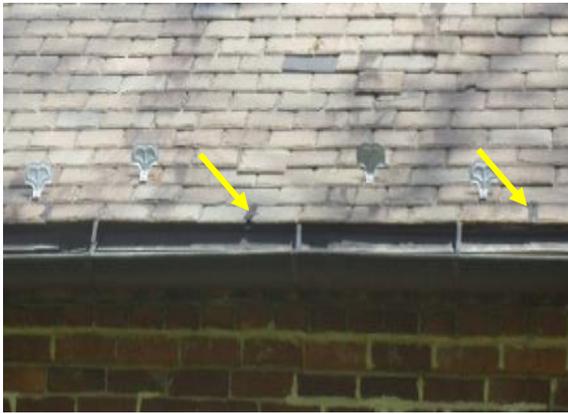
Figure 282. Mastic at slate joints.

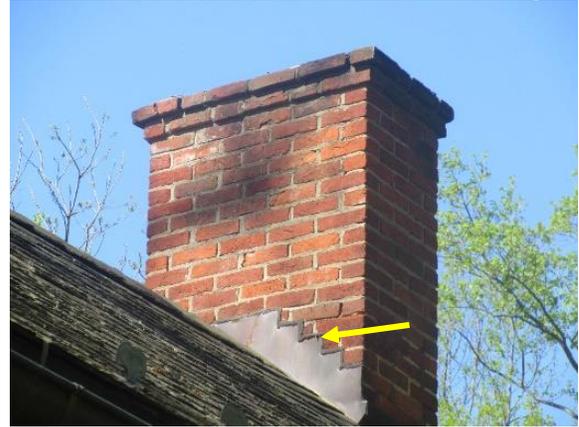
- Copper chimney flashing was detailed with mastic along the interface with the brick units (Figure 283). Flashing edges were lifted/deatched and appeared to not be installed/integrated under the slate shingles (Figure 284 and Figure 285). The flashing may have been installed retroactively.

Figure 283. Mastic at copper chimney flashing.

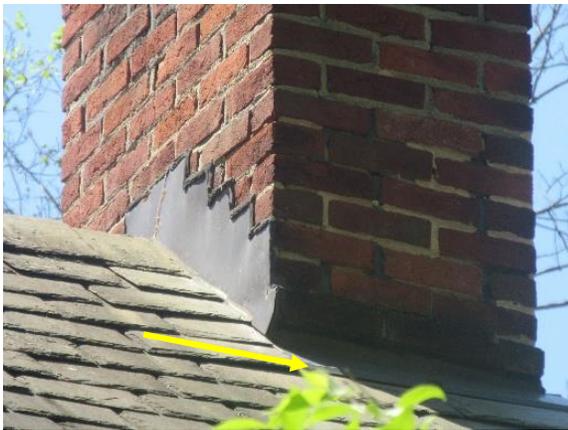
Figure 284. Overall of chimney flashing edges.

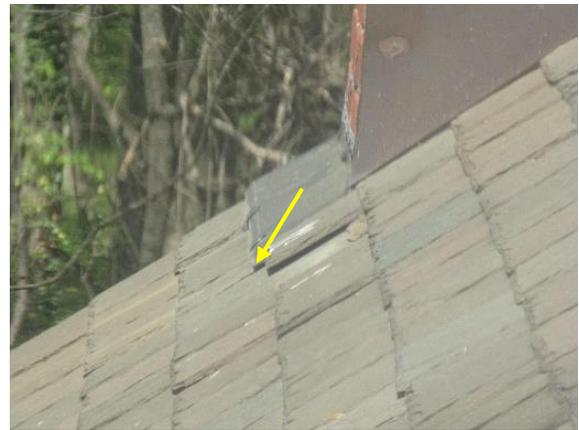
Figure 285. Lifted chimney flashing edge and adjacent slate shingle.

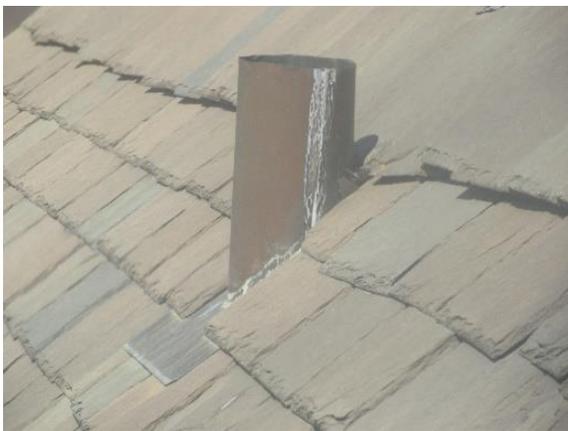
- Vent stack penetrations are detailed with pre-fabricated lead flashing boots and contain deteriorated soldered seams. The flashing cap appears to be missing (Figure 286).

Figure 286. Pipe penetration through slate roof.

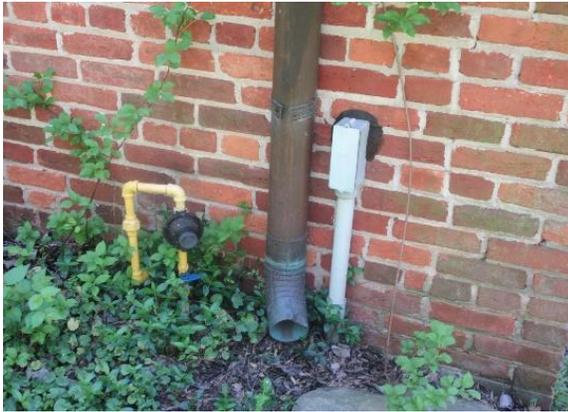
- The gutters are in good condition with minimal foliage and debris in the gutter cavity (Figure 287).
- Most downspouts do not have splash pads or extensions, resulting in water discharge being deposited close to the foundation (Figure 288).

Figure 288. Downspout close to masonry wall.

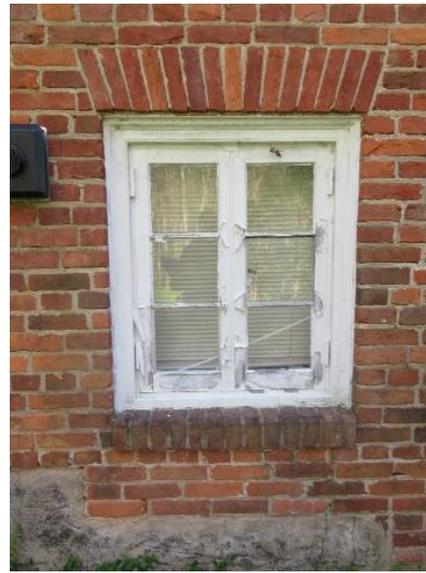
- The majority of the original windows of the home are in fair condition (Figure 289). Exterior storm windows are installed at the second floor of the original section of the home and are in good condition. (Figure 290).

Figure 289. Overall view of window at west facade at the kitchen level.

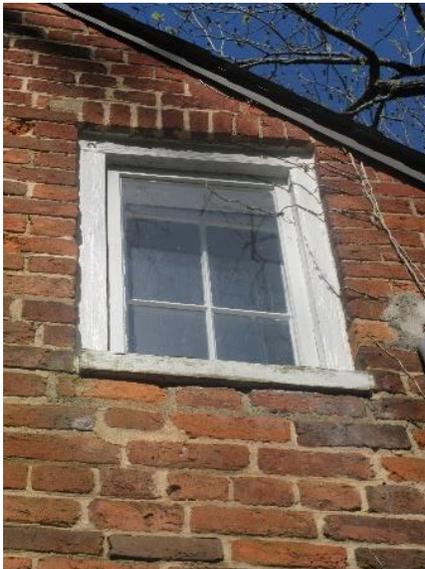
Figure 290. Overall view of exterior storm window at loft window.

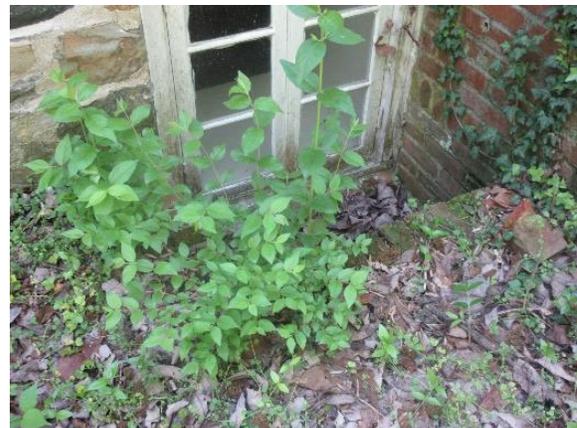
- Foliage and debris accumulation was observed to varying degrees collecting within all ground floor window wells (Figure 291).
- The following exterior conditions were typically observed at the windows:

Figure 291. Foliage and debris accumulation in window well.

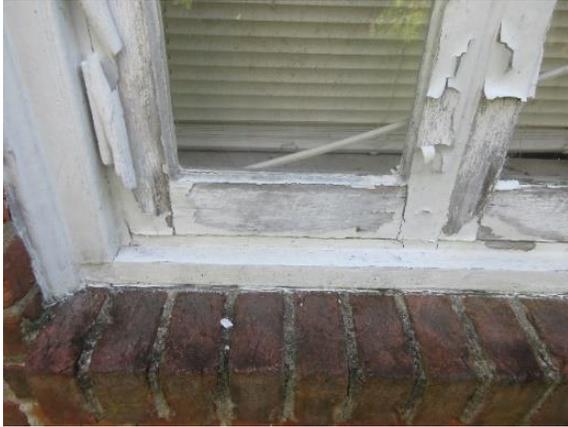
- Cracked and peeling paint (Figure 292),
 - Weatherchecking of the wood sills,
 - Separation of frame joinery (Figure 293), and
 - Cracked, displaced, or missing glazing putty (Figure 294).

Figure 292. Cracked and peeling paint at window.

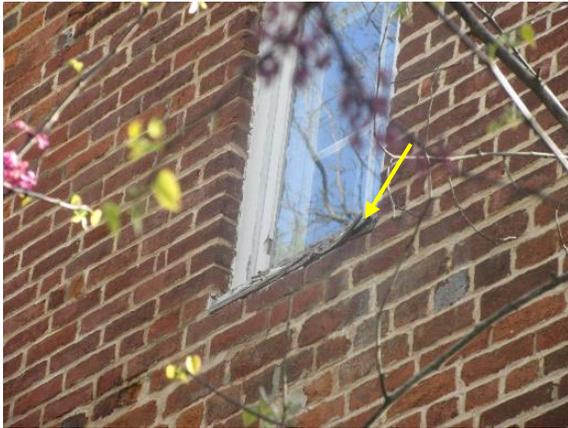
- A wood sill located on the second floor of the west facade is rotting and splitting across the grain (Figure 298).
- Similar to that of the exterior, the interior side of windows exhibit typical cracking and peeling paint, weather checking at the sills, and separation of frame joinery (Figure 299, Figure 300, and Figure 301). Windows throughout the home appear to be painted shut and not operable.

Figure 298. Deteriorated window sill.

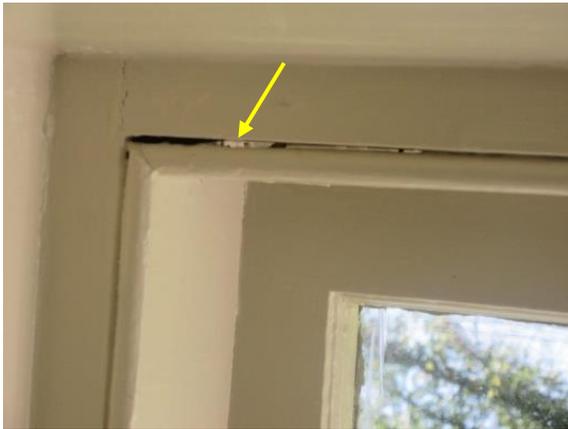
Figure 300. Separation of frame joinery (interior).

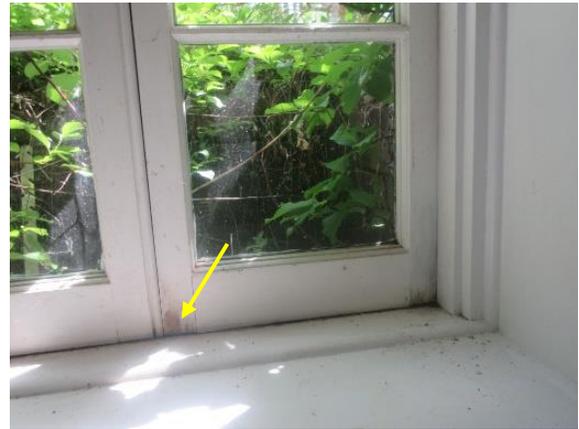
Figure 301. Peeled paint at window (interior).

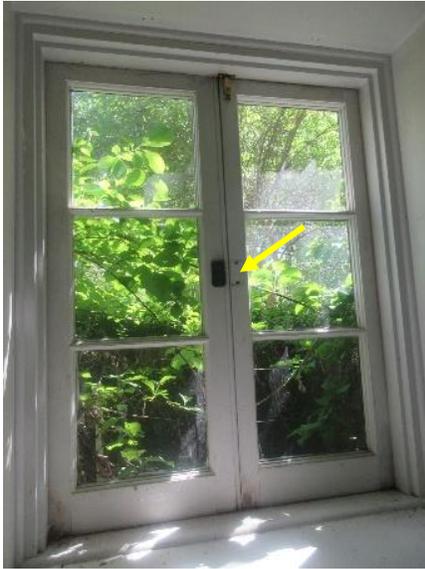
- Missing hinges and associated hardware were noted for several windows located in both the kitchen and cellar (Figure 302). The original hardware at windows located in the kitchen appear have been replaced with contemporary hardware (Figure 303 and Figure 304).

Figure 302. Missing window interior lock (interior).

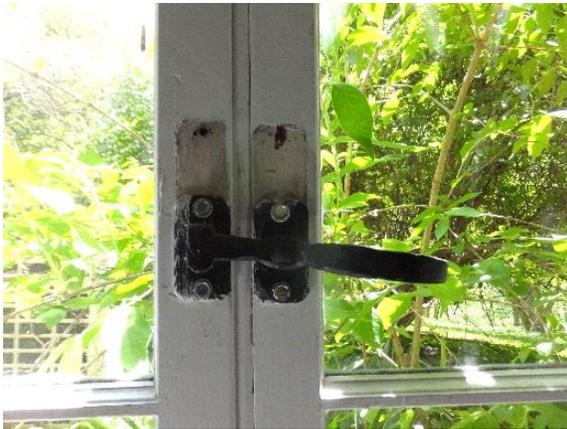
Figure 304. Replaced window hardware.

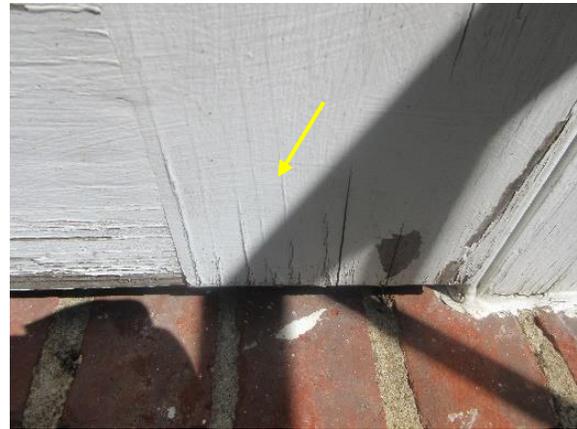
- The exterior doors that are in fair condition. The paint is typically cracked and peeling at the base of the doors (Figure 305).
- Cracked and missing glazing putty was observed at the perimeter of the glass lites within the storm doors (Figure 306).

Figure 305. Cracked paint at door base.

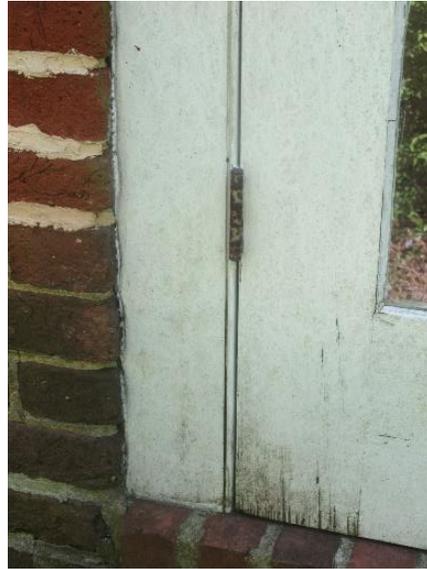
- Modest deterioration at the bottom of the wood frame of the exterior storm door (Figure 307). The exterior storm door located at the south facade contains a crack at the lower panel (Figure 308).

Figure 307. Modest deterioration at the bottom of the wood storm door.

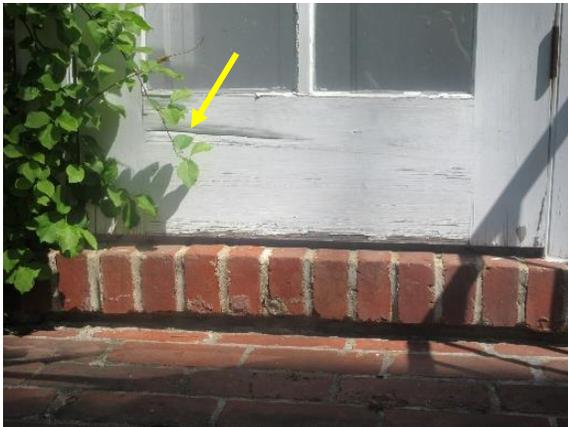
Figure 308. Crack in wood at bottom rail of storm door.

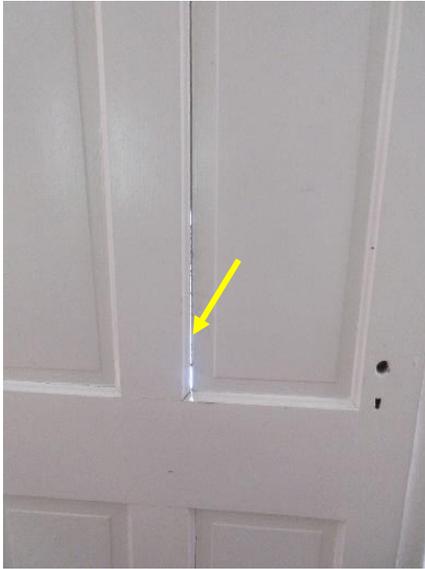
- The wood lintel located above the cellar entry door on the west facade exhibits splintering and checking across its length (Figure 309).
- One door located at the north wall of the hall was observed to have daylight shown through a joint separation at a door panel (Figure 310).

Figure 310. Daylight observed at exterior door panel.

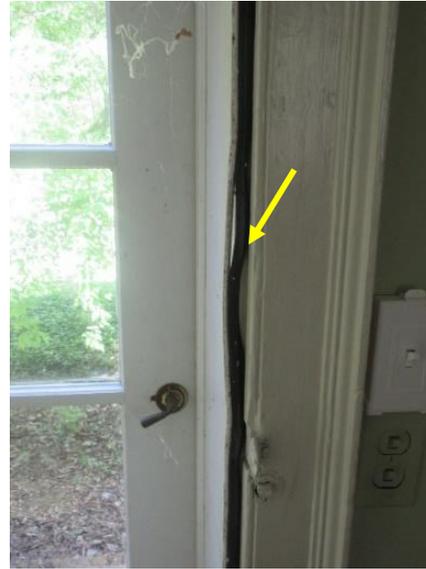
- Foam tape is installed at the head and jamb of the door located on the north wall of the parlor; the tape was likely intended to minimize air infiltration at the perimeter of the door, but is unadhered and therefore ineffective at several locations (Figure 311).

Figure 311. Foam tape weatherstripping becoming detached at door jamb.

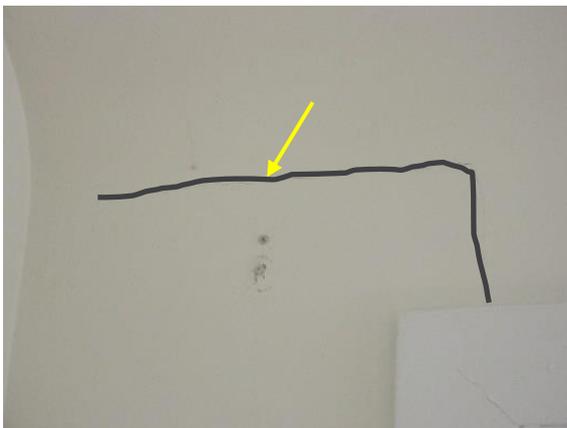
- Interior wall and ceiling finishes consist of drywall/gypsum board and plaster. The drywall and plaster are typically in fair condition.
- Minor cracking of drywall/gypsum board and plaster was observed throughout the home, generally located at window and doorframes, wall seams, and ceiling interfaces (Figure 314, Figure 315, and Figure 316).

Figure 316 Plaster cracking adjacent paneled door frame in parlor (crack traced for clarity).

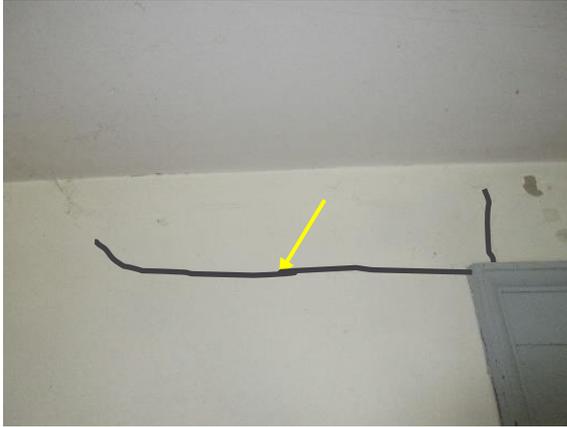
- More significant diagonal cracking was observed in the east loft. Cracks typically emanate from either the edges of the ceiling to wall interface or the window frames (Figure 317, Figure 318, and Figure 319). An additional crack was observed in the mechanical area of the ground floor (Figure 320).

Figure 318. Plaster cracking adjacent to board and batten door frame of east loft (crack traced for clarity).

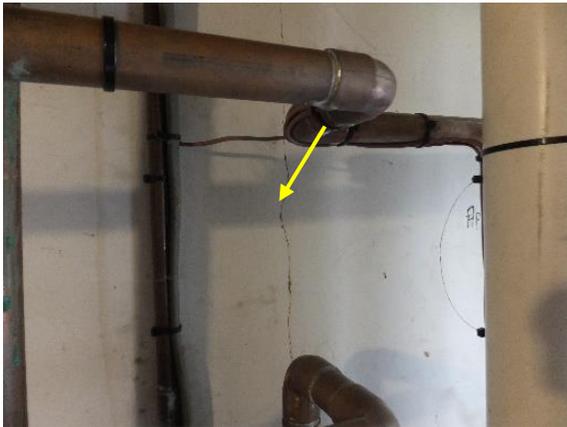
Figure 320. Parge coating cracking in mechanical area.

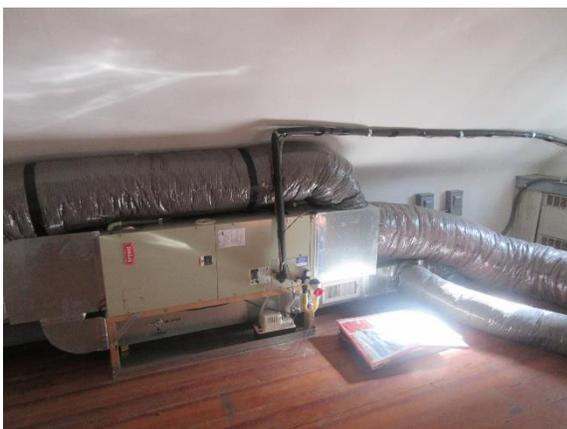
- The interior wall of the built-in cabinetry located at the east wall of the parlor (Figure 321),
 - The east and west lofts (Figure 322, Figure 323, and Figure 324), and

Figure 322. Overall view of ductwork in east loft.

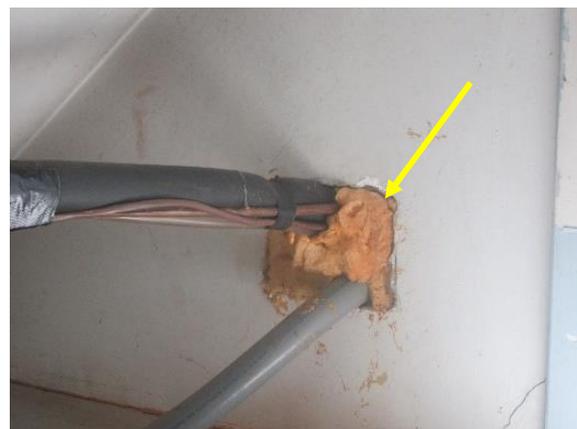
Figure 323. Cut in plaster and spray foam for conduit penetrations at east loft exterior wall.

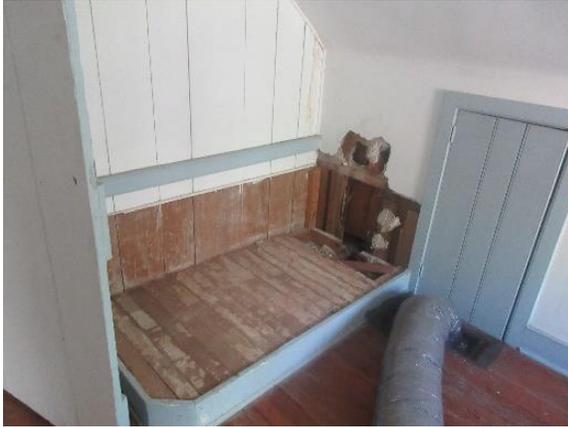
Figure 324. Cut in plaster and beaded wood wall for plumbing in west loft.

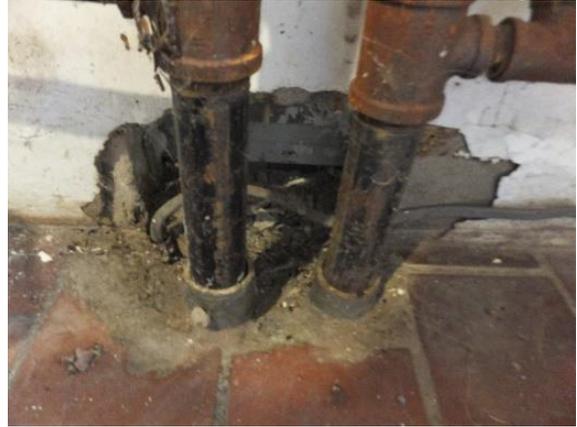
Figure 325. Cut in parge coating for MEP in mechanical area.

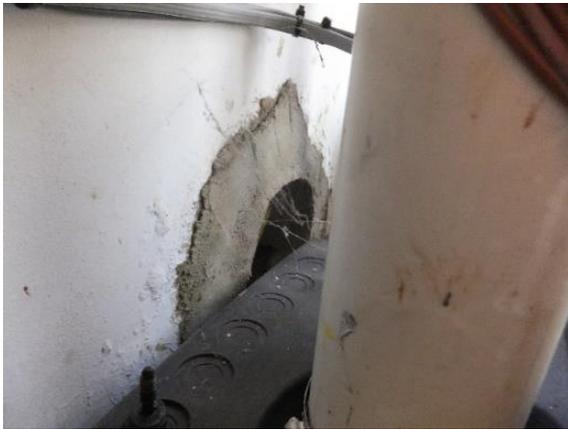
Figure 326. Cementitious material at cut in parge coating for abandoned penetration.

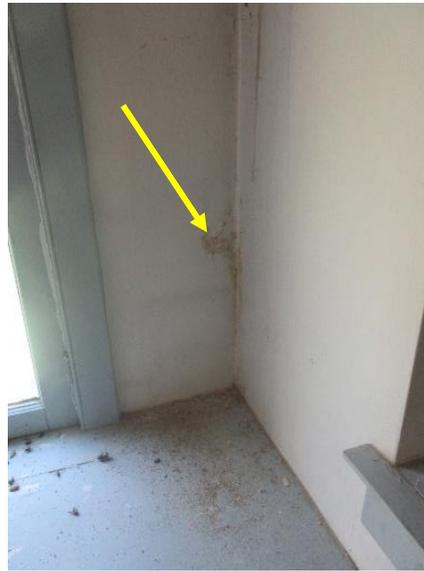
Figure 327. Water staining, bubbling, and material loss of plaster at lower corner of west loft fireplace.

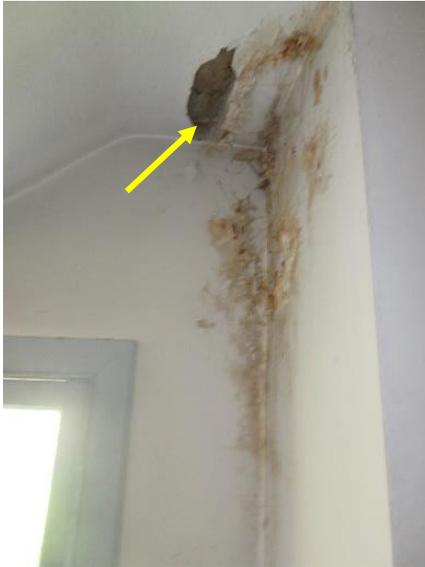
Figure 328. Location of water infiltration with staining, bubbling, and material loss of plaster at upper corner of west loft fireplace.

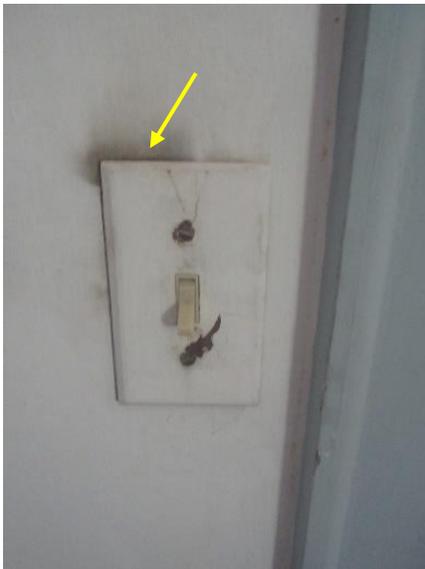
Figure 330. Black burn marks at electrical switch.

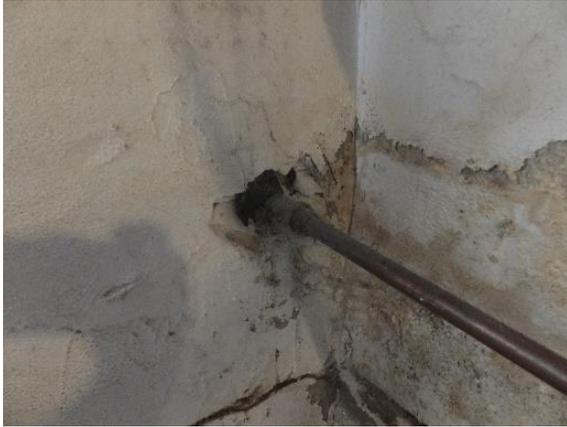
Figure 332. Potential microbial growth at parge deterioration.

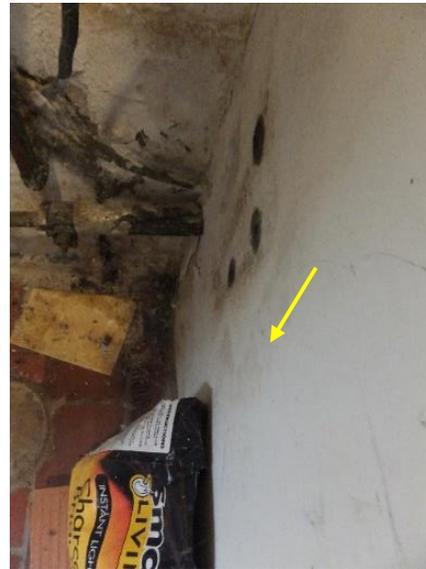
lower corner (Figure 335). These observations indicate that moisture frequently infiltrates through the foundation wall into the interior finishes.

Figure 335. Inward bow of parge coating at exterior wall in mechanical area.

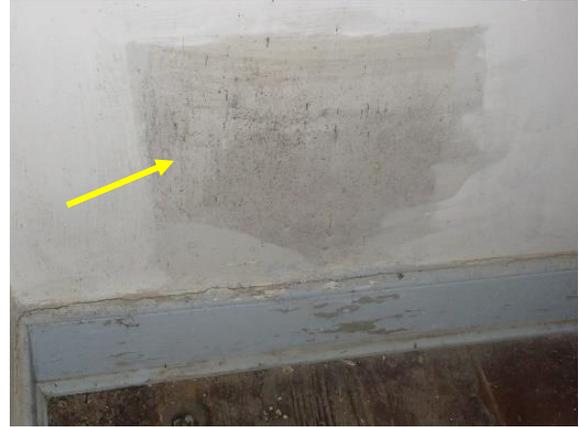
- Potential microbial growth was also observed around the perimeter of ceiling vents in the parlor (Figure 336) and at the west wall where a toilet was removed in the west loft (Figure 337).

Figure 337. Lack of paint coating from previously removed toilet location.

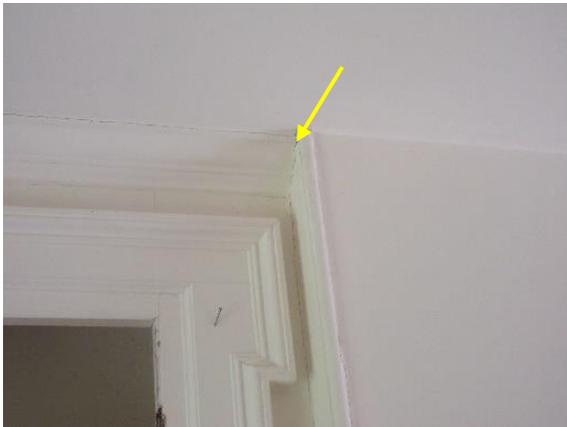
- Gaps and separation at seams were observed between baseboards, cabinetry and mantel trim, and crown molding interfaces throughout the home (Figure 338, Figure 339, Figure 340, and Figure 341).

Figure 338. Separation of joinery at cabinetry trim.

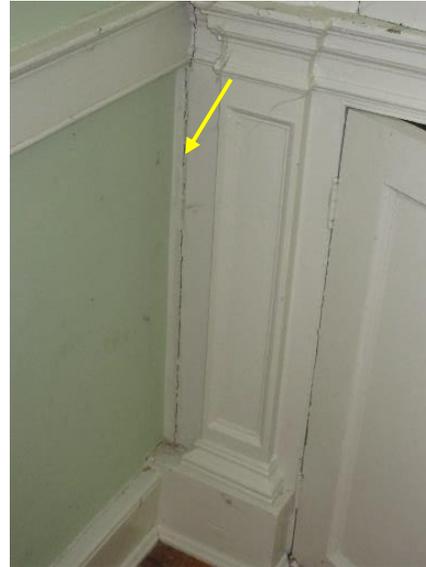
Figure 339. Separation of seams at cabinetry.

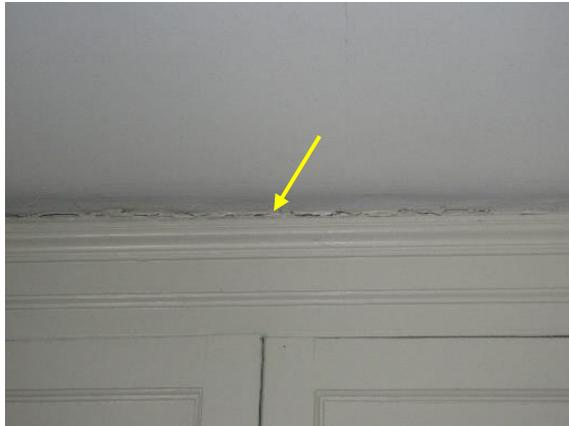
Figure 340. Separation at ceiling and cabinetry seam.

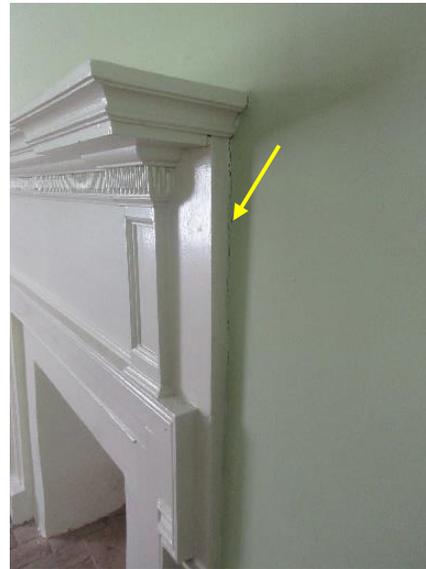
Figure 341. Separation at wall and mantel seam.

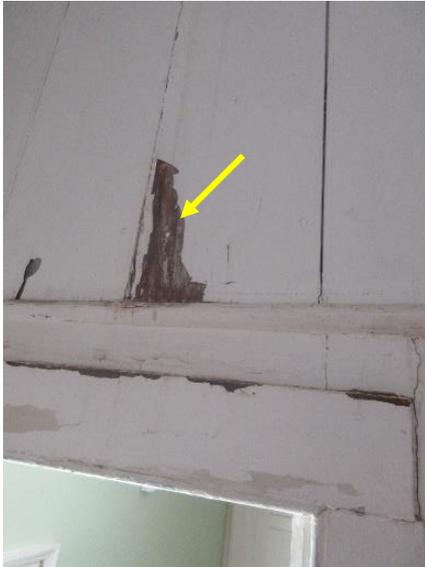
- The painted wood bead board panels in the stairway leading to the second floor are in fair condition with several areas of cracked and flaked paint (Figure 344 and Figure 345). Painted chair rails, window and door frames, crown molding, baseboards, and wood built-in cabinetry exhibit similar forms of deterioration (Figure 346, Figure 347, and Figure 348).

Figure 344. Cracked and flaked paint and wood bead board panels

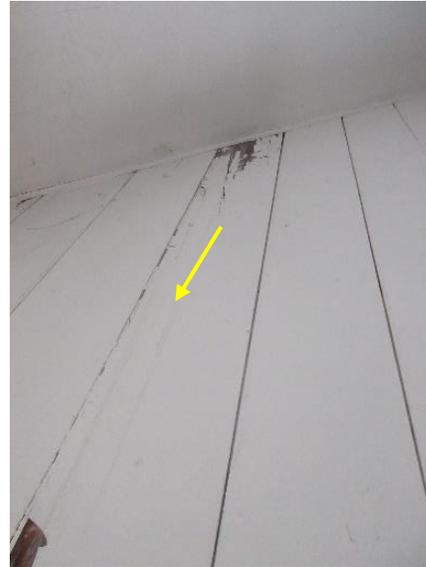
Figure 345. Vertical cracking of paint at wood bead board panels.

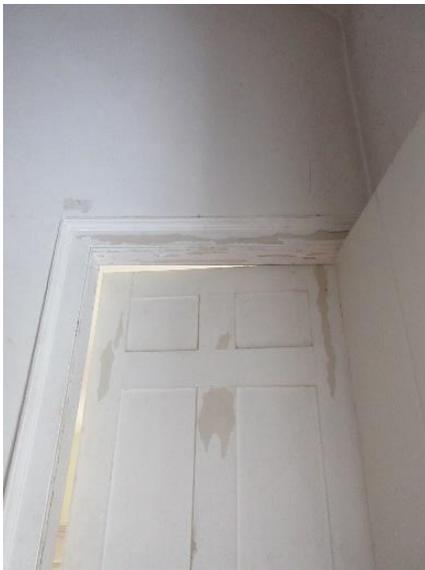
Figure 346. Flaked paint at interior door.

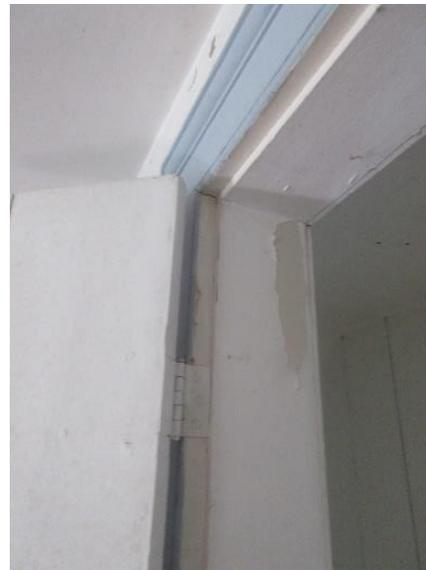
Figure 347. Flaked paint at door frame.

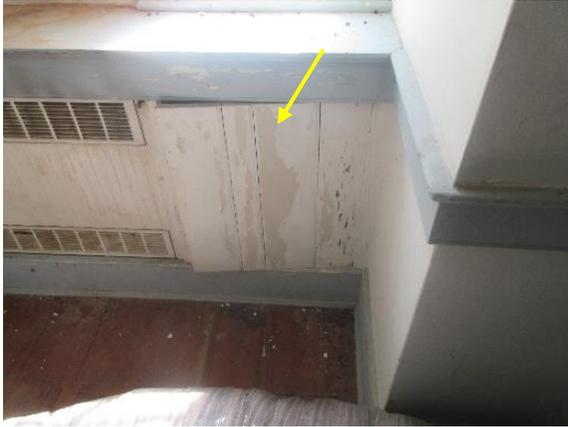
Figure 348. Cracked and flaked paint at built-in cabinetry in loft spaces.

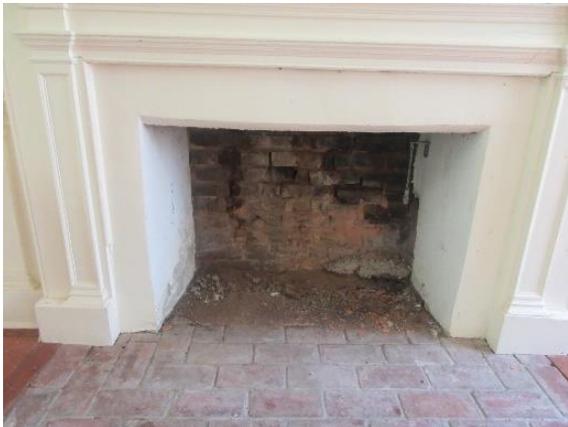
- Deteriorated mortar joints and cracked/spalled brick units were typically observed at fireplaces throughout the home (Figure 349 and Figure 350). Insulation was packed into the throat of the smoke chamber at the parlor and living space fireplaces; this was likely done as a way to weatherize/seal off the home while unoccupied (Figure 351 and Figure 352). Dark staining was observed at the brick arch and firebox of the kitchen fireplace, possibly caused by soot from when the fireplace was used (Figure 353).
- Vertical cracking at mortar joints and several mortar repair campaigns were observed at the fieldstone fireplace in the cellar (Figure 354 and Figure 355).

Figure 350. Dark staining from fireplace use and mortar erosion at fireplace.

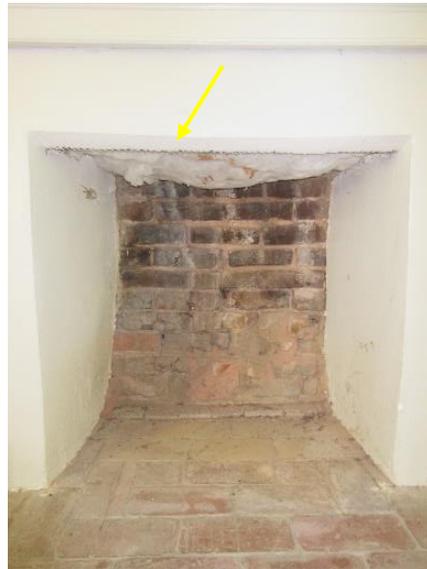
Figure 351. Insulation installed at the throat of parlor fireplace.

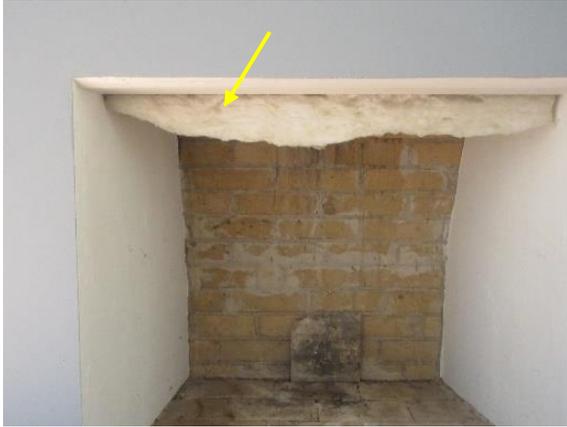
Figure 352. Hanging insulation at the throat of the living space fireplace.

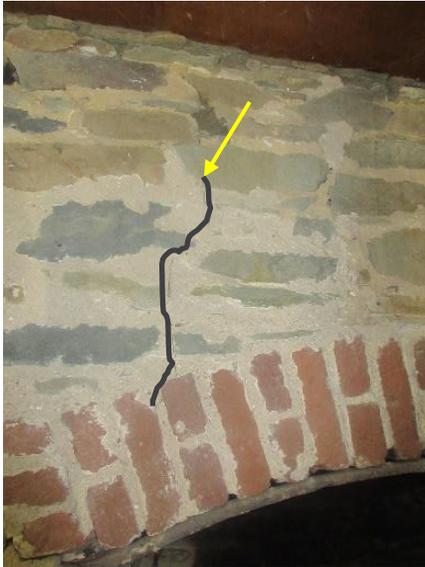
Figure 354. Vertical cracking at mortar of fieldstone fireplace (crack traced for clarity).

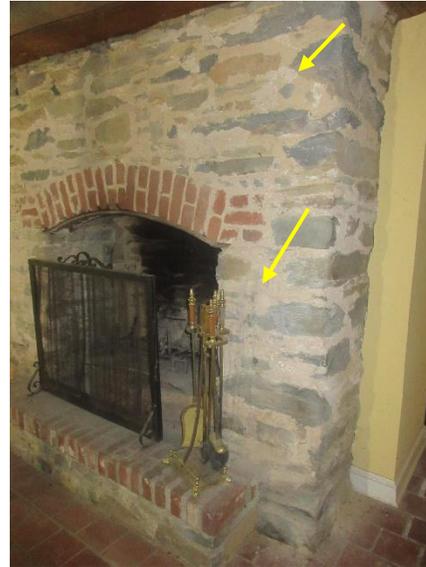
Figure 355. View of mortar campaigns at cellar fireplace.

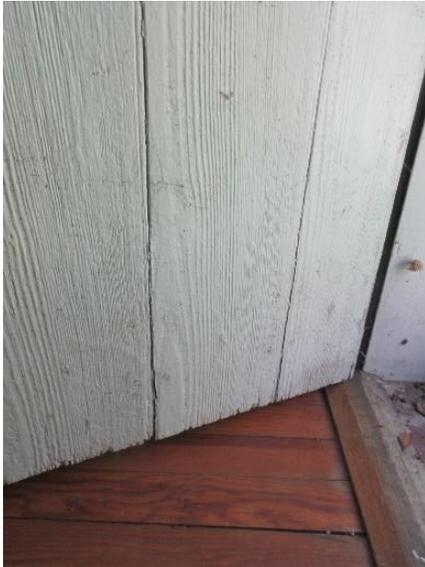
observed includes separation of joinery, isolated locations of cracking, and weatherchecking at the base of the door and thresholds (Figure 356, Figure 357, Figure 358, Figure 359, and Figure 360).

Figure 356. Weather checking at board and batten bead door base.

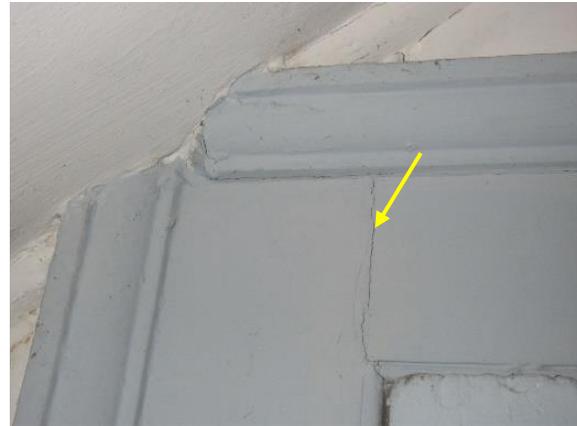
Figure 357. Separation of joinery at board and batten door frame.

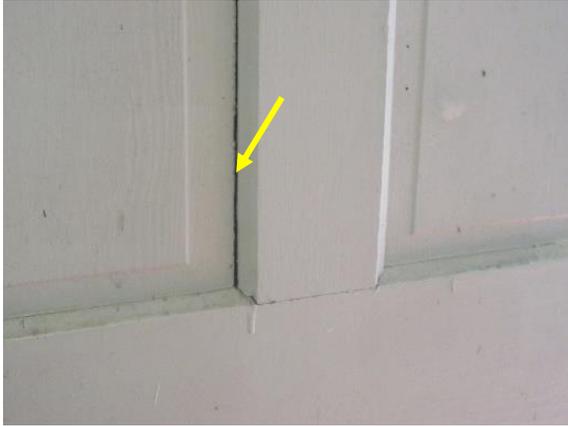
Figure 360. Separation of joinery at center stile of paneled door.

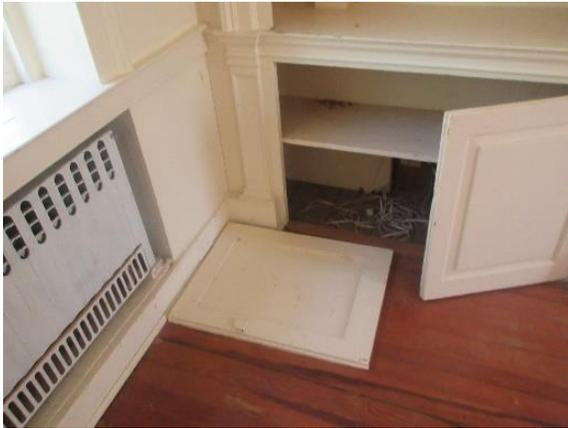
- Several of the built-in cabinetry original hardware on the first floor have been replaced with contemporary ceramic door knobs (Figure 361). The upper doors are missing from the cabinet in the hall. A lower cabinet door was detached and lying on the floor, adjacent to the cabinet (Figure 362).
- Most of the interior and exterior doors had original hardware removed. One bar strap at a door in the west loft was observed to have surface corrosion (Figure 363).

Figure 362. Detached cabinet door.
