LAHEY HOUSE Historic Structure Report

Vienna, Virginia

Final Report

WJE No. 2018.0216

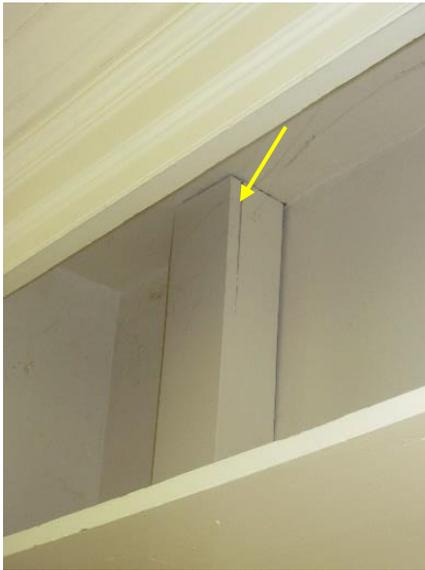
- The built-in cabinetry located on the first floor is in fair to good condition with isolated areas of splitting at vertical support members (Figure 364).

Figure 364. Splitting at vertical support member in built in cabinetry.

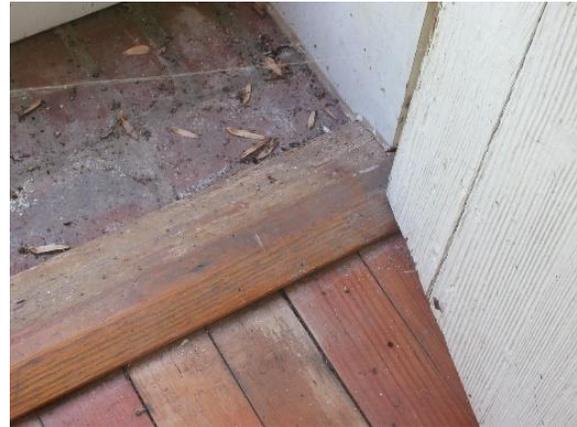
- The typical deterioration observed at the door thresholds includes weatherchecking and fading of applied varnish. This is possibly due the element being uncoated and exposed to dirt, debris, and moisture accumulation (Figure 365). In the east loft, the door threshold has worn to the point of significant section loss (Figure 366).

Figure 365. Weather-checking and fading varnish at door threshold.

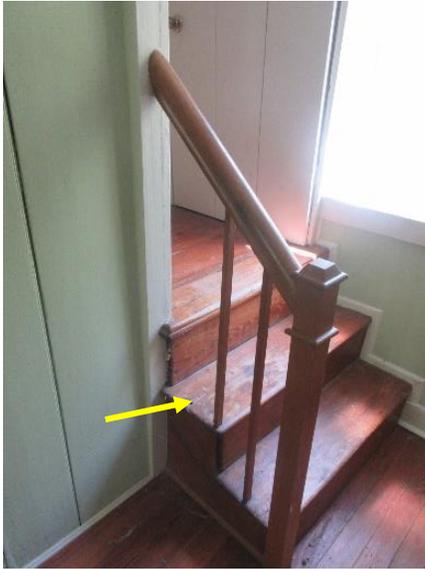
- The stair handrail located in the hall has minor indentations (Figure 367). Two spindels are missing, one in the parlor and one in the kitchen (Figure 368 and Figure 369).

Figure 368. Missing spindle at parlor staircase.

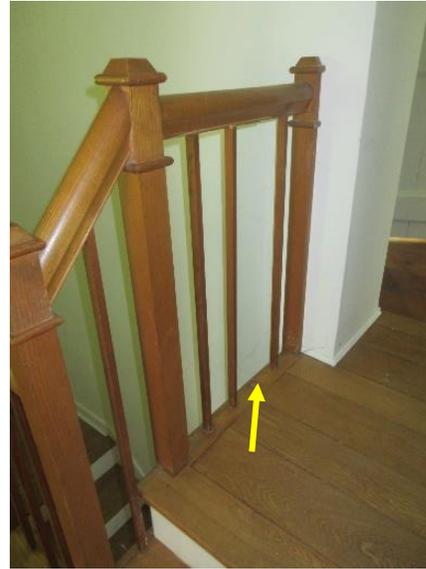
Figure 369. Missing spindle at first floor staircase.

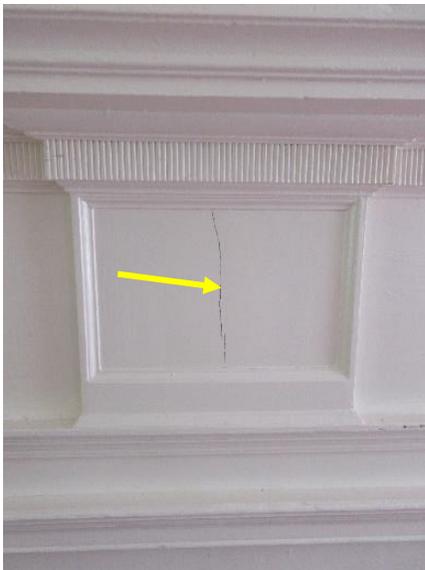
- Mantel trim and paneling is in fair to good condition with isolated vertical cracks in paneling and splitting/separation of trim pieces (Figure 370 and Figure 371).

Figure 370. Vertical crack in wood at mantle panel.

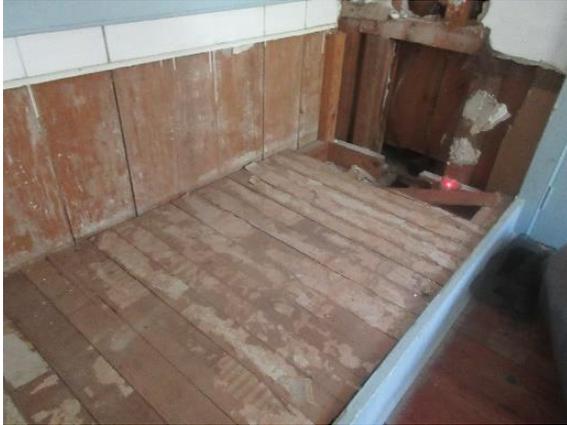
- At the east wall of the west loft, the wood bead board panels where the tub was removed exhibit varying degrees of water staining and soft wood when probed with an awl tool (Figure 372).

Figure 372. Staining at wood bead board in tub area.

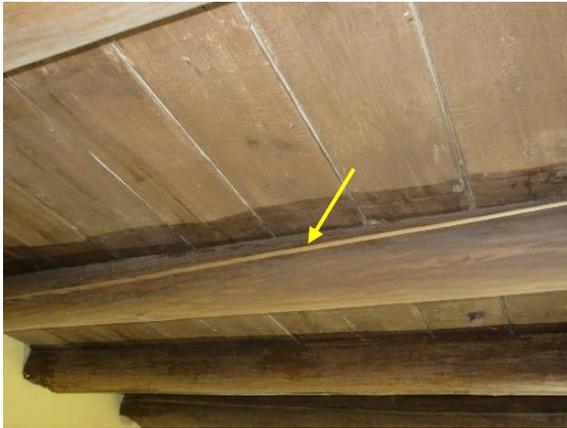
- The round wood joists observed from the cellar are in fair to poor condition with splits typically running the full length of the joist (Figure 373 and Figure 374). These joists are a different wood species and appear to be sawn differently than members observed

Figure 374. Splitting at 3/4 round wood floor beams.

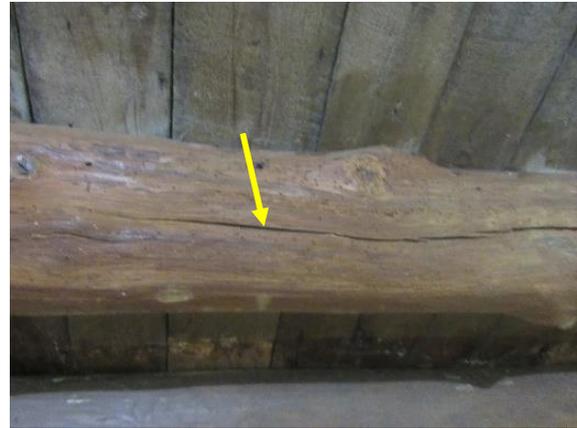
adjacent to the west fireplace (Figure 375). It appears that the supporting beams framing out the field stone fireplace are original given the species and hand hewn sawing method. These supporting beams exhibit similar wood splintering and grain separation (Figure 376 and Figure 377).

Figure 375. Checking at original floor beam in cellar.

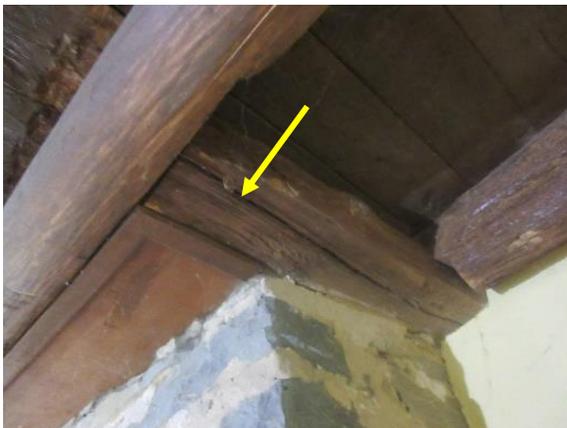
Figure 376. Wood splintering/splitting at original beams framing the cellar fireplace.

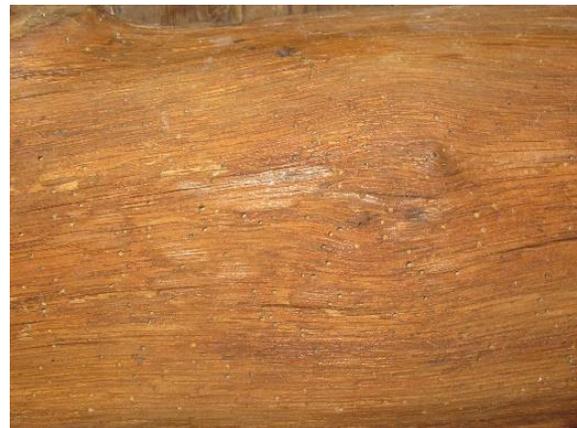
Figure 377. Grain separation at original framing beams. Note pin holes in wood.

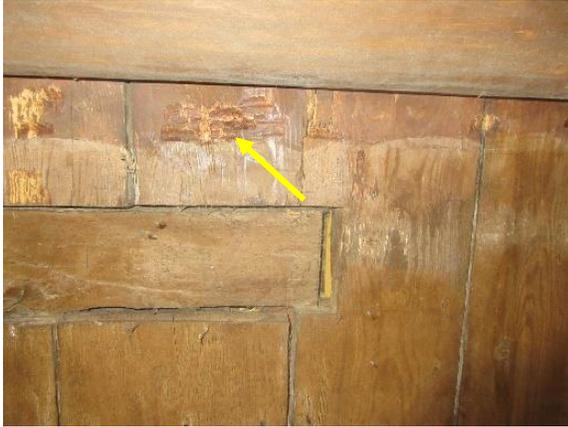
- The subflooring of the first floor (as viewed from the cellar) exhibits varying degrees of indentations and insect damage (Figure 378).

Figure 378. Indentations and insect damage at subflooring of first floor Hall and Parlor.

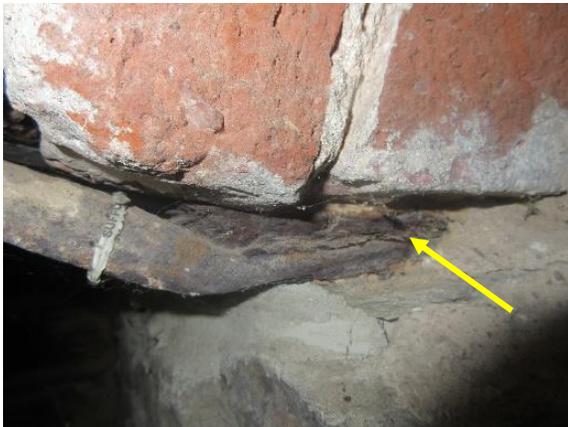
- Surface corrosion was observed at the full length of the curved steel lintel supporting the brick arch at the kitchen fireplace (Figure 379). Areas of corrosion by-product accumulation were primarily observed at the supporting ends of the lintel that are embedded in the masonry (Figure 380).

Figure 380. Corrosion product accumulation at end of curved steel fireplace lintel.

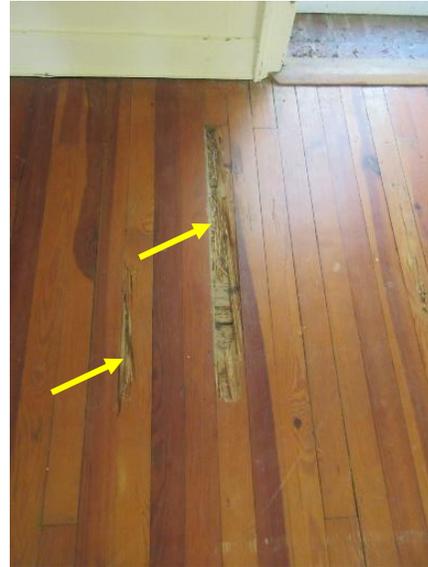
- The wood flooring throughout the house is in fair condition. Typical deterioration/damage includes indentations/scratches, insect damage and areas of damaged boards (Figure 381 and Figure 382).

Figure 381. Missing sections of floorboard in Hall.

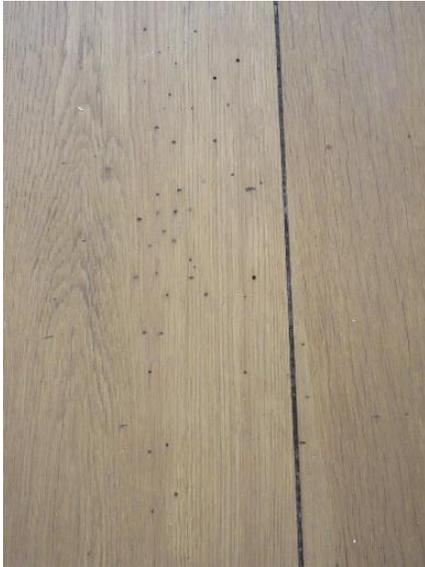
Figure 382. Potential insect damage at floor board in the living room.

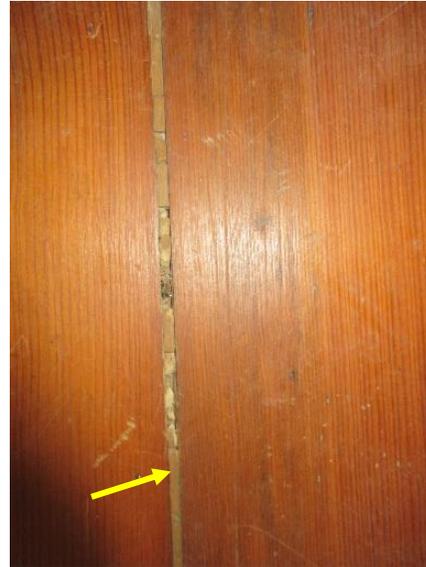
- Filler or other material was used at gaps between wood floor boards. In multiple areas, this filler has either deteriorated or is missing in varying degrees (Figure 383 and Figure 384).

Figure 383. Wood filler at gap between floor boards at east loft.

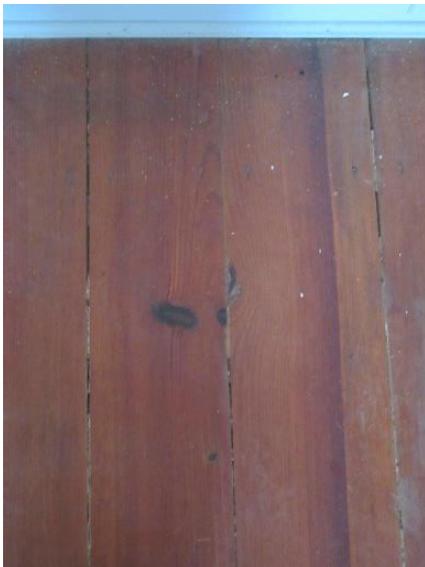
Figure 384. Multiple areas of material accumulation at gaps between floor boards at the east and west lofts.

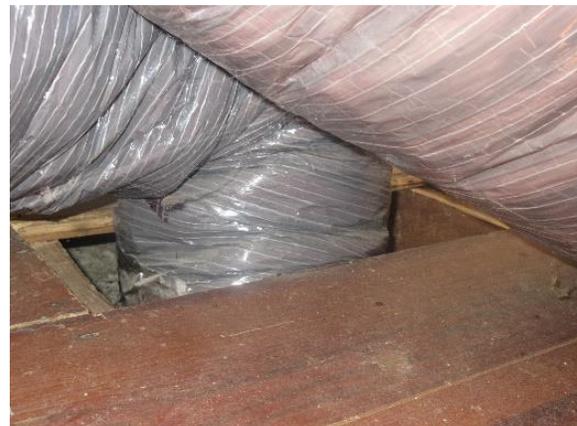
- Several cuts in the wood flooring have been made to accommodate ductwork and plumbing in both the east and west lofts (Figure 385 and Figure 386).
- The linoleum flooring in the bathroom located in the 1941 addition is in good condition with minor dirt accumulation (Figure 387).

Figure 385. Cut in wood flooring to accommodate ductwork at east loft.

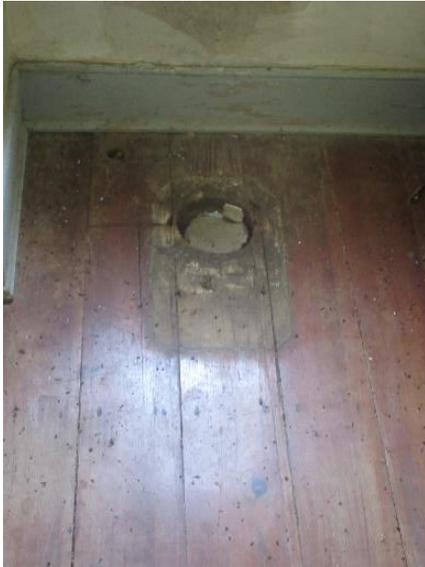
Figure 386. Staining at cut in wood floor board for plumbing at the west loft.

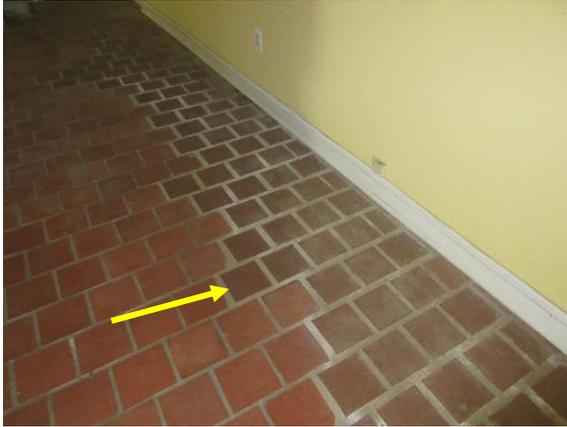
- The clay tile located in the ground floor is typically in fair condition with several areas exhibiting water staining, dirt accumulation, and spalls (Figure 388 and Figure 389). The tiles along the south wall in the cellar have been replaced (Figure 390). Abandoned penetrations were also observed in the clay tile floor at the ground floor mechanical area (Figure 391).

Figure 390. Replacement or staining of clay tile flooring in kitchen.

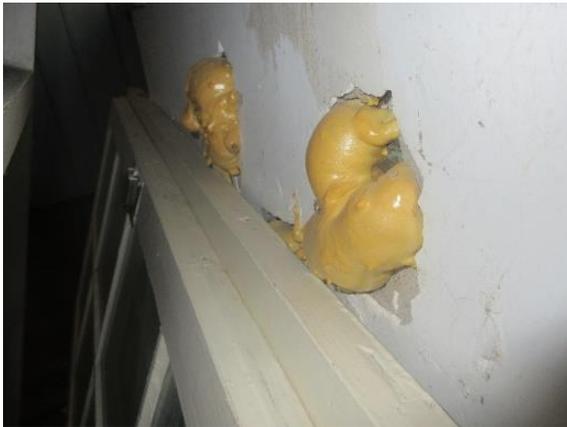
- Plumbing fixtures were removed in the west loft, leaving abandoned penetrations in interior finishes and flooring (Figure 392).

Figure 392. Abandoned penetrations at west loft bathroom infilled with spray foam.
