## Mount Gilead

### Historic Structure Report

### FINAL REPORT

WJE No. 2019.8373

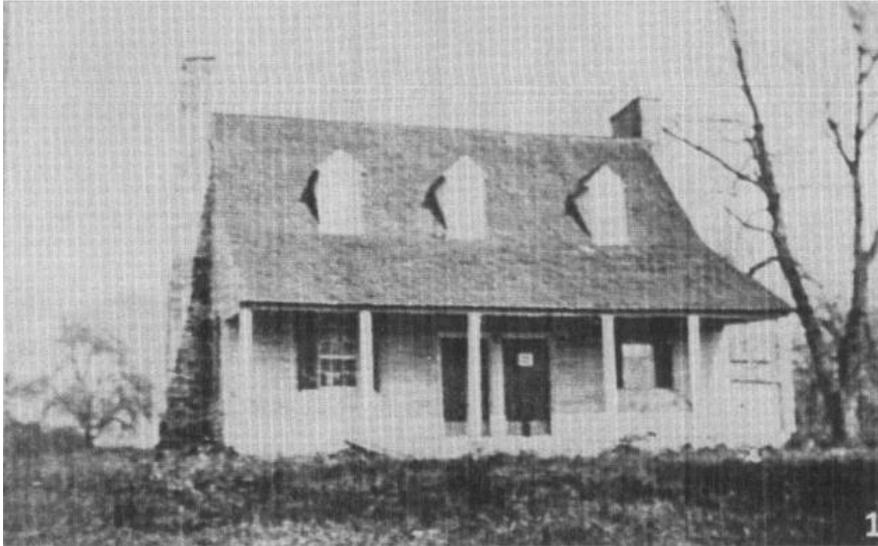
Figure 22. Mount Gilead in 1934 before restoration. It appears that a window on the first floor is missing, while the dormers may be boarded. Source: Smith, Centreville.

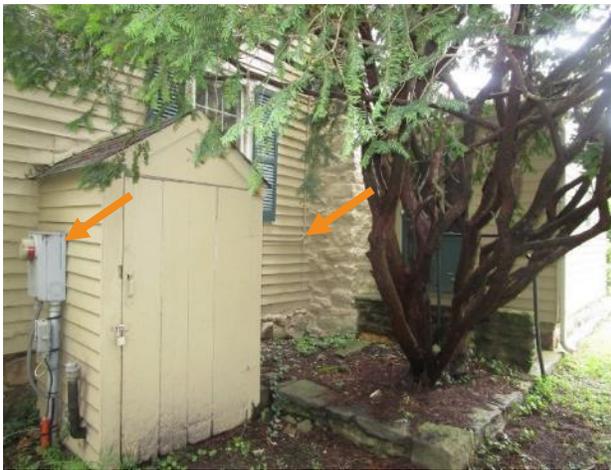
Figure 45. Electrical conduit at chimney (arrow), south wall of cellar access.

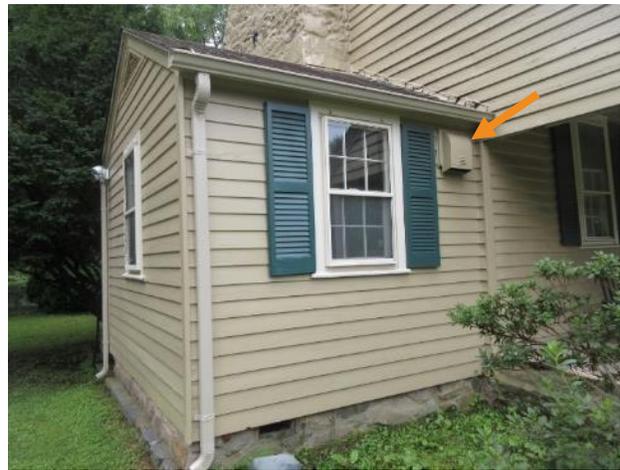
Figure 46. Oven vent (arrow) protruding west of window at north facade, east addition.

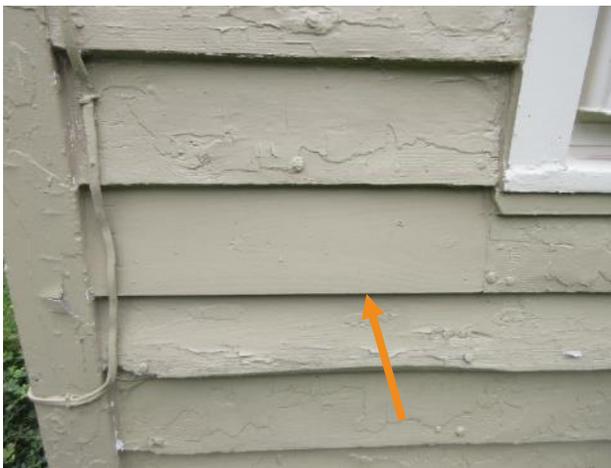
Figure 47. Wood dutchman section of clapboard, north facade study addition.

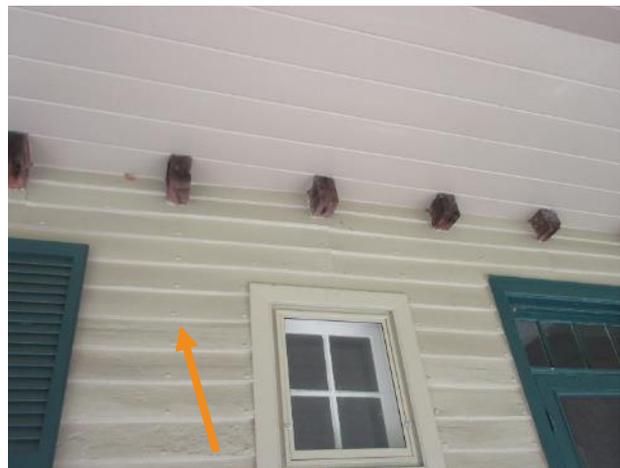
Figure 48. Wood dutchman section of clapboards, north porch roof.

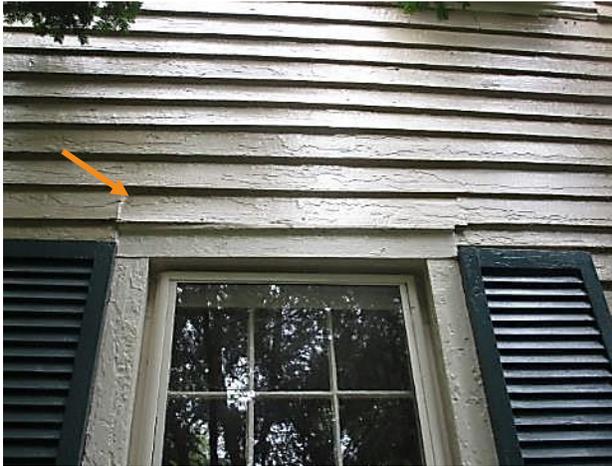
Figure 49. Wood dutchman section of clapboard, first floor southern window at east facade.

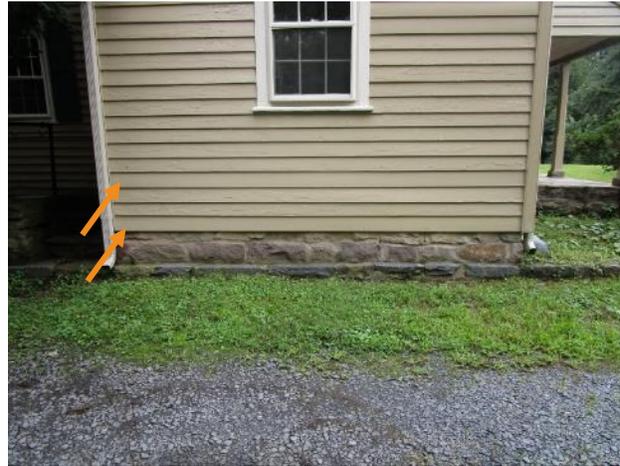
Figure 50. Wood replacement clapboards, kitchen addition at east facade.

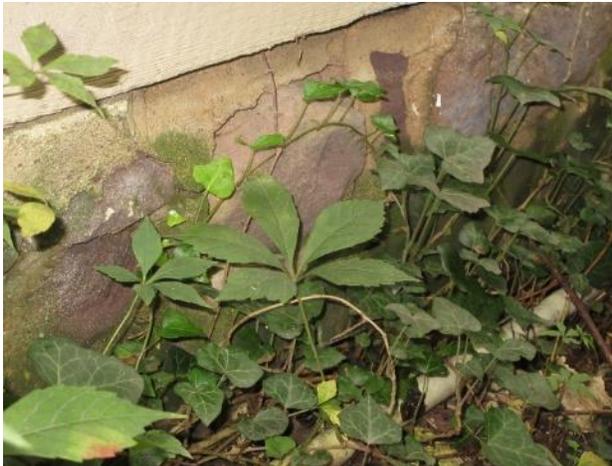
Figure 51. Foundation stone varies in size and shape, west addition.

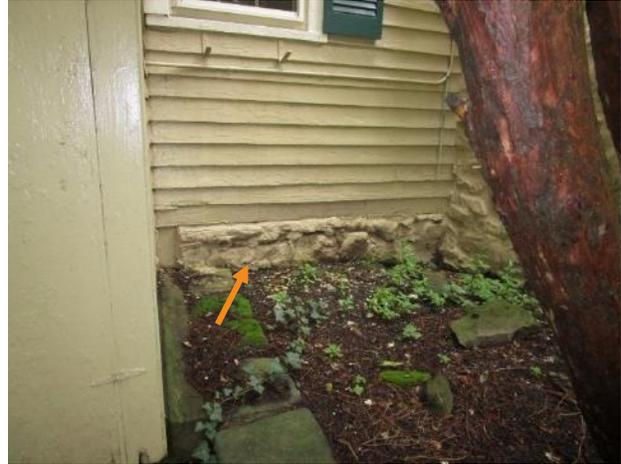
Figure 54. Painted foundation stone and mortar adjacent to chimney, east facade.

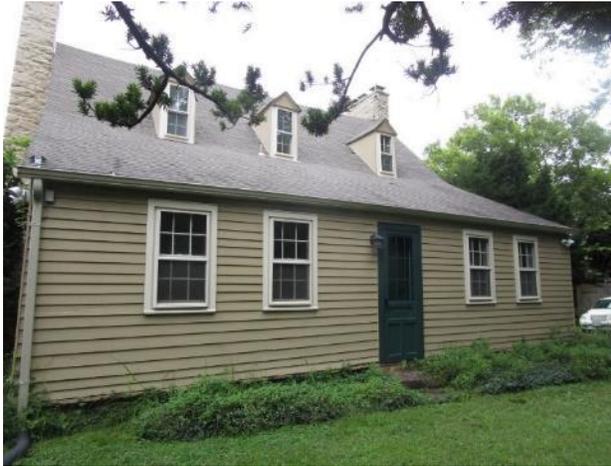
WJE observed several sags and high points in the roof when observed from grade. The spacing of the rafters, at approximately two (2) feet on center, may be adding to this condition. It warrants further review if there are additional concerns regarding the long term durability and stability of the roof and its components.

Figure 58. The gable roof is covered with asphaltic shingles.

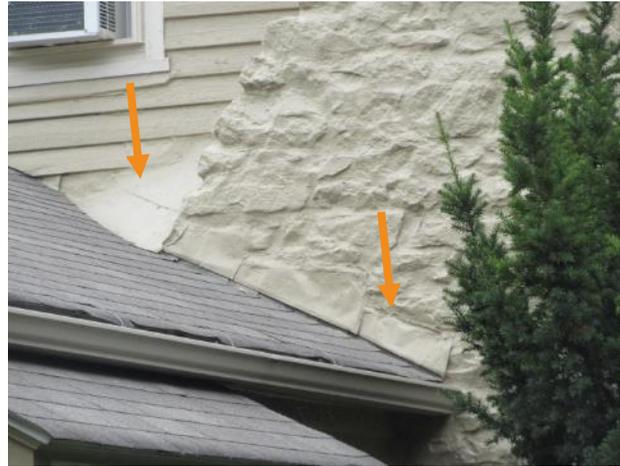
Figure 59. Asphaltic shingles and painted metal flashings (arrows) at roof.

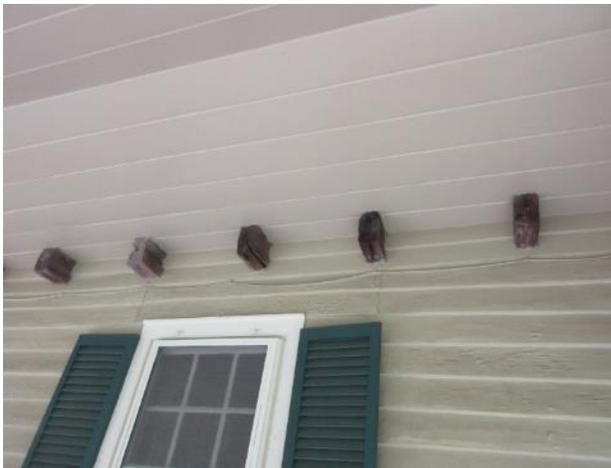
Figure 60. Second floor joists protrude beyond the clapboard, north porch.

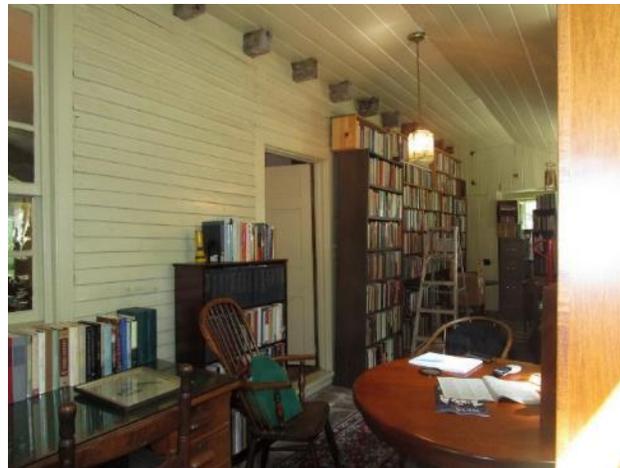
The large gable roof with flared eaves is covered with brown asphaltic shingles as well as flashings at the additions and around the chimneys (Figure 58 and Figure 59). At both the north and south facades, approximately 5 inches of the second floor joist ends protruded beyond the wood clapboard just below the porch roof. These finished wood ends provide a color contrast to the tan painted wood (Figure 60 and Figure 61). The cellar access and east and west additions have gable roofs clad with the same brown asphaltic shingles. Both east and west additions have roof vents just below the roof ridge. The original section of the house has gable end roof vents along the sides of each chimney (Figure 62). The cellar access has an inset floral design at the gable end above the door (Figure 63).

Figure 61. Second floor joists protrude beyond the clapboard, south enclosed porch.

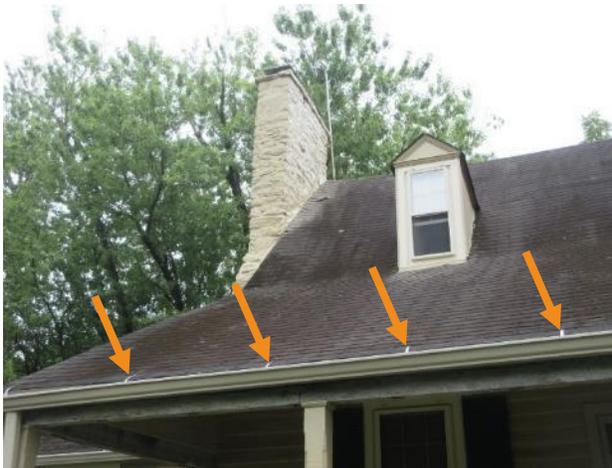
Aluminum gutters and downspouts were added to the north and south ends of the roofing after the installation of the asphaltic shingles, as the mounting brackets are visible on the shingle surface (Figure 64). There are several downspouts at the home located at each roof corner. All were observed to be depositing close to the foundation (Figure 65).

Figure 64. Gutter mounting brackets (arrows) at shingle surface.

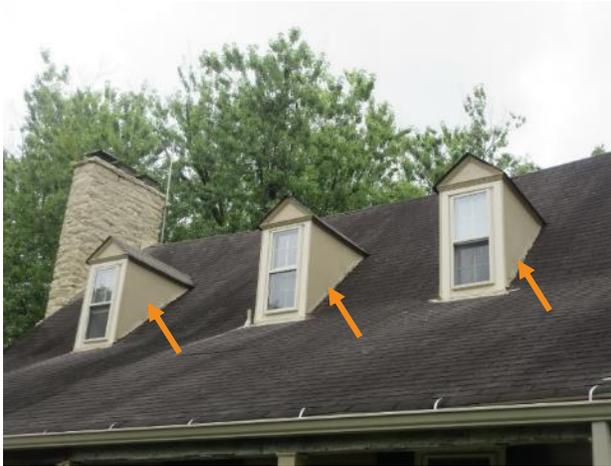
At the second floor, three gable pedimented dormers with 3/32 inch thick glass extend through the north and south sides of the roof (Figure 80). The sides of these dormer windows have been altered as historic photos show diagonally run clapboard that followed the slope of the roof. A flat piece of material is currently in place at these locations (Figure 81 and Figure 82). 6/6 double hung wood windows with 3/32 inch thick glass are also located at the gable ends of the second floor on the side of the chimney (Figure 83). The windows do not have wood shutters, but two hasps are located along the top rail of the casing from some previously removed element. These windows are currently open to accommodate the window air conditioner units. Almost all windows throughout the house have been covered with metal exterior storm windows fastened directly to the window frames. Windows without storm windows are the large picture and garden projected windows located at the west addition.

Figure 82. September 1, 2020 side view of dormers. Note flat surface of material.

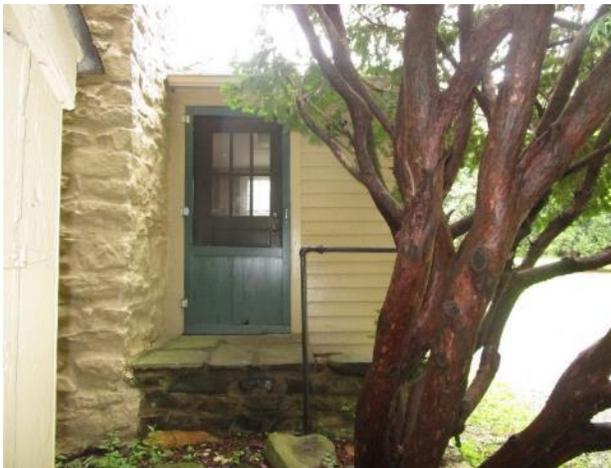
Figure 90. Kitchen door, east addition. Note contemporary hardware.

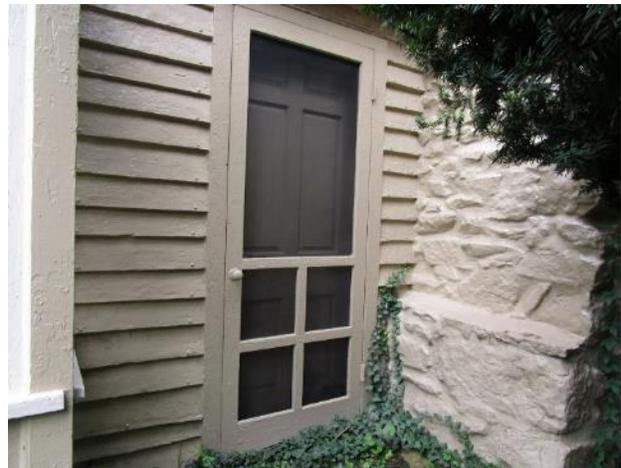
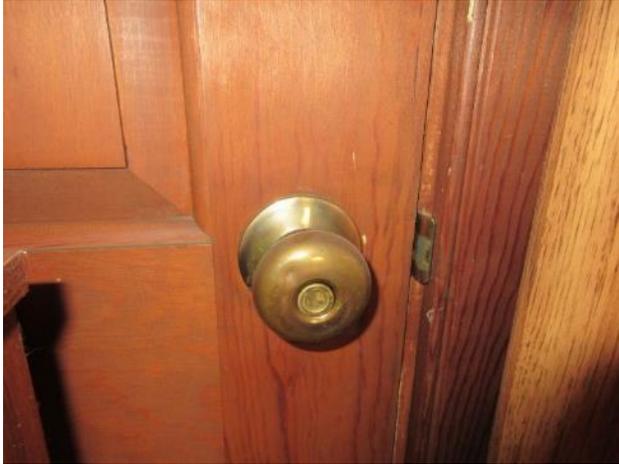
Figure 91. Study door, west addition. Note non-historic hardware.

Figure 92. Interior view of non-historic brass hardware on study door, west addition.

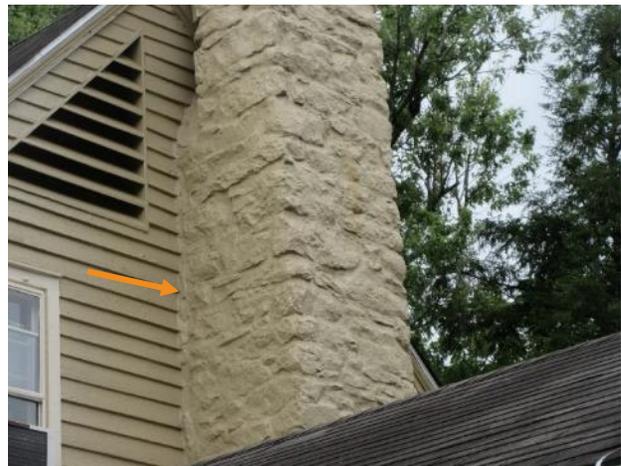
Figure 98. No metal flashings were visible at west chimney-to-clapboard interface.

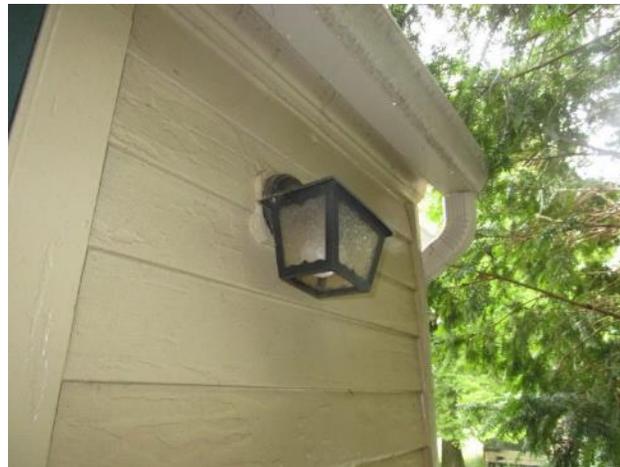
Figure 101. Non-historic metal and glass light (arrow), kitchen door, east addition.

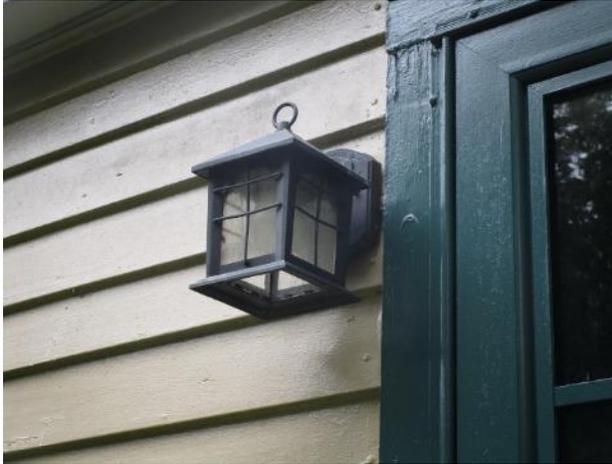
Figure 102. Non-historic light fixture, south entry door.

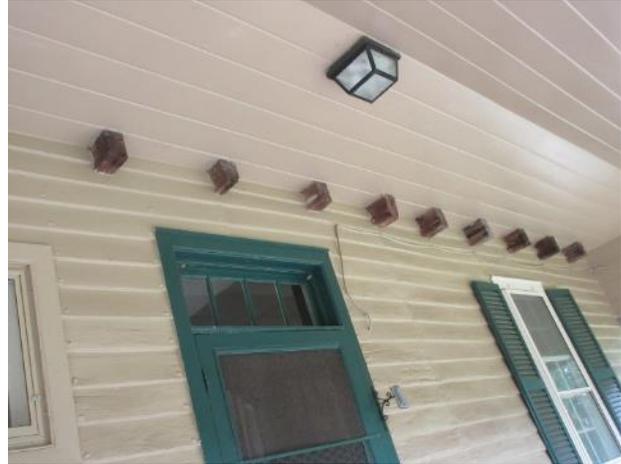
There are several types of light fixtures at the exteriors of Mount Gilead. The most common type is a contemporary two bulb flood light (Figure 100). There are also non-historic metal and glass lights east of the kitchen (east) addition door and west of the south entry door (Figure 101 and Figure 102). A ceiling mounted metal and glass fixture is located in front of the north entry door at the porch (Figure 103).

Figure 103. Ceiling mounted light fixture, north porch.

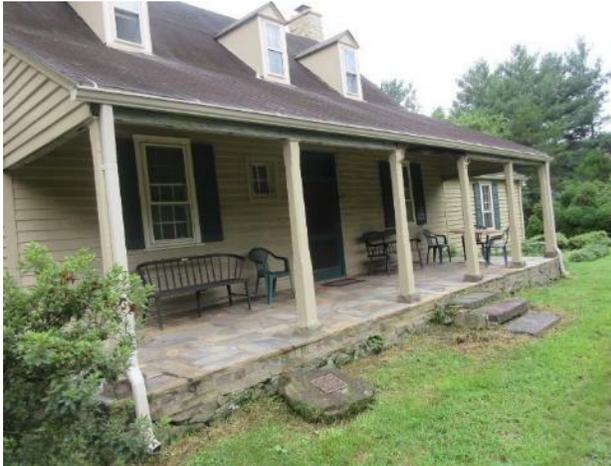
The house has one porch, which is located at the north facade (Figure 104). Originally the house front entry was on the south facade, with a porch. William Ryan, the owner of the house between 1937 and 1946, converted the south porch into a screened porch, and the windows of the porch were added at a later date. During Detwiler's restoration, the "lean-to" house section at the north was opened and transformed into a porch. While we do not have historic photographs prior to Detwiler's ownership that show the original north facade, historic photographs taken at an angle show wood clapboard in place along the east and west walls (Figure 105).

Figure 104. North facade porch.

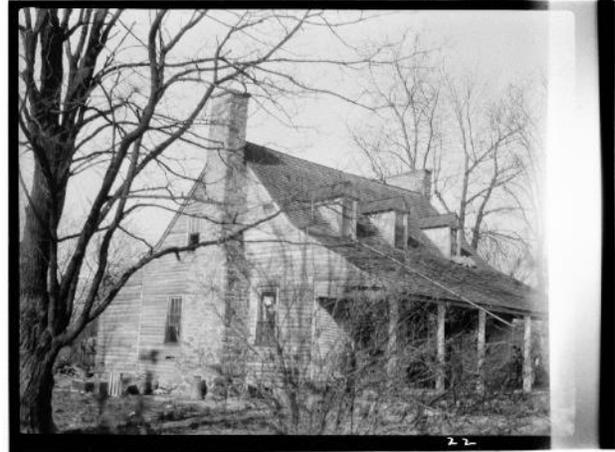
Figure 105. HABS photo prior to Detwiler's restoration showing enclosed north section of the home.

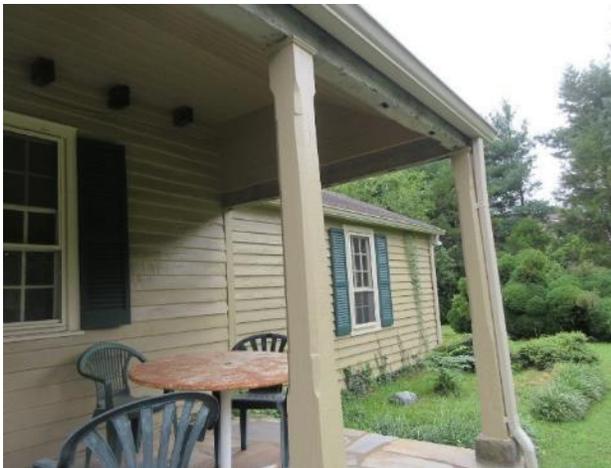
The north porch has a set of six carved posts supporting the overhanging curved eaves. The posts have carved beveled edges that taper from the top of the post and gradually transition to a wider base (Figure 106). All posts are set on top of stone blocks; however, one post has a sloped mortar wash added along the base of the post (Figure 107 and Figure 108). Detwiler's 1947 letter notes replacement of several porch wood posts, "carefully copied from the originals." WJE did not find evidence of these replacements at exposed posts, which may indicate all exposed posts on the north are replacements. The porch roof rim joist (large timber beam that supports the rafters at the eaves) is visible above the posts and is hand hewn with square wood dowels at splice locations (Figure 109). A portion of the rim joist was previously replaced, as the wood is not similarly aged or previously painted like adjacent beams (Figure 109). The rim joist is connected in the historic manner with mitered cuts and wood dowels. Distinctive adze marks were replicated in the replacement section of the beam (Figure 110).

Figure 106. Posts have beveled edges that taper from top and transition to wider base.

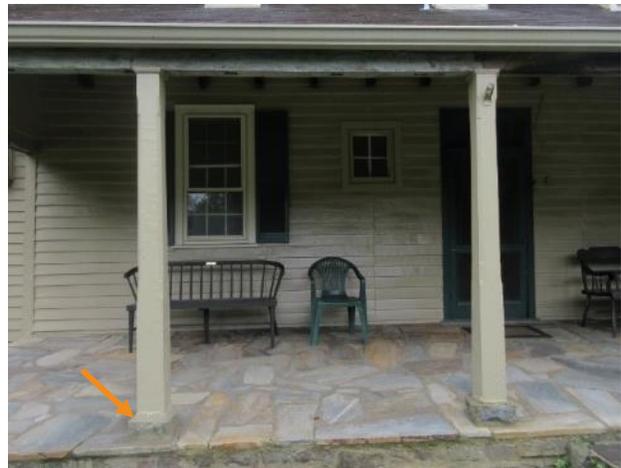
Figure 107. Posts are set on top of stone blocks. Note post at left has sloped mortar wash added along base.

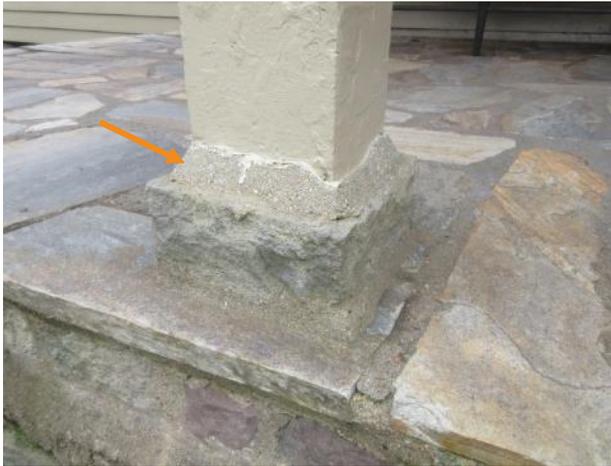
Figure 108. Close-up view of mortar wash at the base of the left post seen in Figure 107.

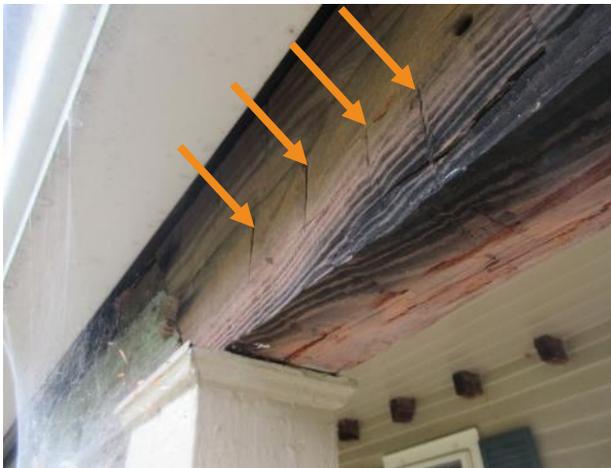
Figure 110. Adze marks on replacement beam(arrows).

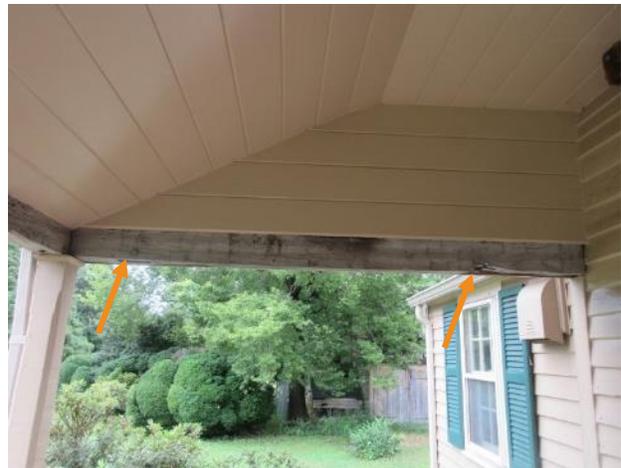
Several notches for mortise and tenon connections with some wood dowels still in place were observed at the bottom side of these timber members (Figure 111 through Figure 113). These notches may have accommodated the previous walls that enclosed this space, visible from historic photographs prior to Detwiler's ownership. Of note, the notches on the east timber member are larger and spaced farther apart, which could relate to the location of the fireplace shown in the photograph of the house during the Civil War.

Figure 111. East end joist has widely spaced notches on bottom side. See Figure 113.

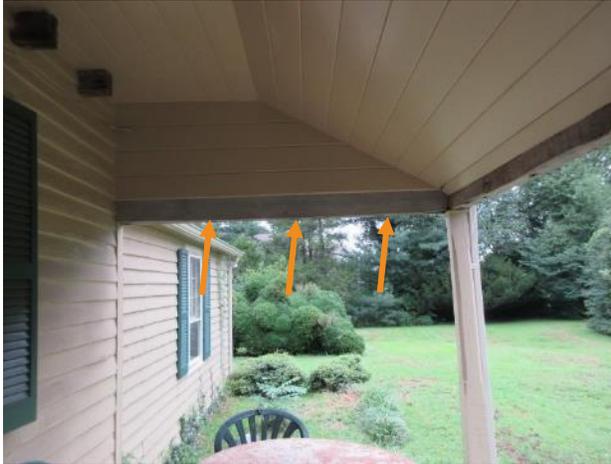
Figure 112. West end joist has notches on bottom side. See Figure 113.

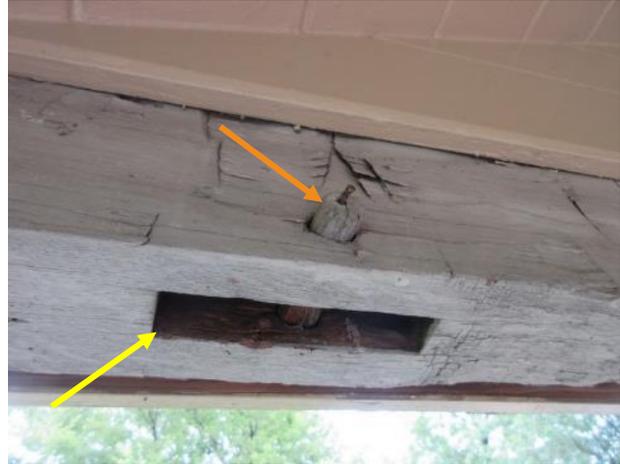
Figure 113. Close-up bottom view of end joist. Note notch (yellow arrow) and wood dowel (orange arrow) for mortise and tenon connections.

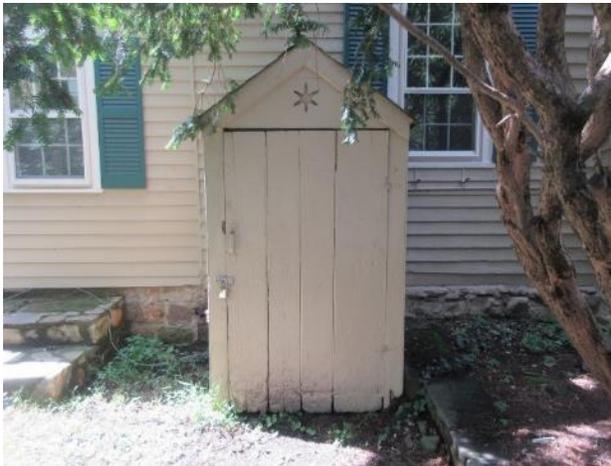
Figure 114. Cellar access, south end, east facade.

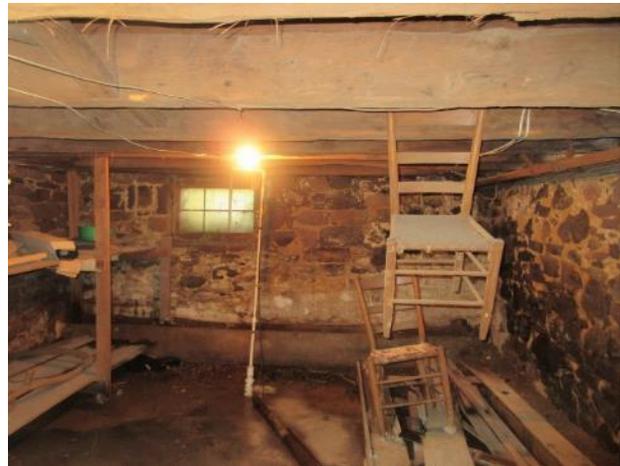
Figure 115. Cellar is an open room at full height aligned with the southern half of the original section of the home.

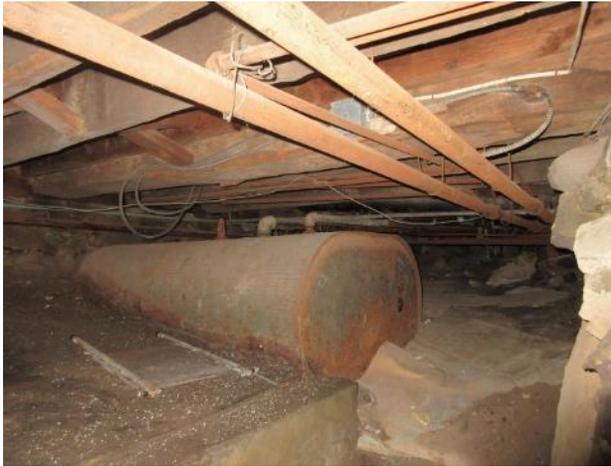
Figure 116. A crawl space is north of the cellar, aligned with the north half of the original section of the home.

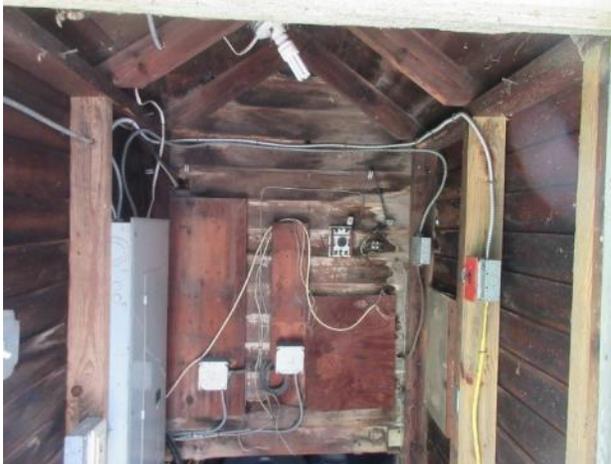
Figure 118. Cellar access shed is wood-clad.

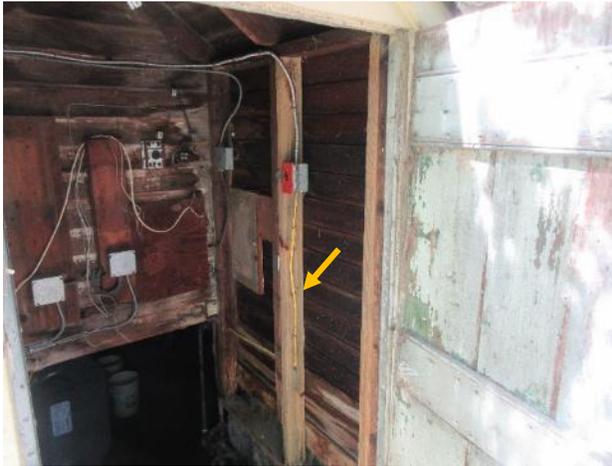
Figure 120. Contemporary 2x4 members sistered to vertical framing on north wall.

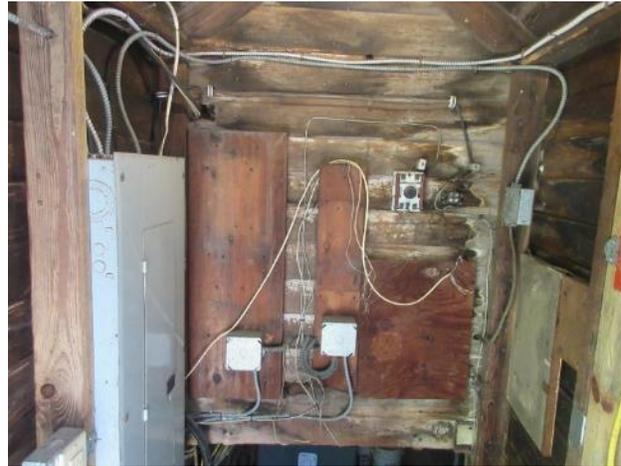
Figure 121. Electrical penetrations feed between house and cellar.

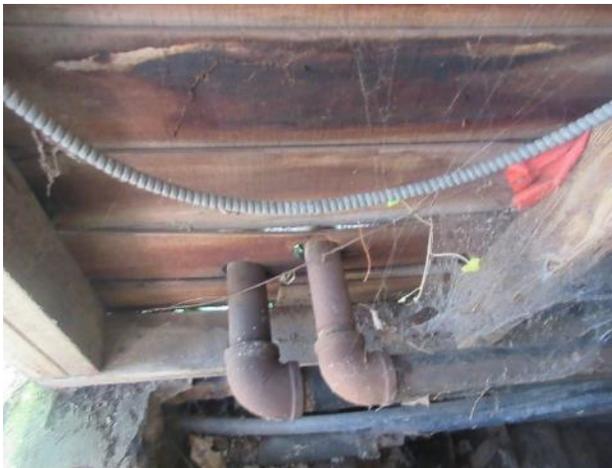
Figure 122. Plumbing penetrations, cellar access.

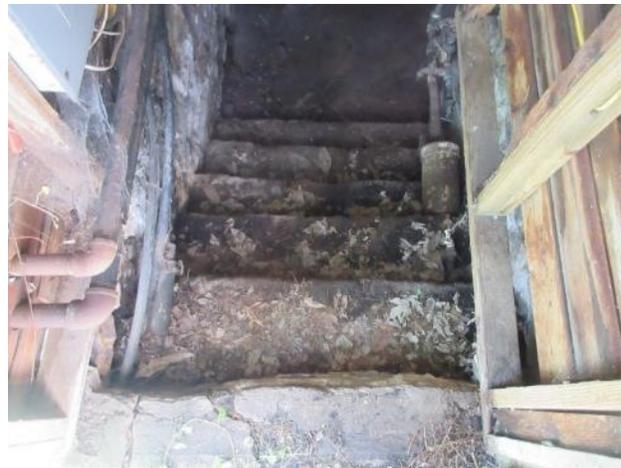
Figure 123. Masonry steps lead down to cellar.

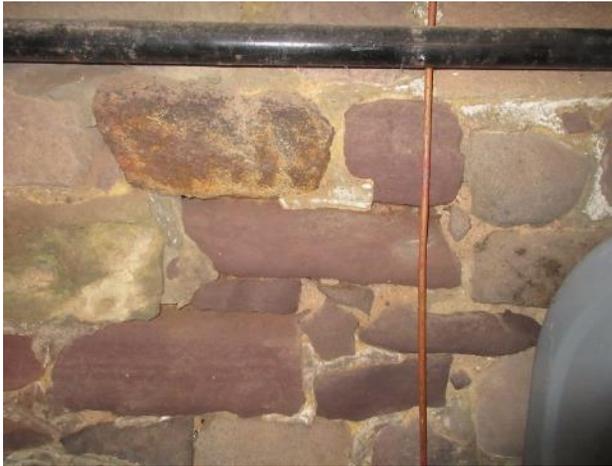
Figure 124. Cellar walls are made up of red sandstone with a sand and lime-based mortar.

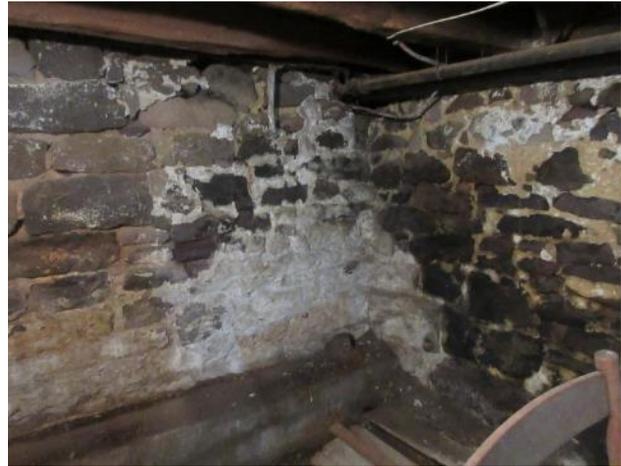
A white coating covers portions of the masonry walls, particularly near grade or at the mortar joints (Figure 125 and Figure 126). Within the cellar, a water heater and furnace are installed in the northeast corner and a gas tank in the southeast corner (Figure 127 and Figure 128). The floor consists of a concrete slab (Figure 129), and an exposed ceiling shows hand-adzed wood first floor joists supporting the floor boards (Figure 130). Contemporary insulating sheathing is installed between the wood joists and first floorboards.

Figure 125. White coating remnant on cellar walls.

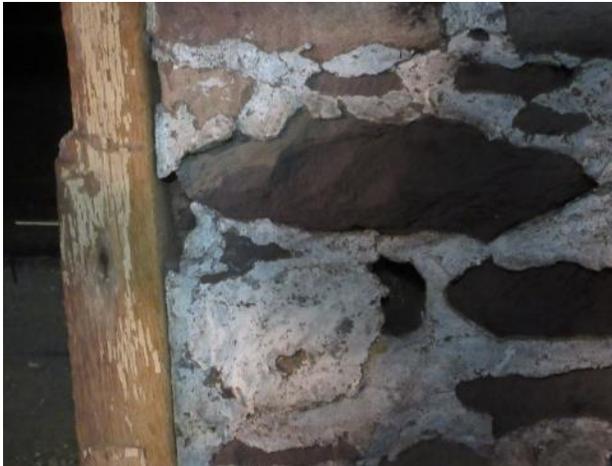
Figure 126. White coating remnants on cellar walls, at mortar joints.

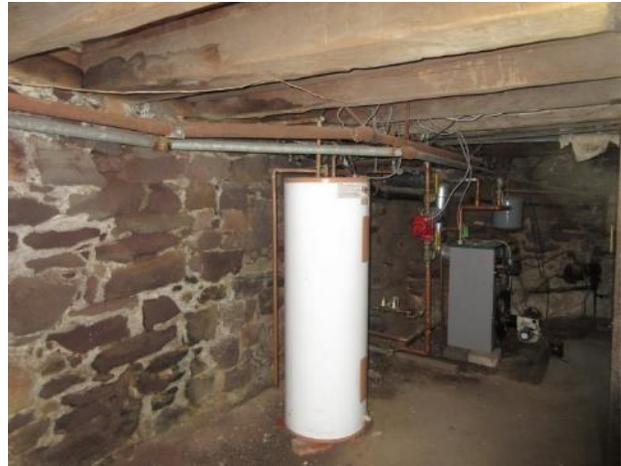
Figure 127. A water heater and furnace are installed in the northeast corner.

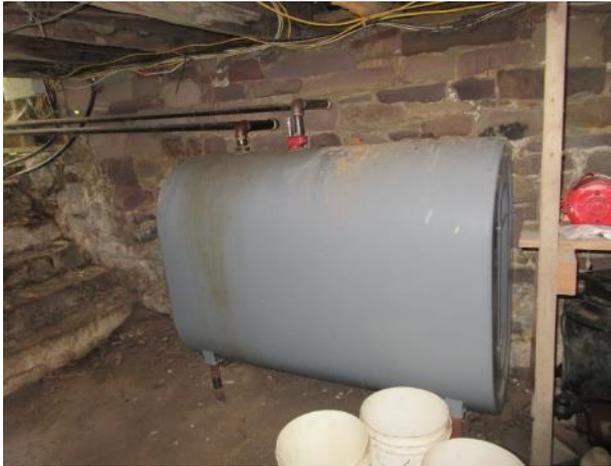
Figure 128. An oil tank sits in the southeast corner.

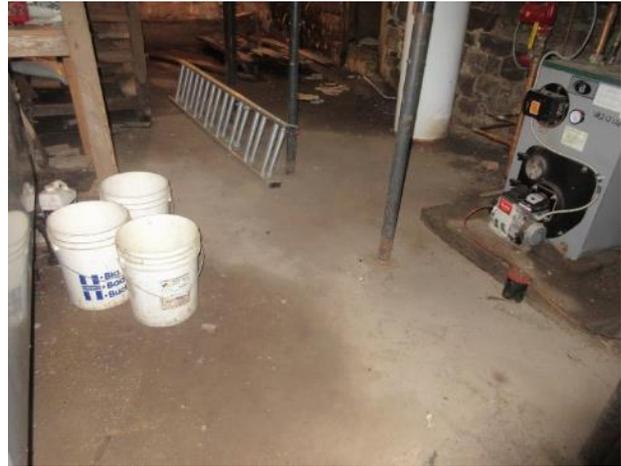
Figure 129. Concrete floor in cellar.

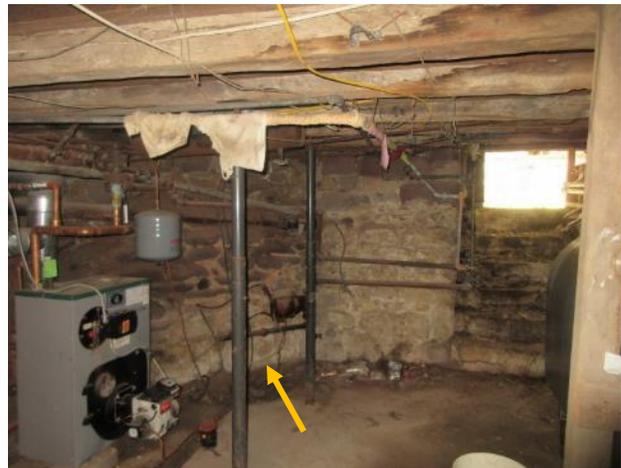
Figure 131. Angled corner foundation of dining room fireplace. See Figure 117.

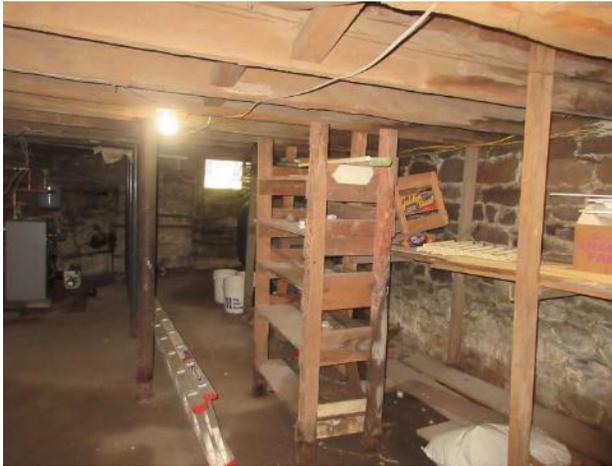
Figure 132. Open wood shelving near gas tank, south wall.

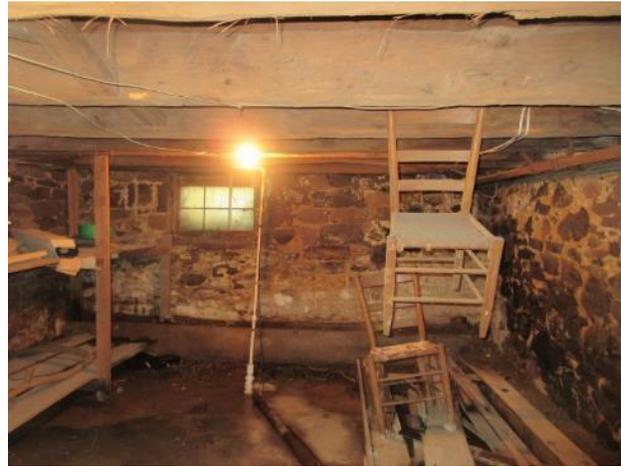
Figure 133. Six-lite frosted window north of open shelving. This window was not observable at the exterior.

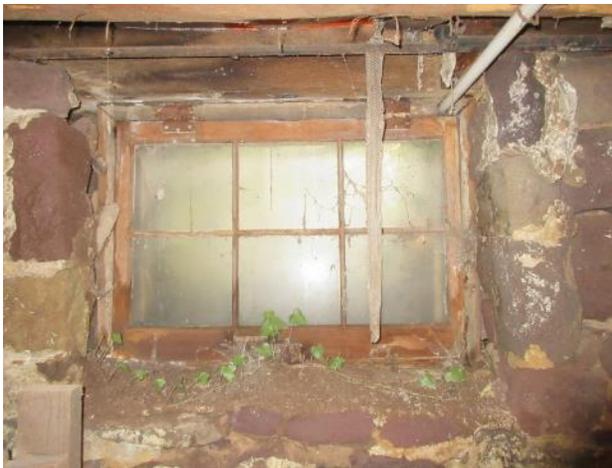
Figure 134. Close-up view of awning window in Figure 133.

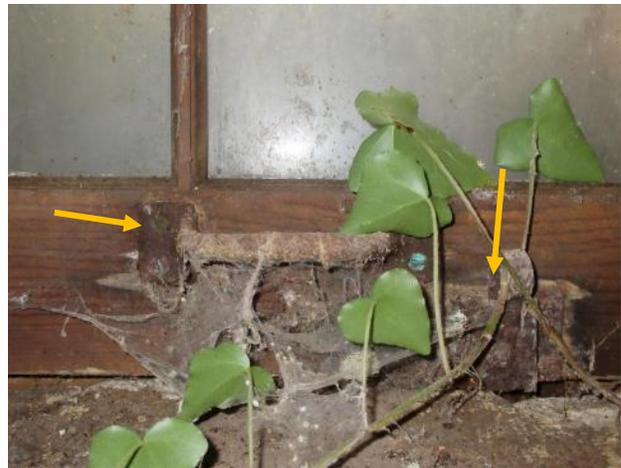
Figure 135. Steel handle and latch of window seen in Figure 133 and Figure 134.

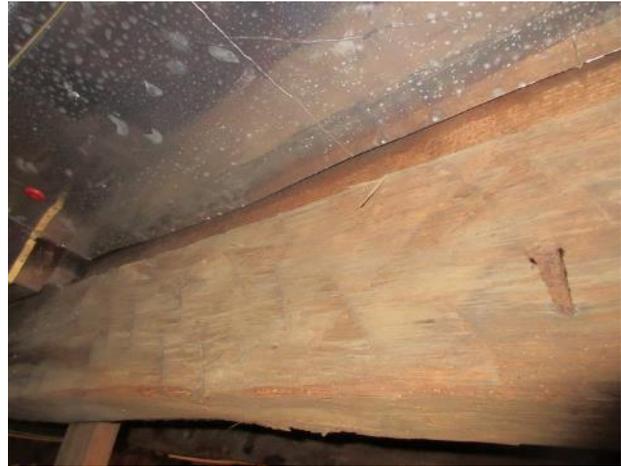
Figure 137. Close-up view of hand-adzed floor joist.

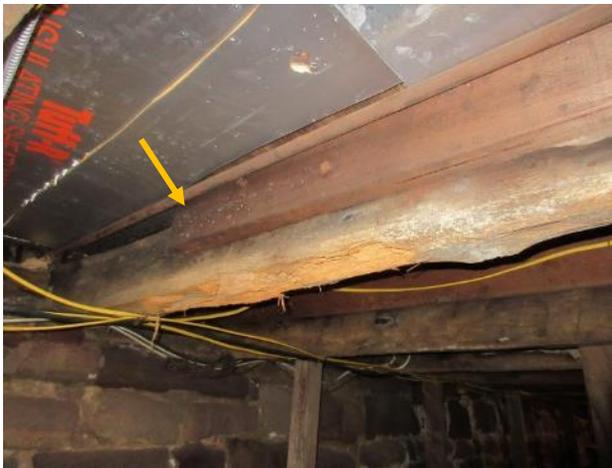
Seventeen hand-adzed wood floor joists supporting the first floor (below the dining and living rooms) are visible running north-to-south (Figure 136 and Figure 137). Some of the wood joists have more contemporary machine-planed wood sistered using bolts to one or both sides, either partial or full-length of the joist (Figure 138 and Figure 139). The hand-adzed wood joists were typically 8-1/4 inches tall by 4-1/4 inches wide. Several joists were wider (up to 8-1/2 inches wide), such as the joist farthest to the east and the joists on either side of the timber-framed crawl space door (Figure 140). Joists, separated by wood ledger boards, are supported on both ends by the north and south load-bearing masonry walls (Figure 141). Four wood joists on the east half of the cellar are supported by scaffold jacks (Figure 142). Planed wood cross bracing provides support between the hand-adzed wood joists, along the centerline of the west half of the cellar (Figure 143). The planed (machine sawn) surface indicates a more recent addition than the adzed wood joists. Detwiler's 1947 letter mentions installing cross bracing. Some carved and written graffiti was observed on several joists (Figure 144 and Figure 145).

Figure 138. Contemporary sistered joist, partial length of the hand hewn joist.

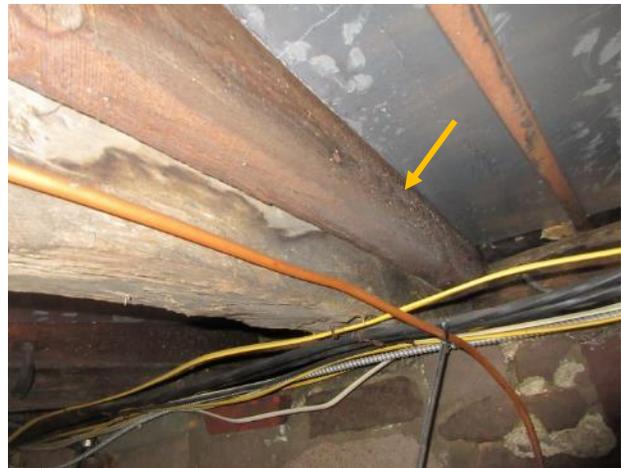
Figure 139. Contemporary sistered joist.

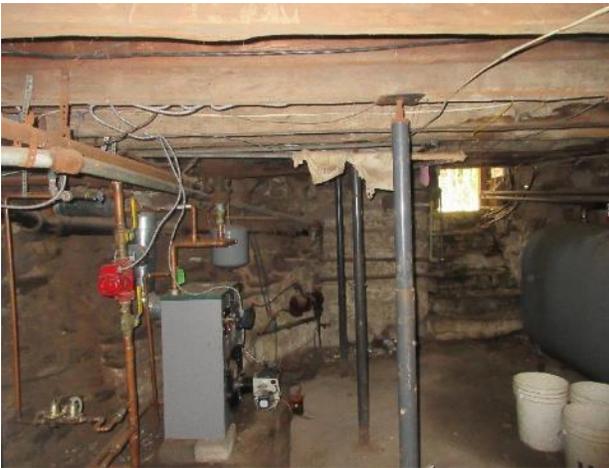
Figure 142. Four joists are supported by metal scaffold jacks.

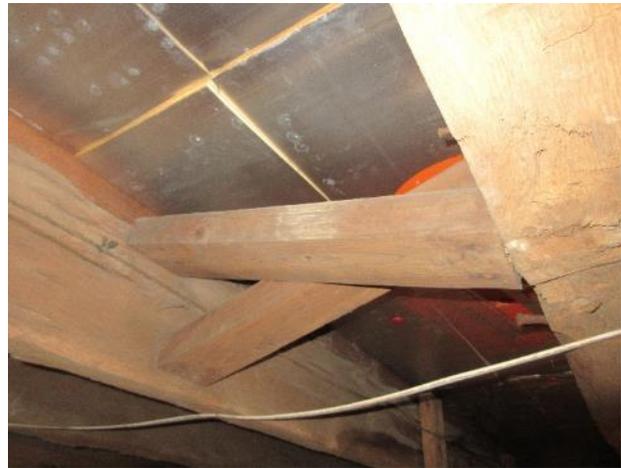
Figure 143. Cross bracing has been installed between several joists.

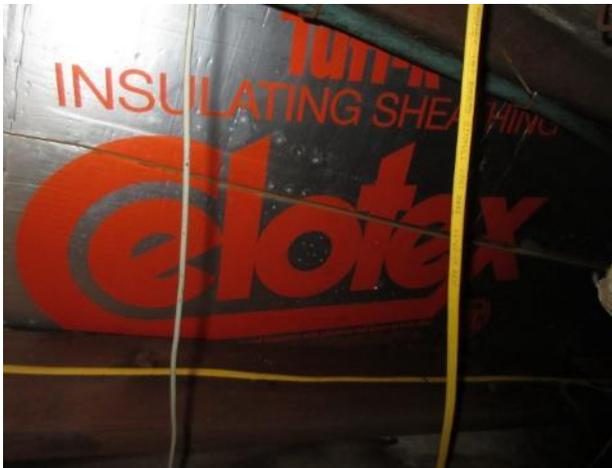
Celotex Insulating Sheathing with aluminum foil facers on both sides has been retrofitted between the wood joists and first floorboards (Figure 146). According to the current occupant, this was added by Fairfax County to deter snakes from entering the first floor residence. Electrical wires and plumbing pipes were attached or hung to the wood joists.

Figure 146. Celotex insulating sheathing installed below the floor boards, between joists.

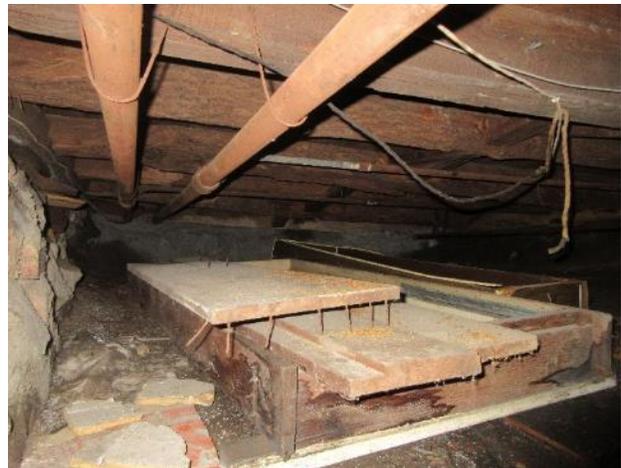
Figure 155. Wood materials and possibly door stored on the dirt in the crawl space.

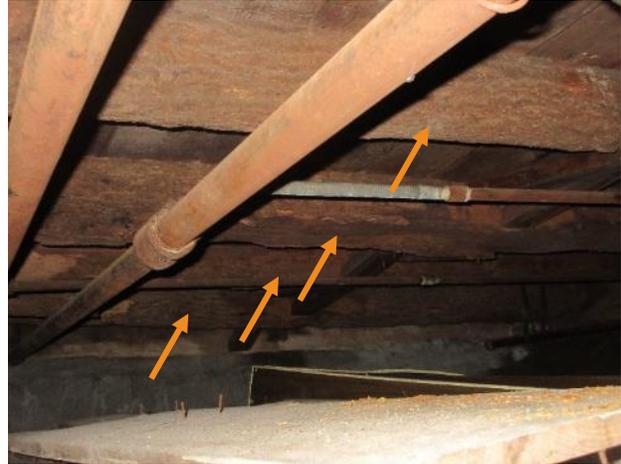
The visible ceiling is similarly composed of mixture of hand-adzed and machine sawn wood floor joists supporting the visible first floorboards (Figure 156). Four of the western-most floor joists are logs that were not debarked (Figure 157). These are likely the floor joists that Detwiler documented replacement of in his 1947 letter to Captain King. Detwiler also noted the need to re-adze some of the joists. Surfacing was observed on several joists to substantiate this claim, including on debarked logs (Figure 158). Similar to the cellar, planed (machine sawn) wood cross bracing provides support between the wood joists, along the entire centerline of the crawl space. Electrical wires and plumbing pipes were also attached or hung to the wood joists.

Figure 157. Westernmost floor joists in the crawl space still have bark on the log.

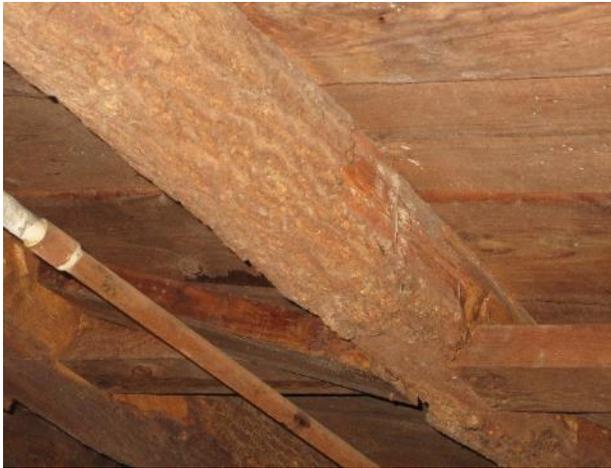
Figure 158. Log joists with cross bracing.

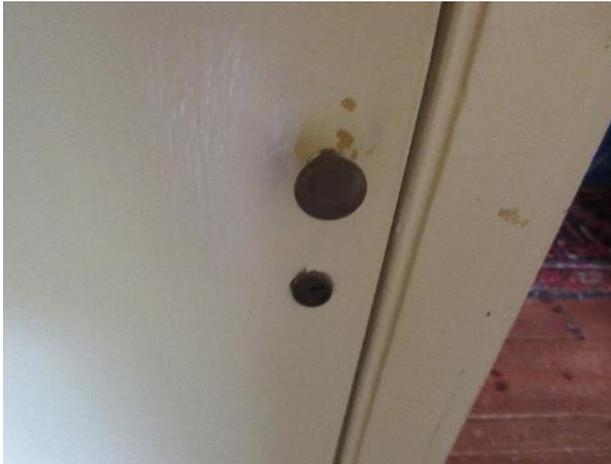
Figure 170. Replacement pull knob at exterior of storage cabinet.

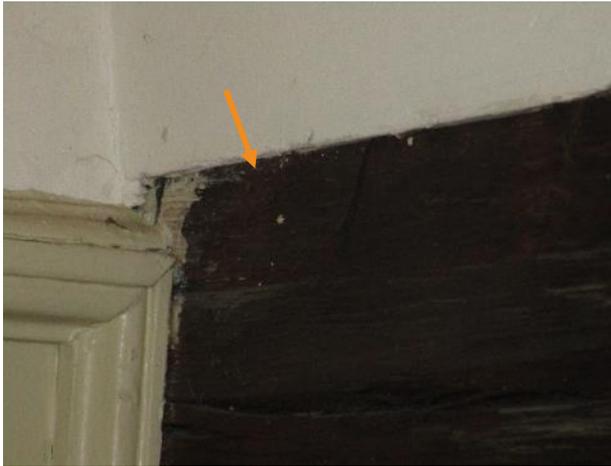
Figure 174. Exposed timber beam along the staircase. This north end has a partial dutchman.

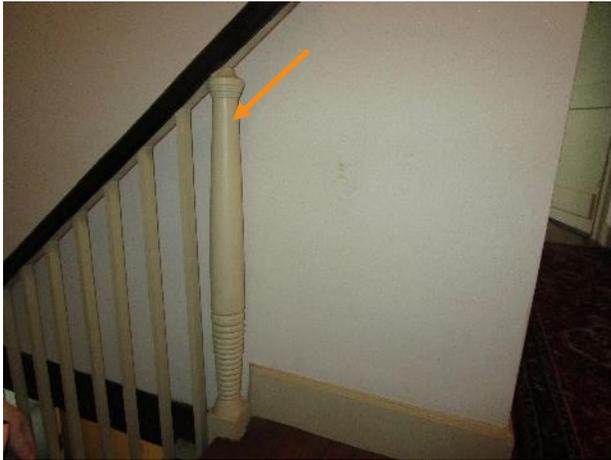
Figure 182. Decorative newel post at the second floor landing.

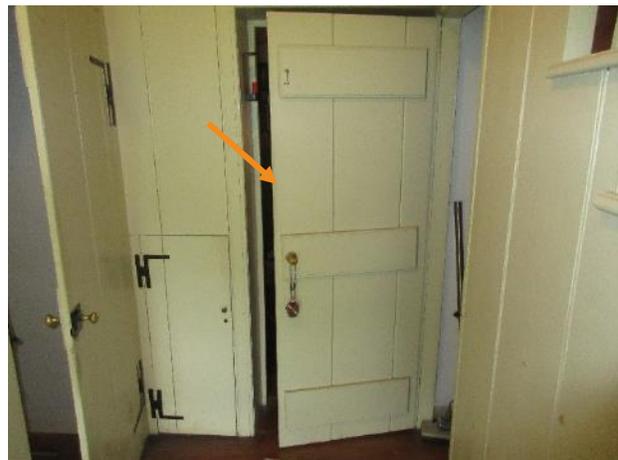
Figure 183. Door leading to the closet as viewed from the hallway.

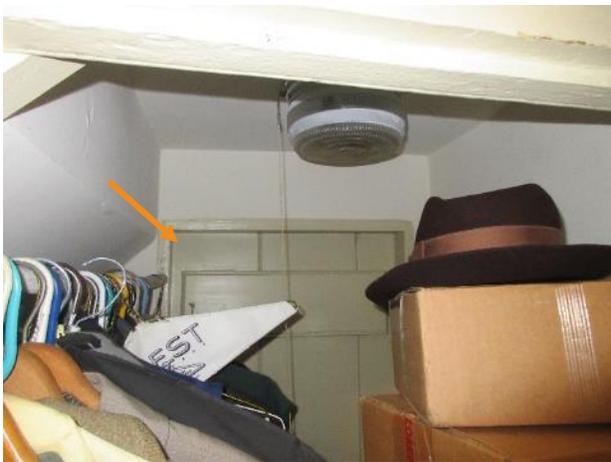
Figure 184. View west inside closet towards a door that leads to the library.

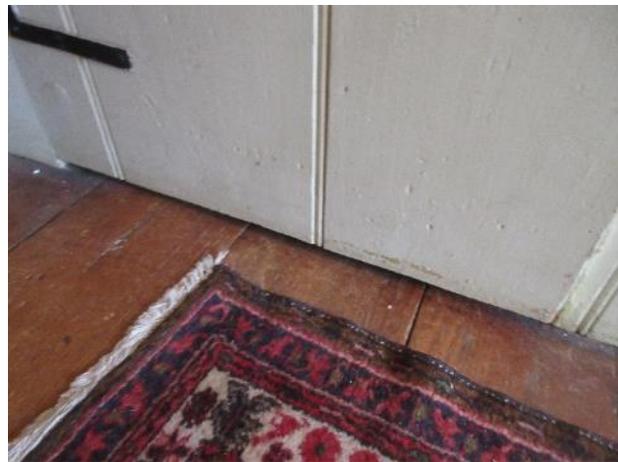
Figure 185. Hallway door and flooring is typical of the rest of the house.

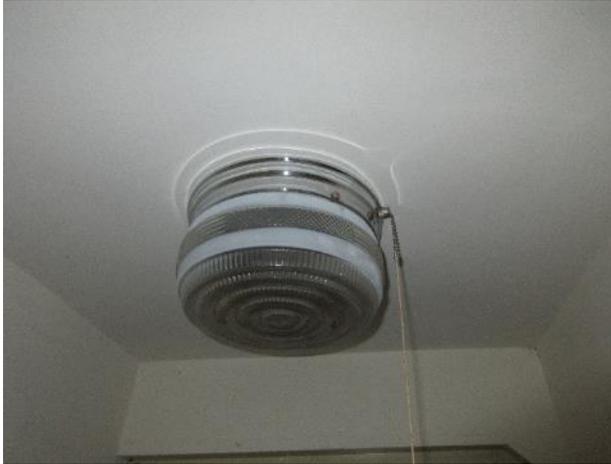
Figure 186. Ribbed ceiling mounted light fixture in the closet.
