## Mount Gilead

### Historic Structure Report

### FINAL REPORT

WJE No. 2019.8373

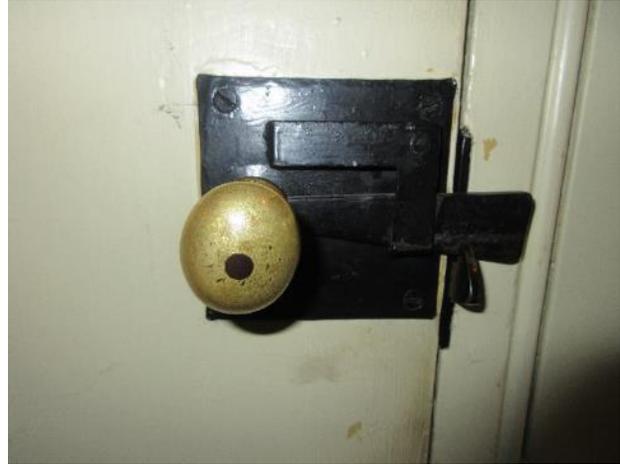
The doors to the powder room, kitchen, closet, and storage in the hallway are composed of the same tongue-and-groove panelling on the walls. All doors have typical iron HL-hinges and iron door plates for the brass door knobs. The door handle has a lever action, with latches located within the hallway (Figure 187).

Figure 187. Typical bar latch hardware that is knob activated.

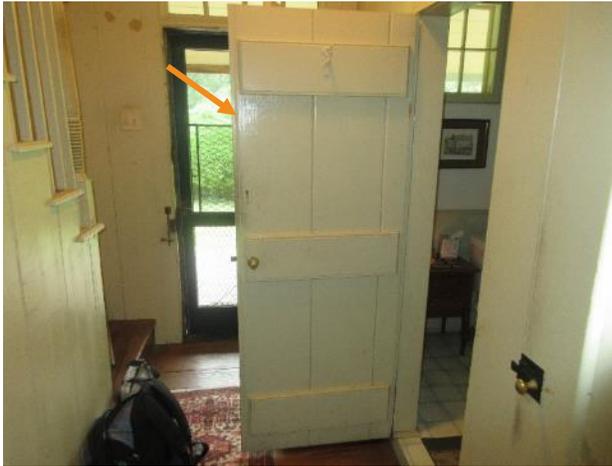
Figure 188. Typical door leading to the powder room.

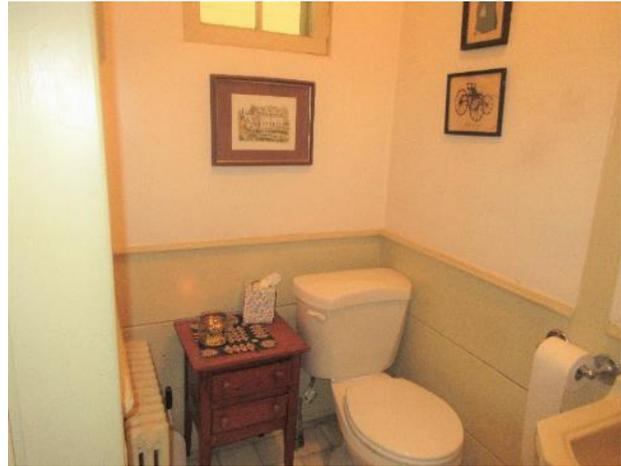
Figure 189. View north into the powder room.

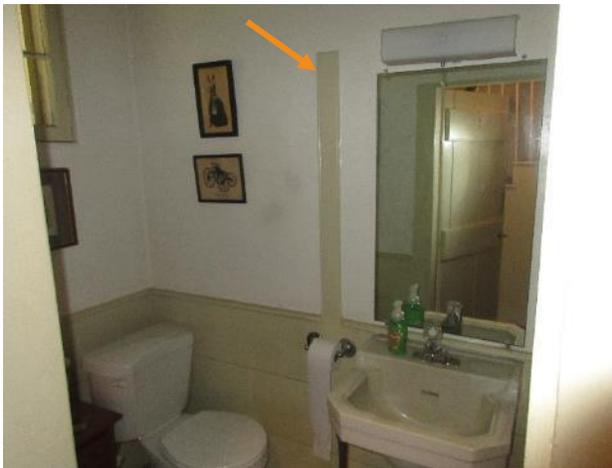
Figure 190. View east into the powder room. Note inset wood panel.

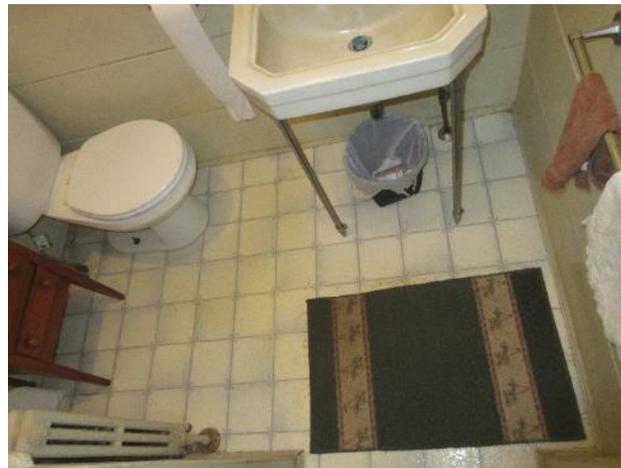
Figure 191. Linoleum flooring in the powder room.

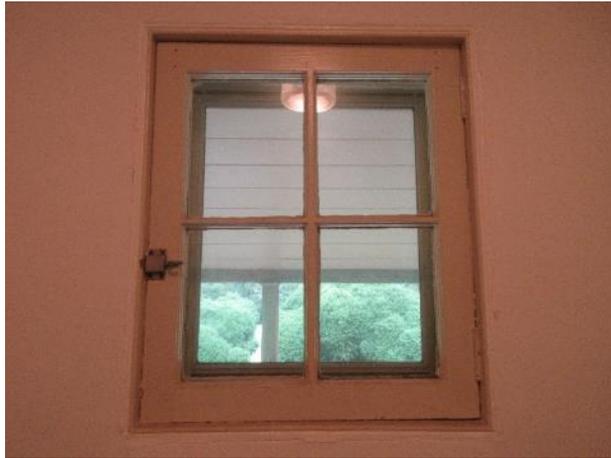
Figure 192. Casement window located at the north wall.

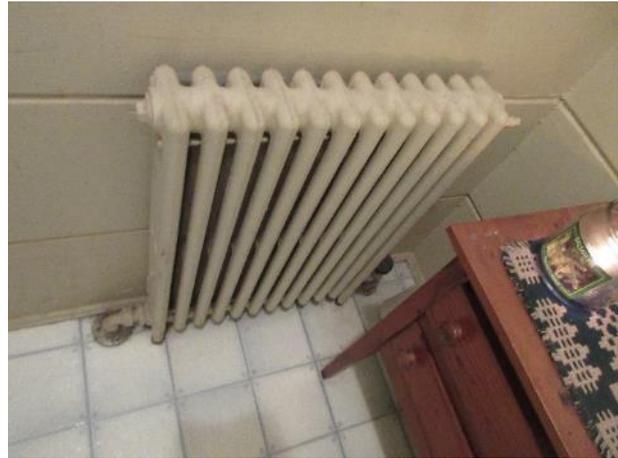
Figure 193. Typical radiator along the west wall of the powder room.

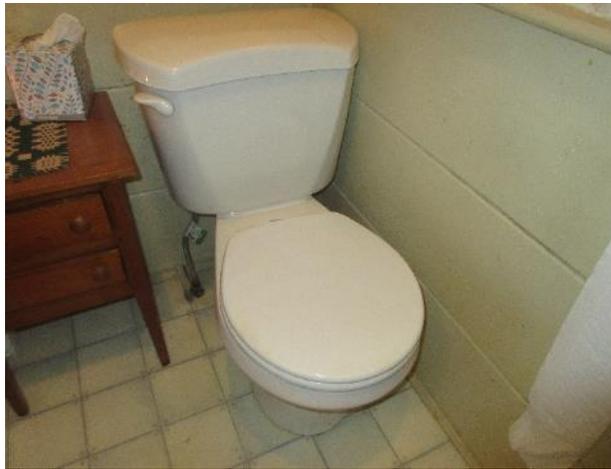
Figure 194. Contemporary fixture in the powder room.

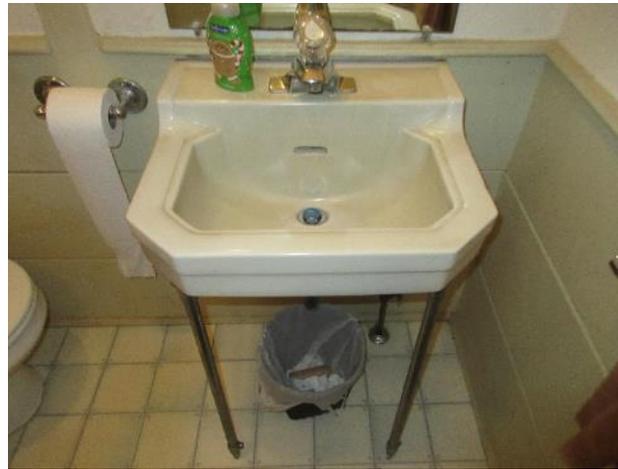
Figure 195. 1930s era metal leg sink, which is a typical style for all bathrooms in the house.

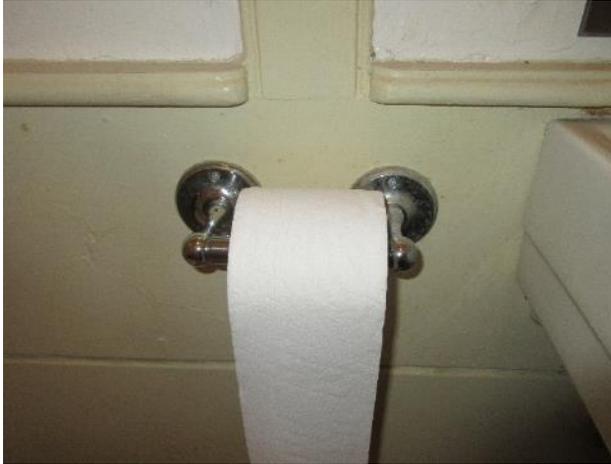
Figure 196. Coordinating fixtures to the 1930s era sink.

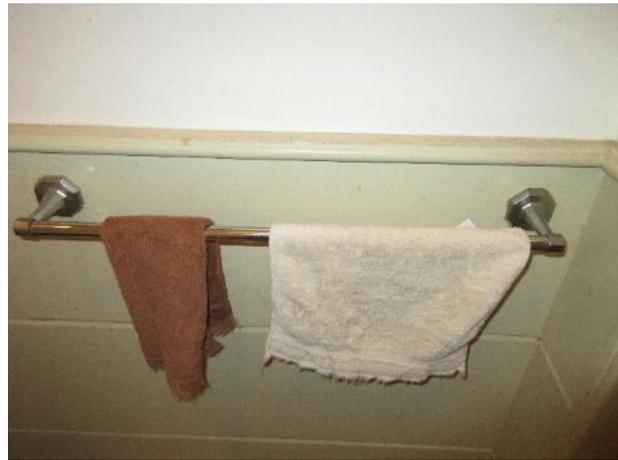
Figure 197. Coordinating fixtures to the 1930s era sink.

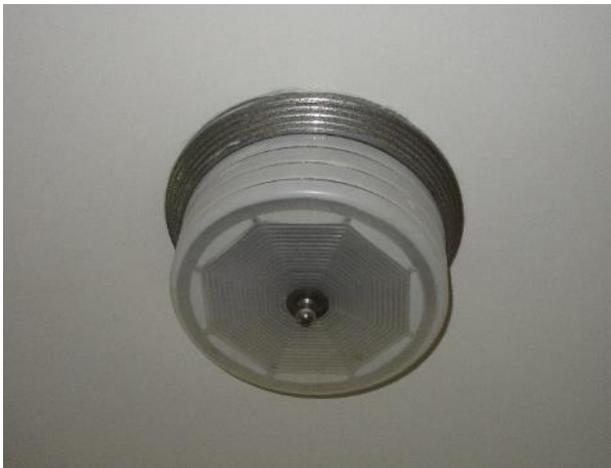
Figure 198. Ribbed milk glass ceiling mounted light fixture.

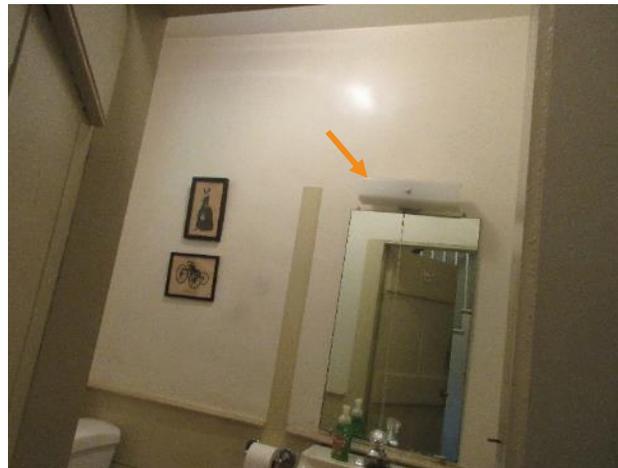
Figure 199. Rectangular light above the mirror at the east wall.

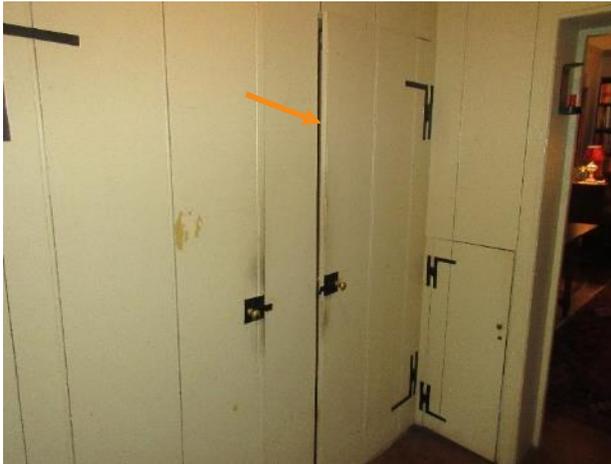
Figure 200. View of kitchen door from the hallway.

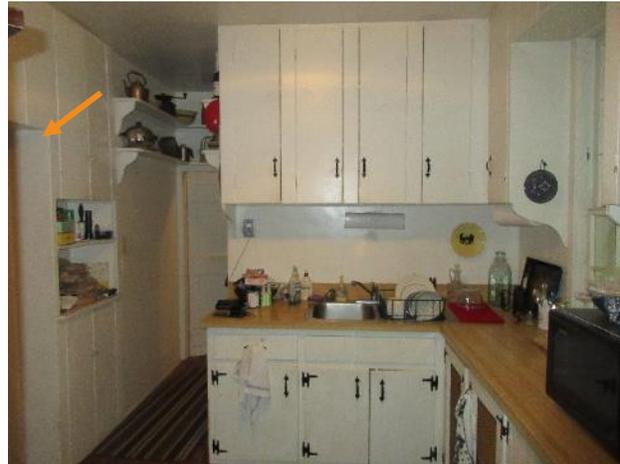
Figure 201. View in kitchen towards the west. Access from the dining room is from the south (left).

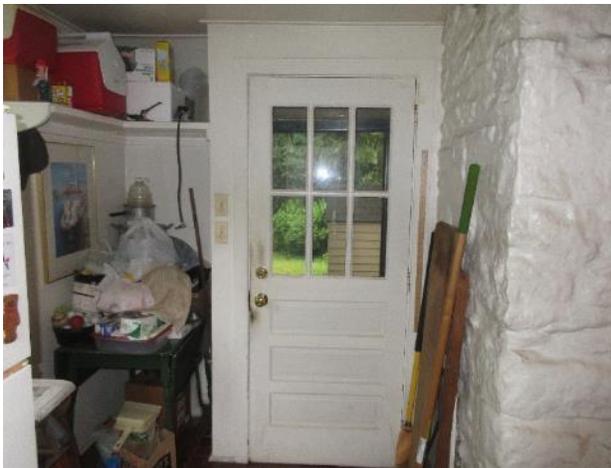
Figure 202. Exterior access at the south into the kitchen addition section.

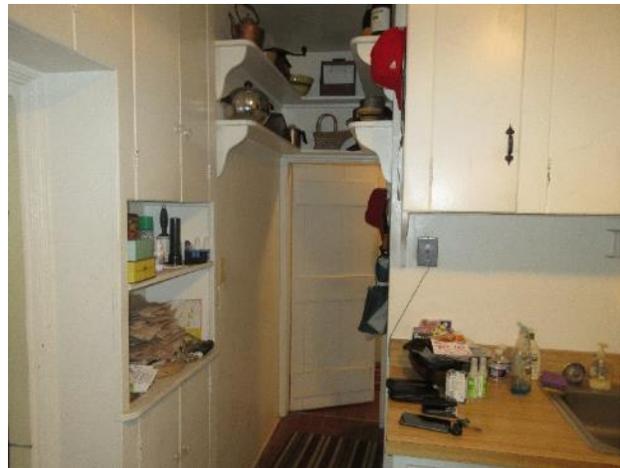
Figure 203. Kitchen hallway passes south of the powder room, looking west.

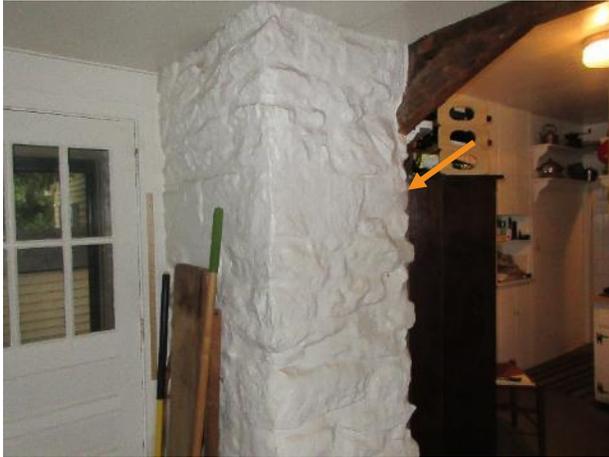
The walls are typical throughout, except for the field stone masonry wall between the original section of the home and kitchen addition (Figure 204), as well as a series of built-in cabinets on the south wall, panelled similar to the look of the tongue-and-groove wood panelling in the hallway (Figure 205). The masonry wall extends into the kitchen at an angle, mirroring the plan of the fireplace in the dining room.

Figure 204. Section of masonry dividing the original kitchen from the kitchen addition.

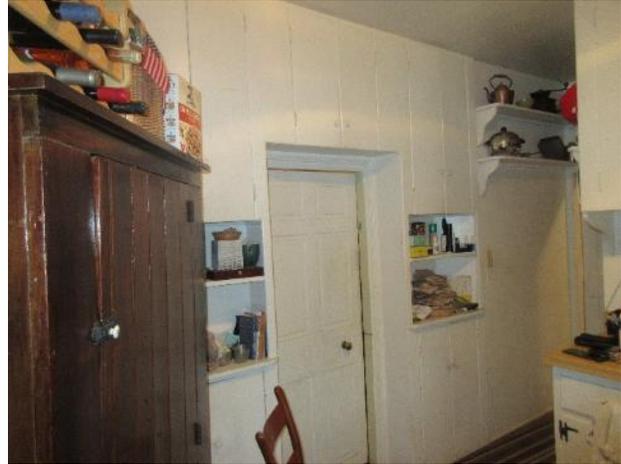
Figure 205. Kitchen finishes in the original section consists of typical wall paneling with built in cabinets. Door way leads to the dining room.

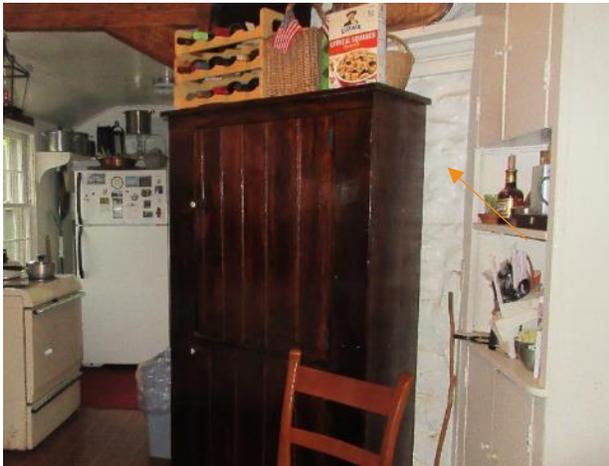
A freestanding cabinet covers the angled interior masonry wall face in the original section of the home. According to the occupant, the masonry wall did not have an open flue and was continuous masonry. A decorative moulding on the masonry wall was visible above the cabinet (Figure 206). The flooring is composed of red thin-set brick pavers set with grout (Figure 207). Two typical ribbed milk glass light fixtures are mounted on the original section of the kitchen ceiling as well as in the kitchen addition (Figure 208 and Figure 209). A wrought iron pendant light fixture with a glass hurricane candle holder encasing a red candle is hung from the wood beam that separates the original section of the home from the kitchen addition (Figure 210).

Figure 206. Angled masonry wall is located behind the cabinet, looking east.

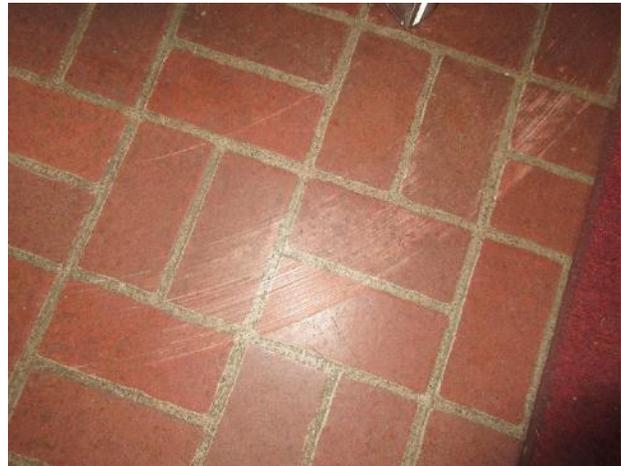
Figure 207. Basket weave brick paver flooring in the kitchen.

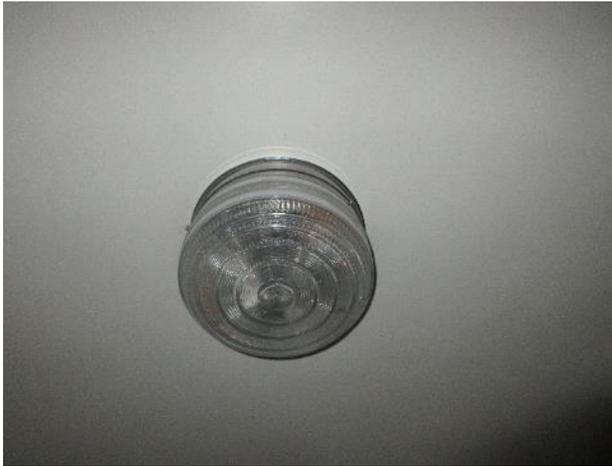
Figure 208. Typical ribbed ceiling mounted light fixture in the original section of the kitchen.

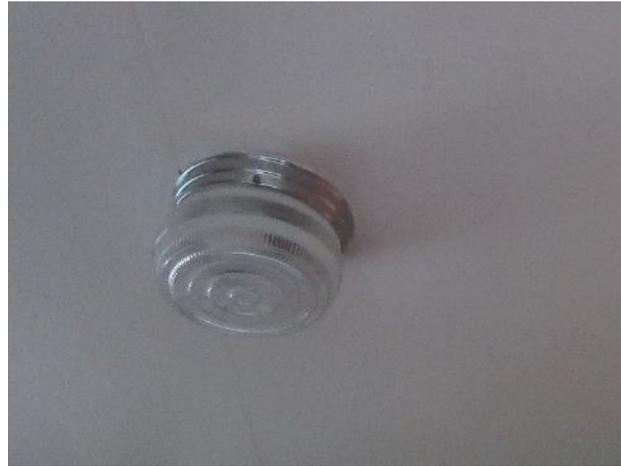
Figure 209. Typical ribbed ceiling mounted light fixture in the kitchen addition.

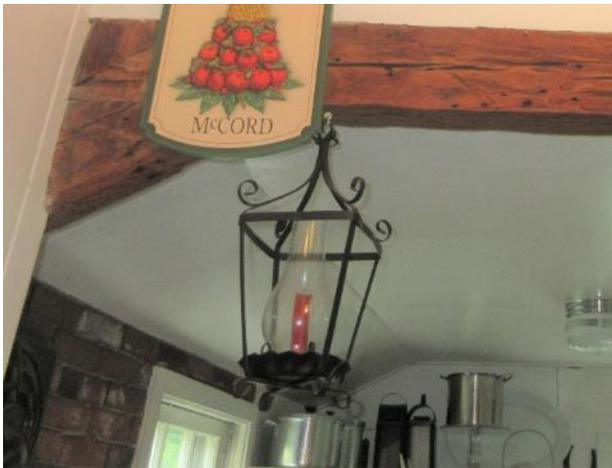
Figure 210. Candle lantern hanging from the timber beam that divides the original section of the kitchen from the addition.

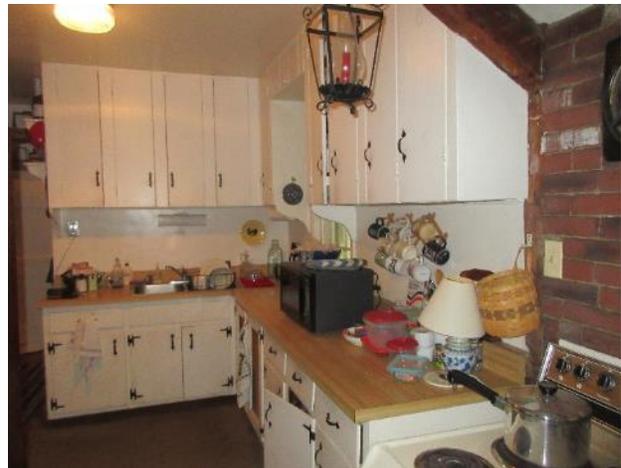
Figure 211. Wood cabinets located along the north and west walls of the kitchen.

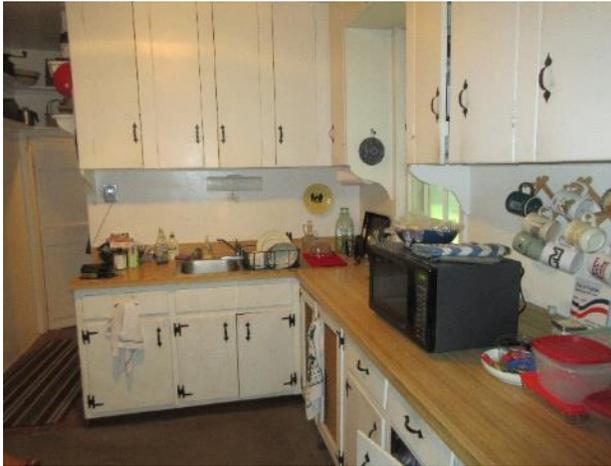
Figure 212. A sink is located centered at the west cabinet wall.

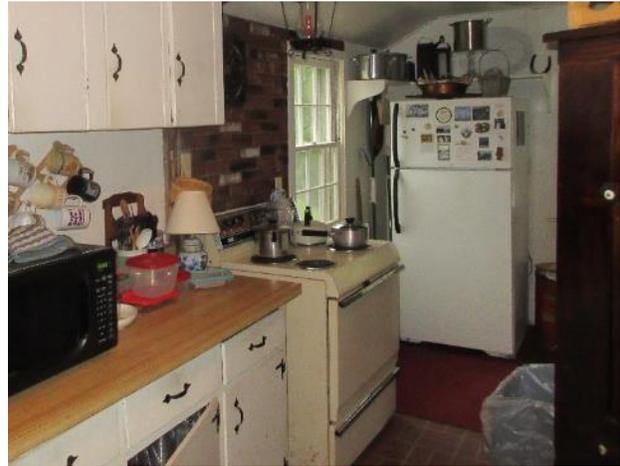
Figure 213. View northeast into kitchen addition where the stove and fridge are located.

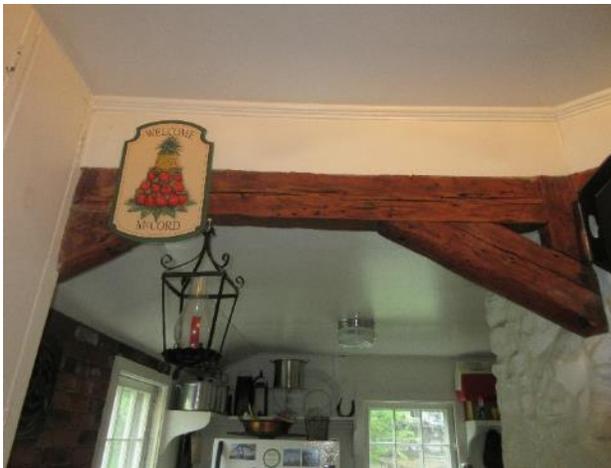
A wood beam, with wood braces to bearing walls on either side of the opening, creates the division of the original space to the addition (Figure 214). The drywall ceiling in the addition is lower than in the original section of the kitchen, with a short section along the north wall installed at an acute angle, which then levels out (Figure 215).

Figure 214. View east towards the timber beam dividing the original kitchen space from the addition.

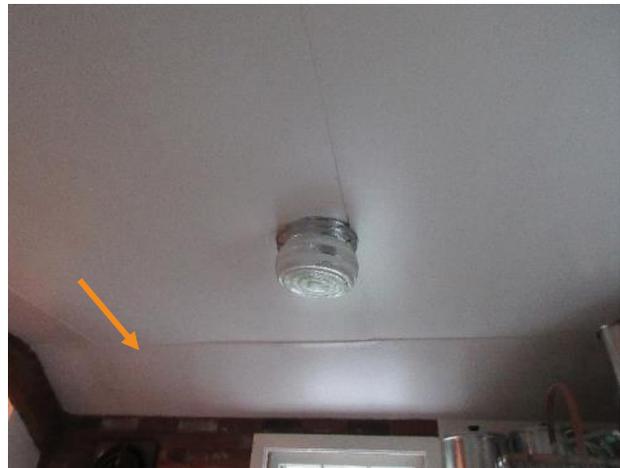
Figure 215. View north at the kitchen addition ceiling, which sloped down along the exterior wall.

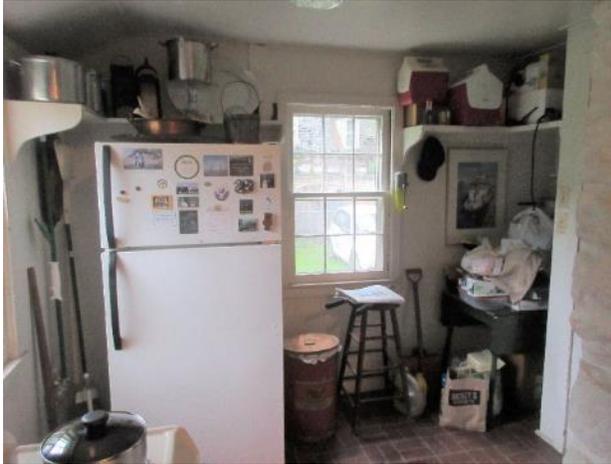
A refrigerator is located along the east wall with wood shelf above. The shelf extends from the kitchen addition north window to the edge of the north wall and wraps along the east wall to the edge of another window (Figure 216). There is an alcove in the kitchen addition, east of the vestibule entrance with another similar wood shelf.

Figure 216. View east into the kitchen addition, which shows the fridge, wood shelves above, and a window.

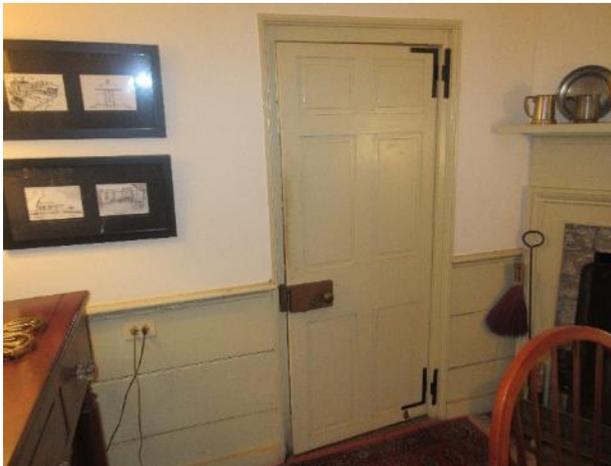
Figure 218. View of door between kitchen and dining room, looking north.

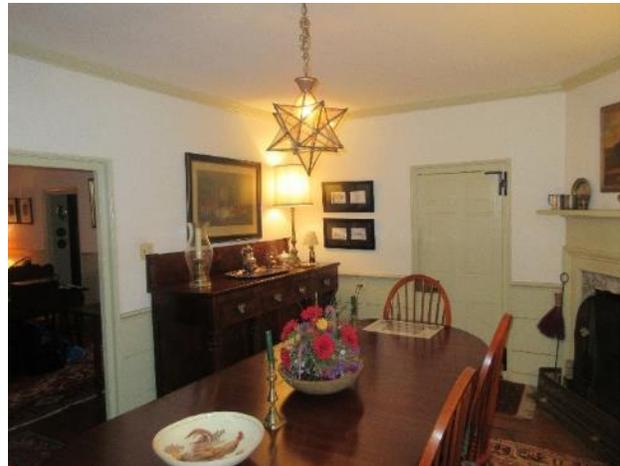
Figure 219. View northwest into the dining room with kitchen door at the north wall.

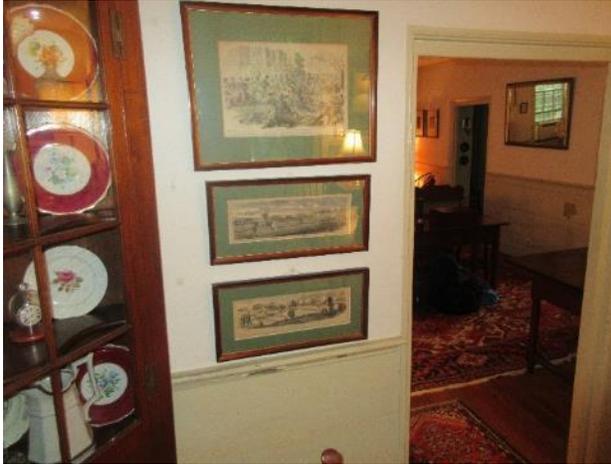
Figure 220. Door opening along the west wall leads to the living room.

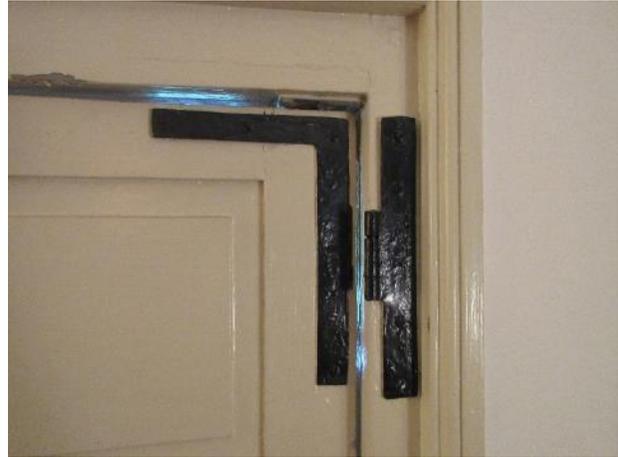
Figure 221. Typical HL-hinges at all doors throughout the house.

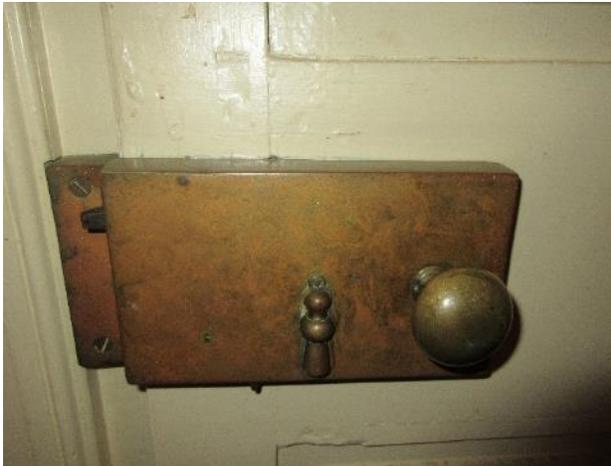
Figure 222. Large brass rim lock located at the dining room side of the door connecting to the kitchen.

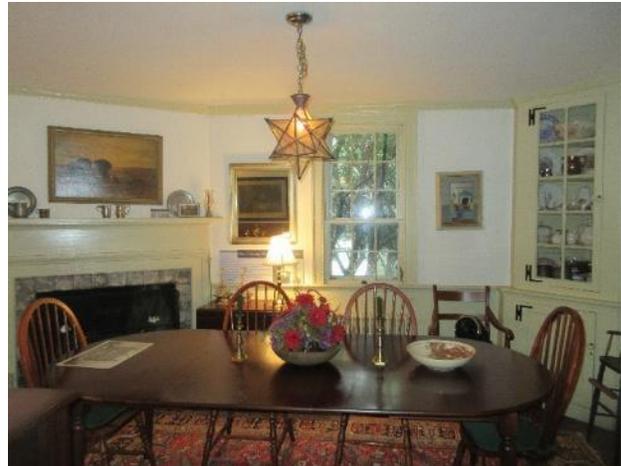
To the east of the kitchen door is a corner fireplace mirroring the floor plan of the masonry wall in the kitchen, both masonry walls align with the triangular foundation observed in the cellar (Figure 225). A wood mantle with decorative moulding encases the fireplace. Mortar is inset inside of the wood firebox, and the outlines of missing square tiles are visible on the concrete-lined surround (Figure 226). A masonry hearth is inset and raised above the wood flooring.

Figure 226. Tiles at the firebox surround have been removed.

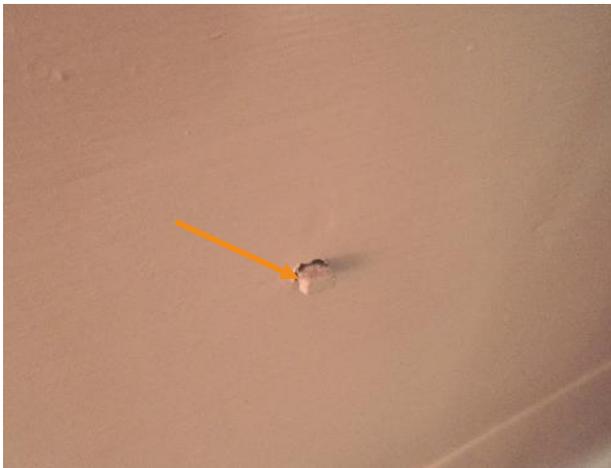
Figure 247. Headless cut nails were observed fastening to the wood wall paneling to studs.

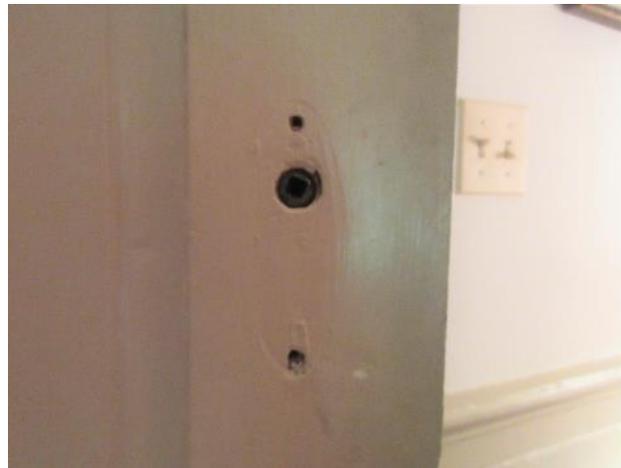
and is of mortise-and-tenon construction. The door has typical iron hinges and a brass doorknob set in a rim lock. A hole for a missing oval escutcheon and knob was present, evidenced by the fastener holes at the top and bottom of the oval indentation of the former plate (Figure 248). Copper weatherstripping is nailed to the inside of the door opening using round head nails (Figure 249). A 9/6 wood sash double hung window is set west of the wood panelled door (Figure 250). Some of the glass panes have a circular imprint, like crown glass, that are not observed elsewhere in the house (Figure 251). The glass is also 1/16 to 1/8-inch-thick, depending on the lite, as opposed to 1/8 to 3/32 inch thick glass measured throughout the rest of the house. Some glass lites in this window might therefore be older than other glass throughout the house. The window stool is set below the chair rail, unlike in the dining room. There is a tan painted radiator mounted to the floor along the south wall, beneath the window.

Figure 248. Evidence of removed hardware at the south dining room door leading to the south enclosed porch. The previous hardware is located above the existing hardware.

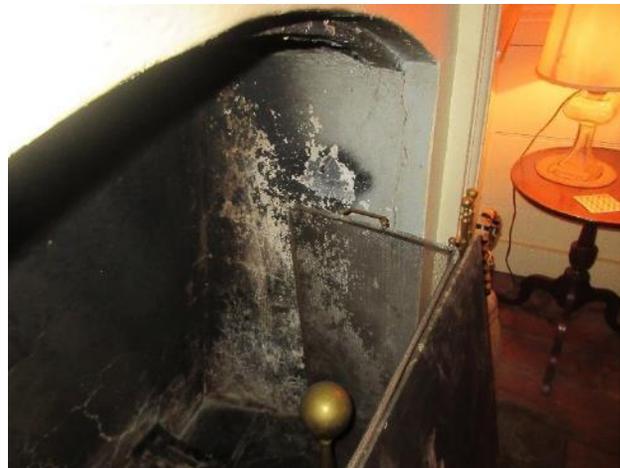
A 9/6 wood sash double hung window is set on the south half of the west wall, south of the fireplace (Figure 252). The stool is similarly set below the chair rail. A wood mantle with wood moulding encases the fireplace (Figure 253). Partial dutchman repairs were observed at both bases of the wood mantle legs (Figure 254 and Figure 255). The concrete-lined firebox is framed by a tan painted segmental arch opening, possibly also composed of concrete (Figure 256). A masonry hearth is inset and raised above the wood flooring (Figure 257).

Figure 255. Wood dutchman observed at the base of the fireplace mantel legs.

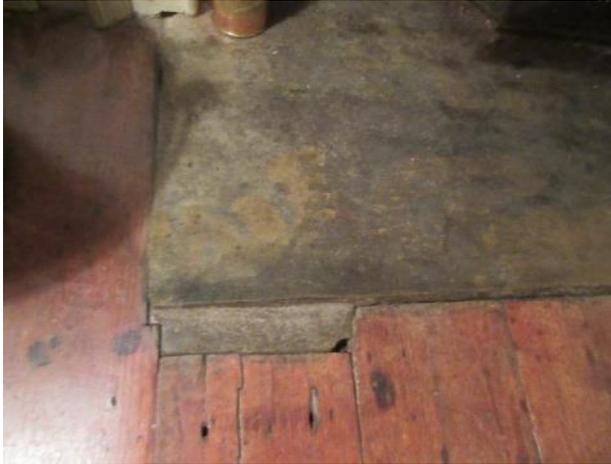
Figure 256. Firebox is lined with a cementitious coating.

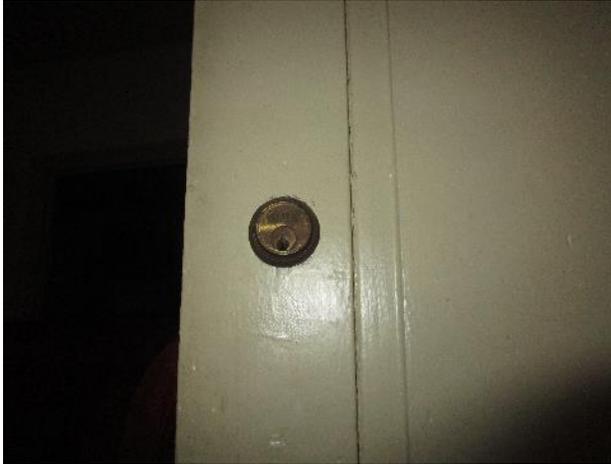
Figure 260. Contemporary deadbolt on the room leading to the living room.

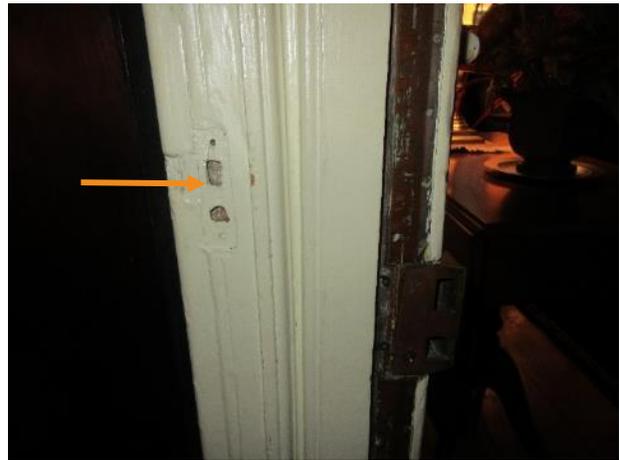
Figure 261. Evidence of a previously removed screen/storm door as chiseled section of latch strike remains on the south enclosed porch side.

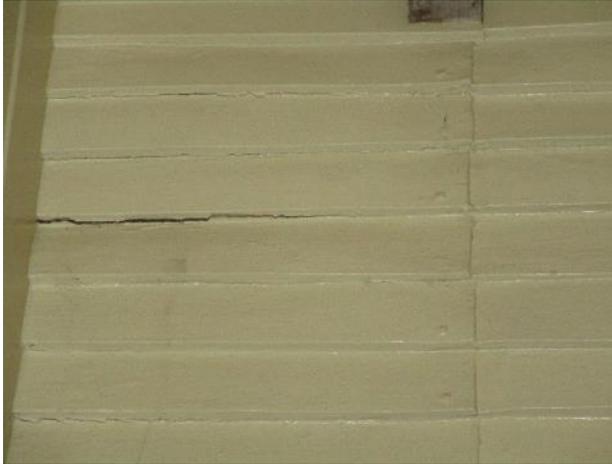
Figure 264. The south enclosed porch features the historic clapboard with rose head nails along the north wall.

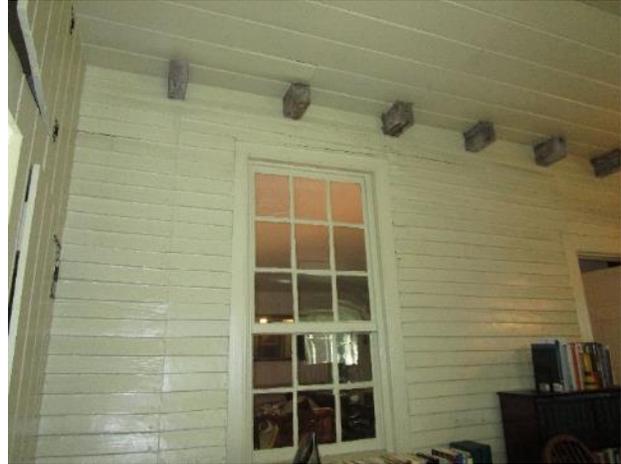
Figure 265. This north wall of the south enclosed porch was historically exposed to the exterior.

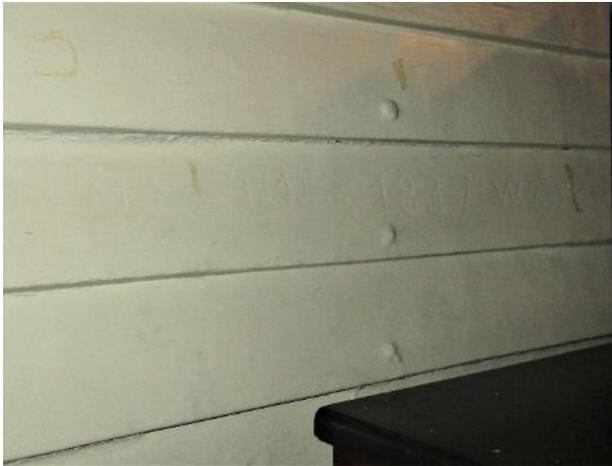
Figure 266. Carvings at the north wall that has been painted over. Carvings read "MMJ", "JMJ", "1837" "W & ...[covered]", evidence during the Jamesson's ownership.

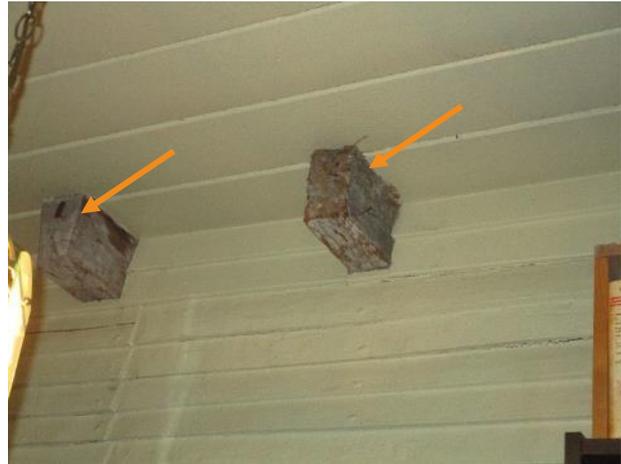
Figure 272. Isolated section of replacement ceiling panel observed at the northwest section of the room.

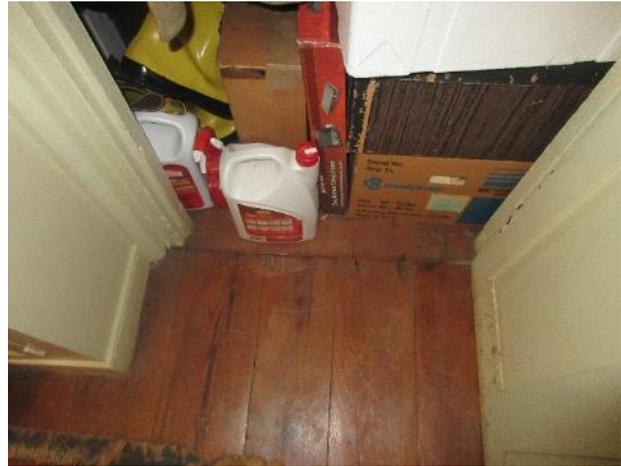
The flooring in the library is not continuous to the closet, living room, or study (Figure 294, Figure 295). The floorboards are roughly 6 inches to 7-1/4 inches wide, fastened with headless cut nails that terminate at the threshold of the closet door. Detwiler mentions replacing wood flooring in this room in his 1947 letter to Captain King. A typical frosted and cut glass light fixture with a metal frame is mounted to the ceiling of the library (Figure 296).

Figure 294. Wood flooring in the library is not continuous into the closet.

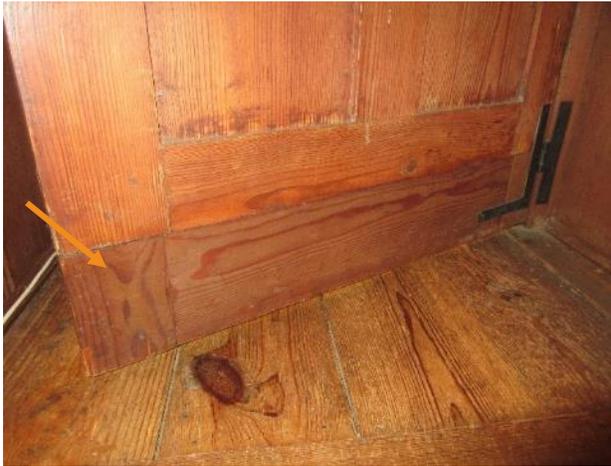
On the west wall, a panelled wood door opens to the study. This door is of mortise-and-tenon construction with four inset panels and has typical iron HL-hinges and brass doorknob and rim lock. A dutchman repair was completed on the bottom rail of the door (Figure 297). Wood putty repair was also previously completed at the door, below the door hardware (Figure 298). A dutchman repair was observed at the lower north portion of the casing trim (Figure 299).

Figure 297. Lower rail of the door between the library and sitting room has been replaced.

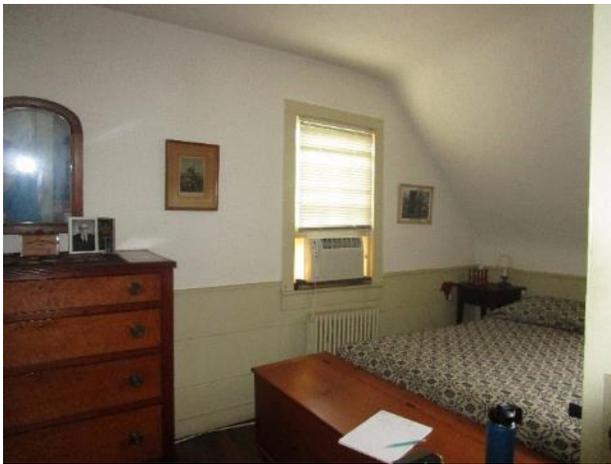
Figure 323. View towards the west wall where the exterior window was open to accommodate the air conditioner unit.

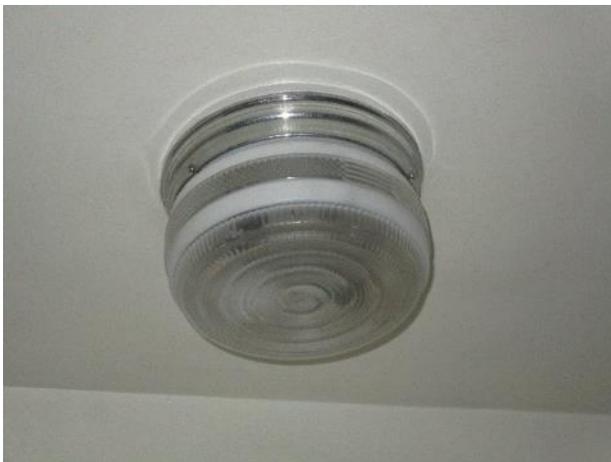
The shower is along the north wall of this room and has a ceiling mounted light fixture with glass bowl above that provides light into the space (Figure 337). This light fixture looks like a typical interior fixture and may not be rated for high moisture areas. Large 48 inch tall by 28 inch wide white tiles surround the shower enclosure above the tub and extending approximately 4 feet high (Figure 338).

Figure 337. Typical ceiling mounted light fixture directly above the shower.

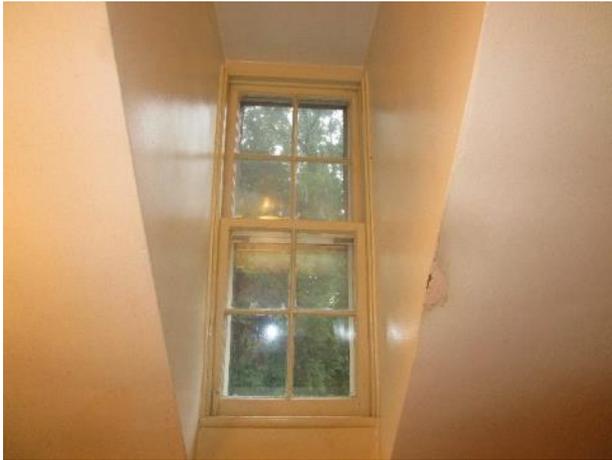
The south dormer window is operable, but it is difficult to open the lower sash (Figure 339). Condensation staining and marks were observable at the sloped ceiling areas. An isolated section of plaster repair was noted at the corner of the sloped ceiling to the west of the dormer window (Figure 340). A radiator is located along the west wall. Black staining on the wall behind (Figure 341 and Figure 342) is likely indicative of high moisture in the air. Tan terrazzo-like linoleum is located throughout this room, with a large portion covered with a bathroom rug (Figure 343).

Figure 339. A window is located at the south wall but is difficult to open.

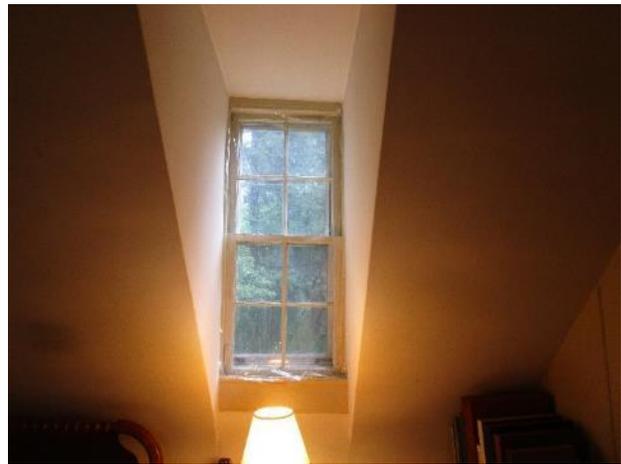
Figure 357. Dormer at the south wall is covered with plastic.

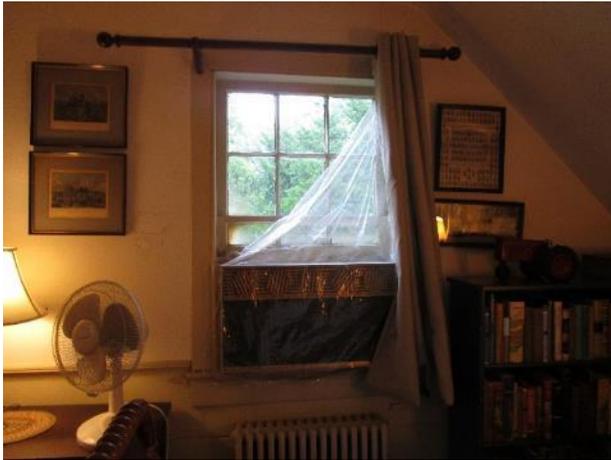
Figure 358. Window at the west wall is covered with plastic and open to accommodate the window air conditioner unit.

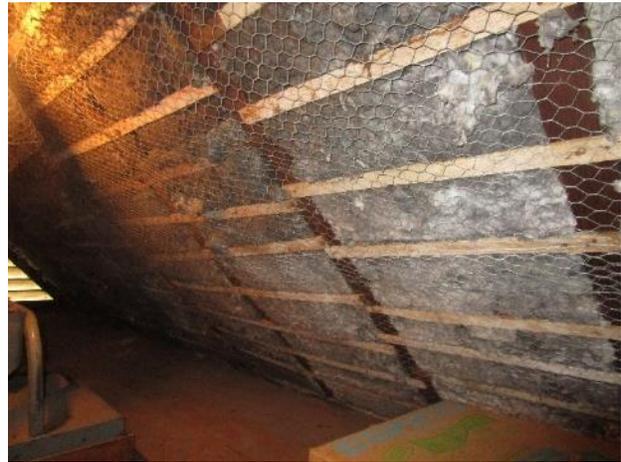
Figure 377. Loose fill insulation between the rafters is being held in place by chicken wire fastened to nailer boards.

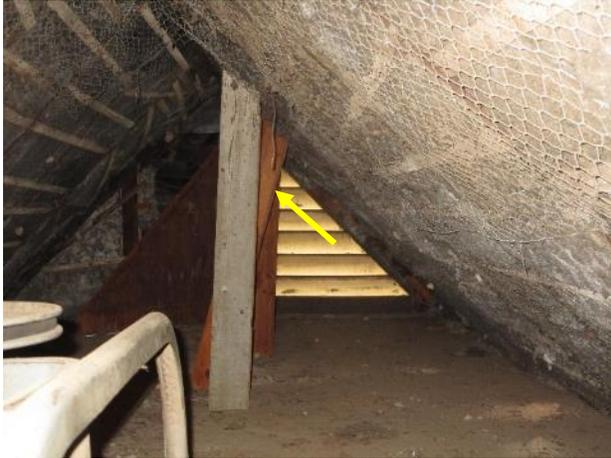
Access to the attic is gained through a dropdown stair ladder in the hallway—Model 18, “EZWay Starway,” manufactured by the Minnesota Wood Specialties, Inc. (Figure 374). The attic space is small and open. An attic fan is located adjacent to the stair ladder (Figure 375 and Figure 376). Machine hewn 2-3/4 inch wide wood rafters supporting the roof are spaced approximately 2 feet on center. Loose fill insulation has been placed between the rafters and is held in place with metal mesh secured to nailer boards (Figure 377). The north rafters have machine sawn vertical supports that connect to the upper part of the rafter and the floor decking. One of the vertical supports appears to be installed at an angle (Figure 378). With the insulation in place, the ridge beam or board could not be observed.

Figure 378. One of the north vertical rafter supports was observed to be out of plumb.

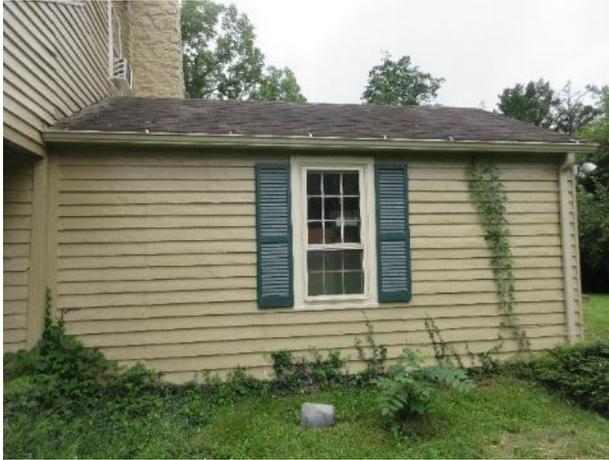
- Vegetation growth was noted close to and in contact with the house (Figure 382 and Figure 383). Trees obscured the second floor window on the east facade (Figure 384) and along the west facade of the enclosed porch (Figure 385). The access and operation of the study door (west addition) and exterior landing were blocked by vegetation growth (Figure 386).

Figure 382. Vegetation on and around the home, north facade of the west addition shown.

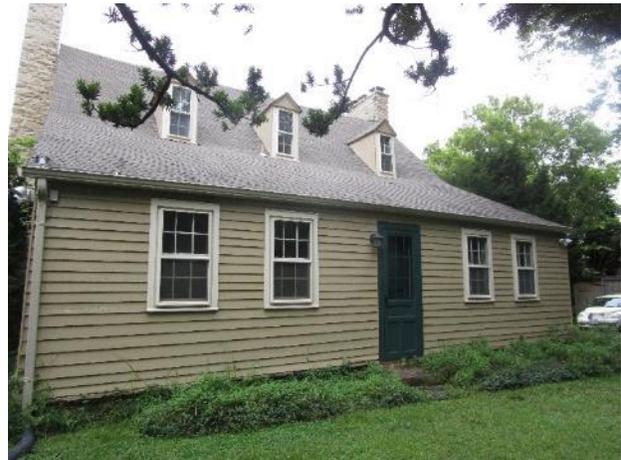
Figure 383. View of the south facade with vegetation around and in contact with the facade materials.

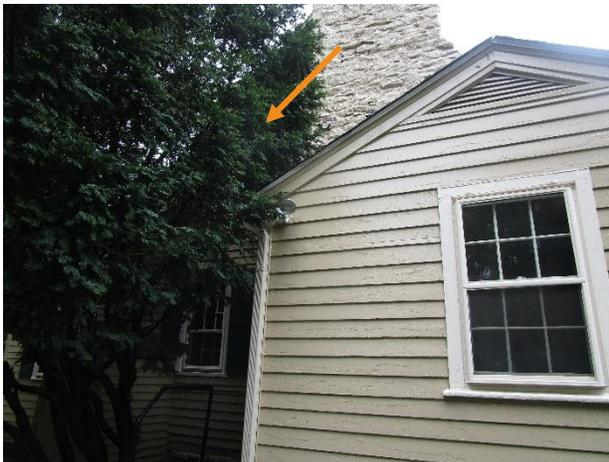
Figure 384. Tree blocking view of the second floor window at the east facade.

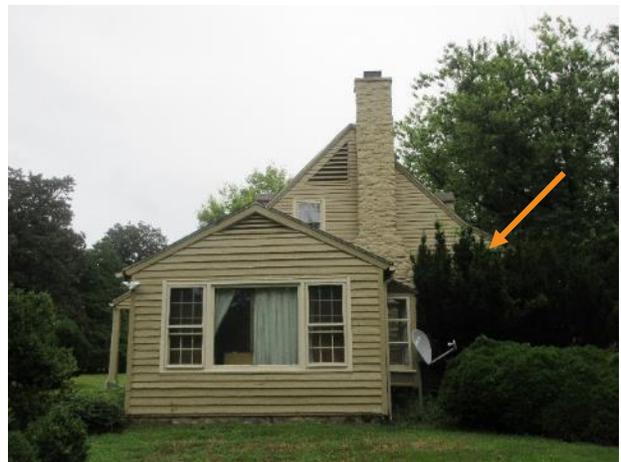
Figure 385. Trees in front of west facade of the south enclosed porch.

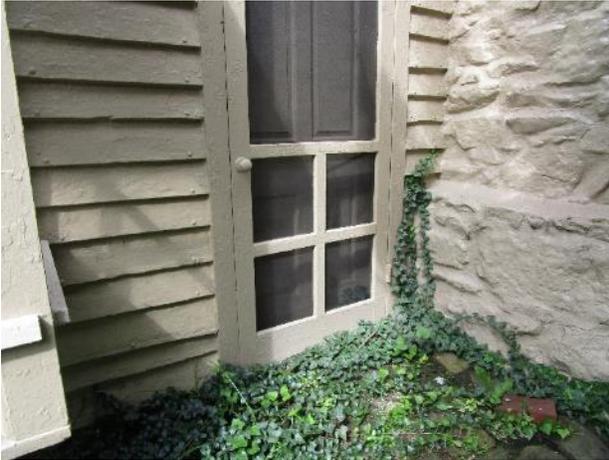
Figure 386. Vegetative growth onto the west addition door and house facade materials.

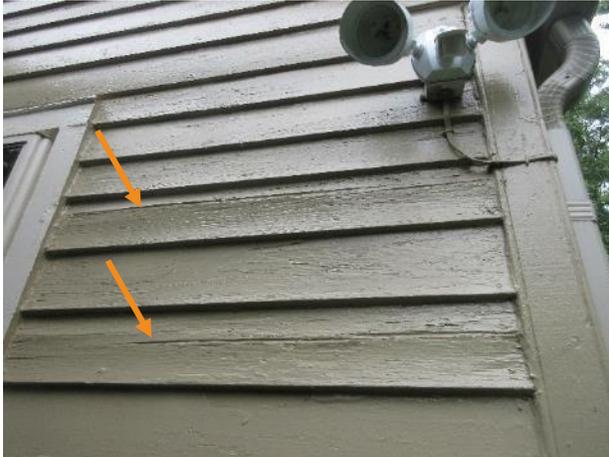
- End splits were observed on multiple wood clapboards on the east, south, and west facades (Figure 387 and Figure 388). An end split clapboard at the base of the west facade addition was previously repaired with sealant that was weathered and contained voids (Figure 389 and Figure 390). Other end split clapboards were also present above the interface between the porch cladding and the study addition. The south end of these boards was also displaced, leaving the end grain vulnerable to moisture as well as providing a path for moisture to travel behind the clapboard (Figure 391).

Figure 387. Clapboards with end splits extending longitudinally in the boards that have been painted over.

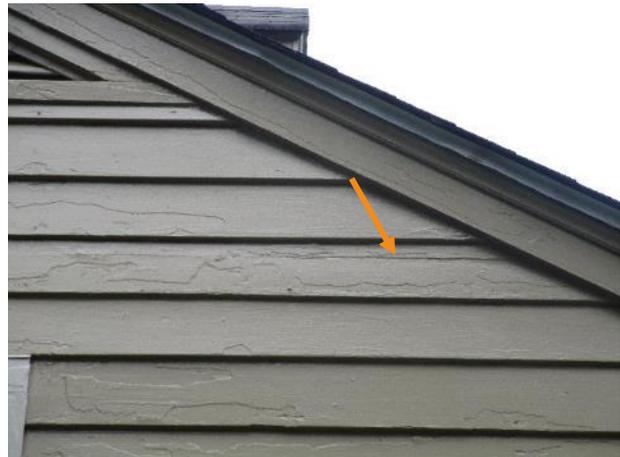
Figure 388. Typical end split in clapboards.

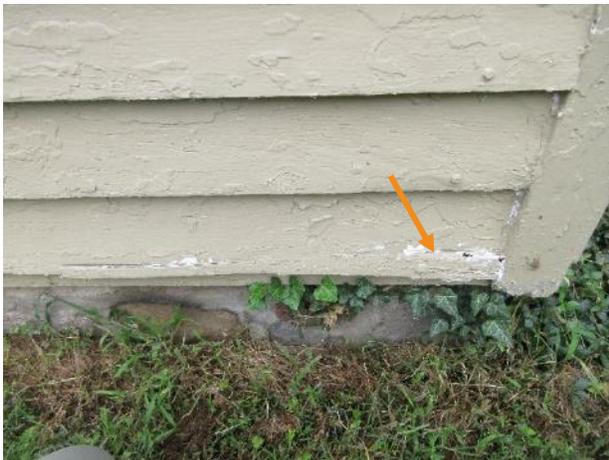
Figure 389. Previously repaired end split at the lowest clapboard at the west addition.

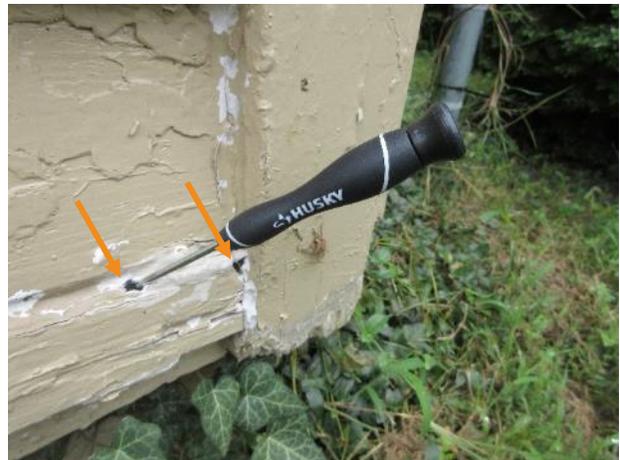
Figure 390. The repair was done with sealant, which contains voids.

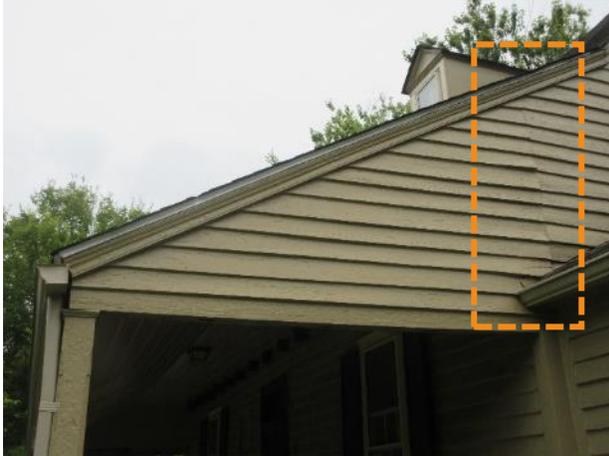
Figure 391. Section of clapboards at the west facade above the porch that is displaced.

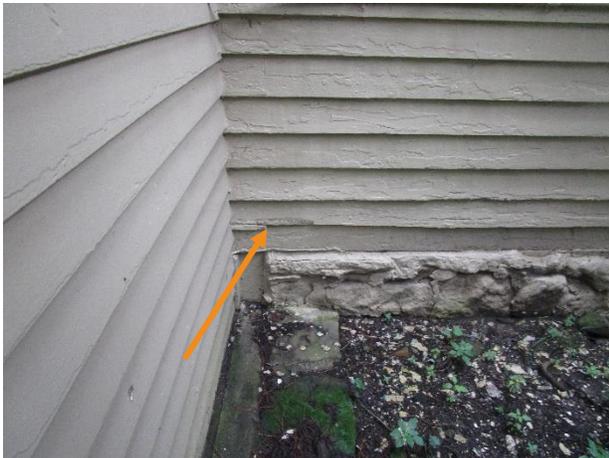
Figure 393. Isolated wood section loss at the east facade, to the north of the cellar access.

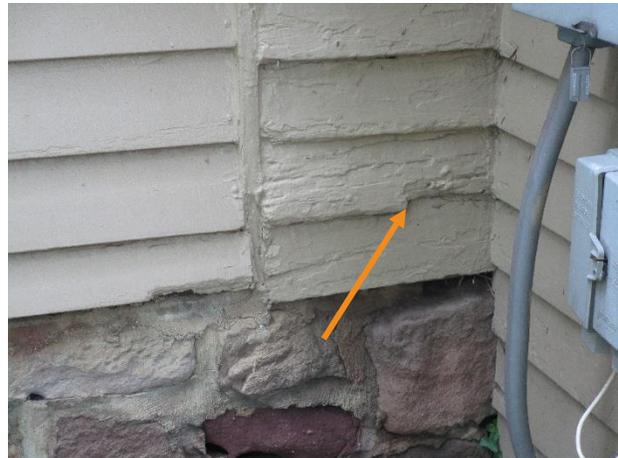
Figure 394. Isolated wood section loss at the east facade, to the south of the cellar access.
