## Mount Gilead

### Historic Structure Report

### FINAL REPORT

WJE No. 2019.8373

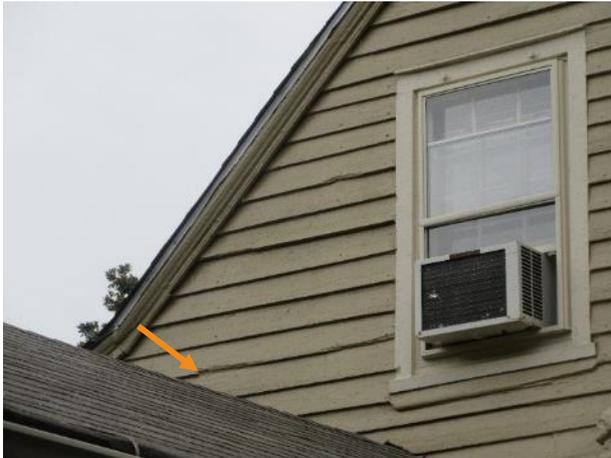
Figure 395. Isolated wood section loss at the west facade.

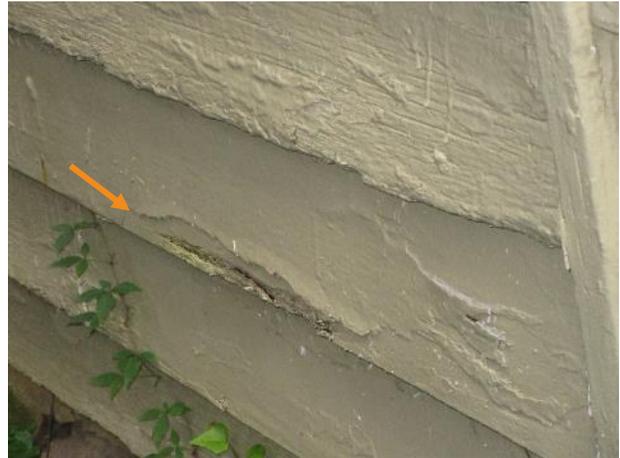
Figure 396. Isolated wood section loss at the west facade.

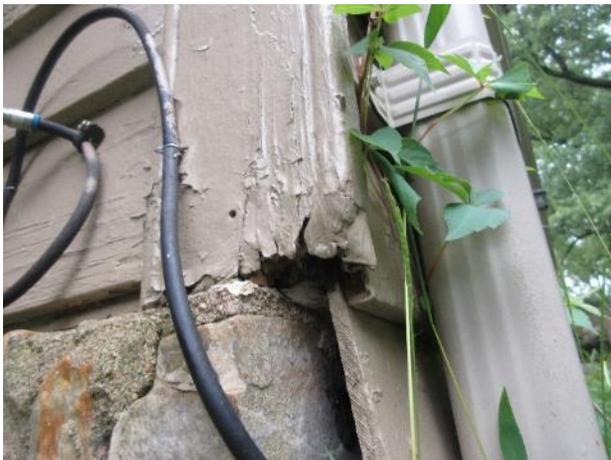
Figure 397. Wood section loss at the west corner of the south enclosed porch.

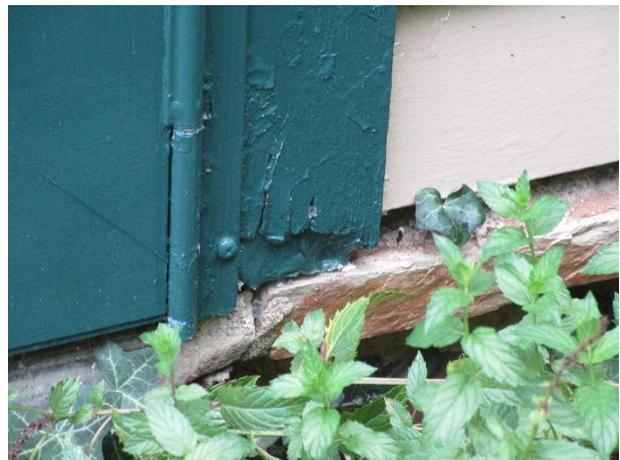
Figure 398. Wood section loss at the bottom of the south enclosed door trim.

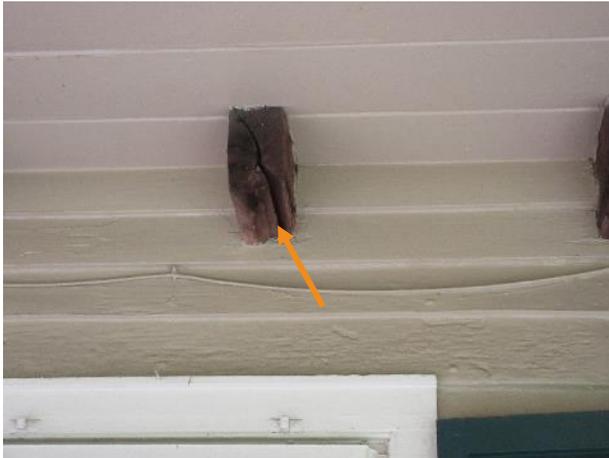
Figure 399. Wood section loss at an exposed wood joist, north facade.

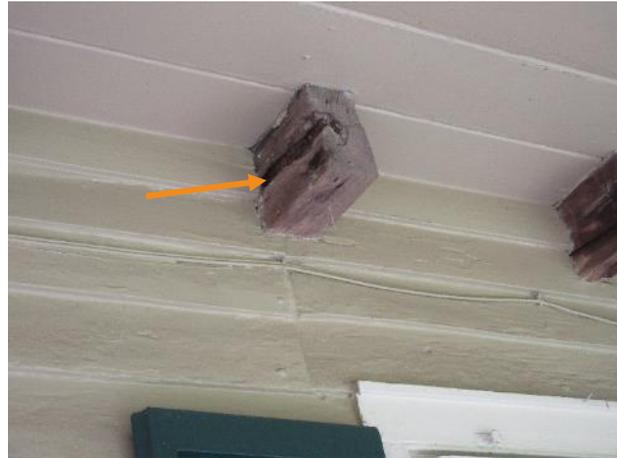
Figure 400. Wood section loss at an exposed wood joist, north facade.

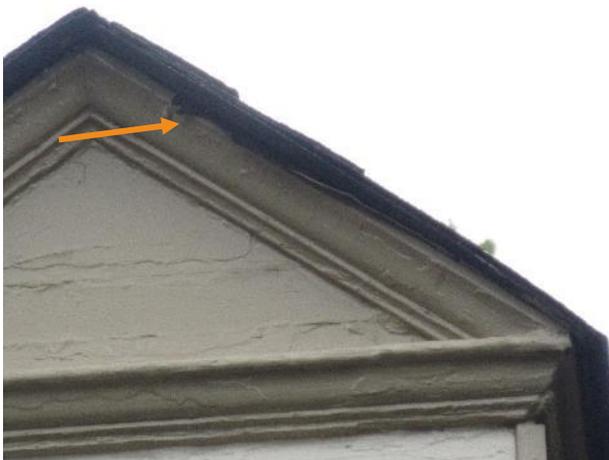
Figure 401. Section of wood section loss at a dormer pediment, north facade.

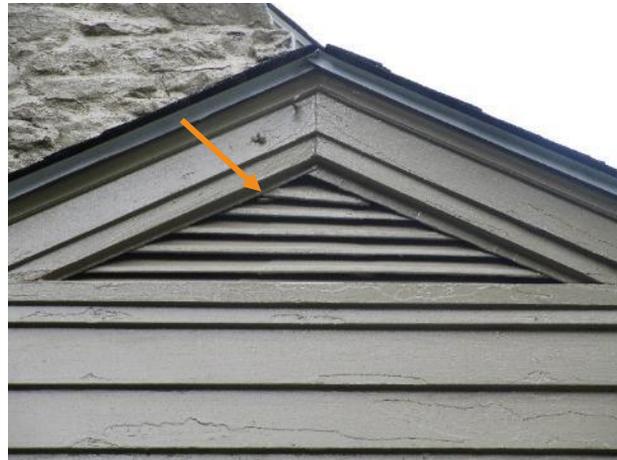
- The top-most wooden slat of the kitchen addition louver was displaced downward (Figure 402).

Figure 402. Displaced slat at the east addition louver.

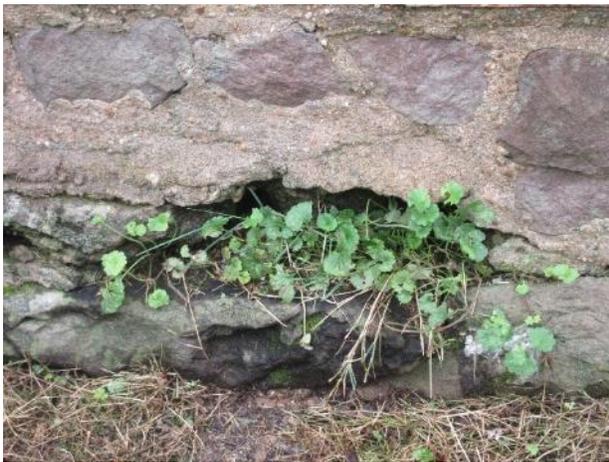
- Cracked and missing mortar was observed at the kitchen addition steps, stone foundation, and entry steps of the north porch. Some of these voids are filled with biological growth (Figure 403, Figure 404, and Figure 405). One area of cracked mortar was located in line with a daylighting pipe embedded in the foundation below the kitchen addition (Figure 406). Bond line failure was also observed at the interface between the flagstone kitchen stoop at the east facade and east chimney (Figure 407).
- A crack through the mortar at the vertical face of the north porch masonry foundation was observed that continued across the full depth of flagstone deck (Figure 408, Figure 409, and Figure 410). Mortar between the flagstone pavers and house wood clapboard at the north porch entry was separated from the clapboards along the entire length of the porch (Figure 411).

Figure 403. Missing mortar at the stone foundation with vegetative growth.

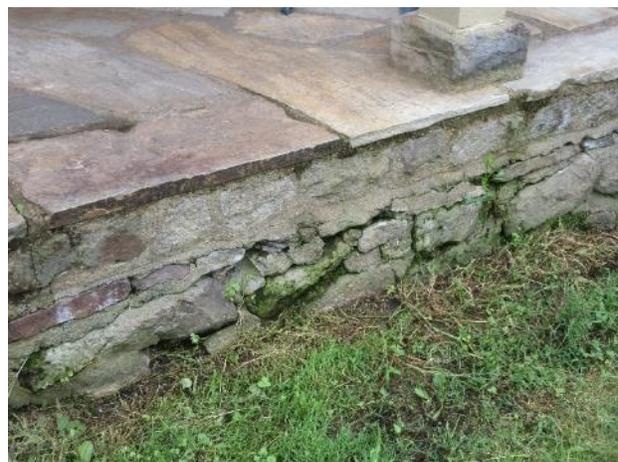
Figure 404. Missing sections of mortar at the north porch.

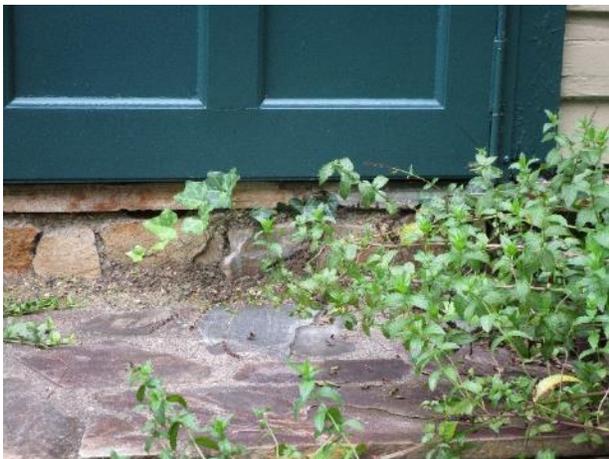
Figure 405. Missing mortar below the south enclosed porch door.

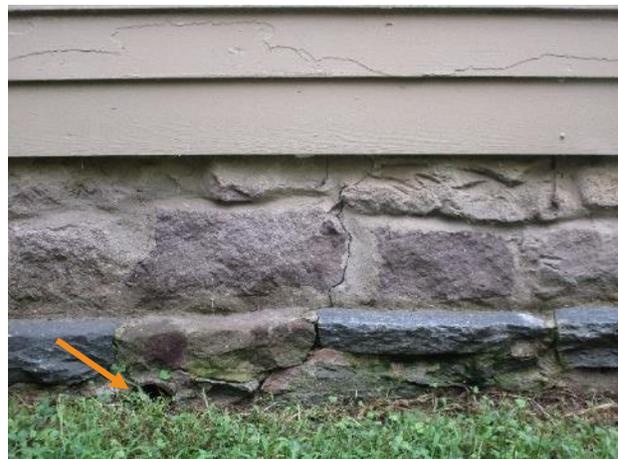
Figure 406. Crack in foundation mortar at the east addition. Note exposed pipe from where the crack originates.

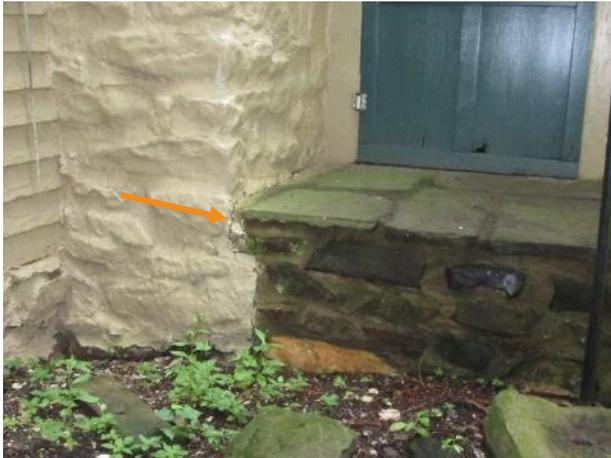
Figure 407. Mortar bondline failure at the interface between the east chimney and kitchen landing.

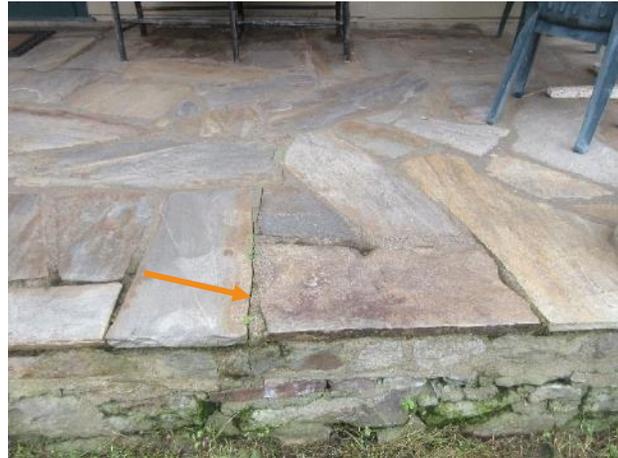
Figure 408. Full depth crack in mortar at the north porch.

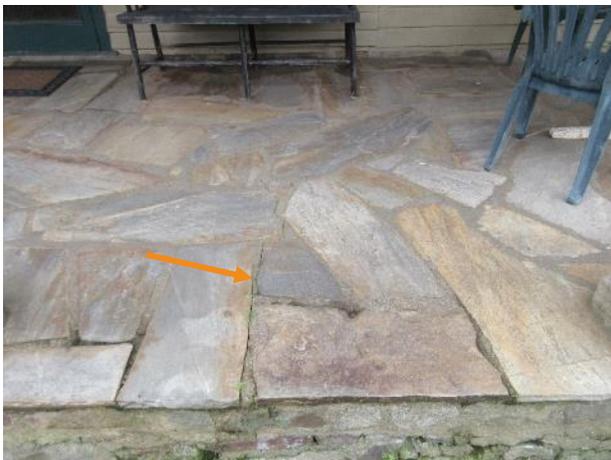
Figure 409. Full depth crack in mortar at the north porch.

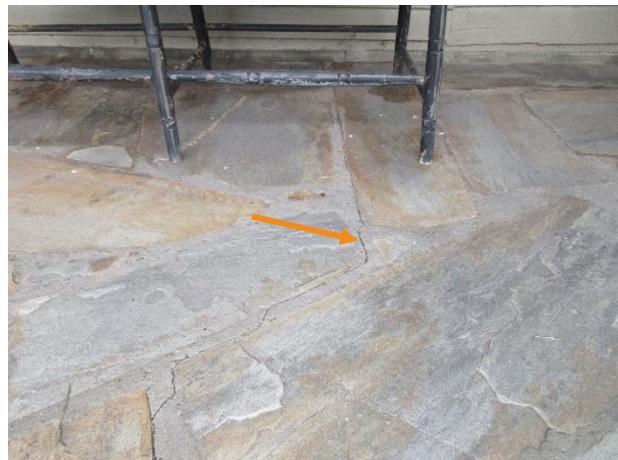
Figure 410. Full depth crack in mortar at the north porch.

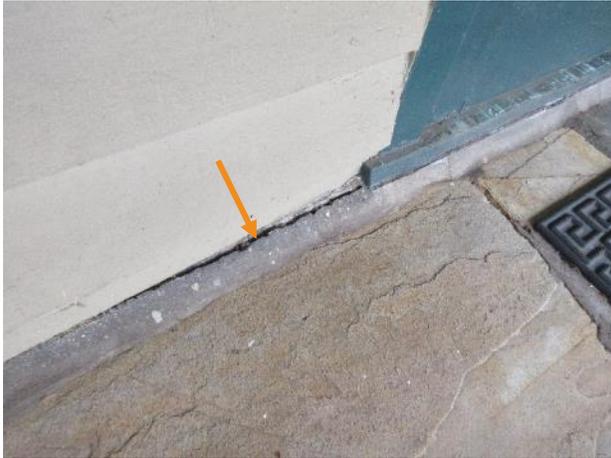
Figure 411. Separation of mortar along the wood clapboard and flagstone paver joint.

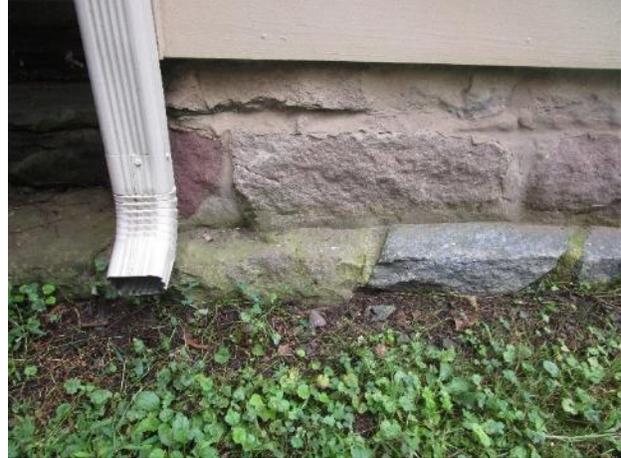
- Biological growth and staining were observed at all facade stone foundations, stone steps, and at downspouts (Figure 412, Figure 413, and Figure 414, and Figure 415). All downspouts deposited water directly onto or close to the house.
- Scaling and weathering of isolated stone masonry surfaces were observed, such as on the top surface of the stone steps to the north porch and at the abandoned steps at the east facade to the south porch (Figure 416 and Figure 417). Severe stone weathering with cracks in the mortar below, resulting in erosion of the stone unit, was observed at the east facade masonry foundation of the south enclosed porch (Figure 418).

Figure 412. Biological staining on foundation stones adjacent to a downspout.

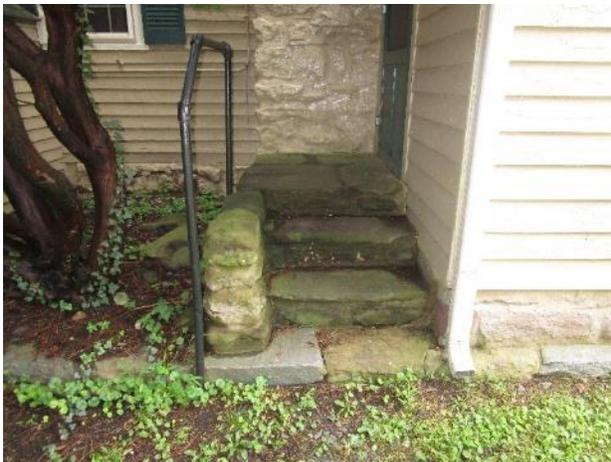
Figure 413. Biological staining on the kitchen steps and landing. Note adjacent tree, which overhangs this area.

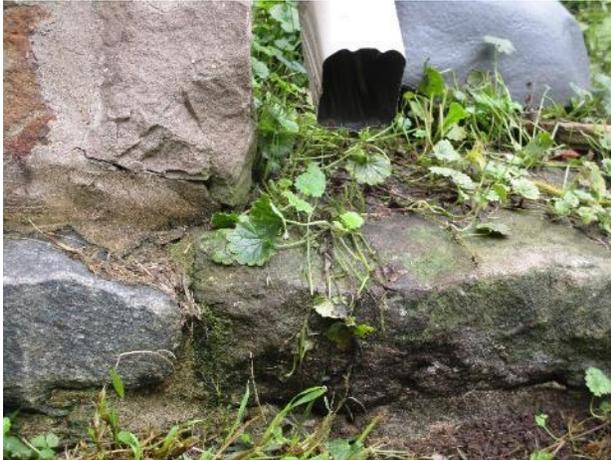
Figure 415. Biological staining on foundation stones adjacent to a downspout.

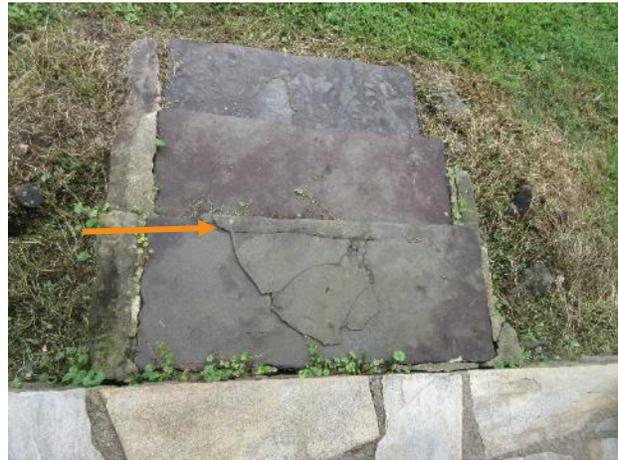
Figure 416. Scaling of stone unit at steps to the north porch.

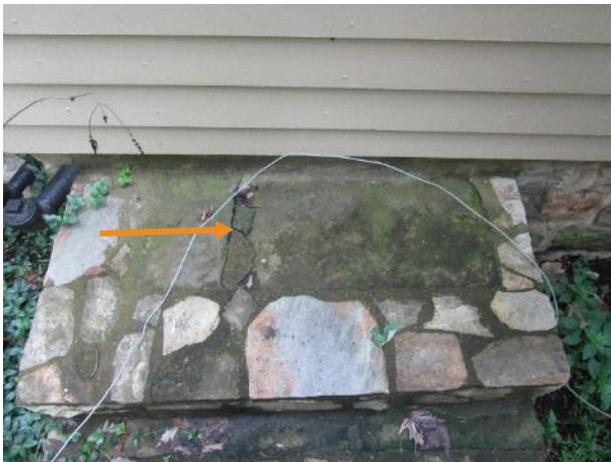
Figure 417. Weathering of stone units at abandoned steps to the south enclosed porch.

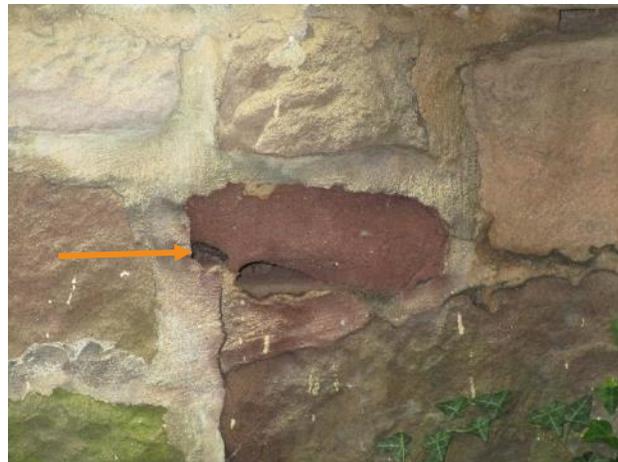
Figure 418. Erosion of a sandstone foundation unit, east facade.

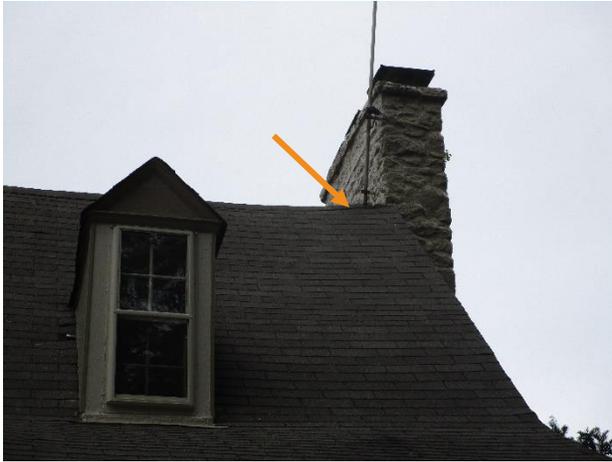
- Several sags were observed along the ridge line, throughout the field, and between the dormers of the roof (Figure 419 through Figure 423).
- Several asphalt shingles edges were displaced on both the south (Figure 424) and north sides of the roof (Figure 425). A missing shingle was observed at the easternmost dormer on the south side (Figure 426). A broken asphalt shingle was observed at the south side of the garden window roof of the study addition (Figure 427).
- Biological growth and dark staining were observed across the entire north roof area (Figure 428 through Figure 431).
- At the interface between the kitchen addition and the east wall of the main house, bent pieces of metal flashing were surface mounted onto the wood shingles and extended below the asphalt

Figure 419. High point of roof at east chimney, view from south.

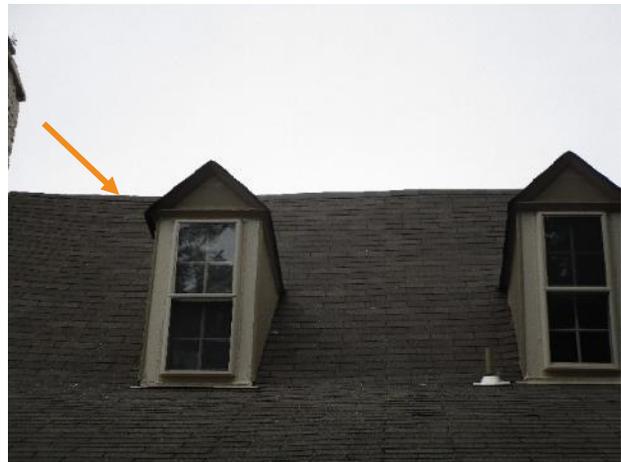
Figure 420. Sag at roof ridge, view from south.

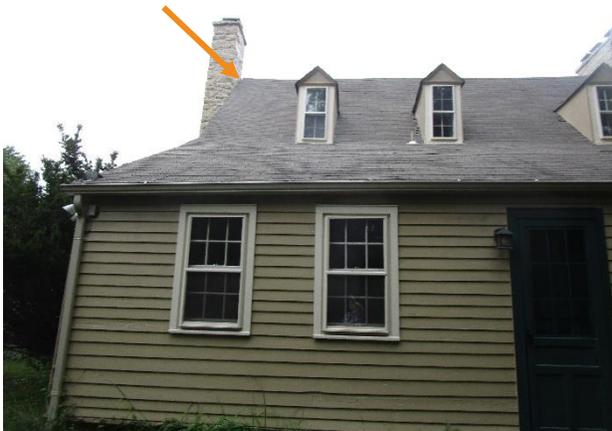
Figure 421. High point of roof at west chimney, view from south.

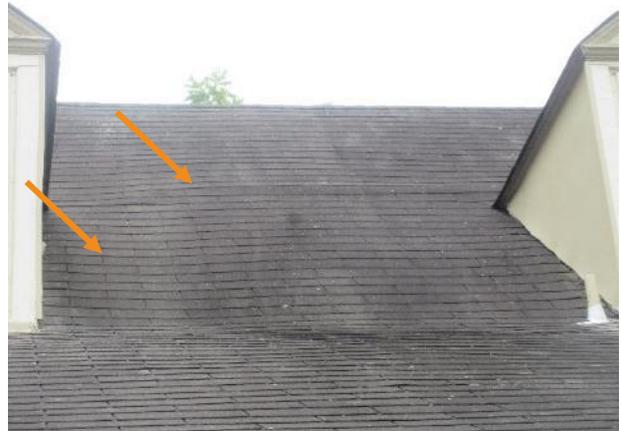
Figure 422. High point and sags between dormers, view from south.

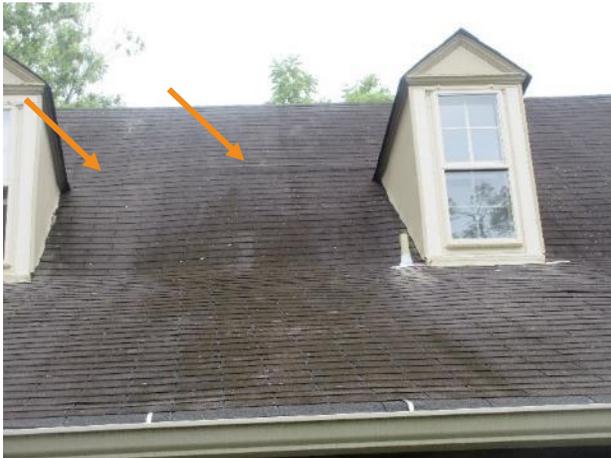
Figure 423. High point and sags between dormers, view from south.

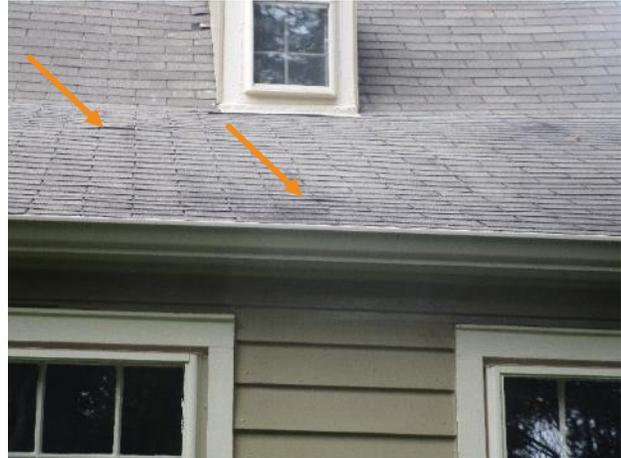
Figure 424. Displaced asphalt shingles, view from south.

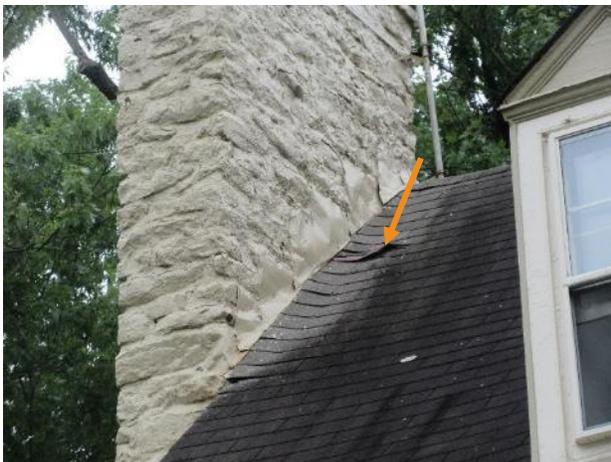
Figure 425. Displaced asphalt shingles at chimney flashing, view from north.

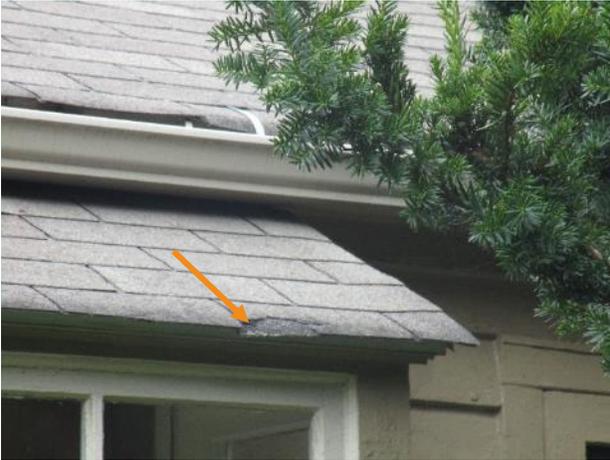
Figure 427. Broken shingle above garden window.

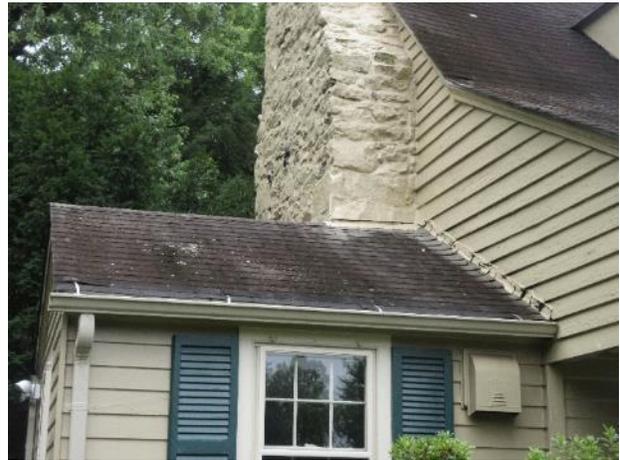
Figure 428. Typical dark staining on the north roof, east addition.

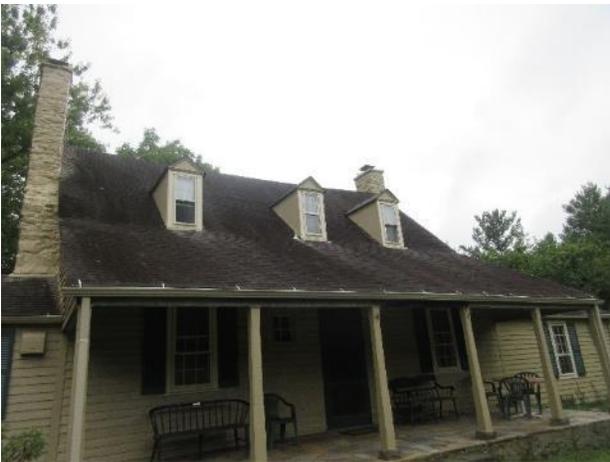
Figure 429. Typical dark staining on the north roof.

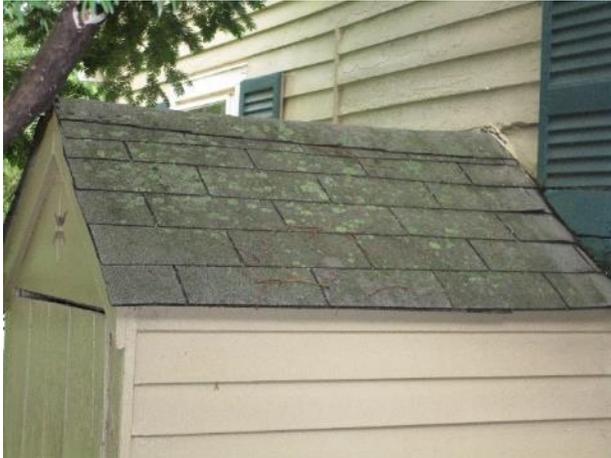
Figure 431. Typical biogrowth on the north roof, cellar access.

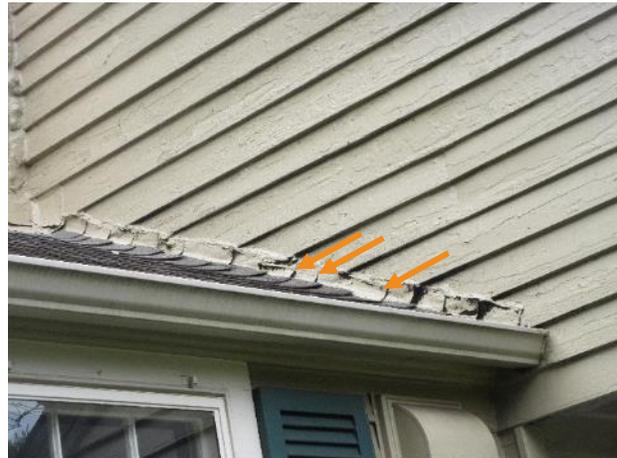
shingles. There were unsealed voids at laps between the metal, and sealant was applied along the top edge to seal to the wood clapboards (Figure 432). Dark soiling was observed at the north area of flashing and above the clapboard. Sheet metal flashing was observed at the interface between the west chimney, and the adjacent study addition roof contained unsealed voids (Figure 433). The west chimney is offset from the upper area of the house and roof, with no flashings observed (Figure 434).

Figure 432. Unsealed laps of metal flashing between house and east addition.

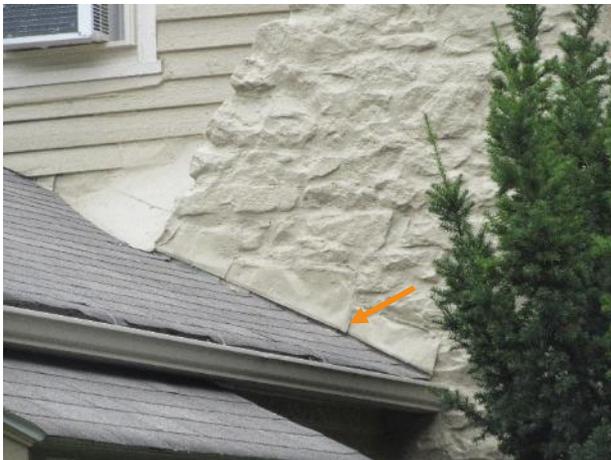
Figure 433. Unsealed laps of metal flashing between house and east addition.

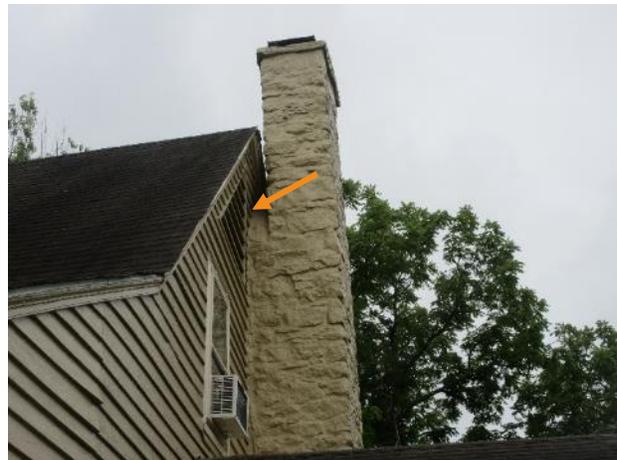
Figure 434. No visible flashings between the west chimney and house.

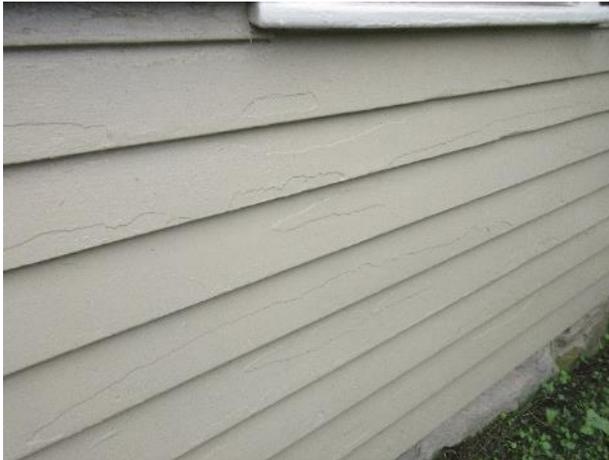
- Paint was applied over old coating(s) at the clapboard and window trim at all facades (Figure 435 and Figure 436).
- At the west addition garden window, the lower rail of the study garden window was cracking, glazing putty at the muntins was cracked and separated from the glass lites (Figure 437), and the bottom eastern-most lite was cracked (Figure 438). The exterior wood stop of the picture window at the study addition had chipped paint, exposing cracked wood (Figure 439 and Figure 440)
- Soft wood was found by probing with an awl at the underside of the easternmost kitchen window sill at the north facade (Figure 441 and Figure 442). Dutchman repairs were noted at the corners of this window casing (Figure 443 and Figure 444).

Figure 435. Paint has been applied over previous coating(s).

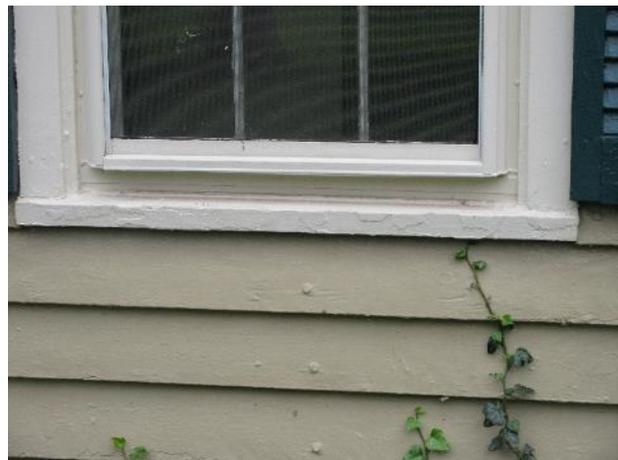
Figure 436. Paint has been applied over previous coating(s).

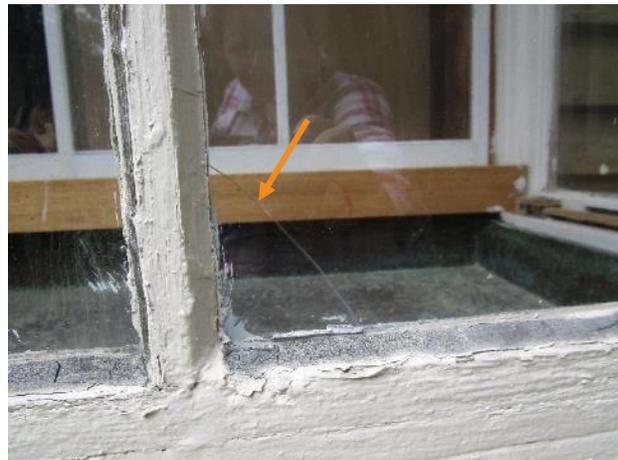
Figure 438. Cracked lite in the garden window.

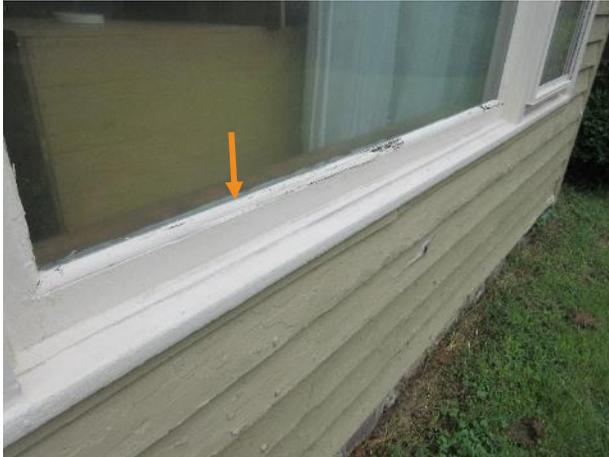
Figure 439. Wood glazing stop at the picture window, west addition.

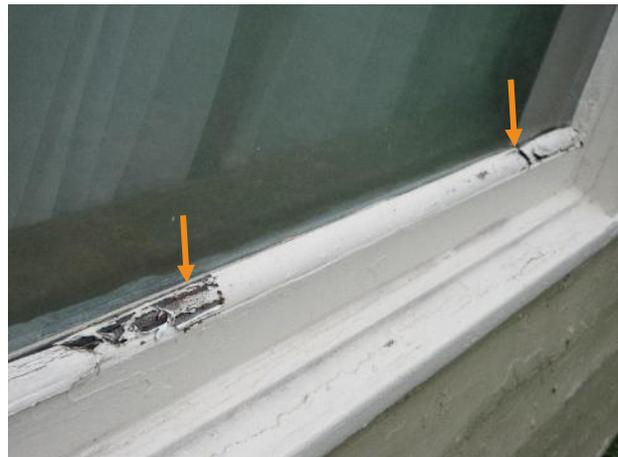
Figure 440. Paint is missing in sections and wood stop has deteriorated wood where exposed.

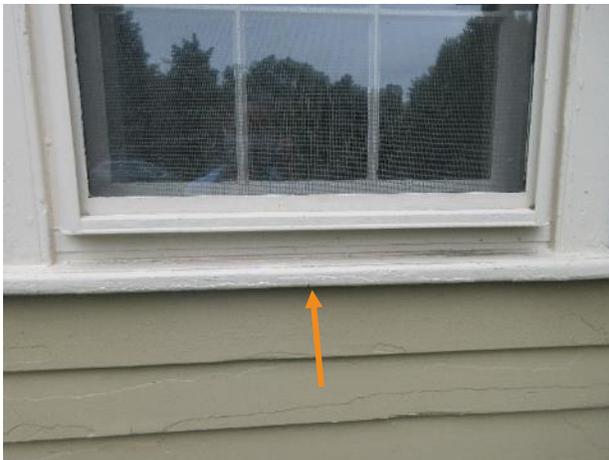
Figure 441. Soft section of wood below sill of east addition, north facade.

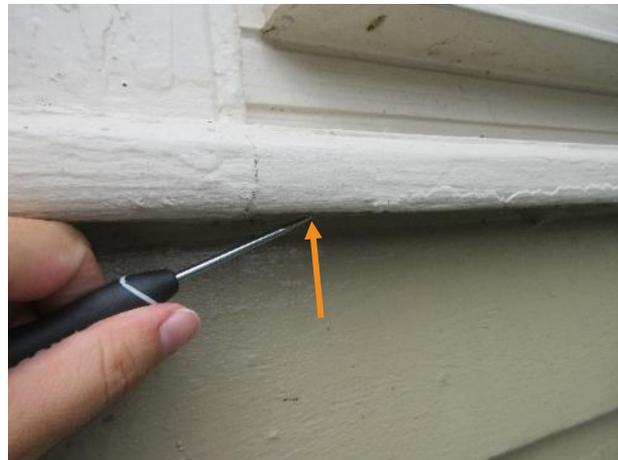
Figure 442. Soft section of wood below sill of east addition, north facade.

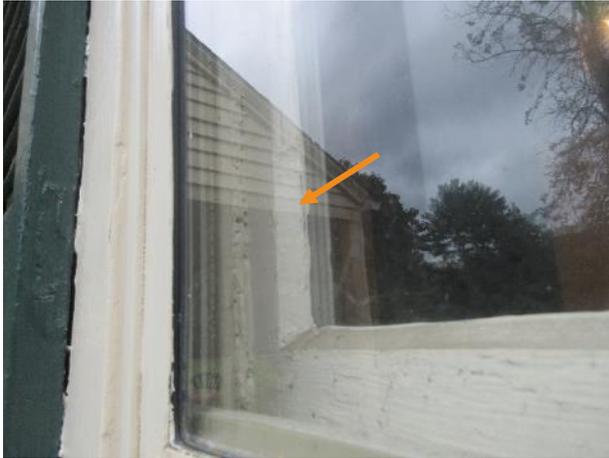
- Delaminated, cracked, and missing sections of glazing putty were observed at several windows along the north facade (Figure 445, Figure 446, and Figure 447).
- Wood section loss, missing paint, and staining were noted at the interior sills, frames, muntins, and surrounding trim of the windows at the first and second floors (Figure 448 through Figure 451). Water staining was also observed below the southwest window within the living room (Figure 452).
- An upper lite of glass at the library window was broken (Figure 453).

Figure 447. Cracked section of glazing putty at a north facade window. Storm windows are in place at this window.

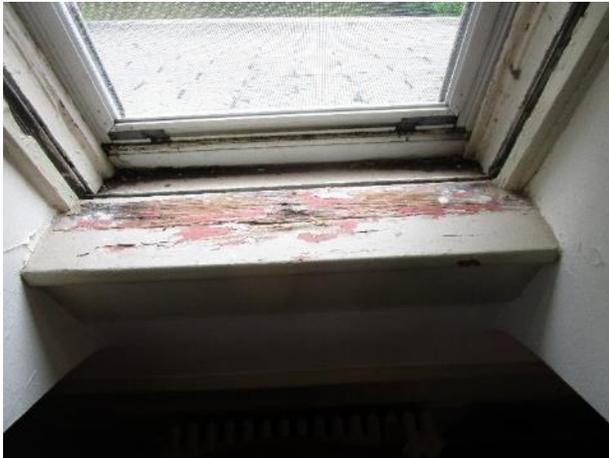
Figure 449. Missing paint with deteriorated wood where exposed at an interior stool, north dormer in guest bedroom.

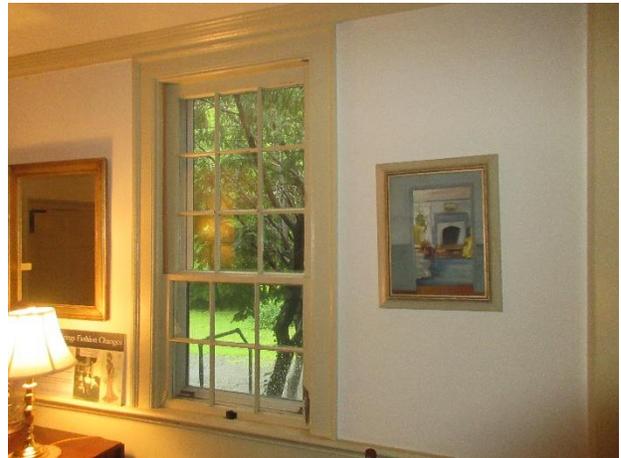
Figure 450. Dining room east window with missing and flaked paint and soft wood.

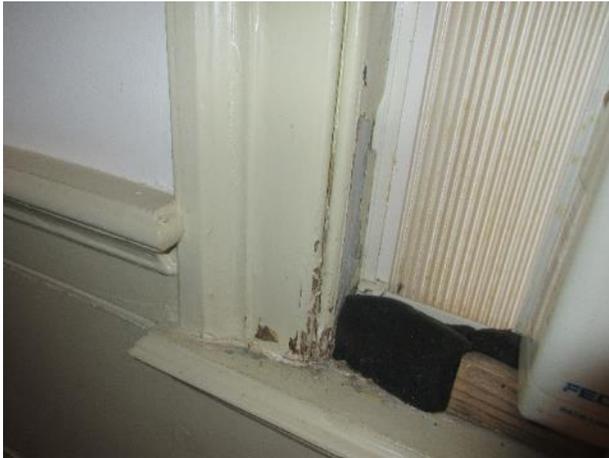
Figure 451. Missing paint at jamb trim with soft wood, living room west window.

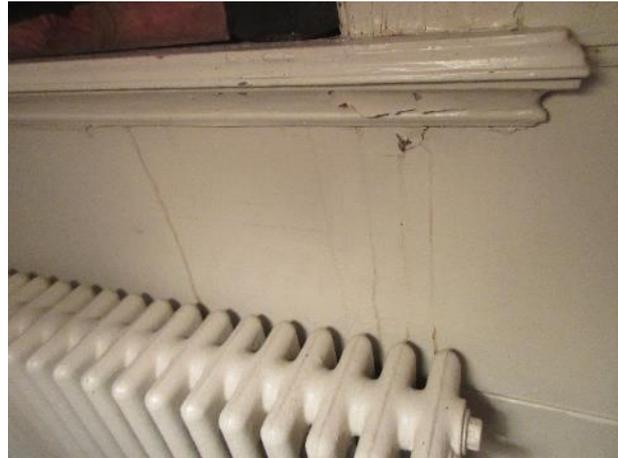
Figure 452. Water staining below the living room south window on the west facade.

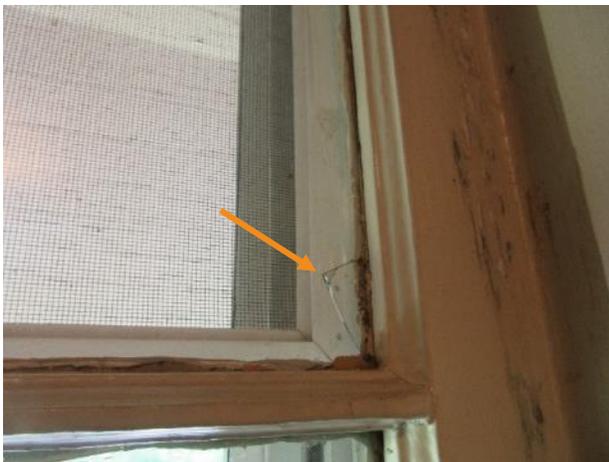
Figure 453. Broken glazing lite in the library.

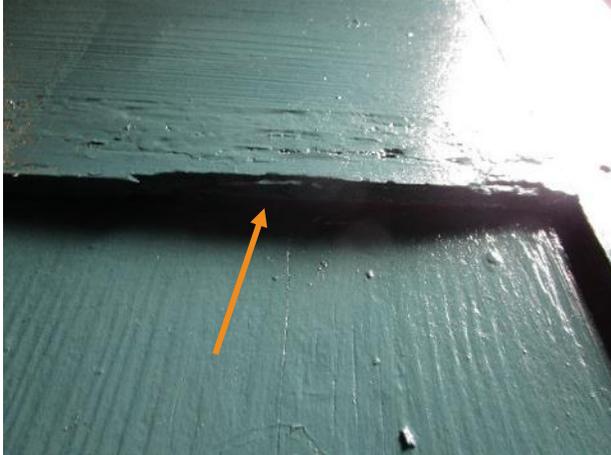
- The lower east inset panel of the south enclosed porch wood entry door was separating from the door stile, and daylight could be seen through the resulting void (Figure 454 and Figure 455). The metal inset panel of the storm door covering the south enclosed porch entry door had an uneven surface (Figure 456). The dents were shallow and did not affect the performance of the storm door.
- There was wood section loss at the base of the kitchen screen door (Figure 457). The screen door was slightly racked in the frame and had resultant minor wood damage at the door jamb corner (Figure 458). The base of the cellar door boards had end splits and section loss (Figure 459).
- The screen door and wood entry door at the study were coated in several layers of paint, which prevented the screen door from operating (Figure 460).

Figure 454. Separation between a lower panel and middle rail of the south enclosed porch door.

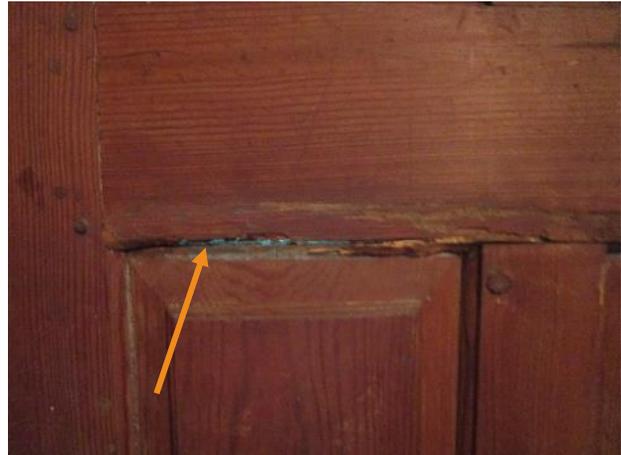
Figure 455. Separation between a lower panel and middle rail of the south enclosed porch door, view from interior to show daylight.

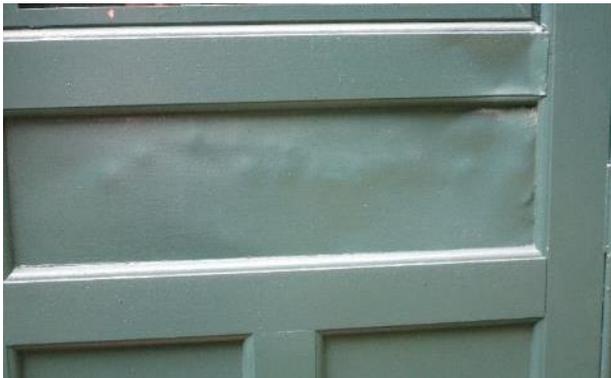
Figure 456. Denting in south enclosed porch storm door.

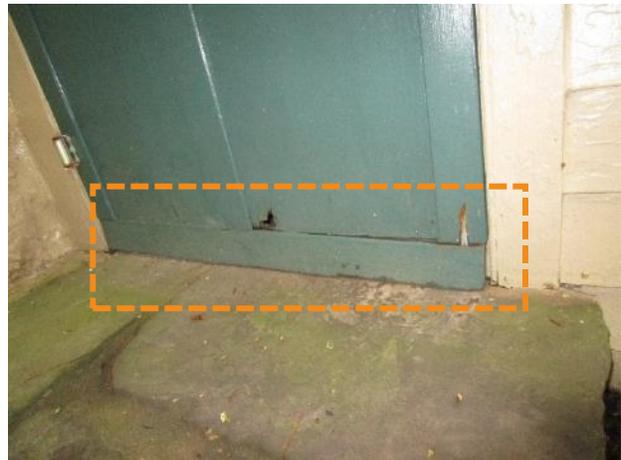
Figure 457. Wood section loss at the base of the east addition screen door.

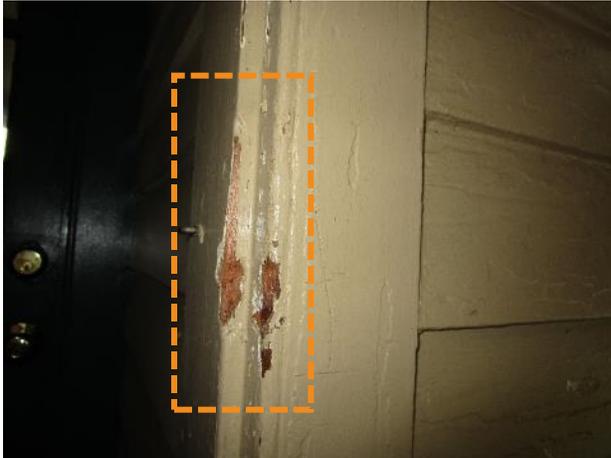
Figure 458. The east addition screen door is racked within the opening causing this impact damage to the trim.

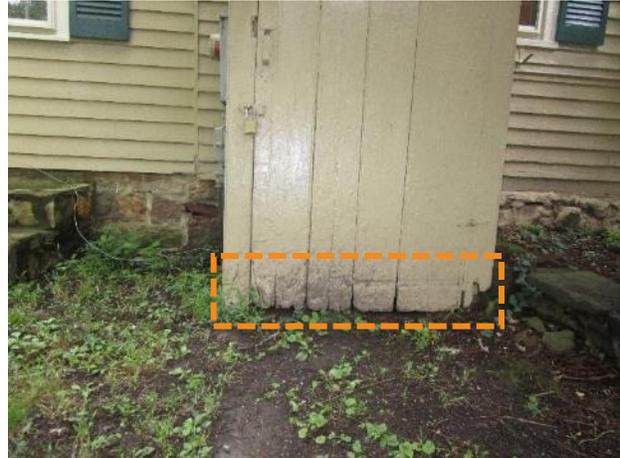
Figure 459. Wood section loss at the base of the cellar access door.

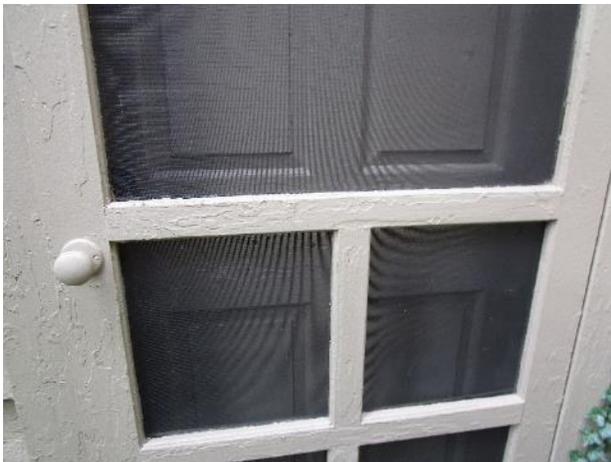
Figure 460. Screen door at the west addition could not be opened, possibly due to overpainting.

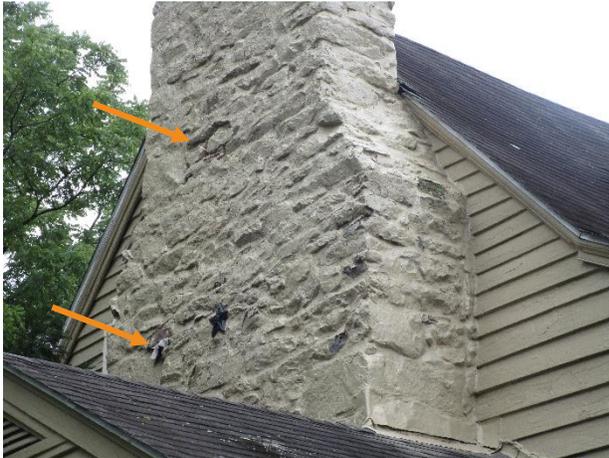
- Several layers of paint had been applied to the east and west chimneys. The outer layer of paint at each chimney was peeling and cracking across its entire surface (Figure 462). Mortar bond line failure was observed across both chimneys, with isolated areas of missing and recessed mortar joints at the east chimney (Figure 463, through Figure 466). Plants were observed to be growing from the chimney caps at both chimneys (Figure 467 and Figure 468).
- The west chimney appeared to be not plumb and angled to the east (towards the ridge of the roof), where the chimney is freestanding (Figure 469).

Figure 462. Typical peeling and cracking paint at the chimneys, east chimney shown.

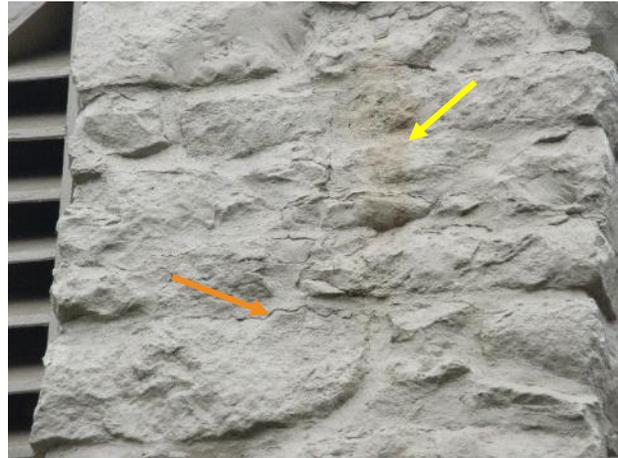
Figure 463. Typical bondline failure of mortar joints at chimneys (orange arrow), east chimney shown. Note adjacent staining (yellow arrow).

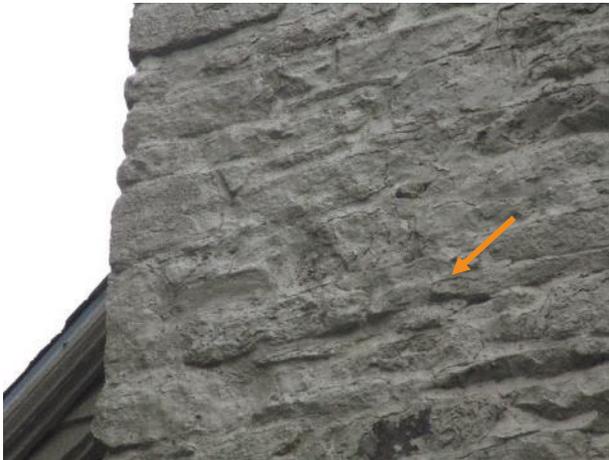
Figure 464. Typical bondline failure of mortar joints at chimneys, west chimney shown.

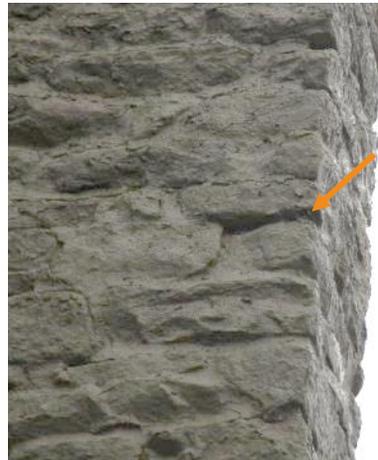
Figure 465. Missing section of mortar at the east chimney.

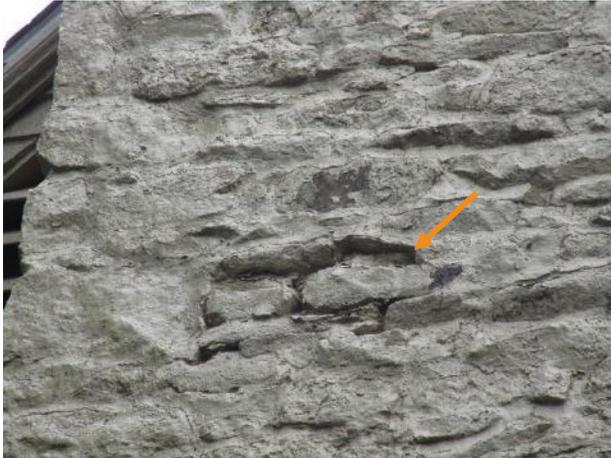
Figure 466. Section of recessed or missing mortar at the west chimney.

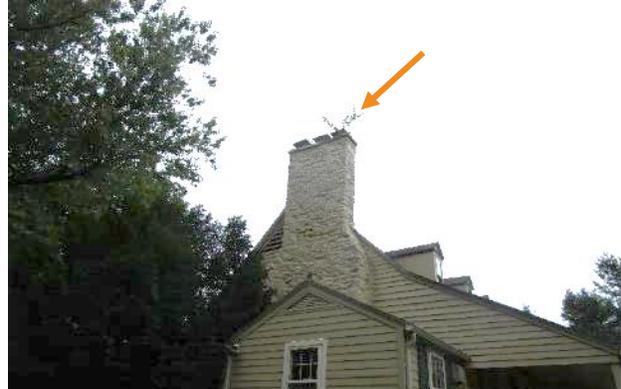
Figure 467. Plants growing at the top of the east chimney.

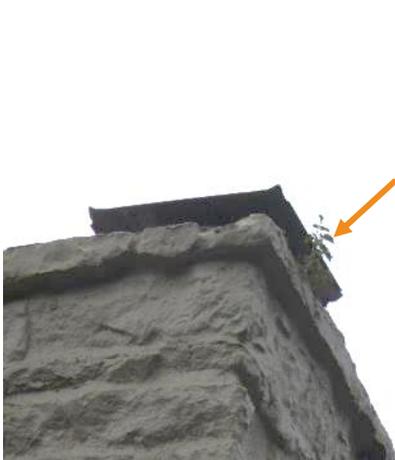
Figure 468. Plants growing at the top of the west chimney.

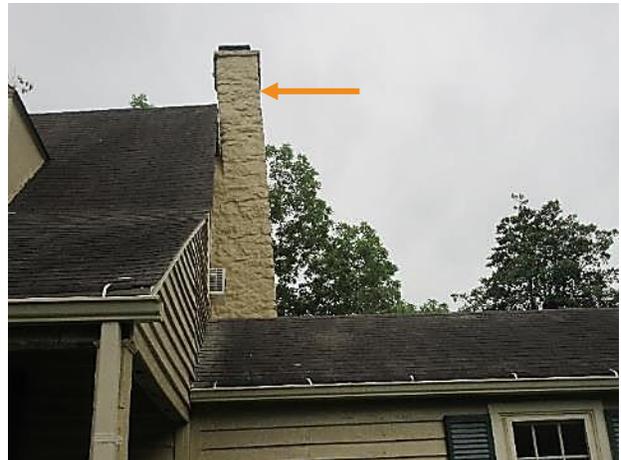
Figure 469. West chimney appears to be unplumb.

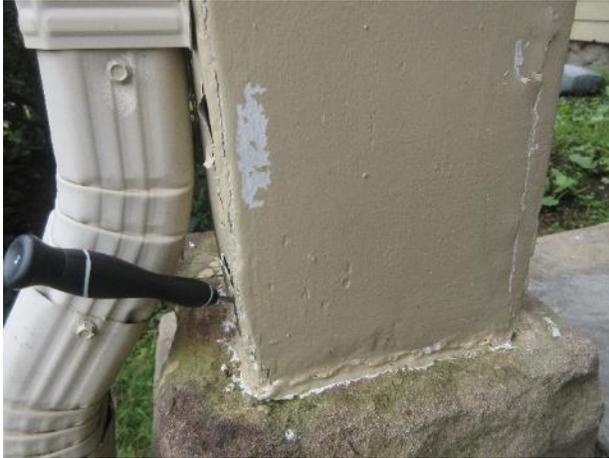
- Sections of soft and rotten wood were noted at the base of the easternmost north facade porch post when probed (Figure 470). A downspout was strapped to this post, possibly promoting additional moisture absorption into the wood. This wood had high moisture readings utilizing a scan mode during WJE's site survey.
- Soft and rotted wood were also observed at a wood post capital (top) of the third westernmost post. Two pieces of wood were separated and displaced (Figure 471 and Figure 472).
- Three out of six north facade porch posts had a mortar wash installed around their base (Figure 473). The other posts had small fillet seals with voids (Figure 474).

Figure 470. Soft and rotted wood found using a probe at the base of the north porch posts. Note downspout attached to this post.

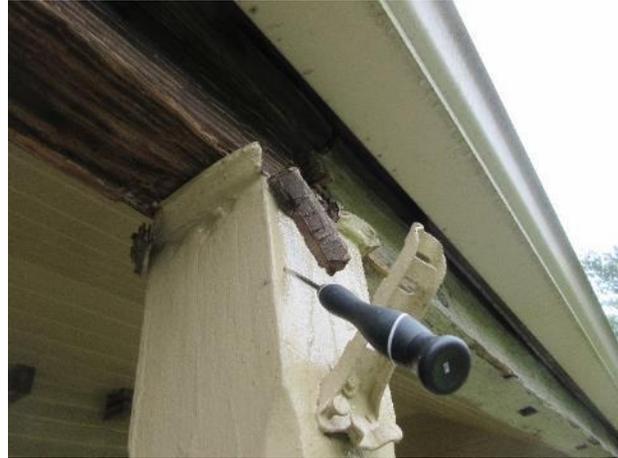
Figure 471. Soft and rotted wood found using a probe at the top of a north porch post.

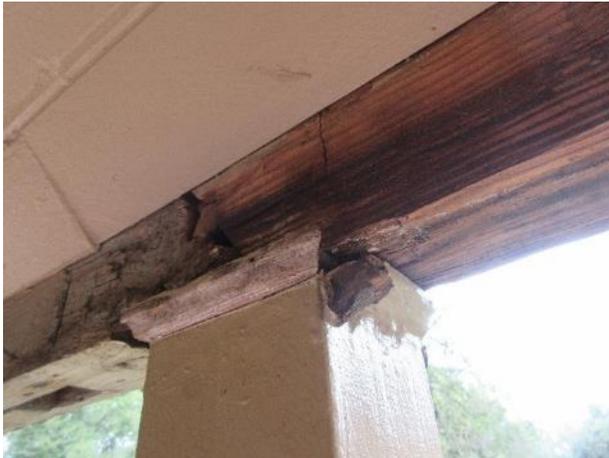
Figure 472. Soft and rotted wood found using a probe at the top of a north porch post.

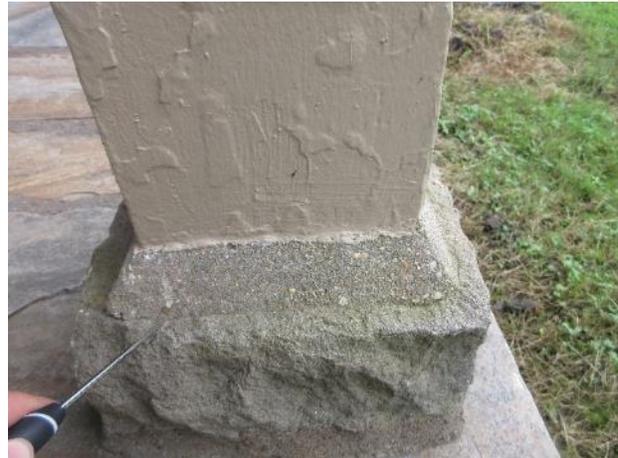
Figure 473. A sloped mortar wash exists on several north porch posts.

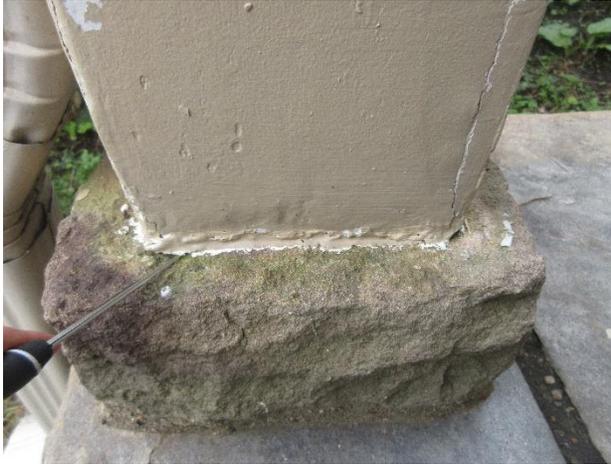
Figure 474. A small sealant fillet seal is in place at other north porch posts. The sealant joints typically had voids.
