## Mount Gilead

### Historic Structure Report

### FINAL REPORT

WJE No. 2019.8373

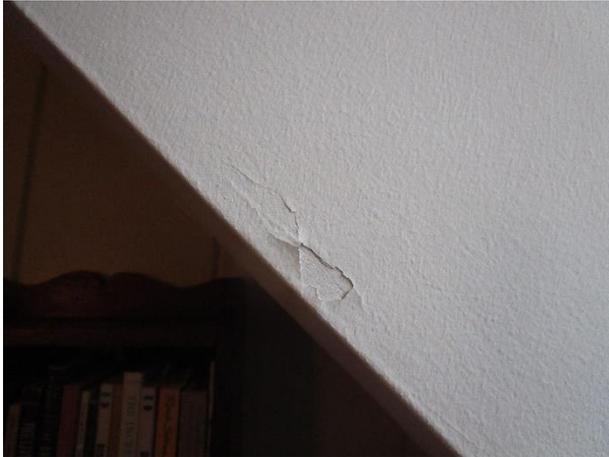
- Cracks in plaster/drywall and peeling paint at interior finishes were observed at several locations, including plaster walls at dormers, wall-to-ceiling interfaces, throughout the ceiling, and along trim (Figure 475 through Figure 481). Cracked and blistered paint and plaster were also observed in the master and guest bedrooms and bathrooms (Figure 482, Figure 483, and Figure 484). Other isolated observations included plaster spalls above the chair rail in the dining room and at the sloped ceiling in the master bedroom (Figure 485 and Figure 486). cracked shower tiles at both showers (Figure 487) and cracking through the cementitious coating at the fireplace hearth opening at the living room fireplace at the first floor (Figure 488). One crack at the ceiling near an exterior wall of the study also had resultant water staining, indicating previous or active water infiltration (Figure 489).

Figure 475. Typical blistered and cracked plaster at dormer wall, guest bedroom shown.

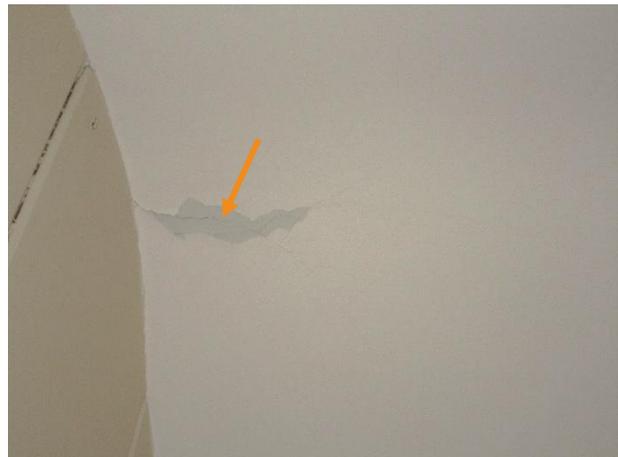
Figure 476. Typical cracking in the plaster ceiling-to-wall interface, guest bedroom shown.

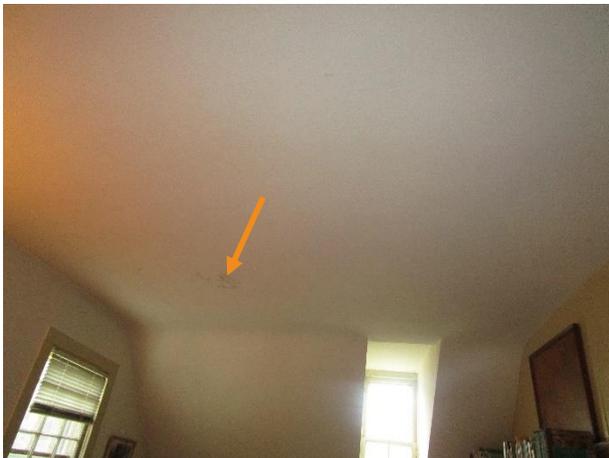
Figure 477. Typical peeling paint at second floor ceiling, guest bedroom shown.

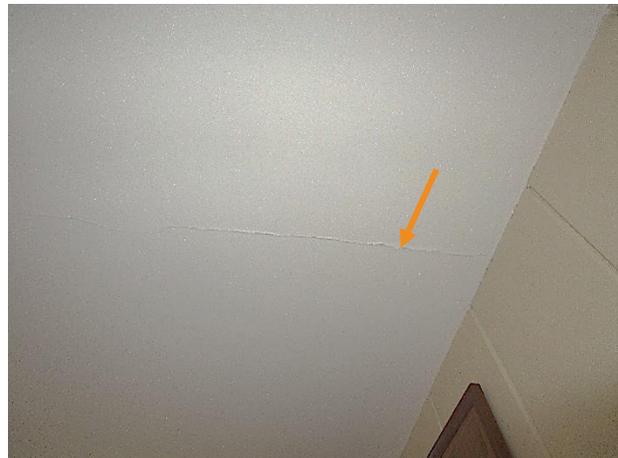
Figure 478. Typical cracking in the plaster ceiling-to-wall interface, guest bedroom shown.

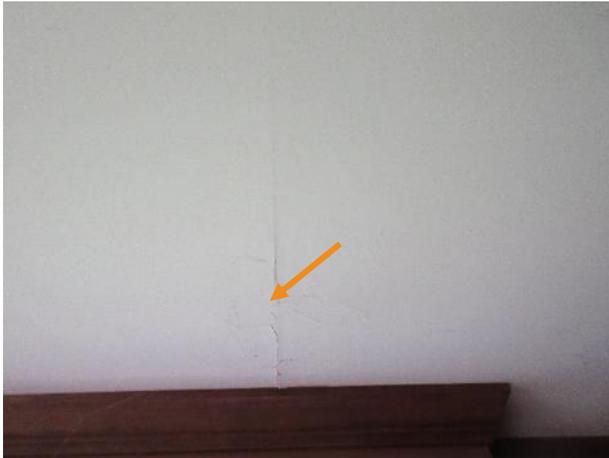
Figure 479. Typical cracking above wood trim, sitting room shown.

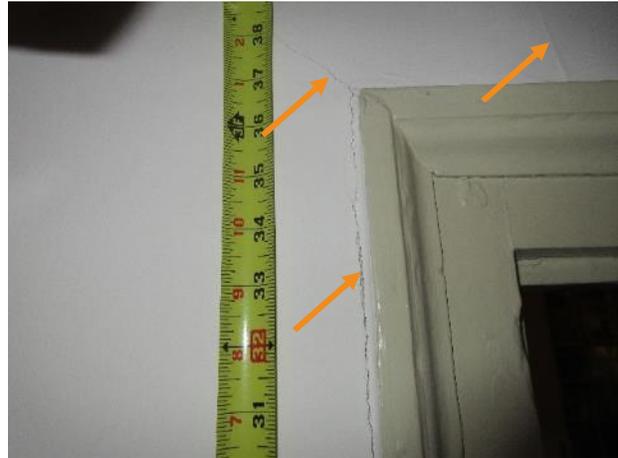
Figure 480. Typical cracking in plaster around and above door and trim, living room shown.

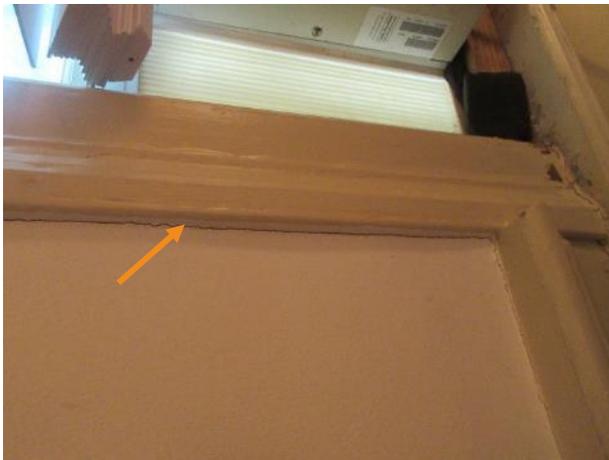
Figure 481. Typical cracking below wood window trim, living room shown.

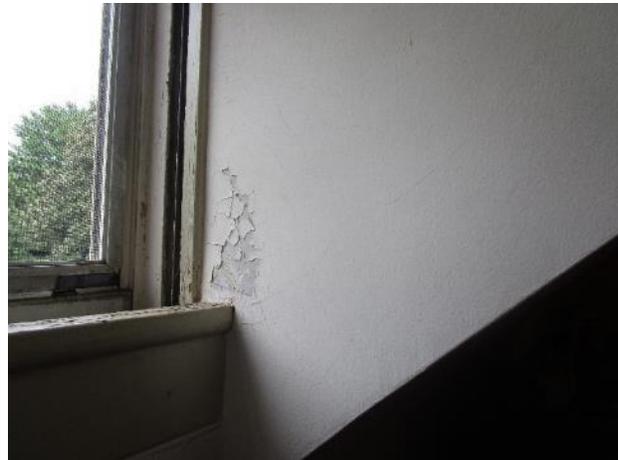
Figure 482. Blistered plaster at a dormer window, master bedroom shown.

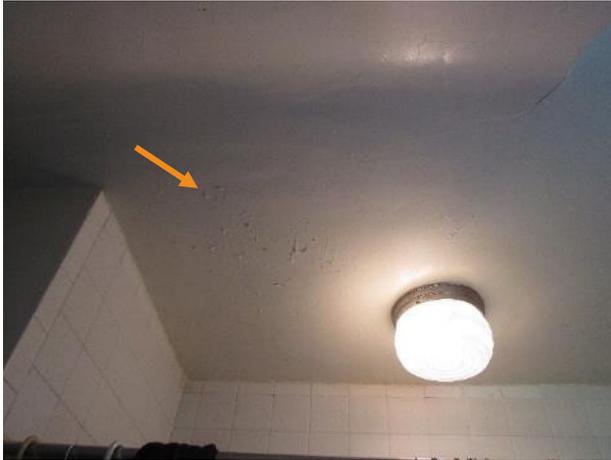
Figure 483. Blistered paint above the master bathroom shower

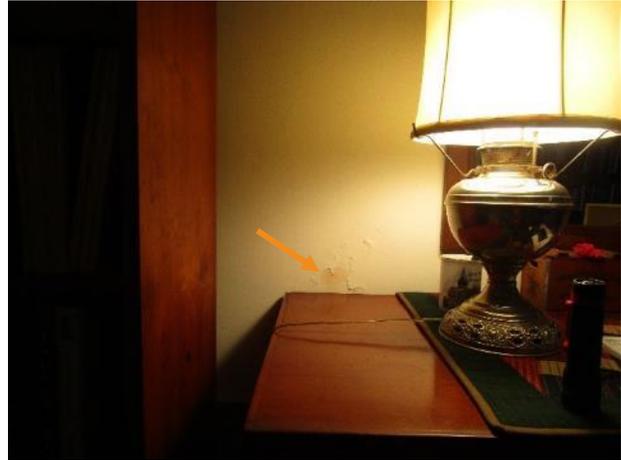
Figure 484. Blistered plaster at the west wall inside the guest bedroom.

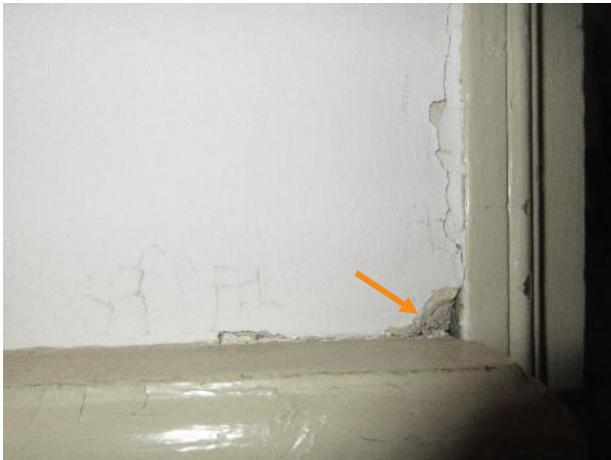
Figure 485. Section of plaster spalls above the chair rail in the dining room.

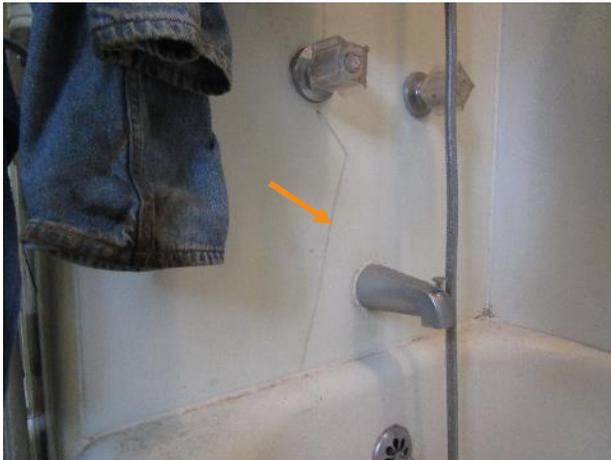
Figure 487. Several of the large shower tiles were cracked.

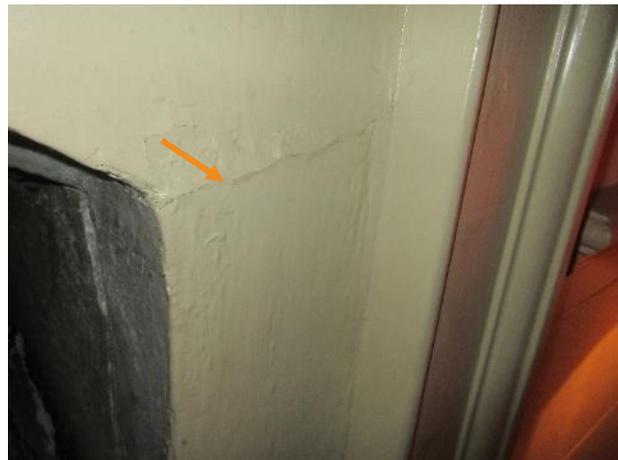
Figure 488. Crack, possible at a cold joint, of the cementitious crack at the living room fireplace.

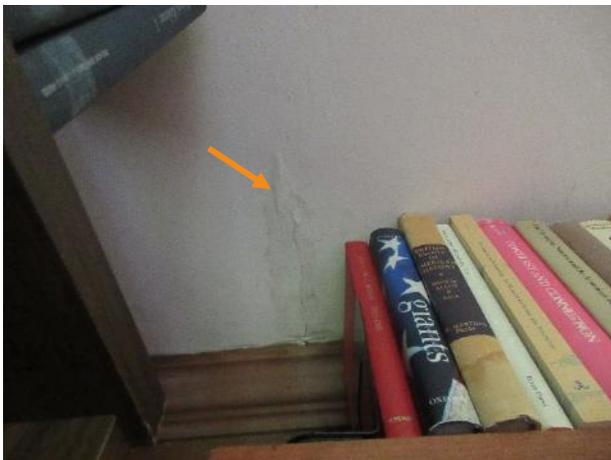
Figure 489. Crack in plaster with water staining at the east wall of the sitting room, possibly indicating an active source of water infiltration.

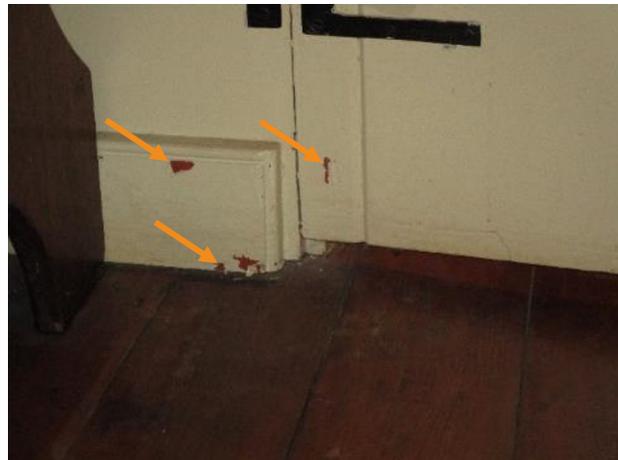
- Areas of flaked and stained painted plaster and wood trim surfaces were observed throughout the house. Areas of peeling or flaking paint were primarily observed at the painted wood wainscoting and trim at the first and second floors (Figure 490 and Figure 491) the walls of the stairwell (Figure 492) and second floor doors and jambs (Figure 493 and Figure 494). Plaster walls were stained in the bathrooms (Figure 495 and Figure 496). These bathrooms are not ventilated by fans or operable windows with the storm windows in place.

Figure 490. Typical peeling or missing tan paint at wood elements, revealing a red undercoat.

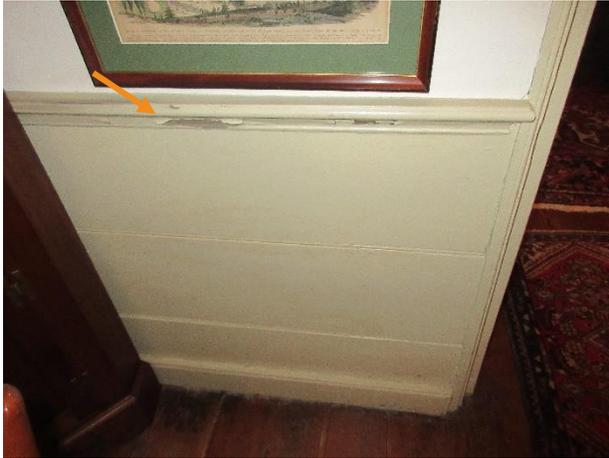
Figure 491. Typical peeling or missing tan paint at wood elements, dining room west wall shown.

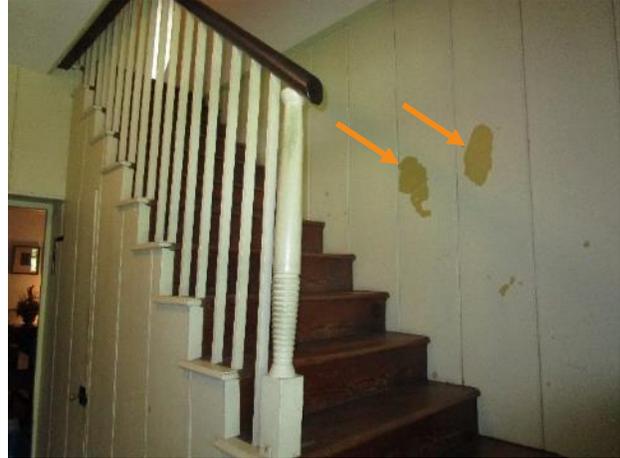
Figure 492. Typical peeling or missing tan paint at wood paneling in the stairwell, revealing a yellow undercoat.

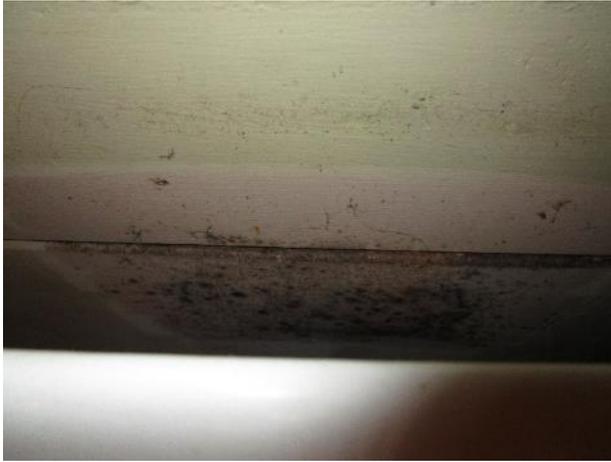
Figure 495. Black staining observed in bathrooms, indicating an issue with ventilation.

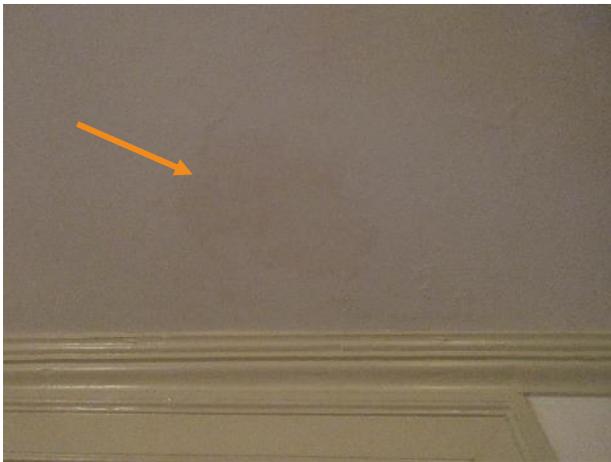
- Plaster finishes were blistered at multiple locations at the first floor ceiling (Figure 497). The largest area of this condition was observed in the living room—the condition was described by the tenant as arising from a failed seal at the plumbing in the second floor bathroom above, which no longer leaks (Figure 498, Figure 499, and Figure 500).

Figure 497. Area of plaster staining, dining room shown.

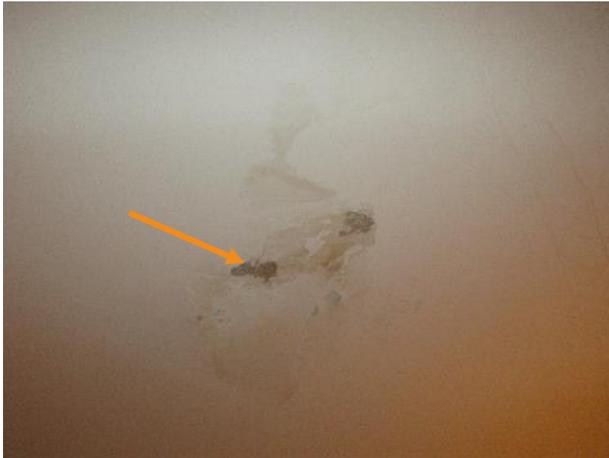
Figure 499. Area of blistered and stained plaster ceiling, living room shown.

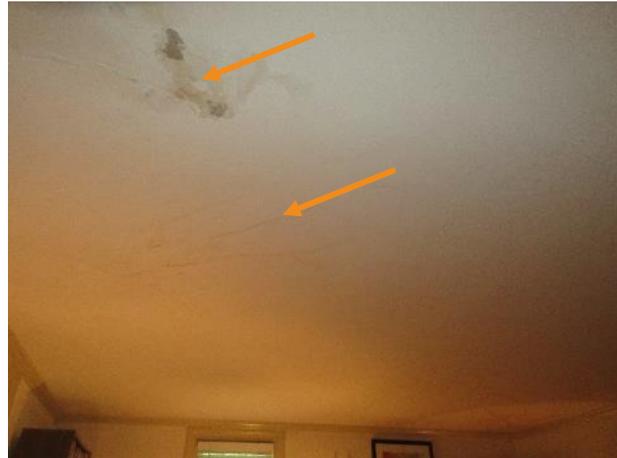
Figure 500. Area of blistered and stained plaster ceiling, living room shown.

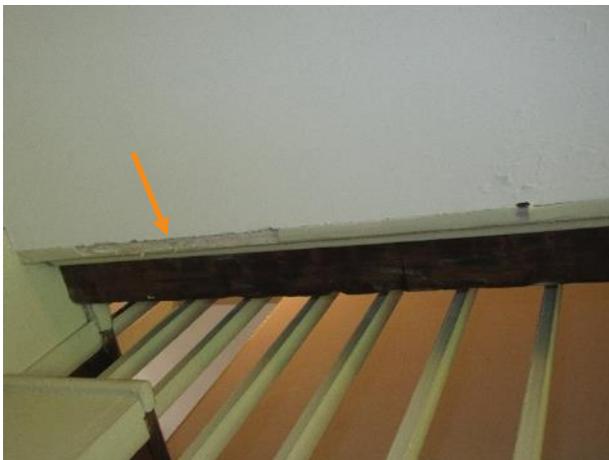
- A section of crown molding was observed to be missing at the underside of the wood beam at the entrance hallway (Figure 501).

Figure 501. Missing section of wood molding along the stairwell.

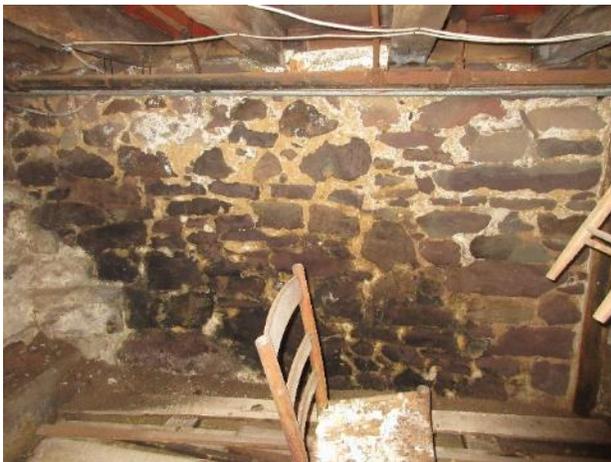
- Staining and biological growth were noted at stone masonry walls and steps within the cellar (Figure 502 through Figure 505).
- Crumbling, recessed, and otherwise deteriorated mortar joints were observed at the stone masonry walls in the cellar (Figure 506). A small section of mortar to the south of the crawl space entry was previously repointed (Figure 507). The mortar in this area differed in color from the surrounding, as did the sand within the mortar matrix. The center of the west cellar wall was observed to be out of plumb (Figure 508).

Figure 504. Staining at the foundation wall, viewed from the cellar.

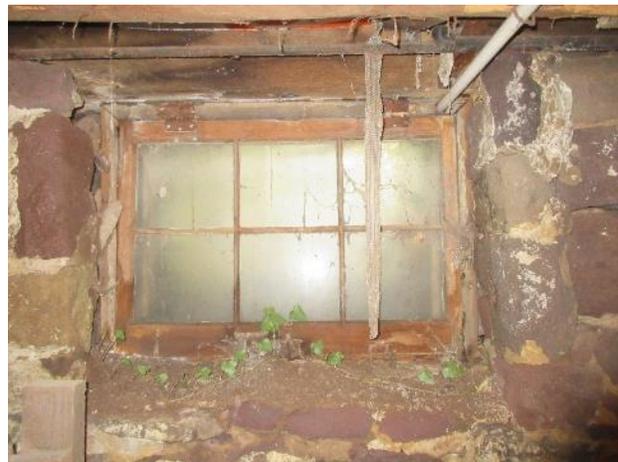
Figure 505. Vegetation growing into the cellar space from the west wall window. This window was not visible from the exterior.

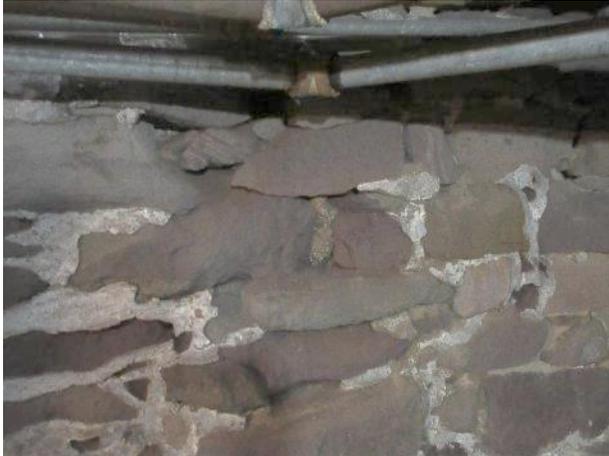
Figure 506. Crumbling and missing sections of mortar in the stone foundation wall.

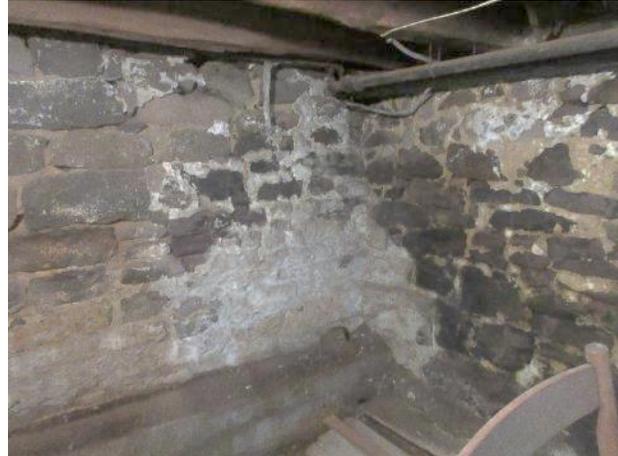
Figure 507. Area of repointing with a white coating at the foundation wall.

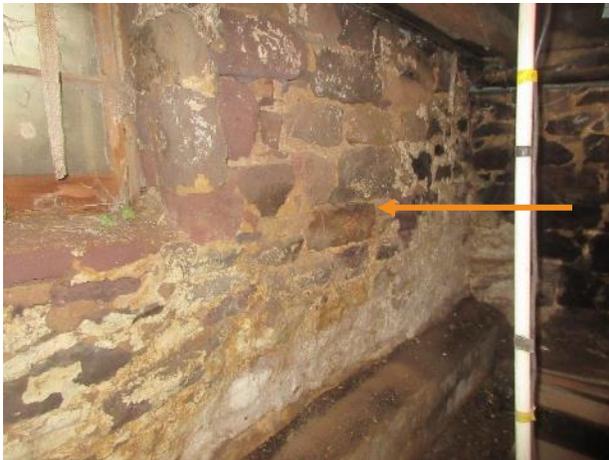
Figure 508. The west wall appeared to be out of plumb.

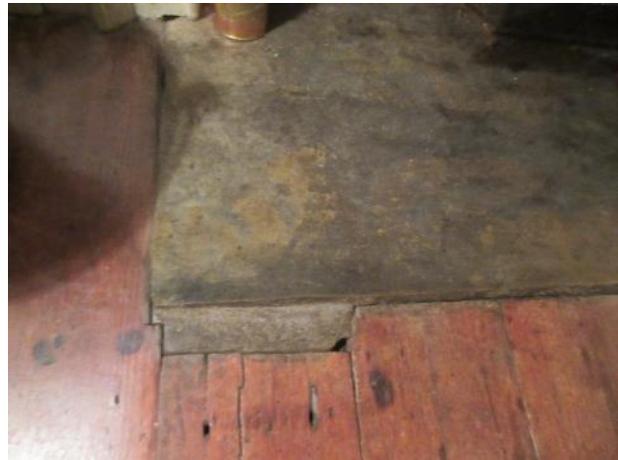
- Cracked mortar was observed at the flagstones and interior of the firebox of the living room fireplace (Figure 509 and Figure 510), at an opening on the side of the kitchen fireplace (Figure 511); at the surround of the dining room fireplace, where it appears that the tile surround was previously removed (Figure 512) and at either side of the hearth stone at the master bedroom fireplace (Figure 513).

Figure 509. Cracked mortar at the stone hearth of the living room fireplace.

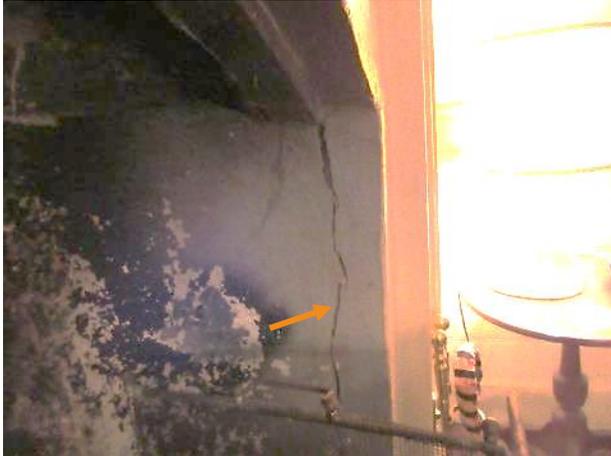
Figure 510. Crack within the cementitious parge coat of the living room firebox.

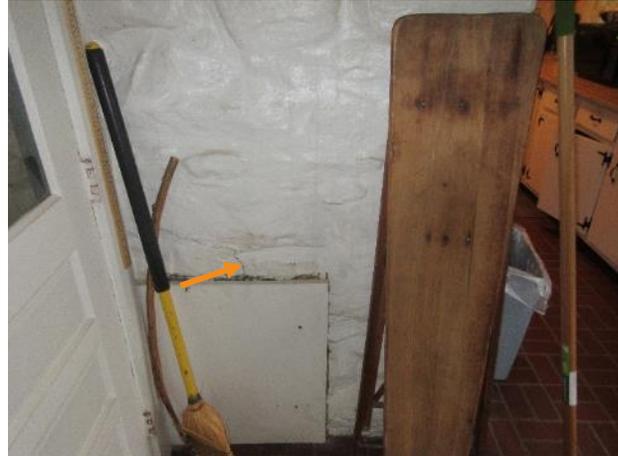
Figure 511. Crack in the mortar originating from an opening on the side of the masonry wall in the kitchen.

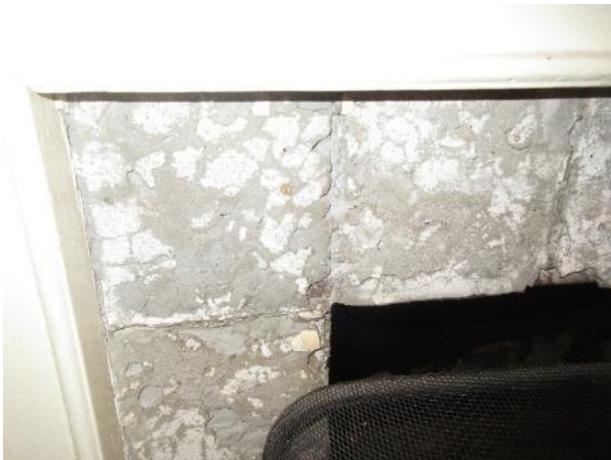
Figure 512. Remove tile at the dining room fireplace surround.

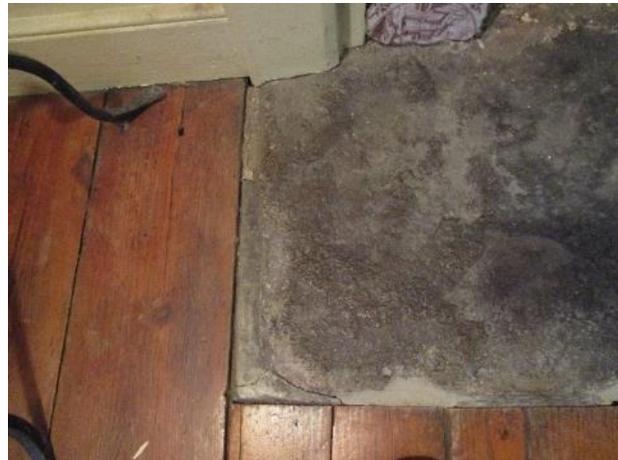
Figure 513. Crack in mortar at the bedroom fireplace hearth.

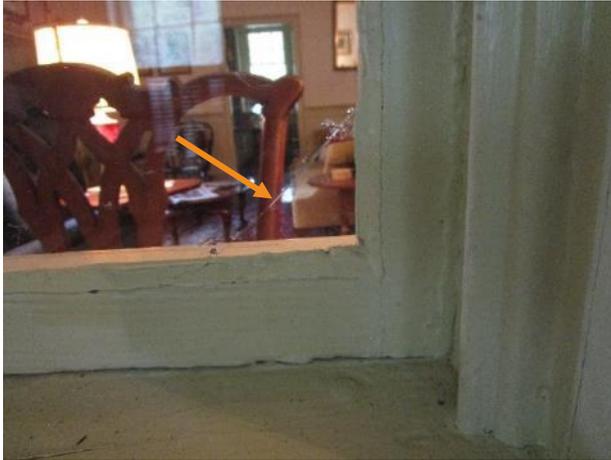
- Isolated cracked window lites were observed at the lower eastern lite at the interior window between the living room and the south enclosed porch (Figure 514) and at an upper lite at the interior window inboard of the planter window within the study (Figure 515).

Figure 514. Cracked glazing lite at window between living room and south enclosed porch.

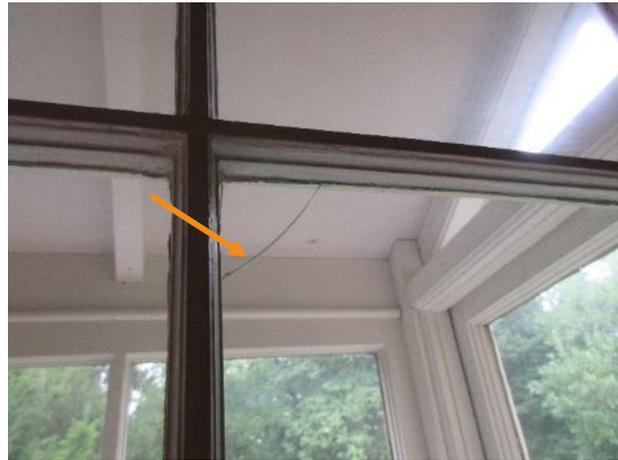
Figure 515. Cracked glazing lite at interior side of the garden window.

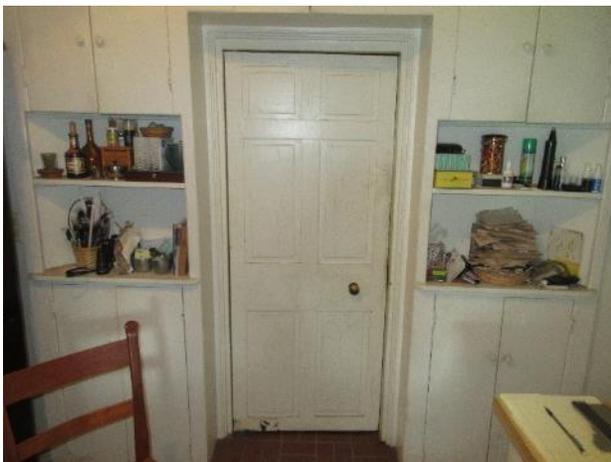
- Multiple doors at the interior were observed to be racked within their frames: at the door between the kitchen and the dining room (Figure 516) the door to the guest bedroom at the second floor (Figure 517), and at the closet doors within enclosed porch (Figure 518).
- The paint at multiple doors and door frames had flaked or peeled from the surface (Figure 519 and Figure 520).
- Surface corrosion at the kitchen door hinges was observed (Figure 521).
- Cracking was observed at the lower west panel of the door between the living room and the south entry porch, with adjacent separation of the paint between the middle stile and rail (Figure 522).

Figure 516. Door between the kitchen and dining room doesn't fully close.

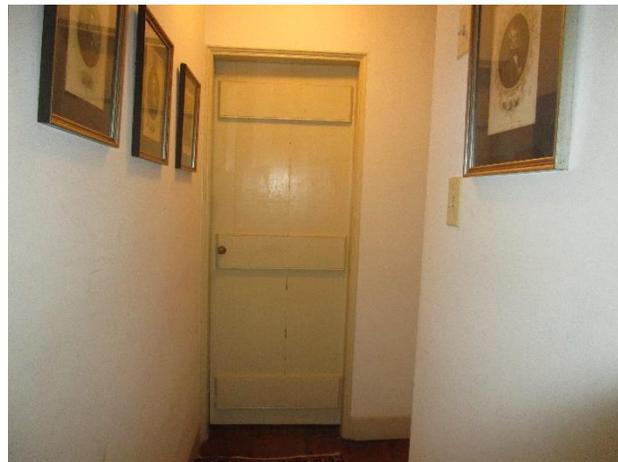
Figure 517. Door between the second floor hallway and guest bedroom doesn't fully close.

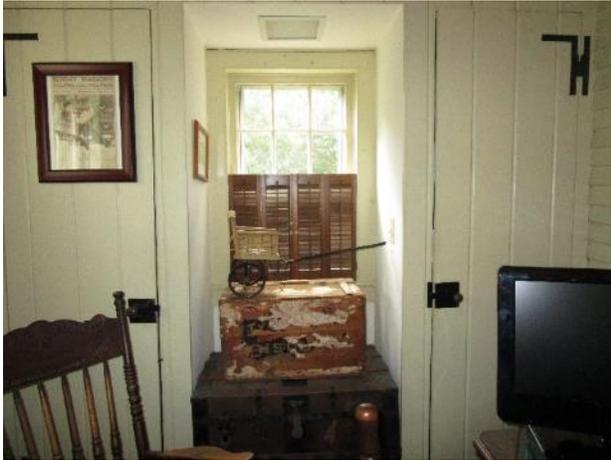
Figure 518. Closet doors in the south enclosed porch doesn't fully close.

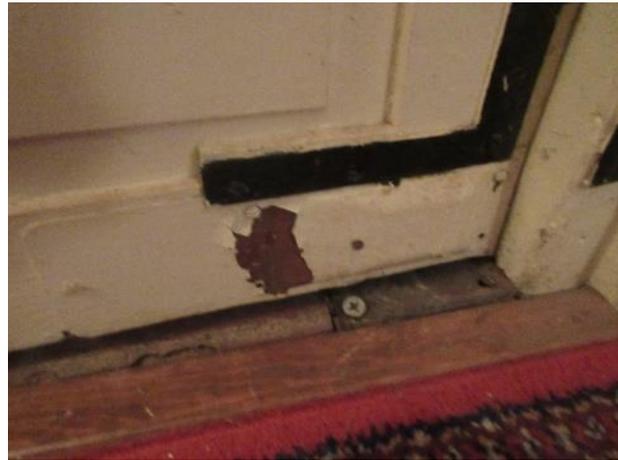
Figure 519. Peeling paint at the base of the kitchen door.

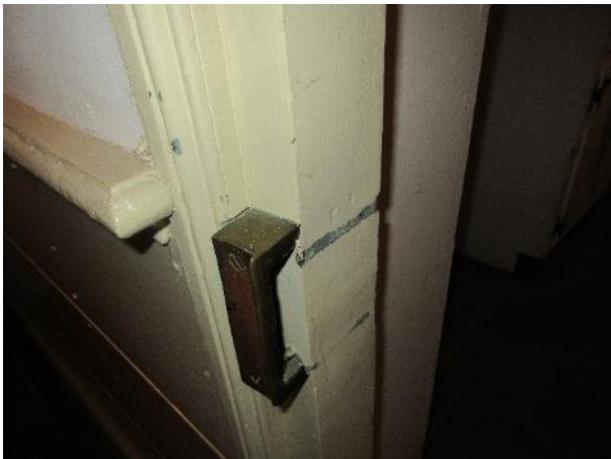
Figure 520. Missing paint at the casing from door abrasion, dining room shown.

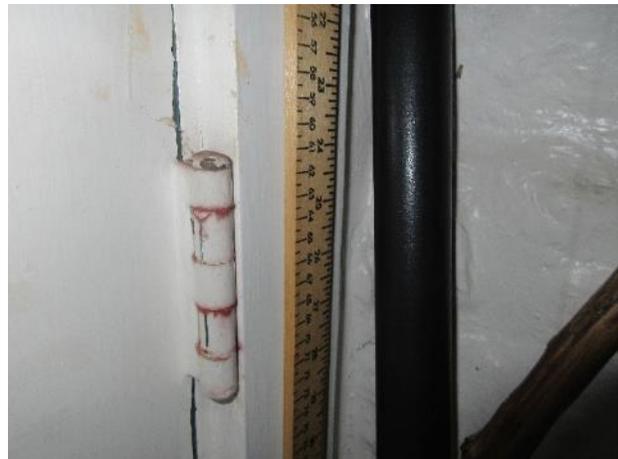
Figure 521. Surface corrosion observed at a kitchen door hinge.

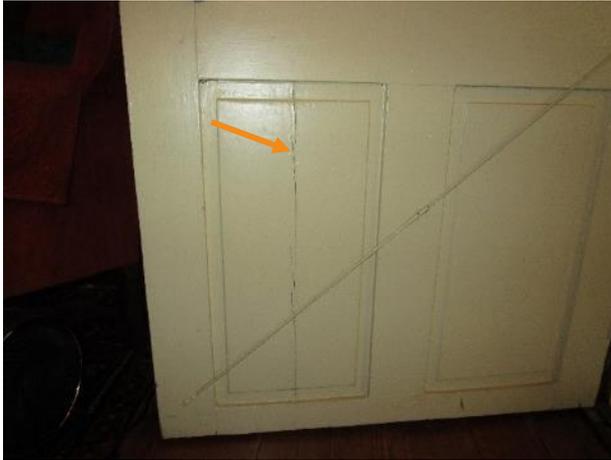
Figure 522. Crack full height of a door panel at the living room to south enclosed porch door.

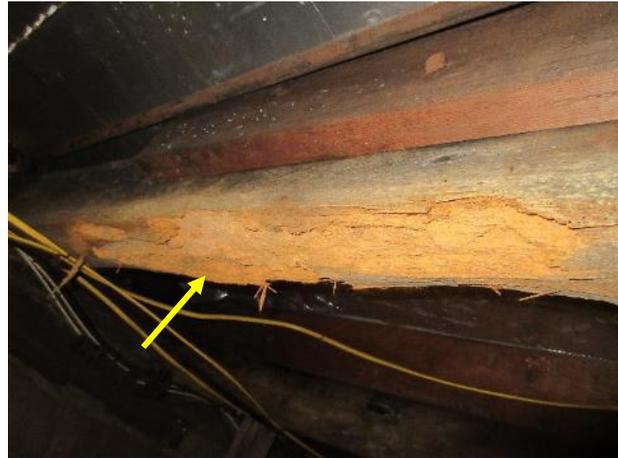
- Insect damage with resultant wood section loss was observed at the cellar exposed joists (Figure 523 and Figure 524) and at exposed joist ends at the south enclosed porch (Figure 525 and Figure 526). The current tenant reported there had been termite activity within the north wall of the south enclosed porch, extending to the exposed ceiling joists. The clapboards at this location were observed to bulge outward from the wall, and several boards were cracked and displaced from the surrounding clapboard (Figure 527, Figure 528, and Figure 529). An isolated portion of the ceiling paneling above the north wall was also observed to be displaced (Figure 530). Evidence of the termite treatment was observed in the filled holes in the mortar of the flagstone flooring (Figure 531). The exposed wood joist ends at the enclosed porch also appeared to suffer from white rot (Figure 532). Wood section loss was observed at the bases of the wood posts that make up the cellar shed and may likely be due to insect activity and increased exposure to water (Figure 533 and Figure 534).

Figure 523. Typical insect damage along the bottoms of the exposed joists in the cellar.

Figure 524. Typical insect damage along the bottoms of the exposed joists in the cellar.

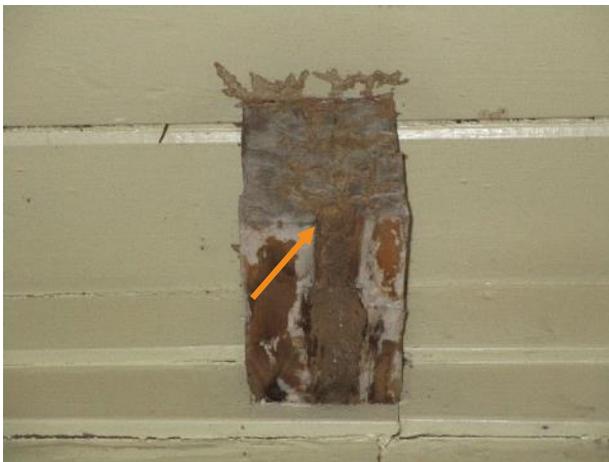
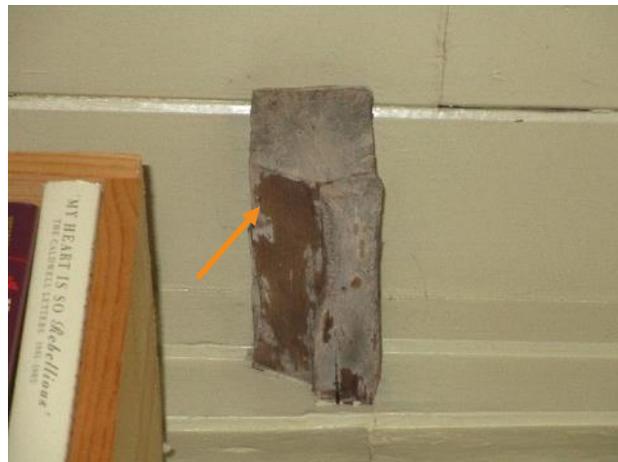
Figure 525. Wood section loss at exposed joists in the south enclosed porch.

Figure 526. Wood section loss at exposed joists in the south enclosed porch.

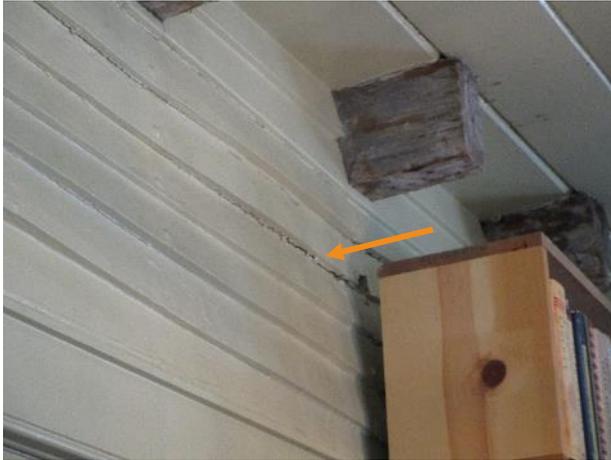
Figure 527. Uneven clapboards below the exposed joists.

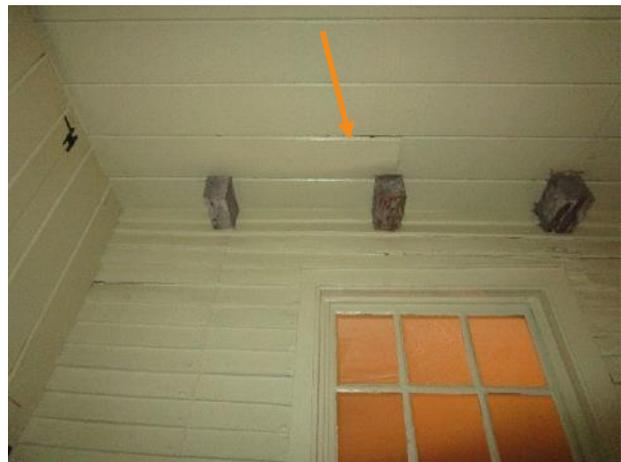
Figure 530. Displaced wood panel at the ceiling above the exposed joists.

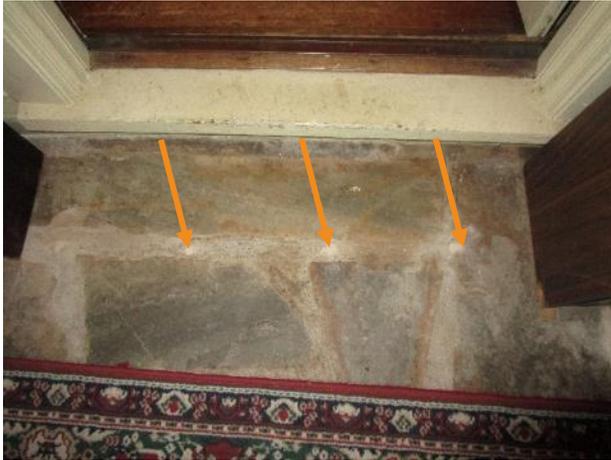
Figure 531. Filled mortar holes at the south enclosed porch from previous termite treatment.

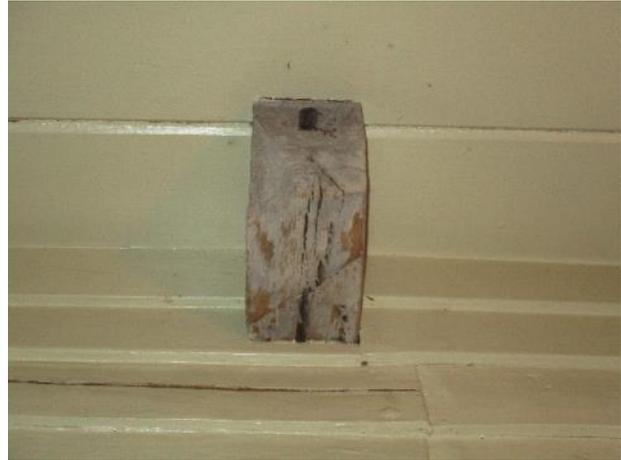
Figure 532. White appearance of the exposed joists.

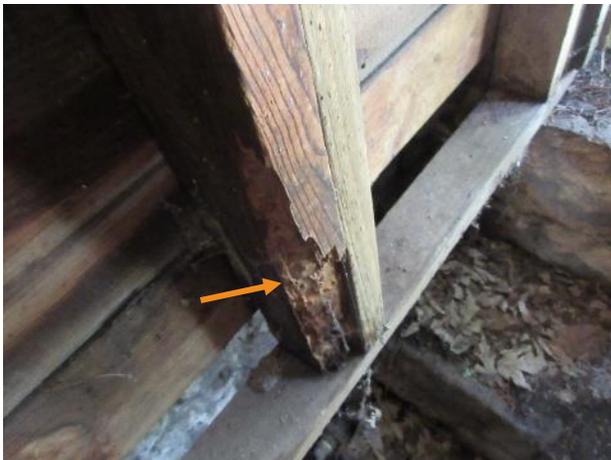
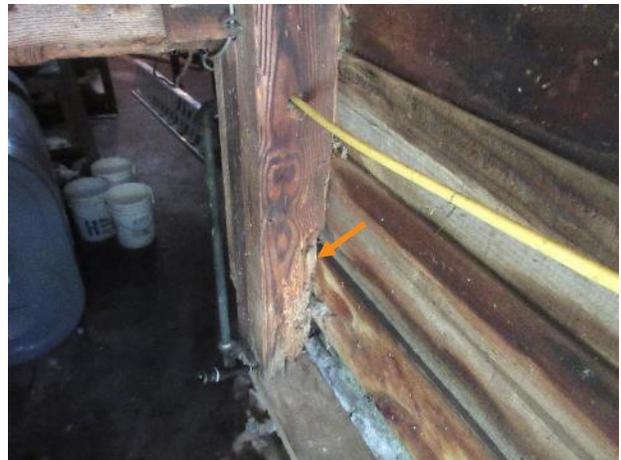
Figure 533. Wood section loss at the wood studs of the cellar access.

Figure 534. Wood section loss at the wood studs of the cellar access.

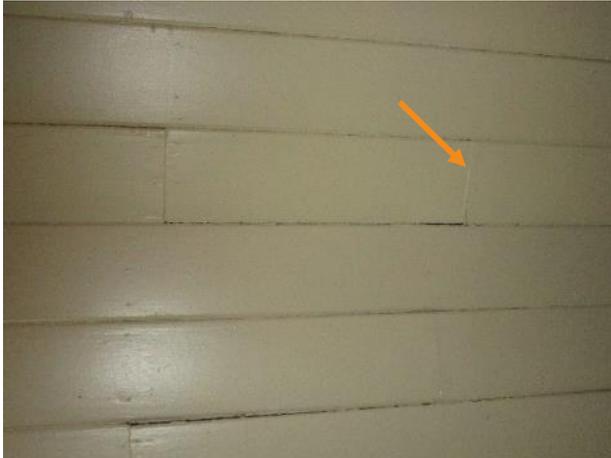
Figure 535. Separation between ceiling panels with one crack in the south enclosed porch.

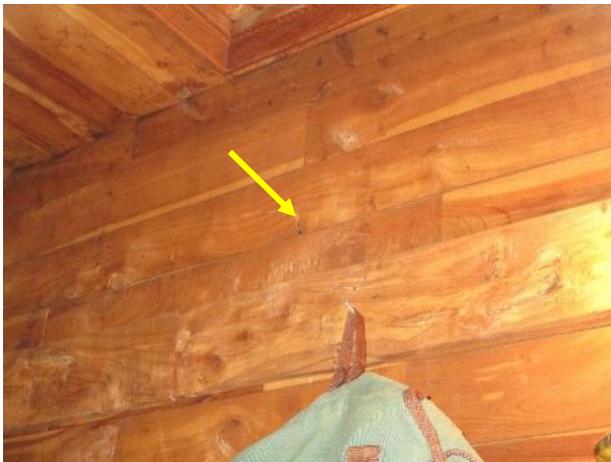
Figure 537. Crack in wood paneling within the hall closet.

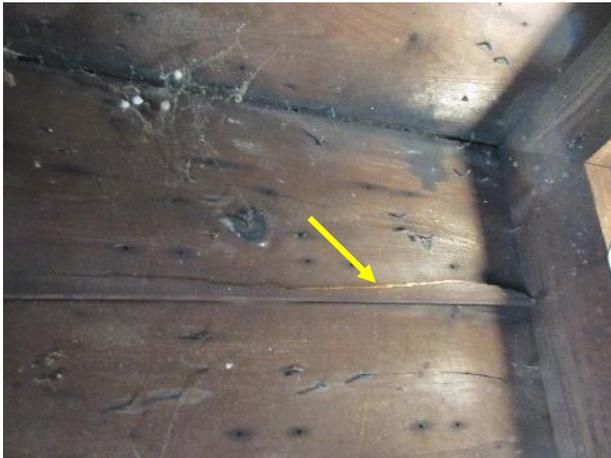
Figure 539. Longitudinal crack along wood paneling in the cellar access.

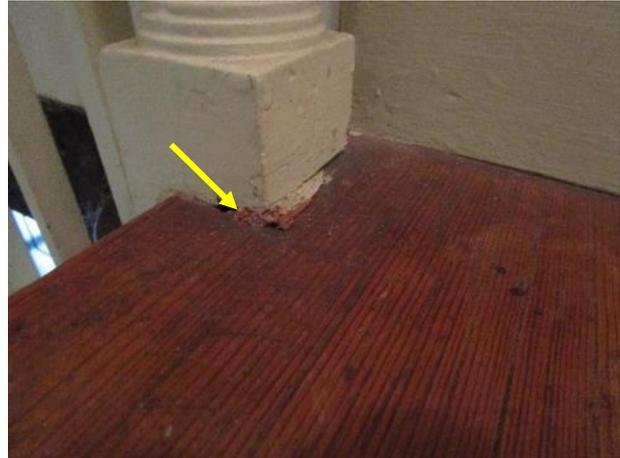
Figure 540. Crack in wood or shim at the base of the newel post.

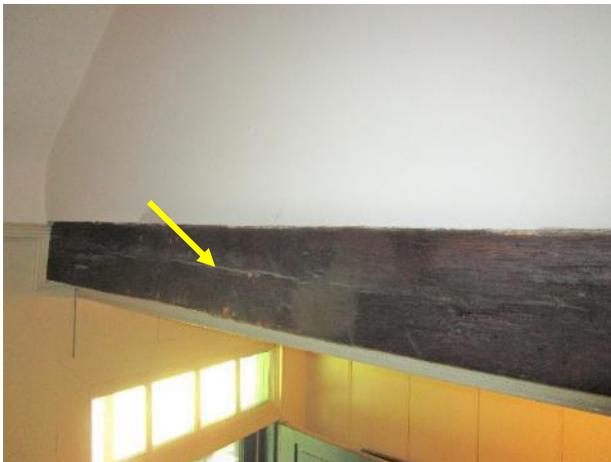
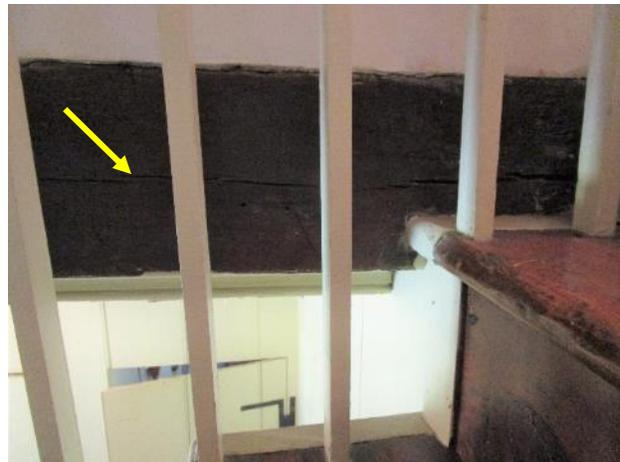
Figure 541. Season check along the exposed timber in the stairwell.

Figure 542. Season check along the exposed timber in the stairwell.

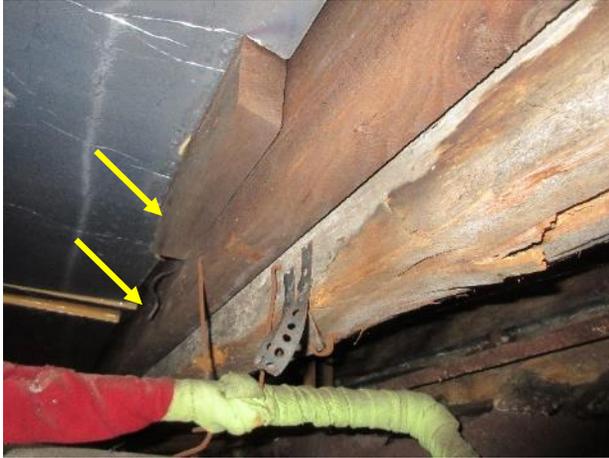
- Several wooden floor joists in the cellar had been previously sistered with retrofit wood material or steel tube columns added below (Figure 543 and Figure 544). Significant water staining at joist ends was also observed (Figure 545).

Figure 543. Partial sistering at a floor joist in the cellar.

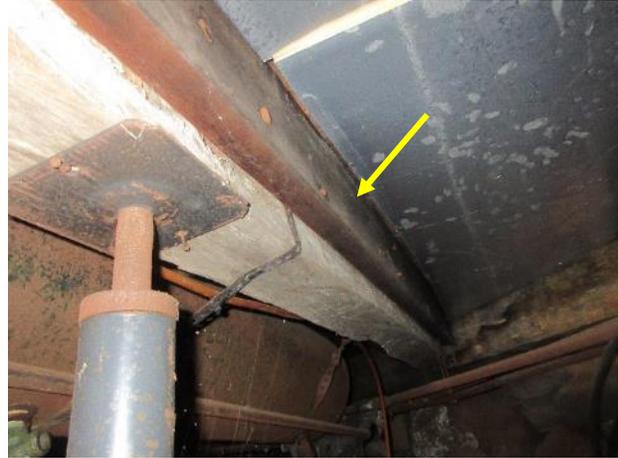
Figure 544. Sistered joist in the cellar.

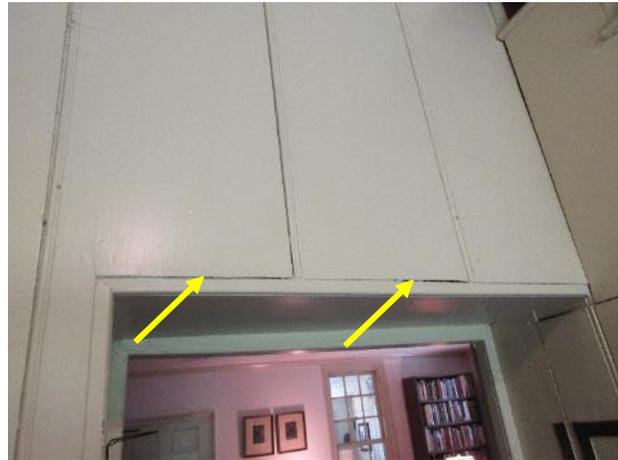
Figure 546. Cupped wood paneling in the hallway.

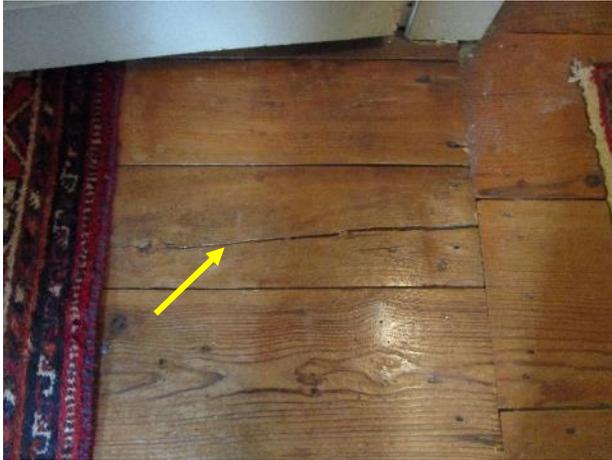
Figure 547. Crack in a floorboard at the guest room.

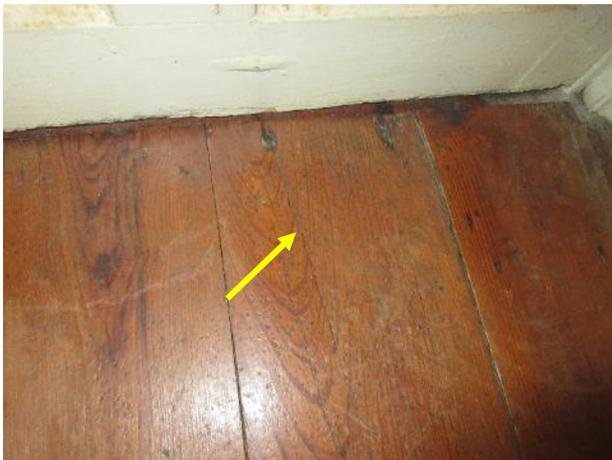
Figure 549. Crack in floorboard from fastener, closet shown.

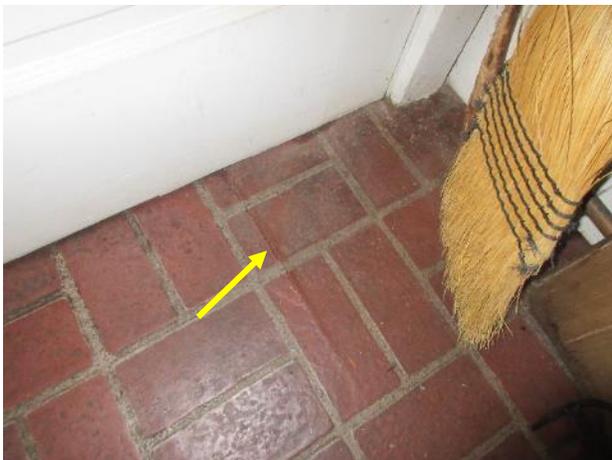
Figure 551. Crack in brick flooring of the kitchen.

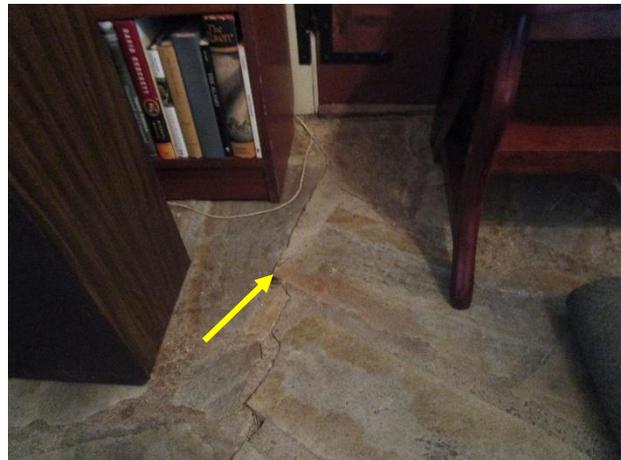
Figure 552. Crack full depth of the south enclosed porch.

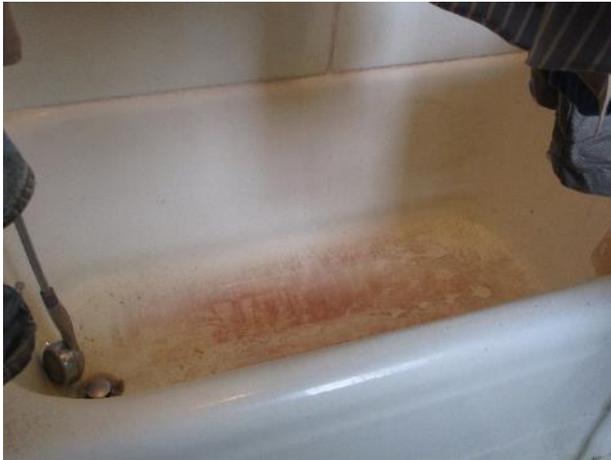
Figure 553. Staining within the master bathroom shower.

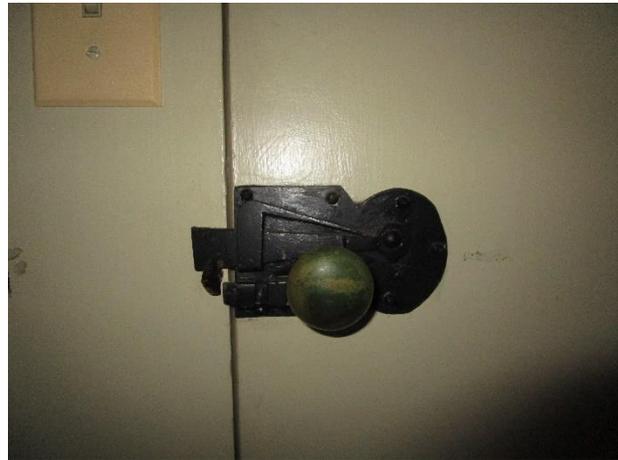
Figure 554. Green patina on the guest bathroom doorknob.

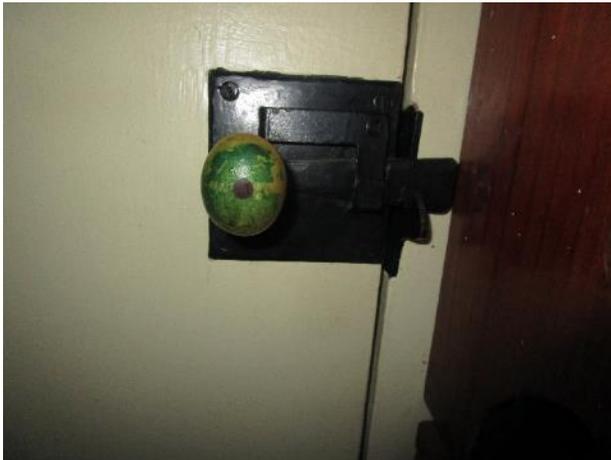
Figure 555. Green patina on the master bathroom doorknob.

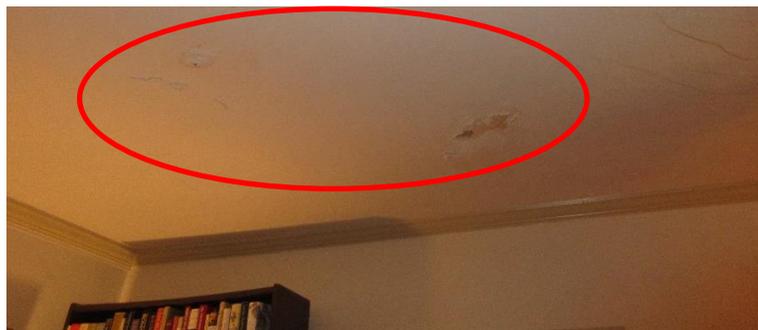
Photo 1: Water damage from leaking water closet wax seal on the second floor. The wax seal has been replaced and the water closet is no longer leaking.

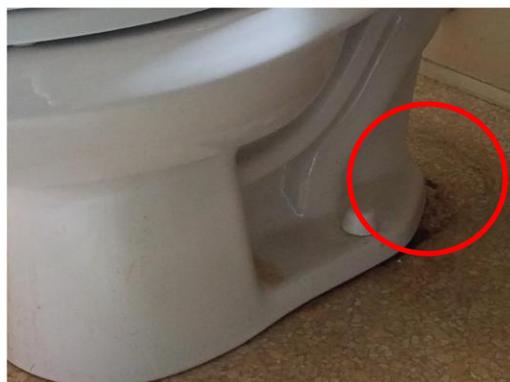
Photo 2: Footprint of the old water closet where the seal was already replaced.

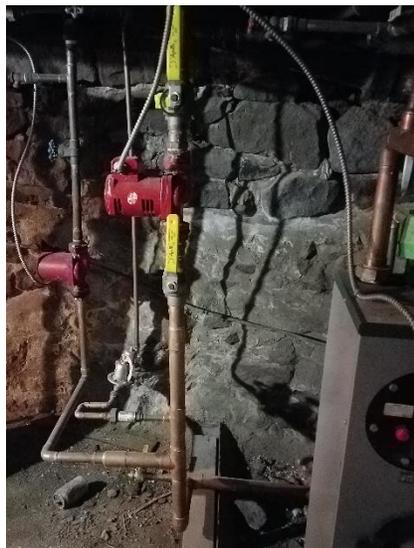
- The oil-fired hot water heating system is only two years old. It was shut down for the summer and was not put into operation at the time of MBP's visit. None of the visible hot water piping was insulated. In this case, insulating the hot water piping is not recommended since the piping is located within the house. The minimal amount of energy that is dissipated from the uninsulated hot water piping will be used to heat the cellar. The dissipated energy will prevent the cellar from reaching low temperatures where equipment within the space is in danger of freezing. Additionally, the rooms above the cellar will also receive the dissipated heat from the pipes as it rises through the building. In this instance, energy is not being wasted and the cost of installing insulation would not be recovered in energy savings.

Photo 8: No piping insulation.
