TURNER FARM
Turner Farm Treatment Report

10609 Georgetown Pike
Great Falls, Virginia 22066

Final Report

November 10, 2016
WJE No. 2015.3162.2

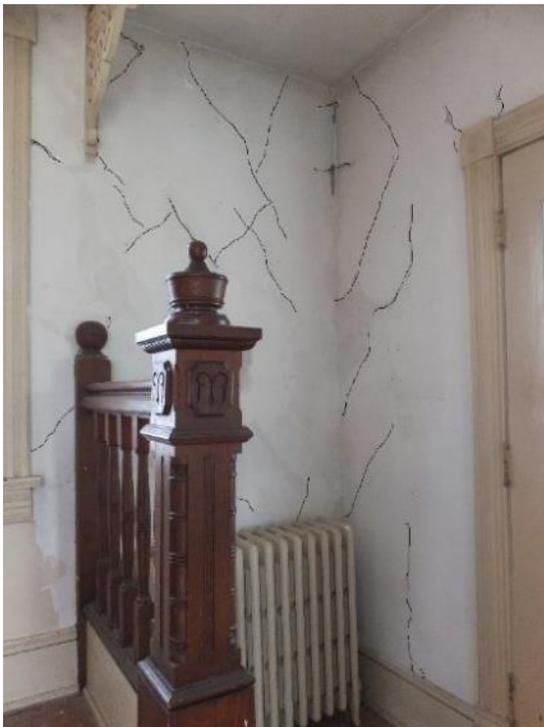
At the interior of the farmhouse, there are numerous cracks, damage, and water staining throughout the plaster walls at the original 1905 portion and 1930 and 1937 additions. The cracks are most severe at the Hallway (100), Hall, Bedroom (201), and main stairwell. (Figure 8 and Figure 9) Almost all of the historic interior doors and built-in cabinets still in place are racked and unable to close. (Figure 10) There is evidence of historic exterior siding enclosed by the 2002 addition at the doorway from the Kitchen (104) to the Parlor (106). There is a gap between the ceiling and door trim at this location. The transom above the door has been infilled. Hinges are still mostly in place along jambs at openings where doors have been removed, which provide evidence of their historic nature as the 1905 hinges are more decorative with steeple tips and the 1930s hinges are simple with ball/globe tips. At the large sliding wood living room doors, the frame is chipped in a few locations and the doors were not able to be moved. The interior door framing at the south wall of the Casual Dining Room (103) is damaged with part of the wood frame missing.

Figure 9. Example of cracking at the entryway at the northwest corner. Cracks have been traced for clarity.

- Clean and repair/replace deteriorated wood elements at the historic attic window. Paint.
- As we have determined that the plaster cracking is likely a result of the house being lifted in 2002, repair plaster cracking once structural repairs have been completed. Repaint all interior plaster finishes once repaired.
- Remove and clean spindlework at entryway while plaster repairs are being undertaken. Reinstall spindlework once plaster repairs and repainting is complete.
- Infill penetrations in wood floor of the Hallway (100) and Formal Dining Room (102) with wood filler and finish.
- Inspect stained wood flooring for any soft wood that should be repaired. The staining typically occurring near radiators. As such, the radiators may need to be removed to fully inspect and perform any repairs and cleaning.

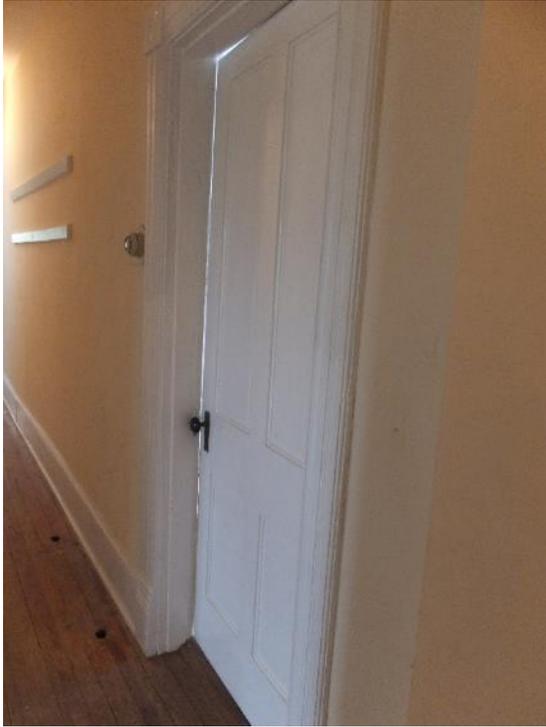
Figure 10. Door leading into room 102 does not fully close.

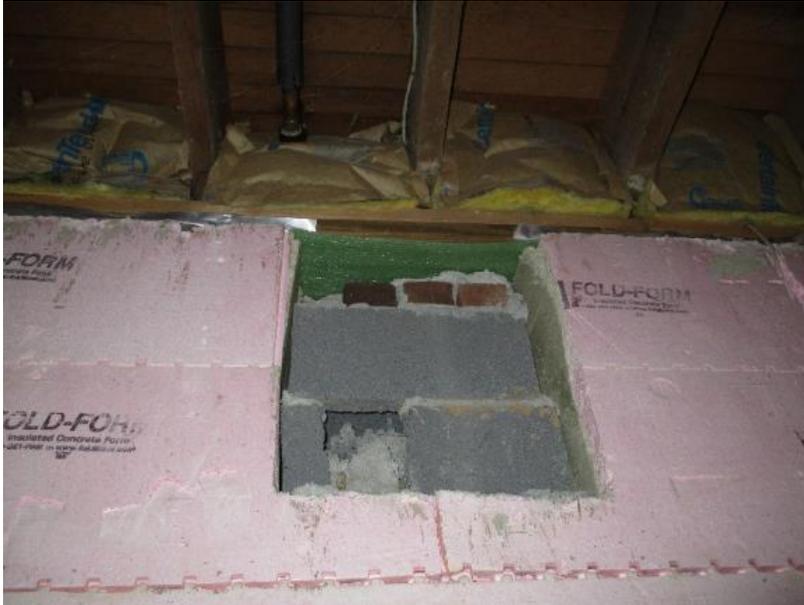
The original foundation walls are concealed. At both the exterior and interior facing sides of the foundation wall, WJE observed rigid foam insulation believed to be, in part, a manufactured system used to form new concrete walls. These types of systems utilize two (2) separate layers of insulation boards that are separated and braced with hard plastic struts. The void space between the two layers of insulation can vary between 4 inches and 16 inches. Wet concrete is poured into the void space between the two layers of insulation to form the structural/load bearing wall. The insulation remains after the concrete is cured to provide insulating value to the new wall system. The sill plate and other structural elements may be tied into the new foundation wall assembly. What is unclear, due to the insulation boards running from floor to ceiling and obscuring a visual review, is whether any of the original foundation wall remains in place or if the original walls were replaced in totality with the new formwork and concrete spanning from floor to ceiling. There are multiple blockouts in the top of the walls that are partially infilled with miscellaneous building materials, i.e. CMU, brick masonry units, and grout (Figure 14). At one blockout location where a CMU unit was damaged, we observed a reinforcing bar in an interior cell (Figure 15). Although no information is available concerning the method by which the house was raised, we anticipate that these blockouts were locations where equipment was installed to raise the house and after the house was positioned on the new walls, the equipment was removed and the blockouts were infilled.

Figure 14. Blockout in cellar wall infilled with CMU, brick masonry, and grout.

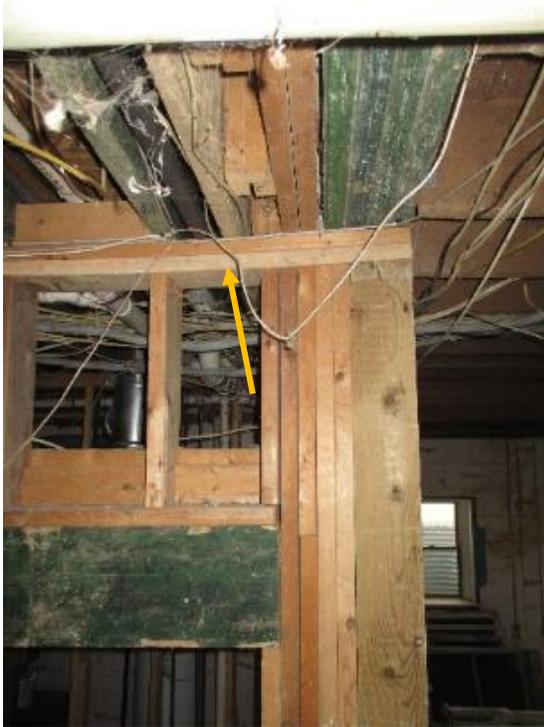
Original main structural members have been removed while several new ones have been installed, resulting in a different distribution of load to framing members than was originally designed for. We observed deflection of members in interior partition walls (Figure 16), which are not typically designed to carry load, indicating that they are taking load. It is unlikely they were designed to act as structural supports and the amount of deflection observed indicates that they are potentially overloaded. The first floor walking surface is significantly warped and out of level and gaps exist between many of the interior finishes as discussed in the Architectural section. There does not appear to be a subfloor below the original finished floor at the first

floor but a subfloor is visible at the additions. It is unclear what the condition of the floor was prior to being raised, but it is possible that the process of raising the house to create additional height in the basement combined with the reconfiguration of structural support for the floor has caused the noted warping. In general, the load distribution is difficult to follow and will require further documentation and evaluation.

Figure 16. Deflection of header at interior partition wall.

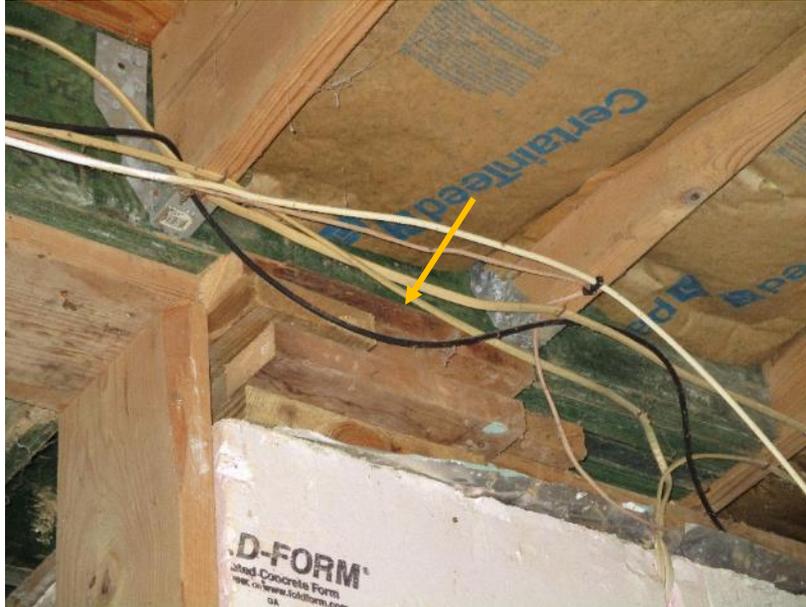
Built-up areas of wood members are located throughout the first floor framing in apparent attempts to make up differences in framing and wall heights (Figure 17). Framing members installed during the first southward expansion are no longer being utilized for structural support as the west ends are no longer supported (Figure 18); new structural composite lumber (SCL) joists now span the entire twenty-seven foot length of the south expansion from east to west. This is a long distance for wood to span and it is common to see steel used to carry load when this distance between supports is necessary or desirable. The SCL joists are notched at their tops at what appears to be an old perimeter beam, which runs perpendicular to the joists²⁰ (Figure 19). New built-up wood columns are installed at several locations in the north portion of the original house and are offset from the interior walls approximately one inch. At one location the bearing area at the base of the column is not sound (Figure 20). Several bolts mechanically connecting built-up flexural members together along the south edge of the original construction are disengaged or missing (Figure 21). Wood bridging between first floor joists, which provides lateral support for the joists, is disengaged or missing at a majority of locations (Figure 22). A new masonry structure consisting of CMU and brick masonry units is installed under the fireplace near the center of the original house and several new and existing wood beams frame into it (Figure 23).

Figure 17. Built up wood blocking.

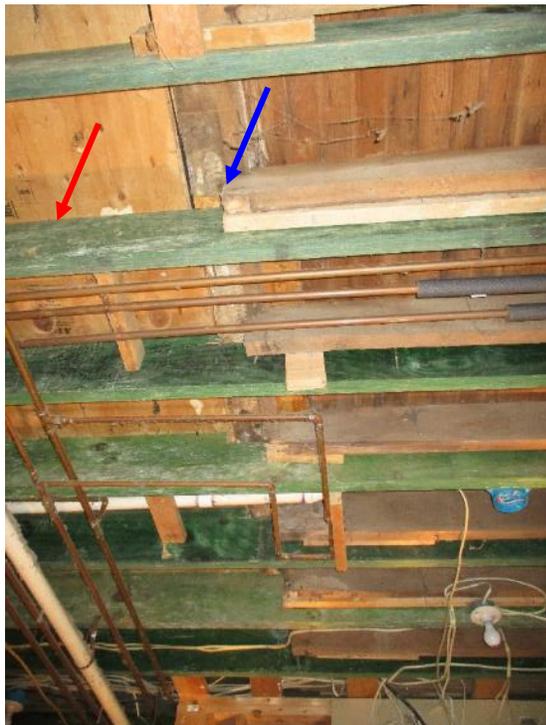
Figure 18. New framing members span the entire width of the south addition (red arrow). Original framing is no longer supported at west ends (blue arrow).

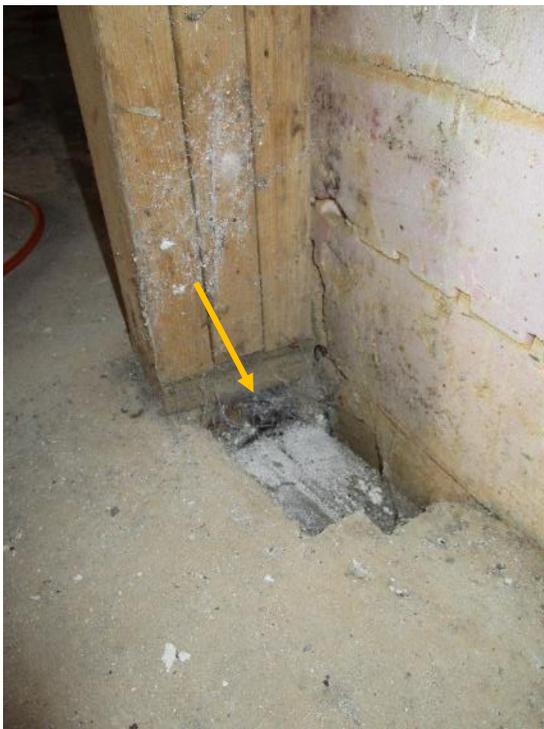
Figure 20. Void in concrete slab below column.

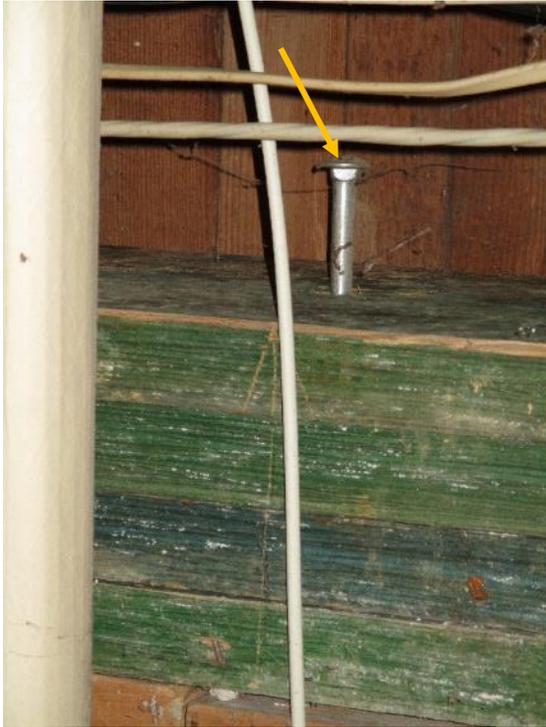
Figure 21. Disengaged bolt in built-up member.

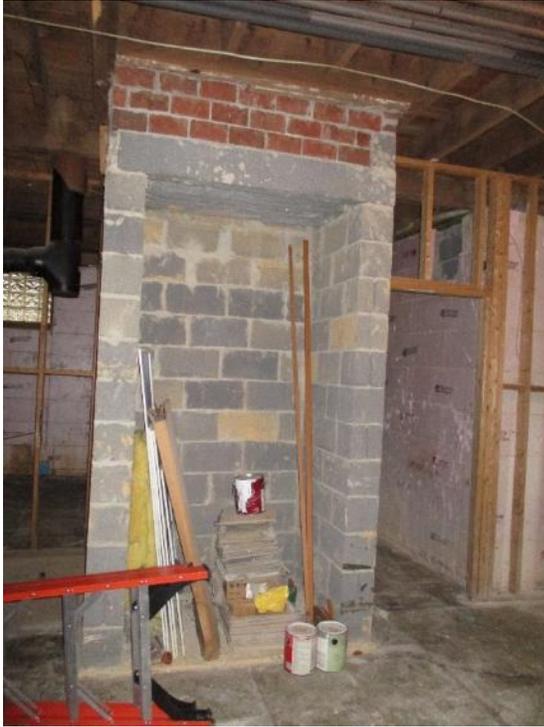
Figure 23. New CMU structure supporting fireplace.

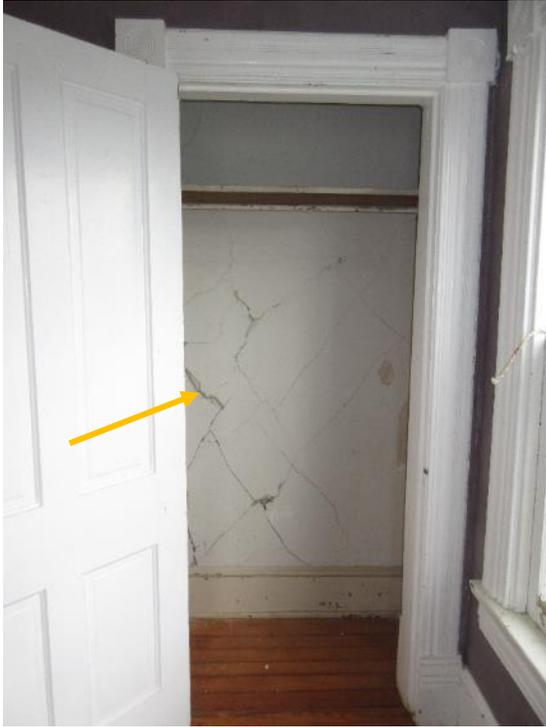
The second floor framing is concealed by interior ceiling and floor finishes and therefore was not included in our review. Significant cracking is present in the plaster wall finish and ceilings throughout the second floor. The cracking is concentrated along the eastern portion of the original house and is most significant in Rooms 201 and 202. It is unclear how long the cracks have existed but based on their patterns, i.e. diamond shaped (Figure 27), and our observations from the first floor framing review, it is likely that the cracking occurred while the house was being raised or shortly thereafter. We anticipate that the house experienced substantial movement during the lifting process and the plaster finish did not have enough flexibility to withstand the movement, resulting in cracking. The cracks appear to be static, i.e. not actively moving, and we do not anticipate that they will grow.

Figure 27. Diamond shaped cracking in closet of Bedroom 202.

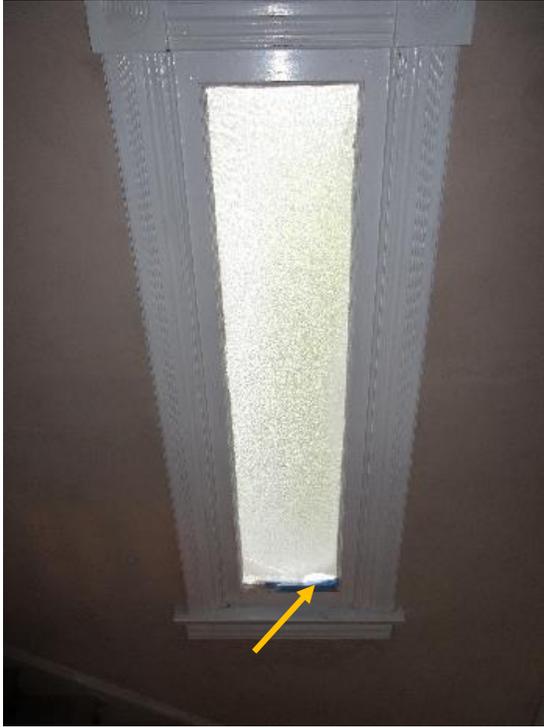
Figure 34. Broken glazing in stairwell fixed window.

- At doors with broken or missing glazing, replace glass with similar glazing, clean and repair wood where needed, and paint. Remove boards at the exterior from obscured doors and windows, inspect and address any additional damage not observable from interior.
- Replace broken glazing and replace with an era appropriate pattern/texture on west facade. (Figure 34)
- Once windows are cleaned and repainted where needed, install sealant fillet joint at perimeter of windows between the window frame and the adjacent exterior siding to help limit air infiltration at the rough opening for the window.
- Replace damaged, non-historic, screen on west facade first floor window.

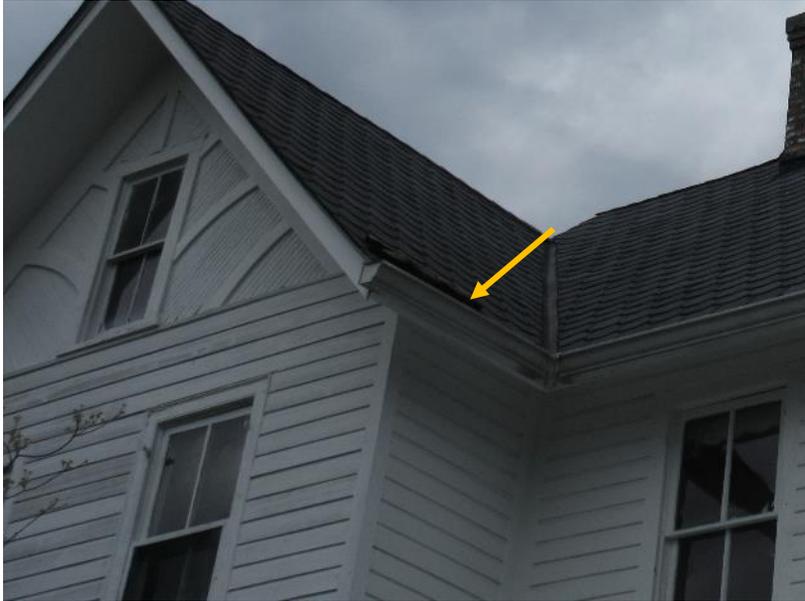
Figure 36. Asphalt shingles out of plane above the gutter.

- Repair shingles at the northeast corner to ensure roofing is watertight. (Figure 36)
- Infill fastener holes at window of enclosed porch on the north facade. Paint.
- Inspect flashing at Juliet balcony to ensure secure and lapped properly to encourage water shed. (Figure 37)
- Repair cracked wood decorative spindle element at Juliet balcony. (Figure 38)
- Remove miscellaneous horizontal boards at decorative gable shingles above Juliet balcony unless archival documentation provides information on why these were installed.

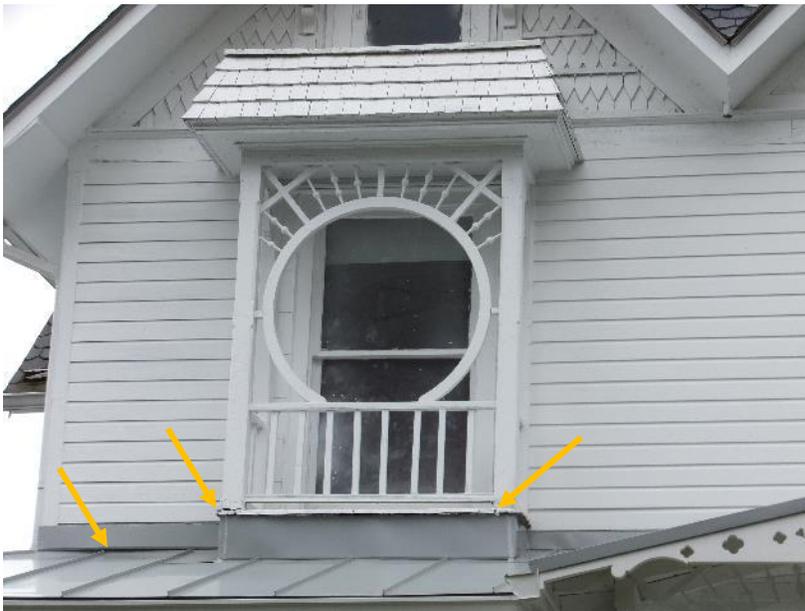
Figure 37. Lifted and separated flashing at Juliet balcony. Note gap between second floor flashing and porch roof.

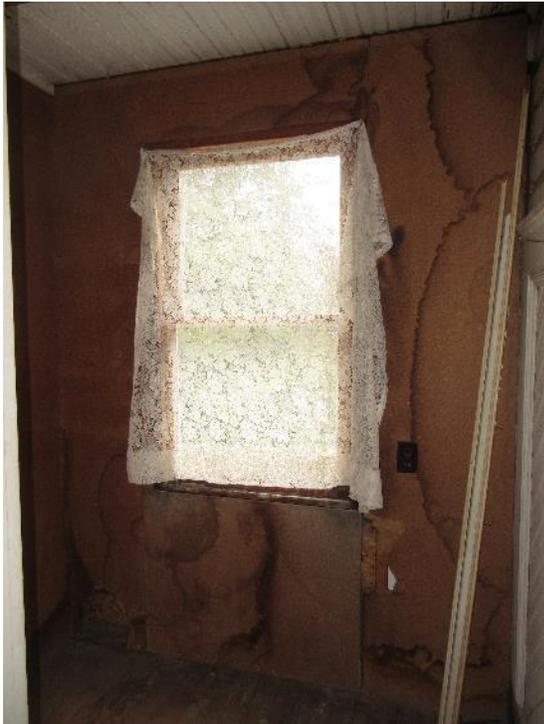
Figure 40. Deteriorated and stained particle board at the enclosed patio on the second floor.

- Modern windows in Kitchen (104) are exposed wood. Wood should be protected either by clear coating or paint.
- Complete interior finishes in Bedroom (204) and Bedroom (207) around windows to obscure insulation and gaps.
- Replace window at the Enclosed Porch (208) with a proper fitting window. Replace all non-historic wood wall finish (particle board) and install new interior finishes with proper interfaces with window. (Figure 40)

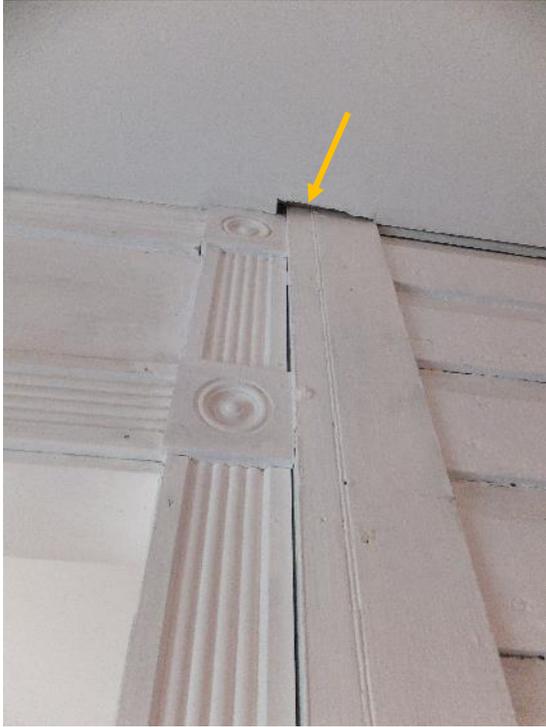
Figure 43. Gap at ceiling and historic door frame.

- Re-secure faucet cap at shower in the Bathroom (105).
- Install backer rod and sealant above medicine cabinet in the Bathroom (105).
- Remove abandoned fasteners and patch at the walls of the Bathroom (105).
- Install sealant at crown molding joints where they have separated in the Bathroom, paint (105).
- Inspect for soft deteriorated wood at the door frame and repair and repaint at the Bathroom (105).
- Infill gap at ceiling at the 2000s Kitchen (104) and the original doorway of the house with backer rod and sealant, which allows for this material to be removed in the future (reversible). (Figure 43)

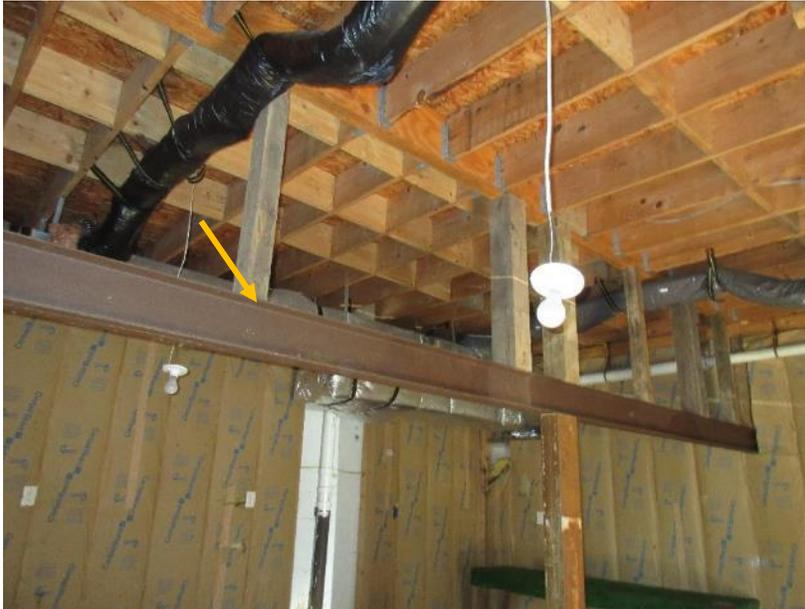
Figure 50. Steel beam runs longitudinally through the first floor of the north portion of the garage.

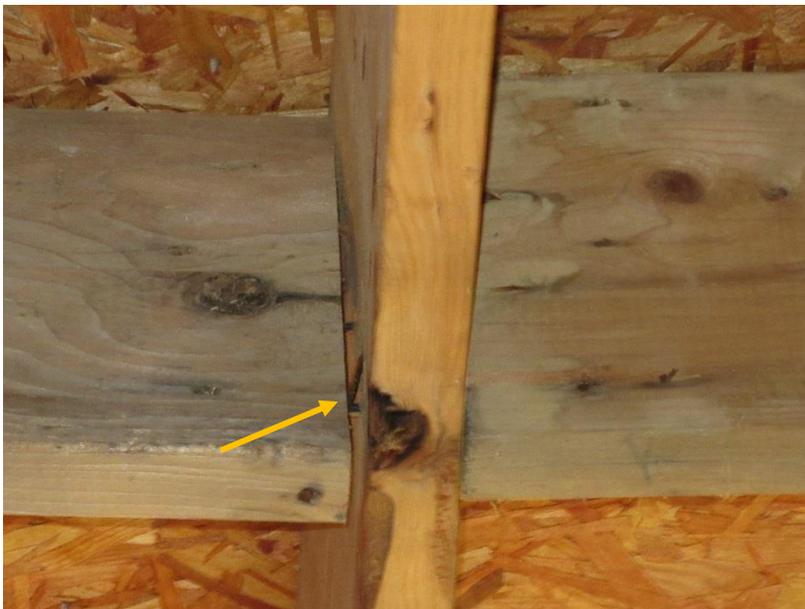
between wood joists (Figure 52) and gaps are present between the ends of the wood bridging and the joists at multiple locations. (Figure 53) Since the interior of the second level was not accessible during our site visits, a review of the interior space should be completed to determine if there is distress resulting from lifting a portion of the house similar to what was observed at the farmhouse. No structural analysis was performed as a part of our evaluation as it is outside of our current scope. In general, the load distribution is difficult to follow as a result of the different additions to the structure. Connections between the first level and second level along with the framing should be further documented and evaluated.

Figure 53. Gap is present between end of wood bridging and joist.

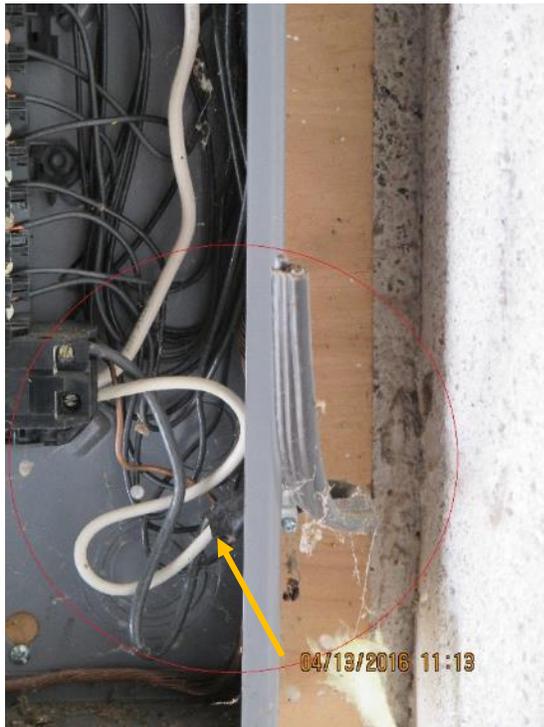
Visible systems located in the spaces opened at the first level were inspected. The garage had relatively modern electrical equipment; however, the panels did not have final inspection stickers from Fairfax County indicating that the equipment was either temporary or roughed-in. Several open junction boxes in the upper levels were observed. Some of the wires extended outside the enclosure and were cut and not properly terminated. (Figure 54) The plumbing systems also lacked a final inspection sticker from Fairfax County. The water supply was turned off at the utility meter located approximately 25 feet west of the driveway. As such, most of the systems in the garage could not be tested. Septic piping for the garage could not be located, but it is anticipated that it goes back to the same distribution box and septic fields tied to the farmhouse. The garage has a natural gas supply line, which feeds one or more high efficiency gas furnaces. The furnace is modern, but was not functioning due to the turned off utilities. The indoor heat pump is in relatively good condition, but ductwork at the unit should be cleaned and insulated. Areas of previous water infiltration at the upper floors was observed at interior finishes and around electrical boxes. The garage has systems for air conditioning; however, one or more of the condensing units had been removed, which was evident from cut refrigerant lines.

Figure 54. Improperly terminated electrical lines. Photo courtesy of MBP.

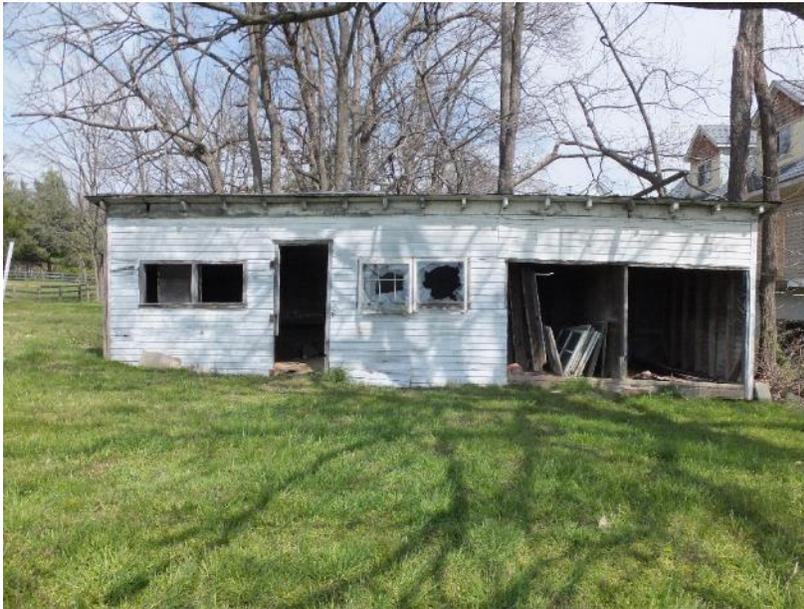
Figure 58. Equipment shed.

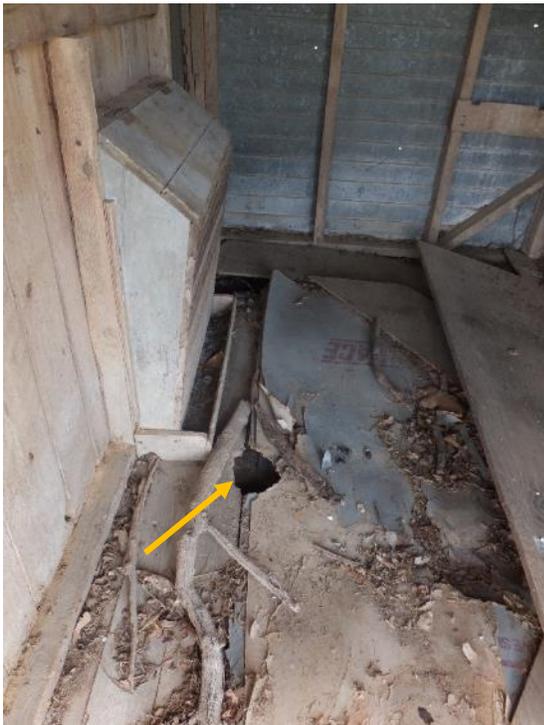
The shed is supported by timber sills, which appear to bear directly on the ground. (Figure 59) No evidence of a foundation was observed. The shed appears to have settled over time as a result of deteriorated wood framing. Tongue and groove floor planks were visible on the east half of the shed. The floor planks are significantly deteriorated towards the north half of the shed. Complete section loss of the plank members along with the presence of an animal habitat, as evidenced by chew marks in a wood plank, are apparent in the east bay. (Figure 60) Carpet is installed on the floor of the west side of the shed and generally conceals the substrate below. At areas that are not concealed by carpet, we observed exposed soil. (Figure 61)

Figure 60. Complete section loss of the plank members along with the presence of an animal habitat, as evidenced by chew marks in a wood plank (orange arrow).

- Excavate the soil below the shed and create short foundation walls to hold the wood structure off the ground, thereby limiting future deterioration of the wood framing due to moisture.
- Perform repairs to the timber sills or replace as necessary.
- Consider installing a new floor system commensurate with the building's function in lieu of tongue and groove floor planks.
- Perform isolated repairs to the wall framing and rafters.

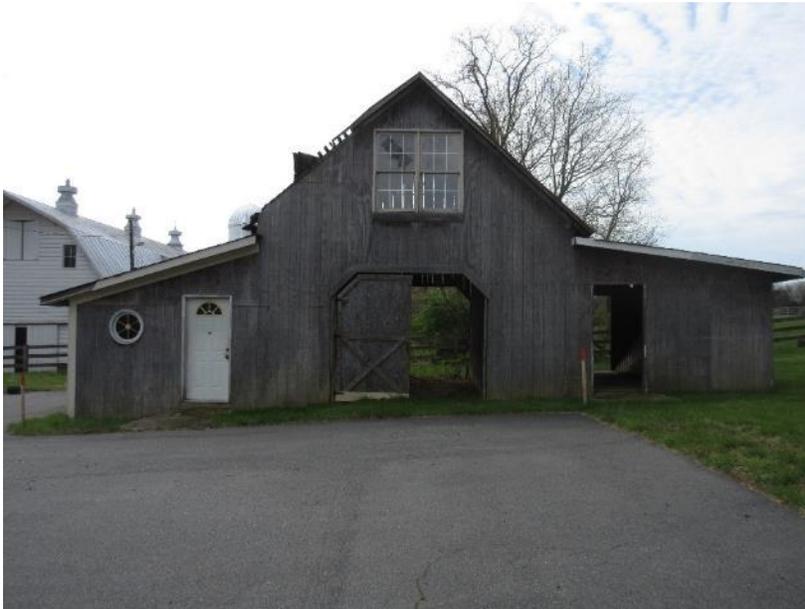
Figure 63. Crib barn as viewed from the north. Note the two “wings” adjacent to the central bay are not original to the structure.

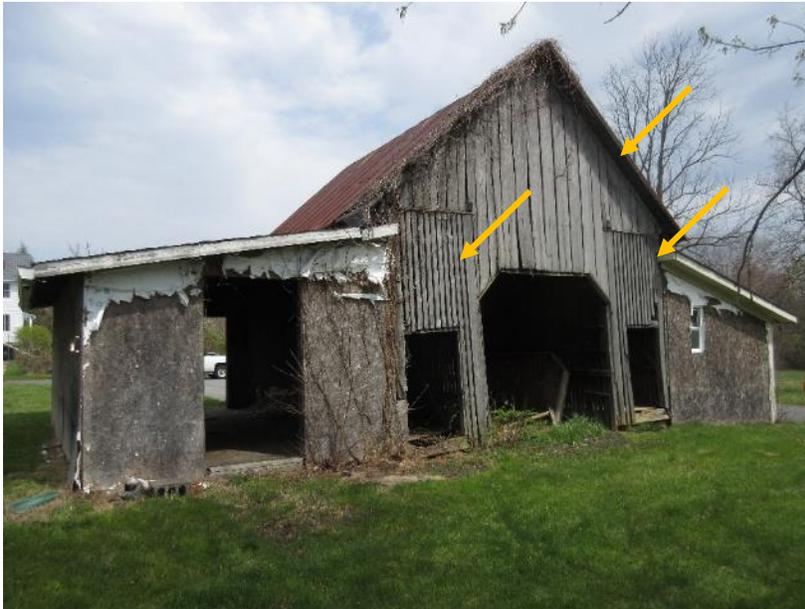
Figure 64. South elevation of the crib barn as viewed from the southwest. Note the historic wood slats and siding.

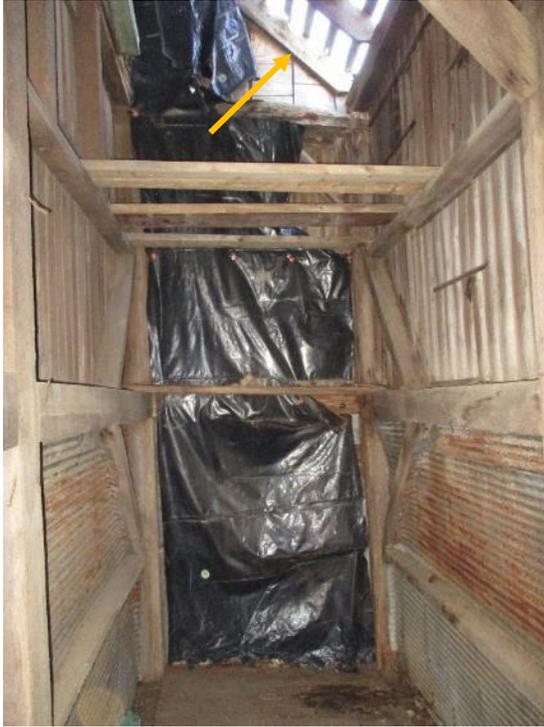
Portions of the metal roof are missing at the northeast and southwest corners of the original structure. (Figure 69) The wood framing below the openings in the roof is significantly deteriorated, likely as a result of long-term exposure to water. Nearly complete loss of bearing is present at the northeast corner column in the east crib. (Figure 70)

Figure 69. A portion of the metal roof is missing at the northeast and corner of the original structure.

- Remove large modern window above central bay and infill with wide wood vertical siding (similar to the historic siding on the south facade).
- Remove areas of deteriorated metal at roof at central bay and perform large patches.

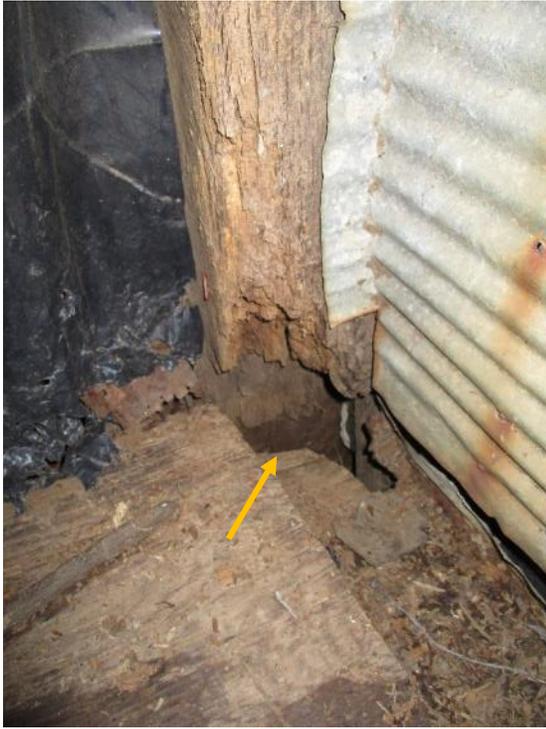
Figure 70. Nearly complete loss of bearing at the northeast corner column in the east crib.

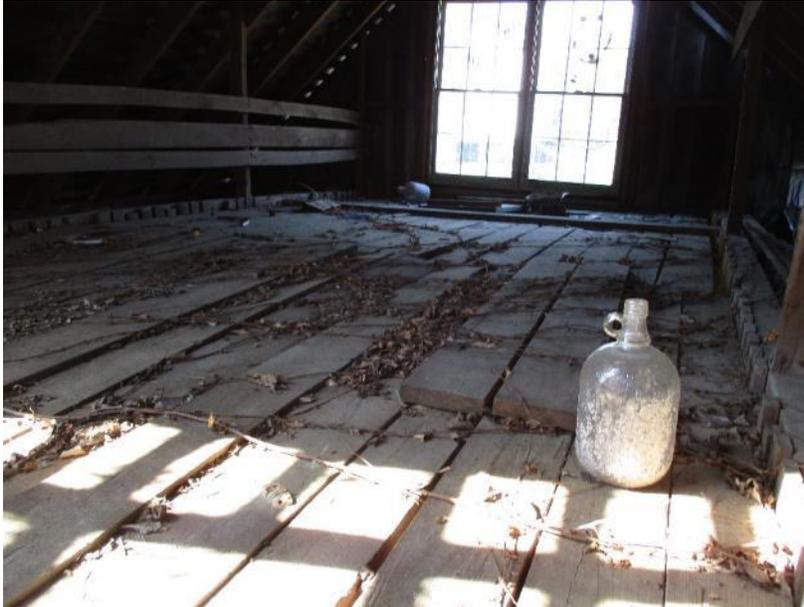
Figure 73. Rough sawn planks in loft.

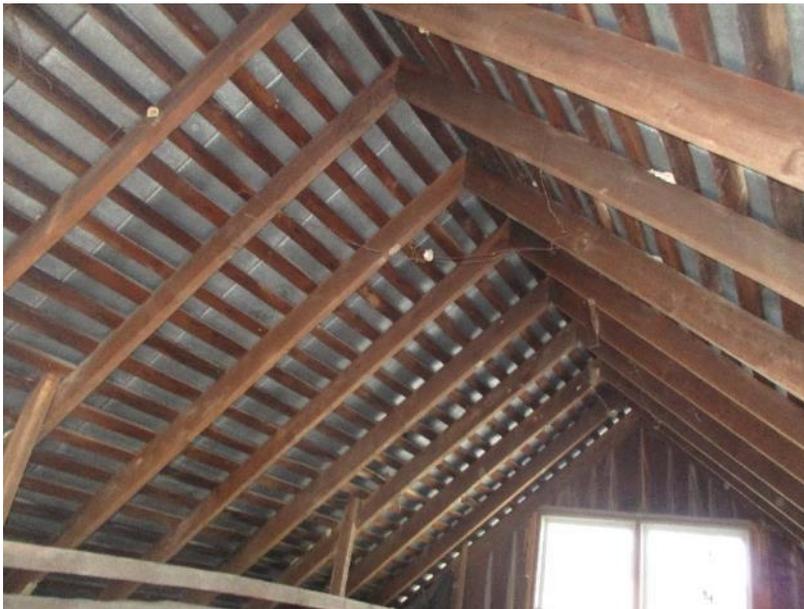
Figure 74. Roof framing as viewed from the loft.

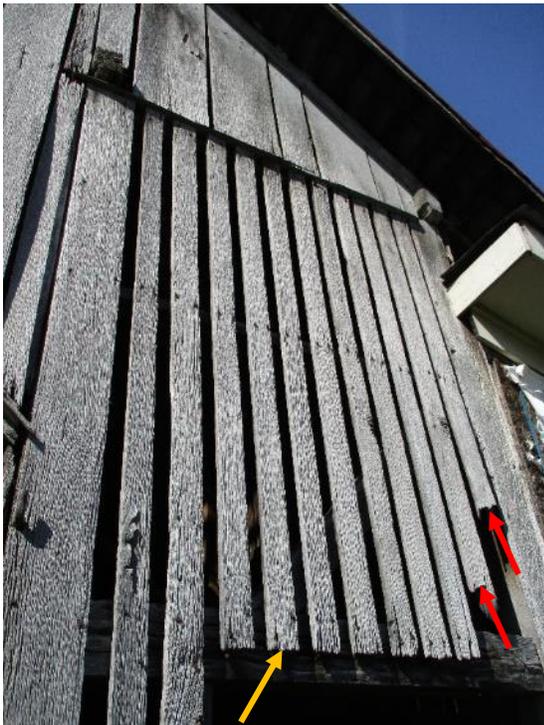
Non-structural vertical wood slats installed on the interior are generally in fair condition; however, WJE did observe several that are fractured from what appears to be impact damage (Figure 75) and several that are deteriorated near grade. Vertical wood slats and vertical rough sawn boards installed as cladding on the exterior facades are slightly deteriorated. Splits in the rough sawn boards and splintering at the ends of the wood slats were observed on the south elevation (Figure 76). WJE anticipates that they will continue to deteriorate unless they are coated with an exterior grade of paint in the near-term.

Figure 76. Splintering at the ends of the wood slats (orange arrow) on the south elevation along with two fractured slats (red arrows).

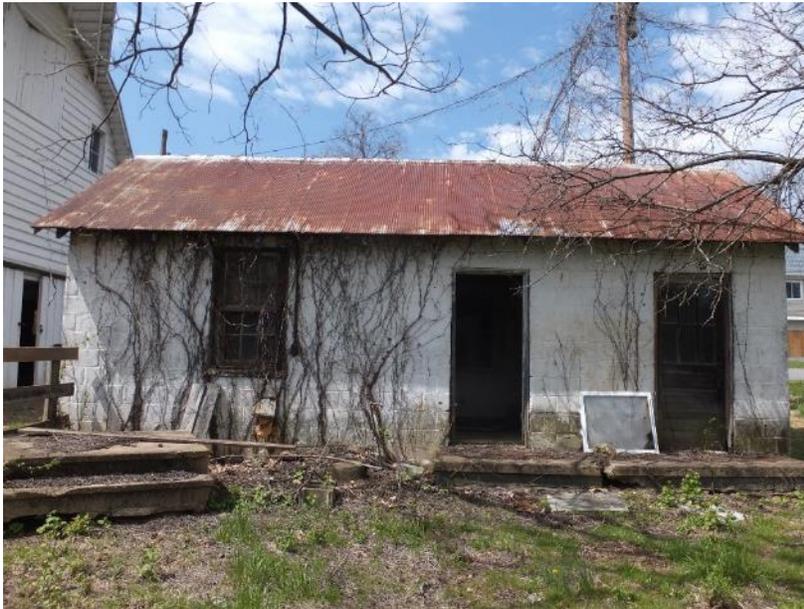
Figure 78. Milk house as viewed from the east.

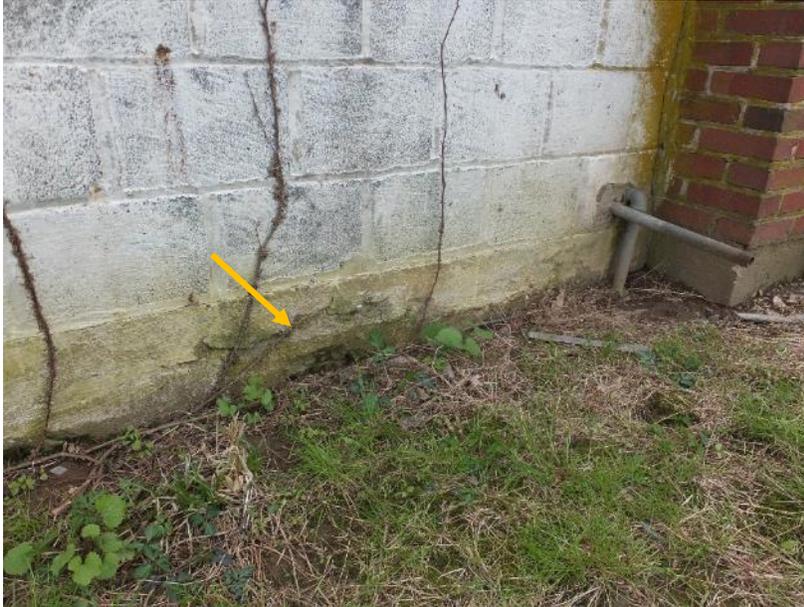
Figure 80. A small spall is present in the concrete foundation wall.

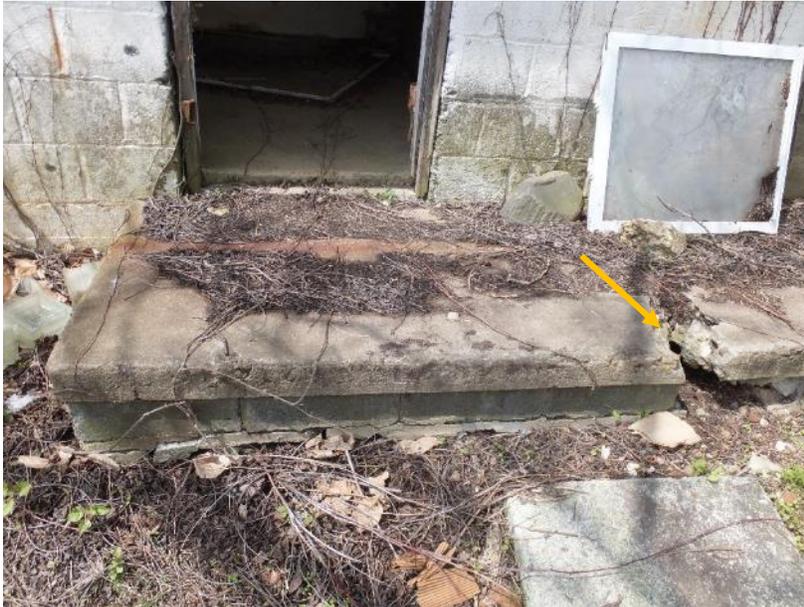
A concrete landing is present in front of the east entrance and appears to be supported by CMU. A large crack through the full thickness of the landing and deterioration of the supporting CMU are present. (Figure 82) Differential movement is likely the cause of the cracking. If the landing and supporting CMU

are installed on top of grade, it will likely be necessary to remove and replace the landing with one that has an adequate foundation. Otherwise, the landing will likely continue to move as the ground expands and contracts due to changes in moisture levels and freeze thaw cycles.

Figure 82. Large crack through concrete landing and deterioration of the supporting CMU.

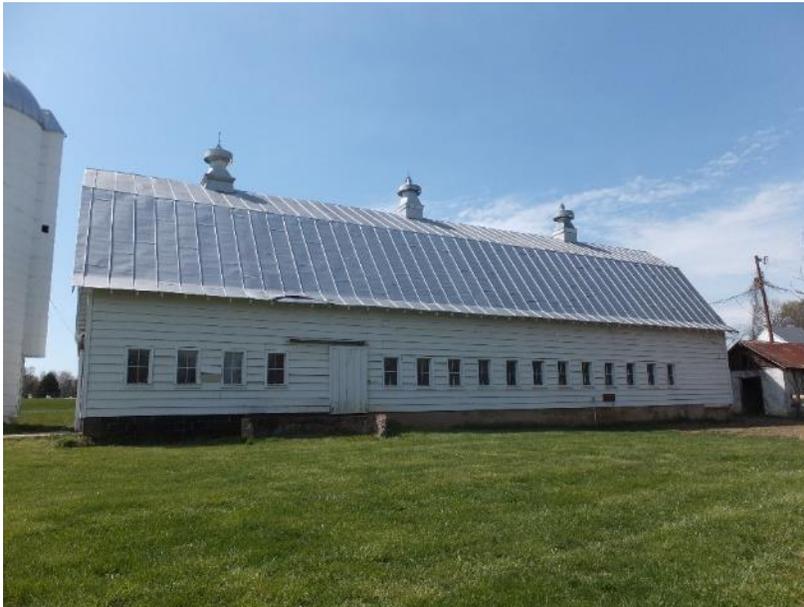
Figure 84. Dairy barn as viewed from the east.

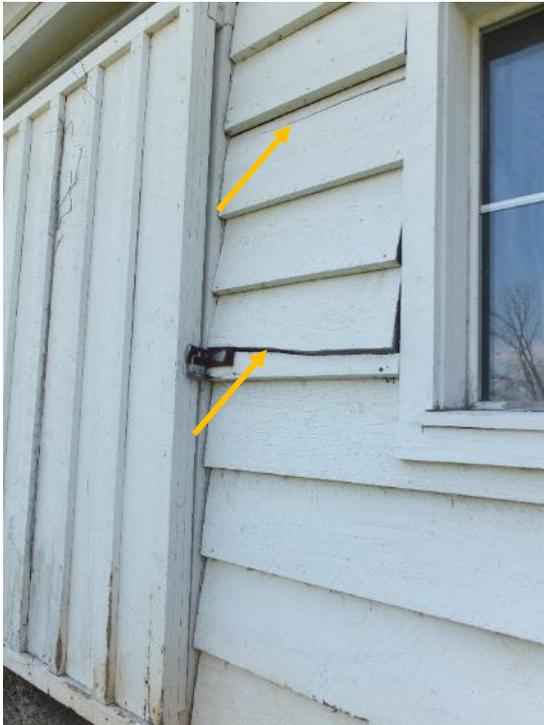
At the exterior, there are areas of siding of loose boards and some board with gaps (no overlap). Throughout the siding there are also areas of cracked siding. (Figure 85) There is a consistent gap between the window

Figure 85. Cracks in siding. The lower crack is due to the installed latch.

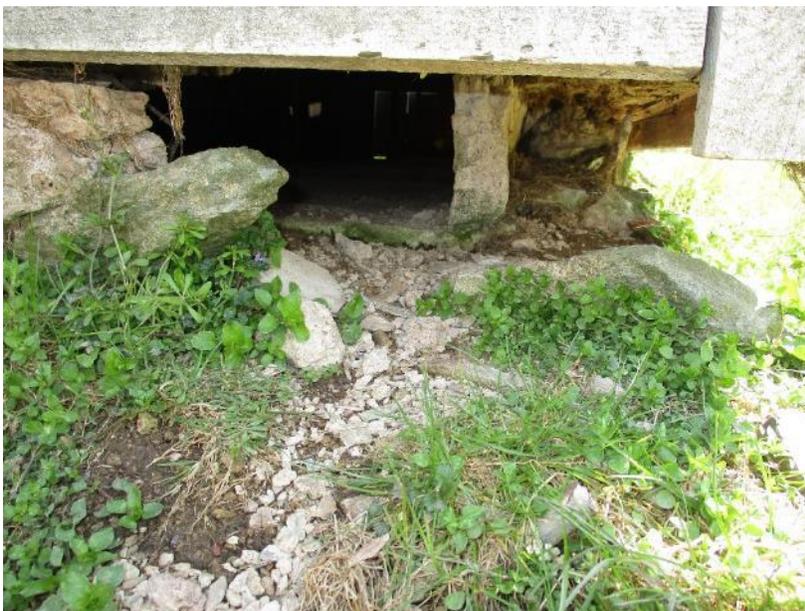
Figure 87. Stones present at foundation wall along west elevation.

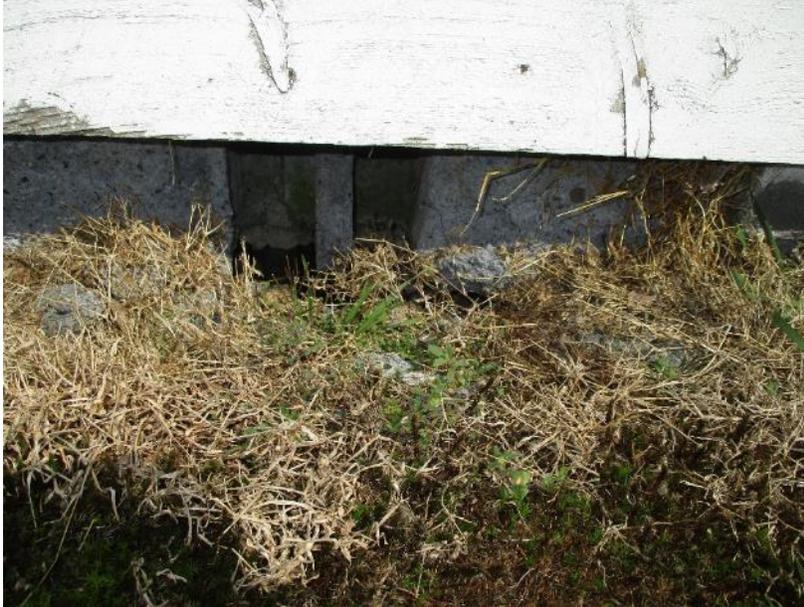
Figure 88. CMU present at foundation wall along west elevation.

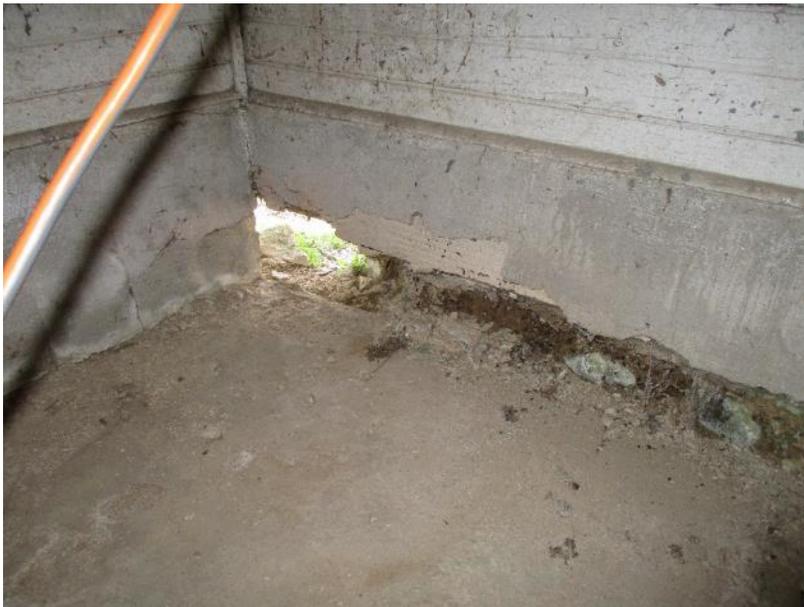
Figure 89. Deteriorated finish at base of interior walls.

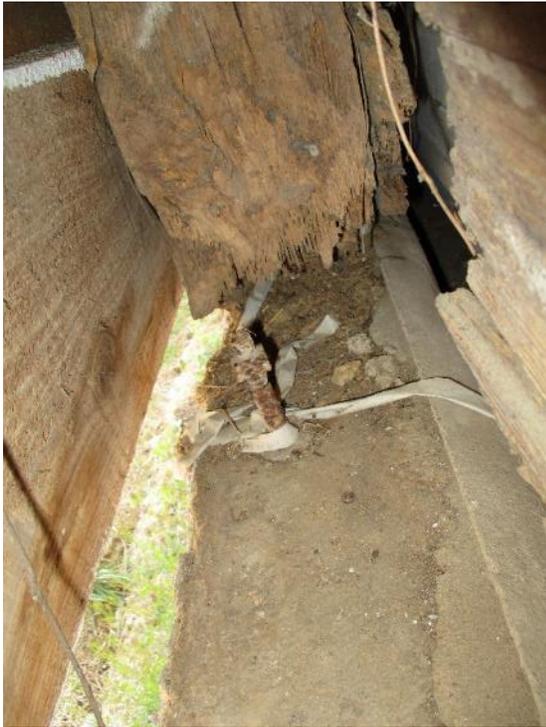
At one location where an opening in the wood cladding exists, we were able to observe a wood column on top of the concrete foundation wall. The base of the column is significantly deteriorated. (Figure 90) Several interior steel pipe columns have been removed. (Figure 91) Complete section loss through the thickness of the member is present at several of the pipe columns, which support built-up wood beams in the loft floor. (Figure 92) The built-up wood beams are clad in wood trim; therefore, we were not able to evaluate their condition except at isolated locations. At one location, trim was removed from the end of the beam and the wood appears to be in good condition. (Figure 93)

Figure 90. Loss of bearing at wood column.

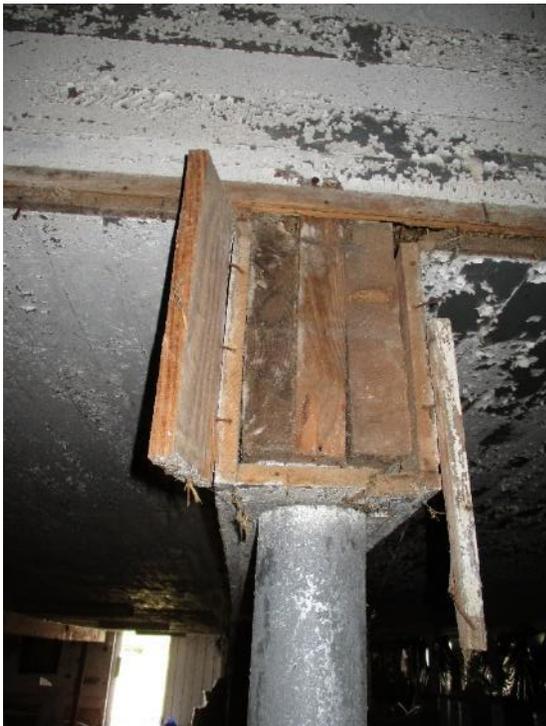
Figure 93. Ends of built up interior beam appear to be in good condition.

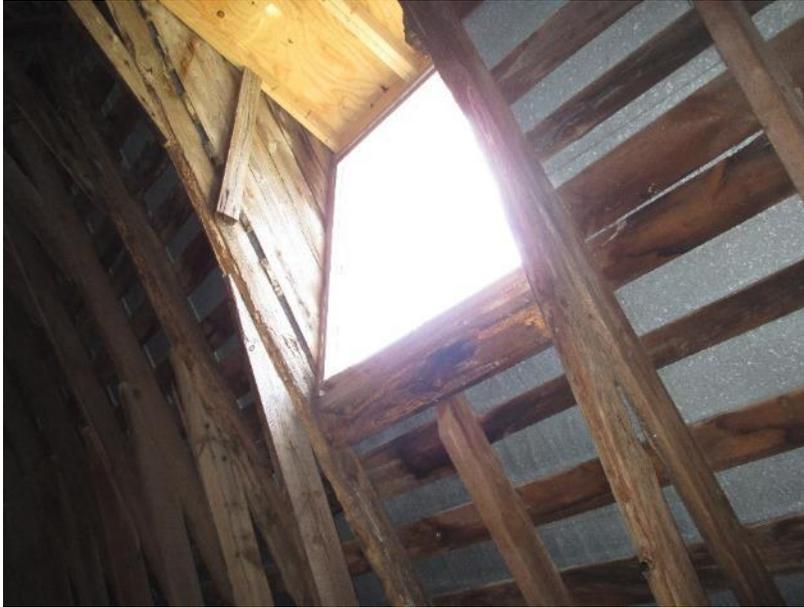
The wood framing and tongue and groove flooring in the loft are generally in good condition and only exhibit isolated deterioration. Deterioration of the wood framing is present at the central dormer along the west elevation (Figure 94) and at floor boards directly below the dormer. (Figure 95) This deterioration was presumably the result of uncontrolled water penetration from an open dormer. Evidence of insect damage

Figure 94. Deterioration of the wood framing at the central dormer along the west elevation.

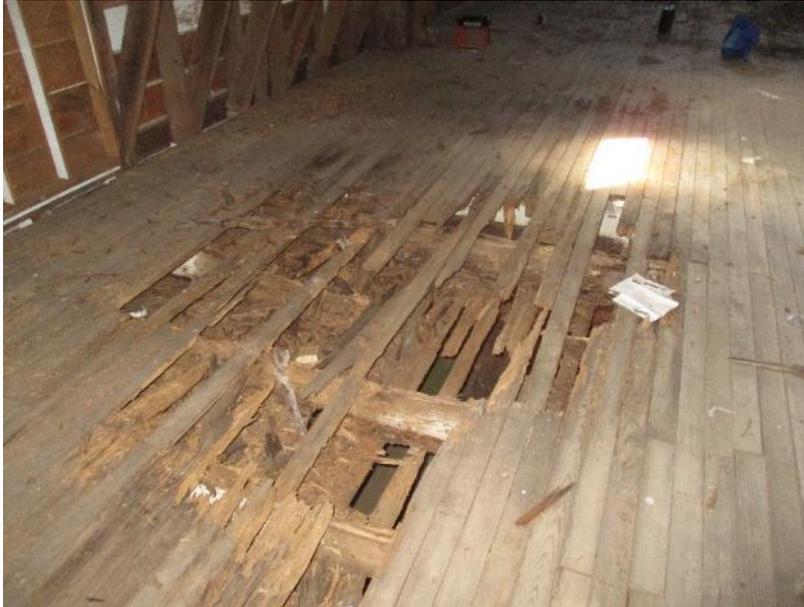
Figure 95. Deterioration of the wood floor boards below the central dormer along the west elevation.
