TURNER FARM
Turner Farm Treatment Report

10609 Georgetown Pike
Great Falls, Virginia 22066

Final Report

November 10, 2016
WJE No. 2015.3162.2

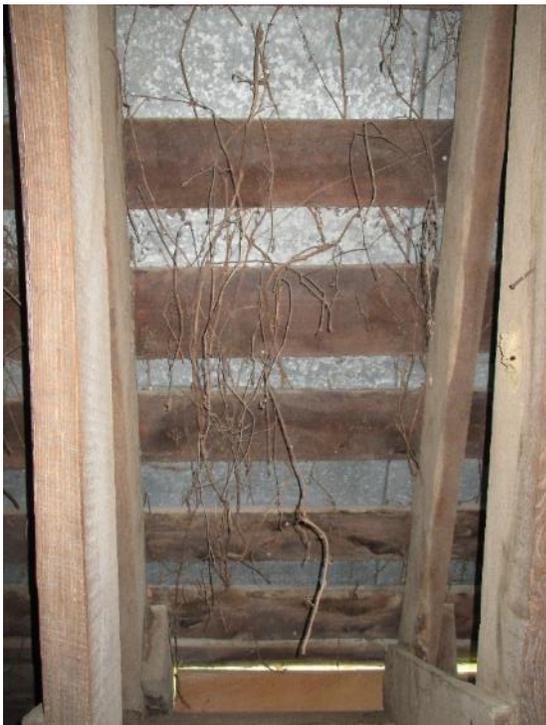
Figure 98. Vegetation between the roof framing and the metal roof.

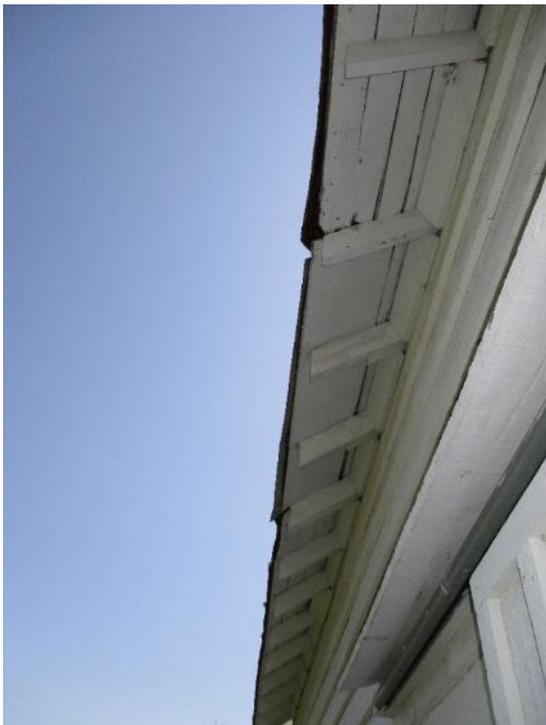
Figure 100. Painted plywood installed at isolated area of soffit.

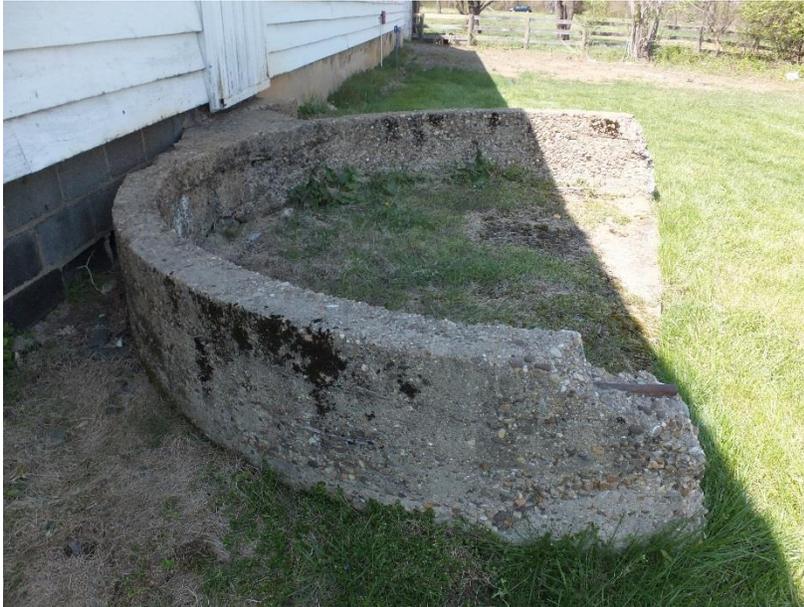
A crescent shaped concrete pit structure is connected to the dairy barn along the east elevation adjacent to a door opening. (Figure 101) Concrete spalls and exposed reinforcing are apparent at the edge of the concrete walls.

*Figure 101. Concrete structure along east elevation of dairy barn.
Note exposed reinforcing and concrete spalls.*

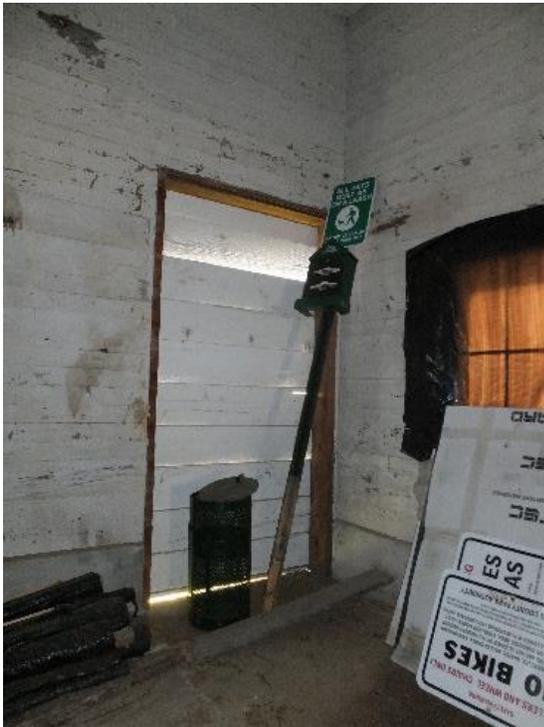
Figure 103. Evidence of previous door at the southwest corner of the barn. This would have connected to the silo.

- Clean and inspect wood soffit. Remove soft and deteriorated wood and replace. Paint. (Figure 102)
- Document interior evidence of previous doors. (Figure 103)

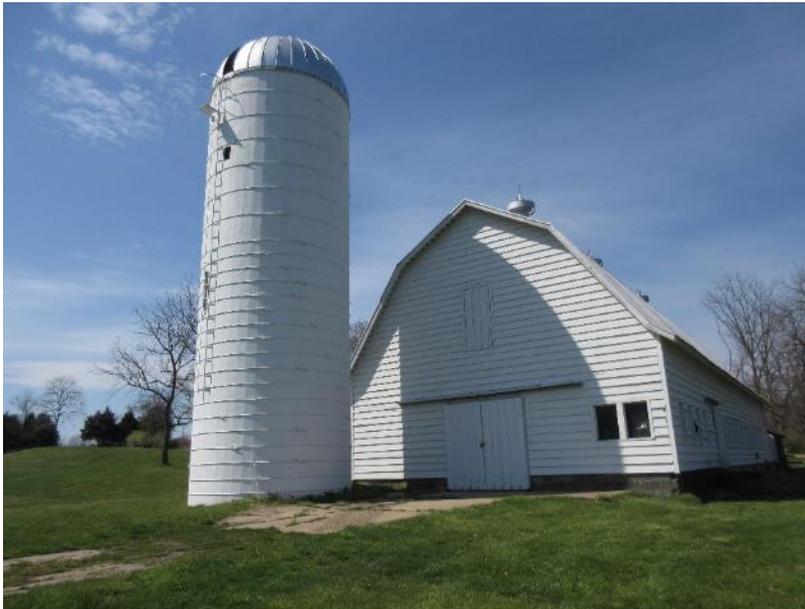
Figure 104. Silo adjacent to the dairy barn.

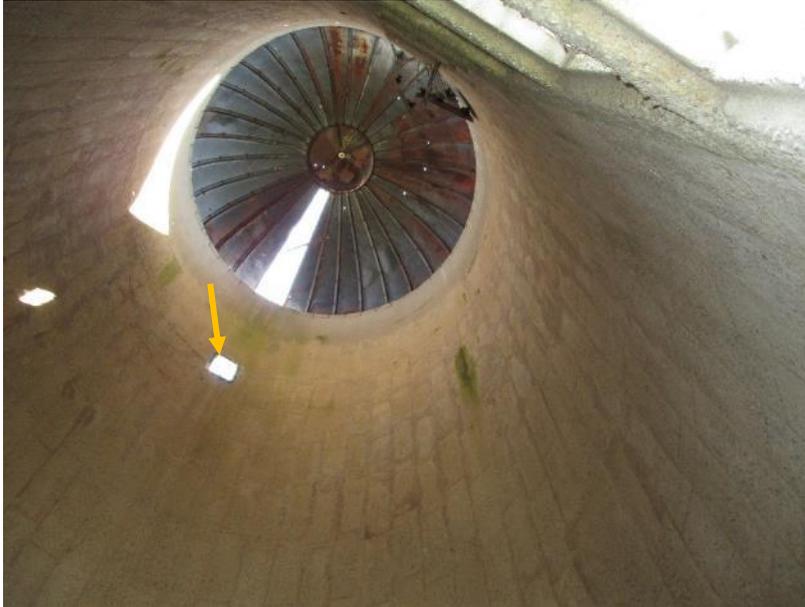
There is an open segment in the main roof, which has allowed water to enter the interior of the structure resulting in some green staining at the interior concrete. Just below the roof on this facade, a square cut opening has been made into the concrete. (Figure 105) There is related cracking of the concrete at the interior of this opening, which is likely static, and no longer actively moving. At the ladder enclosure, there is deterioration of the secondary roof resulting in material loss, which appears to be of similar metal as the main roof. (Figure 106) One concrete spall is present at the base of the silo. (Figure 107)

Figure 105. Interior view of silo. Note small hatch (orange arrow).

- Install hatch at roof and wall opening to prevent further moisture infiltration.
- Green staining at the upper interior portion of the silo may be a result of the open roof. The source of moisture will be mitigated once the roof opening is closed. The staining could be cleaned, if desired, however it is mostly aesthetic.
- Repair metal roof at secondary roof to stop deterioration and protect ladder enclosure.
- Perform isolated concrete repair at base of silo.

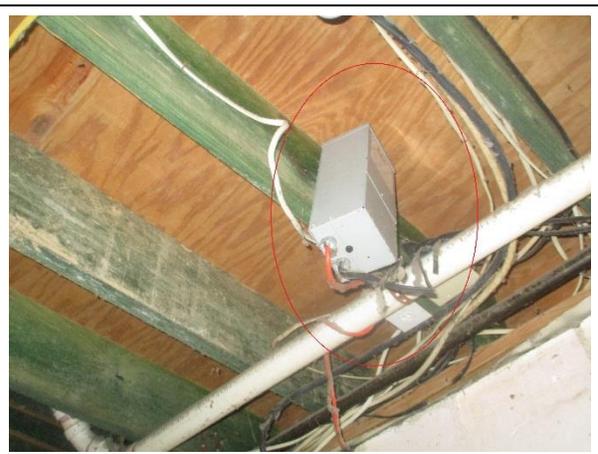
Photo 2: Abandoned box and wires in basement

- Electrical wiring survey and correction
 - In several locations within the basement and attic, electrical wires are cut off, disconnected, or have exposed wire ends either inside or outside of an approved junction box or panel. Recommend having a skilled electrician survey the building to locate, identify, safe, or remove electrical wiring that does not meet current code requirements. Temporary wiring should no longer be left in place. Panel directories should be corrected and completed. Please note that this recommendation should be applied to all of the structures.

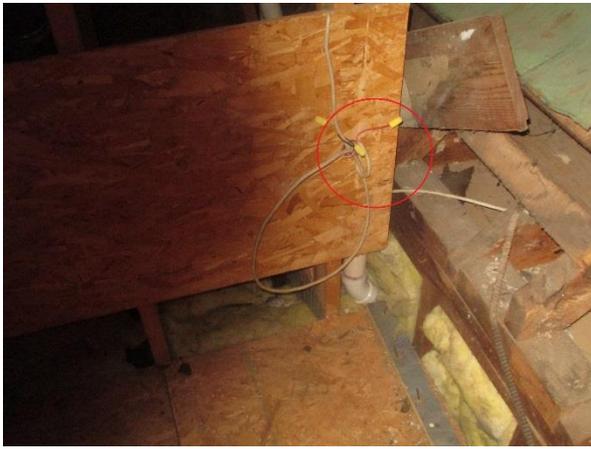
Photo 3: Unsecured wires in attic

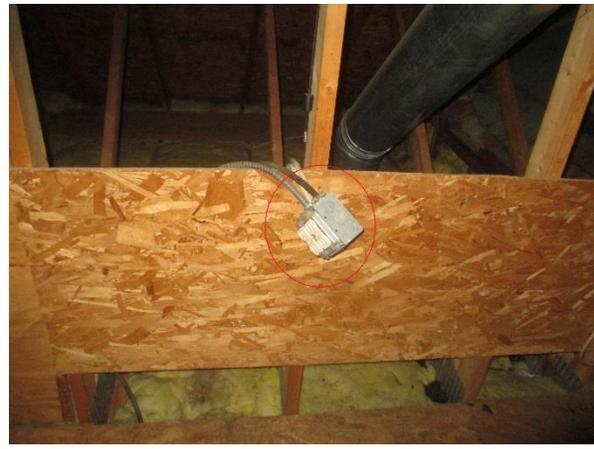
Photo 4: Unsupported box in attic

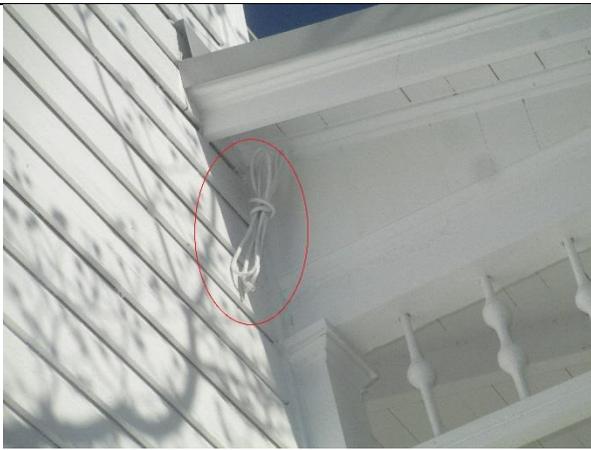
Photo 5: Loose cable near front porch

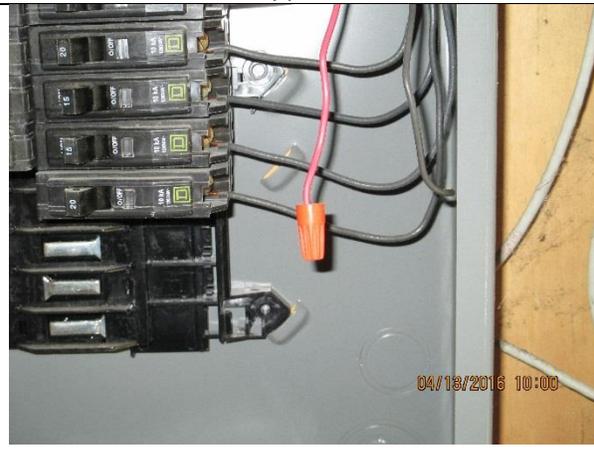
Photo 6: Unsecured conductor in basement panel
(MBP installed orange wire nut)

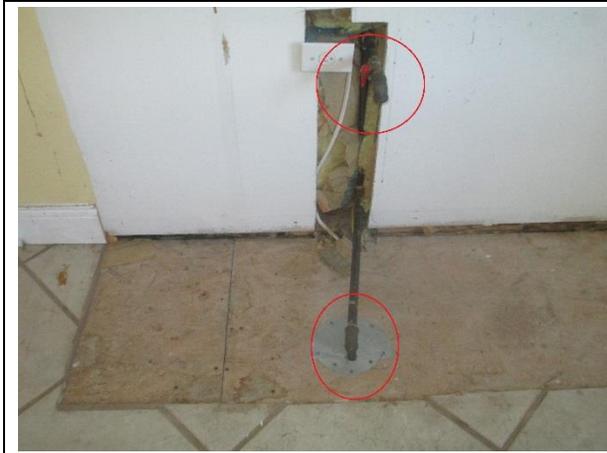
Photo 7: Kitchen gas piping through floor

- Kitchen stove gas connection
 - The gas line intended for a stove/oven in the kitchen was turned off when the appliance was removed, however, the line should receive a pipe plug due to long term abandonment. Recommend installing a one-half inch pipe plug to make the abandoned line safe. Additionally, the location of the floor penetration should be reviewed and relocated closer to the wall to allow better appliance selection.

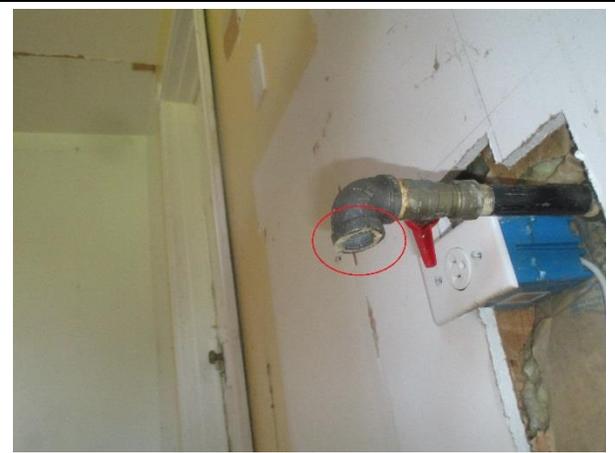
Photo 8: Kitchen gas piping needs plug

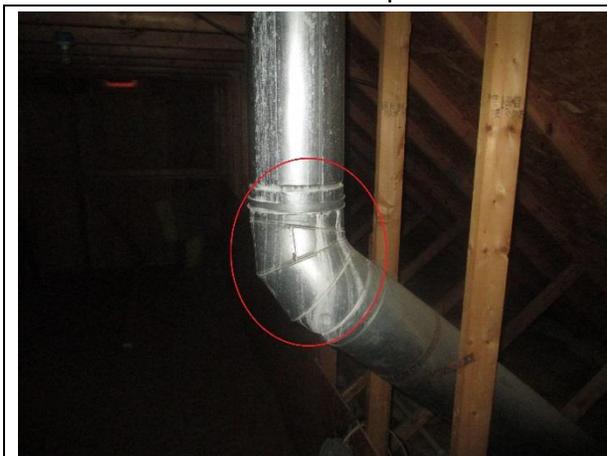
- Roof penetrations
 - The gas vent flue and plumbing vent stack roof boots or collars are leaking water into the attic. Water stains are evident on the flue vent and stack vent pipe. Recommend repairing/re-sealing, or replacing roof penetration boots and collars and a review of flashing around the chimney to prevent water infiltration into the attic space.

Photo 9: Flue vent with water stains

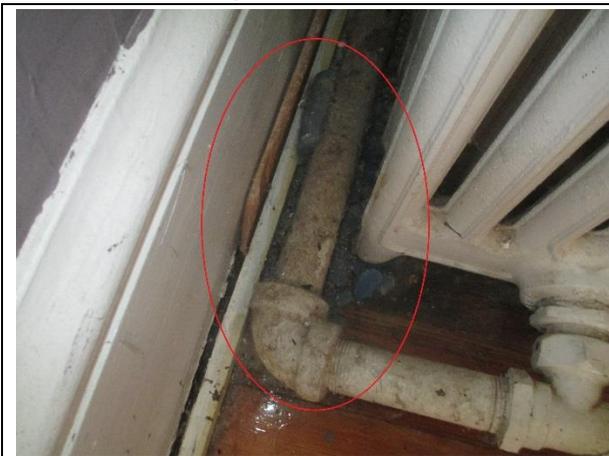
Photo 15: Candle wax behind radiator

- Radiator care
 - Existing radiators in the building are generally in good condition with three exceptions. One radiator in a second floor bedroom at the southeast corner of the original structure has the remnants of a candle behind the radiator. The wax should be cleaned and removed from around the radiator piping. Future occupants should be warned against placing candles or other materials on the radiators in the future because it could be a fire hazard if the candle is aflame when the radiator is heating and melts the base. Additionally, one of the radiators in the southwest corner of the master bedroom is not connected to piping and the piping is not capped. This piping should be connected or capped to prevent flooding if the hand valve fails in the basement. The spare radiator currently in the second floor hallway should be removed to the basement, out of the hallway and should be mounted on a base or strapped to the wall because of the top-heavy nature of the device. Additionally, the heating system should be brought on-line and tested under pressure to ensure that no leaks exist at any of the radiators.

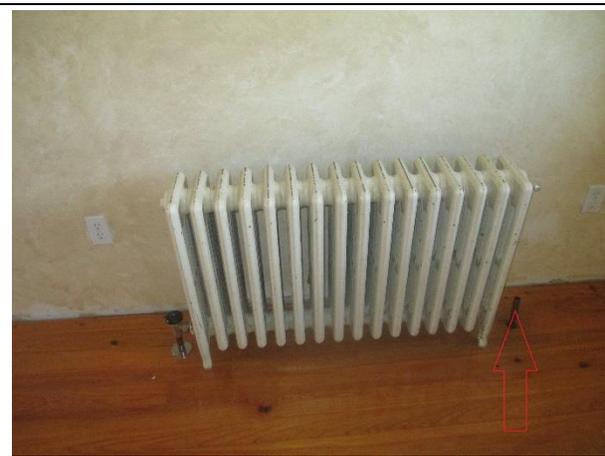
Photo 16: Disconnected radiator

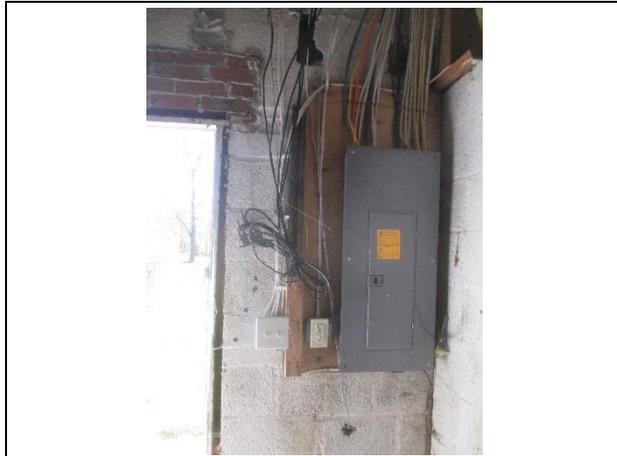
Photo 17: Electrical panel with inspection label

- Similar to the Farm House, the electrical panel in the Garage has an inspection sticker applied to the front of the panel indicating only initial inspections have occurred including temporary electric (8/10/06) and first gas (2/9/07). MBP recommends that all construction is completed and final inspections are received for all trades prior to occupancy or use of the structure.

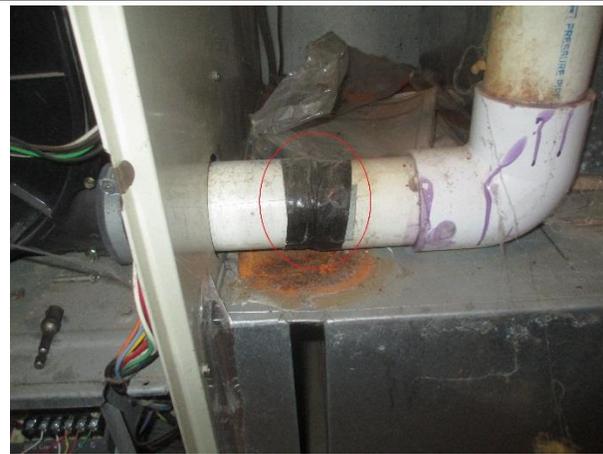
compromised. This taped joint appears to leak. The exhaust pipe is not supported properly between the unit and the exterior wall. One of the pipe clamps at the exhaust connection is unsecured. Long sweep elbows are required on the PVC exhaust piping rather than the short 90 degree elbows currently installed. The condensing unit has been removed and the refrigerant lines are cut. These should be replaced prior to replacing the condensing unit due to moisture and contamination risk. For maximum efficiency, the combustion air inlet should have piping extended to the exterior (note that short 90 degree fittings may be used on the outside air intake if necessary). The condensate pump, necessary for heating and cooling operation, has been removed and is required for operation. All piping penetrations through the exterior CMU wall should be properly sleeved, sealed, and packed.

Photo 21: Taped pipe joint on exhaust

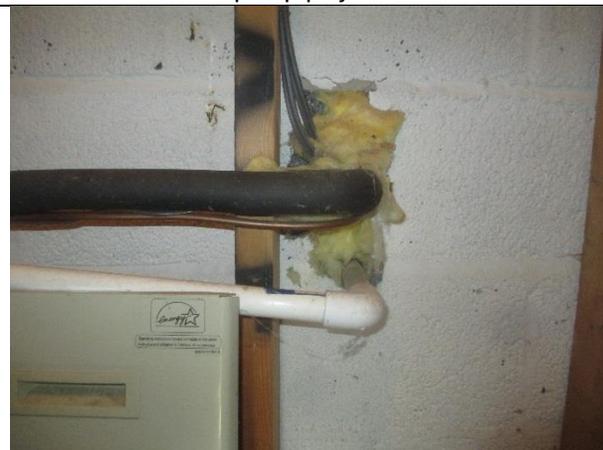
Photo 23: Penetrations not sleeved/sealed (Int.)

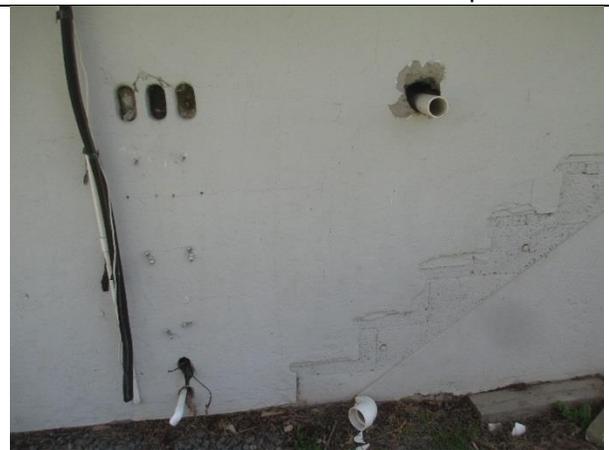
Photo 24: Penetrations not sleeved/sealed (Ext.)

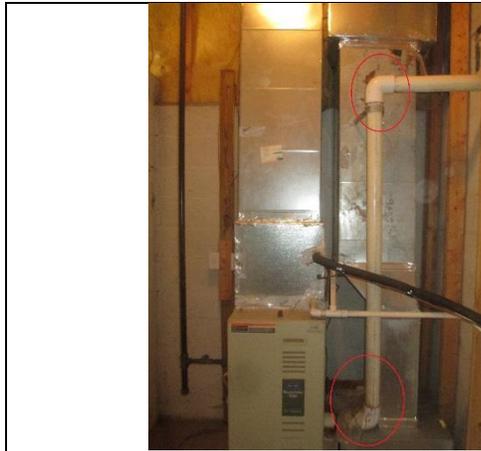
Photo 25: Short 90 fittings on exhaust

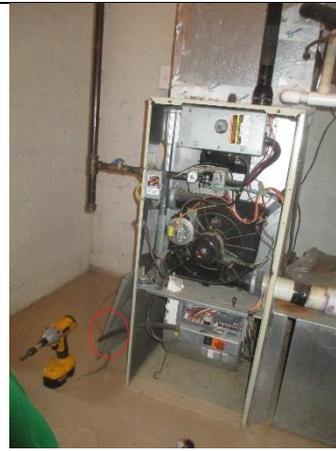
Photo 26: Condensate pump removed (lower left)

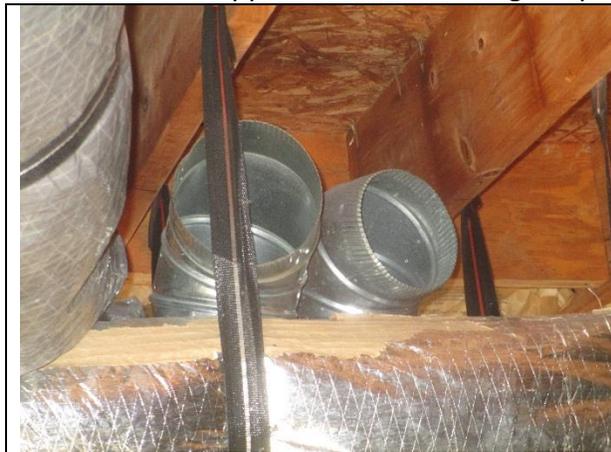
Photo 27: Duct fittings without dampers/diffusers

- Lower level ductwork
 - Lower level ductwork appears to have at least two elbows installed that are not connected to diffusers and do not have balancing dampers installed. All ductwork should be connected to diffusers with balancing devices so the system can be balanced. It may be necessary to confirm that holes in the next level floor that appear to have previously served diffusers are properly sealed and supported to floor ratings required.

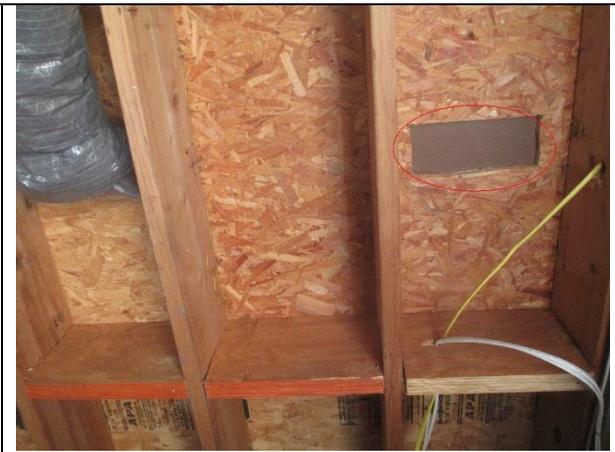
Photo 28: Old floor penetrations

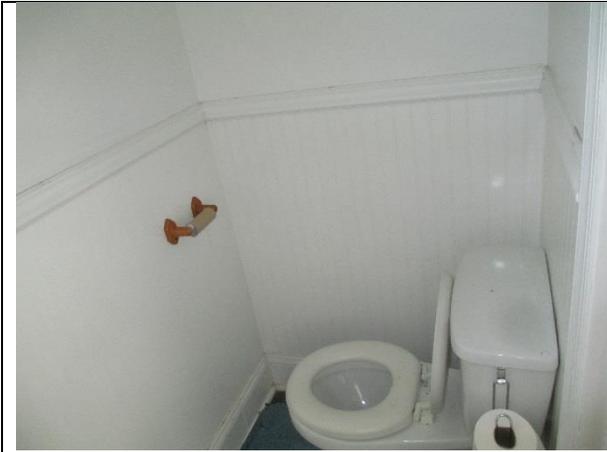
Photo 29: Mid-level hall bath toilet

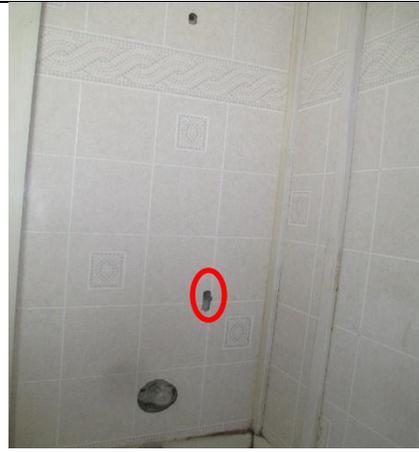
Photo 30: Mid-level hall bath shower enclosure with damage evident

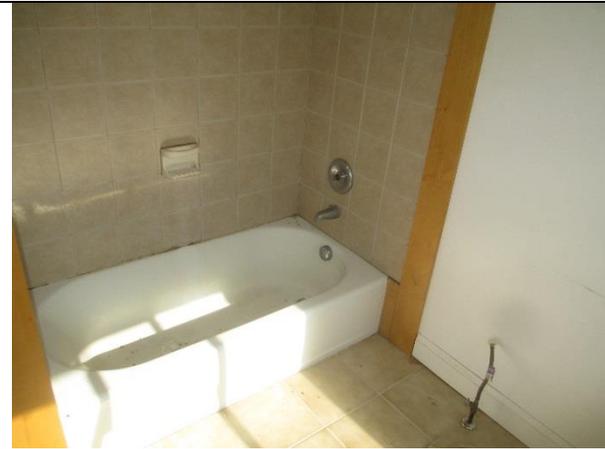
Photo 32: Unfinished bathroom at mid-level (assumed) master suite

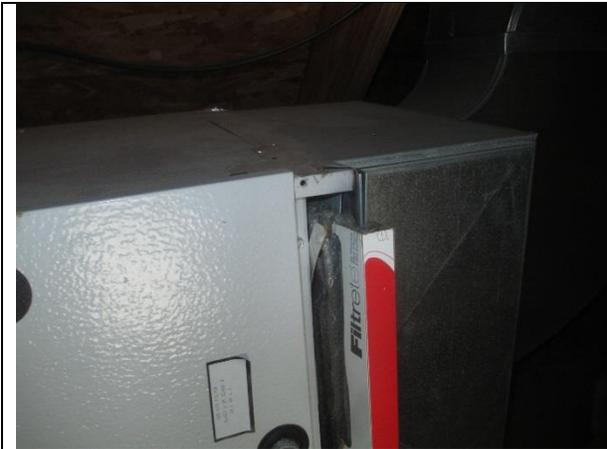
Photo 33: Ill-fitting filter at upper level heat pump unit

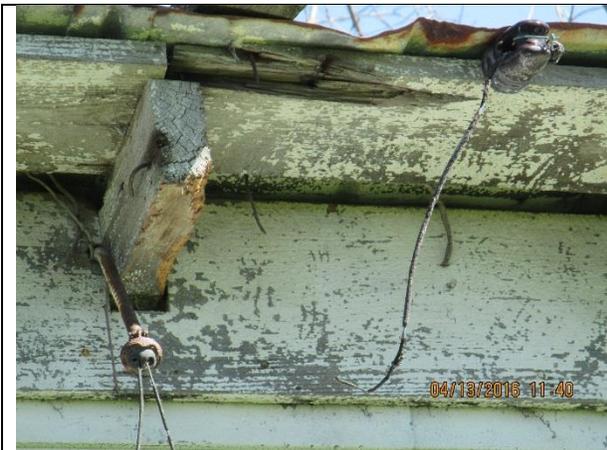
Photo 35: Derelict overhead service

The Equipment Shed is an older structure with only derelict electrical wiring that does not appear to be serviced from the other buildings at this time. Removal of the electrical wiring and fixtures is recommended.

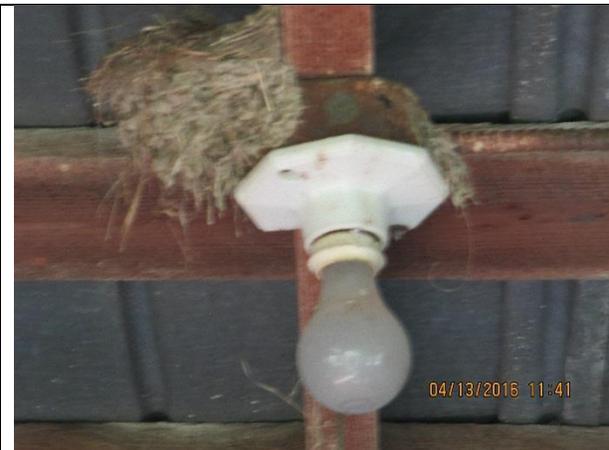
Photo 36: Interior light fixture

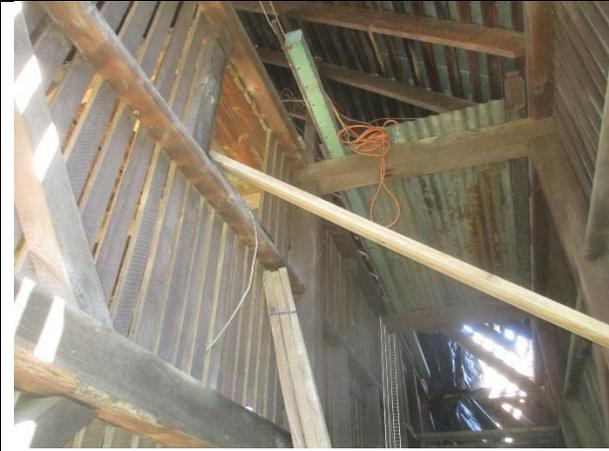
Photo 38: Extension cord for power in unfinished sections

The Crib Barn is an older structure with only minimal electrical circuitry that appears to be provided from the Farm House or Garage. The point of origin could not be determined. The finished portion of the building where the electrical circuits enter is finished and was locked during MBP's observations. Removal of the electrical wiring and fixtures in the open sections of the Crib Barn is recommended.

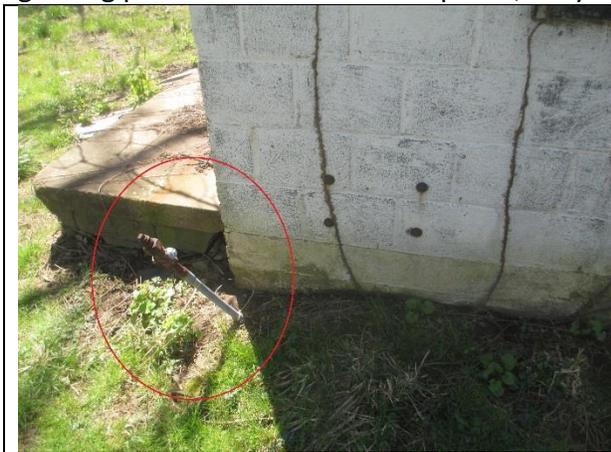
Photo 39: Damaged utility gas piping at NE corner

The Milk House is an older structure with only derelict electrical wiring and plumbing systems that does not appear to be serviced from the other buildings at this time. Removal of the gas and plumbing piping and fixtures, electrical wiring, fuse box, and fixtures from the interior is recommended. The utility gas piping extends to the northeast corner of the building and appears damaged where the meter has been removed from the outside of the building. It is recommended that this utility piping be cut and capped below grade, or abandoned at its connection point to prevent further damage and leaks in the future. Ground or lightning protection cables (copper conductors) extend from the room down to head level at the south doorway of the Milk House exterior and should be removed or replaced. If grounding or lightning protection cables are required, they should be engineered for replacement.

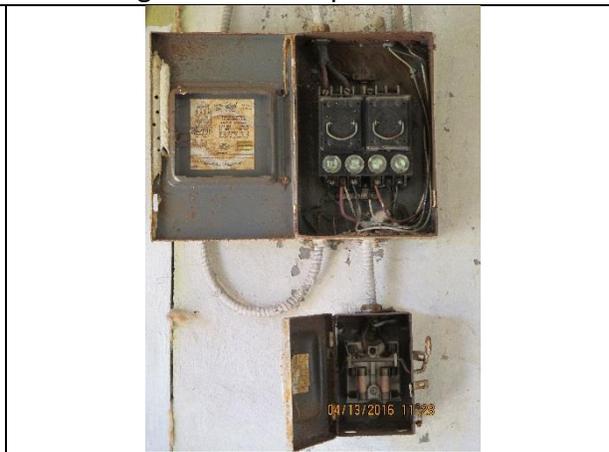
Photo 40: Derelict fuse box and wiring

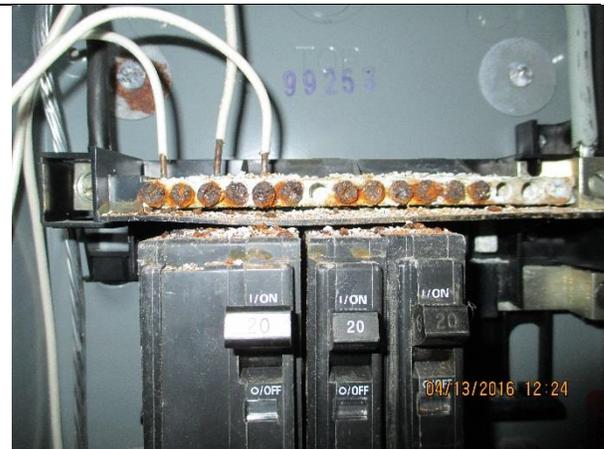
Photo 42: Oxidation/rust at terminations in panel inside the Dairy Barn

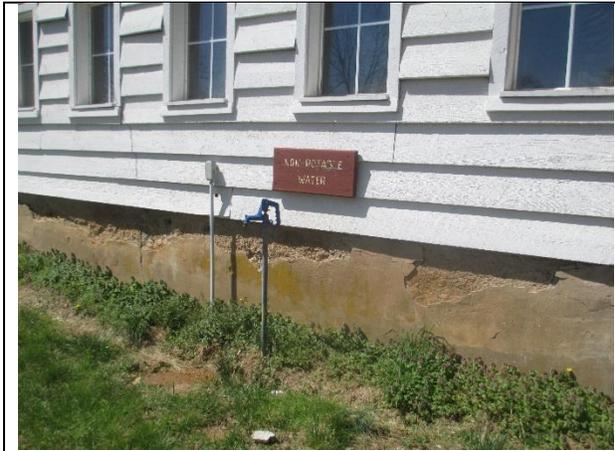
- Water Quality Test
 - Water samples were taken from the outdoor frost proof hydrant located at the east side of the Dairy Barn, which is clearly marked as “non-potable”. Independent laboratory testing indicates the presence of unacceptable levels of Total Coliform Bacteria and Lead. Complete test records are included as Appendix D.

Photo 45: Outdoor hydrant at Dairy Barn

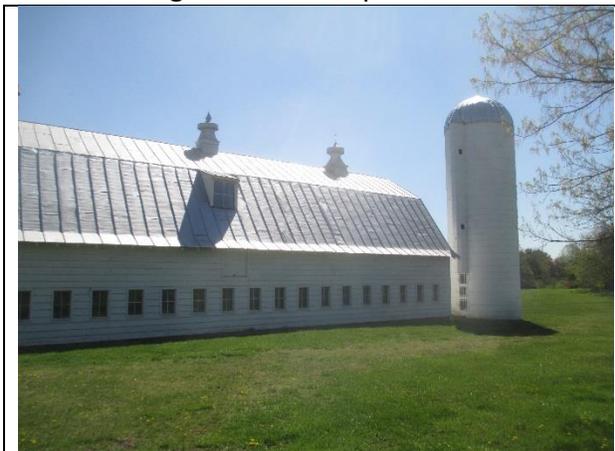
The Silo is an older structure and was secured with padlocks during visual observations. There were no PME systems observed. If grounding or lightning protection cables are required, they should be engineered for replacement.

Photo 46: The Silo stands at the southwest corner of the Dairy Barn

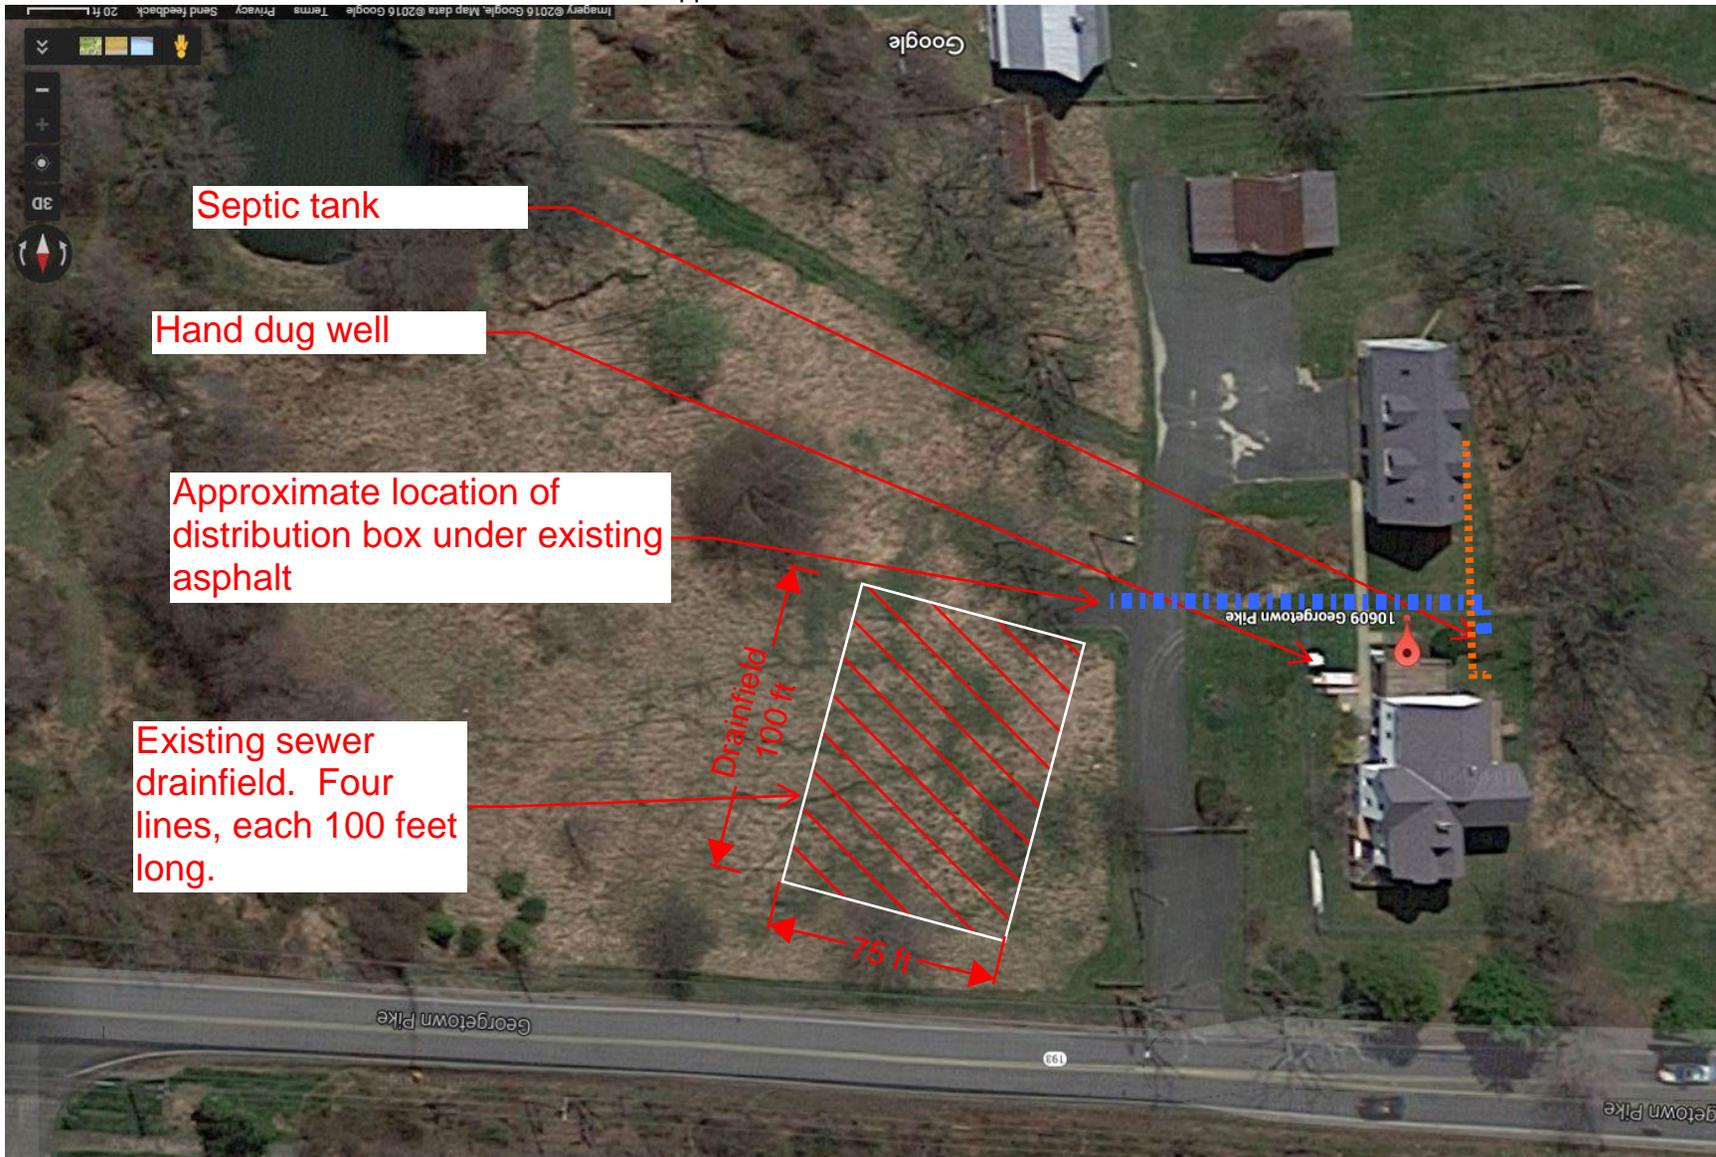
Turner Farmhouse
Approximate Drainfield Location

----- Sewer line from Garage to septic tank (shared) recommended for replacement

----- Septic line from tank to distribution box recommended for replacement

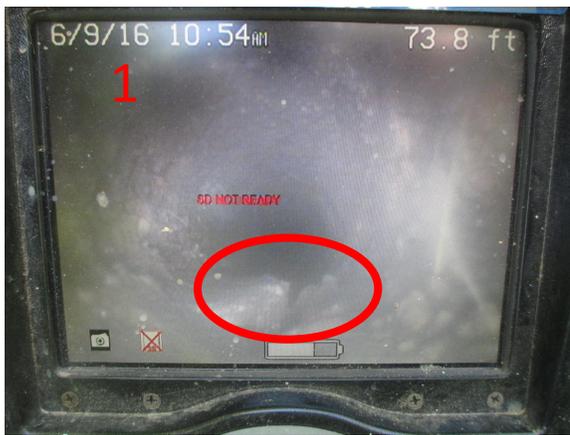
1. Septic pipe between tank and distribution box is broken at 74 feet, immediately west of sidewalk outside existing chain link fence.

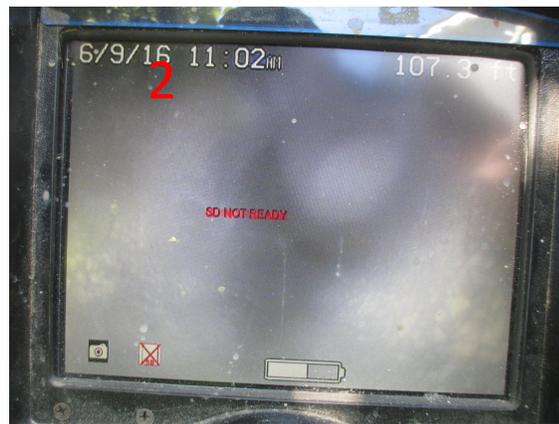
2. Camera was refused at 107 feet, still west of existing driveway. Location of distribution box is approximate.

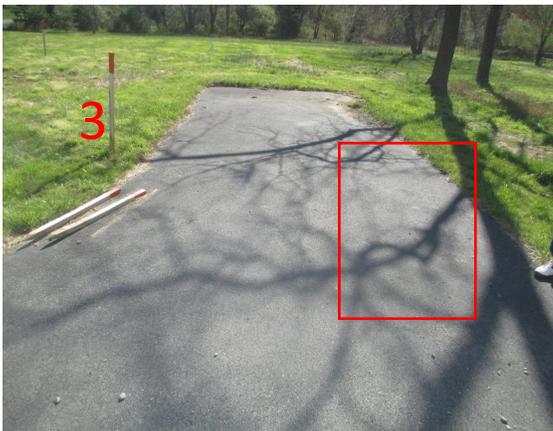
3. Existing parking space east of driveway should be removed. Septic distribution box is located in this area (shown approximate) and would be required to have a traffic rated structure if the parking area remains. Additionally, most local codes require separation between driveways and septic fields.

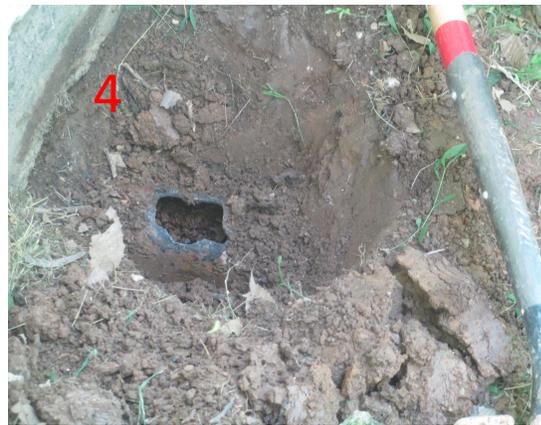
4. Garage sewer line is shown immediately outside west wall of garage. A small existing hole in the top of the pipe was enlarged to allow camera entry because the camera could not be pushed through the cast iron elbow inside the house. The camera could not be pushed more than 18" into the pipe at this location due to corrosion and debris. Recommend replacement of pipe to septic tank.
