ELLMORE FARMHOUSE Condition and Treatment Report

2739 West Ox Road, Herndon, VA

Final Report

March 28, 2018

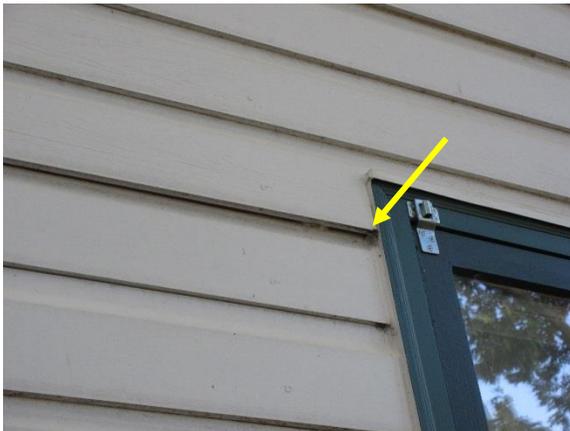
Figure 13. Displaced wood siding adjacent to window a northwest facade.

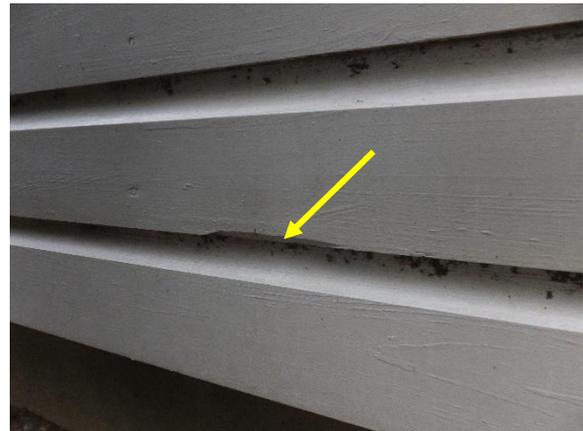
Figure 16. Chipped wood siding at base of siding at northeast facade.

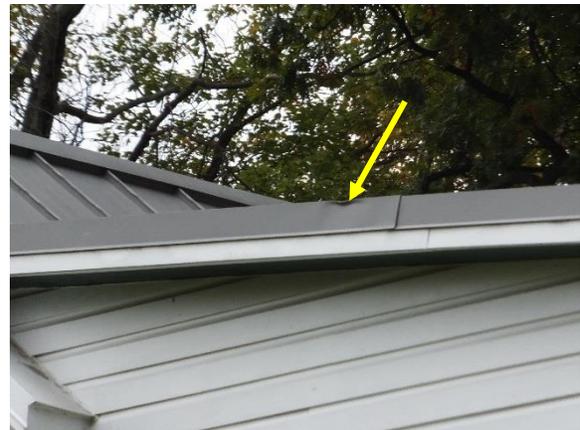
- The metal roofing throughout the home is in good condition with minor areas of soiling such as below gutters (Figure 31).
- A dent and area of displaced metal was observed at the metal coping on the southeast facade (Figure 32 and Figure 33).
- Most downspouts do not have splash pads or extension resulting in the discharged water being deposited close to the foundation (Figure 33 and Figure 34). One downspout was observed to be disconnected at the northwest elevation (Figure 35).

Figure 32. Dent in metal roof coping on southeast facade.

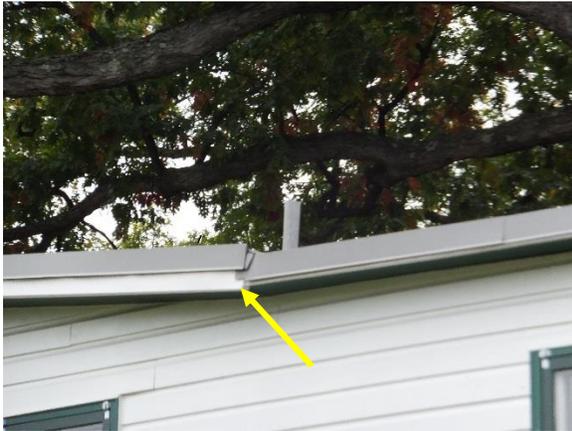
Figure 33. Displaced roof coping on southeast facade.

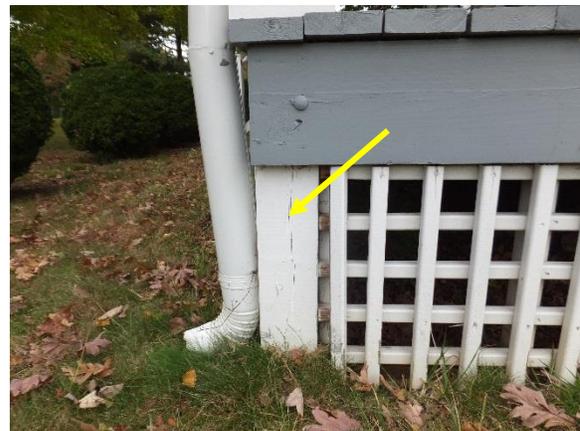
- The porch is generally in good condition with areas of minor deterioration at the door threshold, porch column and porch stairs due to the exposure to the elements. A vertical crack was observed along the base of the southeast porch column (Figure 36). The door threshold was observed to be uncoated (Figure 37) and paint deterioration at the porch stairs resulting in soft wood was exhibited (Figure 38). The decking joists have been replaced in recent years and are in good condition with minor areas of staining (Figure 39).
- The original stone foundation underneath the porch was observed to have deteriorated mortar joints (Figure 40).

Figure 36. Vertical separation (checking) at wood porch column.

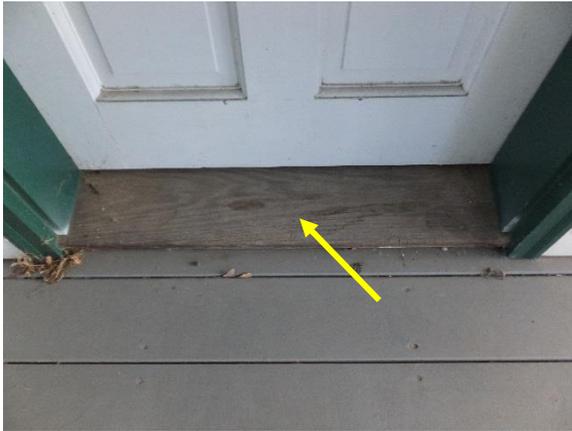
Figure 37. Uncoated wood door threshold at porch with minor areas of splintering.

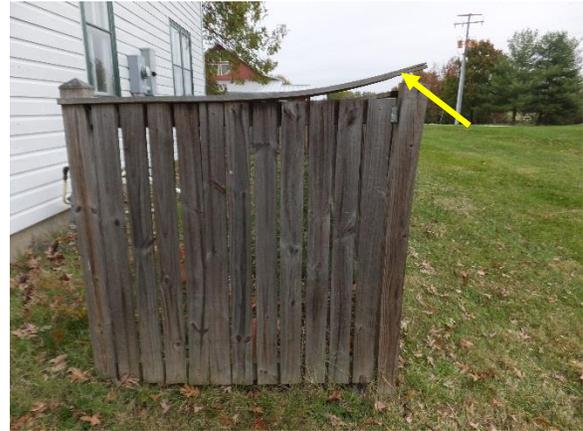
- The wood fence added on the southeast facade is fair condition with areas of multiple cracks, missing areas of wood, and missing rail caps (Figure 41). In addition, as the wood is uncoated, the fence exhibits staining, displacement, and bowing (Figure 42).

Figure 42. Bowed top rail of fence at southeast facade.

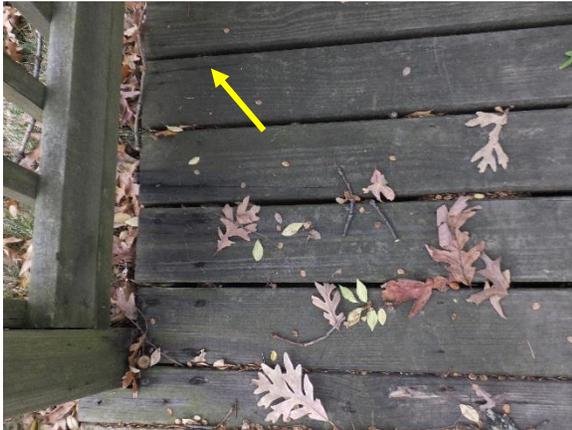
- The wood deck constructed on the northeast facade is generally in good condition with areas of minor deterioration including isolated cracks and wood deterioration due to exposure to the elements (Figure 43).

Figure 43. Multiple areas of splintered wood on wood deck at northeast facade.

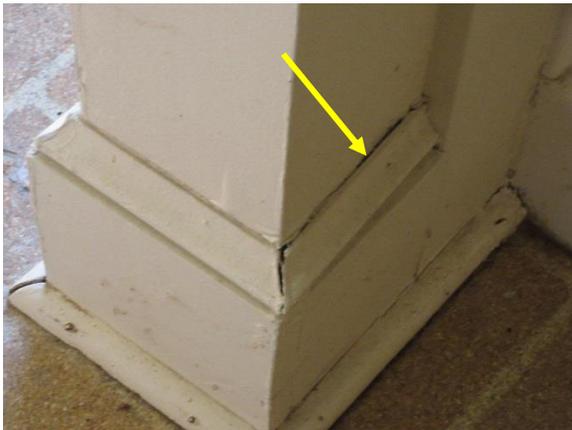
- Gaps and separation at seams were observed between crown molding, baseboards, and ceiling interfaces throughout the home. (Figure 61). Areas of flaked and chipped were observed throughout the home (Figure 62).

Figure 61. Gap and separation at crown molding, typical.

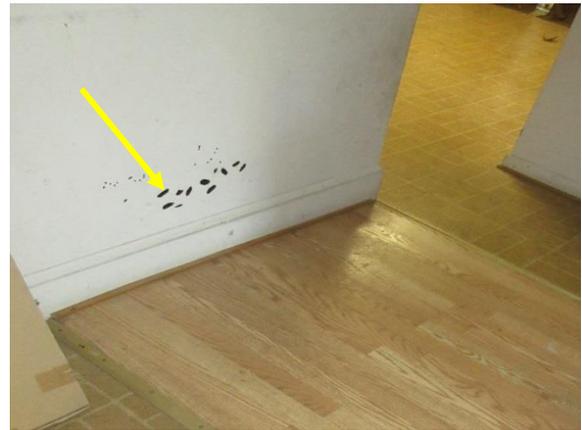
Figure 62. Flaked paint, typical.

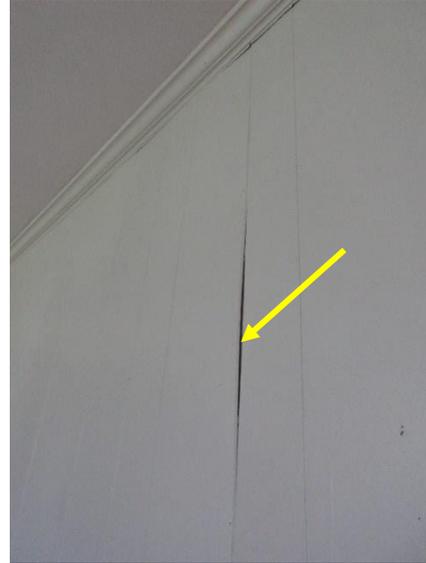
- In room 209 and 210 (offices), observations of the wood paneled siding included separation in joinery, splitting/cracking, tooling damage, and several gaps at crown molding interfaces (Figure 63, Figure 64, Figure 65, and Figure 66). In one isolated area, the siding appeared to bow inward in room 210 (office) (Figure 67).

Figure 66. Displaced wood siding panel, typical.

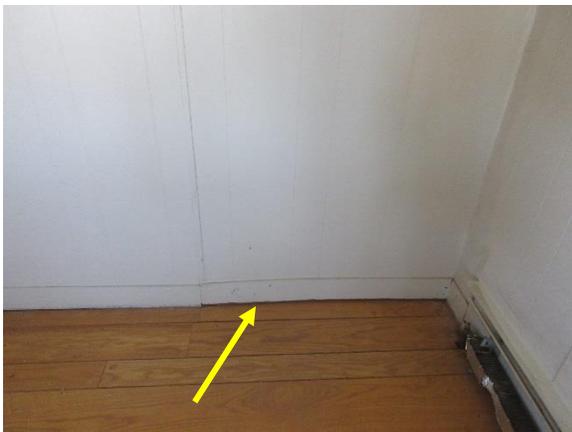
Figure 67. Bowed portion of wood siding panel in Room 210 (office).

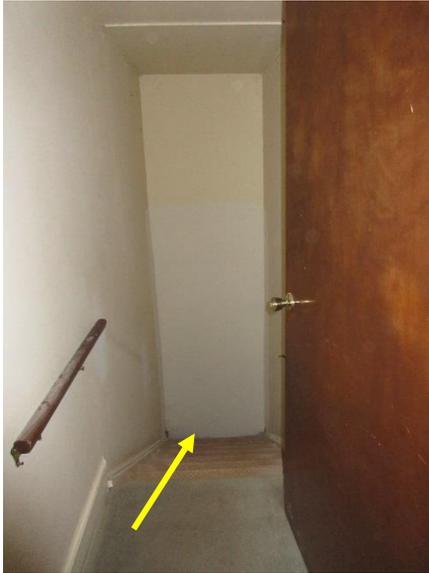
- The historic stairwell and handrail has been enclosed with drywall at the second floor (Figure 68). In addition, drywall installation, as well as exterior siding, has been installed to terminate exterior access for the stairwell located between room 203 (bedroom) and 210 (office) (Figure 69).

Figure 69. Terminated exterior access of stairwell at D205.

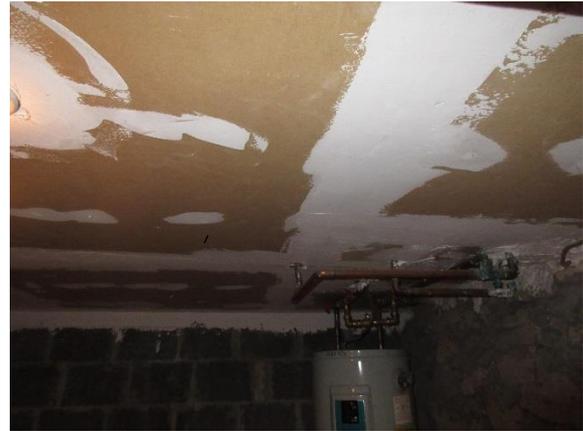
- In the cellar, several pipe penetrations through the drywall were observed. In addition, poor installation of drywall compound was observed between particle board panels and interfaces with foundation walls (Figure 70). Microbial growth is also apparent in isolated areas at the base of the drywall and ceiling (Figure 71 and Figure 72).

Figure 70. Drywall compound installation at gypsum ceiling panels in cellar.

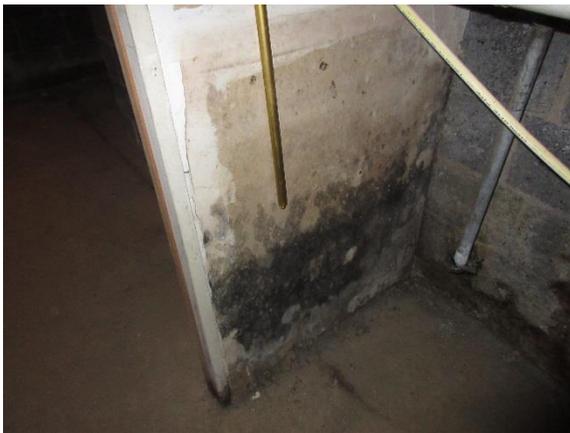
Figure 71. Potential microbial growth at drywall in cellar.

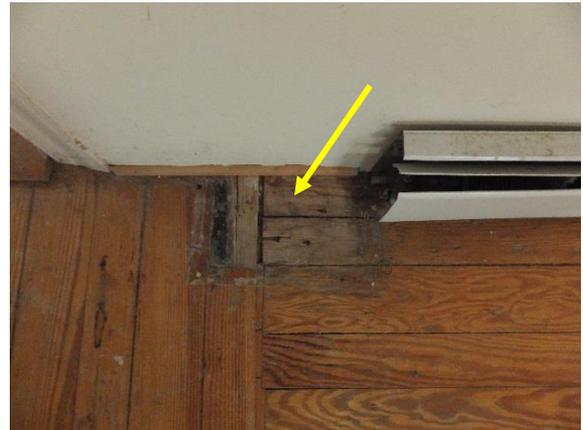
Figure 84. Exposed wood from pre-existing hallway structural elements. Note intersecting floors.

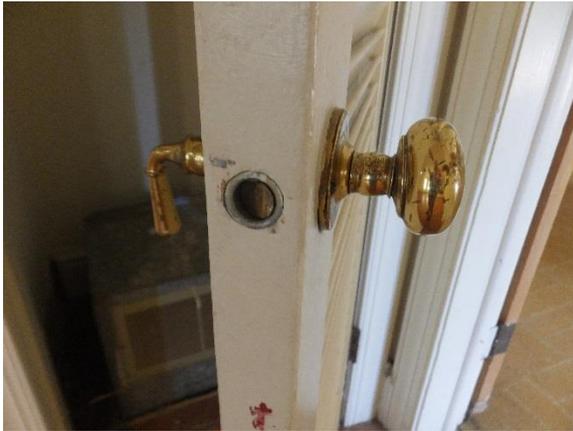
Figure 93. Inoperable doorknob at D101.
