## HANNAH P. CLARK HOUSE Condition and Treatment Report

10605 Furnace Road, Lorton, VA

### **Final Report**

WJE No. 2017.2430

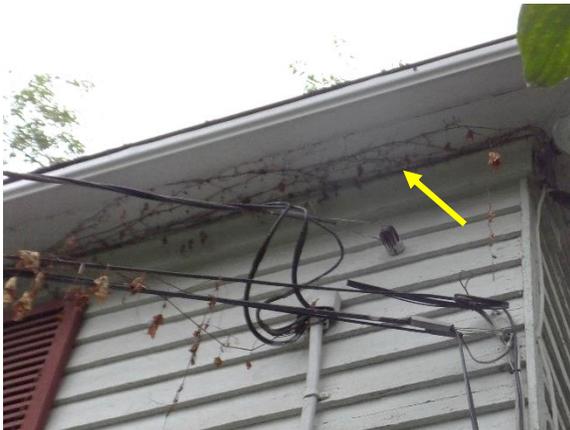
- Vegetation was observed in close proximity to the home with evidence of dried vegetation on the house that may have travelled along the power lines connecting to the home (Figure 10).
- Insect activity was observed at the exterior of the house including abandoned insect nests and a trail of ants on the foundation.

*Figure 10. Vegetation underneath eave and along the power lines at the west facade.*

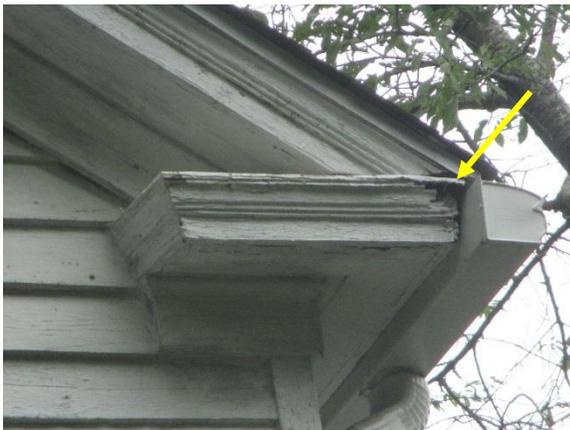
- Deteriorated wood was observed at locations throughout the exterior siding, generally on trim elements at corners and below gutters (Figure 11, Figure 12, and Figure 13). Some of these areas may correspond to damage due to water runoff or overflow. Soft wood areas were particularly found in accessible areas below the southeast corner gutter and adjacent to the wood sided chimney on the east facade (Figure 14 and Figure 15). One section of siding at the chimney was soft enough to allow an awl to pass through the material.

*Figure 12. Deteriorated wood at cornice element on northwest corner behind gutter.*

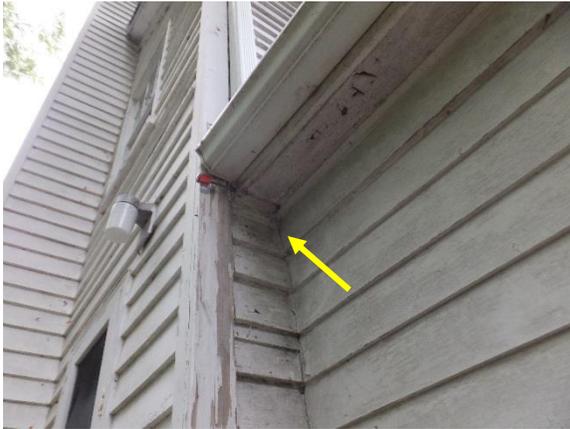
*Figure 14. Deteriorated wood soffit and siding beneath gutter at south east corner.*

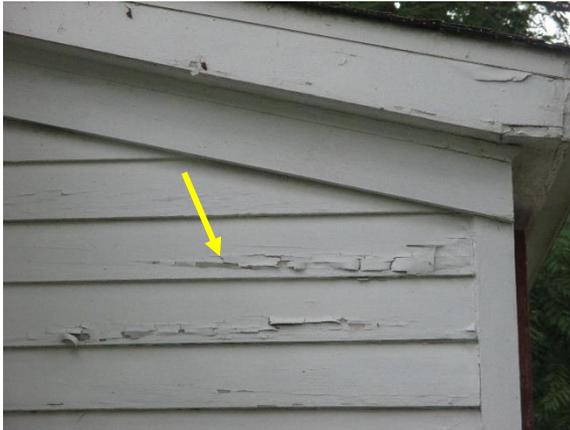
- Paint deterioration such as peeling, cracking, and discoloration was observed throughout the exterior of the home with some areas coincidental with wood deterioration as the wood material became exposed with the compromised coating (Figure 16 and Figure 17).

*Figure 16. Typical paint deterioration on wood siding.*

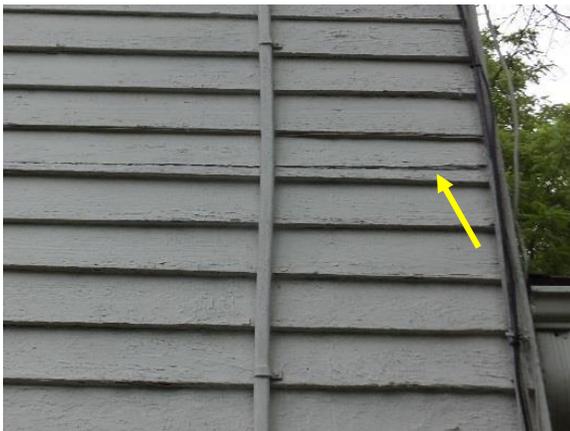
- Isolated cracks and missing areas of wood were observed in wood siding, generally originating from the end of the board or at fasteners (Figure 21, Figure 22, and Figure 23). Separation of some cornice wood members were visible, typically occurring at corners (Figure 24). In addition, one utility line anchor protrudes through the cornice on the east facade through a rough opening that could allow water to enter into the boxed cornice (Figure 25).

*Figure 22. Split in wood originating from southwest corner.*

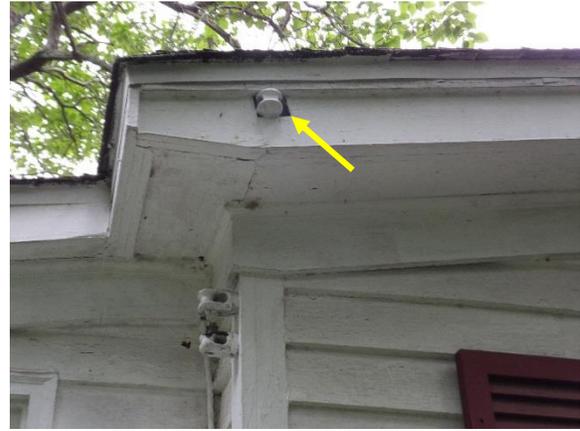
*Figure 25. Rough opening through the cornice for the utility line anchor.*

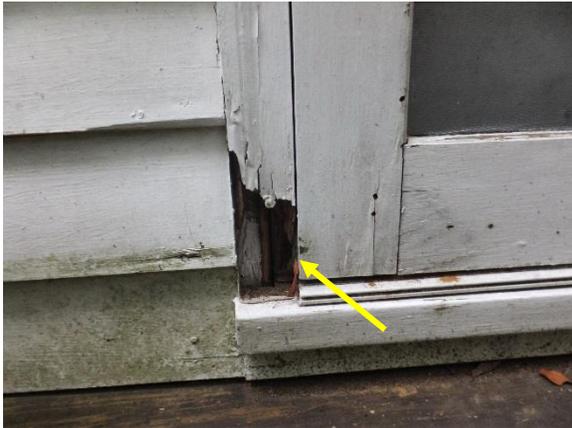
- The doors of the home are in fair to good condition with the paint generally faded, cracked, and peeling on the doors and adjacent trim (Figure 29). Minor separation between joinery was observed at two locations on the exterior doors (Figure 30). The east doors surrounding the chimney have considerable wood deterioration with partially missing wood members at the screen doors (Figure 31 and Figure 32).

*Figure 32. Missing section of wood at the base of an east screen door.*

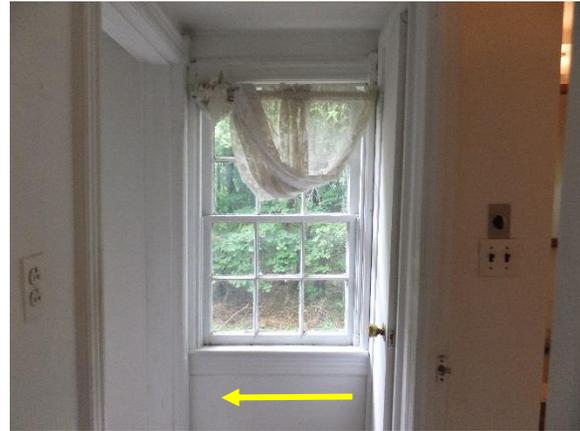
- Two windows located at the north facade and one at the south façade of the second floor, Period I section are racked towards the centerline of the original portion of the house. The north facade windows are slightly displaced towards each other in a similar orientation to floor and ceiling slope observed at the interior. The south facade window slopes towards the center of the house also following floor slope orientation. The window sashes and muntins appear to be absorbing the racking currently with sashes sitting fully in the glazing pocket with no cracked glazing lites (Figure 36 through Figure 38).

*Figure 37. Window 204 sloped to the west.*

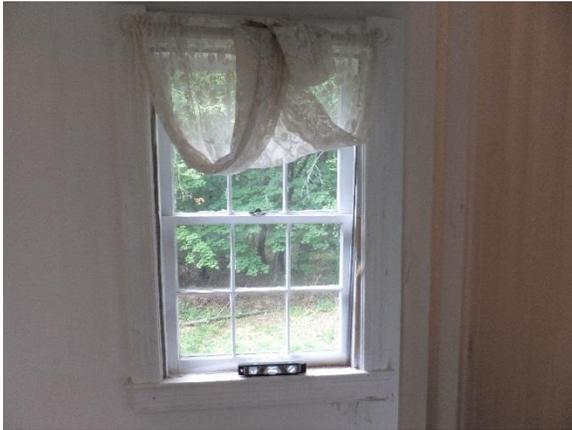
*Figure 38. Window 205 sloped to the east.*

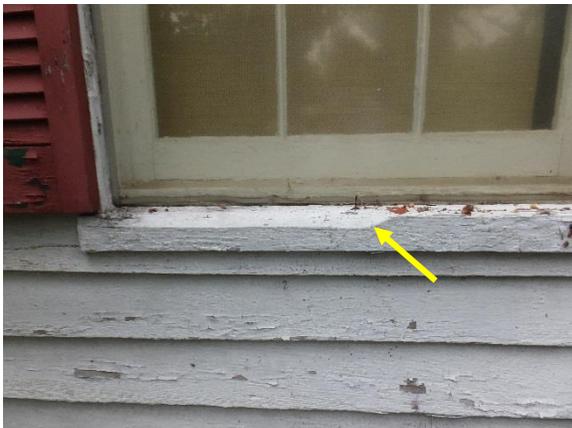
- Isolated conditions observed were cracked glass lites, muntin deterioration typically at the upper sash meeting rail (Figure 45), an area of missing wood from a window sill, an area of missing interior molding, one window with a cracked muntin, and one damaged muntin that reveals the edge of a glass lite (Figure 46 and Figure 47).

*Figure 46. Area of missing wood at a first floor window sill on west facade.*

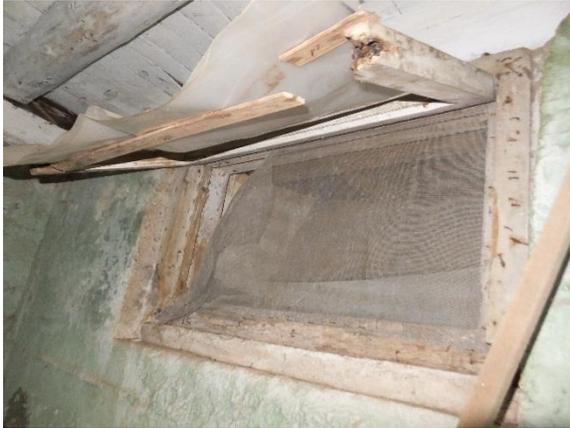
- There are ventilation windows in the cellar, one window, that is not visible from the exterior contains a deteriorated wood awning cover with polyethylene plastic at the interior (Figure 48).

*Figure 48. Window in basement that is not visible from exterior and may be infilled. Deteriorated wood can be seen around the frame.*

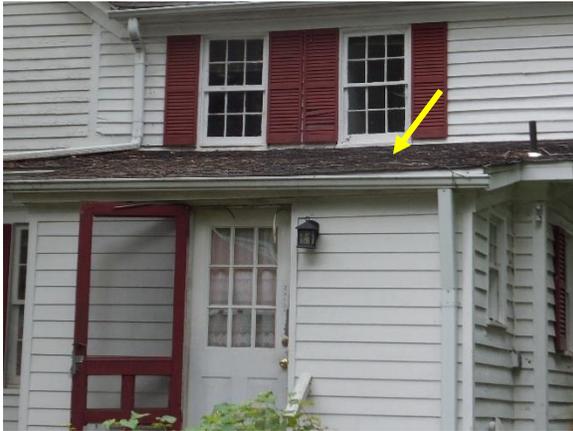
- The asphalt shingles are in fair condition with gutters and downspouts in good condition. Metal flashing appears to have been integrated with the last re-roofing work at the secondary roofs.
- Debris was observed along all gutters, which could be due to build up in the gutters or they could be undersized to accommodate the water flow (Figure 49). Most downspouts do not have splash pads that is resulting in the discharged water being deposited close to the foundation (Figure 50).
- Vegetation was observed growing on the roof and underneath the eaves as well as dark soiling at some areas of shingles (Figure 51 and Figure 52). There were also several shingles missing at the edge of the south gable (Figure 53).

*Figure 52. Soiling of asphalt shingles at the secondary roof on the south.*

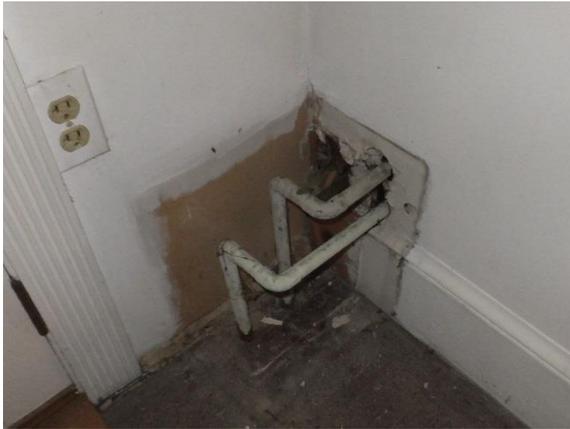
*Figure 71. Pipe penetration through floor and wall in room 101.*

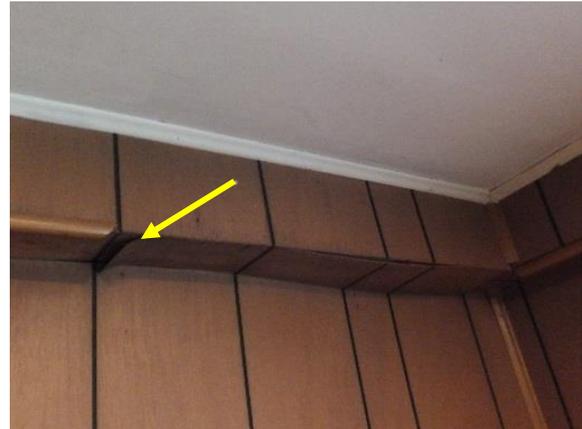
*Figure 72. Delamination of wood panel at the soffit in room 103.*

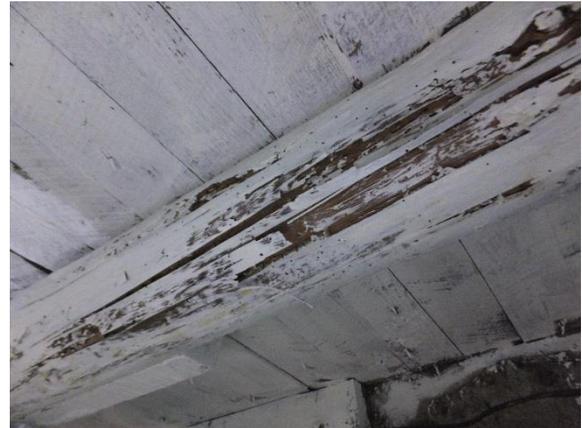
*Figure 74. Soft and splintered 3/4 round beams in cellar.*

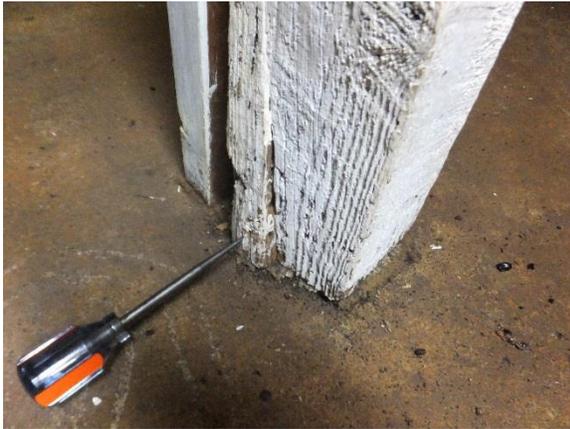
*Figure 75. Soft and split wood at base of solid sawn column in cellar. Retrofit manufactured wood piece has been installed adjacent to the original column.*

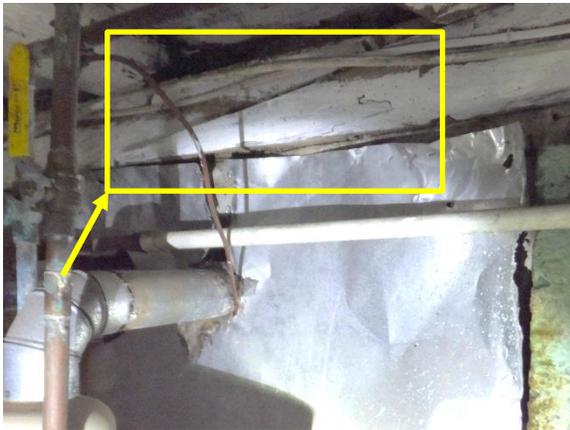
*Figure 77. Full-depth split through timber sill in cellar.*

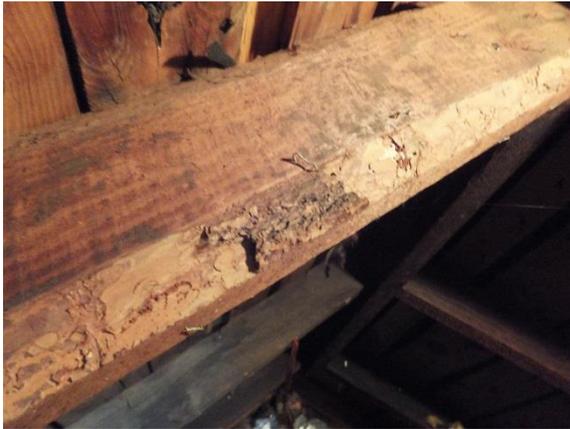
*Figure 79. Damaged edge of rafter potentially from pest activity.*

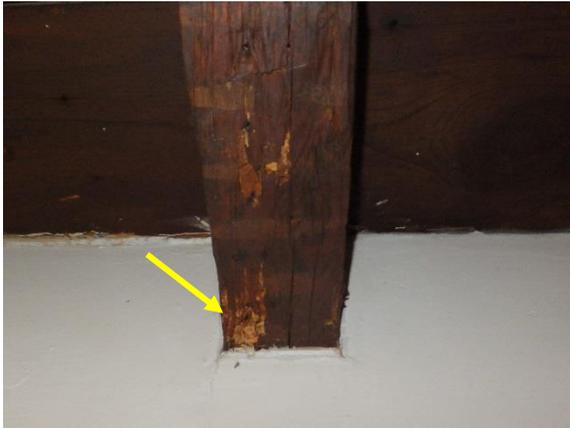
*Figure 81. Deteriorated wood in room 101, potentially due to pest damage.*

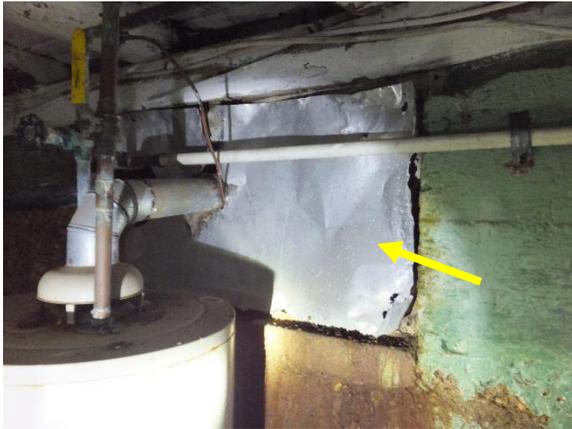
*Figure 91. Unsealed ventilation window opening in cellar below-grade wall.*

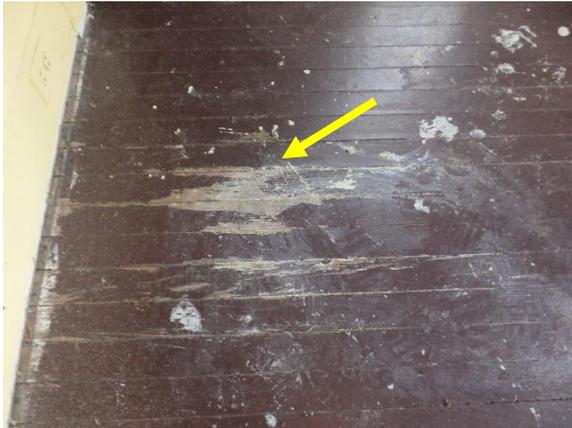
*Figure 93. Paint scraped from wood floor.*

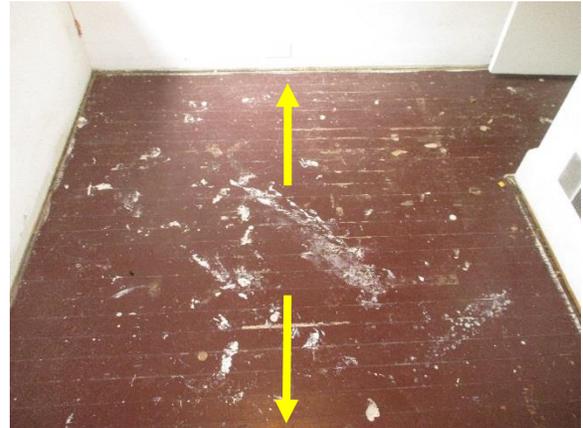
*Figure 94. Sloped floor in room 202.*

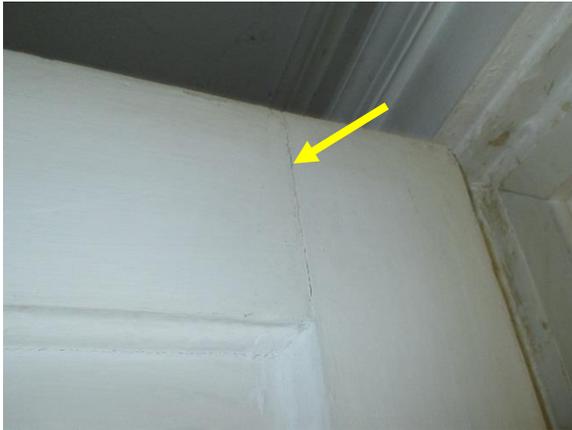
*Figure 95. Typical separation of joinery at historic interior doors.*

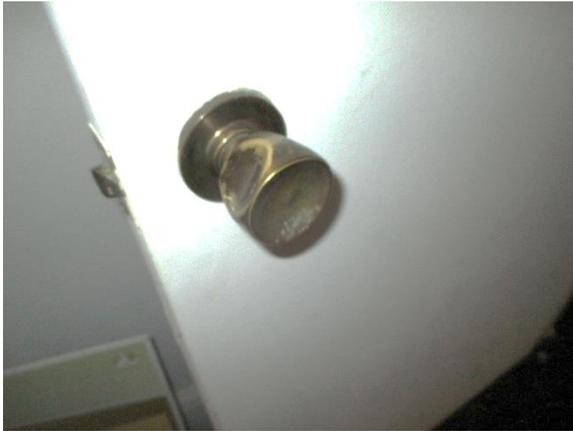
*Figure 99. Crushed door knob at door D115.*
